Void Development Under Bridge Approaches

Study SD90-03

Final Report - Executive Summary

Prepared by
Department of Civil Engineering
South Dakota State University
Brookings, South Dakota 57007-0495

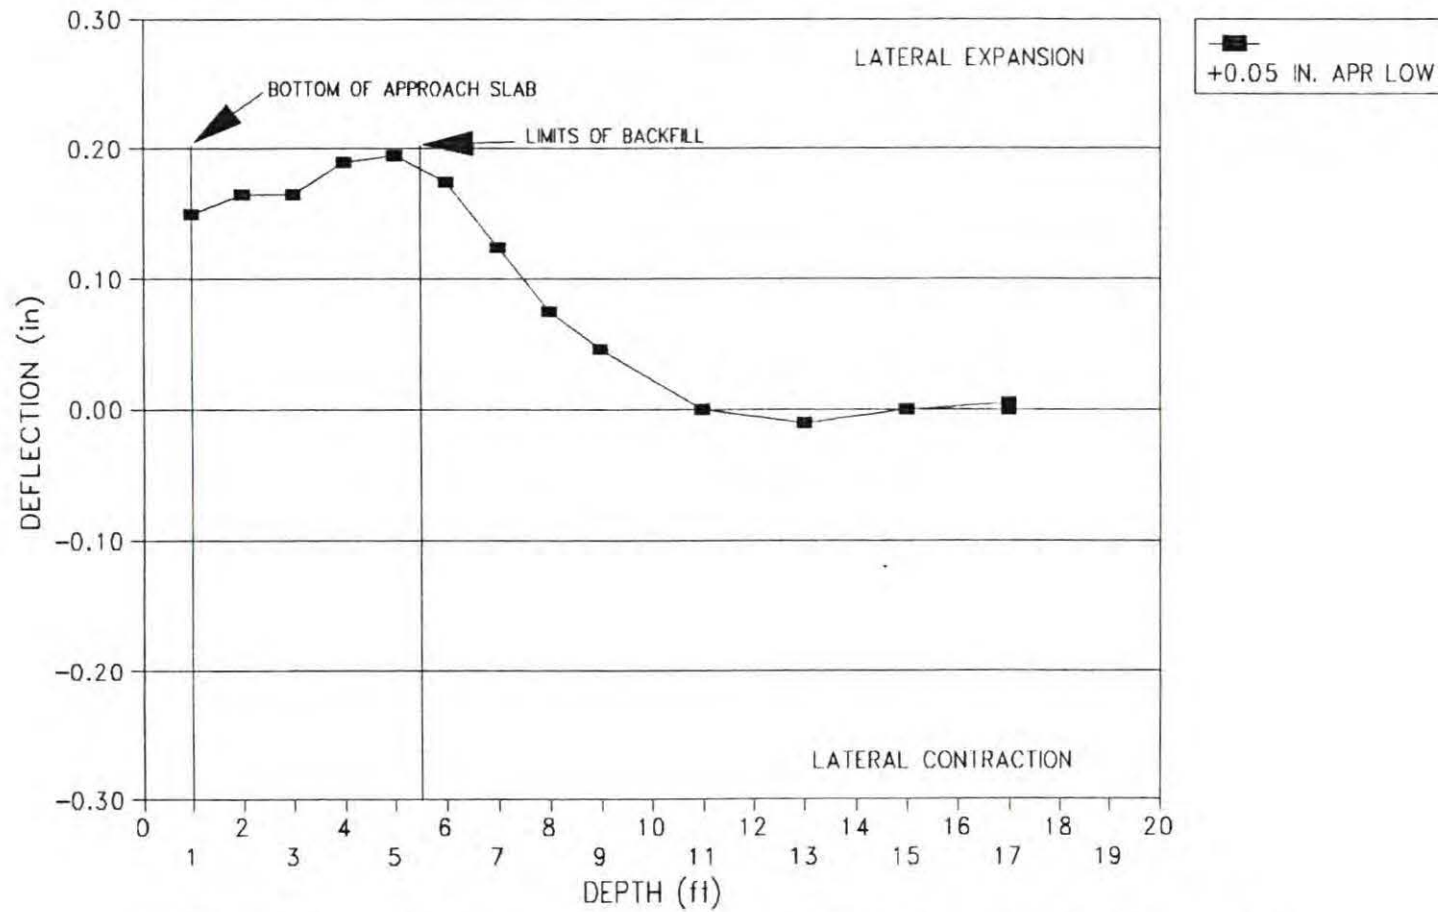
Figures 5-27 and 5-28 show the final results for lateral deflection, with intermediate results presented in Appendix D. It can be seen that little movement occurred in the lateral direction. The north inclinometer recorded a final lateral expansion of only 0.08 inches while the south inclinometer recorded slightly more with a final lateral expansion of 0.19 inches. Although small, these movements show that the backfill is expanding the embankment outward with the cyclic movement. More lateral movement may have been recorded in the area closer to the abutment, but the inclinometer tubes had to be positioned some distance from the piles. The approach slab may have also influenced the movement of the inclinometer tubes in the lateral direction. Figure 5-28 shows the maximum movement at a depth of five feet, with movement decreasing at the approach slab interface. The slot made in the approach slab could accommodate up to one inch of movement, and aggregate may have wedged itself between the tube and the approach slab to prevent further movement. The same trend is visible in the north inclinometer tube to a lesser degree (Figure 5-27). Movement reaches a maximum at a depth of two feet but then decreases at the approach slab interface.

Figure 5-28. Lateral movement of the south inclinometer at the completion of the test.

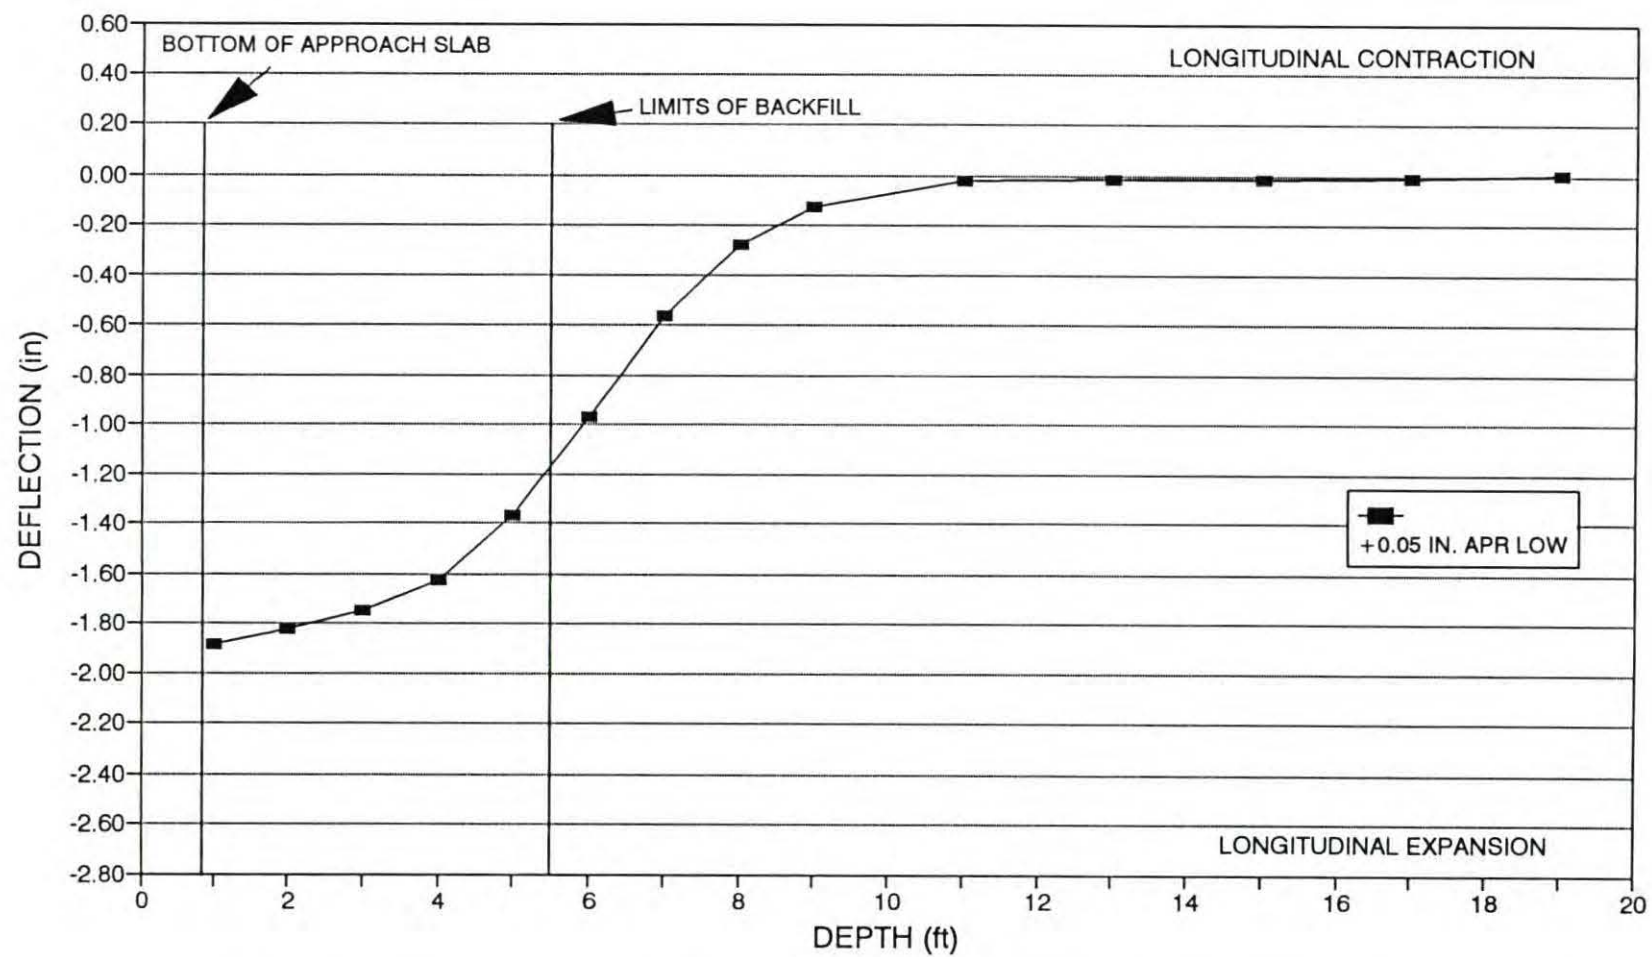
The inclinometers also recorded deflection longitudinally with the bridge and approach. Figures 5-29 and 5-30 show the longitudinal deflection of the inclinometers at the completion of the twelve-month cycle. The longitudinal deflections were significantly larger than the lateral movements. The north inclinometer had a final longitudinal deflection of 1.9 inches away from the abutment. The south inclinometer had a final longitudinal deflection of 2.0 inches away from the abutment. The results for each monthly cycle are presented in Appendix D. The maximum longitudinal deflections were recorded after the April high abutment expansion of 1.2 inches. The two inclinometers recorded approximately 2.6 inches of longitudinal deflection away from the abutment after

Figure 5-29. Longitudinal movement of the north inclinometer at the completion of the test.

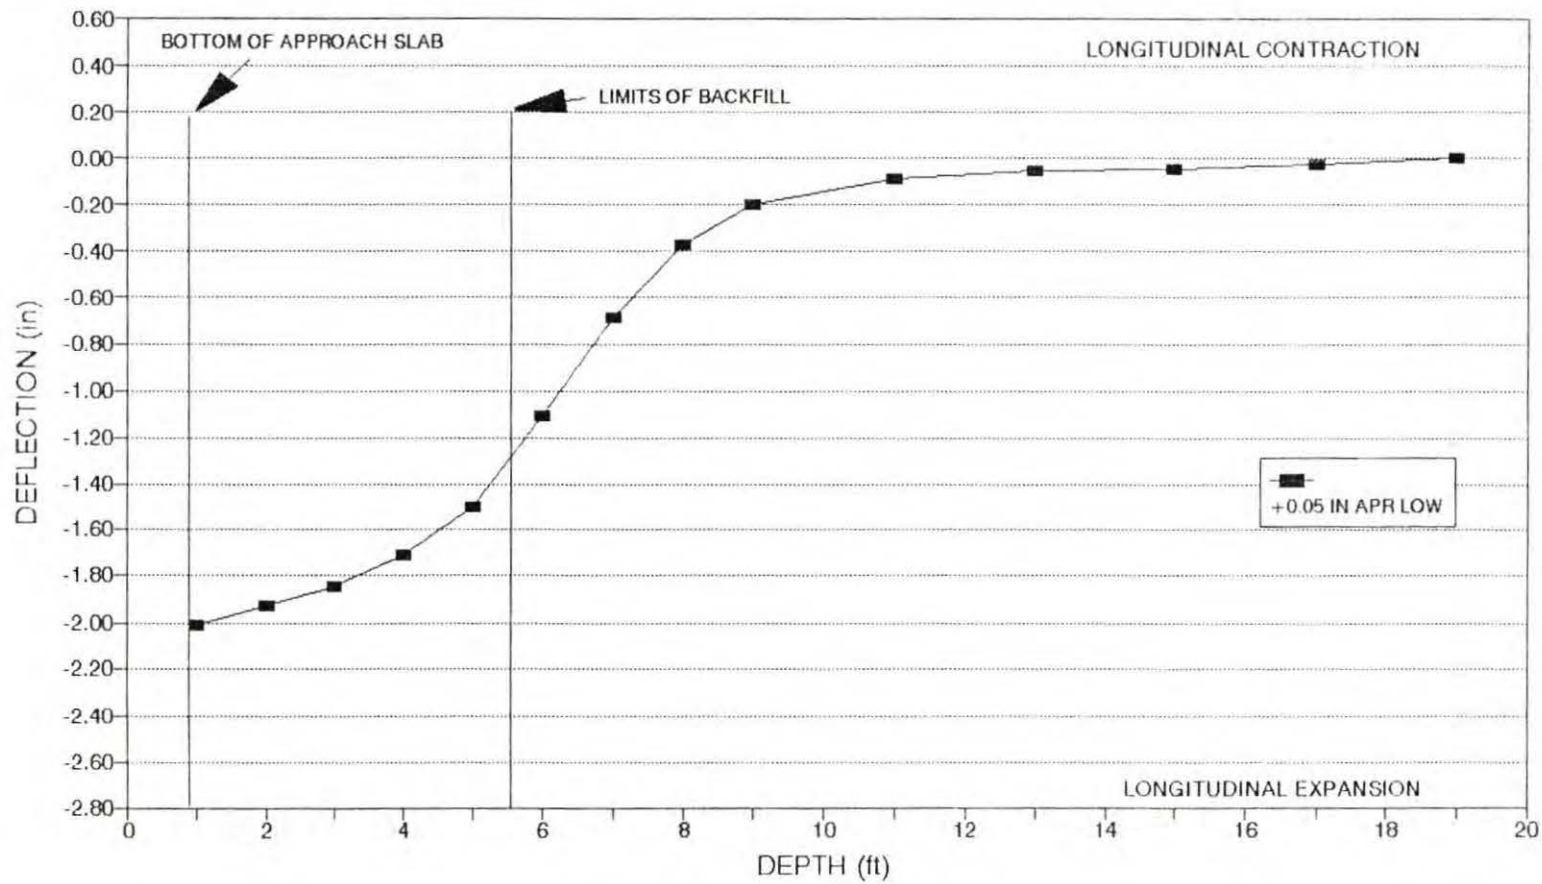
Figure 5-30. Longitudinal movement of the south inclinometer at the completion of the test.

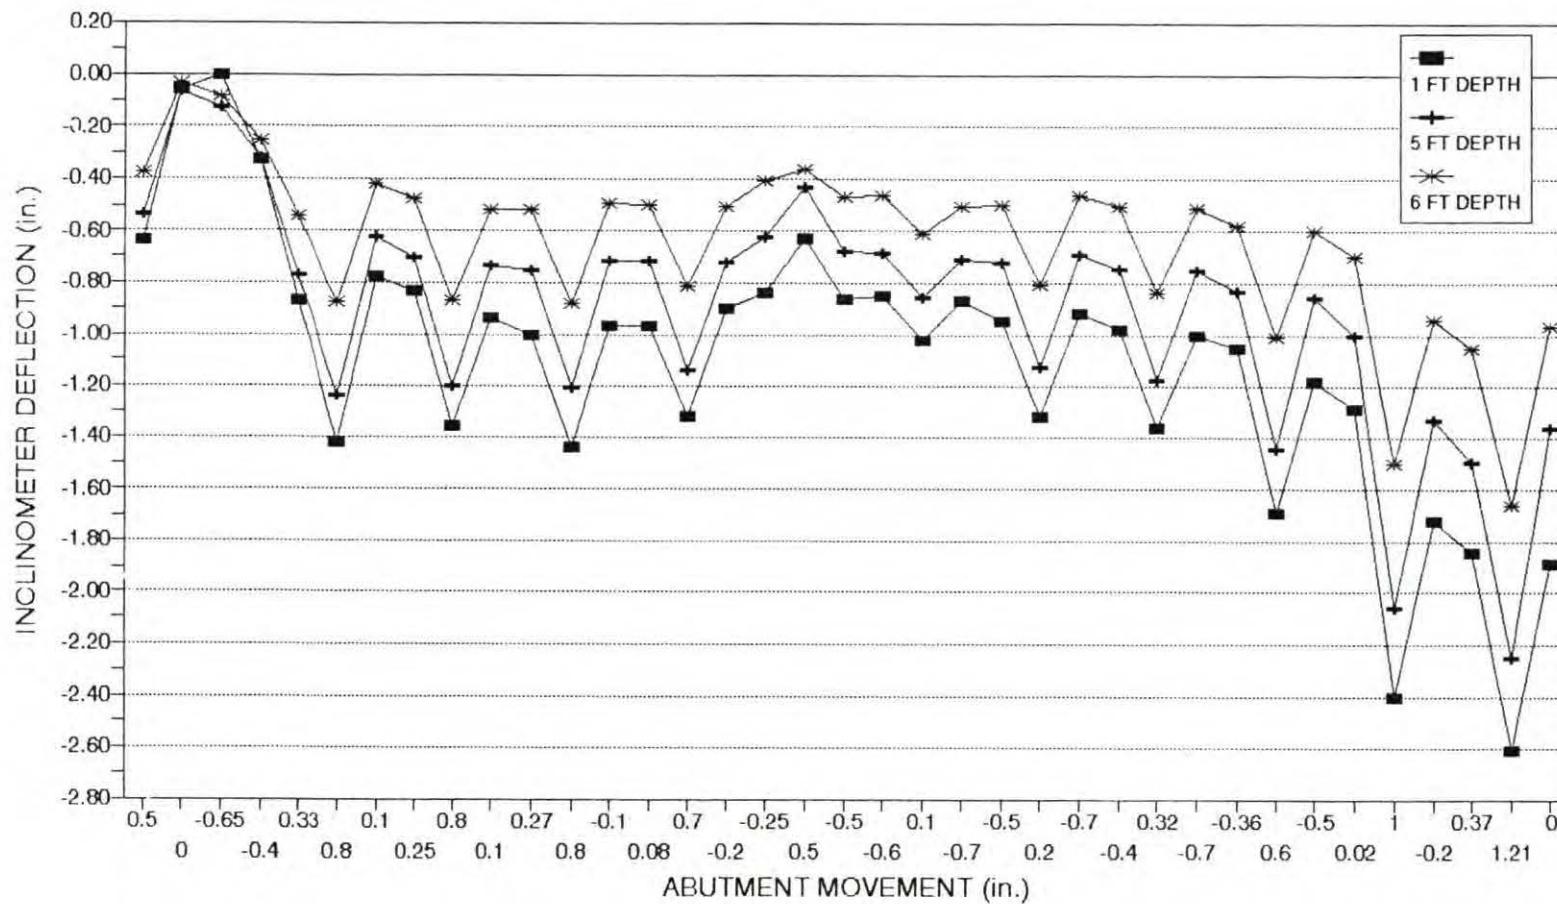
this cycle. The cyclic nature of the longitudinal movements can be seen in Figure 5-31 where the longitudinal movements of the north inclinometer are plotted versus sequential abutment movement. It can be seen that the longitudinal movements cycled as the abutment expanded and contracted. At a depth of one foot the cyclic movement was about 0.4 inches with permanent deformation of 0.4 to 0.5 inches. At depths of five and six feet the cyclic movement was about the same but the permanent deformations were somewhat larger. For most of the test the movements cycled in a narrow band. Abutment expansion would induce longitudinal expansion and abutment contraction would induce recovery of a portion of the expansion. A permanent set was quickly achieved at each level. Even large contractions would not induce much recovery of the permanent lateral set. Near the end of the test much larger abutment movements were induced to model large spring-time temperature changes. These larger abutment movements induced significant additional cyclic and permanent deformation in the backfill and embankment soils.

Figure 5-31. Longitudinal movement of the north inclinometer versus abutment movement.

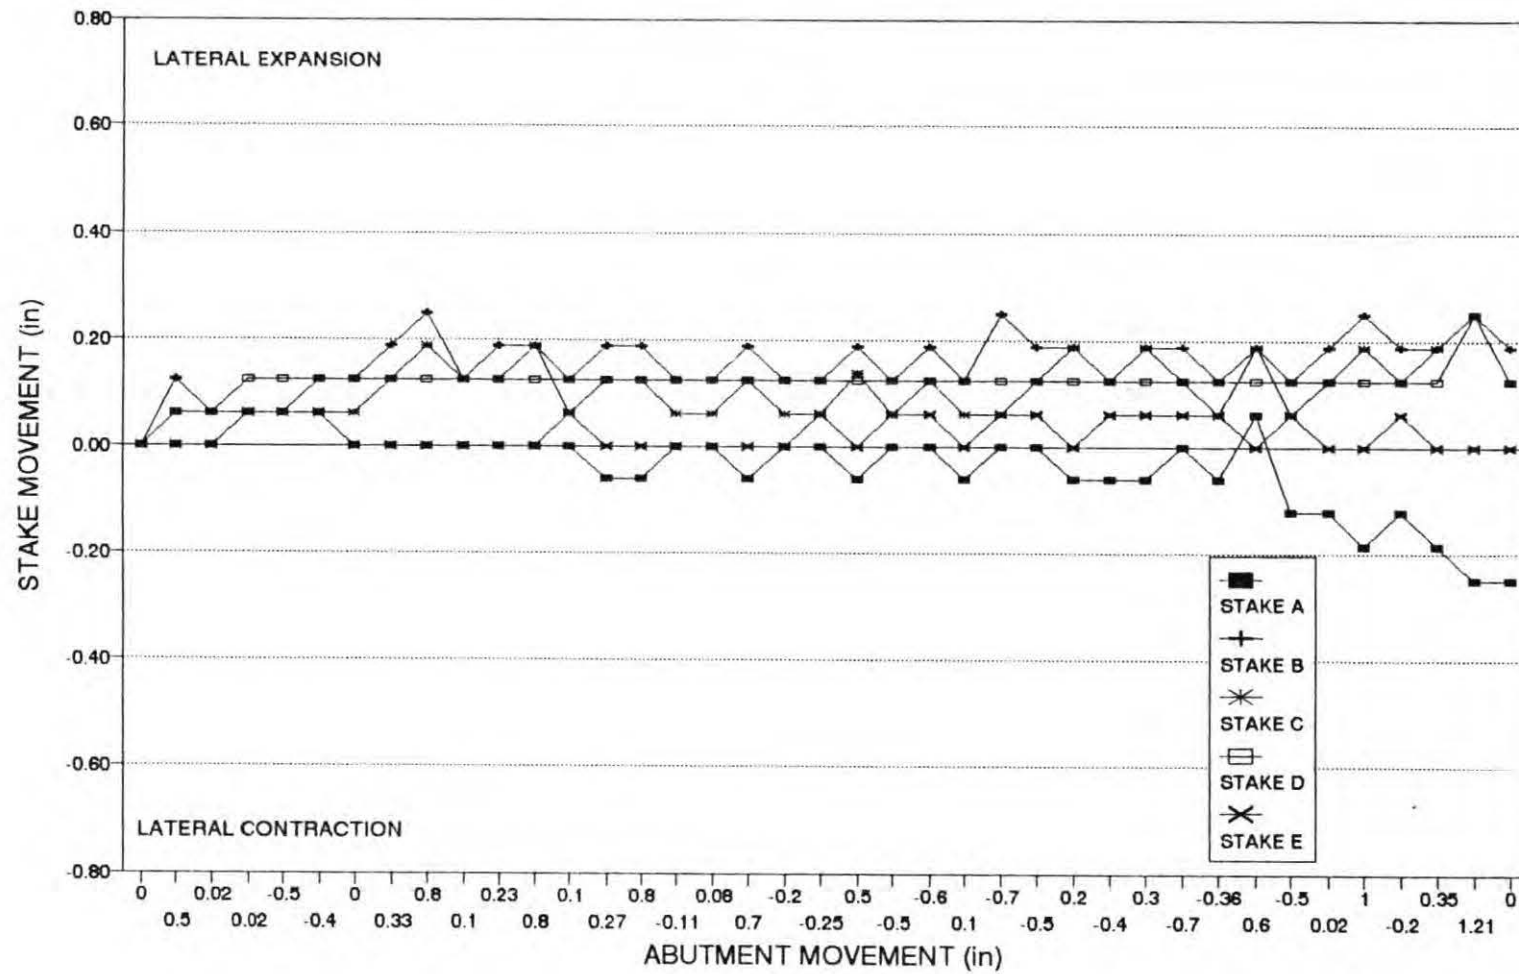
The lateral movements of the embankment stakes on the south and north side of the approach slab are shown in Figures 5-37 and 5-38, respectively. With the exception of the two stakes closest to the abutment (stakes A and F), only a small amount of lateral expansion occurred. Stakes A and F show markedly different behavior, with 0.25 inches of contraction for stake A and 0.6 inches of contraction for stake F. Such behavior is

Figure 5-37. Lateral movement of embankment stakes on south side of approach slab.

consistent with the observed behavior of the embankment near these stakes, where the embankment cracked and appeared to slough into the void created near the abutment. The longitudinal movement of stake F towards the abutment combined with large movement towards the approach slab reflects the conditions shown in Figure 5-13 where the large crack developed provides an opportunity for the stake to make such movements.

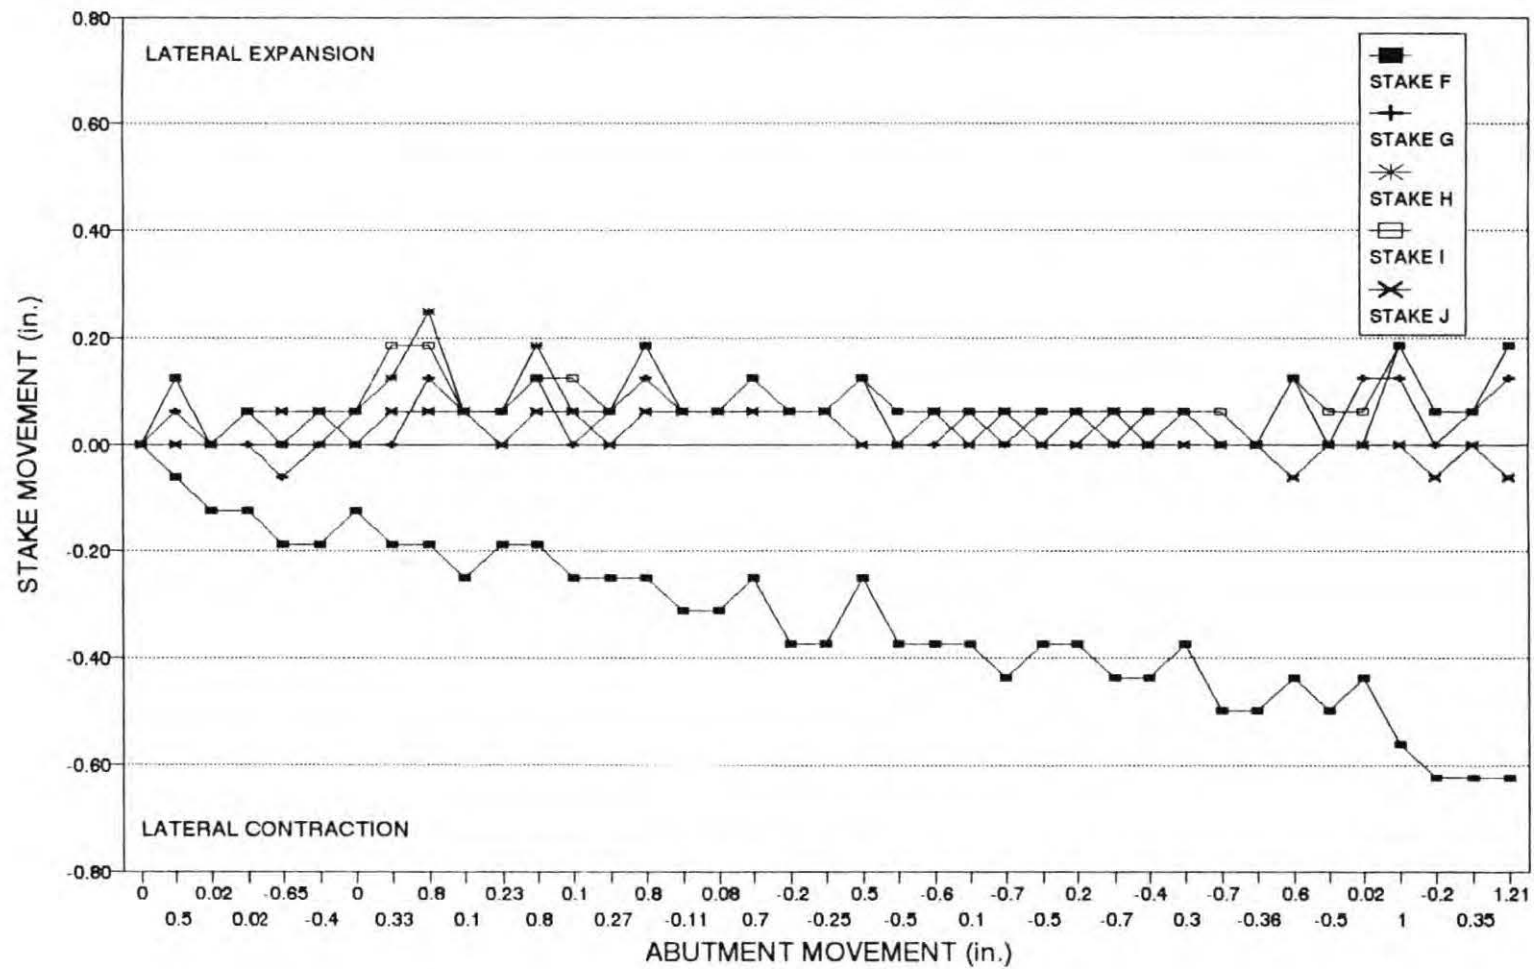
Figure 5-38. Lateral movement of embankment stakes on north side of approach slabs.
