Crash Testing of Standard South Dakota Road Closure Gates

Study SD94-10 Final Report

Prepared by:
Midwest Roadside Safety Facility (MwRSF)
Center for Infrastructure Research
Civil Engineering Department
University of Nebraska-Lincoln
1901 Y Street, Building C
Lincoln, Nebraska 68588-0601
(402)472-6864

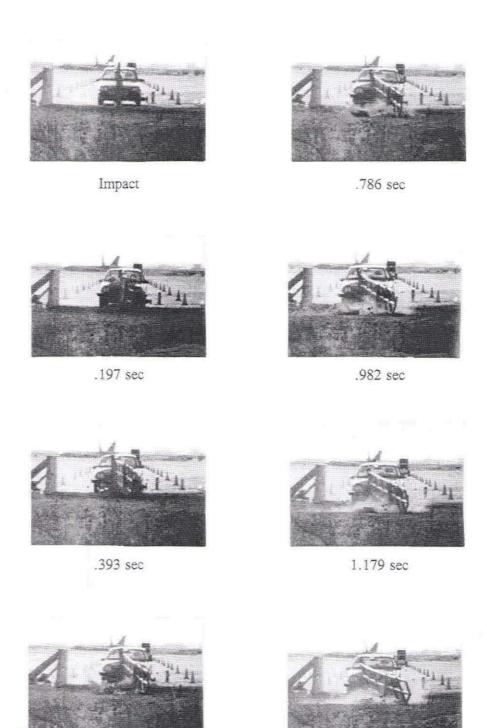
Figure 19. High-Speed Downstream Sequentials, SDG-1

The warning lights disengaged at 0.079 sec, and the hold back post fractured at 0.128 sec, causing small positive and negative yaw rotations to the vehicle and gate, respectively. The vehicle reference system is shown in Figure 22. At 0.523 sec, the rear axle of the vehicle smoothly passed over the fractured frangible couplers. At 0.707 sec, the downstream end of the gate contacted the ground and began to dig into the soil. The vehicle continued to push the entire installation forward until the gate post slipped off the front end of the vehicle at approximately 2.46 sec. The vehicle came to rest approximately 14.0-m (46-ft) downstream of the breakaway support at 3.71 sec after impact, as shown in Figure 19.

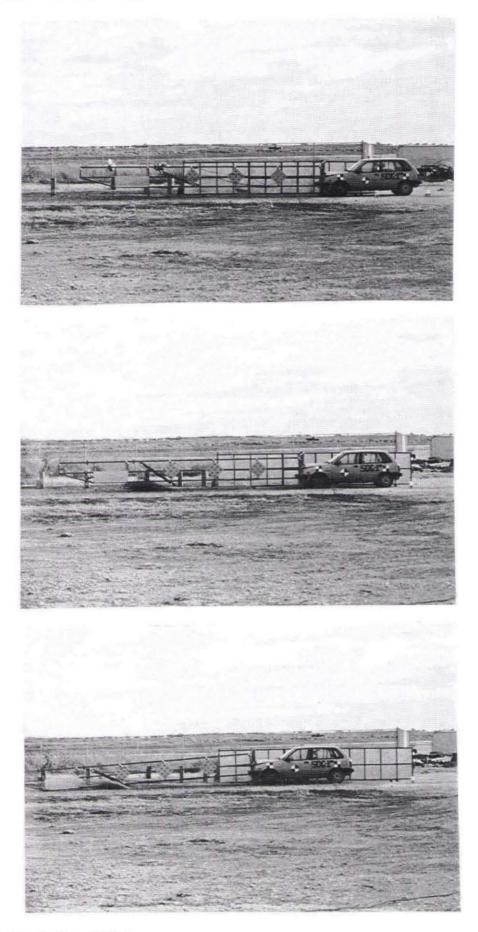
Figure 21. Full-Scale Test, SDG-1

High-speed film sequential photographs of the full-scale crash test are shown in Figures 19 and 20, and photographs of the full-scale test are shown in Figure 21. After the initial impact with the gate post, the front bumper crushed inward for approximately 0.024 sec before the gate post was disengaged from the breakaway support. Subsequently, the vehicle continued its forward movement while pushing the interlocked gate post in front of the vehicle. The gate post and gate were cleanly disengaged from the breakaway support without producing any significant vehicle angular rotations.

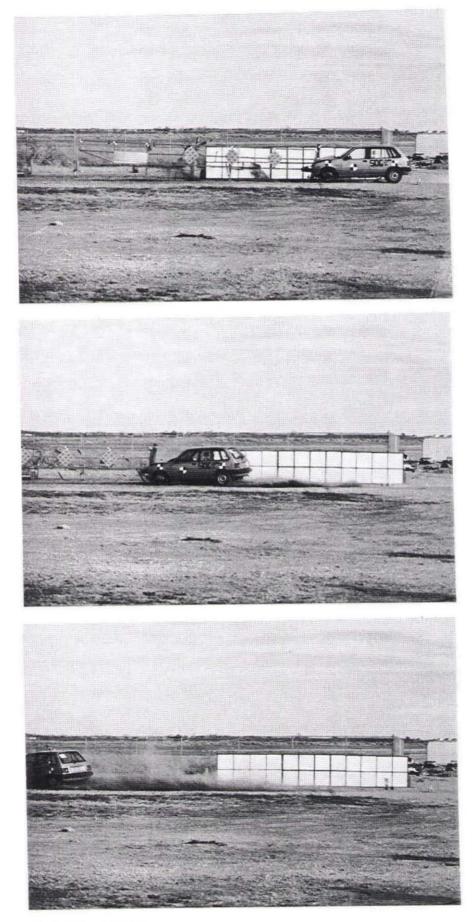
Figure 28. Full-Scale Test, SDG-2

High-speed film sequential photographs of the full-scale crash test are shown in Figures 26 and 27, and photographs of the full-scale test are shown in Figure 28. After the initial impact with the gate post, the front bumper crushed inward for approximately 0.010 sec before the gate post was disengaged from the breakaway support. As the front axle of the vehicle passed over the breakaway support at approximately 0.028 sec, the vehicle began to yaw in a positive direction (refer to Figure 22 for sign convention). The holdback post and the upstream stand fractured at 0.056 sec. Subsequently, the vehicle continued its forward movement while pushing the interlocked gate post in front of the vehicle causing
