*Midwest State's Regional Pooled Fund Program
Research Project Number SPR-3(017)*

CRASH TESTING OF SOUTH DAKOTA'S CABLE GUARDRAIL TO W-BEAM TRANSITION

MwRSF Research Report No. TRP-03-80-98

December 4, 1998

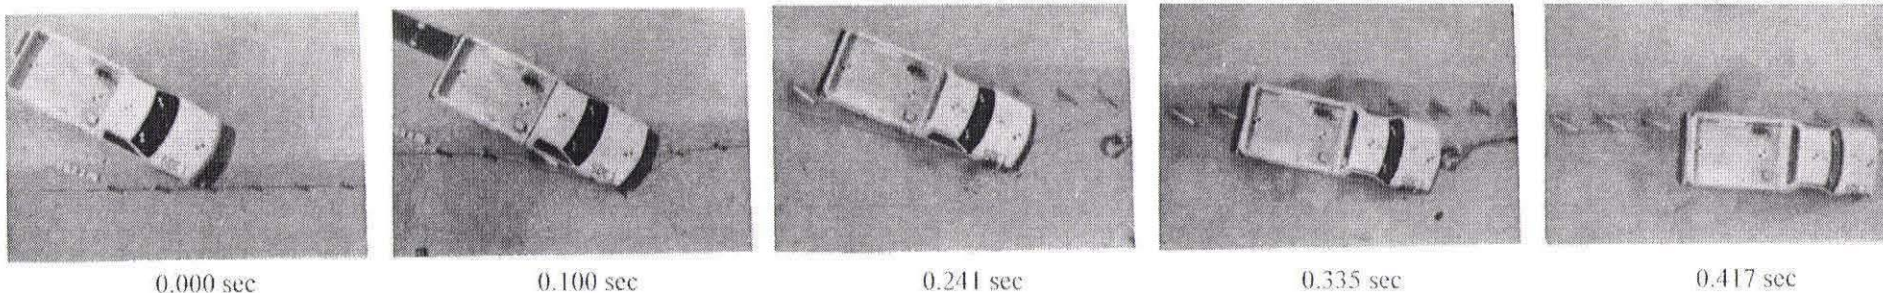
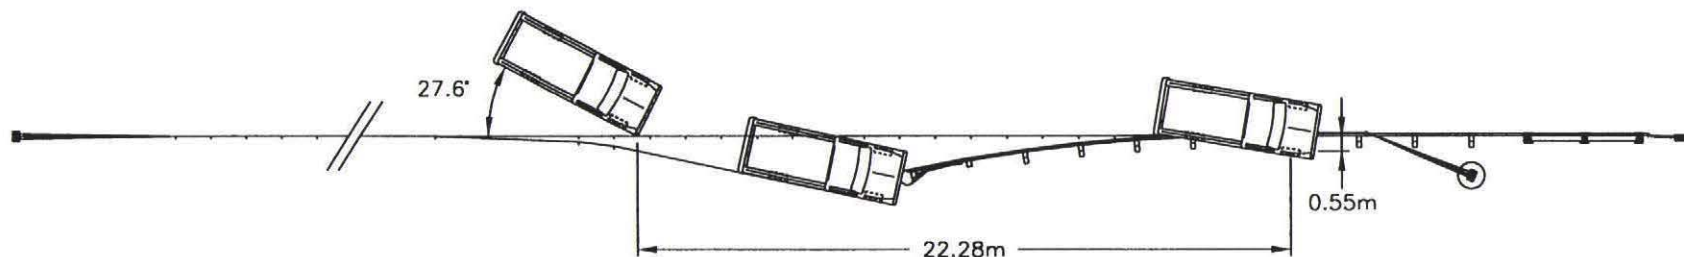
- Test Number SDC-1
- Date 8/11/98
- Appurtenance Cable Guardrail to W-Beam Transition
- Three-Strand Cable Guardrail
 - Diameter 19.0 mm
 - Specification 3 x 7 Wire Rope
 - Top Mounting Height 686 mm (center of upper cable)
- Steel Posts
 - Post Nos. 1C - 32C W76x8.5
- W-Beam Guardrail
 - Thickness 2.66 mm
 - Top Mounting Height 686 mm
- Wood Posts
 - Spacing 1,905 mm
 - Post Nos. 1W - 2W 140 mm x 190 mm x 1,080 mm
 - Post Nos. 3W - 11W 152 mm x 203 mm x 1,829 mm
- Wood Spacer Blocks
 - Post Nos. 3W - 11W 152 mm x 203 mm x 356 mm
- Soil Type Grading B - AASHTO M 147-65 (1990)
- Vehicle Model 1993 GMC 2500 (¾-ton) 2WD
 - Curb 2,173 kg
 - Test Inertial 2,013 kg
 - Gross Static 2,013 kg

- Vehicle Speed
 - Impact 101.9 km/hr
 - Exit NA
- Vehicle Angle
 - Impact 27.6 deg
 - Exit NA
- Vehicle Snagging Minor tire and undercarriage snagging on posts
- Vehicle Pocketing Minor
- Vehicle Stability Moderate roll angle but stable
- Occupant Ridedown Deceleration (10 msec avg.)
 - Longitudinal 12.21 G's < 20 G's
 - Lateral (not required) 7.36 G's
- Occupant Impact Velocity (Normalized)
 - Longitudinal 4.62 m/s < 12 m/s
 - Lateral (not required) 2.99 m/s
- Vehicle Damage Moderate
 - TAD¹³ 1-RFQ-3, 12-FC-3
 - SAE¹⁴ 01RFEW2, 12FCLN1
- Vehicle Stopping Distance 22.3 m downstream
 - 0.55 m behind traffic-side face
- Barrier Damage Extensive
- Maximum Dynamic Deflection 2.4 m
