VOLUME: 1

DATE: JANUARY 14, 2025

# INCIDENT REPORTS

EVENTS REPORTED TO THE CSB UNDER THE ACCIDENTAL RELEASE REPORTING RULE

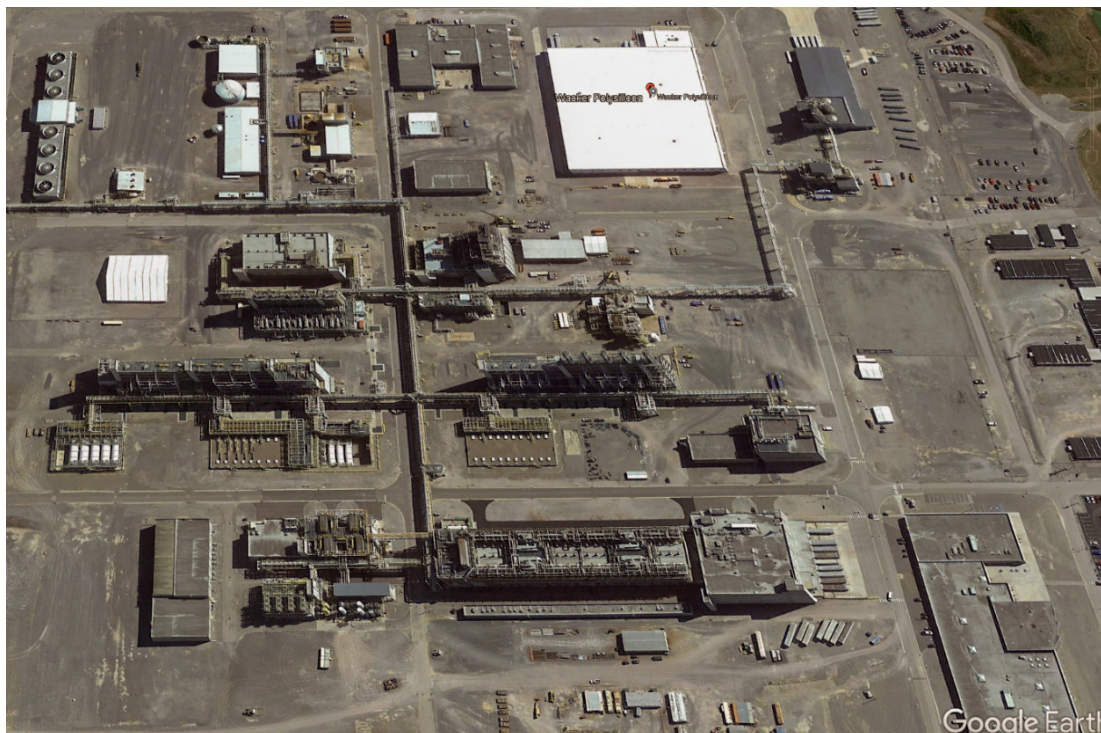
On July 24, 2020, at 1:20 p.m., an accidental release of approximately 100 milliliters of silicon tetrachloride seriously injured two contract workers at the Wacker Polysilicon North America (“Wacker”) facility in Charleston, Tennessee (**Figure 1**).

**Figure 1.** Wacker facility in Charleston, Tennessee. (Credit: Google Earth)

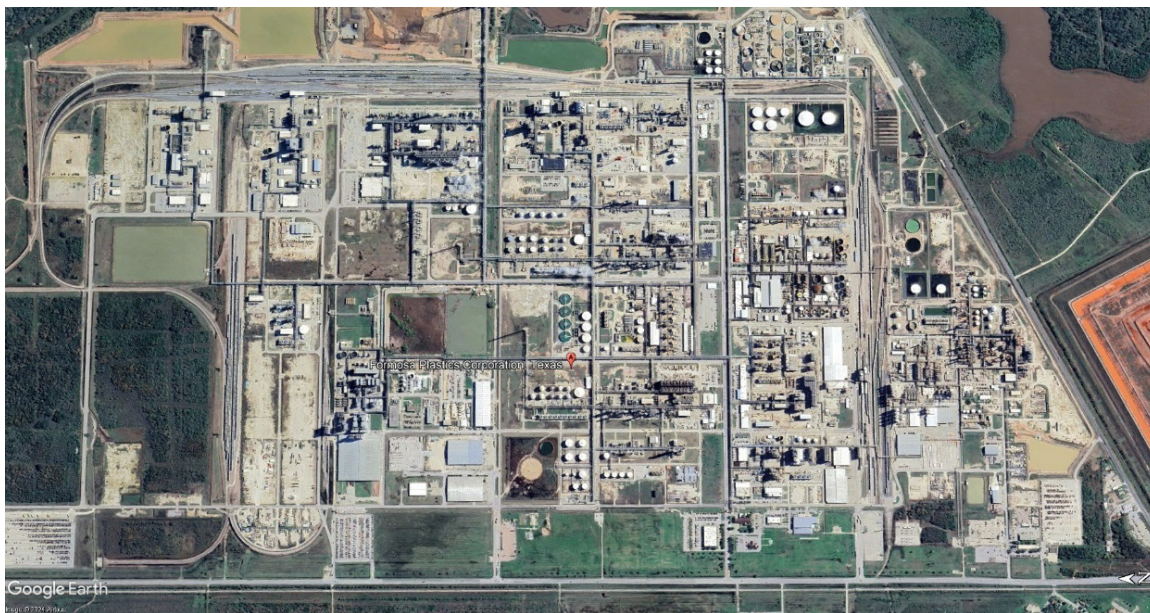
On December 3, 2020, at approximately 2:30 p.m., an accidental release of toxic chlorine gas occurred at a Formosa Plastics Corporation, Texas (“Formosa”) facility in Point Comfort, Texas, and seriously injured one employee (**Figure 1**).

**Figure 1.** Formosa Plastics Corporation - Point Comfort Facility (Credit: Google Earth).

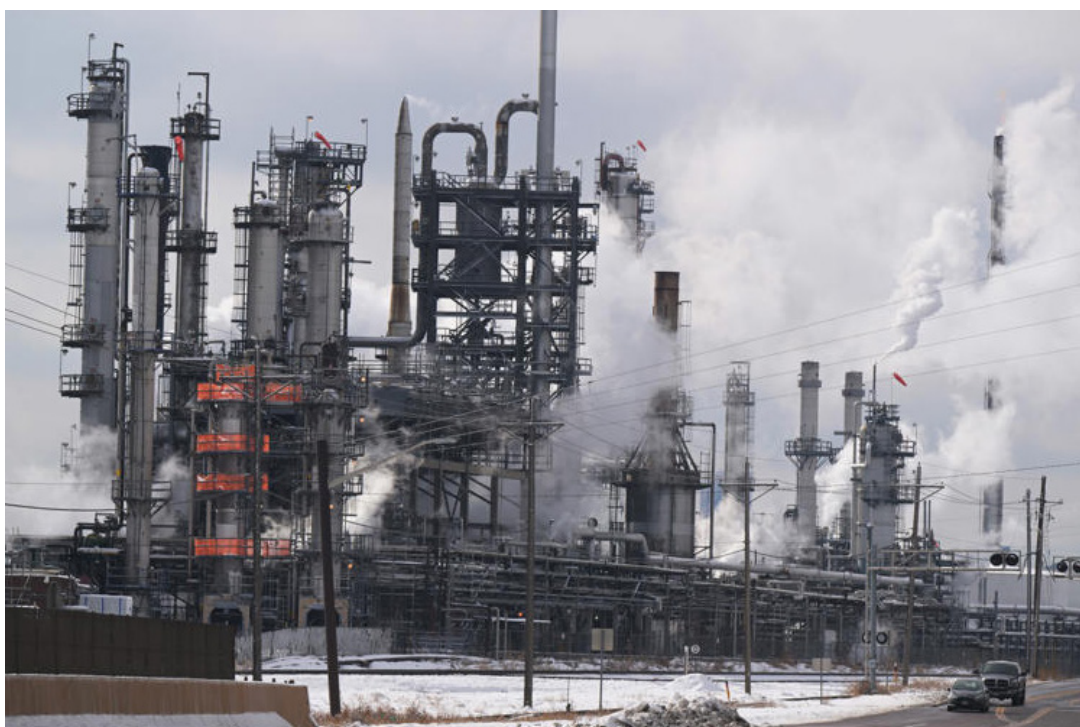
On December 24, 2022, at approximately 10:55 a.m., an accidental release of approximately 1,400 pounds of light straight-run gasoline (flammable hydrocarbon) occurred within a hydrotreating unit at the Suncor Energy (U.S.A.) Inc. (“Suncor”) refinery in Commerce City, Colorado (**Figure 1**). The release formed a vapor cloud that ignited, resulting in an explosion and fire. One Suncor operator was seriously injured due to thermal burns. Suncor estimated \$40 million in property damage. In addition, this event contributed to a Refinery shutdown for inspection and repairs until the end of March 2023.

**Figure 1.** Commerce City refinery on Tuesday, January 3, 2023. (Credit: The Denver Post)

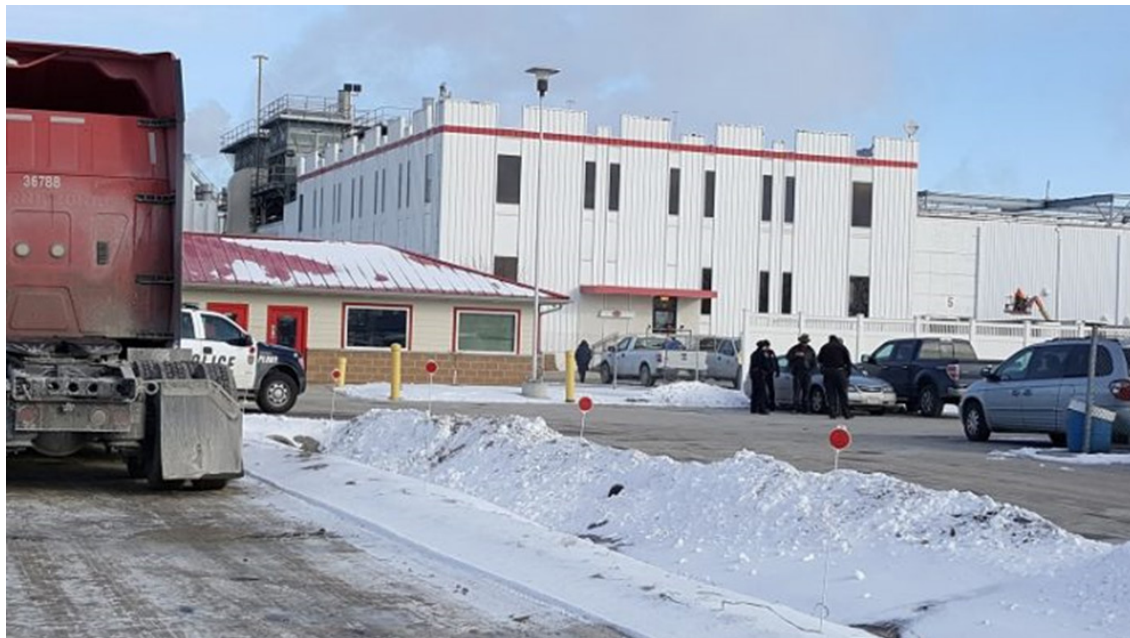
On January 7, 2023, at approximately 4:55 p.m., about one pound of anhydrous ammonia was released at the Tyson Fresh Meats (“Tyson”) facility in Perry, Iowa (**Figure 1**). Exposure to the toxic ammonia gas seriously injured one Tyson employee.

**Figure 1.** Tyson Foods Facility. (Credit: The Perry News)

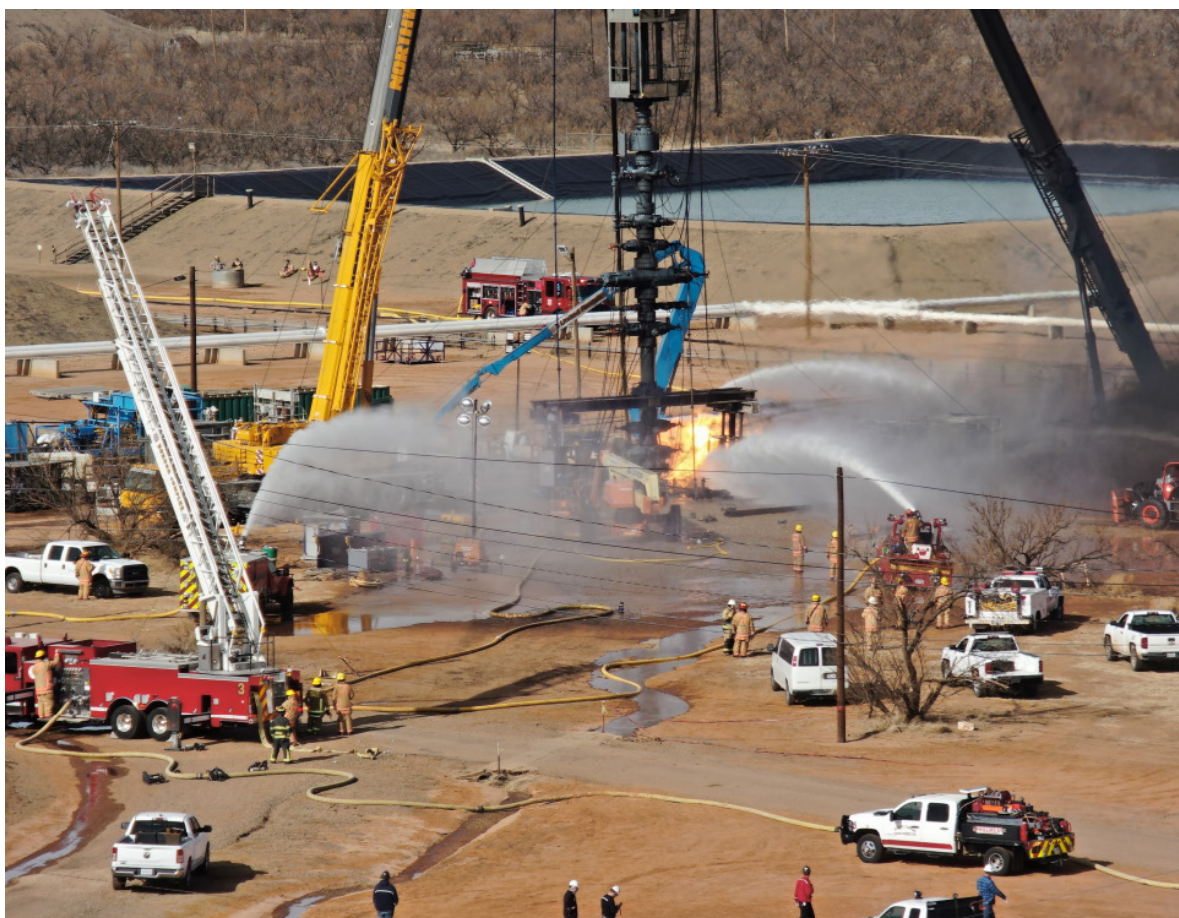
On January 17, 2023, natural gas liquid was accidentally released during maintenance of a natural gas liquid storage cavern at the Phillips 66 Borger Refinery (“Phillips 66”) tank farm near Borger, Texas. The released natural gas liquid formed a vapor cloud and ignited, causing a large fire (**Figure 1**). The fire fatally injured one contract worker and seriously injured another. Phillips 66 estimated the property damage from the incident to be \$3.1 million.

**Figure 1.** Local emergency response to the incident. (Credit: Phillips 66)

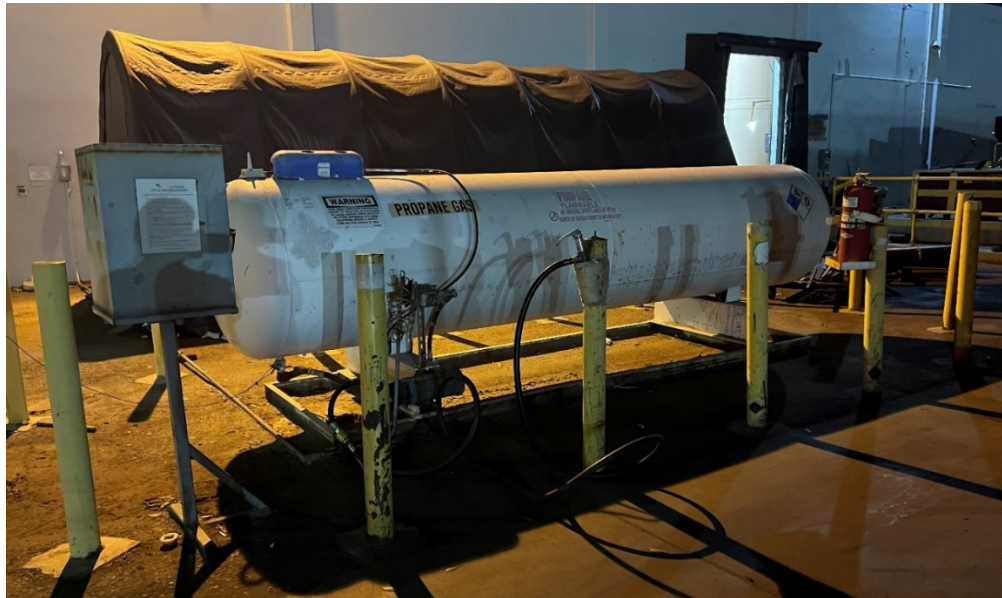
The temporary employee had moved a propane-fueled forklift to the facility’s filling station (**Figure 1**) to refuel its tank. He connected the filling station’s hose to the forklift’s tank and opened the valve to start the propane flow. The hose connection was not secure, and propane immediately discharged into the atmosphere. The employee tried to either tighten or remove the hose during the release. As a result, the cold propane sprayed and cryogenically burned him. The temporary employee was not wearing personal protective equipment (PPE) that could have protected the employee from being exposed to cold propane.

**Figure 1.** Propane Filling Station. (Credit: Georgia-Pacific Corrugated, LLC)

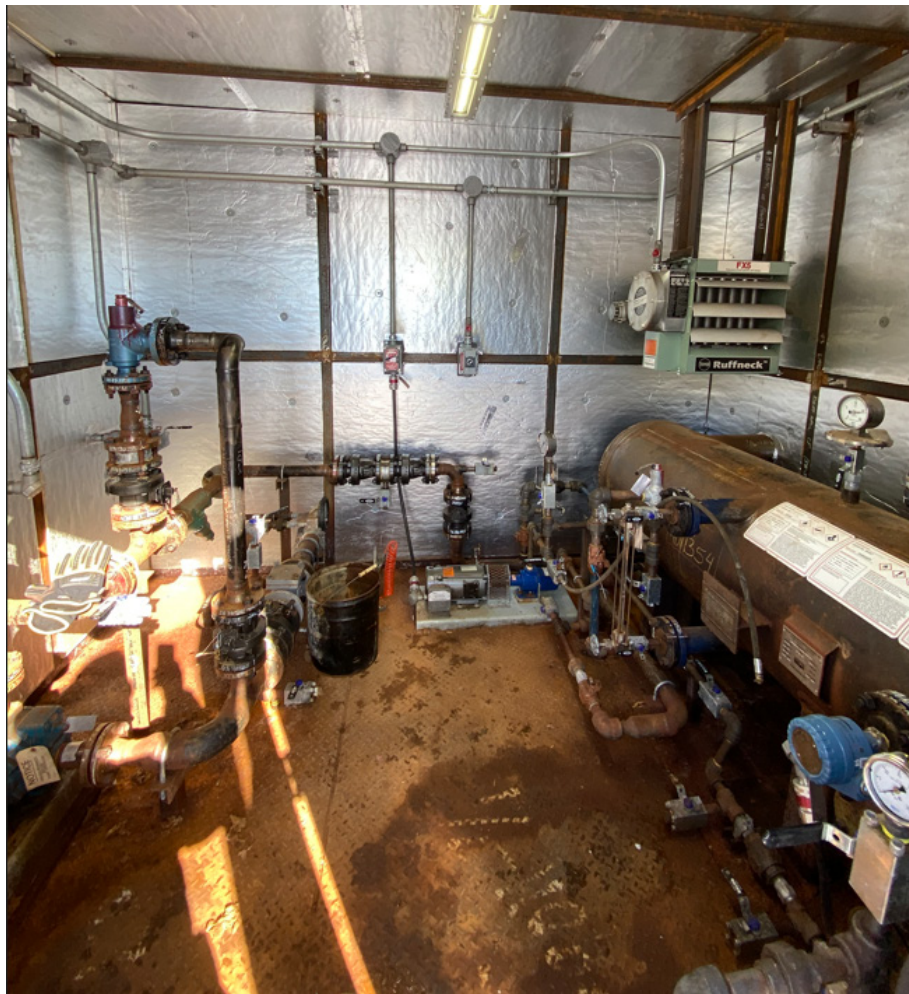
During the morning of February 24, 2023, an unknown amount of hydrocarbons and hydrogen sulfide were accidentally released, fatally injuring an employee inside an enclosed building (**Figure 1**) at a ConocoPhillips oil and gas facility in Watford City, North Dakota. The hydrocarbons and hydrogen sulfide displaced the oxygen in the building, and the employee asphyxiated in the oxygen-deficient atmosphere.

**Figure 1.** The Enclosed Building. (Credit: ConocoPhillips)

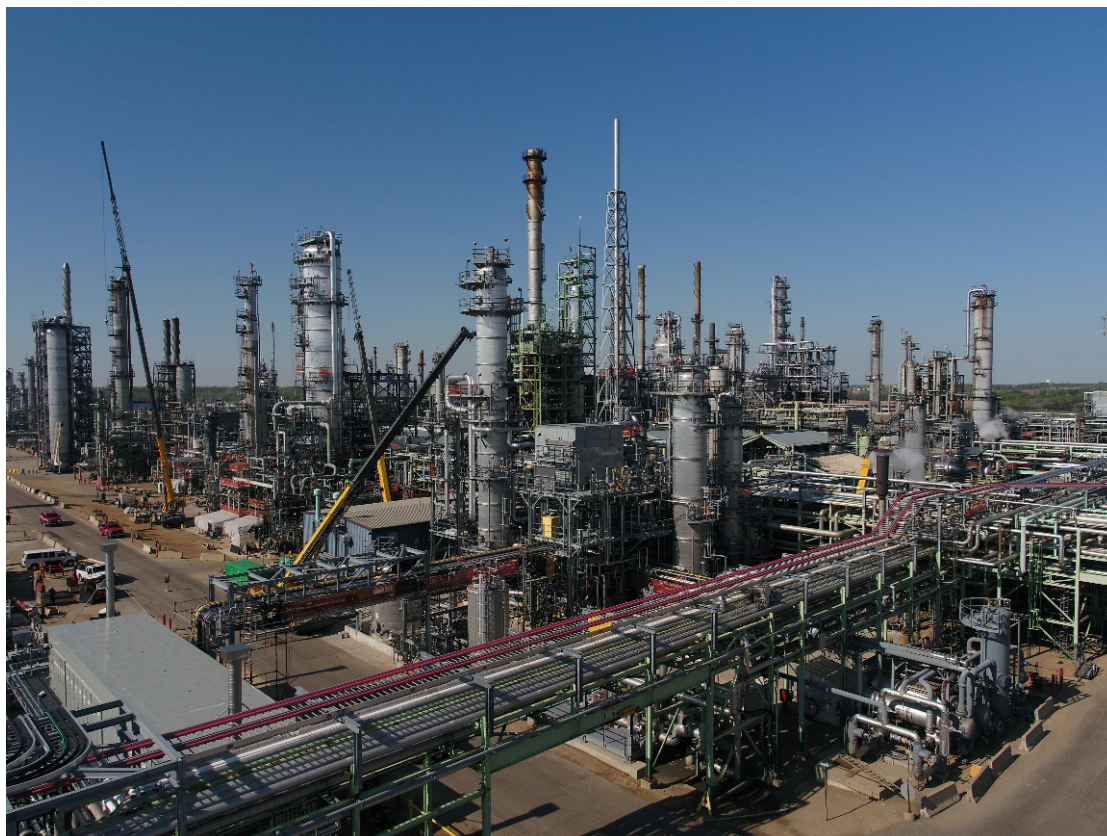
On April 8, 2023, at about 7:45 a.m., hydrogen sulfide and sulfur dioxide were released from the sulfur recovery unit at the Flint Hills Resources Pine Bend Refinery, LLC (“FHR”) in Rosemount, Minnesota (**Figure 1**). This event resulted in \$2.235 million in property damage.

**Figure 1.** FHR Pine Bend Refinery. (Credit: FHR)
