VOLUME: 2

DATE: MARCH 12, 2025

# INCIDENT REPORTS

EVENTS REPORTED TO THE CSB UNDER THE ACCIDENTAL RELEASE REPORTING RULE

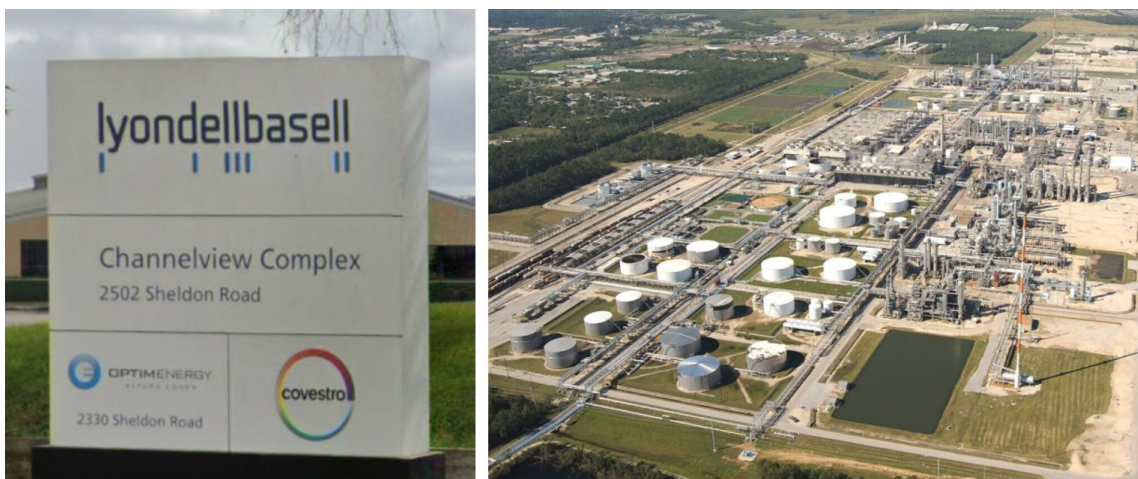
On July 12, 2024, at 7:00 p.m., a mixture of nitrogen and benzene was accidentally released into the firebox of a fired heater. The benzene ignited, causing a fire at the LyondellBasell Industries (“LyondellBasell”) facility in Channelview, Texas (**Figure 1**). Lyondell Chemical Company operates this LyondellBasell facility. The company estimated that the incident resulted in \$9.8 million in property damage.

**Figure 18.** The LyondellBasell facility in Channelview, Texas. (Credit: Google Maps (left), The Center for Land Use Interpretation (right))

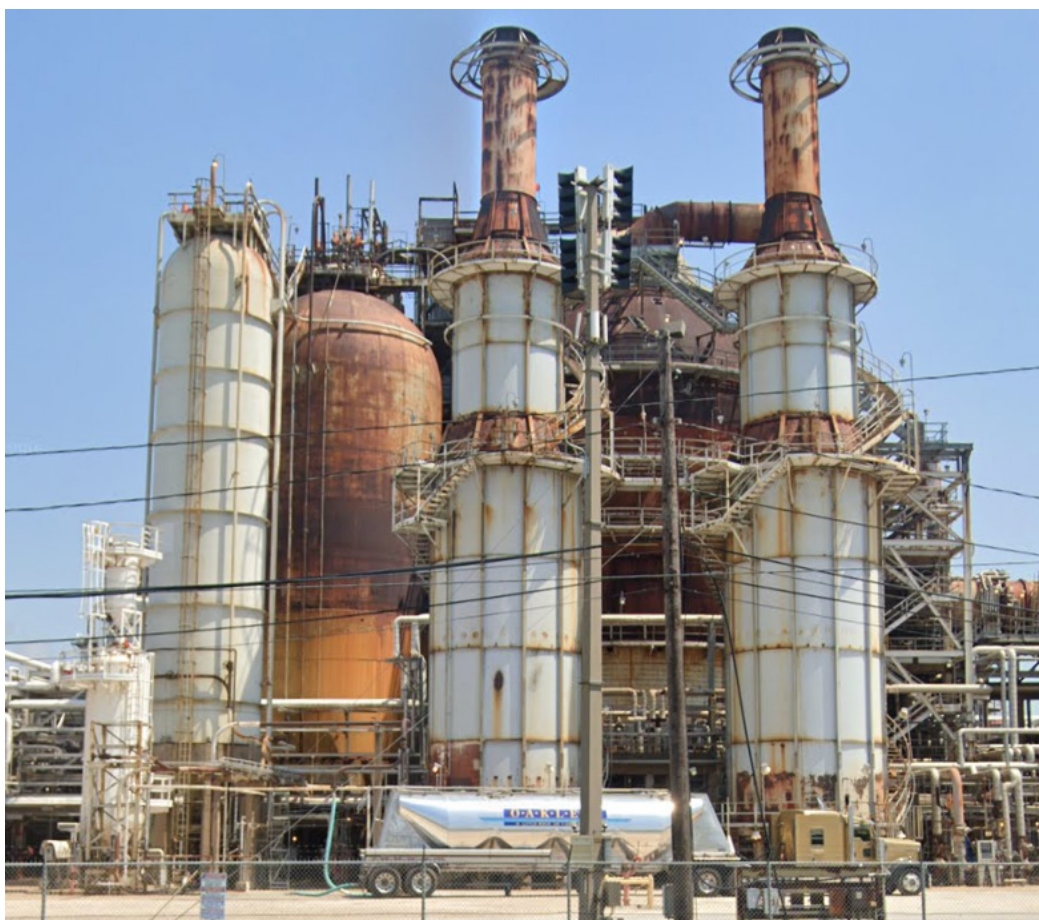
At the time of the incident, employees noticed flames coming from the head of a reactor in the fluidized catalytic cracking unit (“FCCU”) (**Figure 1**). The flammable vapor released from the reactor likely caught fire from autoignition because the reactor operated at 960 degrees Fahrenheit (°F), which is above the autoignition temperature for most of the hydrocarbons released. Unit operators put out the flames with a fire extinguisher. LyondellBasell reported that over 400 pounds of flammable vapors were released during this incident.

**Figure 1:** The FCCU at LyondellBasell. (Credit: Google Earth)
