CIVIL AERONAUTICS AUTHORITY
Technical Development Division

NOTE NO. 14

SUPERFICIAL CORROSION ATTACK ON THE SURFACES
OF ALCLAD SHEETS

DECEMBER 1938

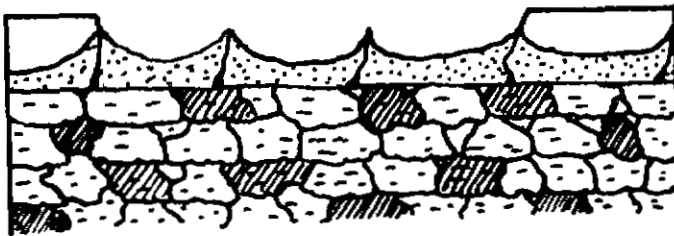
the diffusion zone and core; second, the diffusion zone, which electrolytically protects the core, and finally, the core. Thus, under very severe corrosive conditions the corrosion takes the form shown in Fig. 2. The tooth-like appearance of a corroded cross section is typical. Looking down upon the surface of the corroded sheet the corrosion attack, which appears tooth-like in cross section, has the appearance of hills and valleys. (Fig. 3)

Therefore, if the surface of a piece of Alclad sheet which has been subjected to corrosive conditions is examined with a hand lense of about 10X magnification these hills and valleys may be readily distinguished providing corrosion has proceeded to the extent shown by Fig. 2. Such an appearance indicates that corrosion has proceeded only to the diffusion zone and that the Alclad principle is functioning in electrolytically protecting the core. Of course, the attack may not have proceeded far enough to give this hill and valley effect but then it should be very evident that the corrosion is superficial.

Fig. 2
Schematic cross section showing
corrosion attack extending to the
diffusion zone.

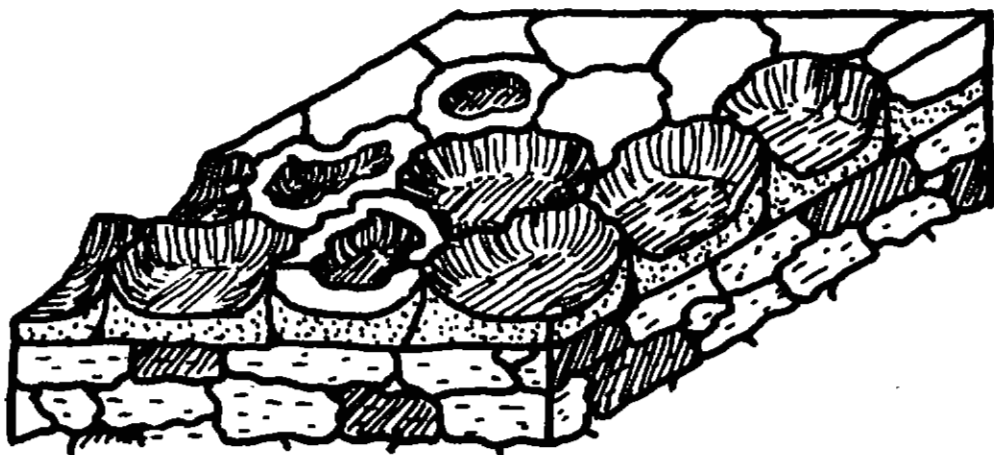
Fig. 3

Schematic block diagram showing appearance of hill and valley corrosion on surface of Alclad 24S-T sheet.
