**DEVELOPMENT OF AIRCRAFT  
WINDSHIELDS TO RESIST IMPACT  
WITH BIRDS IN FLIGHT  
PART II**

**INVESTIGATION OF WINDSHIELD  
MATERIALS AND METHODS OF  
WINDSHIELD MOUNTING**

Pell Kangas and George L. Pigman  
Aircraft Development Division

Technical Development Report No 74

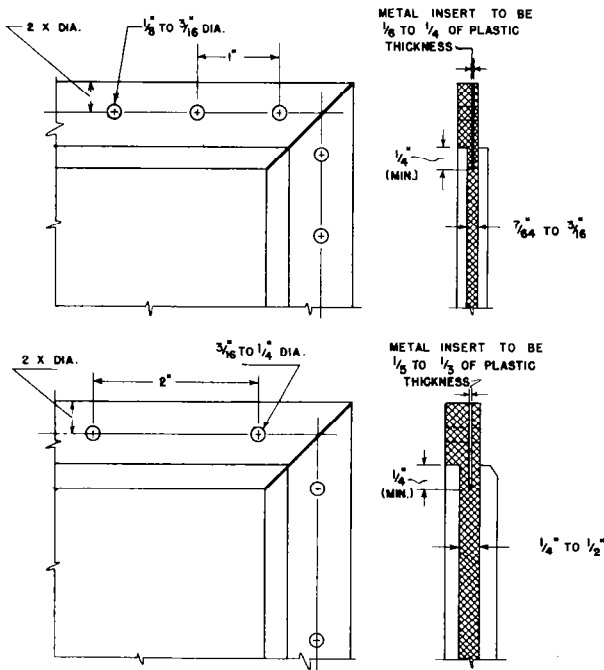
Fig. 20 Design Requirements for Edge Mounting of Laminated Panes With Polyvinyl Butyral Interlayer

In Fig. 20 is shown a typical edge mounting arrangement for panels of such type. The important variables in the method of edge attachment are (a) thickness, width, and type of metal insert strip, and (b) diameter, type, spacing, and edge distance of mounting bolts.

The thickness of the metal insert strip is critical. If the strip is too thin, the mounting bolts passing through the strip will tear through the edge to cause failure. Too great a thickness of the metal insert, with corresponding stiffness and decreased butyral plastic thickness in the edge section, results in shearing of the plastic interlayer along the inside edge of the insert, as is shown in Fig. 21. The optimum thickness of the metal insert is related directly to the thickness of the plastic interlayer.

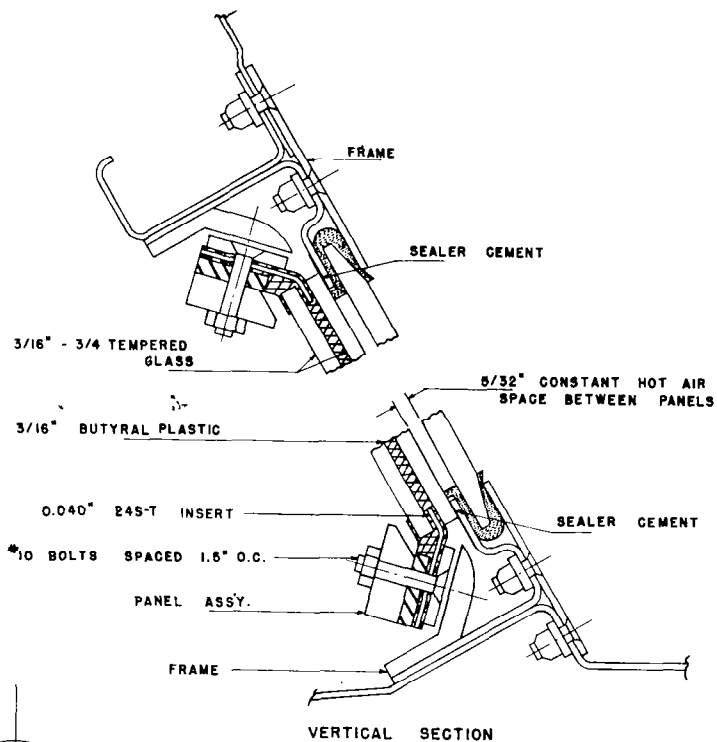
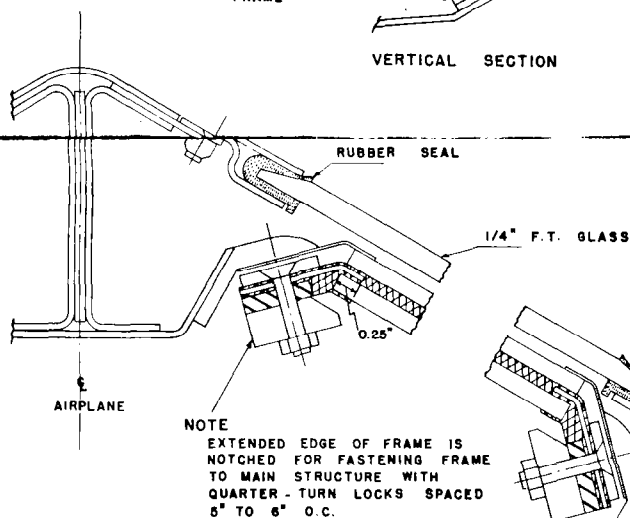
Fig. 24 Section Details and Impact Test Data of Douglas DC-6 Windshield

NOTE  
EXTENDED EDGE OF FRAME IS  
NOTCHED FOR FASTENING FRAME  
TO MAIN STRUCTURE WITH  
QUARTER-TURN LOCKS SPACED  
5\"/>

DOUGLAS DC-6  
PENETRATION VELOCITY - M.P.H. \_\_\_\_\_ 300  
CARCASS WEIGHT - LBS. \_\_\_\_\_ 4  
TOTAL SLOPE - DEGREES \_\_\_\_\_ 38 1/2  
PANEL SIZE - IN. \_\_\_\_\_ 15 X 28  
PANE TEMPERATURE - °F. \_\_\_\_\_ 80  
THICKNESS OF POLYVINYL BUTYRAL - IN. \_\_\_\_\_ 3/16  
S.T. - SEMI-TEMPERED F.T. - FULL TEMPERED  
COCKPIT SECTION SUBMITTED FOR  
TEST AUG. 1946

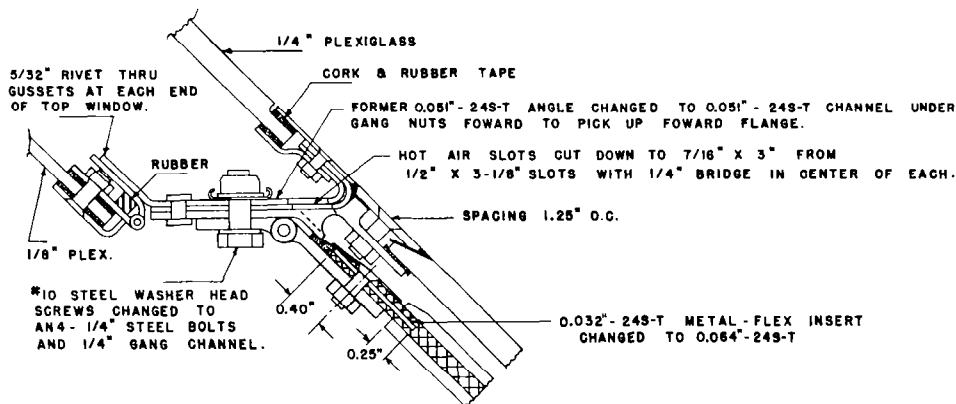
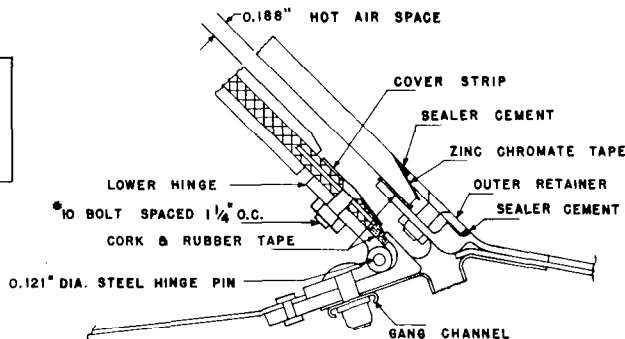
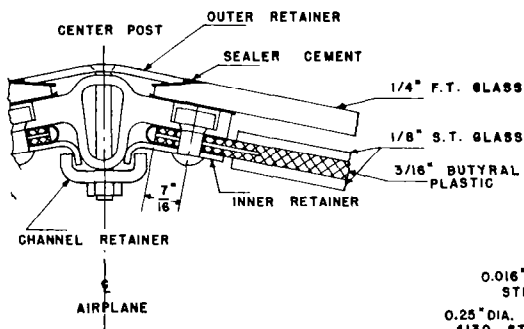
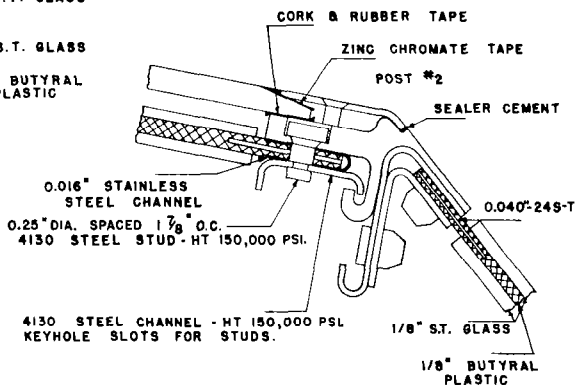
PENETRATION VELOCITY- M.P.H. \_\_\_\_\_ 210  
CARCASS WEIGHT- LBS. \_\_\_\_\_ 4  
TOTAL SLOPE- DEGREES \_\_\_\_\_ 43  
PANEL SIZE- IN. \_\_\_\_\_ 13 X 24  
PANE TEMPERATURE- °F. \_\_\_\_\_ 80  
THICKNESS OF POLYVINYL BUTYRAL- IN. \_\_\_\_\_ 1/8  
S.T.- SEMI-TEMPERED F.T.- FULL TEMPERED  
COCKPIT SECTION SUBMITTED FOR  
TEST SEPT. 1945

Fig. 26 Section Details and Impact Test Data of Curtiss-Wright C46E Windshield

NOTE:  
REINFORCEMENTS FOUND NECESSARY IN TESTS OF COCKPIT NO. 1 WERE INCORPORATED IN COCKPIT NO. 2 AS INDICATED IN THIS DRAWING.

ADDITIONAL REINFORCING:  
NO REINFORCEMENTS WERE USED IN COCKPIT NO. 2.

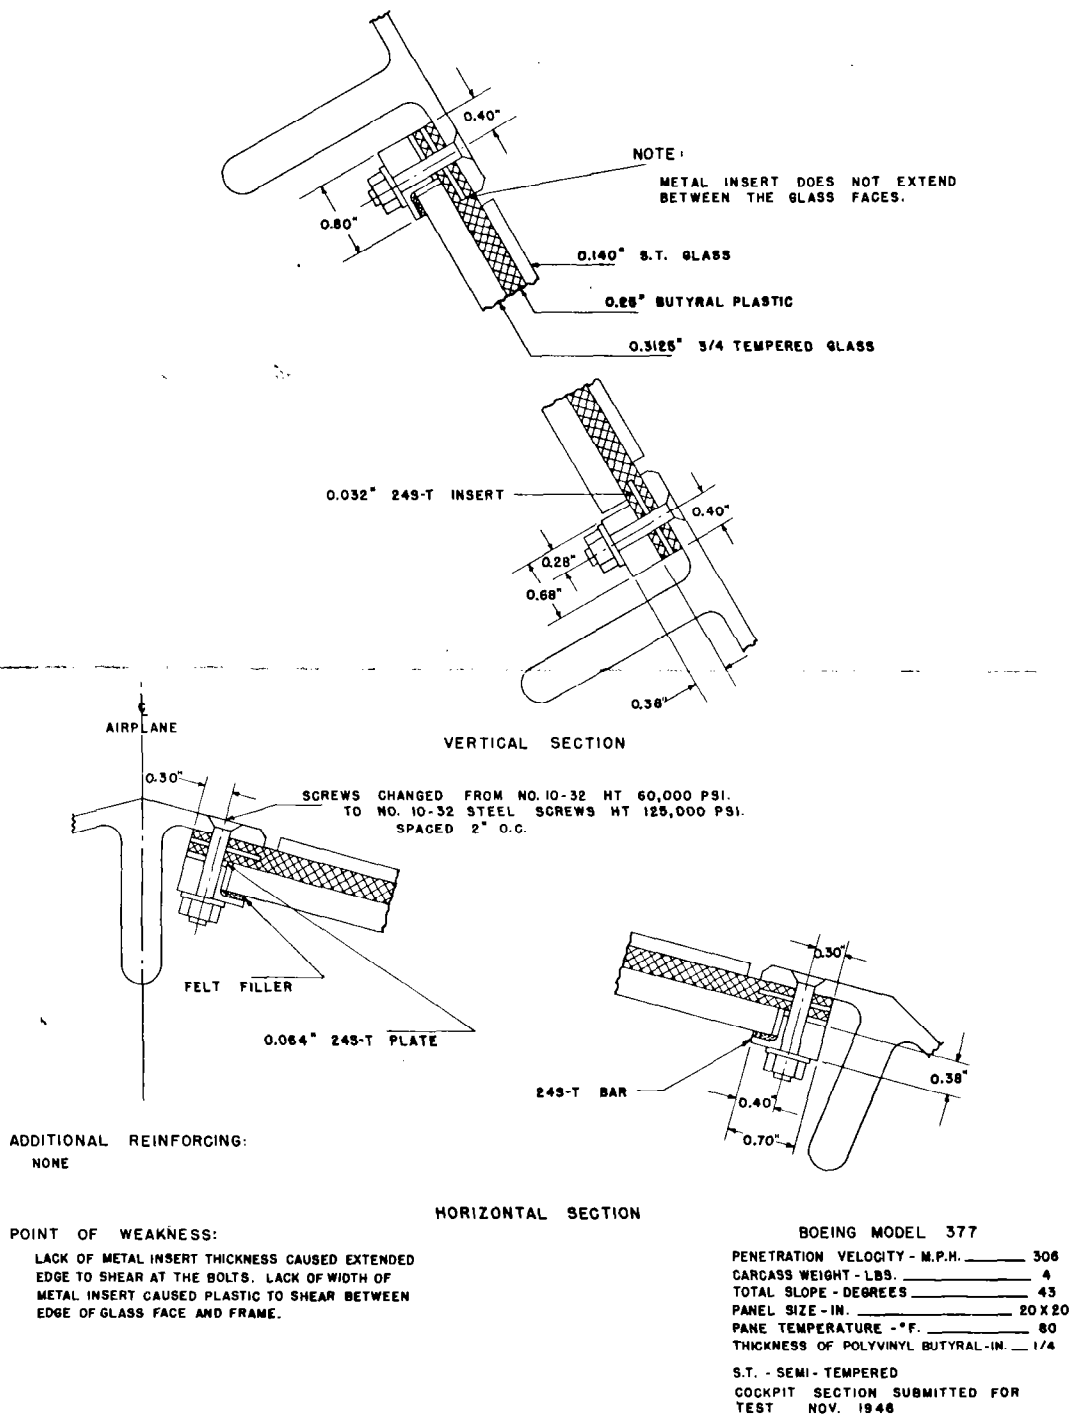
Fig. 29 Section Details and Impact Test Data of Boeing Model 377 Windshield

cause failure of bolts or structural members carrying the principal impact load. In many tests, wedging of the bird carcass along such edges has caused rotation of outside retainer strips and other members, and has resulted in twisting and failure of retaining bolts.

Application of some of these principles is shown in the practical installations of Figs 24 to 29. Also shown in these illustrations are the various frame, sill, and post component dimensions, bolt and rivet arrangement and sizes, and other details of construction, as well as the velocities at which panels mounted in these structures were tested, and the apparent points of initial structural failure.

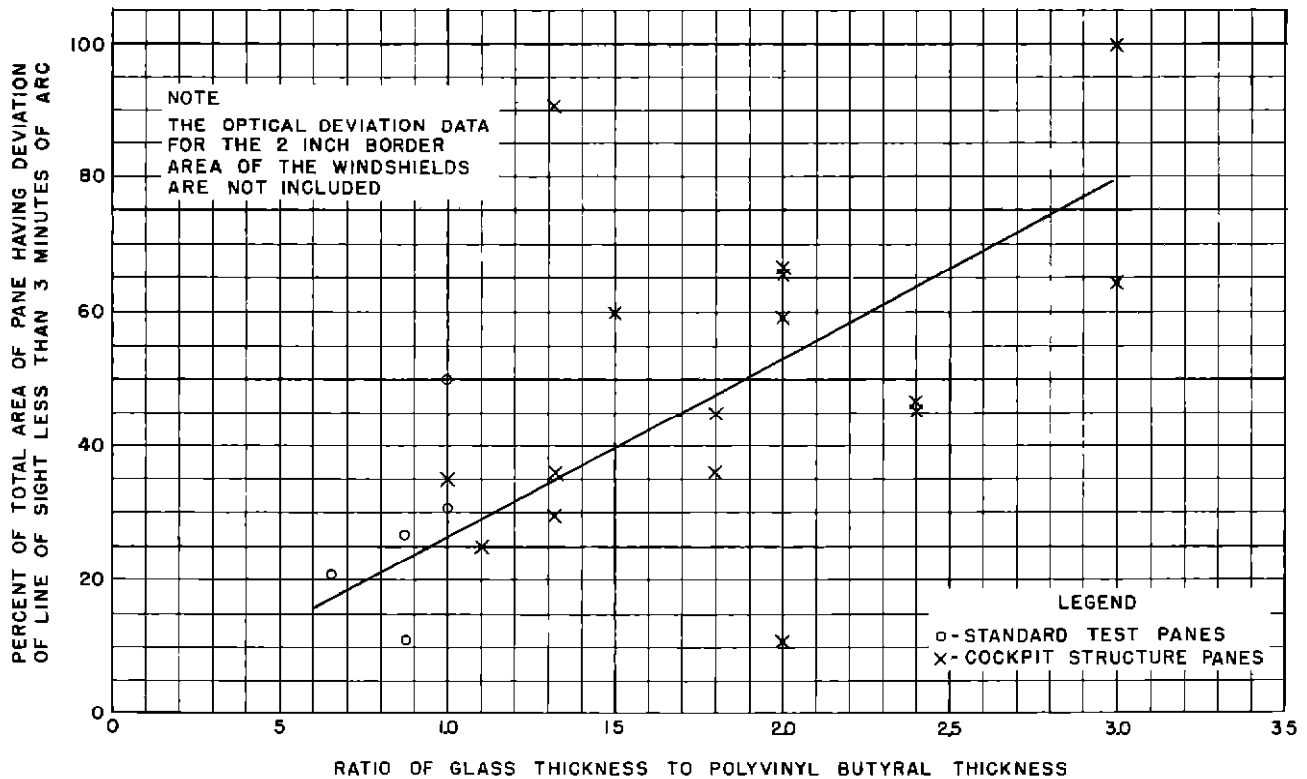
Fig 30 Variation of Deviation of Perpendicular Line of Sight With Glass-Plastic Thickness Ratio of Laminated Panes

Optical deviation measurements were made upon various laminated panes with different thickness combinations of surface glass and butyral plastic interlayer. Some results in this connection are shown in Fig. 30. These show that the proportion to the total panel area of the area with less than three minutes of arc deviation will increase as the ratio of glass thickness to plastic interlayer thickness increases.

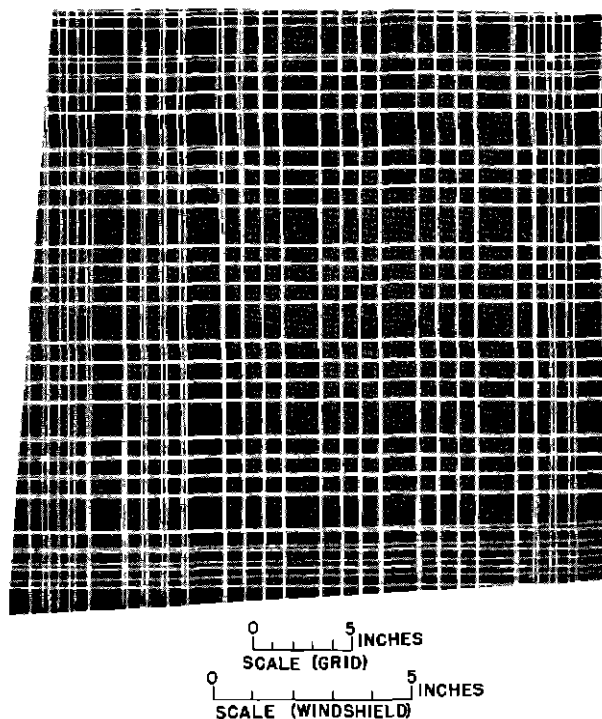
Fig 31 Typical Optical Deviation  
Photograph of Windshield Pane  
With 0.25-in. Polyvinyl Butyral  
Interlayer and 0.188-in. Semi-  
Tempered Glass Faces

In Fig. 31 is shown a typical optical deviation photograph of a glass plastic laminated type windshield pane consisting of 0.25-in butyral plastic interlayer and 0.188-in full-tempered glass faces. The center area of the pane is relatively free from deviation of line of sight, however, at the edges the amount of optical deviation increases in a characteristic manner. Usually this relatively high optical deviation associated with the edges of the pane is limited to a border area of one to two inches around the pane.

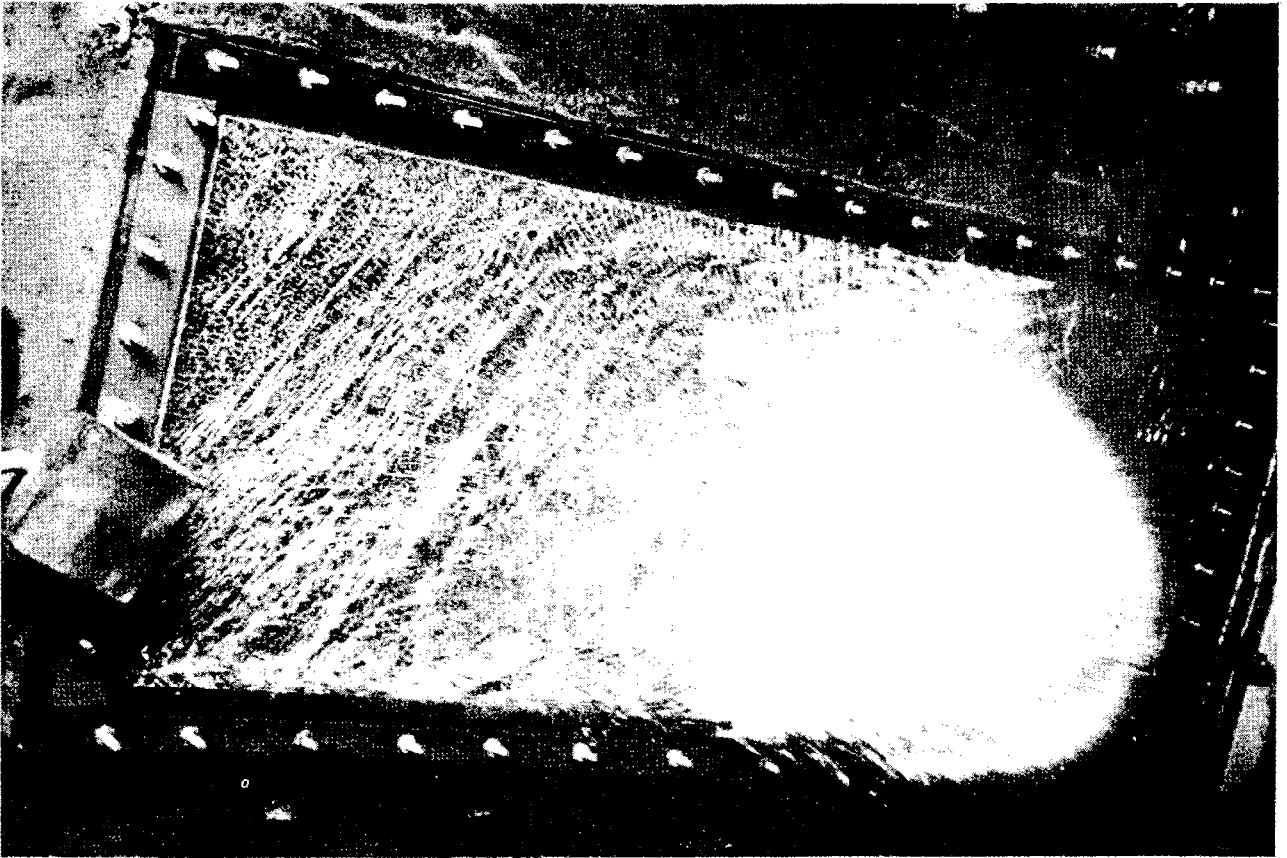
Fig. 32 High Speed Photograph of Splintering of Glass-Plastic Pane at Time of Impact

In addition to the hazard associated with penetration of a windshield panel, by a colliding bird which enters the cockpit with considerable residual velocity, a hazard exists from splinters or larger sharp-edged pieces of glass or plastic resulting from the impact. A photograph of glass splinters thrown off the rear surface of a laminated pane during impact is shown in Fig 32. Broken particles are produced by the impact with all types of glass used for the rear surface of the pane, even though no penetration of the pane by the carcass occurs.

The laminated glass-butyral plastic pane possesses serious splintering characteristics. At impact velocities greater than that required to crack the glass faces, but considerably lower than that required for panel penetration, splinters are thrown from the rear pane face. These splinters are small in size and travel at a velocity of the order of 500 feet per second as estimated from high speed photographs.

Several possibilities for controlling the projection of splinters from the rear face of the laminated pane into the cockpit were investigated. Two methods were tried.

(1) utilizing a relatively hard plastic in place of glass on the rear face of the laminated pane.
