TECHNICAL DEVELOPMENT REPORT NO. 106

AN INVESTIGATION OF THE EFFICACY OF THE
XF9F-3 FIRE SCREEN INSTALLATION

Power Plant Branch
Aircraft Division
April 1950

CIVIL AERONAUTICS ADMINISTRATION
TECHNICAL DEVELOPMENT
AND EVALUATION CENTER
INDIANAPOLIS, INDIANA

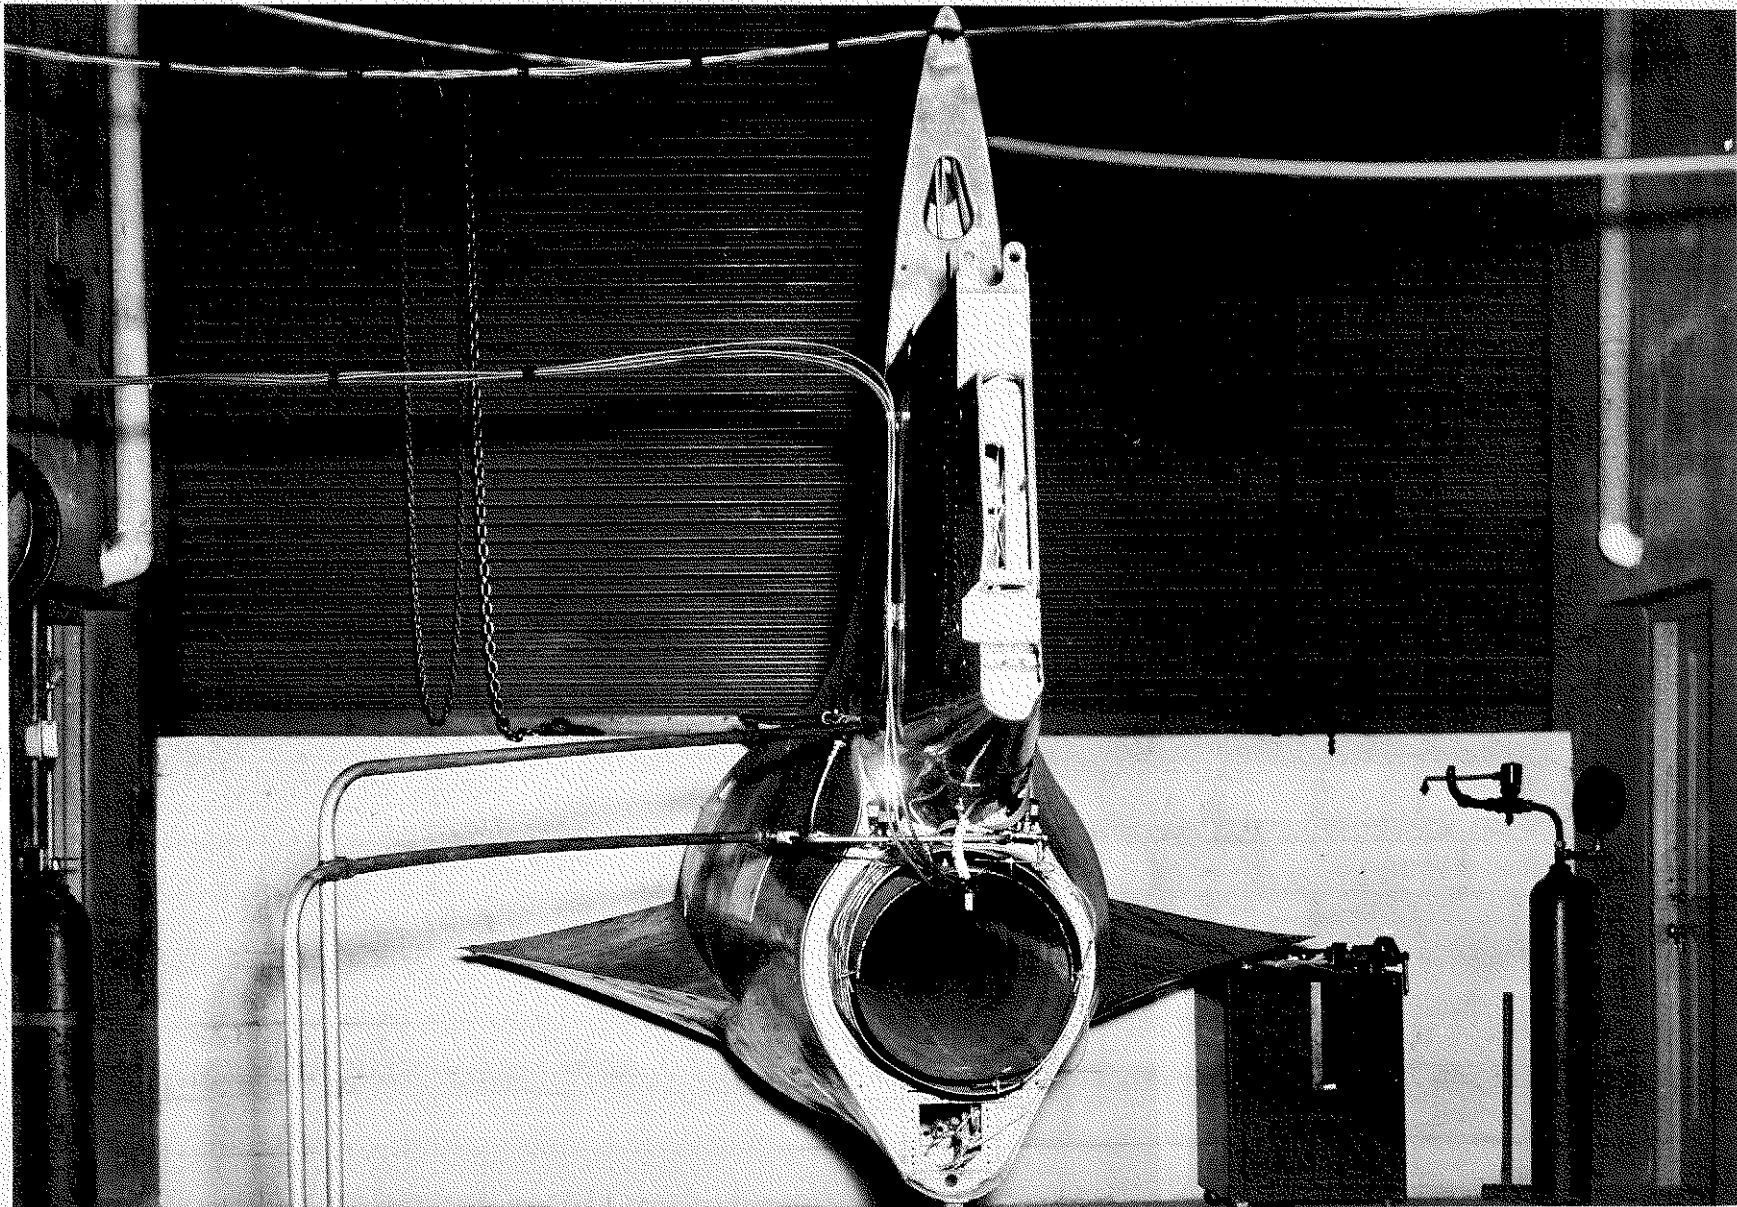
The test article was a static test tail section of a Grumman XF9F-3 airplane which incorporated a fire screen installed between the forward (engine compressor) compartment and the rear (turbine and tail pipe) compartment. Photographic views of the tail section and the cylindrical fire screen installation are shown in Figs. 1, 2, and 3.

FIG 1 REAR VIEW OF XF9F-3 TAIL SECTION INSTALLATION AS MOUNTED IN TEST CELL
— RESTRICTED —

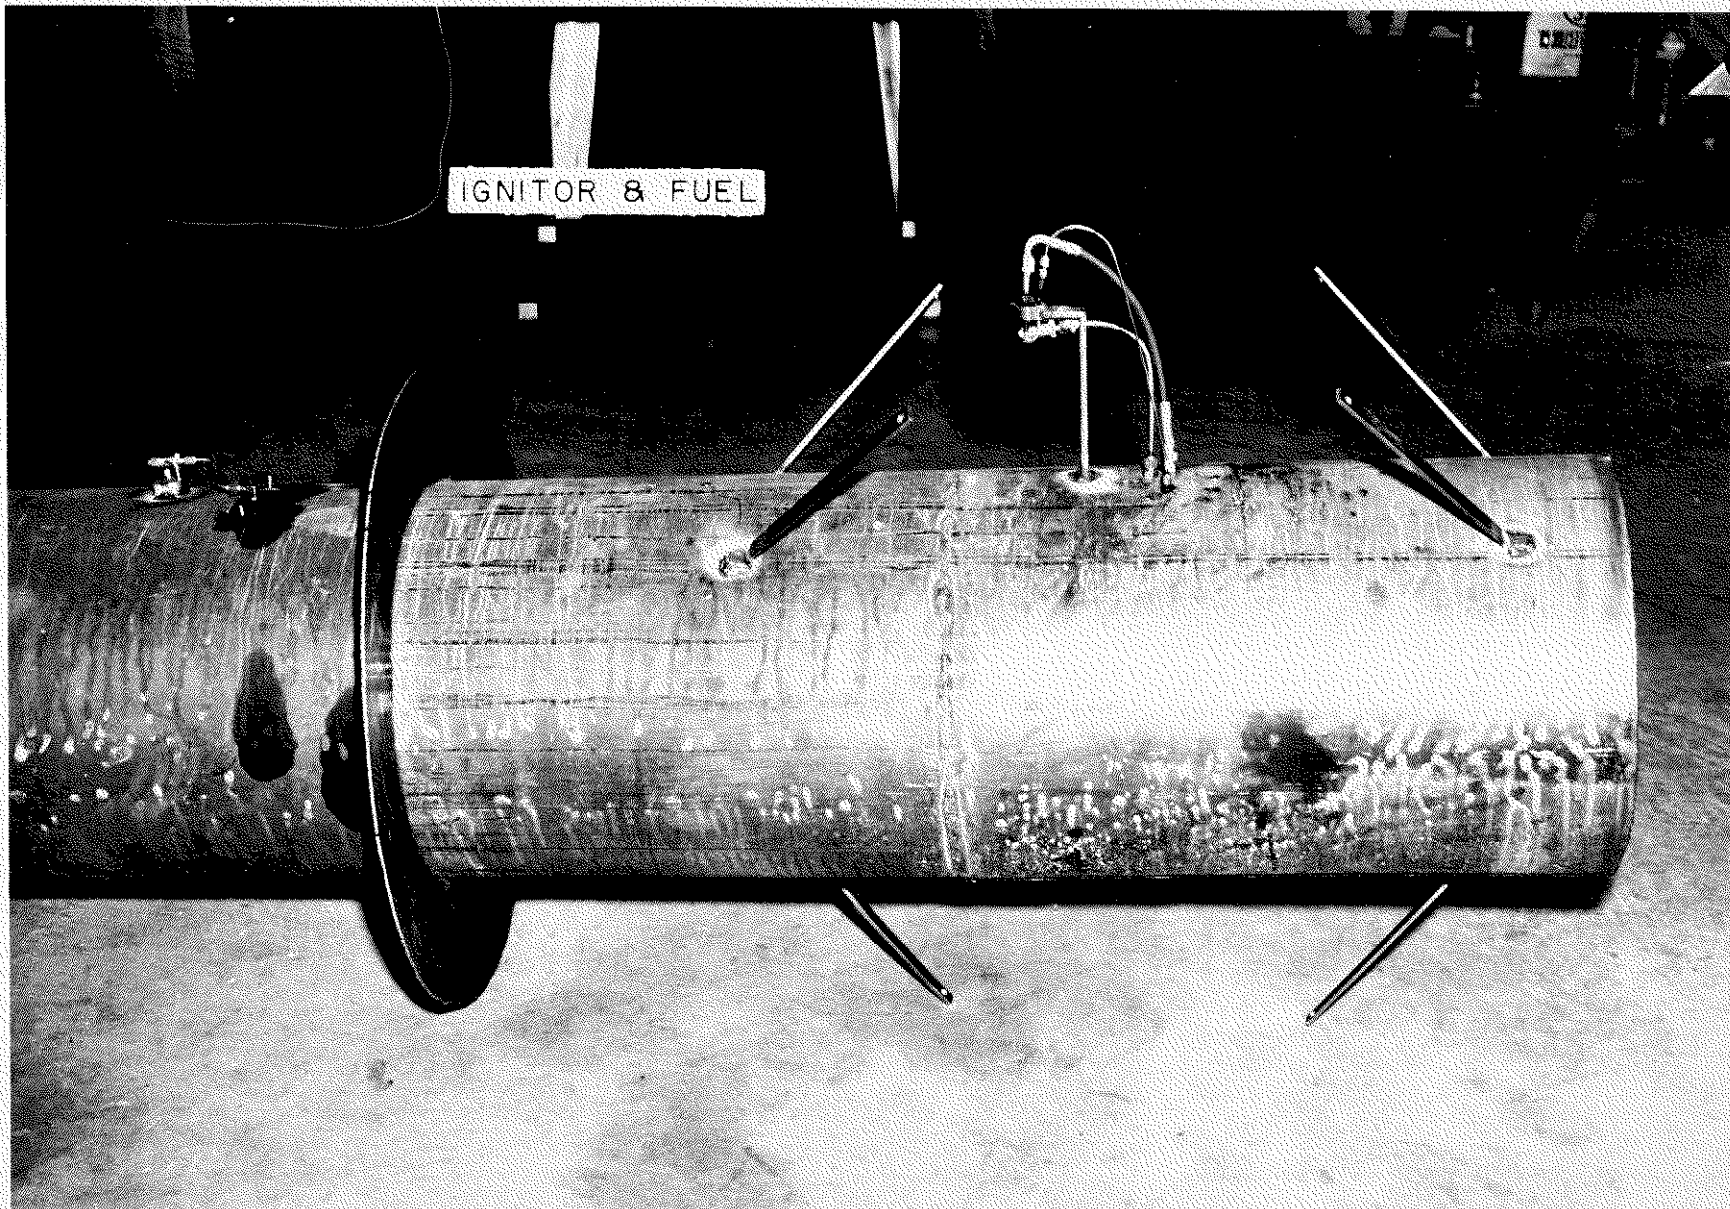
Air flow conditions between the engine and nacelle were simulated by installing an 18-inch pipe and flange in the tail section as shown in Fig. 4. This illustration also shows the general location of the ignitors and fuel nozzles used in the tests. The installation is shown in Fig. 5. For test purposes, the tail section of the XF9F-3 airplane was bolted to a 42-inch air duct. See Fig. 2. Air in various quantities was supplied through this duct by blowers.

FIG. 4 PHOTOGRAPH OF 18 INCH PIPE AND FLANGE INSTALLED IN TAIL SECTION
— R E S T R I C T E D —

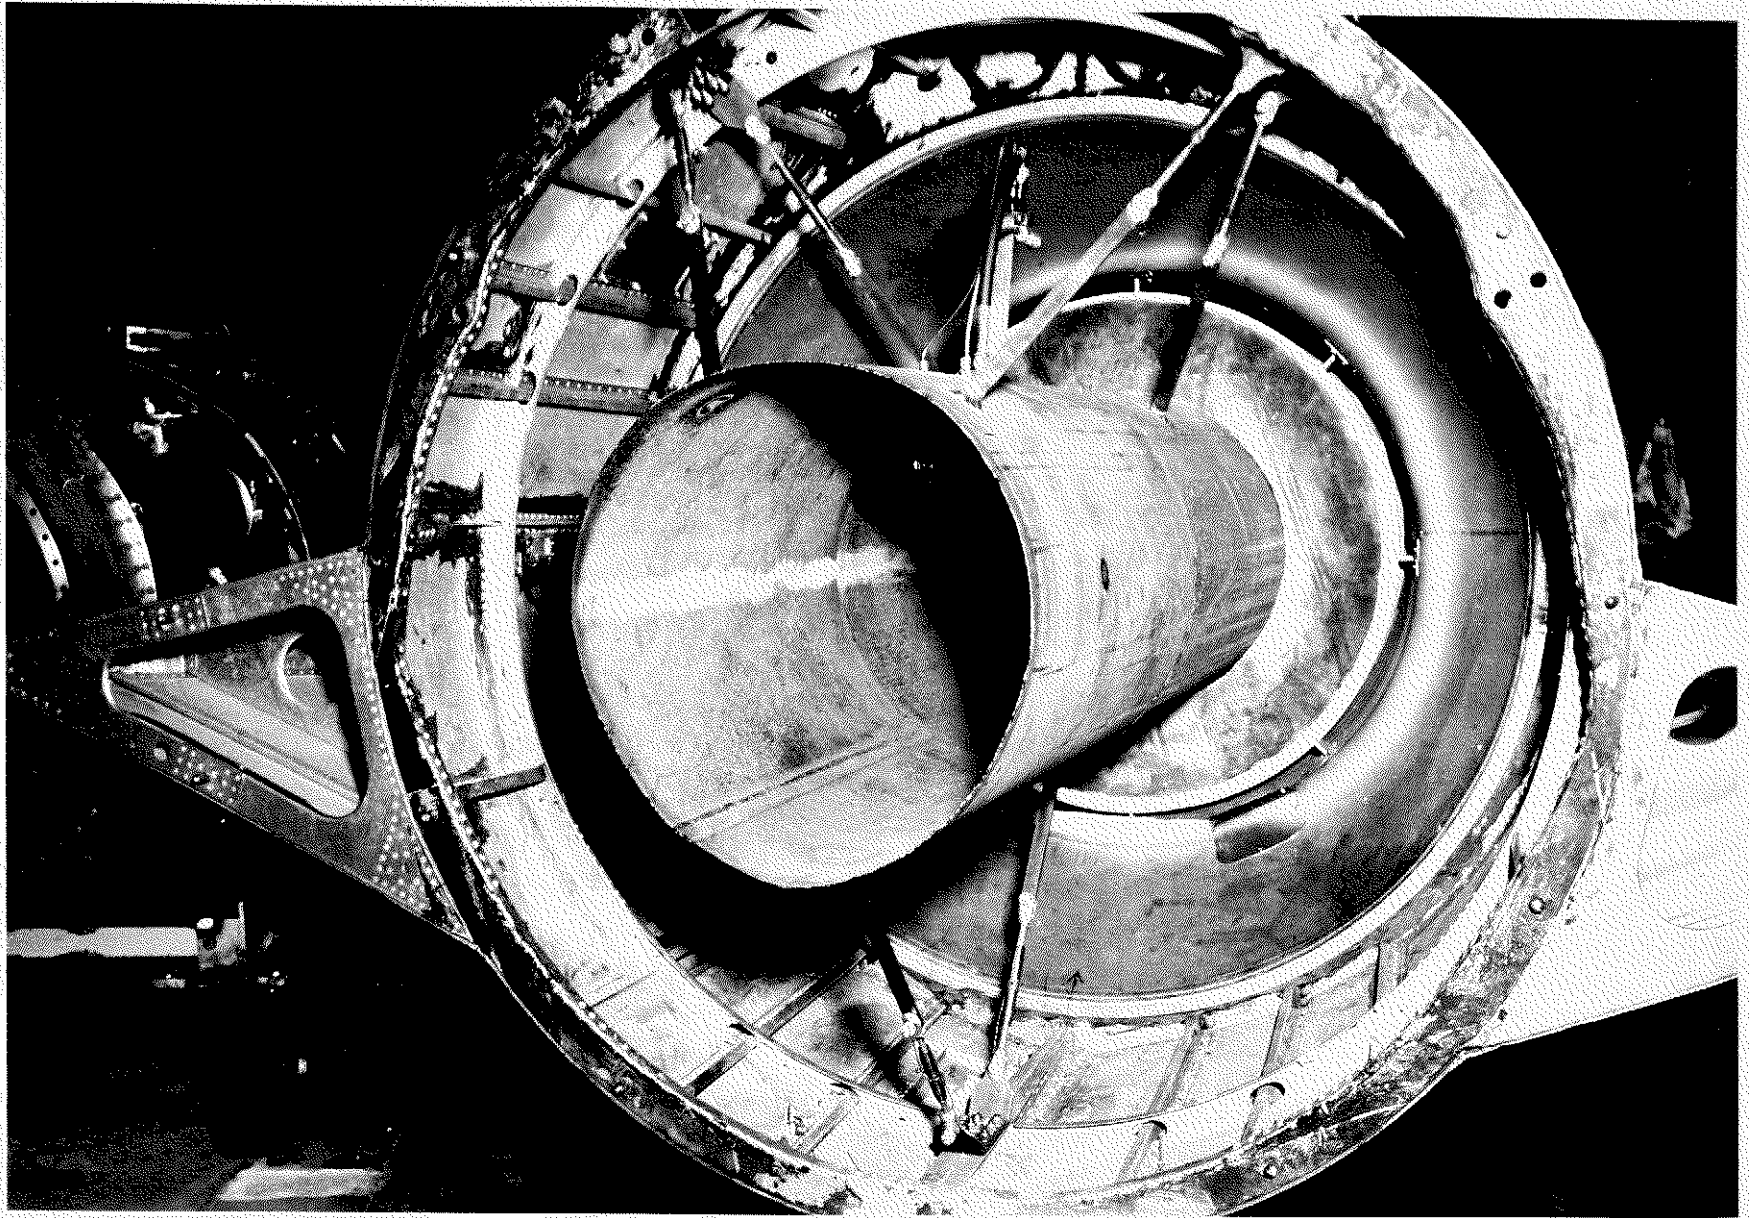
FIG. 5 PHOTOGRAPH OF 18 INCH PIPE AND FLANGE INSTALLATION
— RESTRICTED —

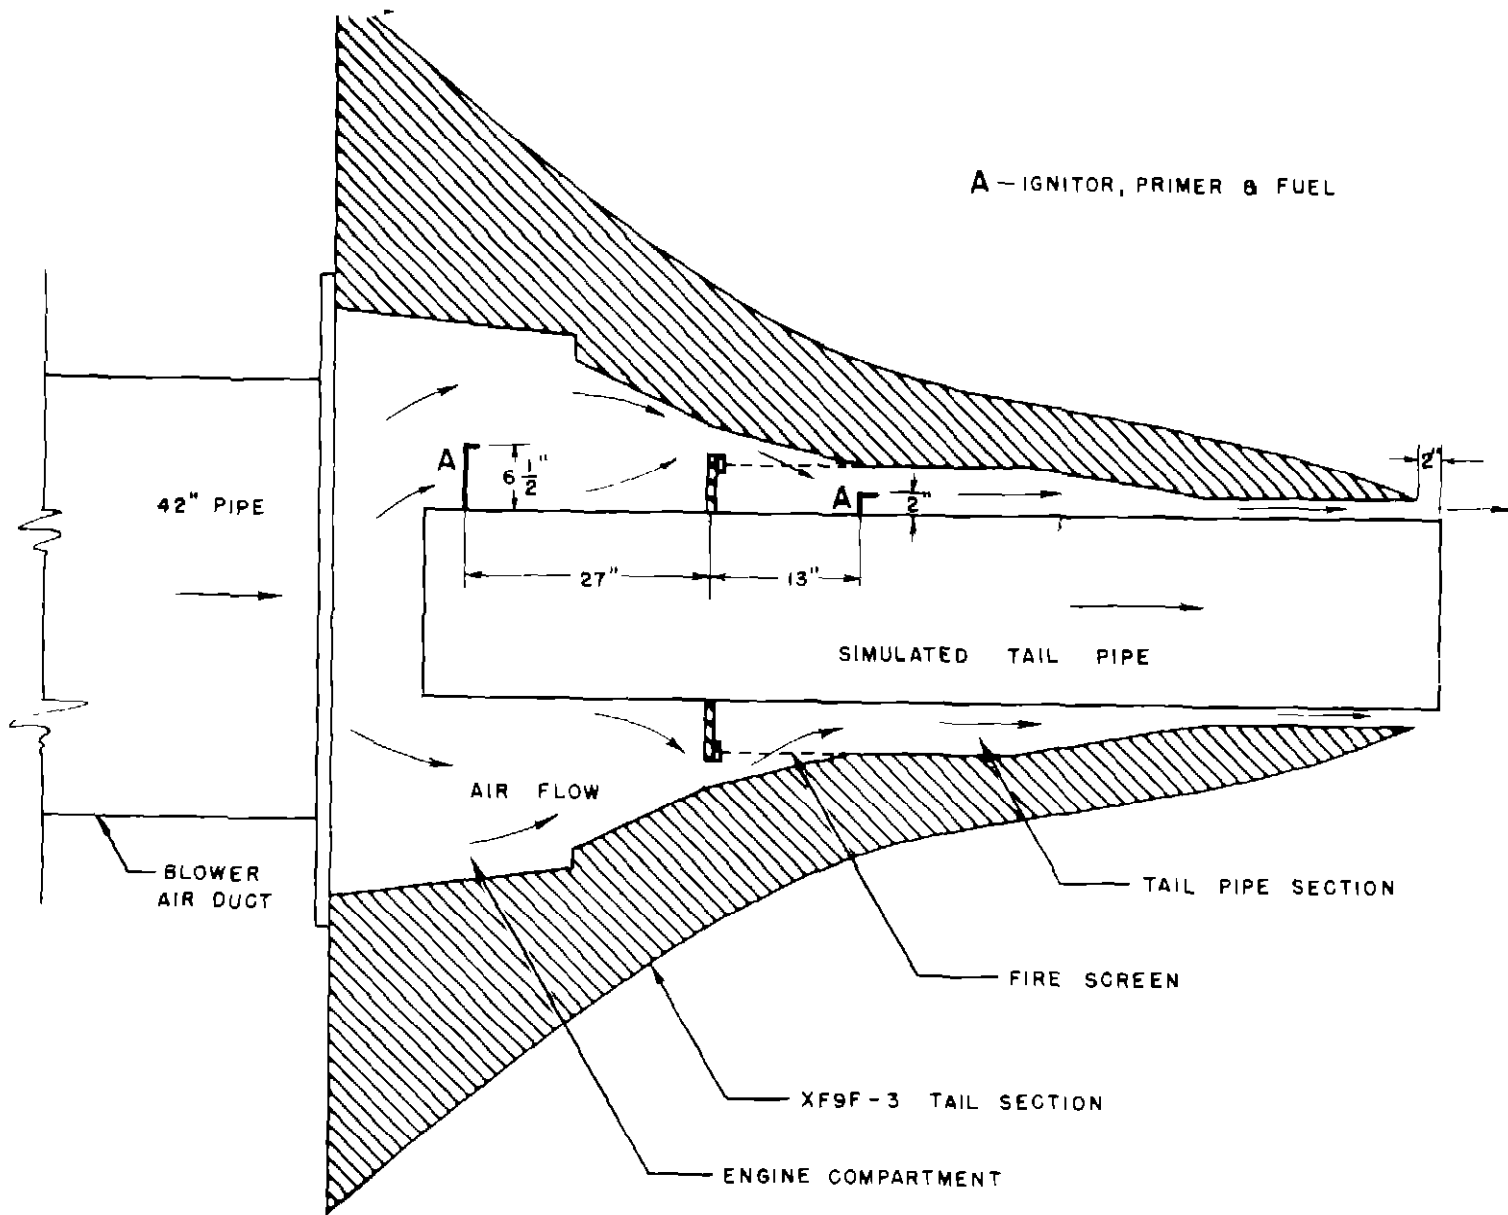
Fig. 6 is a top sectional view of the tail section, showing the general direction of air flow through the nacelle during the tests. The locations of ignitors and fuel nozzles used in producing fires in either compartment also are shown. During the tests, aviation gasoline was supplied as fuel through an open end one-eighth-inch copper tube at a rate of 6 $\frac{1}{3}$ gph. All fuel outlets were pointed downstream.

FIG 6 TOP SECTIONAL VIEW OF XF9F-3 TAIL SECTION
 SHOWING DIRECTION OF NACELLE AIR FLOW
 — RESTRICTED —

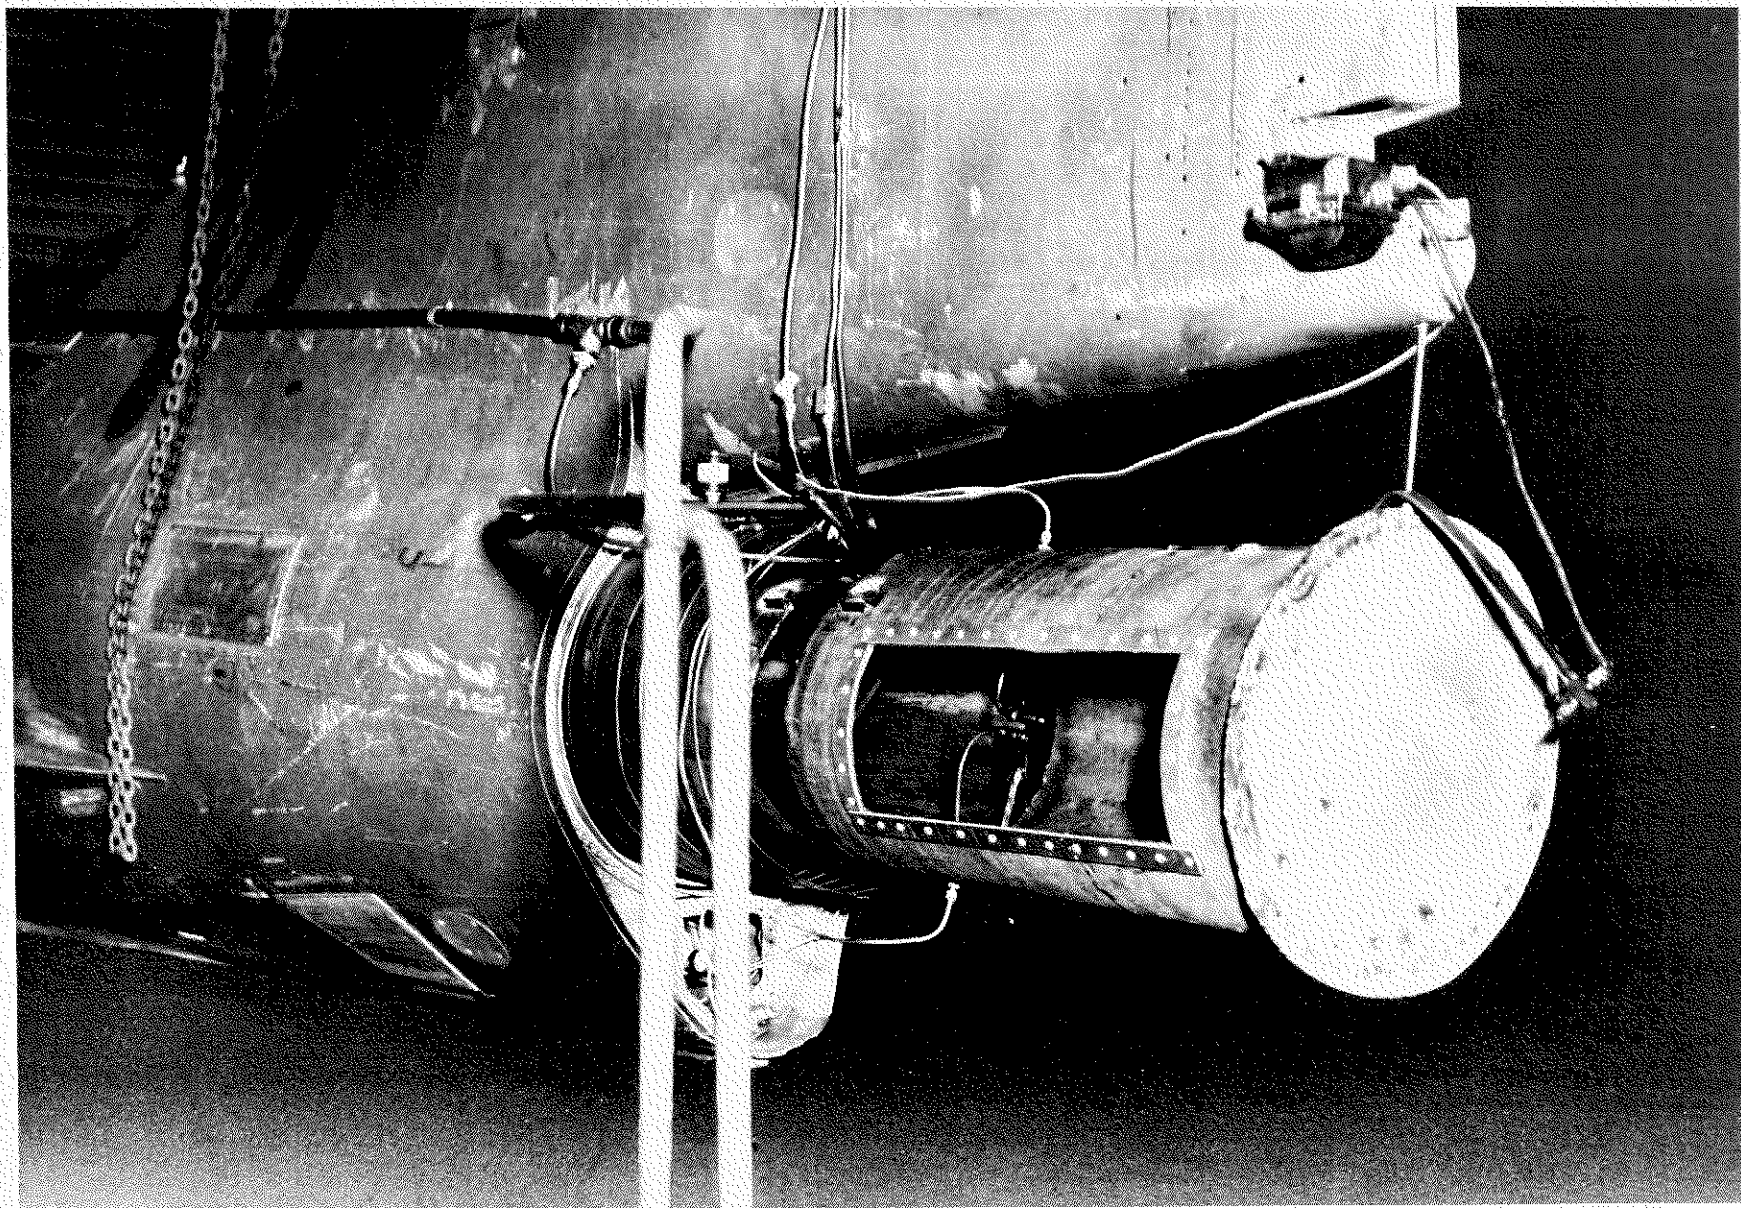
A brief study of fire screen characteristics was made by installing 30-mesh monel metal screens in an 18-inch air duct. One of these was installed normal to the direction of air flow at the end of the duct as shown in Figs. 7 and 8A. Also, two horizontal screen arrangements were installed in the duct as shown in Figs. 8B and 8C. The horizontal screens represent roughly the configuration of the upper and lower portions of the XF9F-3 installation in the sense that the screen at those locations is horizontal and mounted parallel to the general direction of air flow. A turbulent condition in the vicinity of the screens for this configuration is probable.

FIG. 7 PHOTOGRAPH ILLUSTRATING SUPPLEMENTARY TEST SETUP
— RESTRICTED —
