**DETERMINATION OF MEANS TO
SAFEGUARD AIRCRAFT FROM
POWER PLANT FIRES IN FLIGHT
PART IV**

THE BOEING B-29

By
Lyle E Tarbell and H R Keeler
Aircraft Division

Technical Development Report No 107

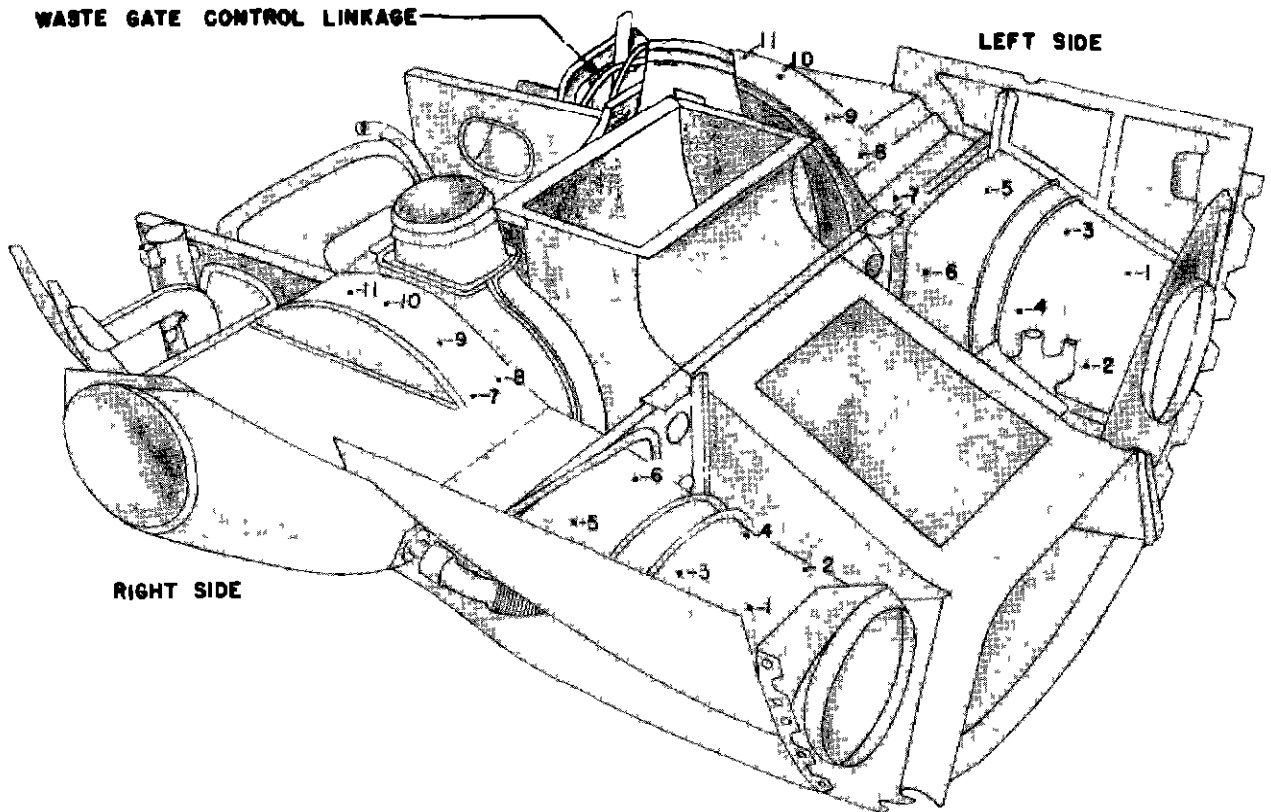
Fig 3 Location of Thermocouples Inside Accessory Section

Preparation for the survey began by mounting 32 thermocouples inside Zone 2 (accessory section) as shown in Fig. 3. Twenty-two of these were brazed to the inside surface of the two stainless steel shrouds which form the separating wall between the exhaust stack well and the accessory section. The other ten were fixed in the air just above or beside the shrouds. Thus, there were 16 thermocouples arranged almost symmetrically on each side of the zone, and each group of 16 was connected to a 16-point recording potentiometer calibrated from 0 to 2,000° F.

The maximum temperature recorded on the inner surface of the exhaust stack shroud during normal operation was 460° F at thermocouple No. 7, left side, Fig. 3.

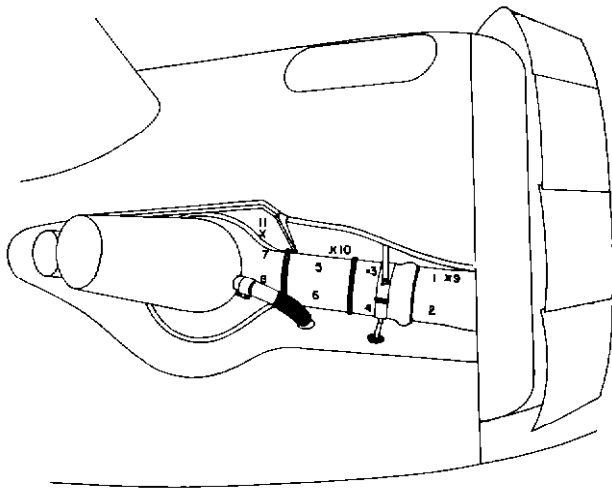
Fig 4 Location of Thermocouples on
 Right Hand Exhaust Stack Surface
 and in Stack Well

Later, eight thermocouples were brazed to the surface of the right exhaust stack as shown in Fig. 4. These also were connected to a 16-point recorder. Three additional thermocouples, connected to single-point recording potentiometers, were used to measure air temperatures at three points in the exhaust stack well.

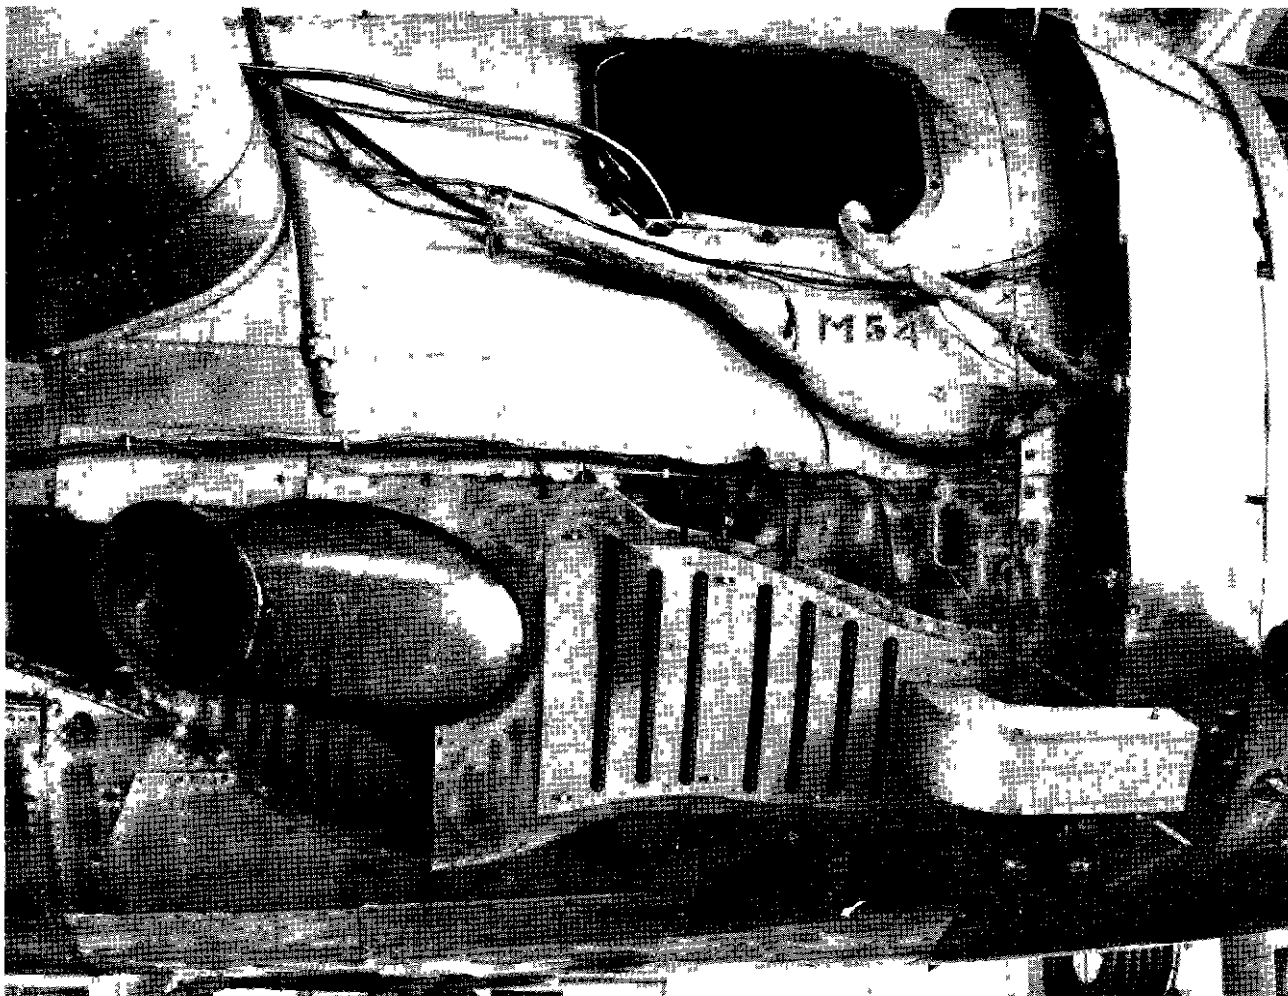
Fig 5 Air Scoop and Louver Cover on Exhaust Stack Well

To study the effect of air flow on temperatures in the stack well, a special air intake duct was added to the louvered cover of the right exhaust shroud at its forward end just aft of the air seal diaphragm. The duct was equipped with a valve by which the amount of air passing into the duct could be controlled. For further control of the air through the well, a sliding cover plate was placed over the louvers so that the area of the louver

openings could be remotely controlled by a pull cable acting against a spring return. The duct and sliding cover plate are shown in Fig 5. The special air duct controlled the quantity or rate of air flow, while the cover, in effect, controlled the turbulence of the air flow inside the stack well (the greater the louver opening, the greater the turbulence). Thus, between them, they controlled the important characteristics of the air flow around

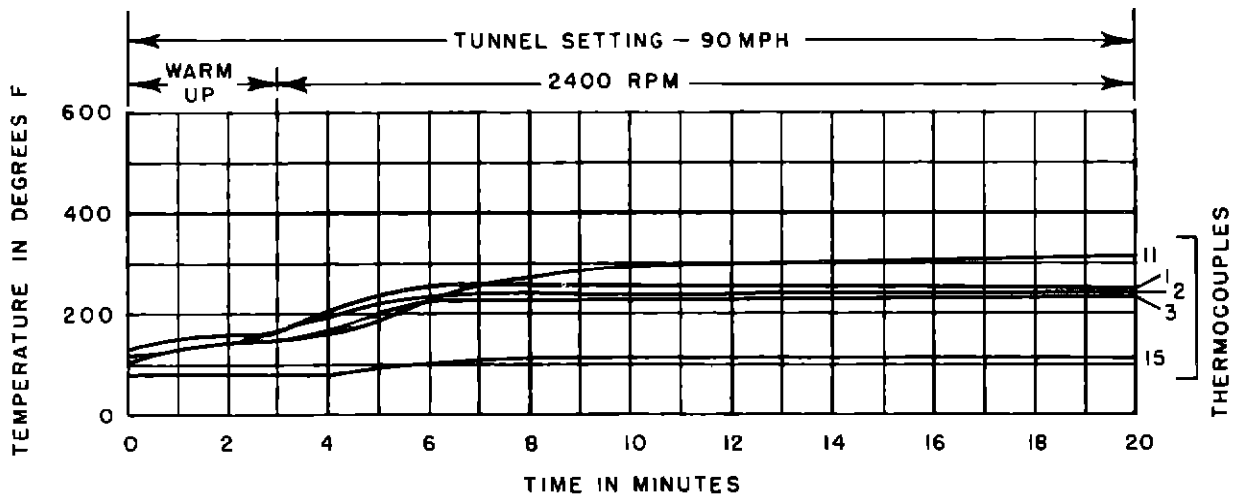
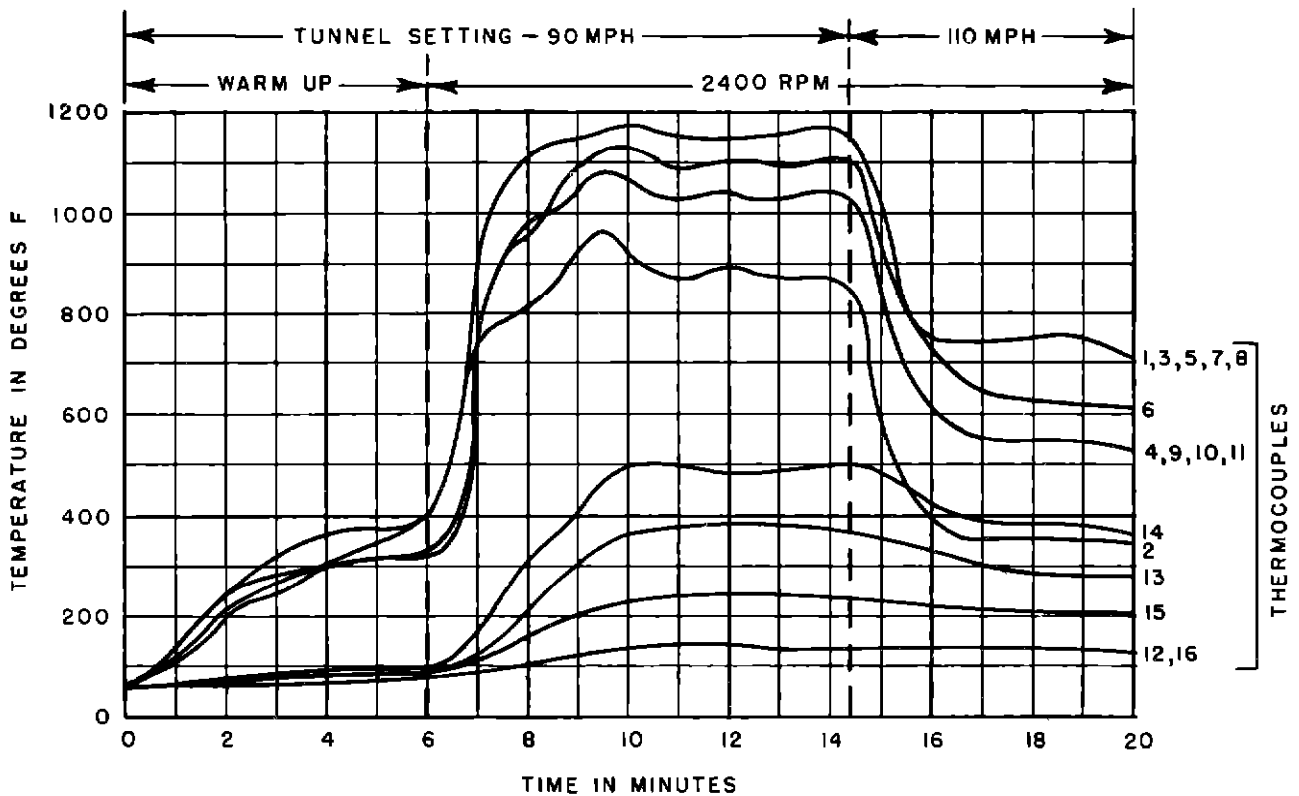
Fig 7 Internal Zone 2 Temperatures, on Shroud Surface and in Air During Normal and Abnormal Engine Operation (See Fig 3 for Thermocouple Locations)

Next, the flanged joint farther forward just aft of the air seal diaphragm was opened three-eighths inch for a test at 2,400 rpm. The vibration at this speed caused the opening to enlarge and within three minutes the maximum temperatures were near $1,200^{\circ}$ F at thermocouples Nos 3 and 5. High temperatures were more widespread than in the previous test. This was attributed to the fact that escaping exhaust gases were able to gain entrance to the space between the two layers of shroud. During these runs, the wind tunnel air speed was kept low. When it was increased to maximum, the temperatures dropped as much as 400° to 500° . Representative curves illustrating the above conditions are shown in Fig 7.

(a) ENGINE NORMAL (TEMPERATURES OF ALL THERMOCOUPLES NOT SHOWN RUN BETWEEN THOSE OF NUMBERS 11 AND 15)

(b) SIMULATED EXHAUST STACK FAILURE (BREAK JUST AFT OF AIR SEAL DIAPHRAGM)

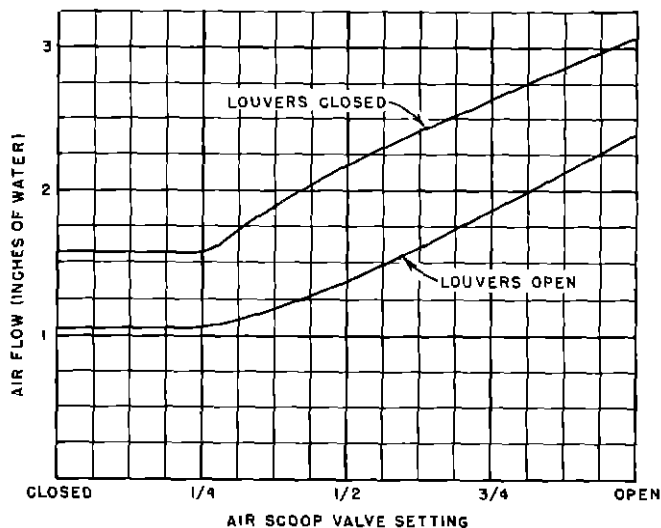
Fig 8 Variation of Air Flow Through Exhaust Stack Well with Change in Setting of Valve in Added Air Scoop (Air Flow Measured Adjacent to Waste Gate Tail Pipe)

Pressure readings in inches of water, taken near the waste gate, gave an indication of the relative amount of air passing through the well as the air valve and the louver openings were varied Fig 8 shows the pressures recorded The normal condition of the well is represented by having the louvers open and the air scoop closed Pressures for this condition averaged about 1.1 in of water The highest pressure was noted when the louvers were fully closed and the air scoop fully open The pressure under this condition was 3.1 in of water

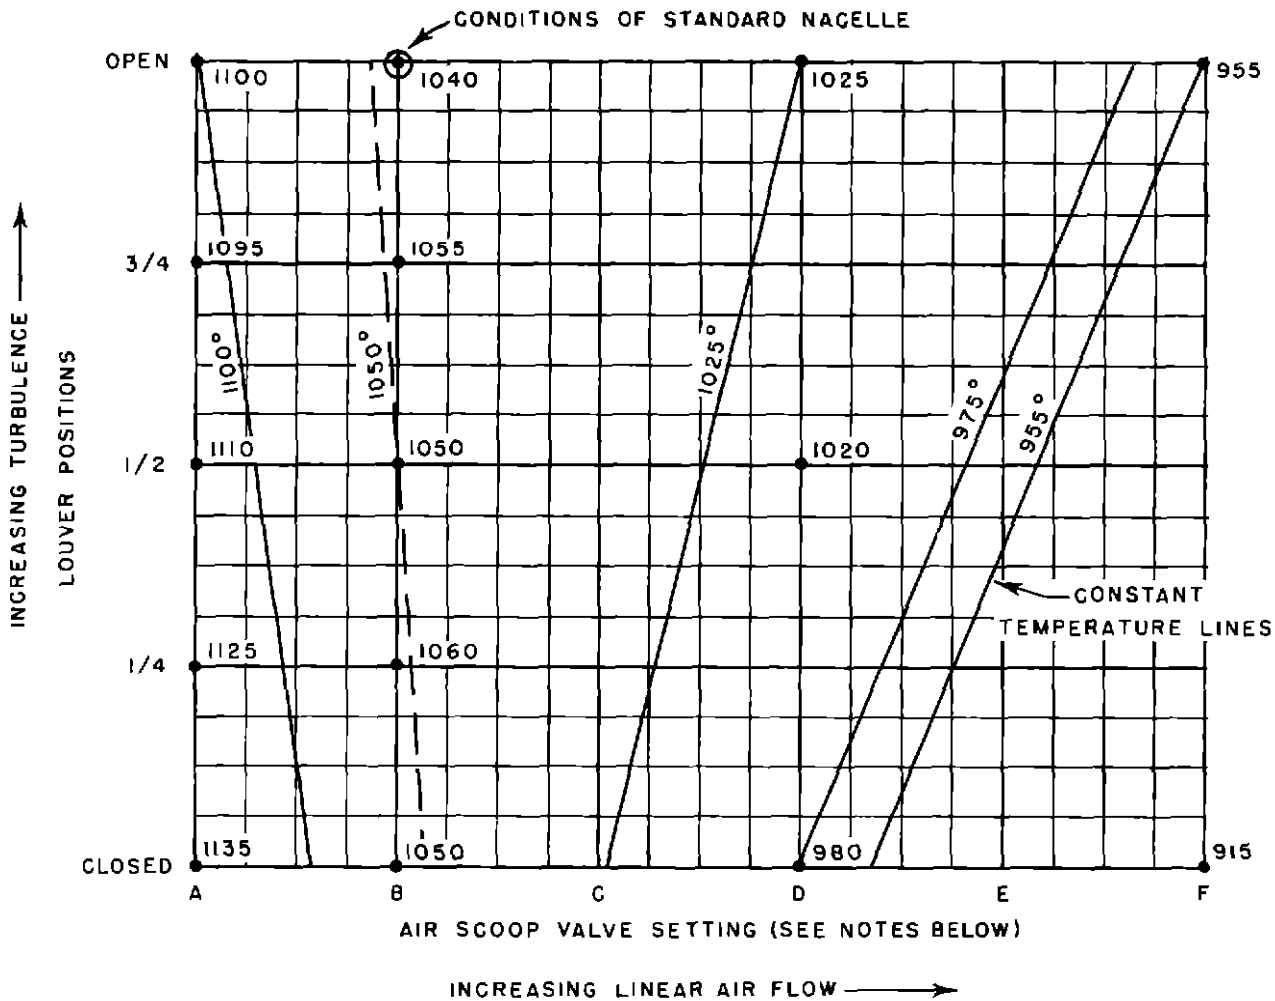
Fig 9 Effect of Character of Air Flow Through Exhaust Stack Well on Temperature of Stack Surface

Fig 9 shows graphically the relationship between the rate or quantity of air flow through the well, the turbulence of the air flow, and the temperature of the heated surface over which the air is flowing The curves are based on data obtained by thermocouple No 7 (Fig 4) in 32 tests wherein the character of the air flow in the exhaust stack well was varied by changing the opening of the valve of the special air intake duct and the opening of the louvers In the first case, rate of flow increased with increased opening of the valve, as shown in Fig 8 In the second case, turbulence increased with increased opening of the louvers

The significant region of this plot is the region of higher flow rates where increasing turbulence in the vicinity of a hot surface is shown to have an adverse effect on safety by causing higher surface temperatures Furthermore, the higher the linear flow rate the greater this adverse effect becomes as revealed by the increasing slope of the constant temperature lines The apparent effect of this on fire ignition was revealed in the tests

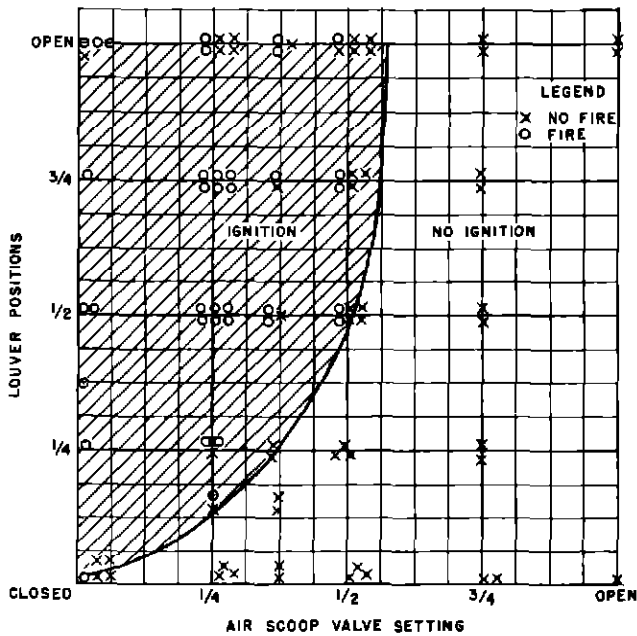
Fig. 10 Effect of Character of Air Flow Through Exhaust Stack Well on Ignition of Gasoline by Exhaust Stack

The results of 89 engine exhaust stack well tests, using gasoline for fuel, are shown graphically in Fig 10, using the same coordinates as for the temperature plots of

Fig. 9 In Fig 10, a circle represents a test in which ignition occurred and an x represents a test in which no ignition occurred. The location of the mark shows the relative conditions of air flow existing in the stack well during the test as determined by the position of the valve in the added air intake scoop and of the louver cover. All other conditions are unchanged except the location of the fuel nozzle and the rate of fuel flow. Two positions were used for the nozzle, one inside the accessory section secured about 5 in. above the shroud at the overlapping joint previously referred to (just forward of the flanged connection between stack and turbosupercharger), and the other position within the stackwell, 7 in. forward of the forward edge of the turbosupercharger cooling bell, 1 in. below the upper surface of the stack well, and 4 in. inward from the well cover. In the first position, the rate of gasoline flow was about 0.5 gpm, in the second about 0.2 gpm (through a nozzle having a No. 60 drill hole).

A comparison between this plot and that of Fig. 9 shows that the boundary line of ignition deviates from the constant temperature lines most sharply in the range of minimum turbulence and in the direction of greater safety (less likelihood of ignition). This deviation substantiates what might be theoretically reasoned, viz., that turbulent air in a region of potential ignition does double duty in facilitating ignition by increasing surface temperature and by more thoroughly distributing the fuel around the surface and encouraging the existence of localized explosive mixtures.

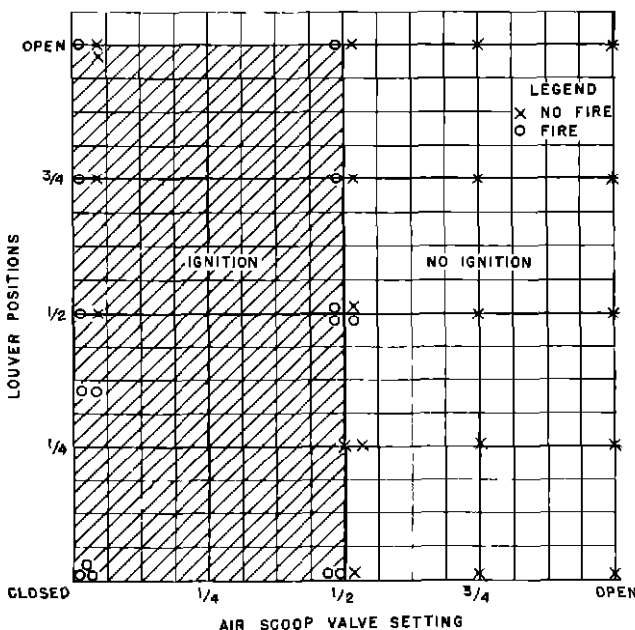
Fig. 11 Effect of Character of Air Flow Through Exhaust Stack Well on Ignition of Oil by Exhaust Stack

A series of 35 tests was conducted in which SAE 10 oil was the flammable fluid used. The tests were conducted in a similar manner to the tests involving gasoline and the results are plotted in Fig. 11 using coordinates similar to those of Fig. 10 for gasoline. Comparison of the two plots shows a larger area of potential ignition for oil be-

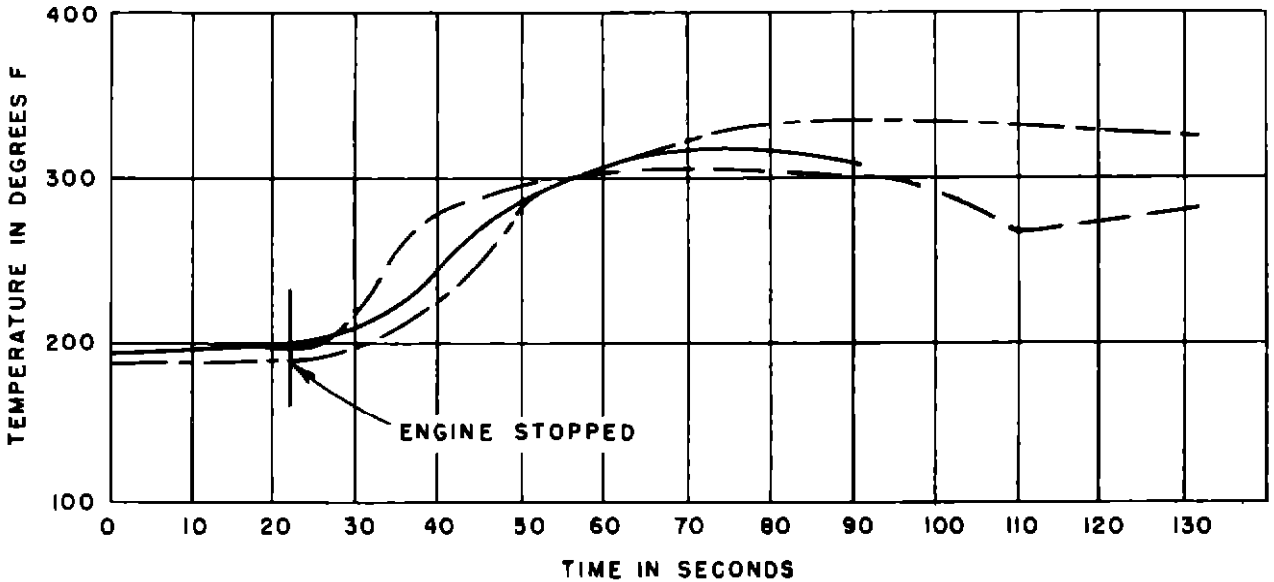
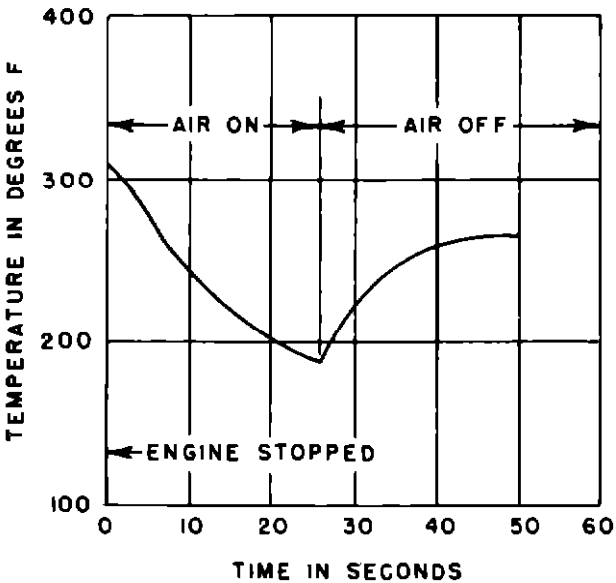
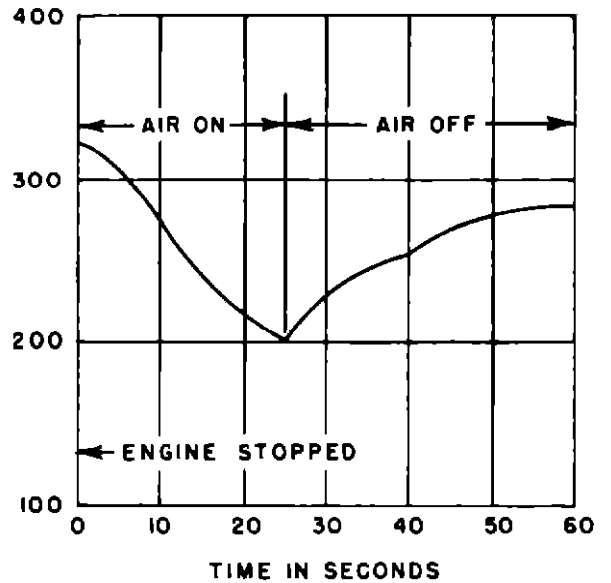
Fig 12 Curves Showing Temperature Changes in the Region of the Cowl Flaps During Engine Operation

The results obtained from the cowl flap thermocouples in three representative tests are reproduced as curves in Fig. 12. The maximum rate of temperature rise obtained in any test was about 450° F per minute, but this rate lasted only four seconds, and the average change of temperature was approximately 100° in all tests. The maximum temperatures and maximum rates of rise occurred in the top sector of the engine and in the regions adjacent to the two exhaust stacks. A series of six Edison type detectors mounted in the top of the cowl flap opening did not operate during any of the tests.

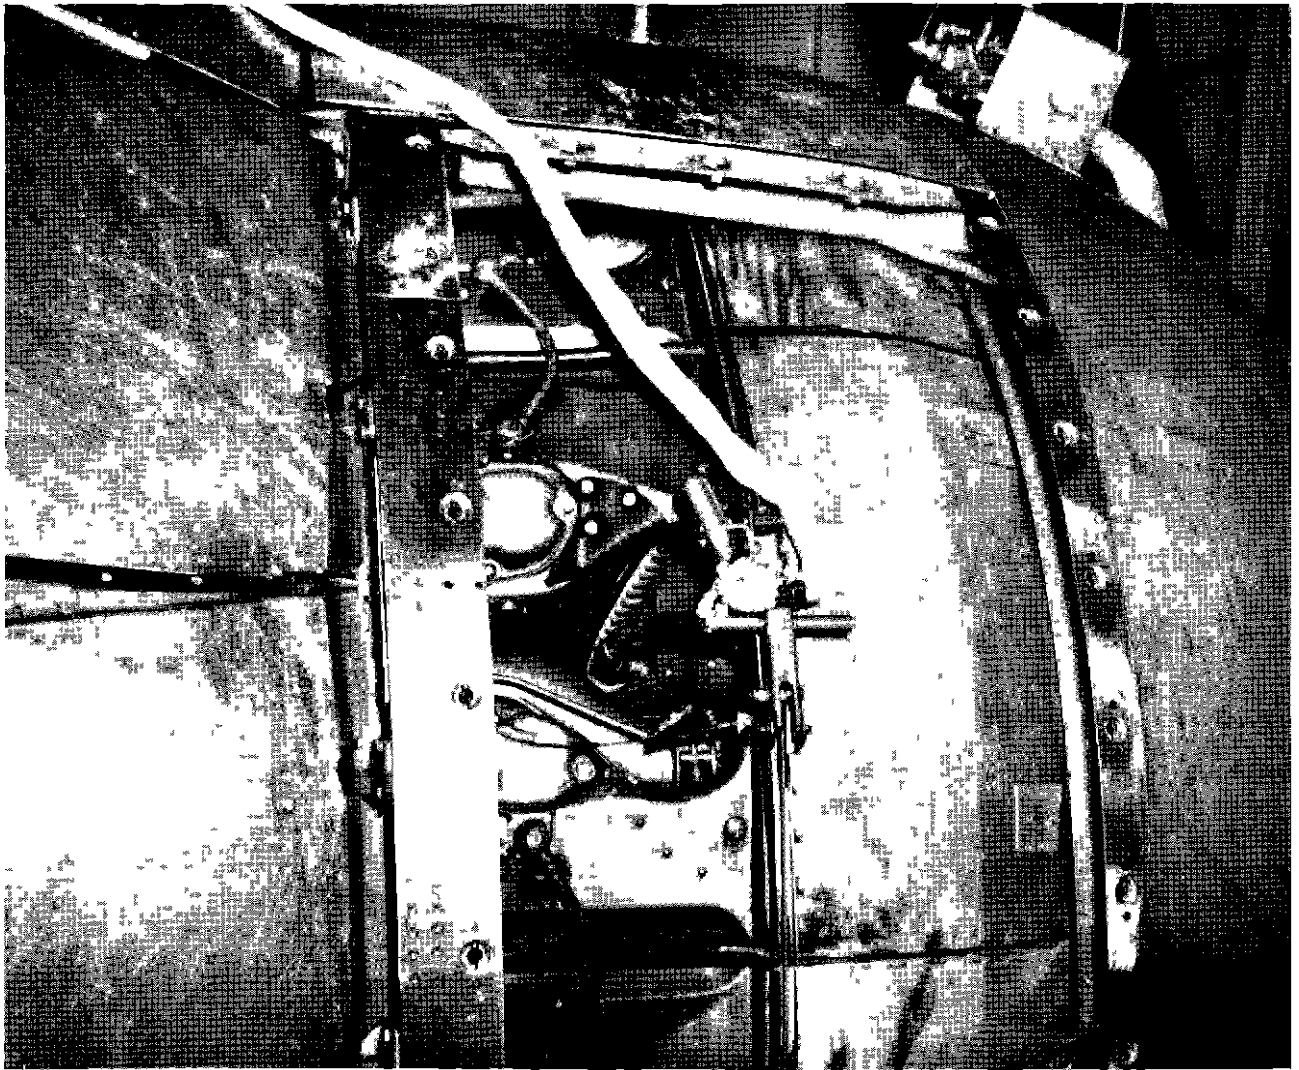
Fig 13 Photoswitch Detector Mounted on B-29 Engine for Tests

The Photoswitch detector (trade-mark "Fireye") used a photocell. One photocell unit was placed in the power section near the cowling at about Station -30 (see Fig. 19) and radially at about Cylinder No. 4 (see Fig. 13). It was pointed to observe the area downward and rearward of that point. Fires were originated at a number of different points, both in front and in back of the engine, simulating failure at cylinders on the right side of the engine. The other photocell was located just below the accessory door at about Station 15 on the right side of the accessory section and pointed to observe the opposite side of the nacelle. Fires were originated at a number of points on the right side of the accessory
