# **HAILSTONE IMPACT TESTS ON AIRCRAFT STRUCTURAL COMPONENTS**

By  
Pell Kangas  
Aircraft Division

Technical Development Report No. 124

**CIVIL AERONAUTICS ADMINISTRATION  
TECHNICAL DEVELOPMENT AND  
EVALUATION CENTER  
INDIANAPOLIS, INDIANA**

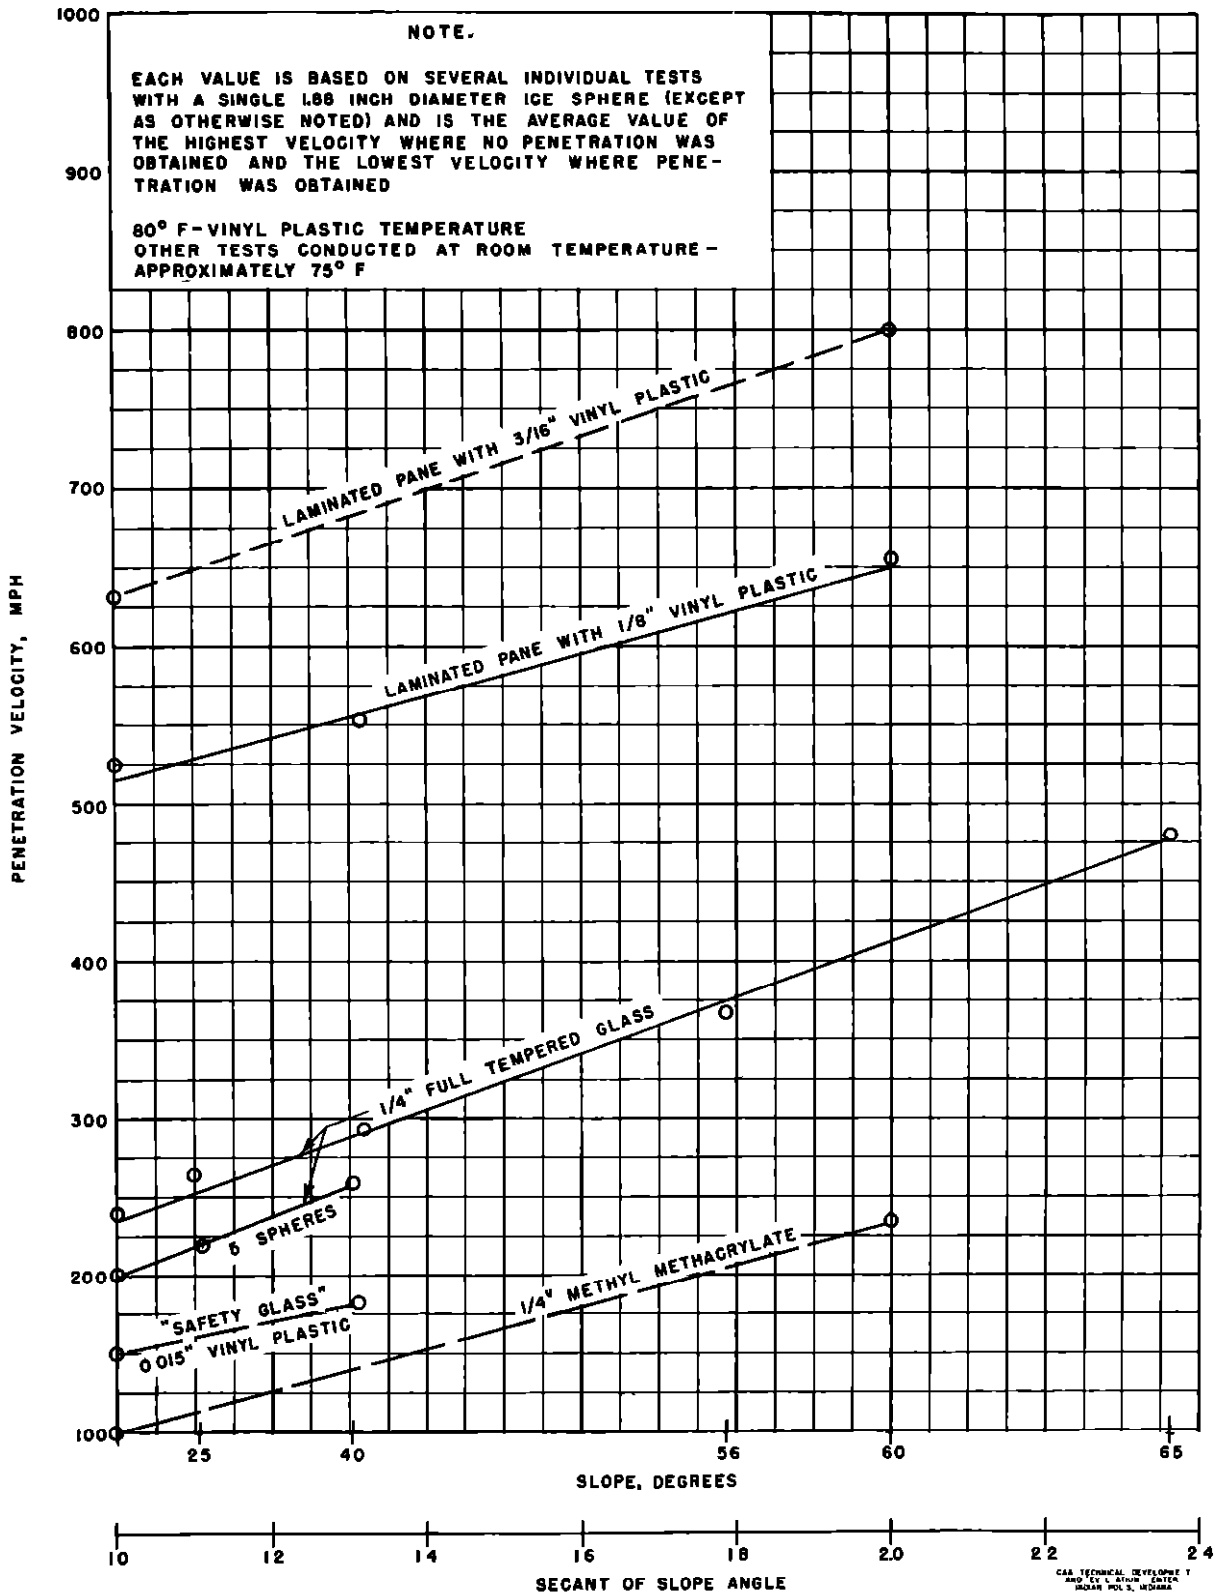
Fig 4 Impact Tests With 1.88-Inch Diameter Ice Spheres on Various Windshield Materials Showing Effect of Angle of Windshield Slope on Penetration Velocity

The results of tests of the various windshield materials are shown in Fig 4, in which the penetration velocity is plotted against the secant of the angle of slope of the windshield pane. Each value of penetration velocity shown in Fig 4 is based on several individual tests with the 1 88-inch diameter ice sphere, and is the average value of the highest velocity where no penetration was obtained and the lowest velocity where penetration was obtained. It will be noted that, for three of the six curves, representing 0 125-inch vinyl plastic laminated pane and 0 25-inch full-tempered glass, there exists a linear variation between the penetration velocity and the secant of the angle of windshield slope. Since the curves for "safety-glass," 0 25-inch methyl methacrylate panes and 0 188-inch vinyl plastic laminated panes, are determined by only two test values, they are indicated by broken lines.

is only slightly greater for the 0 25-inch full-tempered glass than for any of the other curves shown in Fig 4. For example, the penetration velocity of 0 25-inch full-tempered glass was 235 mph, or 45 per cent of that of 0 125-inch vinyl plastic laminated panes at 0° slope, and at 60 per cent of that of the 0 125-inch vinyl plastic pane.

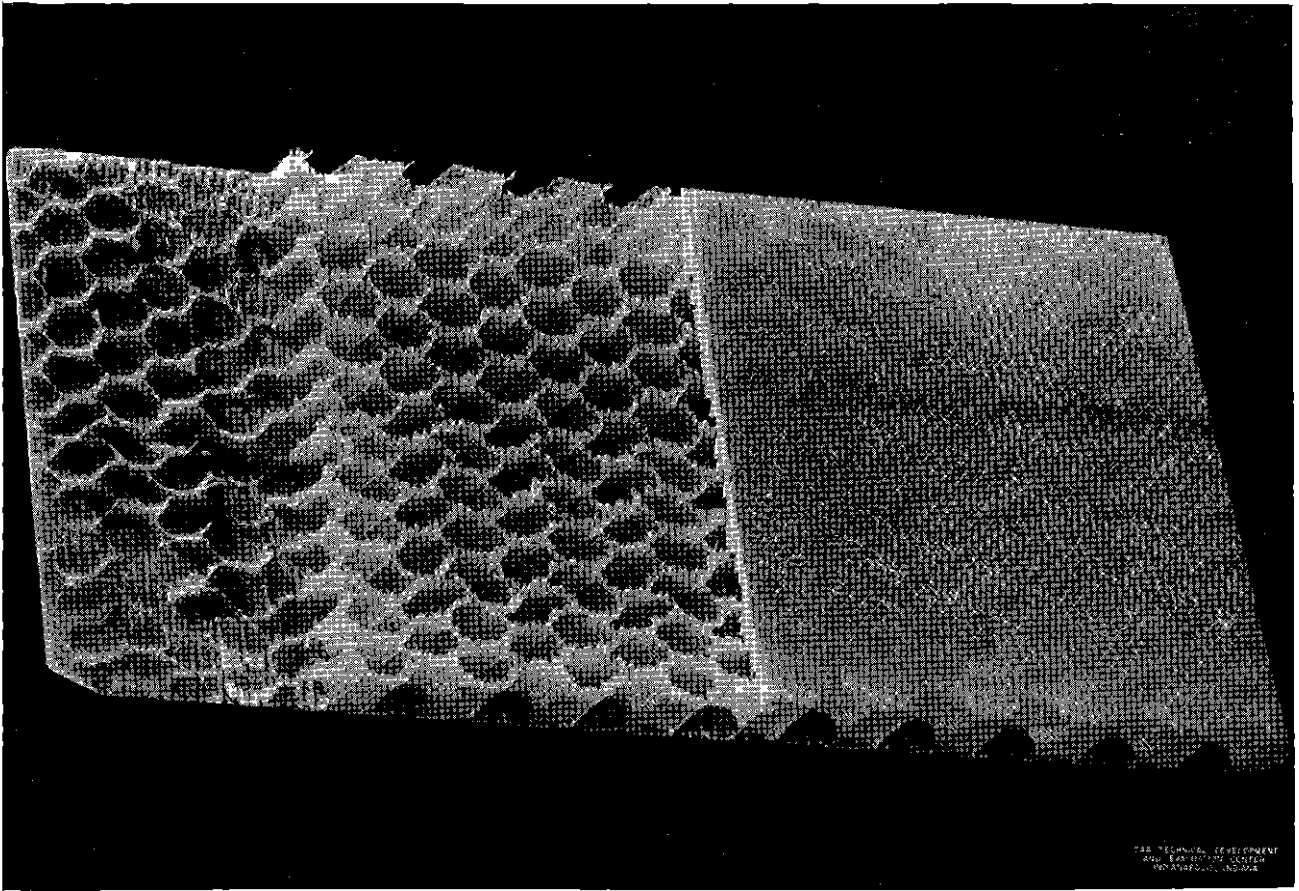
Fig 7 Fiberglass Honeycomb Test Panel Section, Actual Size

The radomes consisted of two or more surface layer laminations of fiberglas cloth bonded to a fiberglas honeycomb core. A section of a flat test specimen is shown in Fig 7. Various resins were used as impregnating and bonding agents. The unit weight of the resulting laminations ranged from about 0.75 to 1 pound per square foot. Further details concerning dimensions, types of cloth and resins used are given in Table I.
