TECHNICAL DEVELOPMENT REPORT NO. 301

BIRD-IMPACT TESTS OF THE  
BOEING MODEL 707 AIRPLANE WINDSHIELD

February 1957

CIVIL AERONAUTICS ADMINISTRATION  
TECHNICAL DEVELOPMENT CENTER  
INDIANAPOLIS, INDIANA

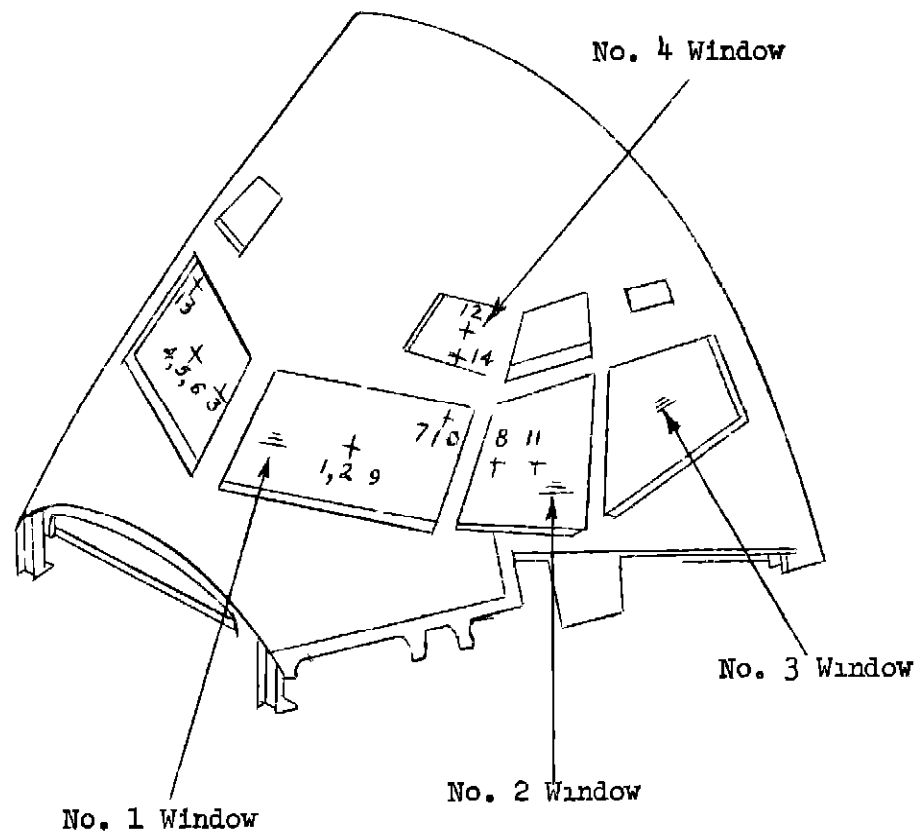
## POSITION OF IMPACT

Test No.	Velocity (mph)	Results
1	355	Penetration*
2	380	Slight penetration*
3	393	No penetration
4	416	No penetration
5	422	No penetration
6	440	No penetration
7	380	No penetration
8	378	No penetration**
9	400	No penetration
10	460	No penetration**
11	420	No penetration
12	393	Penetration
13	450	Penetration
14	405	No penetration**

\*Vinyl temperature below optimum for maximum strength.

\*\*Supporting structure failure allowing part of carcass to enter cockpit.
