TECHNICAL DEVELOPMENT REPORT NO. 342

BIRD-IMPACT TESTS OF THE  
BOEING MODEL 707 AIRPLANE EYEBROW WINDOW

April 1958

CIVIL AERONAUTICS ADMINISTRATION  
TECHNICAL DEVELOPMENT CENTER  
INDIANAPOLIS, INDIANA

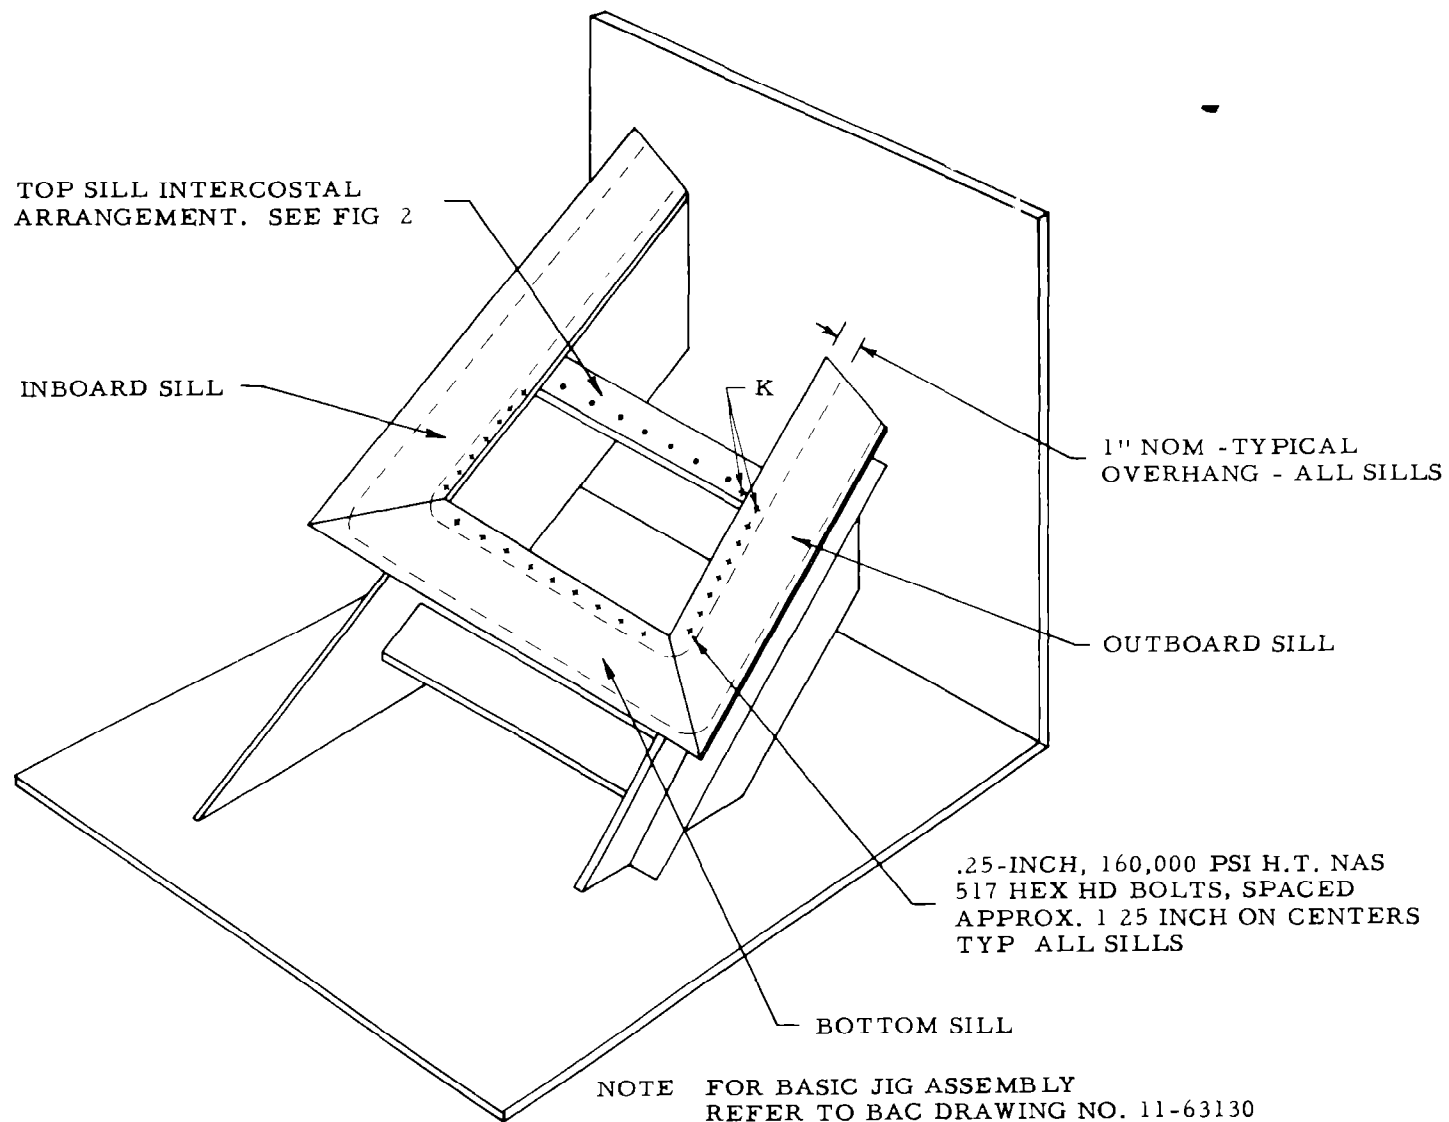
FIG 1 TEST JIG ASSEMBLY

TWO .25-INCH, 160,000 PSI H.T. NAS 517 HEX HD BOLTS  
WERE ADDED IN TESTS NOS. 22, 23, 24, 25, AND 26 AT K.

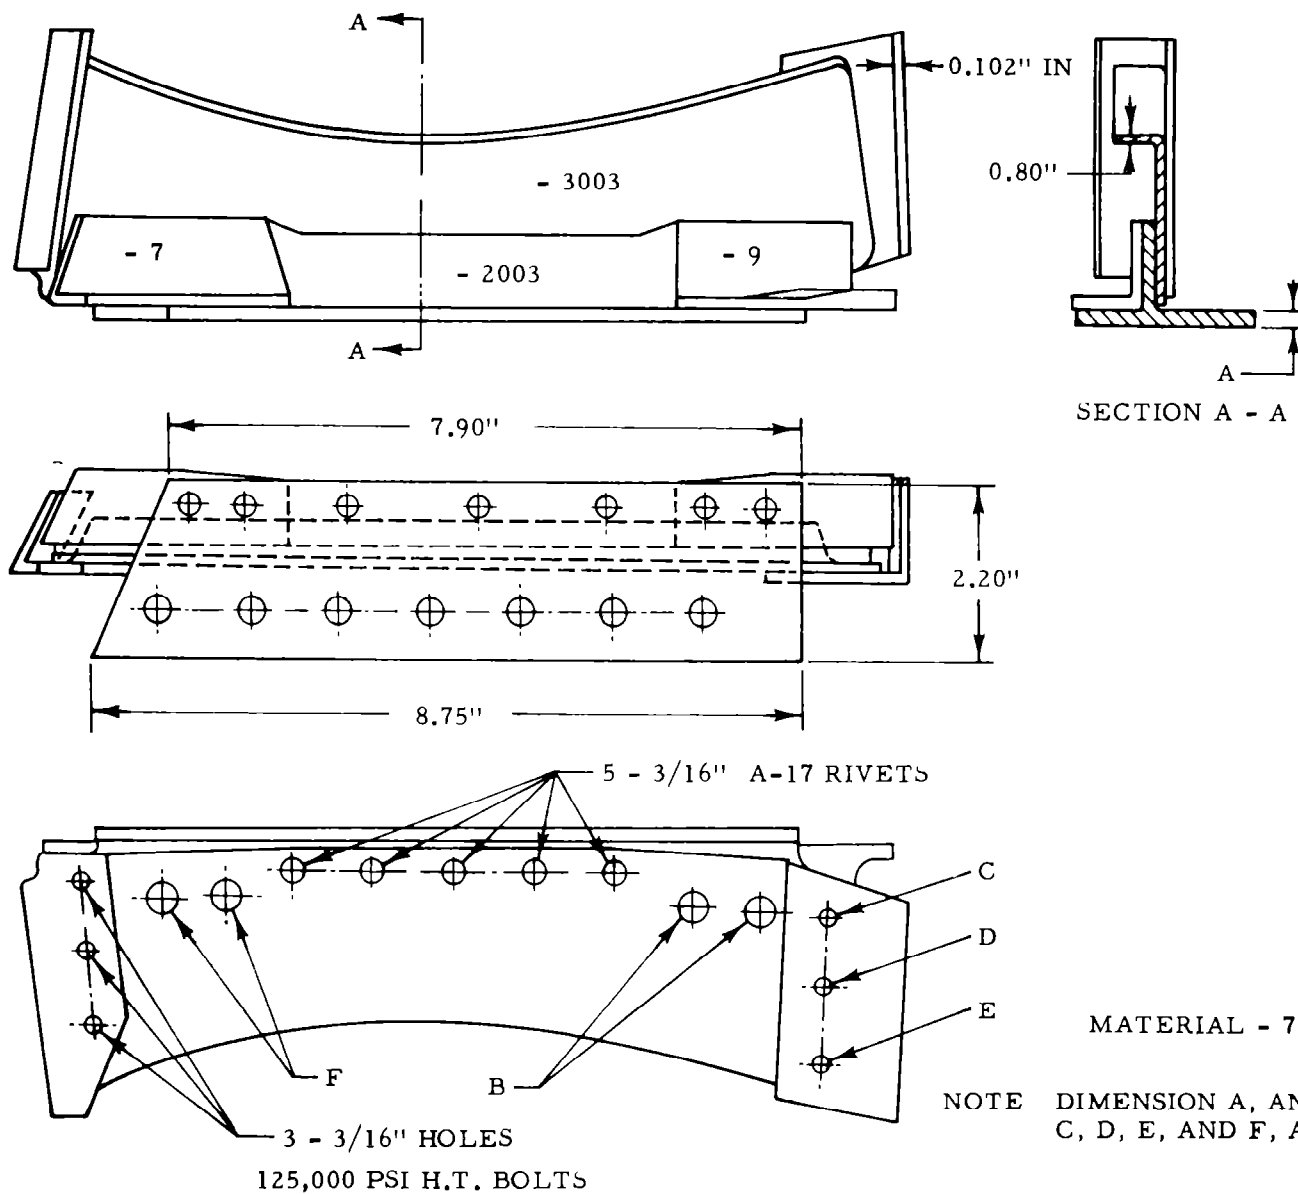
FIG. 2 TOP SILL INTERCOSTAL ASSEMBLY NO. 5 - 71779

Part of the carcass penetrated the window as the top sill intercostal failed and one-half of the outboard sill failed as shown in Figs. 54, 55, 56, and 57. The two 3/16-inch-diameter rivets and one 3/16-inch-diameter bolt, shown as C, D, and E of Fig. 2, failed and permitted the remaining portion of the top intercostal sill to deflect rearward and downward. Parts of the carcass which penetrated the window extruded through the structure between the top sill and the attached skin, and passed over the position of the pilot's head. The Plex-55 inner face crazed, but did not depart from the inner-layer vinyl. The inner vinyl-Plex-55 laminate tore at the center of impact and from the top outboard corner toward the center of the window. A few 1/4-inch-thick full-tempered glass particles escaped through the tears in the vinyl-acrylic and impinged upon the floor and vertical wall of the test jig, as determined from high-speed film. Glass fragmentation from this window was less severe than in any of the previous tests.

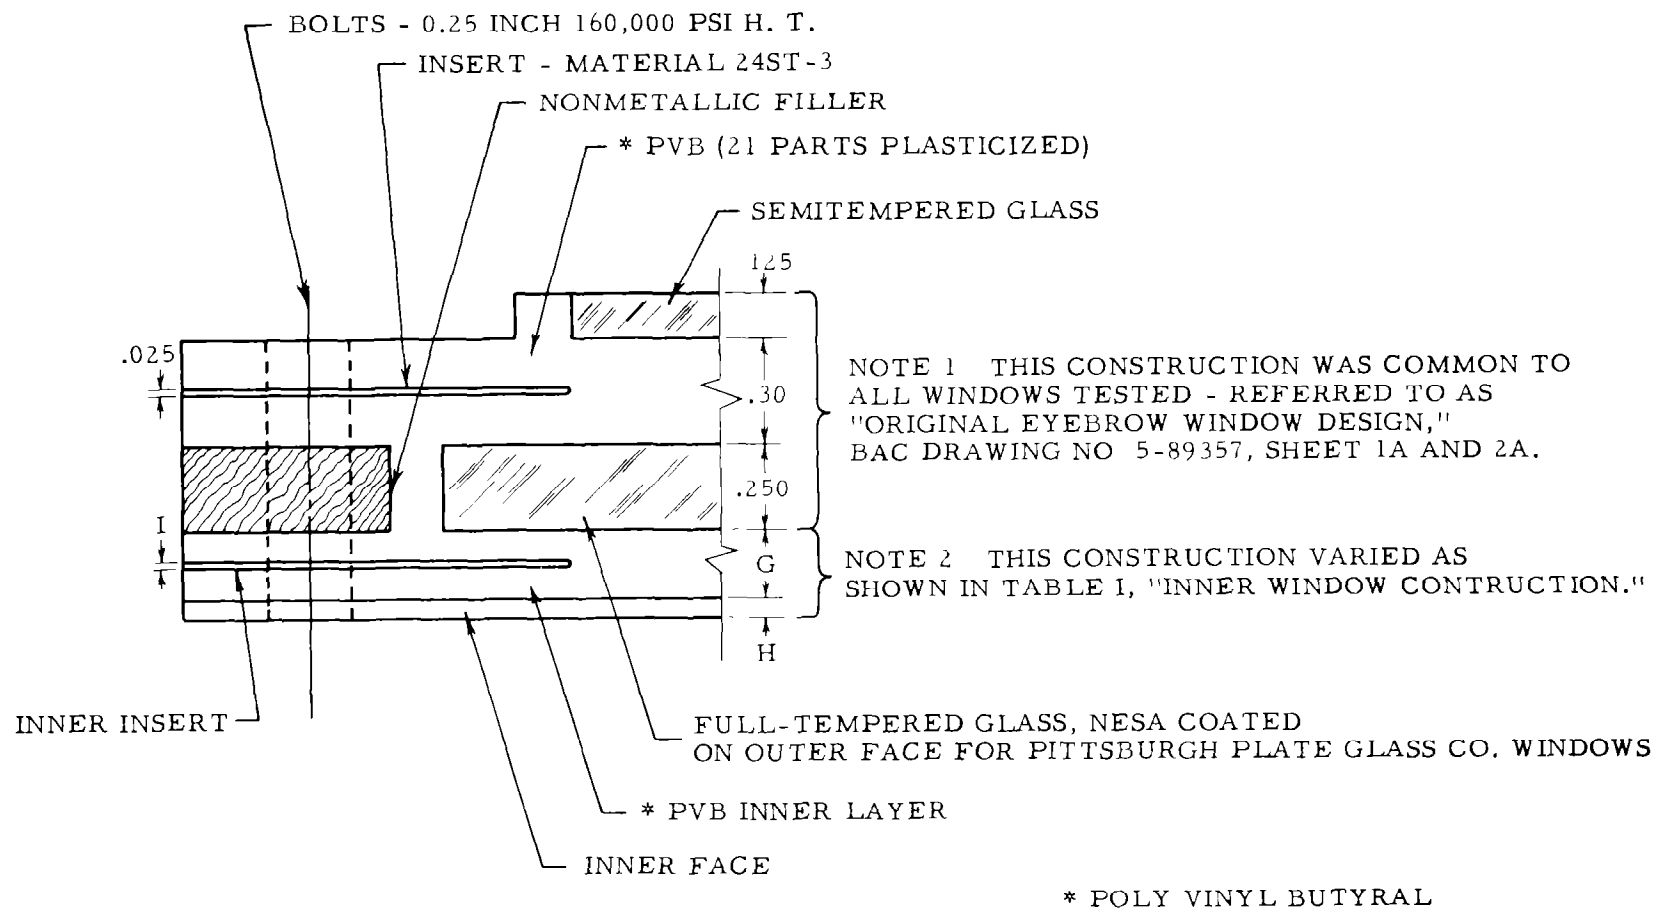
FIG. 3 TYPICAL WINDOW CONSTRUCTION

The eyebrow window is fastened directly to the sill structure by bolts which pass through the edge of the window as shown in Fig. 3. The window is mounted from the inside and retaining nuts bear against a washer plate. The window, mounted in the jig assembly, is shown in Fig. 4.
