TECHNICAL DEVELOPMENT REPORT NO. 348

BIRD IMPACT TESTS OF THE DOUGLAS  
MODEL DC-8 AIRPLANE WINDSHIELD

May 1958

CIVIL AERONAUTICS ADMINISTRATION  
TECHNICAL DEVELOPMENT CENTER  
INDIANAPOLIS, INDIANA

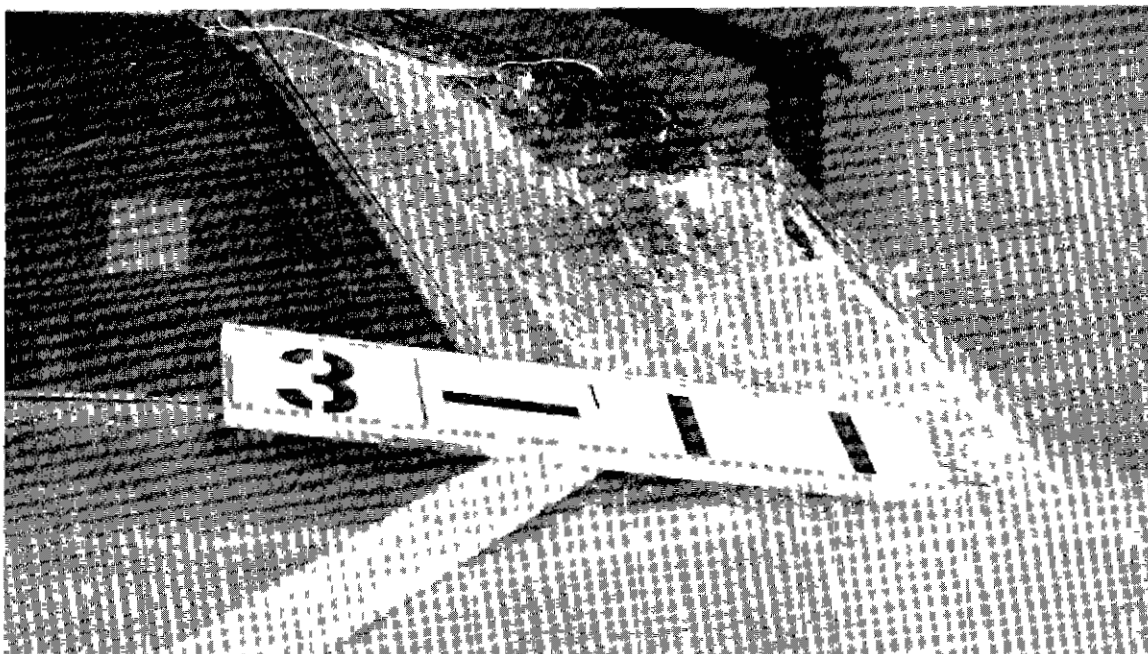
FIG 38 TEST NO 11 - EXTERIOR PANEL, PROJECTILE VELOCITY - 444 MPH

The carcass struck about three inches below the target point. A slight amount of the bird carcass entered the cockpit area and passed between the pilot and copilot positions. The exterior window failed as the vinyl interlayer pulled away from the metal insert for a length of 13 inches from right center into the upper left corner of the window. This failure continued around the upper left corner and downward a length of five inches parallel to the left centerpost sill, as shown in Fig. 38. The vinyl in the inner window failed in such a manner that a large circular-shaped glass-vinyl-glass flap, approximately 12 inches in diameter, and hinged parallel to the right centerpost sill, was formed. See Fig. 39. The failures of the two

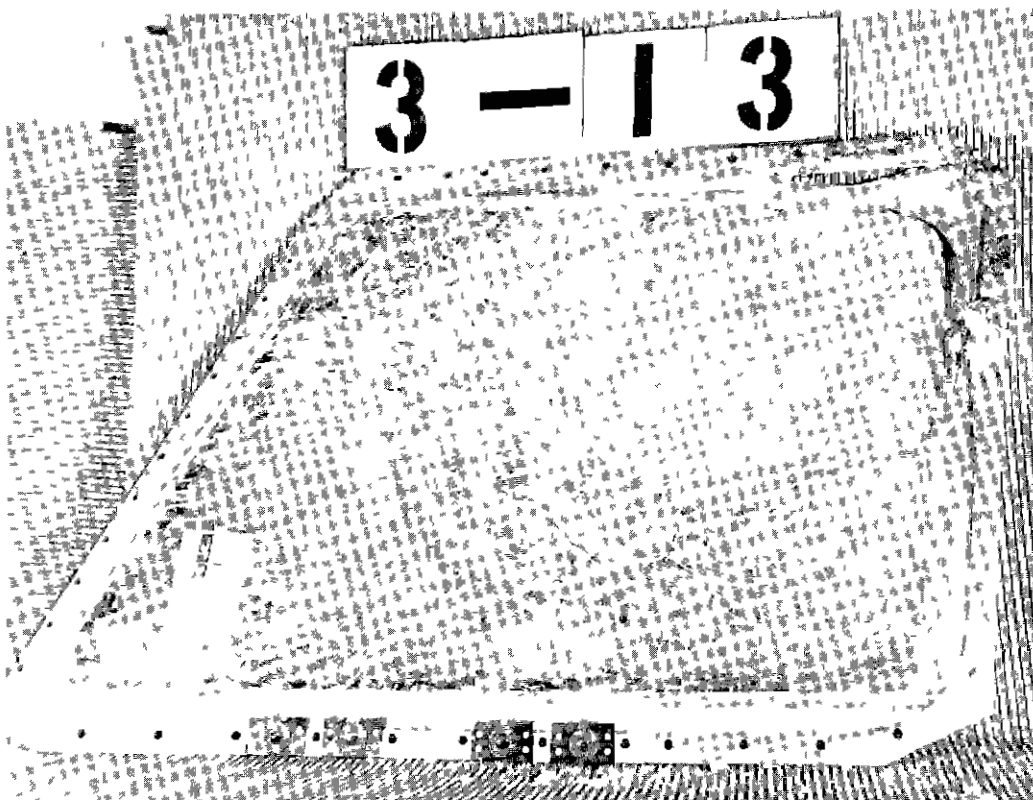
FIG 44 TEST NO 13 - EXTERIOR PANEL, PROJECTILE VELOCITY - 482 MPH

The carcass hit two inches inboard of the target point. None of the bird carcass entered the cockpit. The exterior window panel failed as the metal insert sheared along the top edge for a length of five inches toward the upper outboard corner, and the vinyl sheared along the cornerpost edge downward a length of eight inches from a point two inches inboard of the upper outboard corner, as shown in Fig. 44. No vinyl failure of the interior window panel occurred. See Figs. 45 and 46. Numerous particles of semitempered glass which departed from the aft face of the interior window were directed toward the pilot's face from chin to eyebrow level. The glass particles, which were sliver-like with sharp edges, penetrated into the clay about 1/32-inch. The pilot's goggles remained intact except for numerous scratches on both of the 0.020-inch-thick cellulose acetate lenses caused by flying glass particles. See Fig. 47 for the glass-impingement pattern on the pilot's face.

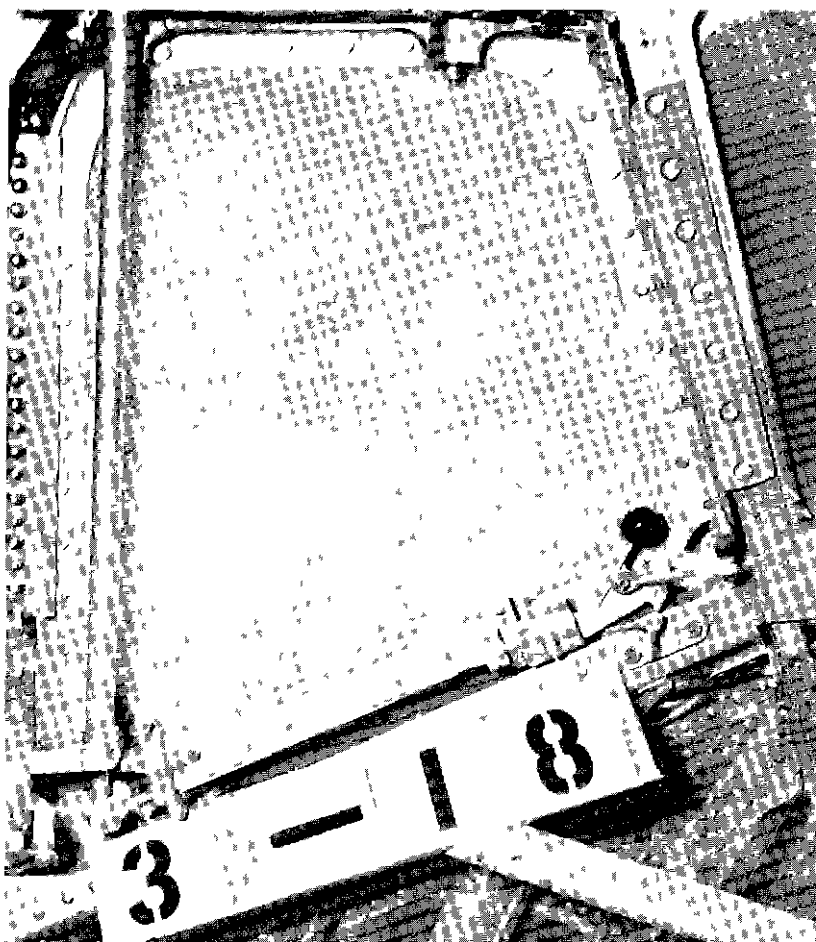
FIG. 60 TEST NO. 18 - INTERIOR PANEL, PROJECTILE VELOCITY - 448 MPH

The bird carcass hit near the forward edge of the window frame, which would be considered the critical strike area as far as flying glass is concerned. The external Flex-55 window panel failed as shown in Fig. 59. The vinyl of the interior window did not fail, preventing penetration. See Fig. 60. A small portion of the bird carcass extruded through the structure between the window frame and aft post into the cockpit. The window frame cracked near the upper aft hinge point as in Test No. 7. The aft frame fixed retainer remained intact. The center section of the aft outer doubler facing plate bowed outward as in previous tests of this window, and two retaining bolt heads failed in tension. Numerous semitempered glass particles from the aft face of the interior window impinged upon the left side of the pilot's head from neck level to above the left ear, as shown in Fig. 61. Only two of these particles were imbedded to any degree in the clay. The pilot's eye area was untouched as the goggles with 0.020-inch-thick plastic

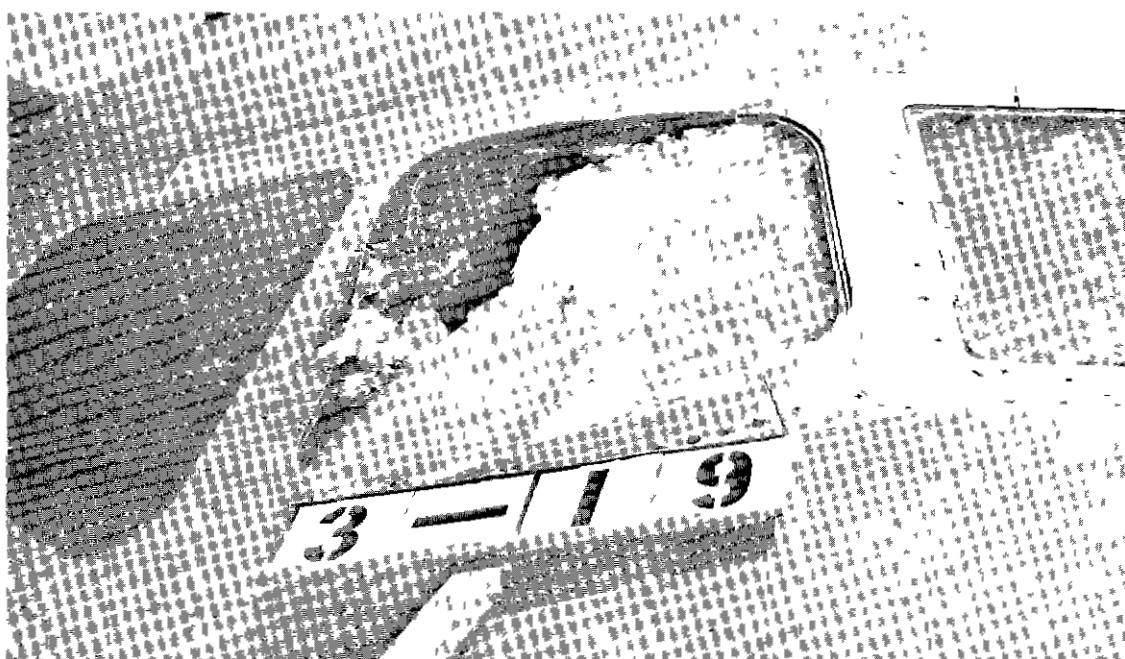
FIG 62 TEST NO 19 - EXTERIOR PANEL, PROJECTILE VELOCITY - 435 MPH

For this test, the interior glass-vinyl-glass panel for the clear-view window was reduced in temperature to nearly 45° F to determine whether a lower temperature limit extrapolation relative to penetration velocity could be applied to the window. Upon impact, part of the carcass entered the cockpit as the external stretched Plex-55 panel shattered, as shown in Fig. 62, and the interior panel vinyl interlayer failed, as shown in Fig. 63. About one-quarter of the interior window panel tore loose and was forced inward and to the rear of the cockpit, missing the pilot. The window frame cracked just forward of the upper aft corner as in two previous tests of this window (Tests Nos. 7 and 18). The upper hinged window frame retainer failed partially, and the aft fixed retaining bar failed in bending and direct tension. The copilot was struck on the right side of the face and neck area by small semitempered glass particles and bird-carcass entrails, as shown in Fig. 64. Most of the glass merely impinged upon the clay with little or no penetration.
