# **Determination of Means To Safeguard Rotary-Wing Aircraft From Powerplant Fires in Flight**

**Fire-Detection and Fire-Resistance Studies  
of a Sikorsky H-5A Helicopter**

**TECHNICAL DEVELOPMENT REPORT NO. 351**

**February 1959**

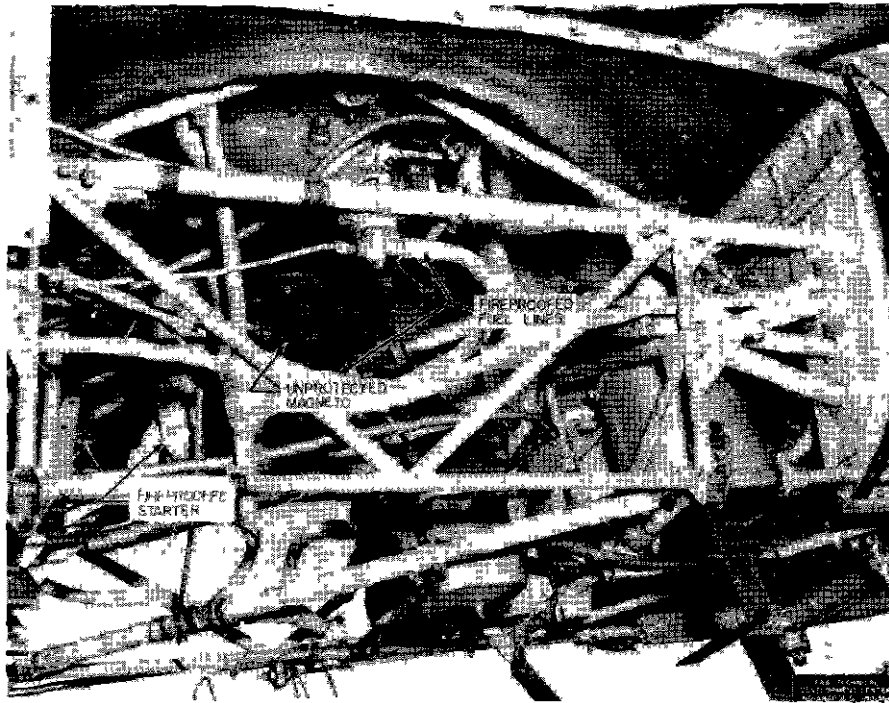
Fig 3 Left Side View of H-5A Engine Accessory Section

Engine controls and accessories were located in the accessory compartment below the engine power section. Many of the accessories, as well as the fuel and oil lines, were protected from flames during the tests by a covering of asbestos and water glass, as shown in Fig 3. Critical control surfaces, air ducts, bolted joints, tubular truss structure, cowling, firewalls, and oil coolers were left exposed to the fire.

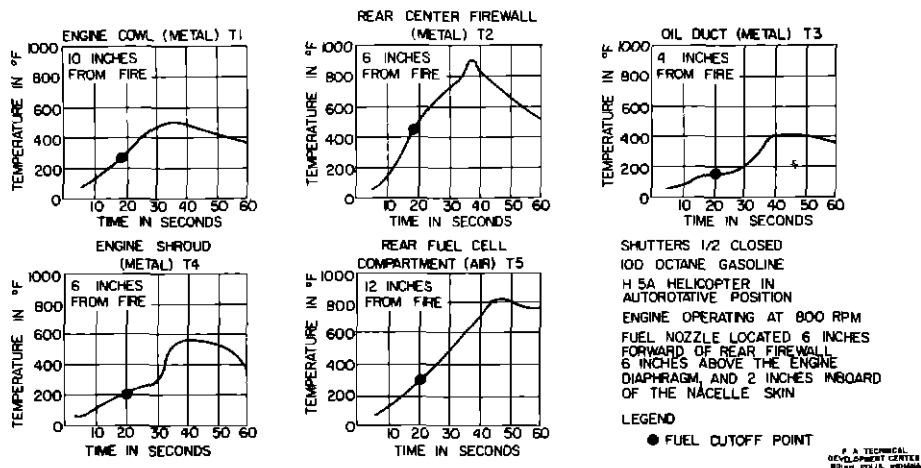
The first of this series of fires was supplied fuel with the nozzle placed 6 inches forward of the rear center firewall, 6 inches above the engine diaphragm, and 2 inches inboard of the nacelle skin. Temperatures recorded during this test are shown graphically in Fig 9. Abnormally high temperatures were recorded in the rear fuel compartment. Motion pictures taken during these tests disclosed that flames were forced by the engine cooling fan through leaky compartment seals that had burned through during previous fires.

Fig. 9 Temperatures Recorded During a 2.4-GPM Gasoline Fire

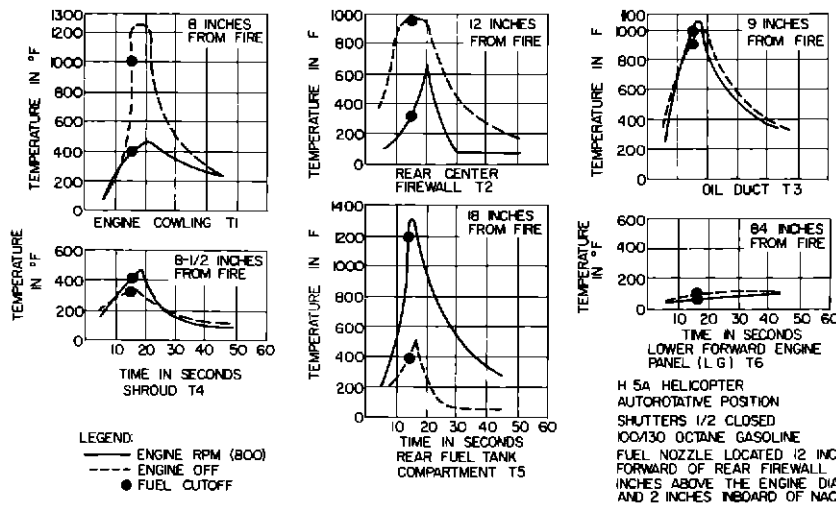
The second fire of this series was supplied fuel with the nozzle placed 12 inches forward of the rear center firewall, 6 inches above the engine shroud, and 6 inches inboard of the nacelle skin. The temperatures during this test are shown graphically in Fig 10. These results showed that maximum temperatures occurred 18 seconds after the fire was ignited. The engine cowl temperature was considerably lower with the engine operating, as the cooling fan forced the fire below the engine cowl.

**Fig. 10** Temperatures Recorded During a 2.4-GPM Gasoline Fire

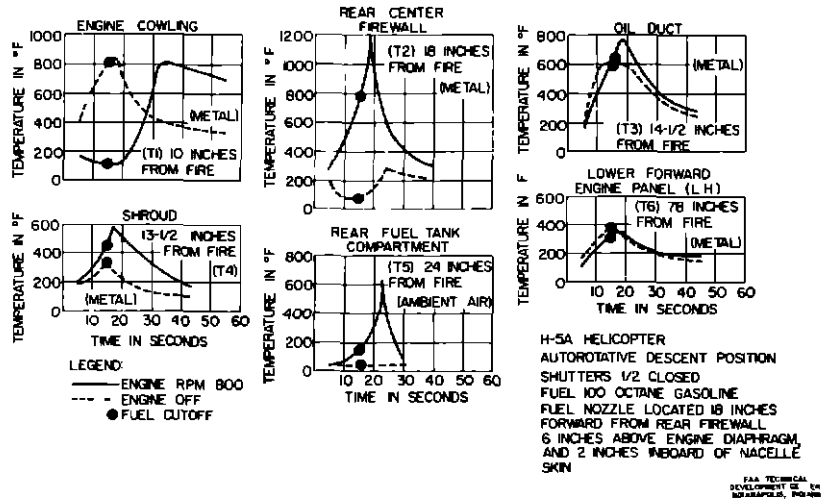
The third fire of this series was supplied fuel with the nozzle placed 18 inches forward of the rear center firewall, 6 inches above the engine shroud, and 2 inches inboard of the nacelle skin. The temperatures recorded during this test are shown graphically in Fig 11. These results indicated that temperatures of all instrumented surfaces were lower with the engine not operating. The rear fuel-tank compartment had no appreciable rise in temperature when the engine was not operated. Visual observation indicated that the flames were distributed entirely throughout the power section and were of greater intensity than in previous fires. These visual observations were corroborated by the measured temperatures within the engine section.

Fig 11 Temperatures Recorded During a 2 4-GPM Gasoline Fire

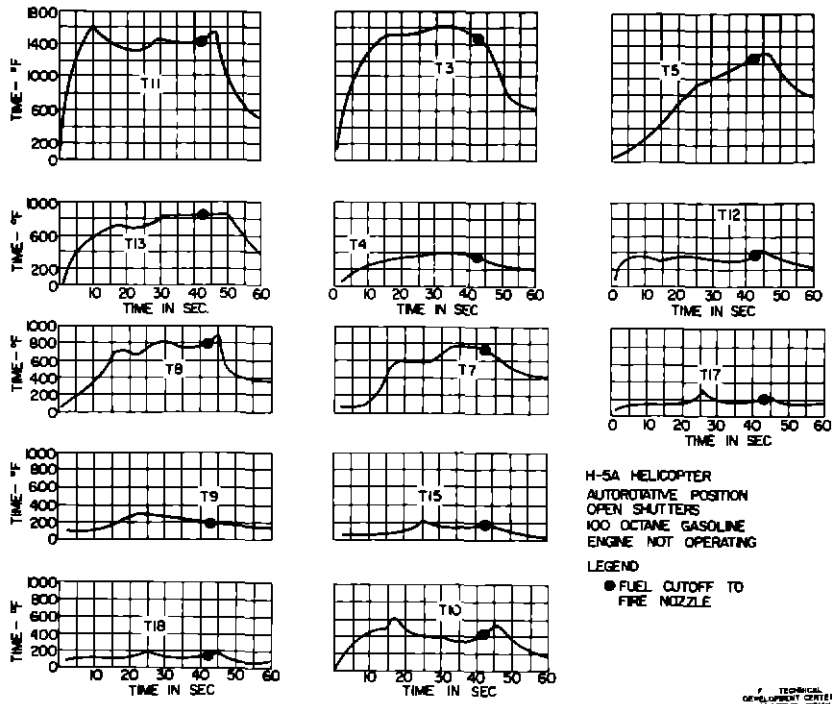
The first of these fires was ignited with the helicopter *simulating autorotative flight* and the engine not operating. The temperatures recorded during this test are shown graphically in Fig 14, and damages are listed in Table VI. These results indicated that the highest ambient temperatures were measured in the area surrounding the fuel nozzle.

Fig 14 Temperatures Recorded During First 3 0-GPM Gasoline Fire

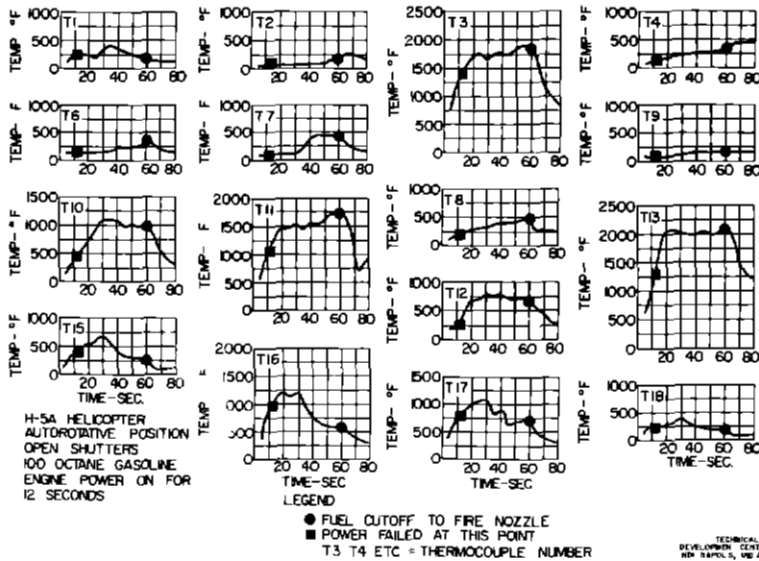
The second of these fires was ignited with the helicopter simulating autorotative flight and the engine running for the first 42 seconds, at which time the engine was stopped. The damaged areas are described in Table VII and are shown pictorially as the shaded areas in Fig 15. Temperatures measured during this test are shown graphically in Fig 16. These results showed the highest temperature of 2,200° F to have been measured in the vicinity of the fuel nozzle.

Fig 16 Temperatures Recorded During Second 3 0-GPM Gasoline Fire

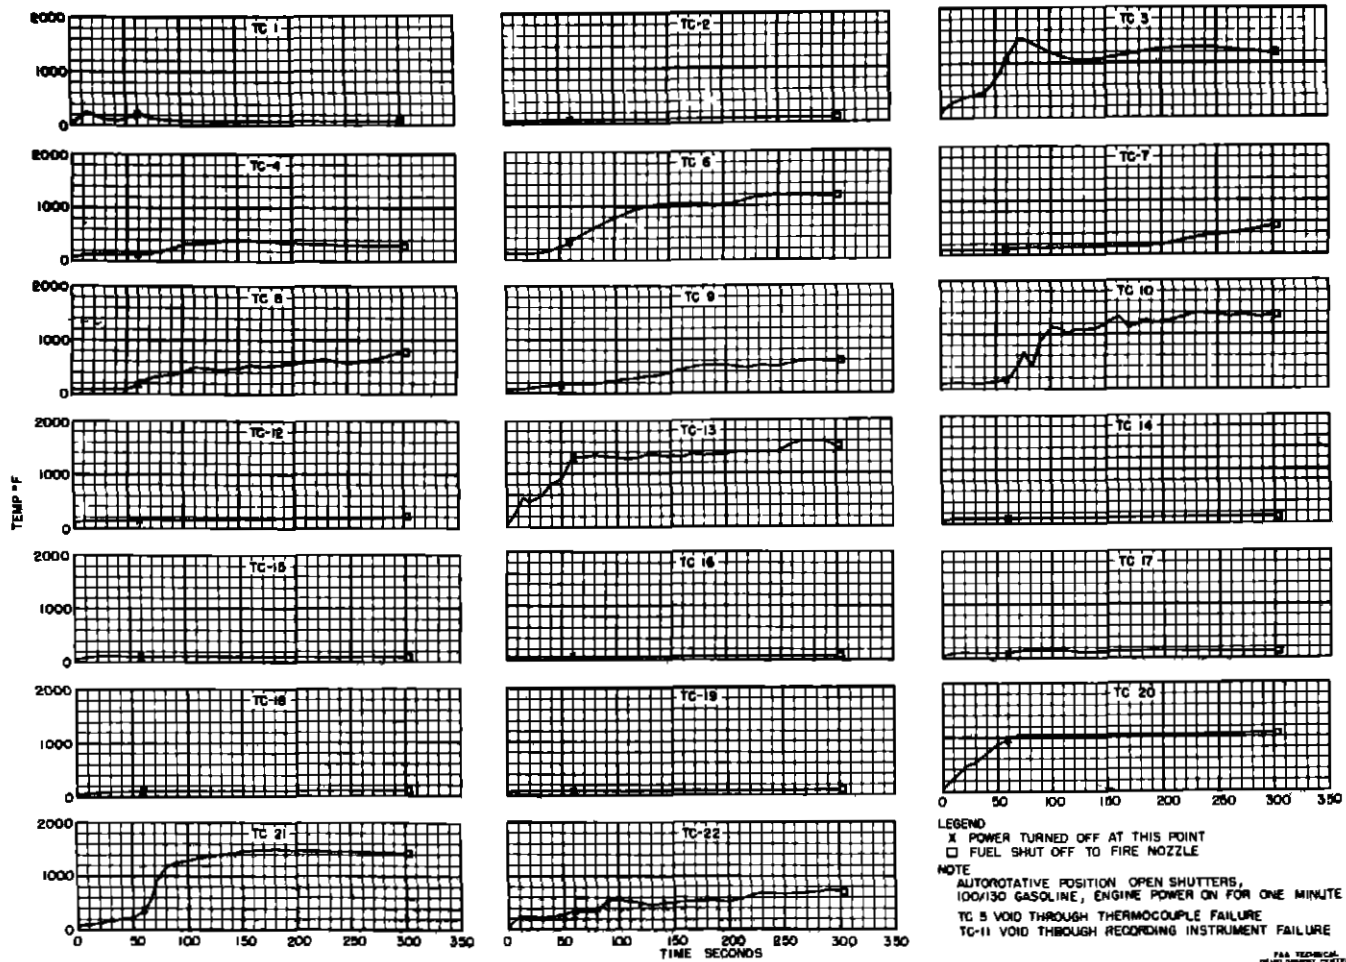
first minute of the test fire and then shut down. Fire damage is listed in Table VIII and a pictorial presentation of the damaged areas is shown in Fig 17. Temperatures recorded during this test are shown graphically in Fig 18. The helicopter, prior to this 5-minute fire, is shown in Fig 19. The damage incurred by the 5-minute fire is shown in Figs 20 and 21. Flame impingement past the stainless steel panels burned a hole through the aluminum skin of the fuel and oil compartments. A section of the oil tank also was burned away. The oil contained within the tank did not ignite, apparently, the main body of oil dissipated the heat.

Fig. 18 Temperatures Recorded During 30-GPM Gasoline Fire of 5 Minutes' Duration
