# **A Study of Ignition Hazards and Fire-Resistance of the Boeing 707 Powerplant**

**TECHNICAL DEVELOPMENT REPORT NO. 357**

**CIVIL AERONAUTICS ADMINISTRATION  
TECHNICAL DEVELOPMENT CENTER  
INDIANAPOLIS, INDIANA**

**August 1958**

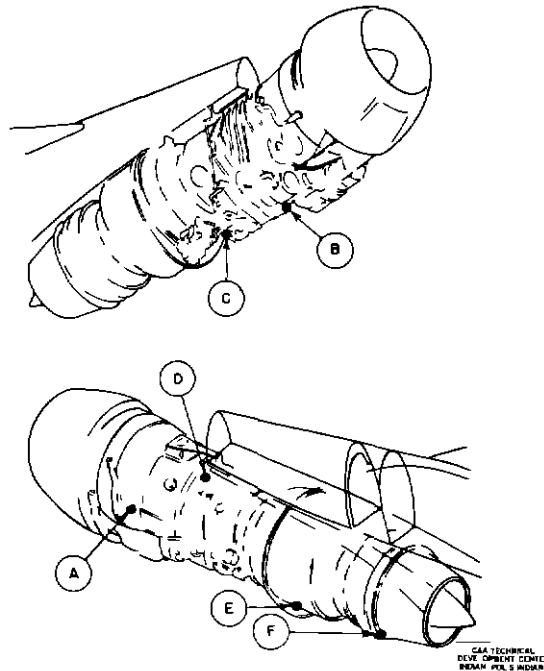
Fig 4 Location of Engine Oil Release Points

During the discharge of oil simulating failure of the oil pressure line to the rear turbine bearing at both locations in the burner section, ignition of MIL-L-7808 oil occurred after several attempts with the JP-4 primer fire. When oil was released at Location E, Fig 4, nacelle station 179, it puddled and burned in the bottom of the nacelle just aft of the firewall causing minor distortion of the nacelle latch line. Several short bursts of flame escaped from the nacelle and were carried away in the external airstream. The fire at nacelle station 211 burned in the annular opening around the tailpipe for 55 seconds and then was carried forward by the oil as it drained to the lower part of the nacelle just aft of the firewall. It continued to burn in this location for the duration of the test.

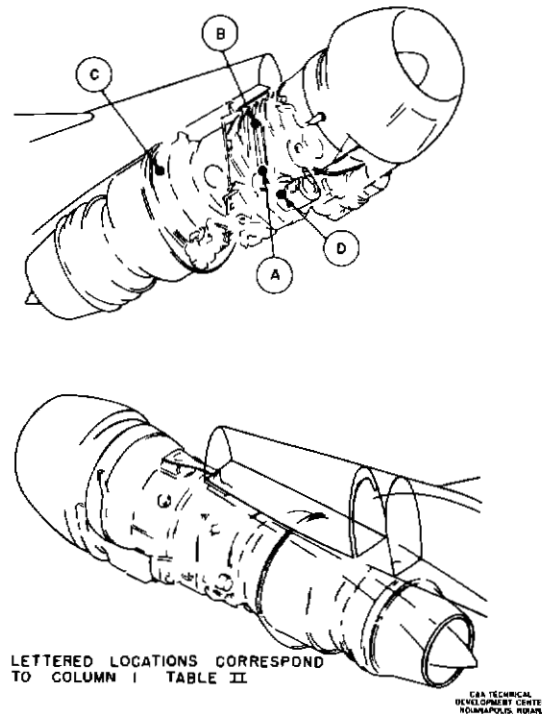
Fig 5 Location of Hydraulic Fluid Release Points

MIL-O-5606 hydraulic fluid was supplied at 3,000-psi pressure to the test location from an external reservoir and separate pump. The test location selected was at the fitting of the high-pressure hydraulic line on the plumbing shelf at the 2 o'clock position and at nacelle station 128. See Location B, Fig 5. The end of the test line was restricted, allowing only a small stream of hydraulic fluid to escape to simulate a loose fitting or a cracked line. Due to the high release pressure, the small stream of fluid sprayed over most of the right side of the compressor section.

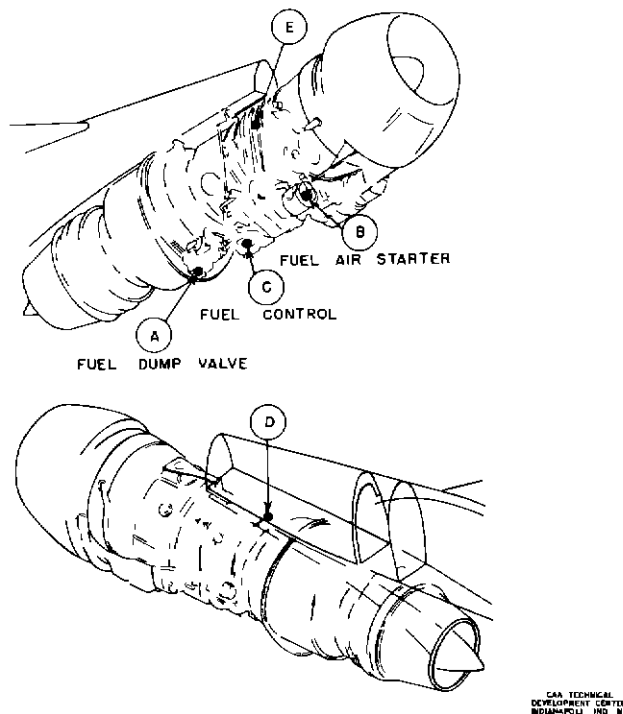
Fig 6 Location of JP-4 Fuel Release Points

Run No	Ignitor and JP-4 Fuel Discharge Location	Engine Power Setting	Fuel Flow to Fire				Results and Observations
			Time (min -sec )	Rate (gpm)	Time (min.-sec )	Total (gal )	
1	6 o'clock position, under fuel control, nacelle station 145, Location C, Fig 6	A	0-22	0 3	1-40	0 5	Small low-intensity fire caused very minor cowling damage, very small flames at nacelle door latch line
		B	1-0				
		C	3-24				
2	12 o'clock position, nacelle station 159, Location D, Fig 6	A	2-0	2 2	3-15	7 15	Low-intensity fire burned a 4- to 5-inch diameter hole in left cowl near hinge line and 20 inches forward of firewall Left air bleed duct seal destroyed
		B	1-0				
		C	2-2				
3	2 o'clock position, nacelle station 129, Location E, Fig 6	A	6-32	5 0 0 3	5-59 0-22	29 80 0 12	Intense fire destroyed 50 per cent of right nacelle door Several engine accessories made inoperative Some pylon skin burned through No flame damage other than discoloration observed in pylon No flames impinged on wing surfaces Total fire time 9 minutes - 1 second
