TECHNICAL DEVELOPMENT REPORT NO. 374

**Bird Impact Tests of the
Douglas Model DC-8 Airplane
Eyebrow And Clear-View Windows**

FEDERAL AVIATION AGENCY
TECHNICAL DEVELOPMENT CENTER
INDIANAPOLIS, INDIANA

BIRD IMPACT TESTS OF THE DOUGLAS MODEL DC-8 AIRPLANE EYEBROW AND CLEAR-VIEW WINDOWS

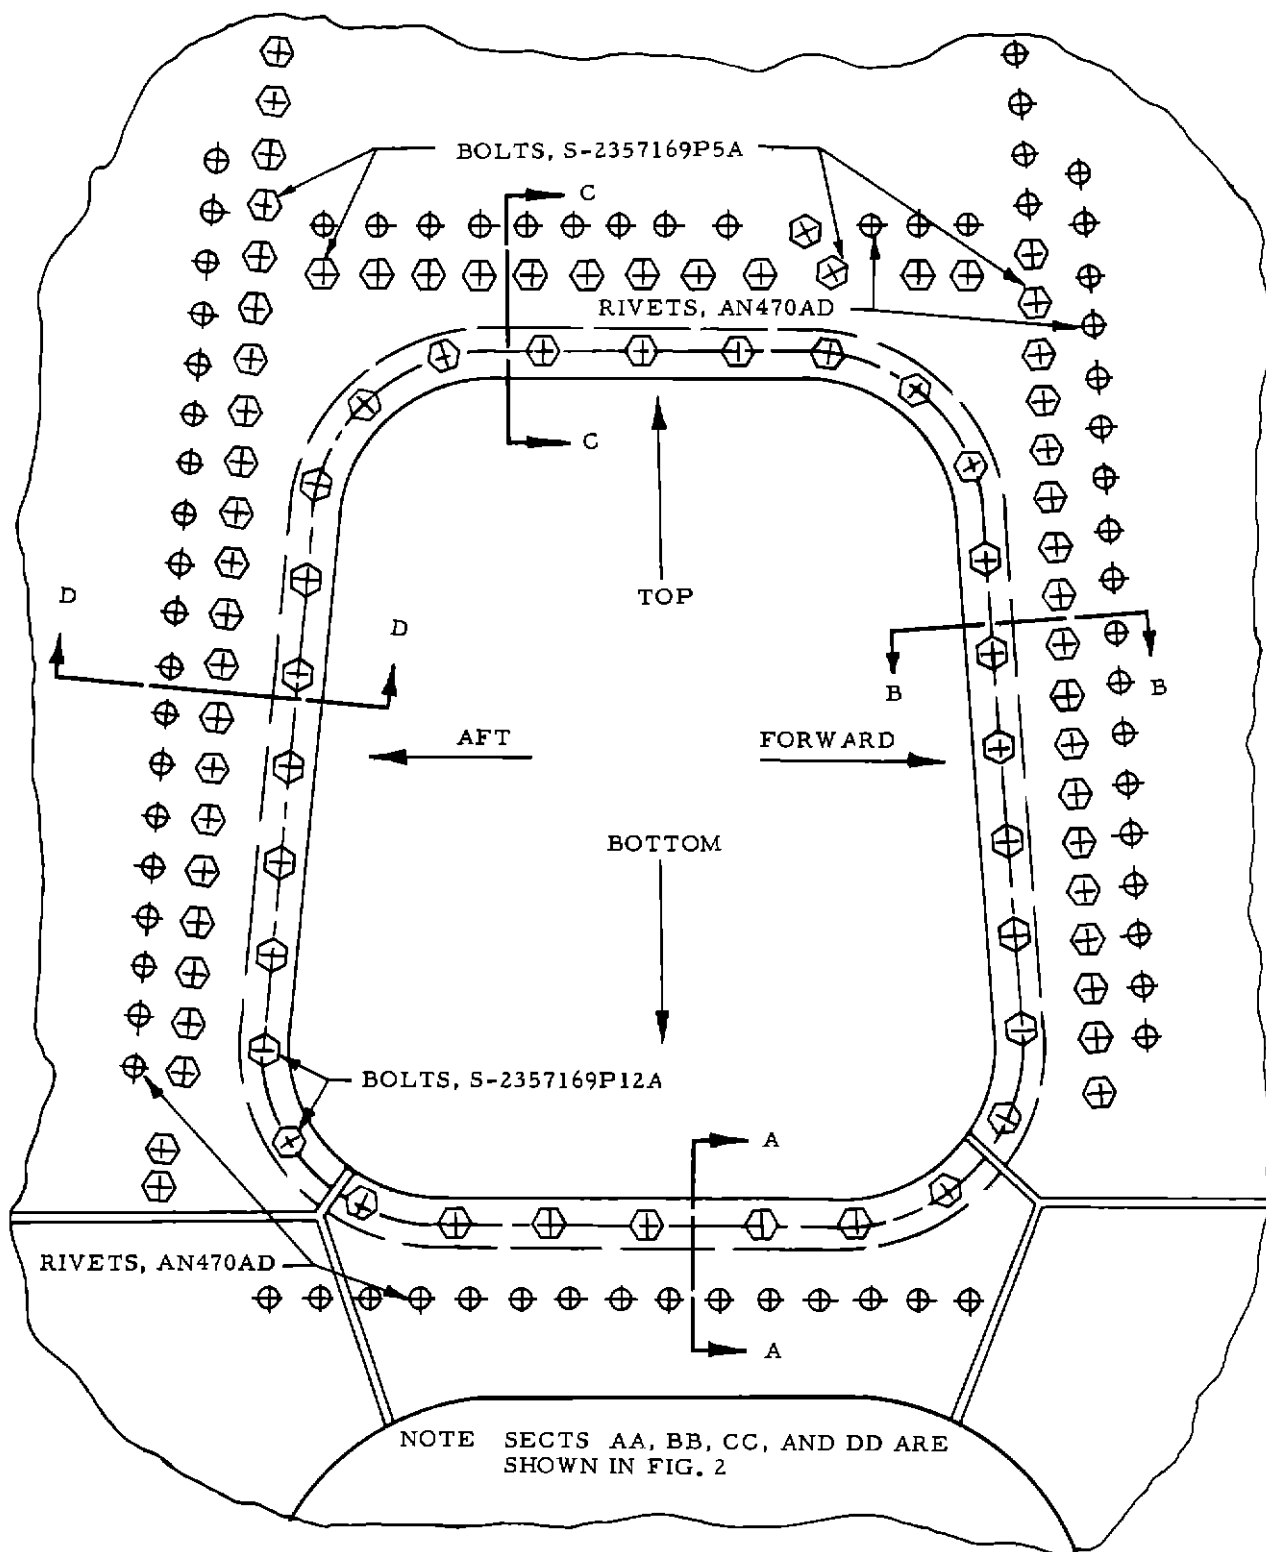
FIG 1 EYEBROW WINDOW INSTALLATION EXTERIOR VIEW COPILOT'S SIDE

1. The eyebrow window arrangement, as shown in DAC Drawing No. 5653470, Rev. B, and Figs. 1 and 2, will withstand satisfactorily the impact of a 4-pound bird carcass at a velocity as high as 485 mph provided the following structural modifications are incorporated

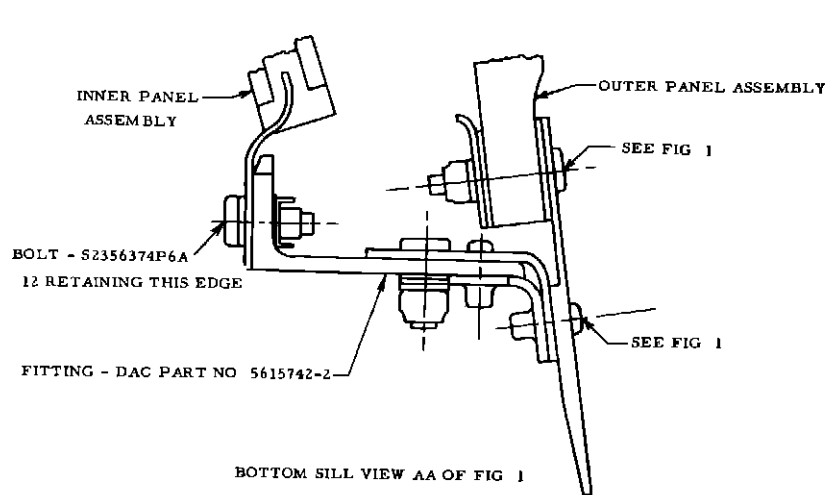
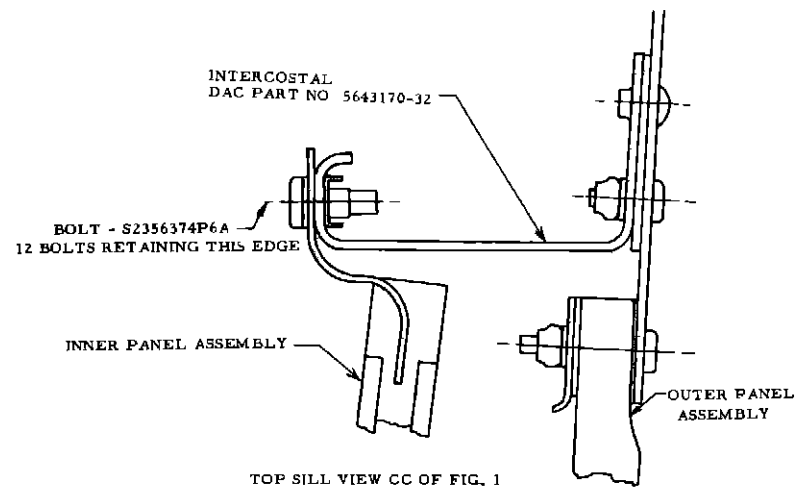
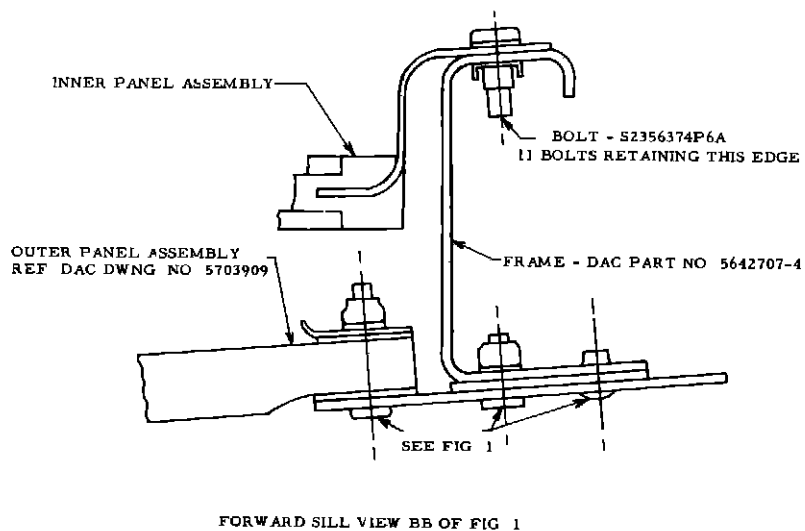
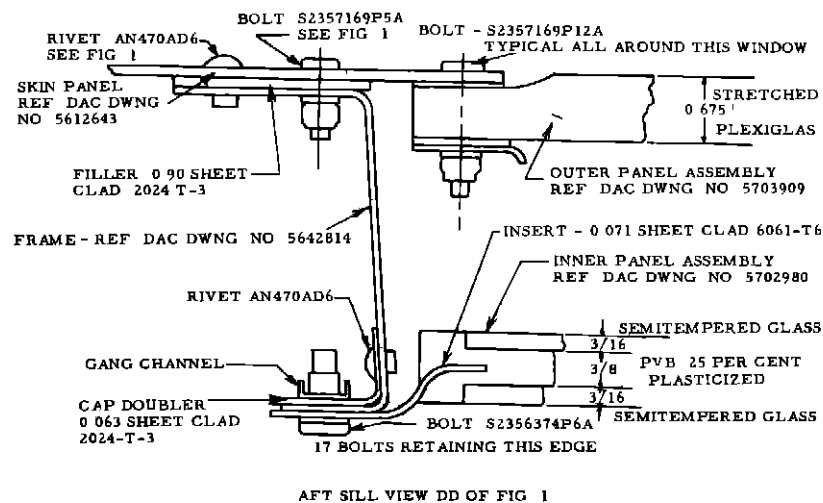
FIG 2 SECTIONAL VIEW OF EYEBROW WINDOW
REF DAC DRAWING NO 5653470

* Failure of the sill frame supporting structure allowed part of bird carcass to enter the cockpit

*** MODIFICATIONS ARE GIVEN WITH REFERENCE TO THE AFT SILL OF TEST NO. 3-21, SHOWN IN FIG. 2**

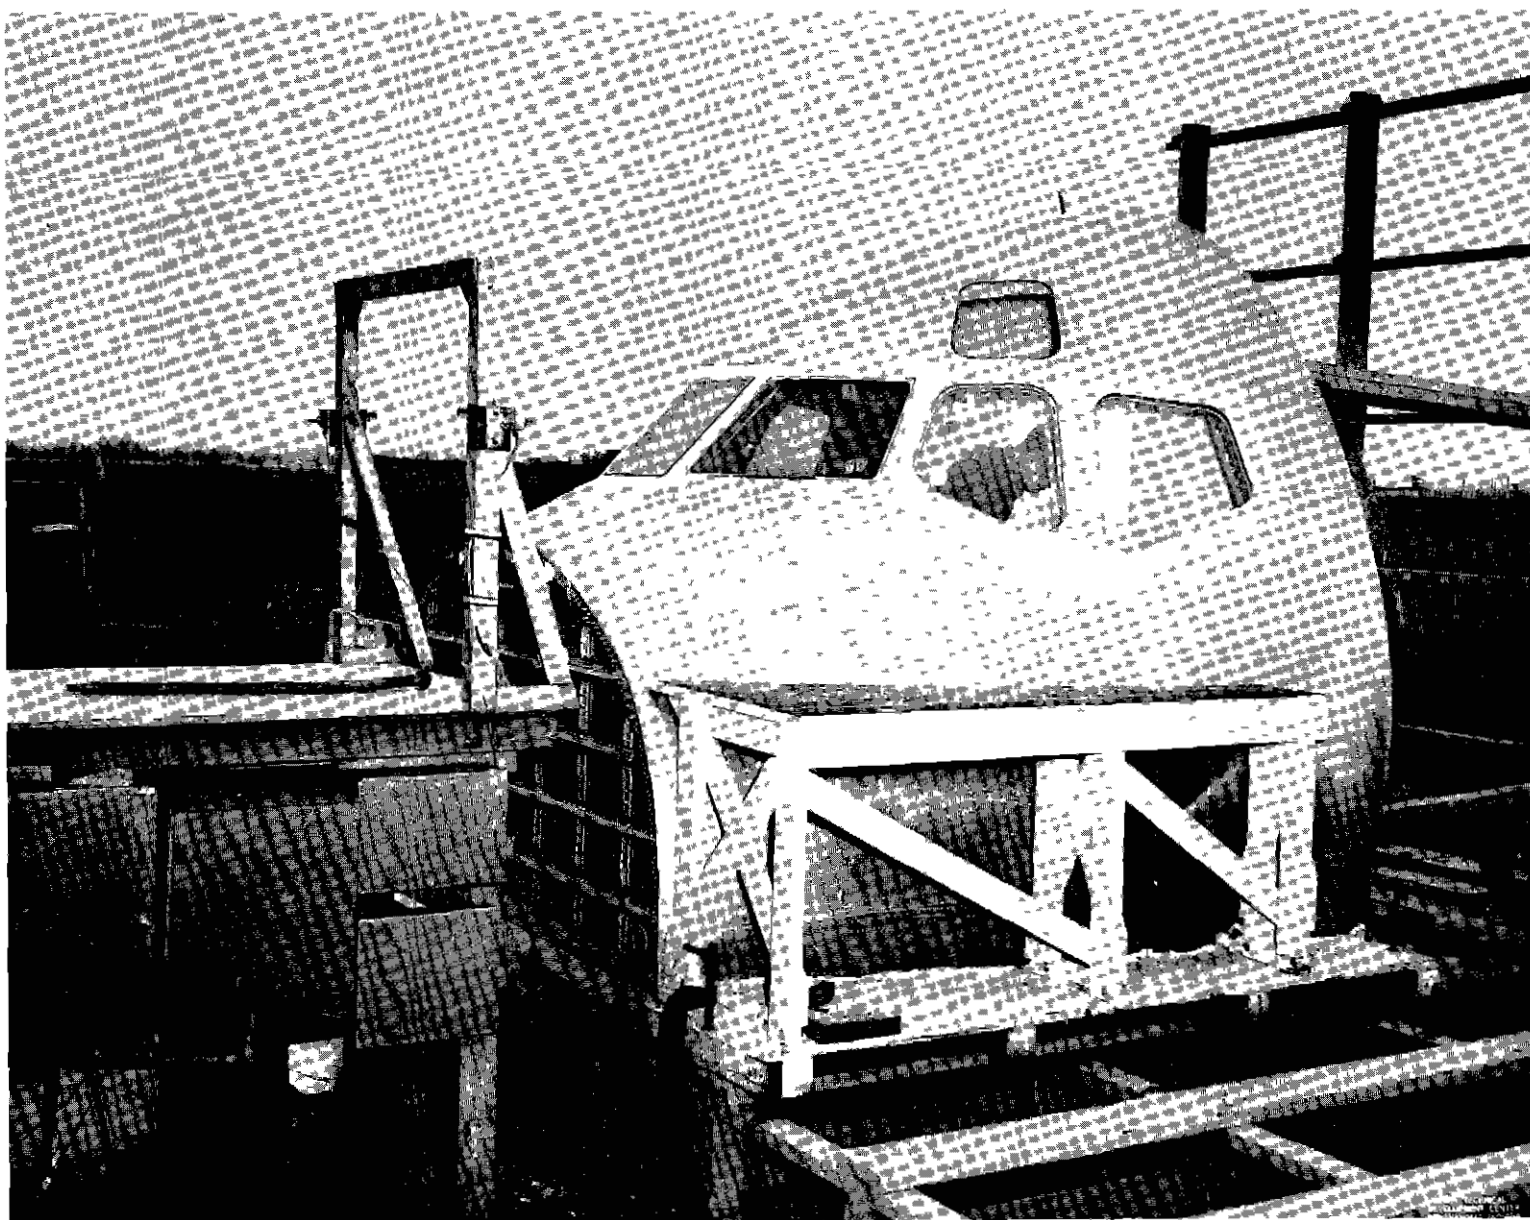
FIG 7 TEST STRUCTURE MOUNTING ARRANGEMENT

The cockpit structure was positioned so as to line up the desired impact position with the expected line of flight of the projectile. The projectile flight path was determined by sighting through "peep" sights mounted at both ends of the gun barrel. The cockpit base was fastened securely to the test-cell bed, and 4- by 4-inch wood members were positioned between the principal longitudinal members of the cockpit and test-cell backstop to prevent excessive rearward movement of the structure. This mounting arrangement is shown in Fig. 7.

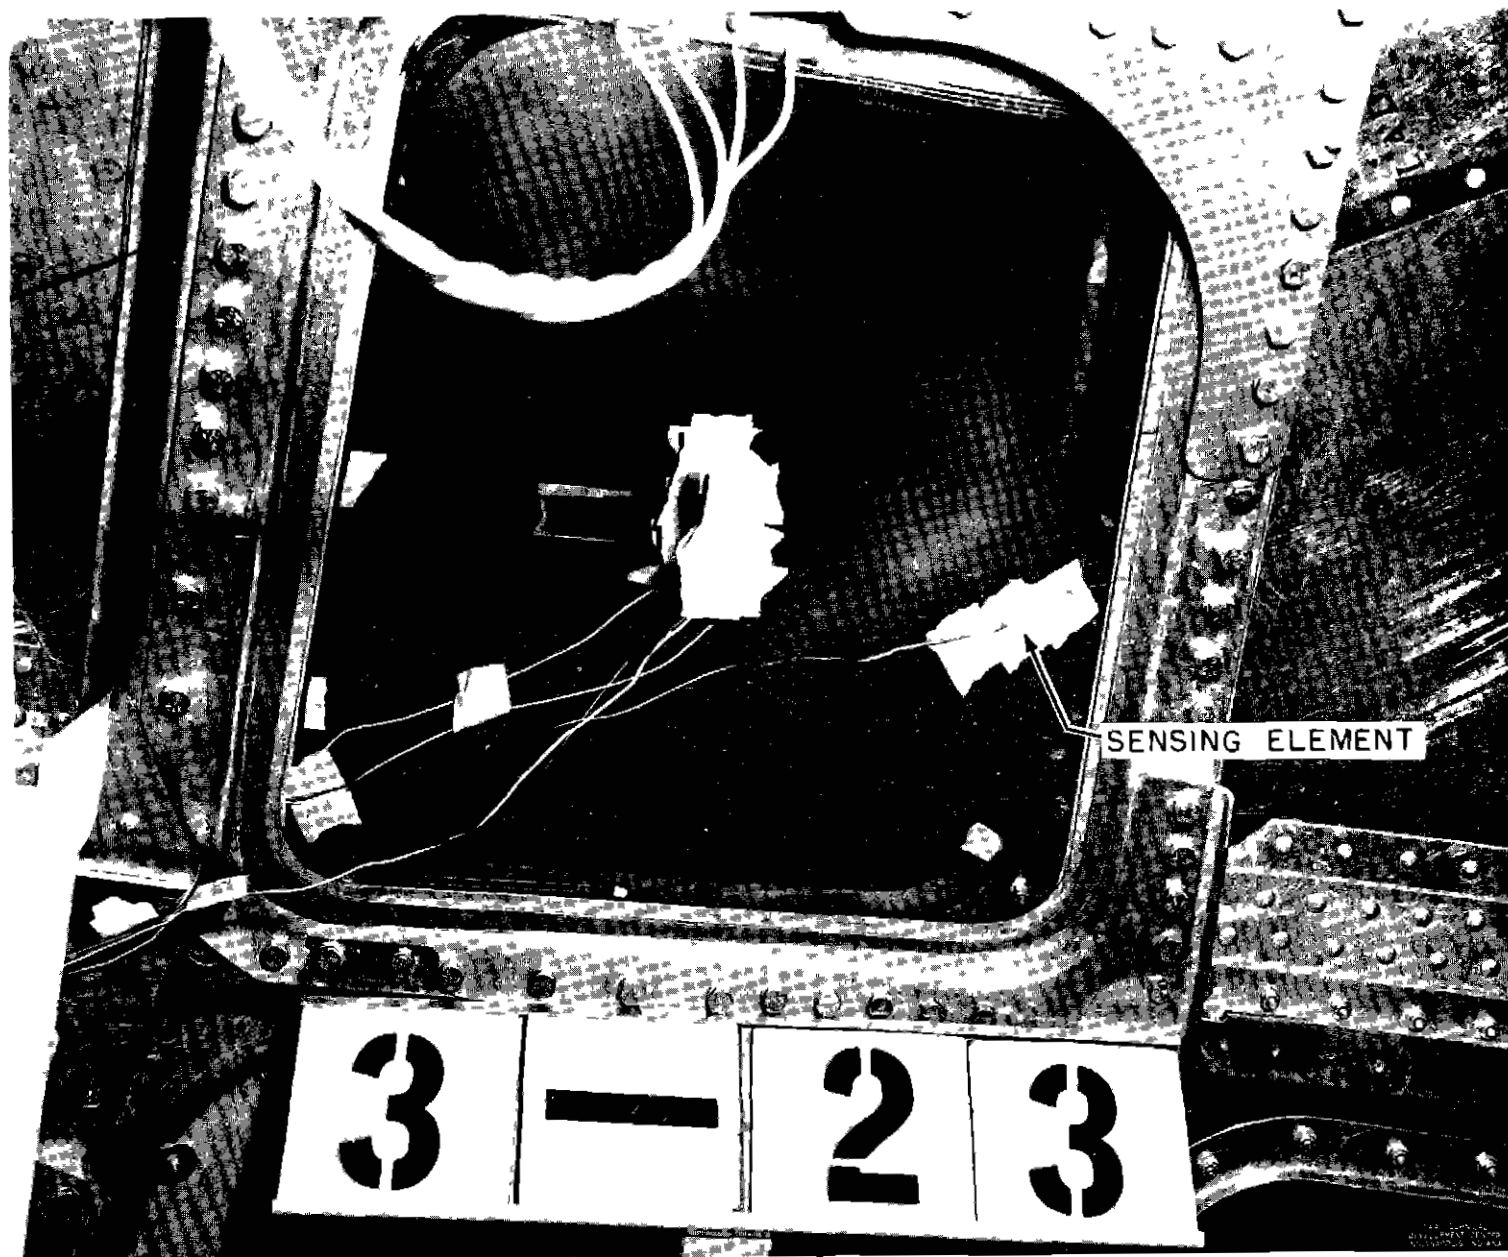
FIG 8 THERMOCOUPLE LOCATIONS FOR THE EYEBROW WINDOW

Eyebrow window temperatures were obtained prior to each test from thermocouples attached to the faces of the exterior and interior panels by means of masking tape. The thermocouples were placed at the geometric center of the outer and inner faces of the exterior stretched Plex-55 panel and the interior glass-vinyl-glass panel assembly. Also, one thermocouple was placed on the outside face of the glass-vinyl-glass panel assembly directly opposite the sensing-element control. The location of these thermocouples is shown in Fig. 8.

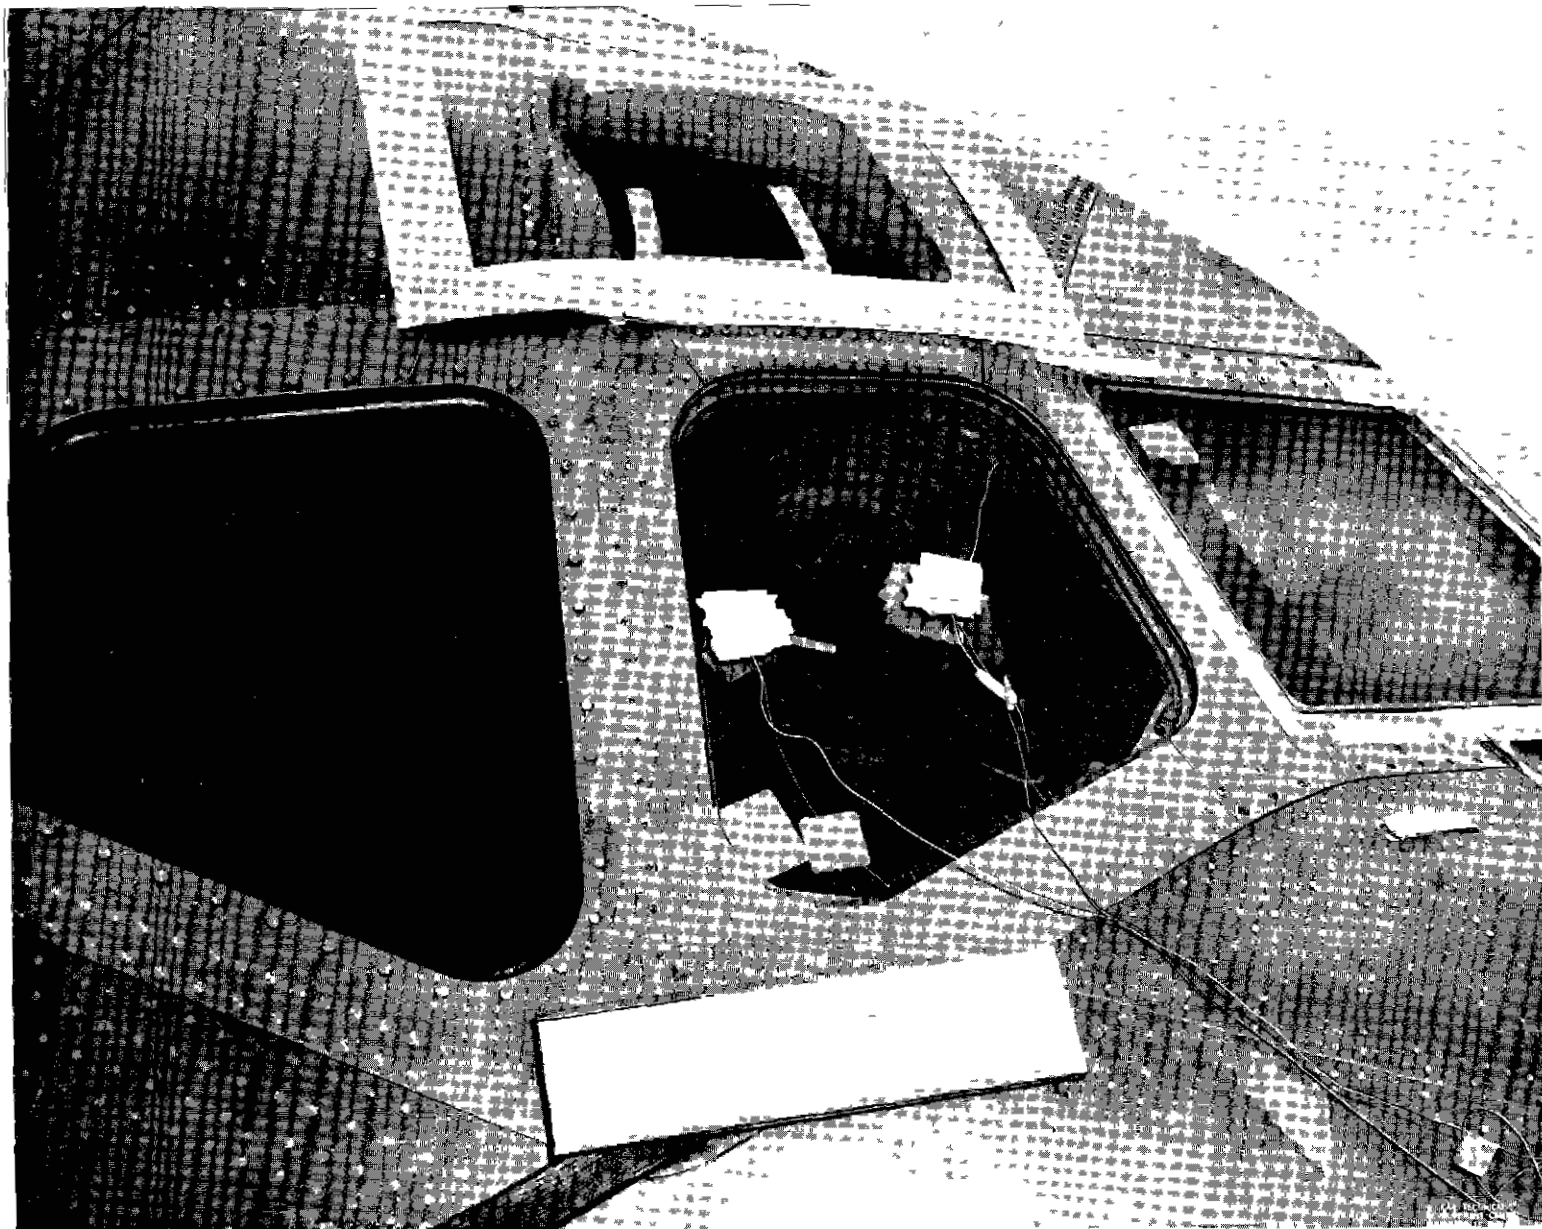
FIG 9 THERMOCOUPLE LOCATIONS FOR THE CLEAR-VIEW WINDOW

Clear-view window temperatures were obtained from thermocouples attached at the geometric centers of the outer face of the exterior stretched Plex-55 panel and the inner face of the interior glass-vinyl-glass panel assembly. In addition, one thermocouple was attached to the inner face of the interior glass-vinyl-glass panel assembly near the temperature sensing element built into the vinyl interlayer and one thermocouple sampled the air-gap temperature. Figure 9 shows the physical location of the thermocouples attached to the clear-view windows.
