CORROSION OF POST-TENSIONED TENDONS IN FLORIDA BRIDGES

Research Report No. FL/DOT/SMO/04-475

By: Rodney G. Powers¹ Alberto A. Sagues² and Yash Paul Virmani³

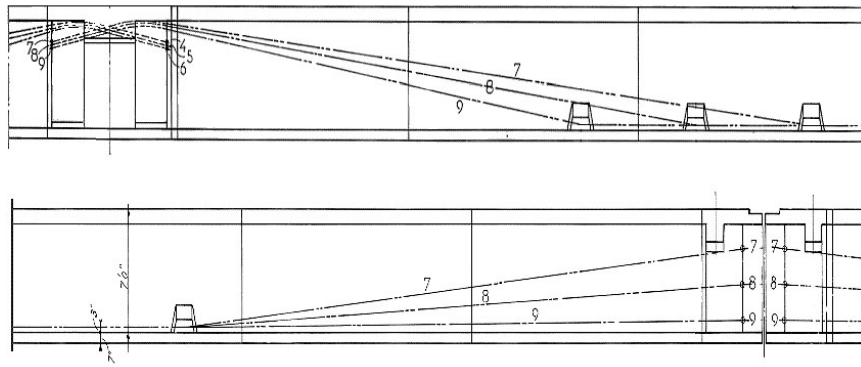
Figure 1 – Typical tendon configuration in the superstructure of the affected bridges.

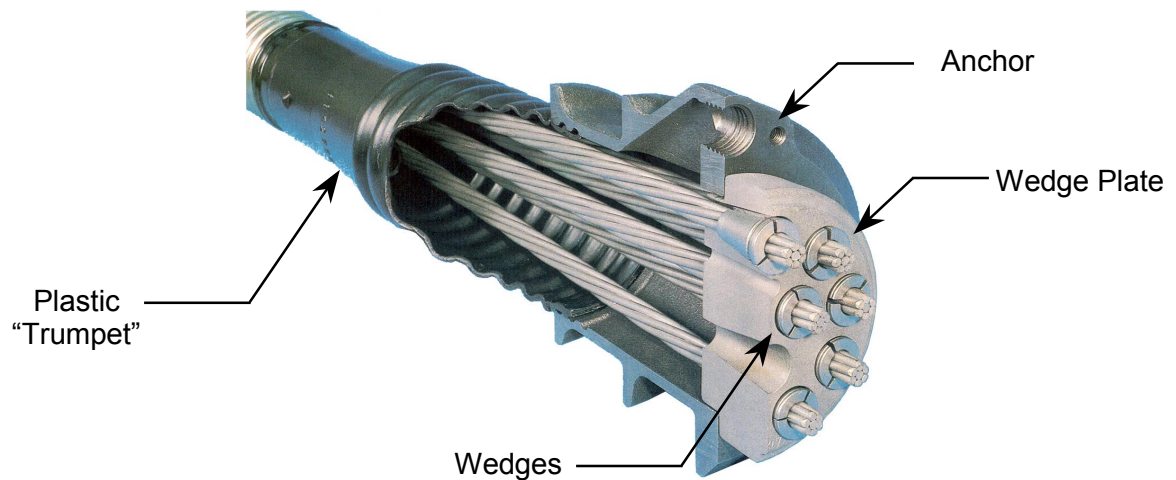
Anchorage Mock-up Details: The mock-up utilized a proprietary anchorage system (Figure 2) of the same type and from the same manufacturer as that used at MBB. The system consists of a ductile iron, multi-plane anchor manufactured to ASTM A27, Grade 65-45-12 specifications and a forged steel wedge plate manufactured to ASTM A688 specifications. The post-tensioning strands were seven-wire, 14.3mm nominal strand diameter, Grade 1860 manufactured to AASHTO M 203 specifications. Composition of the components was verified via metallographic examination and spectrographic analysis. The wedge plate in this experiment was represented by a cut-off piece of plate cast into the anchorage grout. The wedge plate section measured 5.5cm wide (the thickness of the plate) by 12.7cm in length. Since this specimen was cut from the edge of the wedge plate, one side of the test specimen had a sawn edge while one side was in the “as-manufactured condition”. The total surface area of the portion of the specimen in contact with grout was approximately 81cm². This metal-to-grout surface contact area is proportionate to the contact area that would exist with a horizontally positioned anchor approximately 50% filled with grout. The surface area of the anchor in contact with the grout was 856cm². All of the metal components used in the experiment were “as-new” and showed no signs of deterioration or contamination. The strands were gray in color, free of grease and oils and had a mill finish.

Figure 2 – Details of the anchorage system used in the Niles Channel and Mid Bay Bridges.

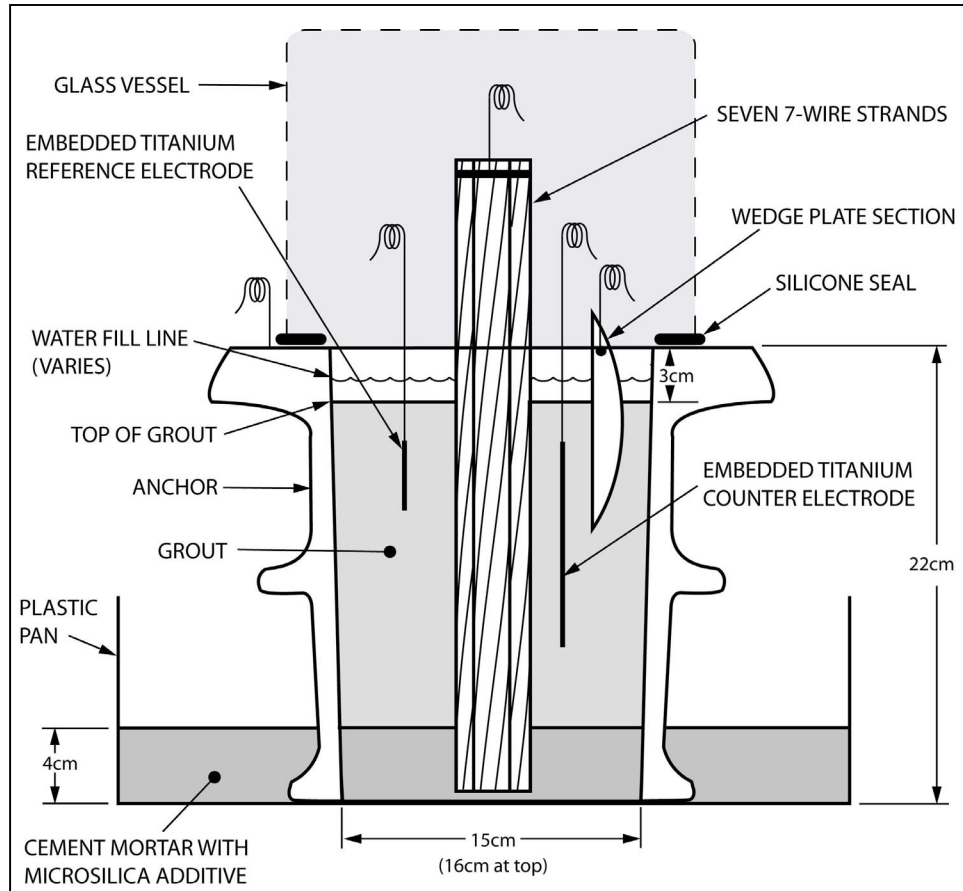
The mock-up (Figures 5 and 6) consisted of seven bundled, seven-wire strands and a cut-off section of the wedge plate cast into the anchorage in a vertical position. A thick grout made up of cement and micro-silica was used to seal the bottom 4cm of the anchorage. Care was used to ensure that none of the metal components were in contact with one another. The grout used in this experiment was as previously described using 1 percent (by weight) aluminum based expanding admixture. Approximately 3.3L of grout was placed into the anchor. The grout filled the anchor to a point 3cm from the top (outer end). During grout placement, the strands and wedge plate section were suspended in place using cloth tie-wires. Following introduction of the grout, the specimen was vibrated (as indicated earlier) continuously for four hours. Subsequently, measurements were made for grout shrinkage and bleed-water. Each of the metallic components was equipped with securely attached and sealed electrical connections to facilitate testing and establishing electrical continuity between the anchorage components. Two activated titanium rods (3.2mm diameter) were imbedded into the grout. One rod was 10cm in length; the other was 4cm in length. These served as counter and reference electrodes in the polarization resistance tests. The open end of the anchor was fitted with a suitably sized glass vessel to minimize evaporation during the laboratory evaluation. A silicone seal approximately 2mm thick by 25mm wide was used between the glass vessel and anchor. A section measuring 10mm wide was cut out of the silicone seal to replicate a defect in construction that would be of sufficient size to allow water re-charge and aeration similar to that which might be experienced in actual field conditions.

Figure 5 – Schematic of the experimental anchorage mock-up.

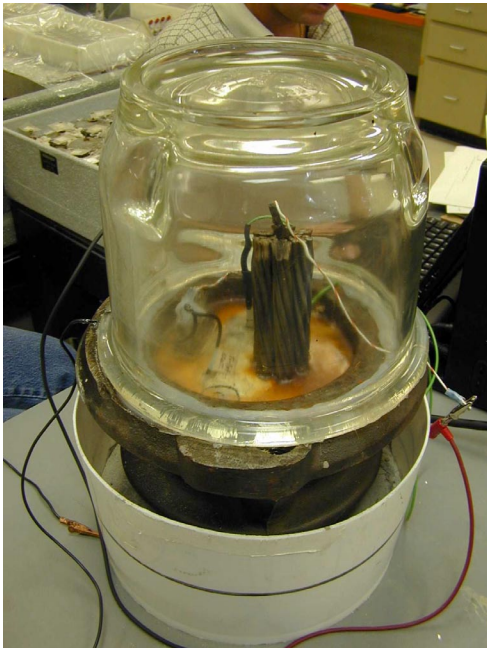
Figure 6 – Photograph of the experimental anchorage mock-up.

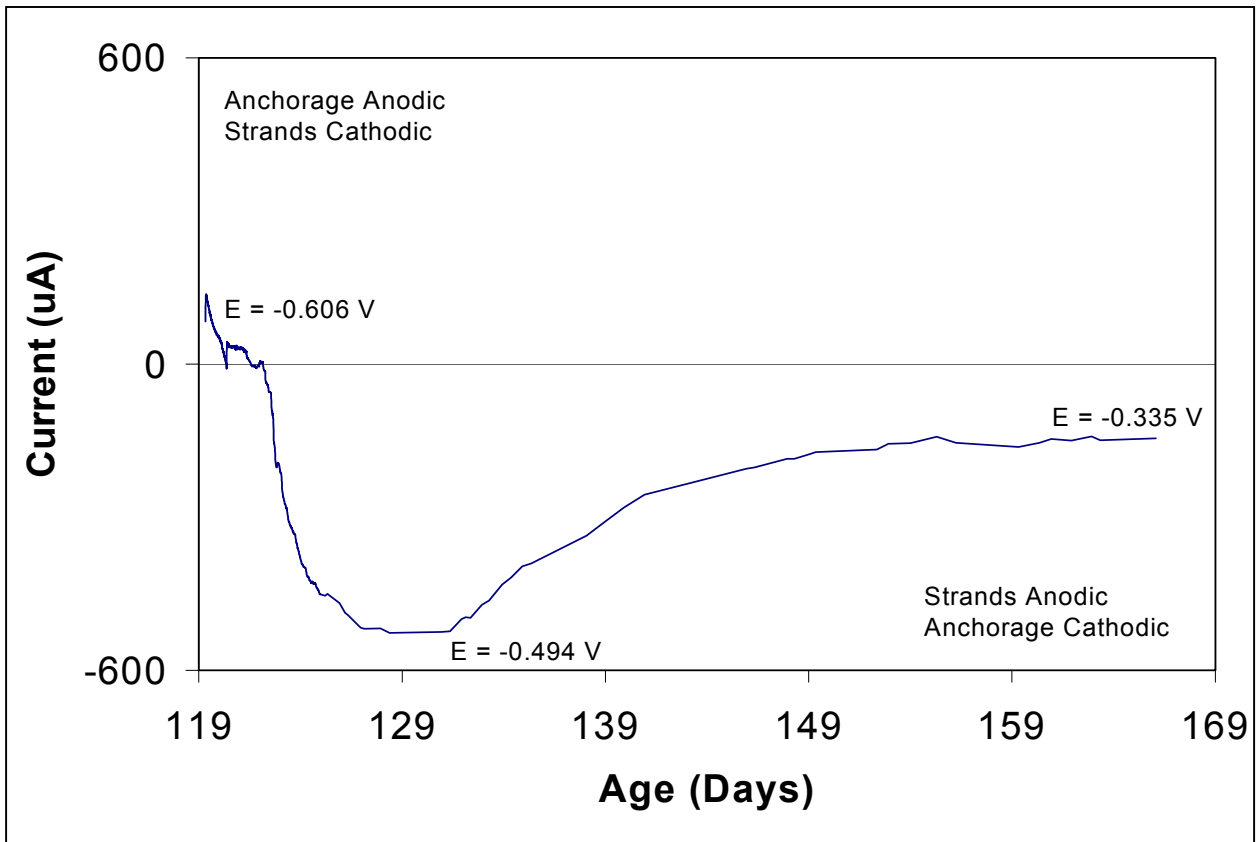
Figure 10 – Macro-cell current and half-cell potentials for the fifth water re-charge event.
