## Experimental and Analytical Evaluation of Residual Capacity of Corrosion-Damaged Prestressed Concrete Bridge Girders

**Final Report VTRC 25-R18**

This report presents the results of testing of six corrosion-damaged prestressed beams removed from existing bridges during their demolition. Three beams were Type II AASHTO I-beams extracted from the Lesner Bridge in Virginia Beach, and three were 48 in wide by 27 in deep box beams extracted from the Aden Road Bridge near Quantico, Virginia. Prior to testing, the beams were visually inspected and two types of non-destructive evaluations were performed to identify corrosion activity: resistivity measurements and half-cell potential measurements. The beams were then tested in the lab to determine their flexural strength. Following testing, samples of strand were removed and tested to determine their tensile properties. Cores were taken from the Aden Road beams and from both the beams and decks of the Lesner Bridge beams to determine compressive strength. Powdered concrete samples were removed to perform chloride concentration tests.

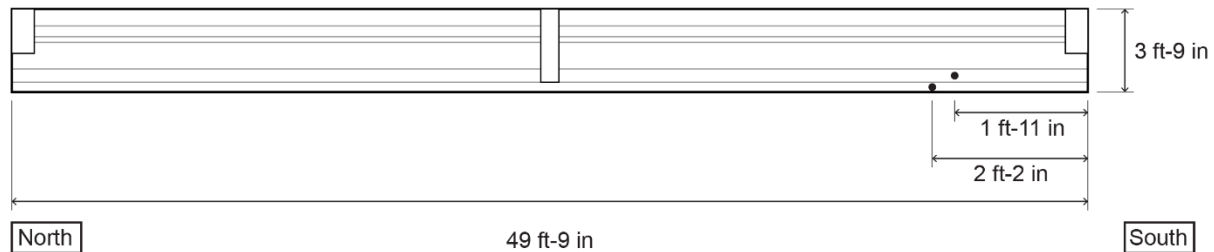
**Figure 11. Locations of Chloride Samples Taken from I-Beam 7 – Good Condition**

The results of chloride content testing for I-Beam 7 are shown in in Figure 76. Figure 11 shows the locations of the extracted samples on I-Beam 7, with “Horizontal” on the chart referring to the sample taken from the side of the bottom flange, and “Inclined” referring to the samples taken from the inclined face of the bottom flange.

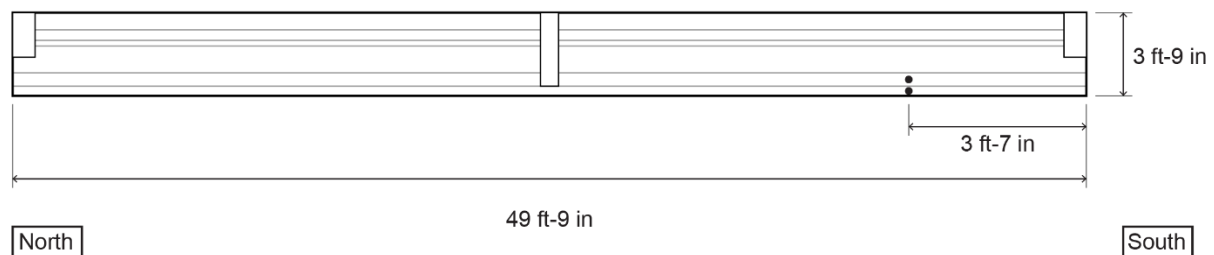
**Figure 12. Locations of Chloride Samples Taken from I-Beam 6 – Medium Condition**

The results of chloride content testing for I-Beam 6 are shown in Figure 77. Figure 12 shows the locations of the extracted samples on I-Beam 6. The bay side – horizontal sample had a steep increase in the chloride content from 0.5 in to 1.0 in; this result can be explained by the fact that water or rain could probably wash off chloride content at the concrete surface which resulted in a low reading. The inland side – horizontal showed similar results as the bay side – horizontal, but with slightly lower chloride concentrations. This result can be explained by the fact that the bay side was subjected to higher chloride exposure as the wind coming from the bay

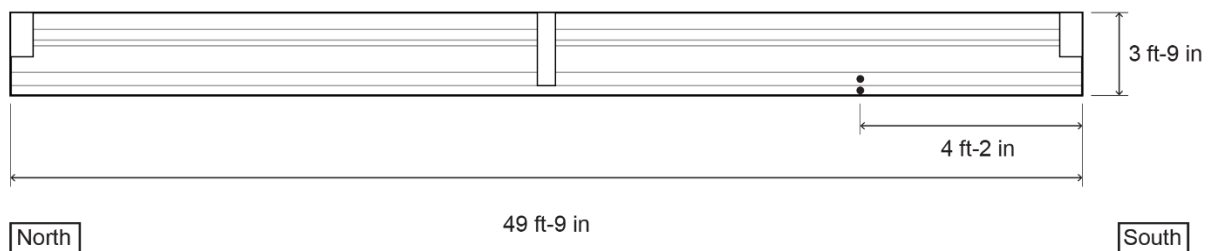
**Figure 13. Locations of Chloride Samples Taken from I-Beam 3 – Bad Condition**

The results of chloride content testing for I-Beam 3 are shown in Figure 78. Figure 13 shows the locations of the extracted samples on I-Beam 3. As a general trend, the chloride content in both the inclined and horizontal samples were the highest near the concrete surface and decreased gradually with deeper samples. However, for the inland side inclined and bay sides, the penetration depth of 1 in had a higher chloride content than the starting depth 0.5 in. This can be explained by the fact that water or rain could probably wash off chloride content at the concrete surface which resulted in a low reading. The highest chloride content was found in the bay side with (5.6 lb/yd<sup>3</sup>) which is considered in a high risk of corrosion category.

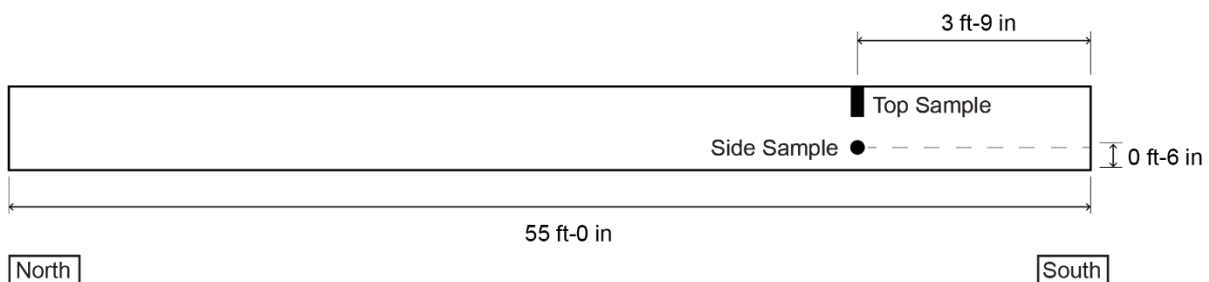
**Figure 14. Locations of Chloride Samples Taken from Box Beam 1 – Good Condition**

The results of chloride content testing for Box-Beam 1 are shown in Figure 79. Figure 14 shows the locations of the extracted samples on Box Beam 1. As can be seen from the graph, the chloride content of the top portion of the box beam had the lowest chloride content compared to the east side and the west side. This result can be explained by the fact that the top of the box beam was covered with an asphalt overlay that was a first line of defense against chloride penetration. Additionally, cracks are known to form in the top surface and along the longitudinal

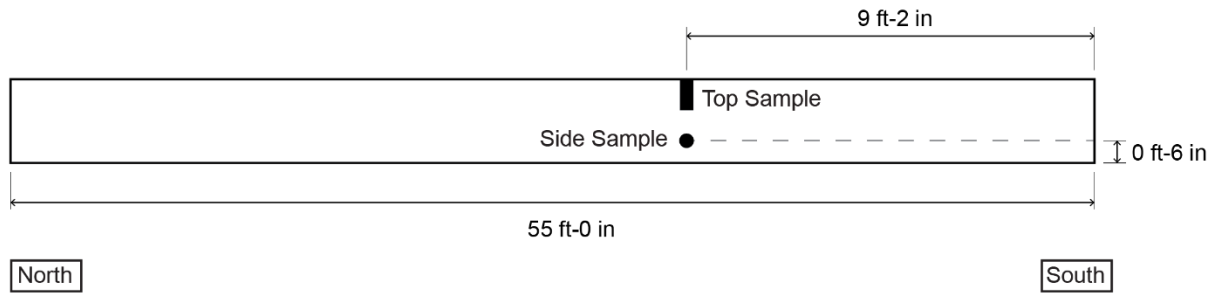
**Figure 15. Locations of Chloride Samples Taken from Box Beam 4 – Medium Condition**

The results of chloride content testing for Box Beam 4 are shown in Figure 80. Figure 15 shows the locations of the extracted samples on Box Beam 4. The west side had the highest chloride content at 1.0 in depth, and the chloride content fluctuates as the depth increase. There was no detected chloride content for the east side. For the top side, the chloride content was very low with 0.313 lb/yd<sup>3</sup> at 2.5 in and 0.235 lb/yd<sup>3</sup> at 3.5 in. One possible explanation is that these box beams had been stored outside for more than five years, allowing rain water to wash off much of the chlorides at the shallow depths.

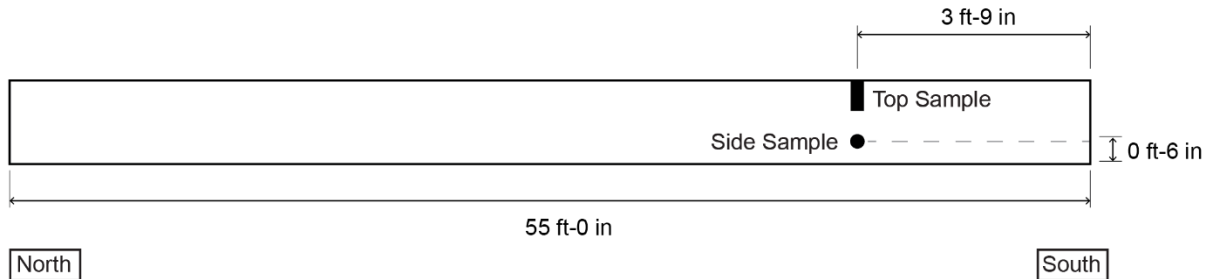
**Figure 16. Locations of Chloride Samples Taken from Box Beam 2 – Bad Condition**

The results of chloride content testing for Box Beam 2 are shown in Figure 81. Figure 16 shows the locations of the extracted samples on Box Beam 2. As can be seen in the graph, overall, the west side had the highest chloride content at 1.0 in depth. The second highest chloride content was the east side at 0.5 in and 1.0 in. For the top section, the chloride content was the lowest compared to the other parts of the concrete. For all of the sections, as a general trend, the chloride content decreased gradually with depth of the sample.

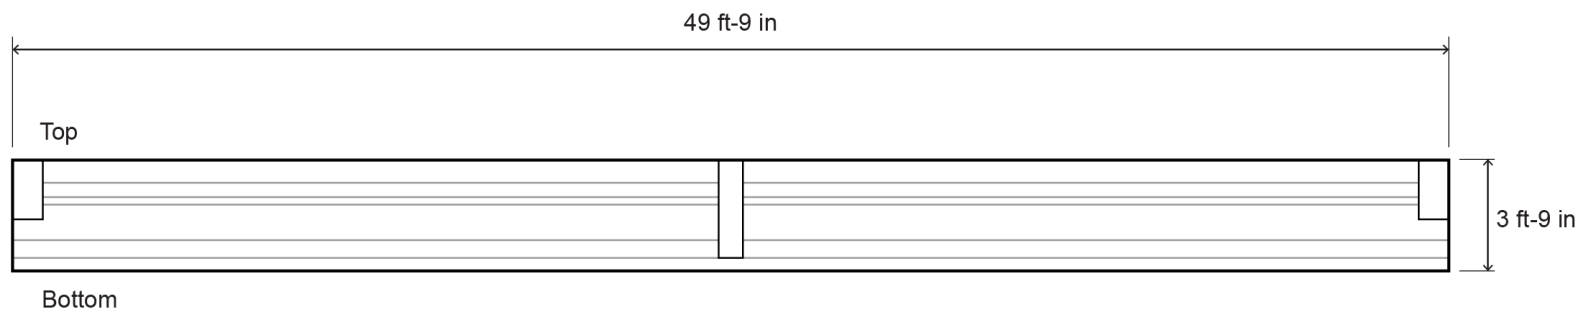
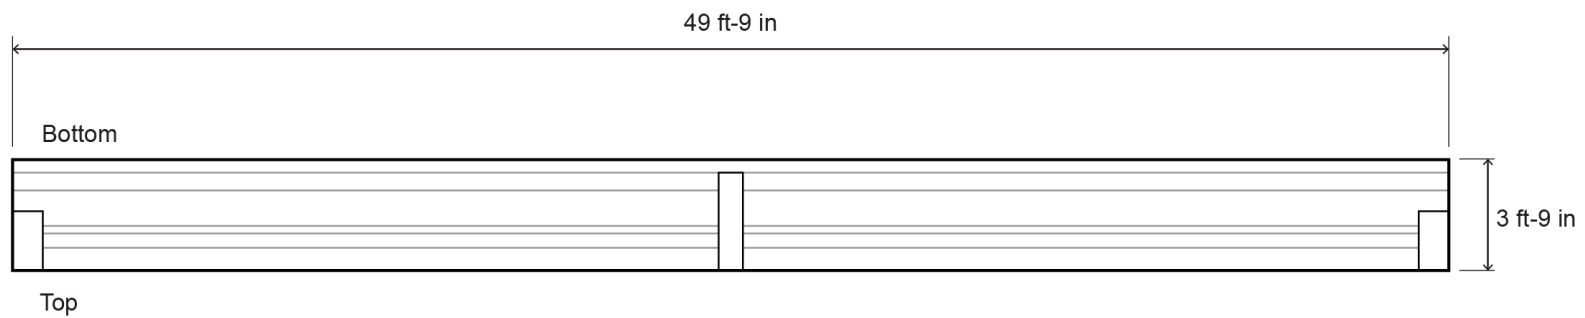
**Figure 25. I-Beam 7 – Good Condition**

For the rating system devised, a high score indicated good condition, while a low score indicated bad condition. Based on the results presented, I-Beams 3, 6 and 7 were chosen from the Lesner Bridge. I-Beam 7 was chosen since it had the best score and would represent the baseline, undamaged state (good). I-Beam 3 was chosen since it had the worst score and would represent a severely damaged beam (bad). Finally, I-Beam 6 was chosen as an average score, representing a moderately damaged beam (medium). Of the six Aden Road box beams available, three were selected for testing. The Aden Road Bridge beams were not as accessible for inspection as the Lesner I-beams. The three beams that were most easily accessed in the storage yard were retrieved and moved into the lab. The conditions of these beams were examined once they were brought inside the testing facility. Damage maps of the six selected beams selected for study testing in this study are shown in Figures 25 through 30.

In Figures 25 through 30, each figure presents three sides of the beams. The top sketch is one side, oriented right-side-up, the middle sketch is the bottom of the beam, and the bottom sketch is the other side of the beam, oriented up-side-down. This allows the reader to see how side damage and bottom face damage are related to each other spatially.

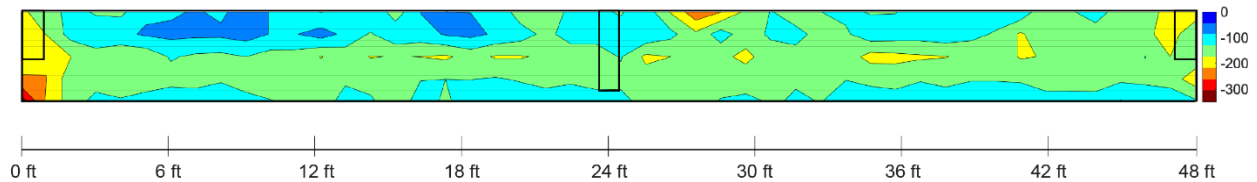
**Figure 33. Half-Cell Potential Results for I-Beam 7 - Good Condition - Bay Side (mV)**

As discussed in the Methods section, half-cell corrosion mapping was used to identify the possibility of active corrosion in the girders. Unfortunately, for I-Beam 3, which was in poor condition, the half-cell potential data could not be retrieved from stored files, and no back-ups had been made. For the good condition I-Beam 7, the half-cell did not show any indication of corrosion, which matched the visual damage maps. For I-Beam 6, which was considered to be in medium condition, visual inspections indicated active corrosion along much of the bottom flange of the bay side of the beam. The half-cell also indicated possible corrosion along the bay side bottom flange and near the ends of the beam.

The available results of the corrosion potential for the girders are shown in Figures 33 through 42. In all figures, blue indicates a low probability of active corrosion, and dark red indicates a high probability.

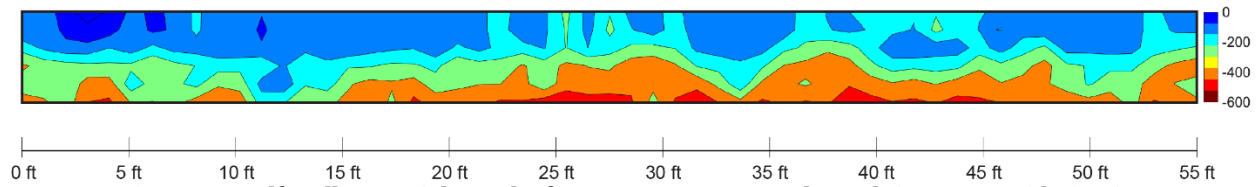
**Figure 37 Half-Cell Potential Results for Box Beam 1 – Good Condition - East Side (mV)**

All of the Aden Road box beams showed high potential for corrosion along the bottom edge of the beams. These results for the box beams are in agreement with the visual inspection, which indicated considerable spalling, delamination and exposed, corroded strands.

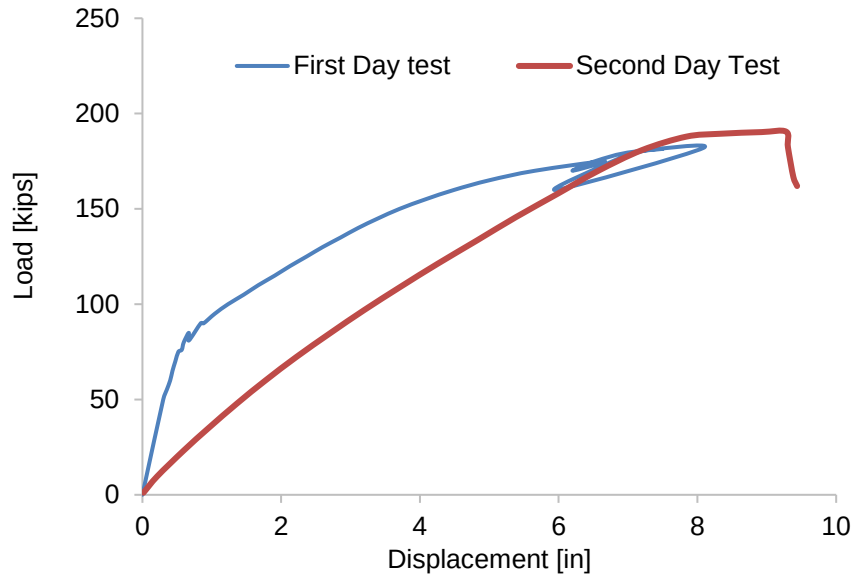
**Figure 45. Load Versus Displacement on First and Second Day of Testing I-Beam 7**

The load-deflection plot is shown in Figure 45 for first day and second day. For the first day test, a slight change in the slope of the line can be seen at around 80 kips, confirming the

first cracking load determined visually. For the second day test, at around 190 kips the load-deflection curve begins to plateau, indicating the strands were yielding.

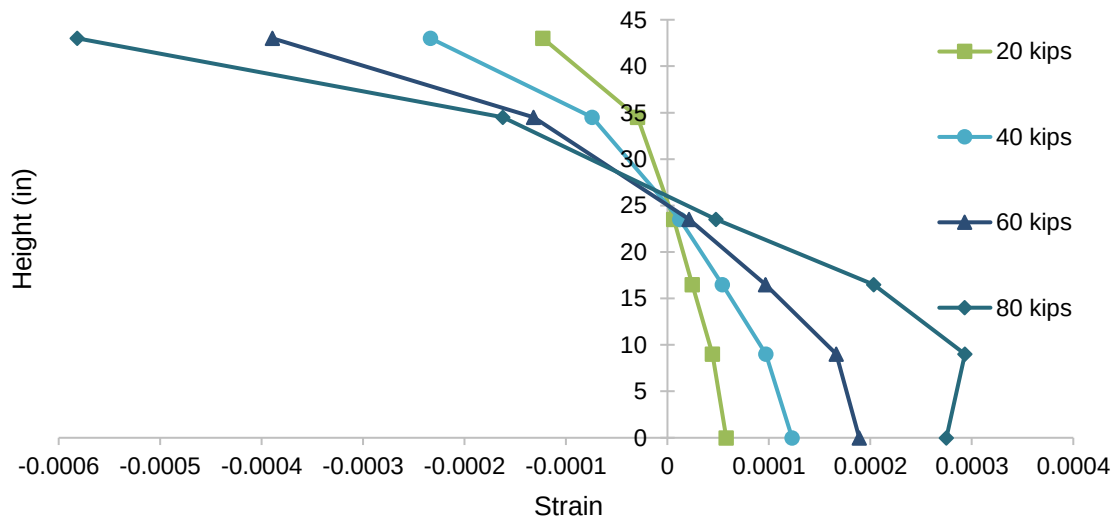
**Figure 46. Strain Versus Height for I-Beam 7**

Figure 46 shows a plot of longitudinal strain versus distance from the bottom of the beam measured by the gages at mid-span of the beam. Several load steps are presented in the figure. The neutral axis determined from the strains measured just before the cracking load is 26 in from the bottom of the beam. The neutral axis based on calculation, including all the strands and the concrete modulus obtained from the compressive strength test, was 28.8 in, which was 10% higher than the measured neutral axis. The strain distributions were relatively linear, except for the upper most and lower most gages. However, the highest strain reading was on the side of the slab, and for unknown reasons, was larger than expected based on calculations. The strains on the bottom flange were smaller than expected, possibly due to the damage to the concrete on the bottom.

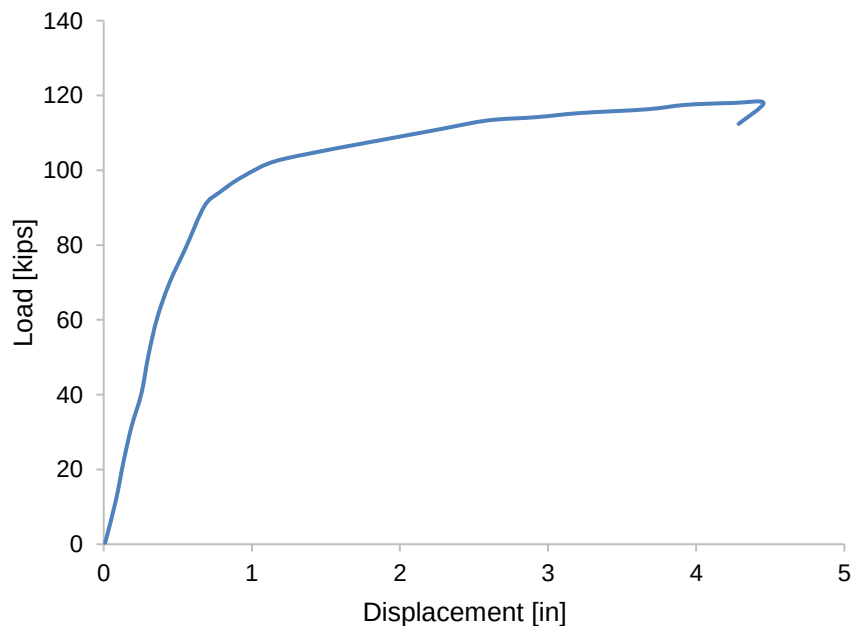
**Figure 48. Load Versus Displacement Plot for I-Beam 6**

I-Beam 6 failed at an applied load of 118 kips and a deflection of 4.46 in, due to crushing of the top flange. The load versus deflection plot is shown in Figure 48. The first crack was visually observed at 50 kips; however, there was no noticeable change in the slope of the load displacement plot at that load.

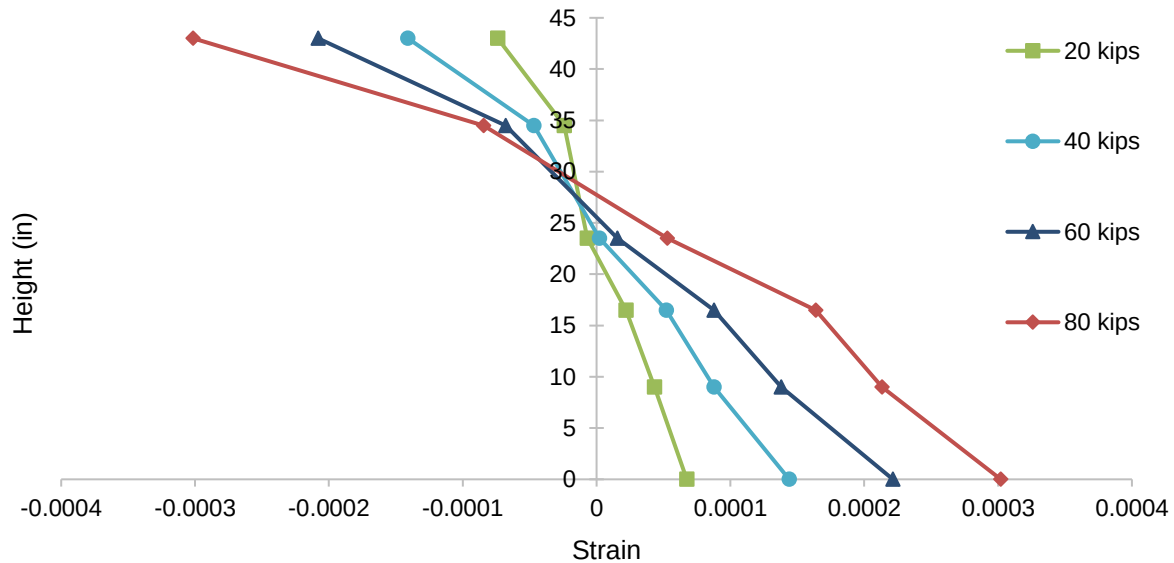
**Figure 49. Strain Versus Height for I-Beam 6**

Figure 49 is a plot of longitudinal strain at mid-span versus distance from the bottom of the beam for several different load steps. The figure indicates that the measured neutral axis prior to cracking was 24 in, while the calculated neutral axis was 26 in, based on the remaining cross-sectional area of the strands and the tested concrete compressive strength. The difference of the neutral axis location was about 8%. As with the strains measured for I-Beam 7, the gage on the top slab had strain readings that were higher than expected.

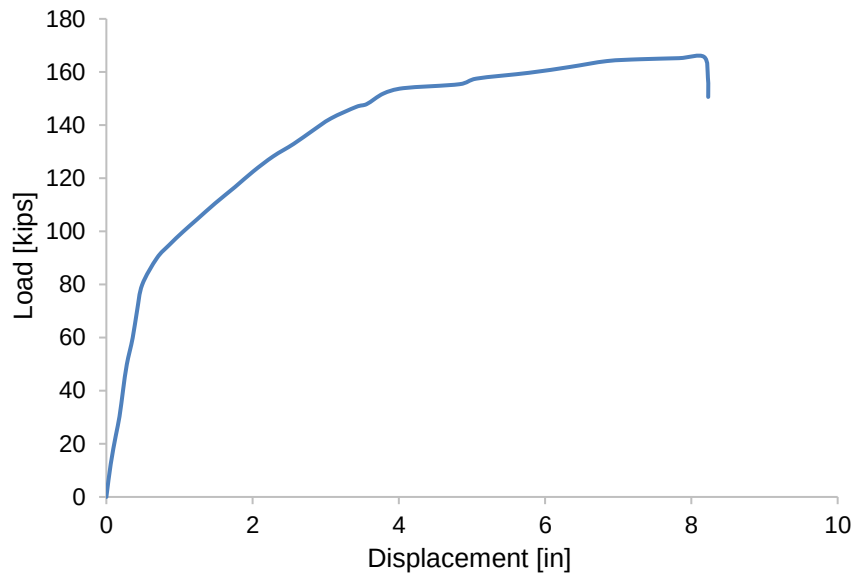
Figure 53. Load Versus Displacement Plot for I-Beam 3

The first flexural crack of the I-beam in “bad condition”, I-Beam 3, was observed at a load of 80 kips. For reasons of safety, the beam was no longer closely inspected between load intervals after an applied load of 125 kips. The load deflection plot is presented in Figure 53. Based on strain measurements through the depth of the beam, the neutral axis, just before the cracking load, was 26 in from the bottom of the beam (see Figure 54), which is comparable to the calculated neutral axis of 26.7 in, which was based on the cross-sectional area of the remaining strands and the concrete compressive strength from testing. The beam ultimately failed due to crushing of the top flange (see Figure 55), with an applied load of 166 kips and a deflection of 8.19 in.

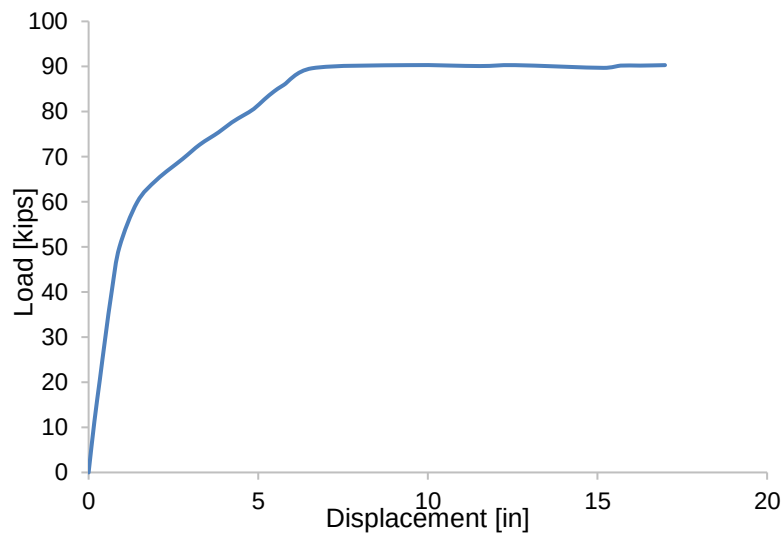
**Figure 58. Load Versus Displacement Plot for Box Beam 1**

First cracking was observed at a load of 50 kips. After cracking, the researchers applied additional load in 5-kip increments up to 70 kips, after which, the beam was no longer closely inspected, out of concern for safety. Also, after 70 kips, displacement control was used with 0.25-in increments. The test was terminated at 90.3 kips, when the deflection reached 16.99 in without any increase in load. This can be seen in the load versus deflection plot in Figure 58. The large deflection at the ultimate load can be seen in Figure 59.

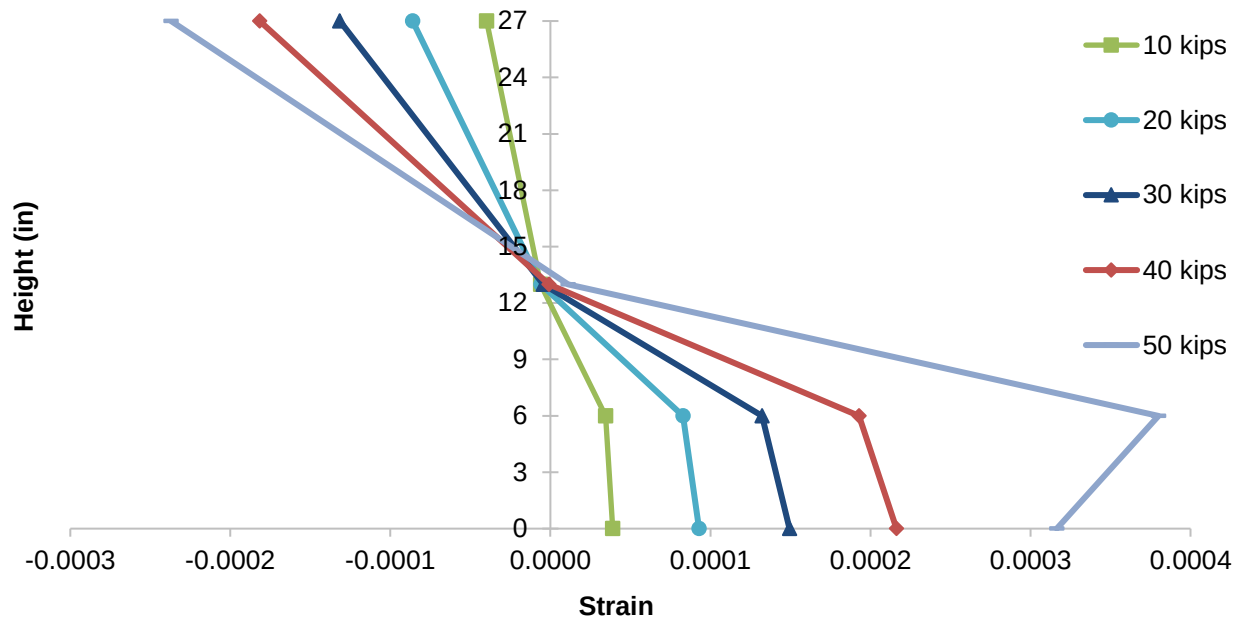
Figure 60. Strain Versus Height for Box Beam 1

Based on the mid-span strain measurements through the depth of the beam and just before the cracking load, the neutral axis was 13.5 in from the bottom of the beam (see Figure 60). The neutral axis based on calculation was also 13.5, identical to the neutral axis determined from measurements. A slight change in the location of the neutral axis can be seen at the 50 kip load increment, which corresponds to the load at which cracking was observed. Again, the measurements from the strain gages became erratic shortly after first cracking. Thus, Figure 60 only contains data up to that point.

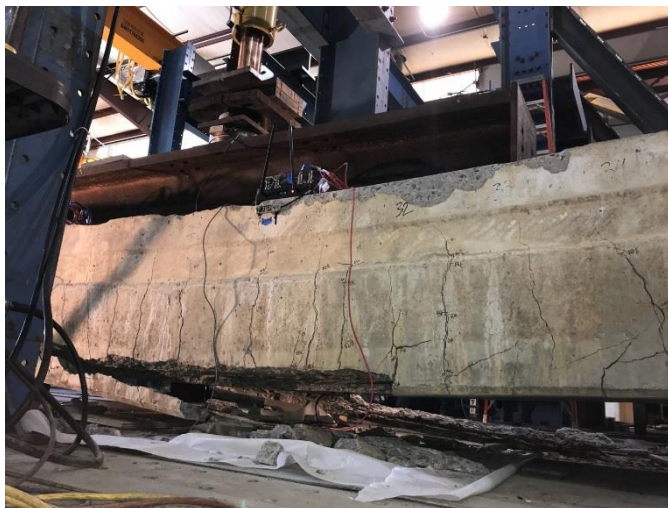
**Figure 64. Condition of the East Side of Box Beam 1 at the End of the Test**

Before the test, severe corrosion was observed in the three bottom strands on the west side of the beam (see Figure 61). The cracks during the test were marked and the propagation was observed (see Figure 62 and 63). Figure 64 shows the beam at the completion of testing.

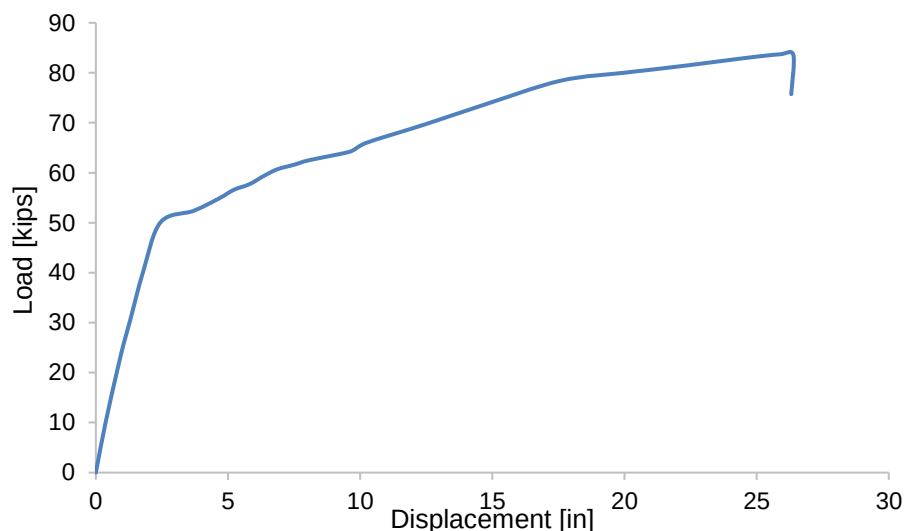
Figure 65. Load Versus Displacement Plot for Box Beam 4

First cracking was visually observed at a load of 45 kips, as confirmed by the change in slope of the load-deflection plot in Figure 65. During the test and at high deflection, considerable water began leaking from the void in the beam. At that point, the load was held constant, and buckets were used to collect the leaking water. After a load of 65 kips, the beam was no longer closely inspected, due to safety concerns. The beam failed when the corroded strands ruptured at an applied load of 83.8 kips. Unfortunately, there was some difficulty with the data collection system before approximately 52 kips of applied load. Thus, strain measurements were not recorded. Additionally, deflection readings were taken manually after 52 kips of applied load, thus the deflection data in the second part of the test was not as accurate as in the previous tests.

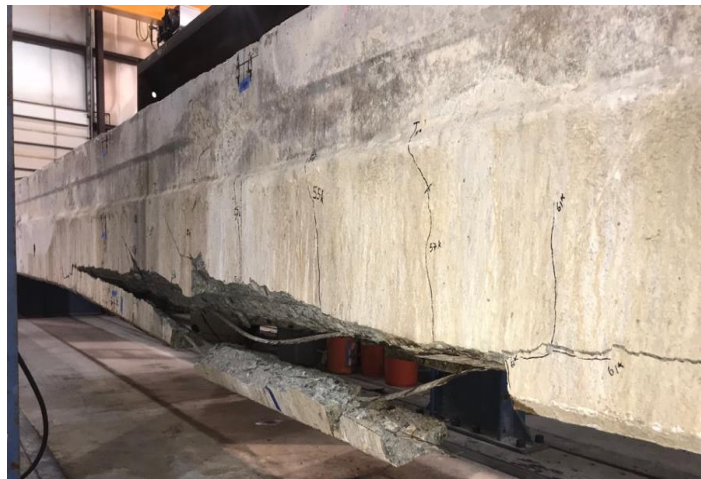
Figure 66 shows a horizontal crack along the east side of the beam prior to testing. Upon examination after the test, strands along that side did not show significant corrosion, but the strands had yielded (see Figure 67). Figure 68 shows the condition of the west side before testing. It can be seen that the edge strands in the lowest level had severe corrosion, possibly exacerbated by the water that had been trapped in the beam. Figure 69 and Figure 70 show the condition of the west side of the box beam after testing. After the bottom concrete cover had spalled off, it was apparent that the three outermost bottom layer strands were severely corroded.

**Figure 67. Box Beam 4 East Side after Testing**

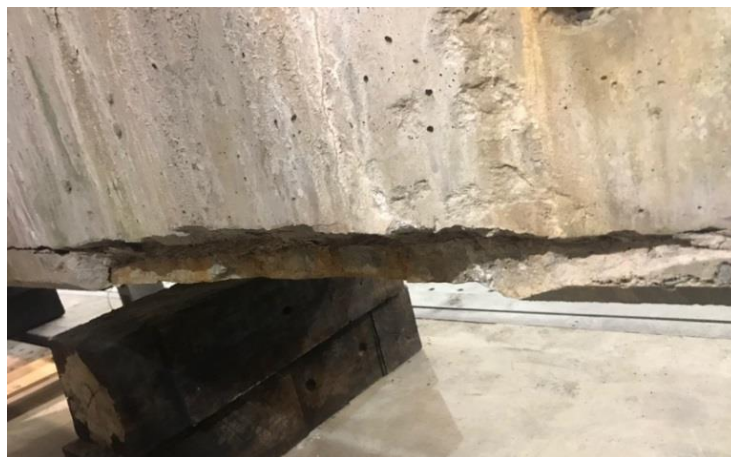
**Figure 68. Box Beam 4 West Side Before Testing**

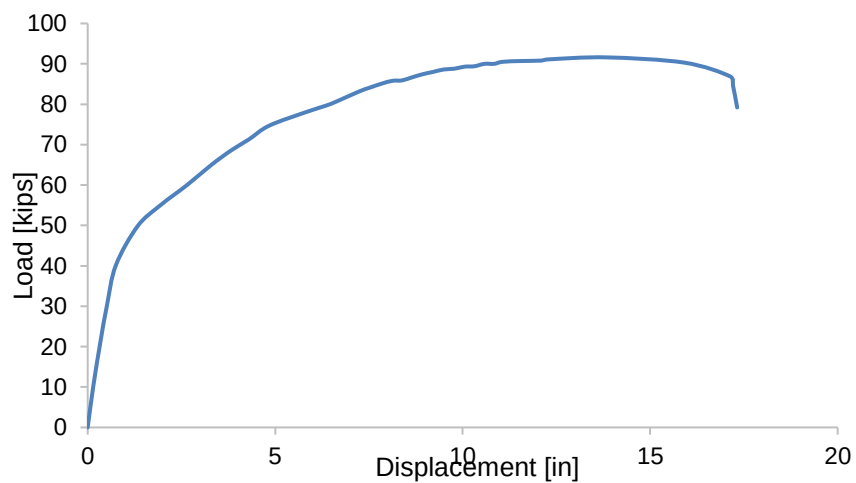
**Figure 71. Load versus Displacement Plot for Box Beam 2**

safety purposes, the beam was no longer closely inspected after 65 kips of applied load. Figure 71 presents the load-versus-displacement plot, and Figure 72 shows the top flange crushing.

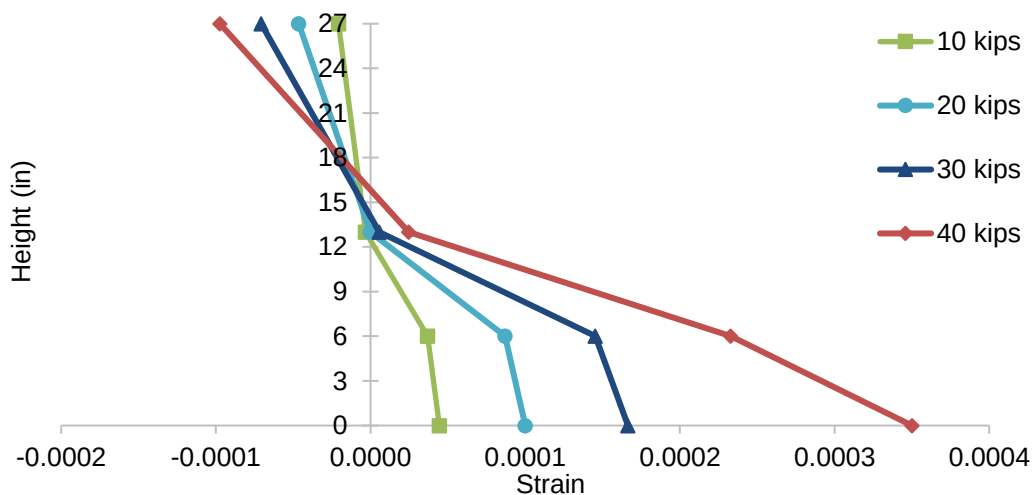
**Figure 73. Mid-span Strain Versus Height of Box Beam 2**

Based on strain measurements through the depth of the beam at mid-span from loads of 10 kips to 30 kips, the neutral axis was 13.5 in from the bottom of the beam (see Figure 73). The neutral axis based on calculation was also 13.5 in, identical to the neutral axis determined from measurements. Note that the height to the neutral axis increased at 40 kips, indicating that there may have been some microcracking that was not visible to the naked eye. Also note in Figure 71, the change in slope of the load-deflection plot occurred near 40 kips, which also indicated that cracking occurred before it was visually identified at 49 kips. Note that the measurements from the strain gages became erratic shortly after first cracking. Thus, Figure 73 only contains data up to that point.

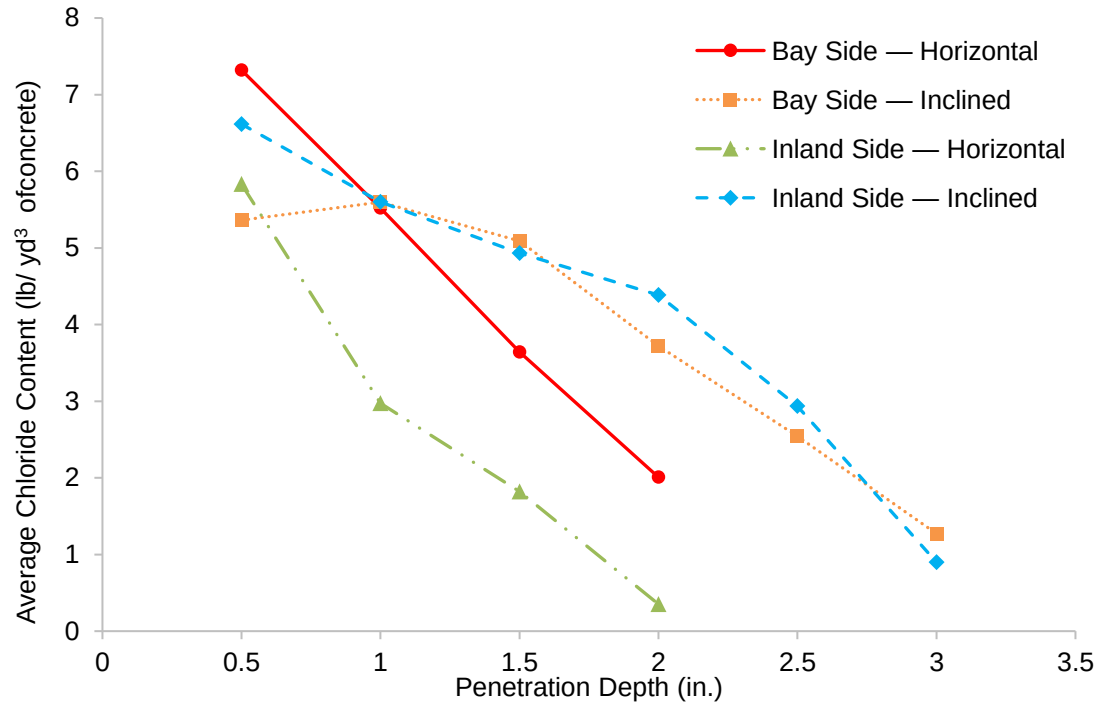
**Figure 76. Results of Chloride Testing for I-Beam 7**

For I-Beam 7, the chloride concentration of all of the sides decreased significantly as the depth of the sample increased. The only exception was the bay side – inclined which had a slight increase in the chloride content from 0.5 in to 1.0 in. For the samples taken from the vertical faces, the chloride content in the bay side was substantially higher than the inland side at each depth point, likely because the bay side was exposed to a harsher environment compared to the inland side. On the inclined faces, the bay and inland sides had very similar chloride contents at each depth, and were higher than the vertical faces. This could be explained by salts being deposited on the inclined faces, and not washing away as easily as on the vertical faces.

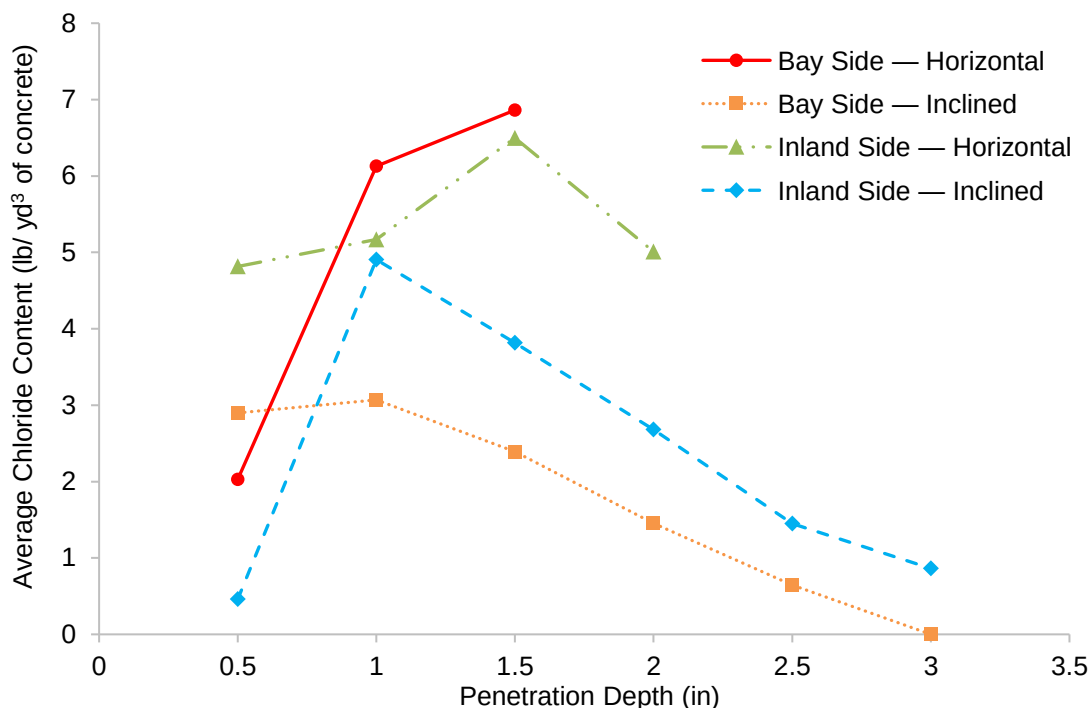
**Figure 77. Results of Chloride Testing for I-Beam 6**

side direction pushed salt directly onto the bay side surface of the beams. For both sides, the chloride content in the inclined face of the bottom flange in the girder decreased considerably from 1.0 in to 3.0 in. with the inland side, surprisingly, having a higher chloride content. It is not known why the chloride concentration on the inland side is higher, as it is subjected to a milder environment.

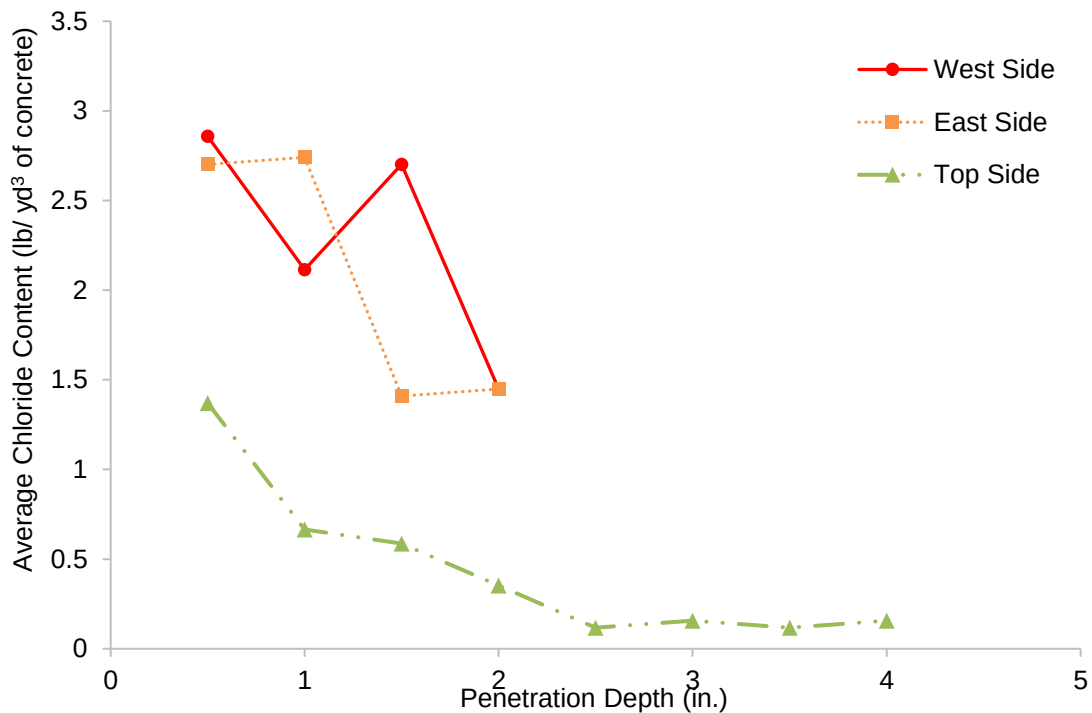
**Figure 79. Results of Chloride Testing for Box Beam 1**

joints between adjacent precast box beams. These longitudinal cracks provide a direct path for chloride-laden water to reach the side and bottom of the beams. Similar to all other beams, the chloride contents gradually decreased as the depth of the sample increased. For the west side, the highest chloride content was at a depth of 0.5 in and lowest at a depth of 2.0 in. While for the east side, the highest and lowest chloride content was at 1.0 in and 1.5 in, respectively.

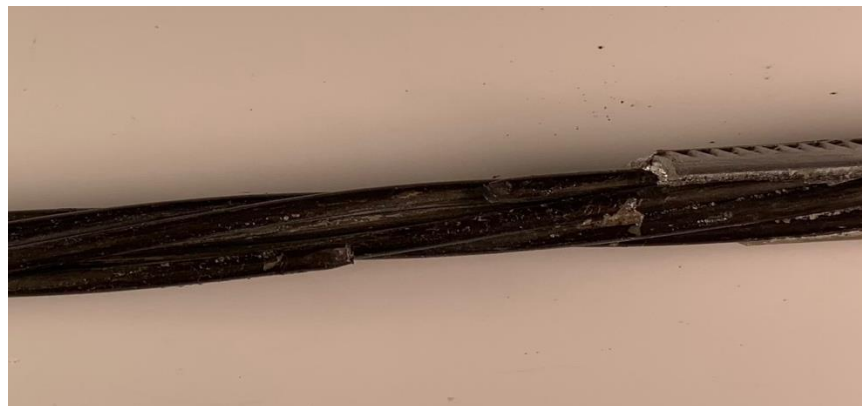
**Figure 83. Strand Taken from I-Beam 7 after Testing**

Table 10 shows the yield and ultimate tensile strengths of the prestressing strands that were extracted from the end of each beam. As specified in the plans, 7/16-in, stress-relieved grade 270 strands were used in all of the beams. Figures 82 through 93 show the stress-strain relationships and photographs of the prestressing strands. In the plots of stress-strain behavior, the tensile tests results are compared to the stress-strain model which was used in the calculation of the capacity of the beams. The condition of the strands varied from beam to beam. Some of them were heavily damaged, such as the strand from I-beam 6 and all box beams, while strands from I-beam 3 were in a good condition. I-Beam 7 strand had light damage.

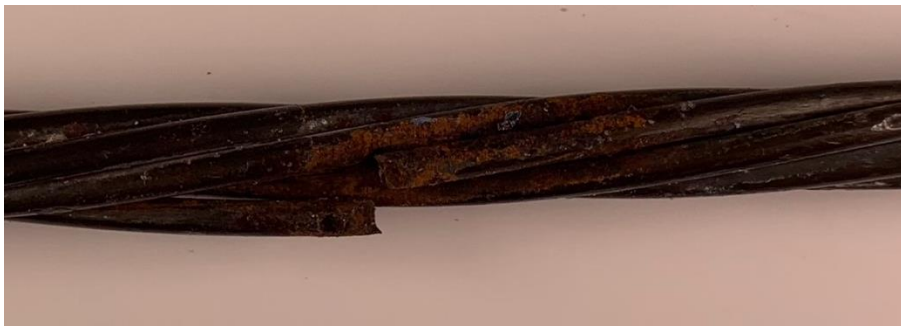
**Figure 85. Strand Taken from I-Beam 6 after Testing**

All the tensile tests were very similar to the stress strain model, prior to yield, except for the strand from Box Beam 4. The strands extracted from I-beam 6 and all three box beams failed to reach a strain of 0.02, because of their heavy corrosion. The stress-strain behavior of the strand from I-beam 3 was identical to the stress strain model, because it did not show any signs of damage. The strand from I-beam 7 did not achieve the expected ultimate strain, but also had light corrosion on its surface.

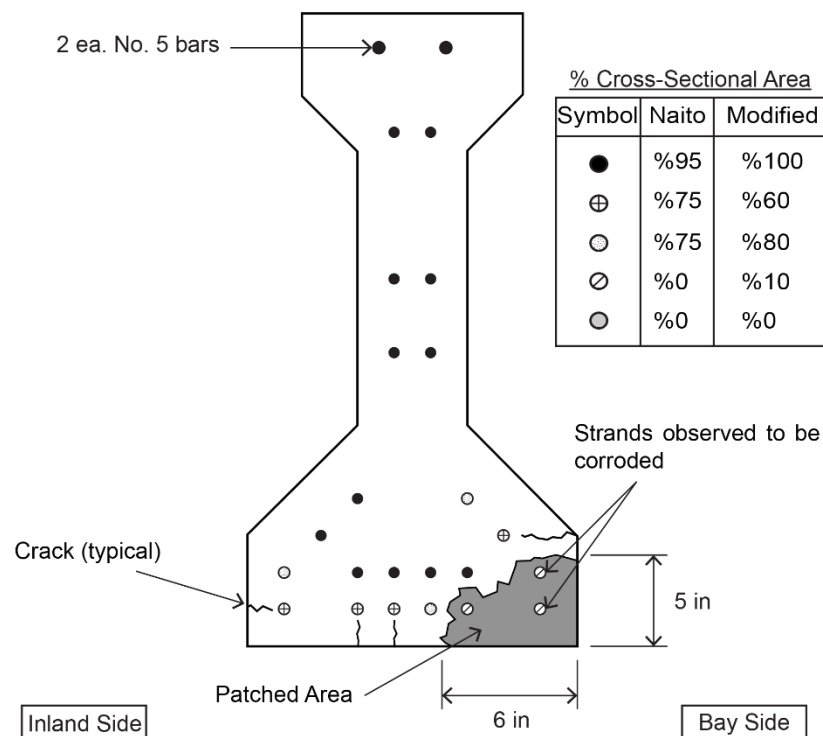
**Figure 96. Damage Estimated from Visual Inspection for I-Beam 6**

The strength for this beam was calculated using two methods to account for the damage: the recommendations of Naito et al. (2010), and the modified method. The damage inferred from the pre-test visual inspection is presented in Figure 96. The calculations were performed with the tested deck concrete strength of 2900 psi and the beam concrete strength of 6100 psi. The haunch at mid-span was 1.5 in. The tested strength of this beam was 1393 k-ft. The calculations using strain compatibility and the AASHTO method are presented in Table 12. Based on the damage maps, two out of six strands in the first lower level were in a patched area, and the other two had longitudinal cracks. Additionally, one strand out of six in the second lower level was in the patched area.

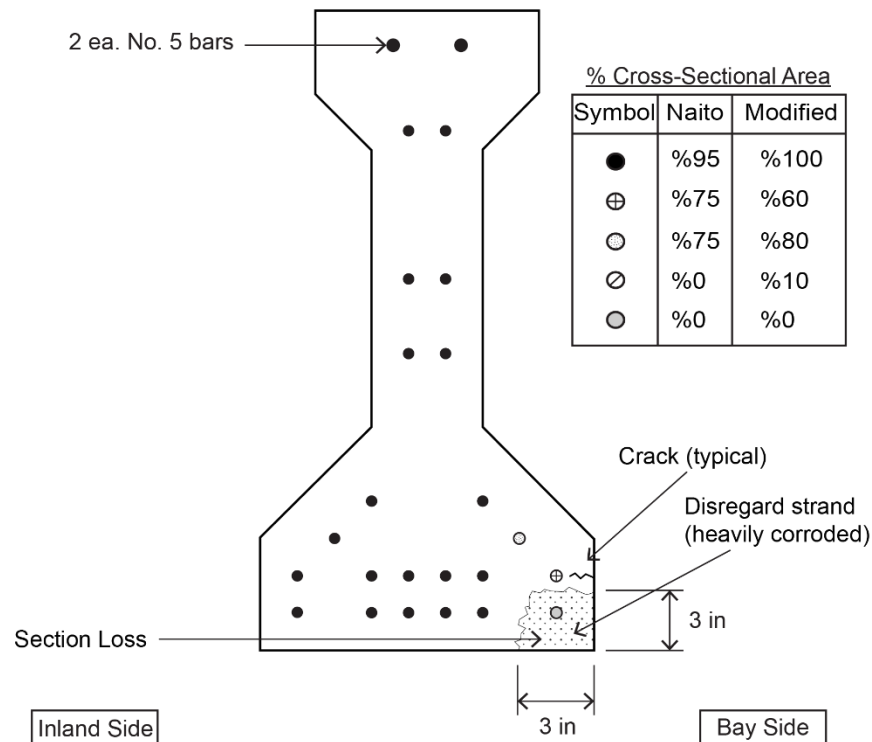
**Figure 98. Damage Estimated from Visual Inspection for I-Beam 3**

Naito et al. (2010) and the modified method were used to account for the damage in I-Beam 3 (see Figure 98). Prior to testing, there was one exposed strand in the first lower level. The deck concrete strength was 3500 psi and the beam concrete strength was 5600 psi. The haunch at mid-span was 1.5 in. The tested strength of this beam was 1873 k-ft. The effective

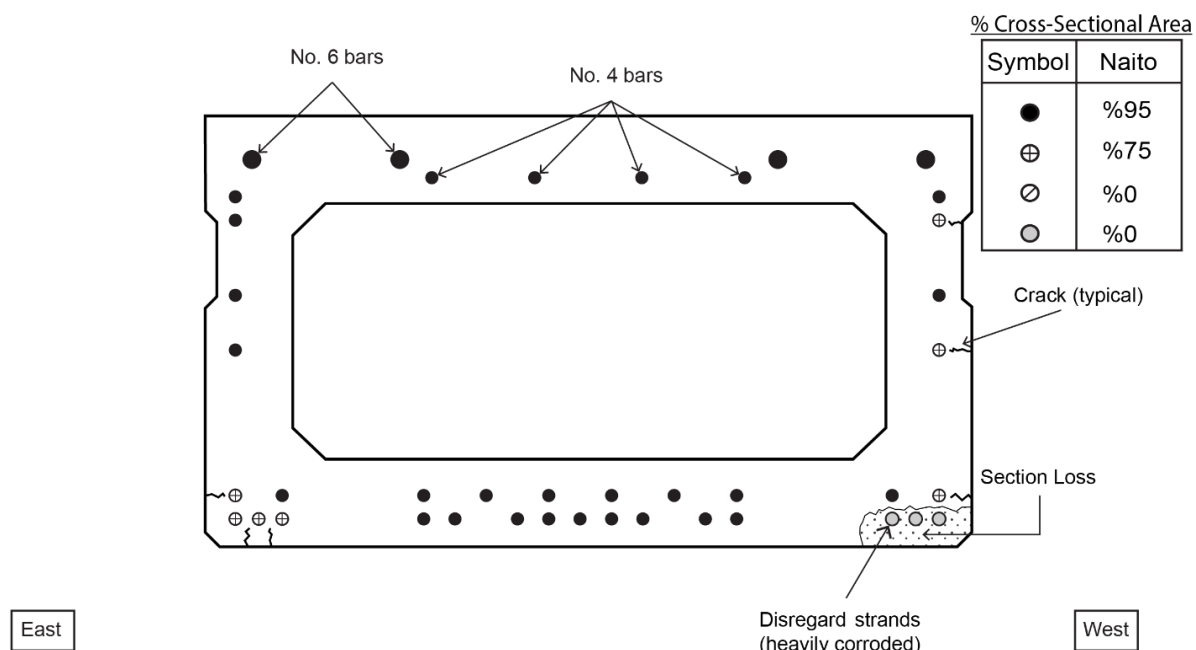
**Figure 99. Damage Estimated from Visual Inspection for Box Beam 1**

The cross-sectional area of the strands in Box Beam 1 to be used for calculations were assumed using the recommendations of Naito et al. (2010). Based on visual inspection, three exposed strands in the first lower level were heavily corroded (see Figure 99). Those assumptions, along with the tested concrete strength of 7250 psi, resulted in estimated flexural strengths that were within about 1% the actual strength determined from load testing. The total moment on the beam during testing, including self-weight, was 1269 k-ft. Using strain compatibility, the calculated flexural strength was 1253 k-ft, while the capacity at ultimate using the AASHTO method was slightly lower at 1251 k-ft. Note that the effective prestress calculated from the AASHTO method was 156 ksi. On the other hand, the effective prestress calculated from the observed 50-kip cracking load and the Naito et al. (2010) recommendations was 128 ksi, which was about 18% below the AASHTO-based effective prestress.

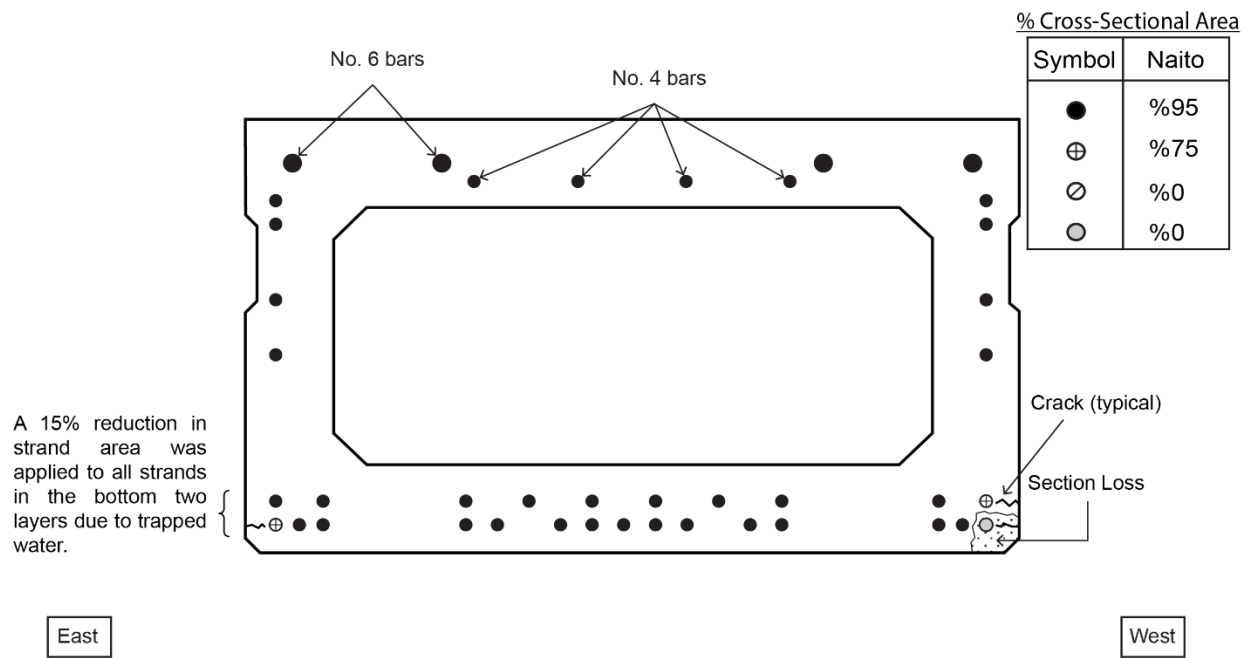
**Figure 100. Damage Estimated from Visual Inspection for Box Beam 4**

Box Beam 4 had different conditions than the other two box beams, with water trapped in the beam leading to a lower strength. The recommendations of Naito et al. (2010) were used with a small modification to account for the trapped water, where a 15% reduction was applied on top of the Naito reductions to the two lower strands levels (see Figure 100). This percentage reduction gave reasonable calculated results. Based on the compressive test, the concrete strength was 6250 psi. The tested strength of this beam was 1196 k-ft. The calculations using strain compatibility and the AASHTO method are presented in Table 14. Note that the actual cracking load of 50 kips resulted in an effective prestress equal 167 ksi. On the other hand, the effective prestress calculated from the AASHTO method was 156 ksi. This latter value for effective prestress was used in the strain compatibility calculation method for flexural strength.

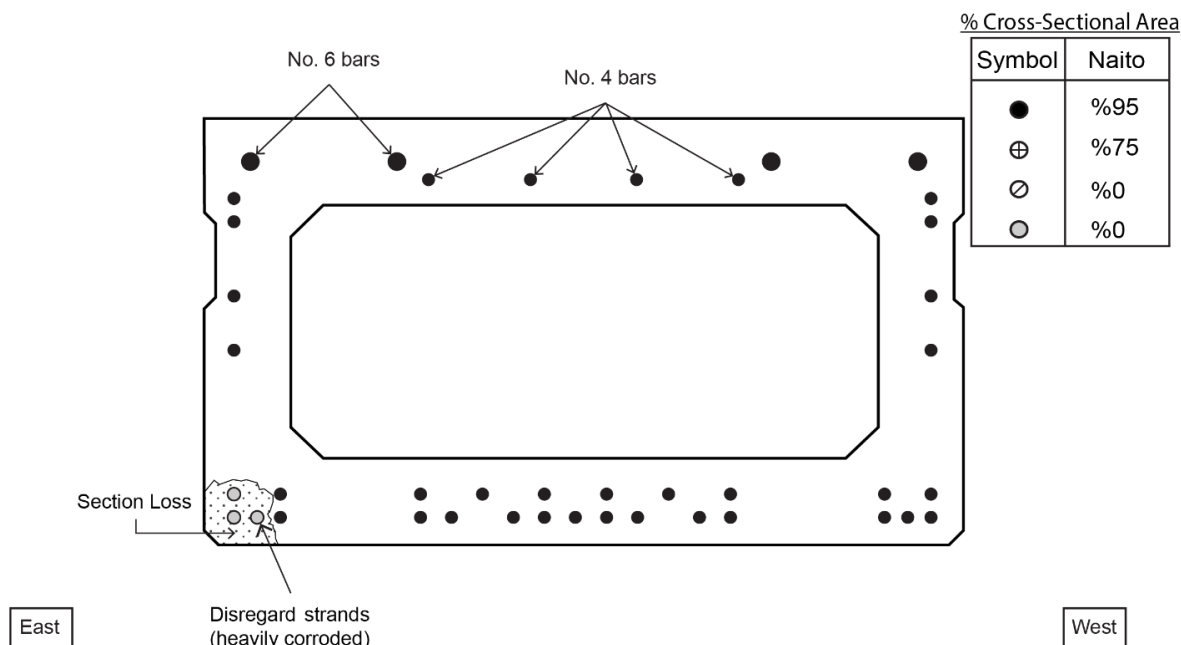
**Figure 101. Damage Estimated from Visual Inspection for Box Beam 2**

The residual capacity for Box Beam 2 was calculated using the recommendations of Naito et al. (2010) to estimate the remaining cross-sectional area of the strands. Three exposed strands were disregarded in the calculation of the flexural strength (see Figure 101). The concrete

strength used in the calculation was 7100 psi which was obtained from compression tests of extracted cores. The tested strength of this beam was 1284k-ft. Following the strain compatibility method, the flexural strength was calculated to be 1292 k-ft. Using the AASHTO method resulted in a moment equal to 1289 k-ft. Based on the actual cracking load (49 kips), the effective prestress calculated was 146 ksi. On the other hand, the effective prestress calculated from the AASHTO method was 156 ksi.
