Railroad Crossing Study

Study SD90-14
Volume II: Appendices

Prepared by
Department of Civil Engineering
SD School of Mines & Technology
Rapid City, South Dakota

January, 1992

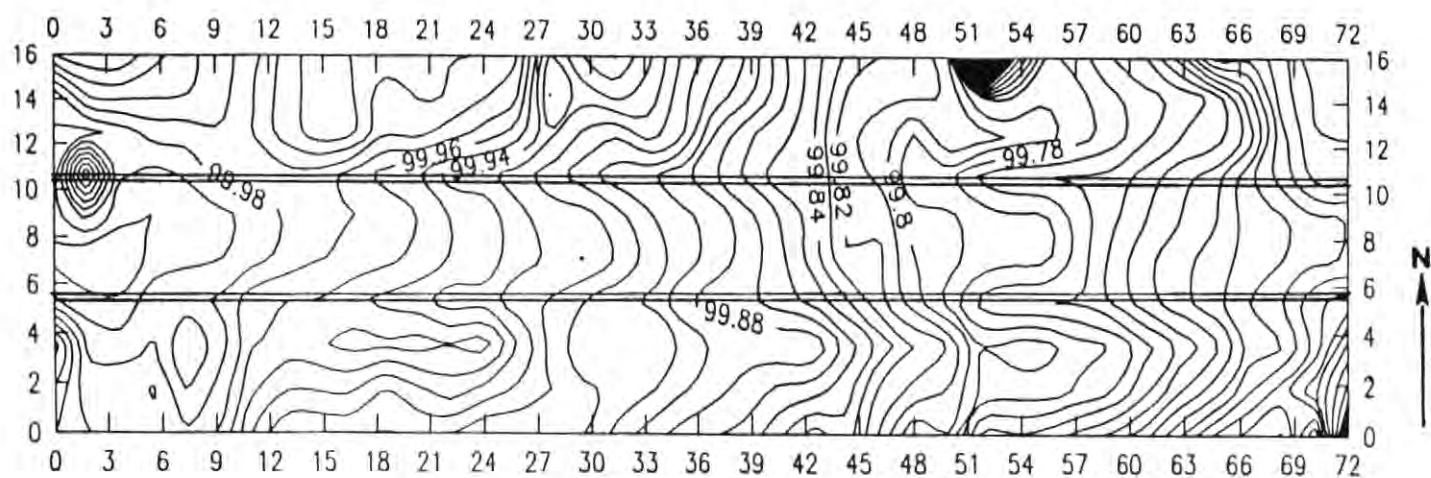
Figure A1 LaCrosse Street, Rapid City (Rubber)

The results of the survey are shown in Figure A1 through A3. The contour map (Figure A1) shows that the crossing is relatively even, but minor signs of depressions can be seen beginning to form in the driving lanes from 9 to 18 feet and 24 to 30 feet from the west curb. The survey data show that the rail is slightly lower than the panels and the panels tilt towards the rails. This can be seen in Figure A3, which shows cross-sections at one of the wheel paths and in between the wheel paths. In addition, Figure A3 shows that the south panels have settled more than the center and north panels, and that the overall settlement of the crossing in relation to the pavement is on the order of 1/4 to 1/2 of an inch. In addition, the sections on Figure A3 show more settlement and pavement wear under the wheel path than in between the wheel paths. There is a nearly a 1/2 inch difference in the elevation of the pavement at the wheel path as compared to in between wheel paths.

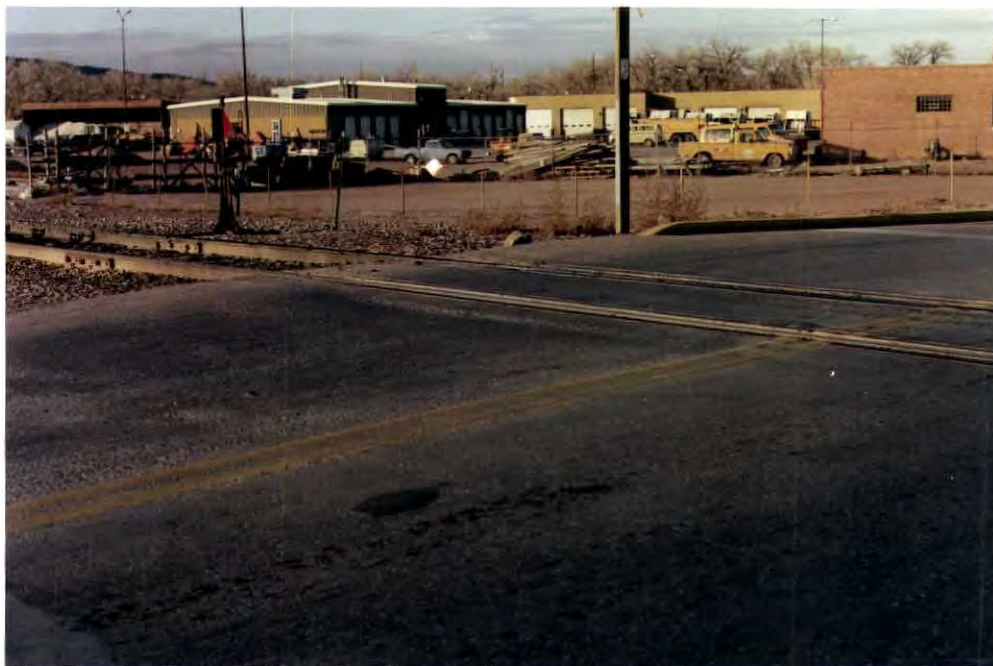
Photo 5. Steele Avenue - Approach Pavement Settlement

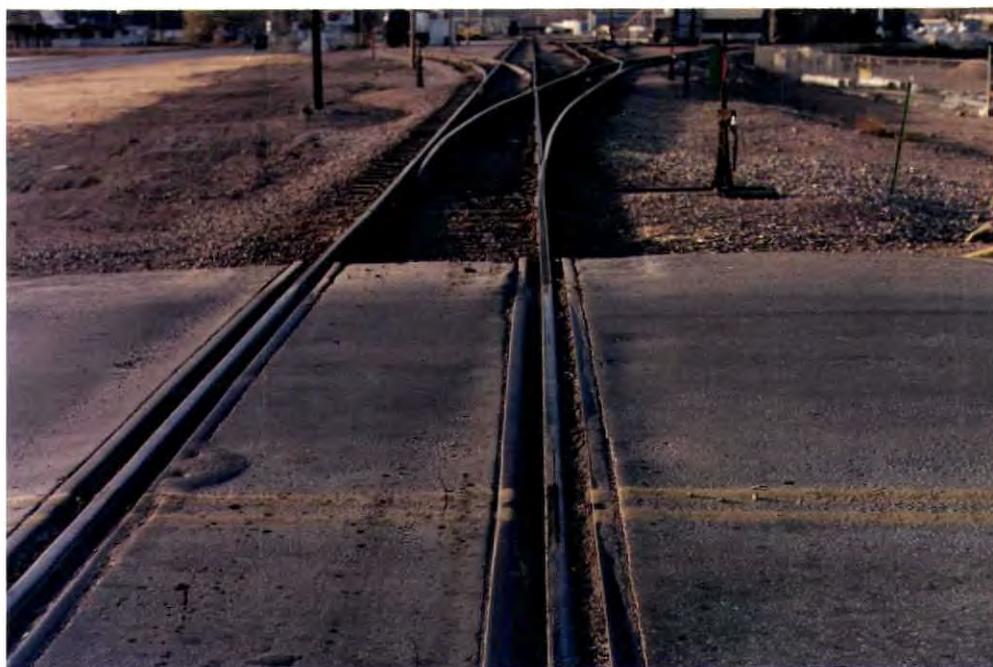
Photo 6. Steele Avenue - Yielding of Asphalt and Mud-Filled Track

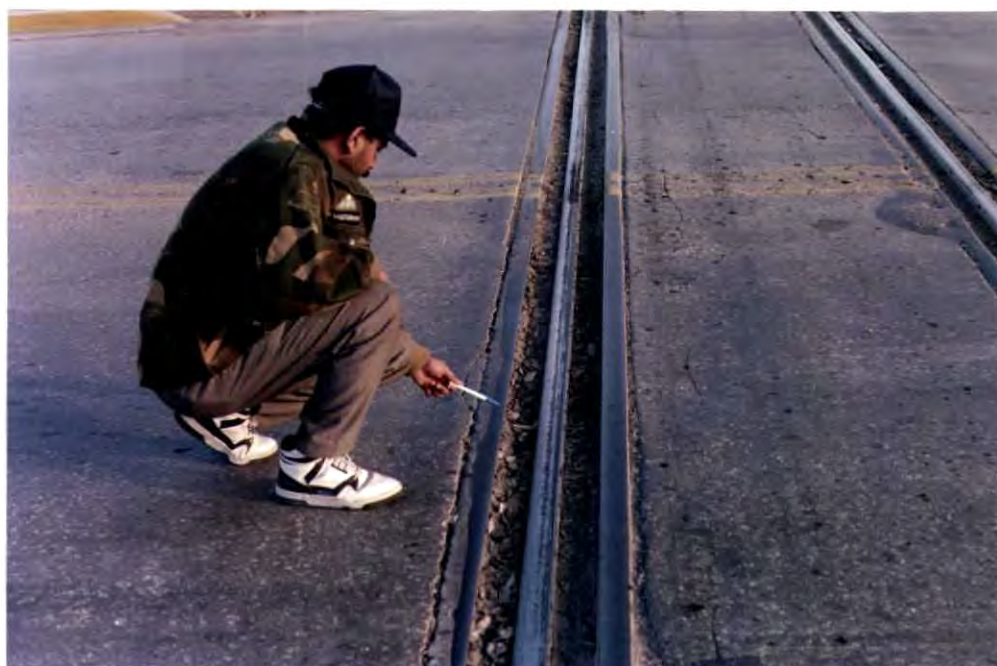
Photo 7. Steele Avenue - Debris Collection on the Either Side of Rail

to the crossing. Rail deflections during rail traffic at the ends of the crossing were measured to 0.25 inches. Significant debris can also be seen on either side of the rails (See Photo 7).

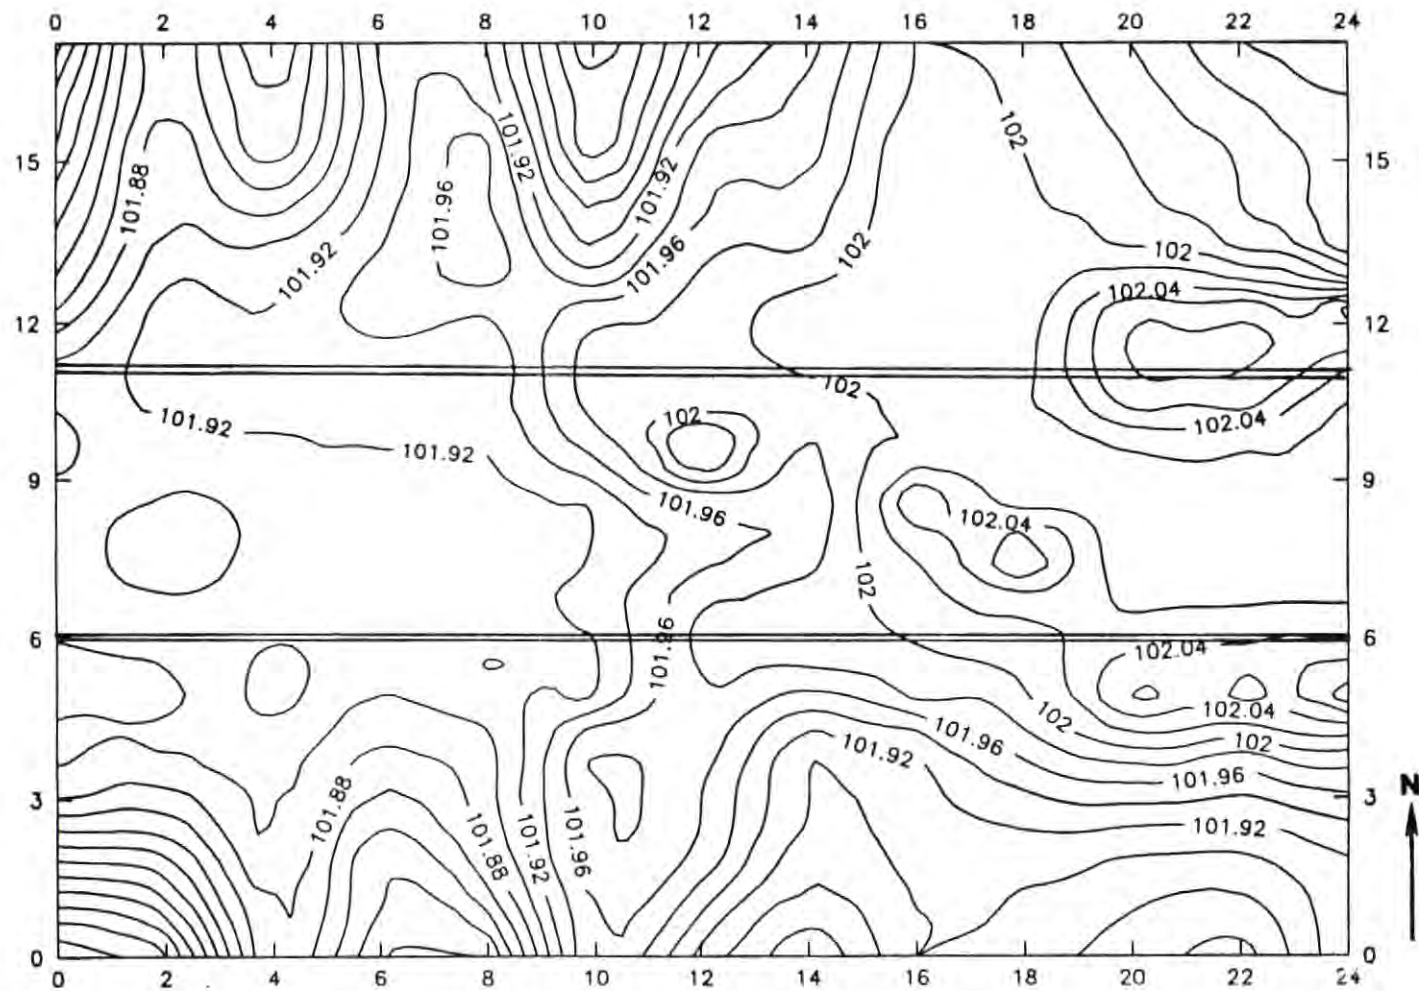
Figure A4 Steele Avenue, Rapid City (Asphalt)

The results of the survey are shown in Figures A4 through A6. The contour map (Figure A4) shows a relatively uneven crossing with differences in elevation in excess of one inch over distances of less than 3 feet. The map also shows that there is some rutting of the asphalt in the wheel paths, especially on the west side of the crossing. Considerable approach pavement settlement can also be seen in Photo 5 and in Figure A6. Pavement distortion was considerably less at the curb, however (Figure A5). The survey data show that the rail is slightly lower than the asphalt adjacent to outer mud rails and that there is a trough in the pavement between the rails (See Figure A6). The approach pavement has settled nearly 1 to 1 1/2 inches with respect to the track. The north rail is uneven and is up to 1 inch higher than the south rail (See Figures A5 and A6). Figure A6 also shows more settlement and pavement wear under the wheel path than in between the wheel paths.

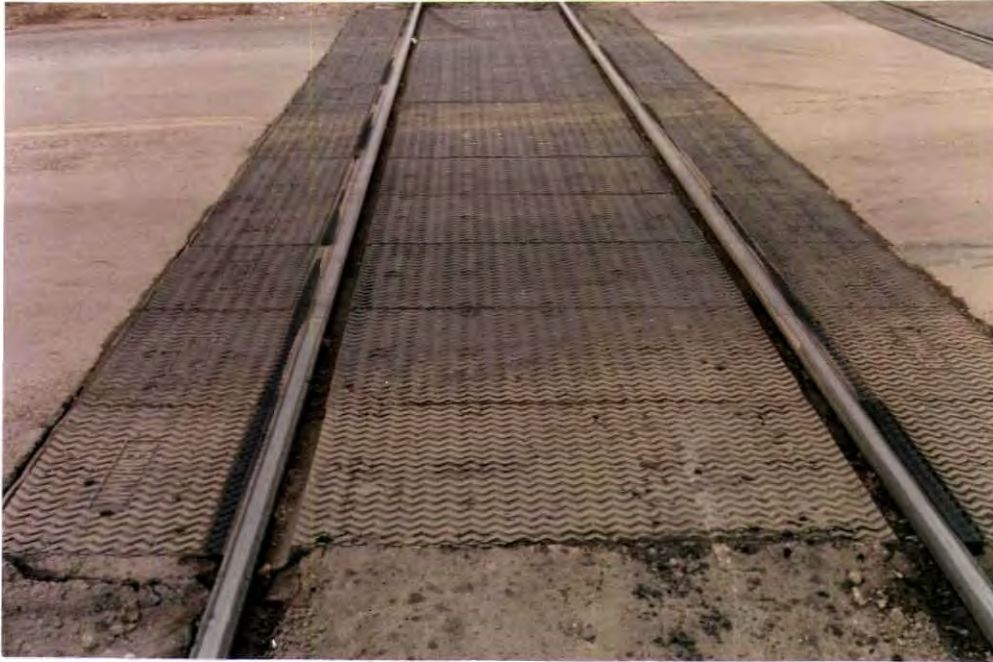
Photo 8. Maple Avenue - Overall View

The rubber headers are slightly separated from the pavement along the south side of the track (See Photo 8) and the headers have settled with the track, leaving a sharp drop-off from the pavement to the outer panels at some locations (See Photo 9). Debris is collected between the track and the center panels (See Photo 8).

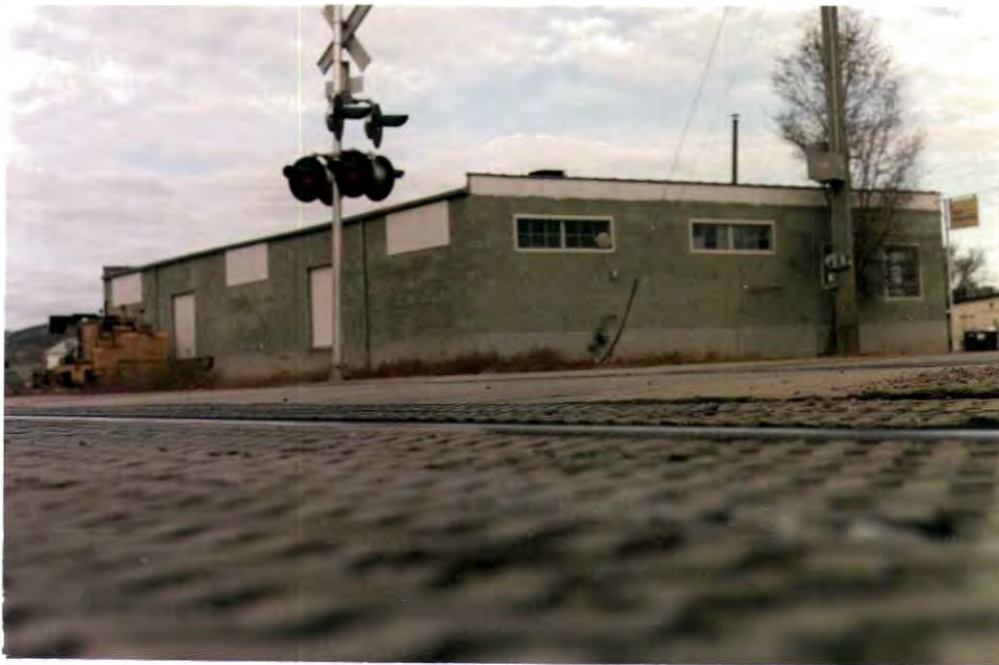
Photo 9. Maple Avenue - Differential Settlement between Crossing and North Approach

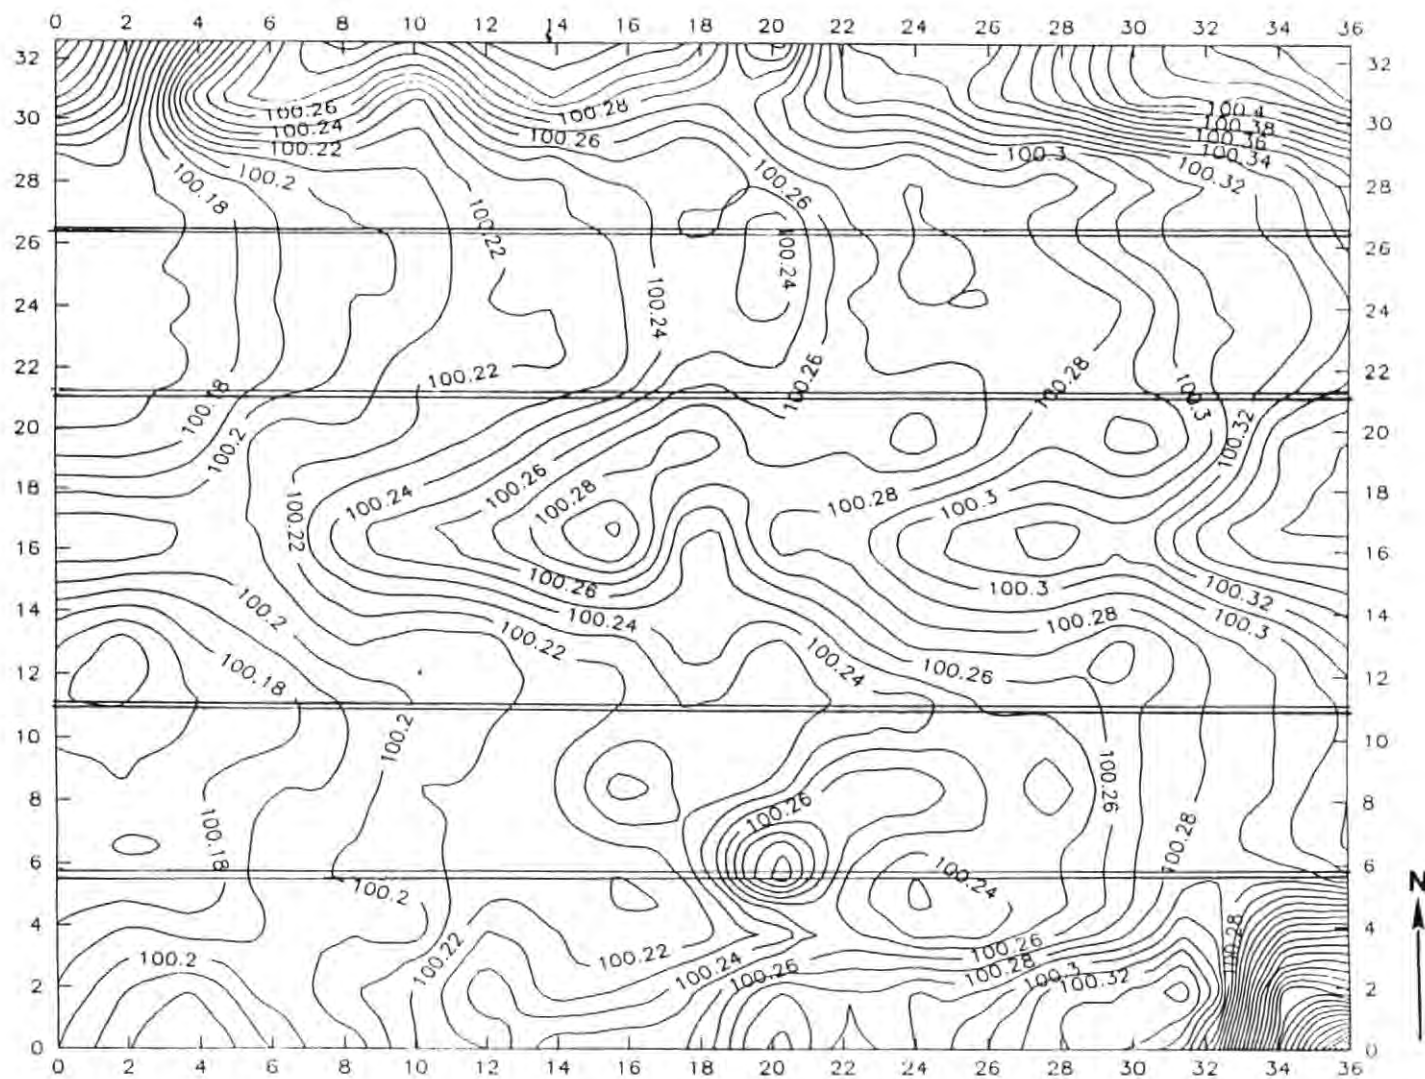
Figure A7 Maple Avenue, Rapid City (Rubber)

The contour map and profiles of the crossing are presented in Figures A7 through A9. The most pronounced feature shown in Figure A7 is the overall settlement of the crossing with respect

to the north approach, and the settlement of the southeast shoulder. Evidence of depressions beginning to form along the wheel paths can also be seen, especially in the east lane. Overall settlement of the track is on the order of 1/2 to 1 inch (Figures A8 and A9), but the drop in elevation from the north approach onto the crossing exceeds one inch at some locations. The pavement between the tracks is also slightly higher than the crossing. The surveying data show (Figures A8 and A9) that the rail is slightly lower than the outer panels. Tilting of the outer north panels towards the rail can also be seen (See Figure A8) and there is more settlement along the wheel path than in between wheel paths (Figure A9).

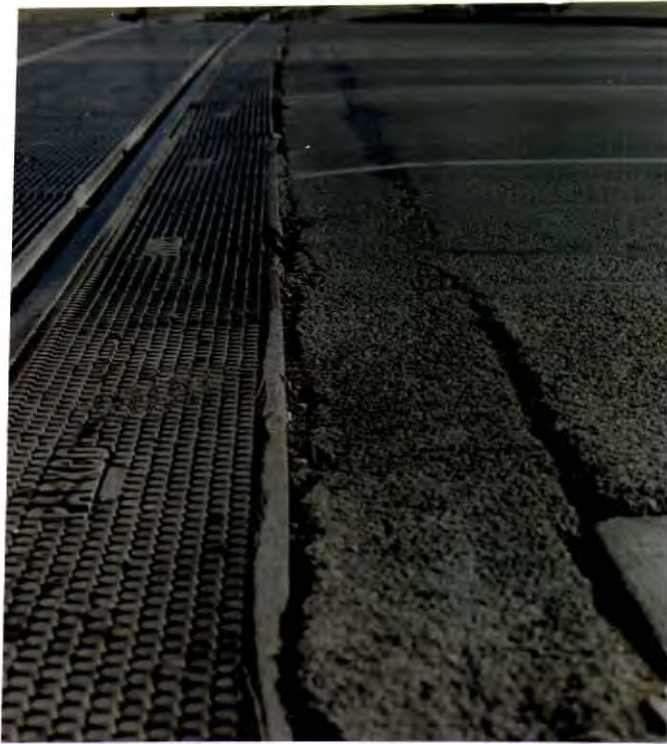
The wood headers are damaged (See Photo 12). This can be seen over most of the crossing along with loose rubber panels on the entire track. The center panels have popped up on the east side of the north track (See Figure A11 and Photo 11) and failure of the approaches is found along the entire track (See Photos 13 and 14). Debris collection next to the rail and the approach can be seen in Photo 14.

Photo 13. East Boulevard - Failed Joint Along the Shoulder and Damaged Header Board on North Side of Track

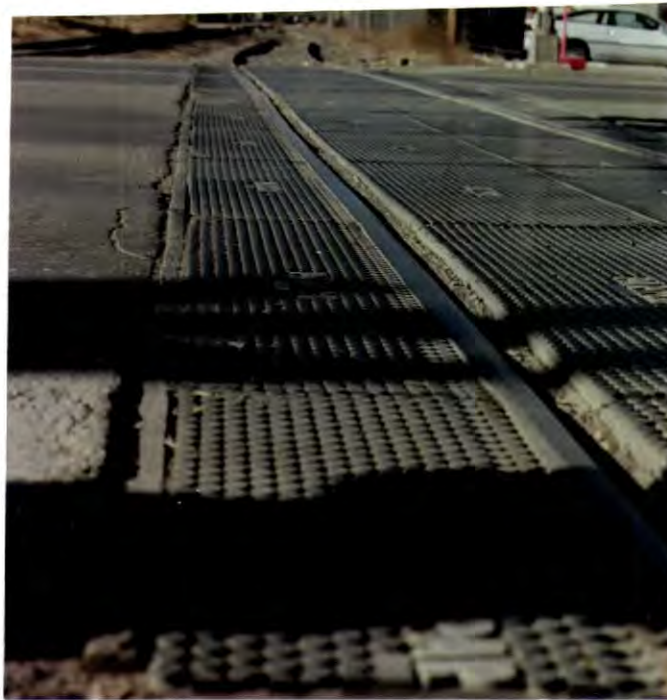
Photo 14. East Boulevard - Pavement Cracking on South Side of Track and Debris Collection Next to the Rail

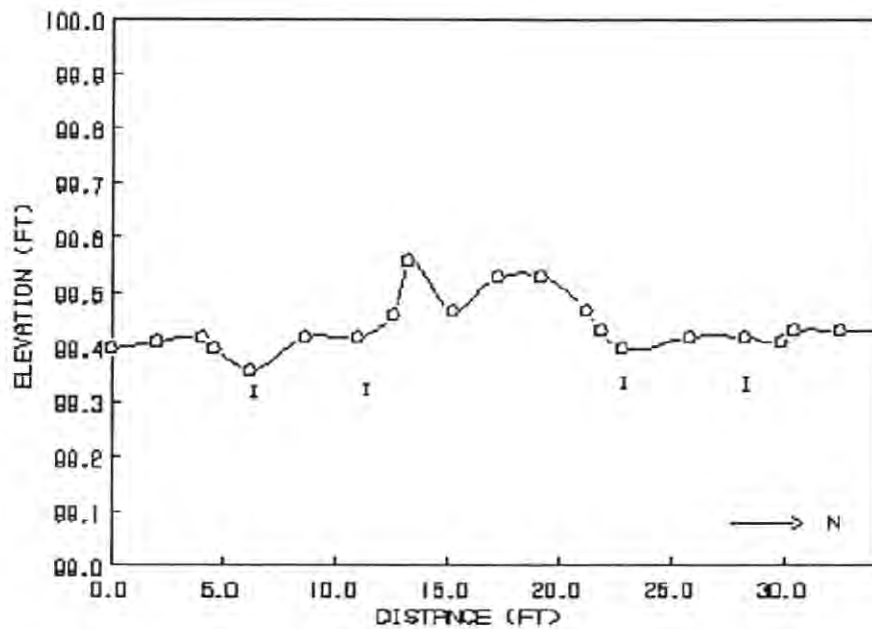
Figure A12 East Boulevard, Rapid City, (Rubber)
Cross section at curb.

Considerable panel wear can be seen along the entire crossing (See Photos 11 and 12). Figure A10 shows that the differences in elevation within the crossing on the south track is up to one inch, and elevation differences on the approaches are as much as 1.5 inches. This is mainly due to rutting (Photo 11). The south rail has settled approximately 1 inch more than the north rail at the curb (See Figure A12). On the north track (Figure A11), the differences in elevation within the crossing are generally less, but failure of the panels can easily be seen on the east side of the crossing. The rail on the north track has settled about 1 inch compared to the adjacent pavement, and the settlement of the approach pavement in the wheel path is distinctly greater in between wheel paths (See Figure A13).

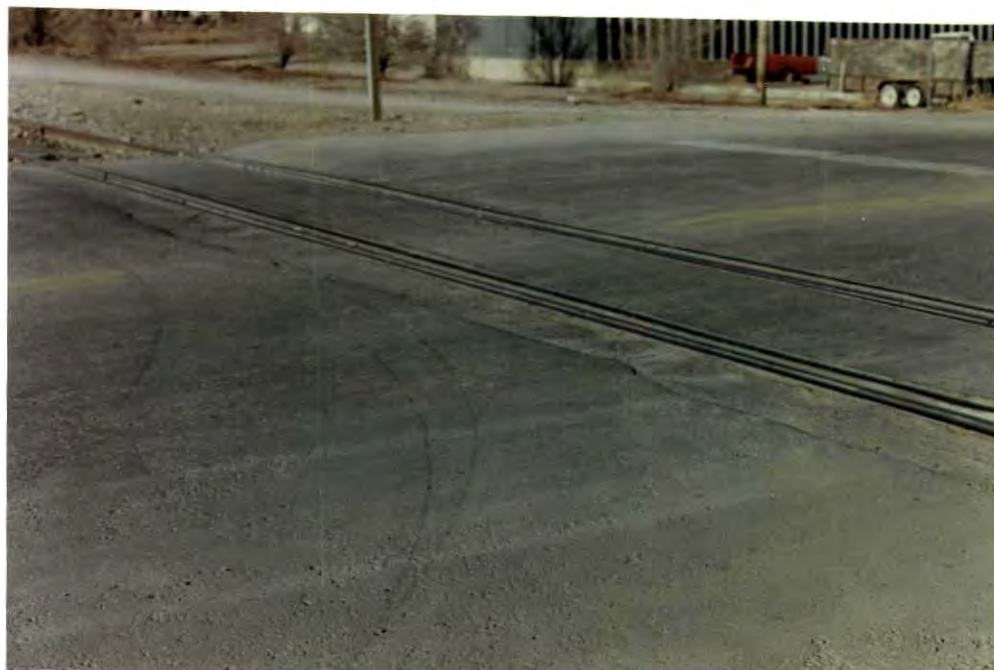
Photo 16. Third Street - Overall View of Track Settlement
(See Upper Left)

Pavement cracks are seen all along the track (See Photo 15 through 17) and there is considerable debris collection between the rails.

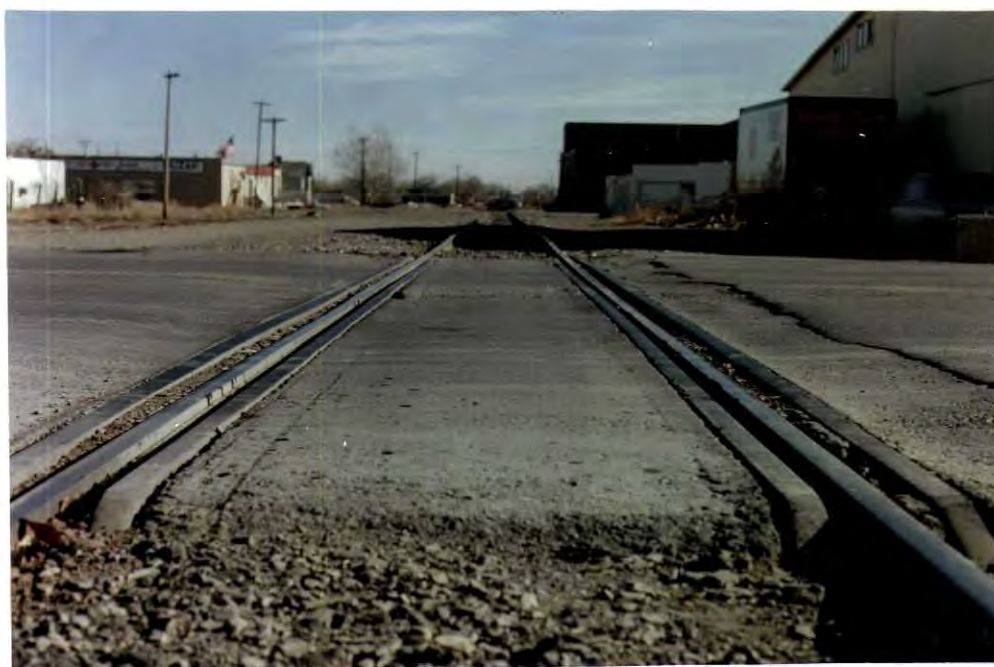
Photo 17. Third Street - Debris Collection and Uneven Mud Rails

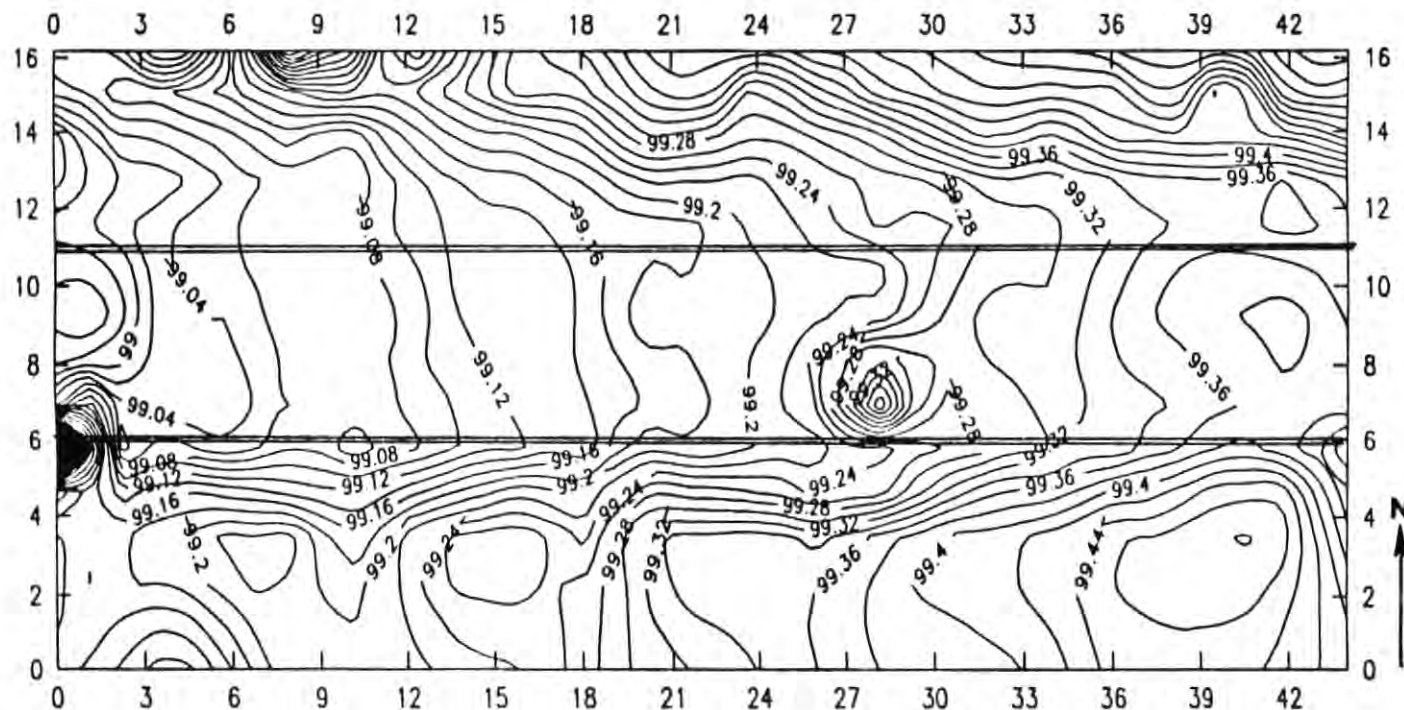
Figure A14 Third Street, Rapid City (Asphalt)

The survey data show (See Figures A14 through A16) that the track is considerably lower than the pavement (also see Photos 15 through 17). The contour map (Figure A14) show that the track has

settled between two and three inches relative to the approaches along the entire crossing. Evidence of heave in the pavement can also be seen between the tracks to east of the centerline. The overall settlement of the track can also be seen in Figures A15 and A16. Figure A16 also shows that there is more settlement and pavement wear at the wheel path than between the wheel paths.

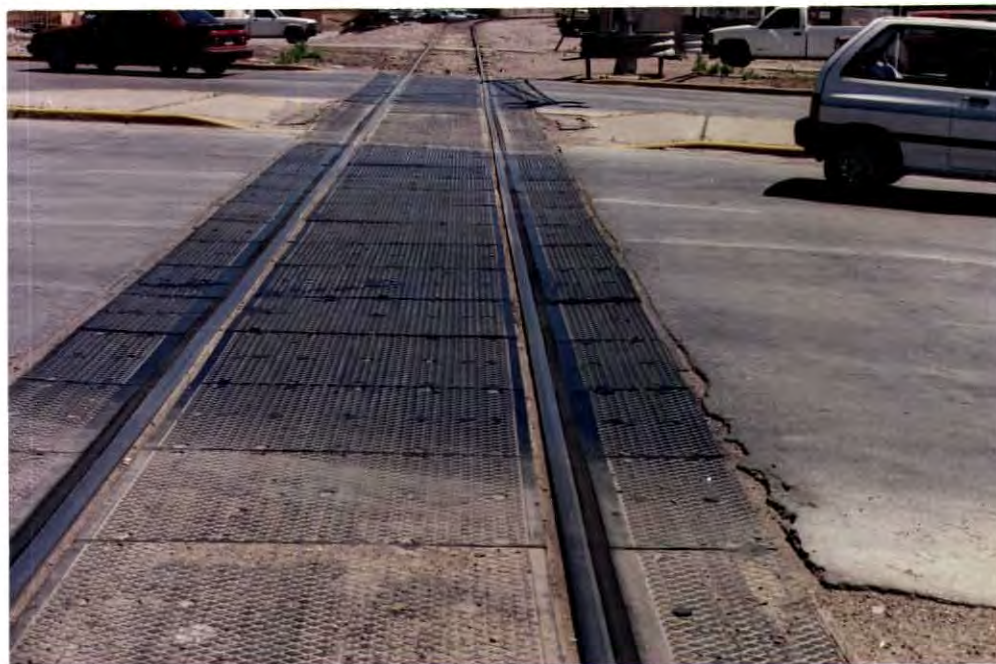
Considerable panel wear and loosening of panels was seen during the surveying (See Photos 18 and 20). Settlement of the track with respect to the approach can be seen in Figures A17 and A19. The contours in Figure A17 show the crossing may have been slightly elevated with respect to the road at the time of construction, as the elevation increases towards the crossing from both the north and the south. However, the contour map also shows that the track has settled in excess of one inch with respect to the approaches. The north outer panels on the east side of the crossing have popped out (Figures A18 and Photo 20). From the sections in Figure A19 it can also be seen that there is more settlement and pavement wear under the wheel path than in between the wheel paths. Panel deflection on the west side has also taken place at the wheel paths. The panels in this crossing

Photo 18. West Boulevard - Failed Joint at Wood Header Board

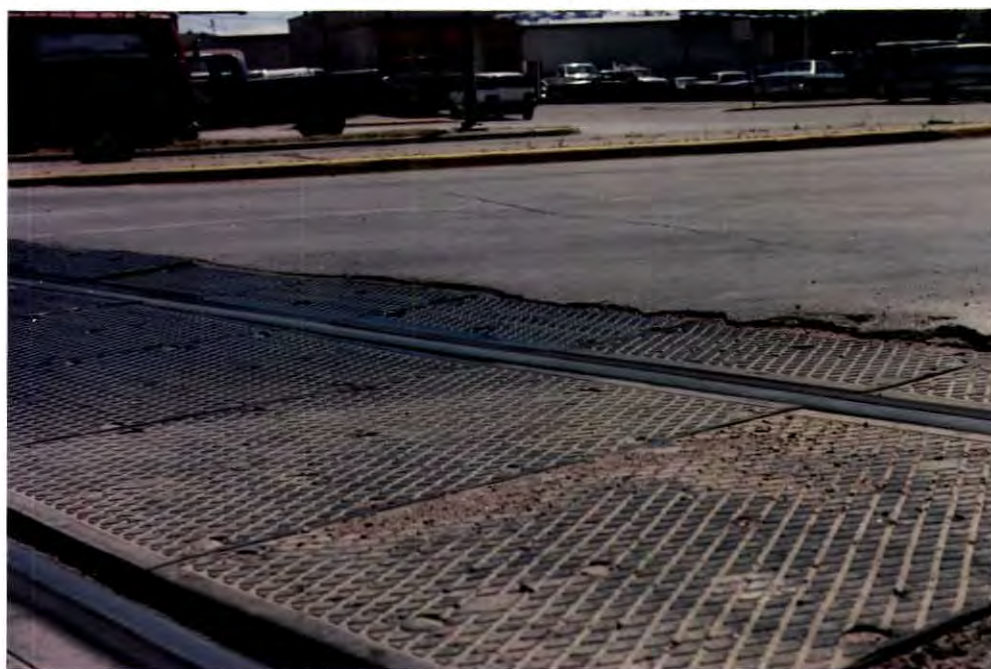
Photo 19. West Boulevard - Settlement of Crossing and Uneven Panels

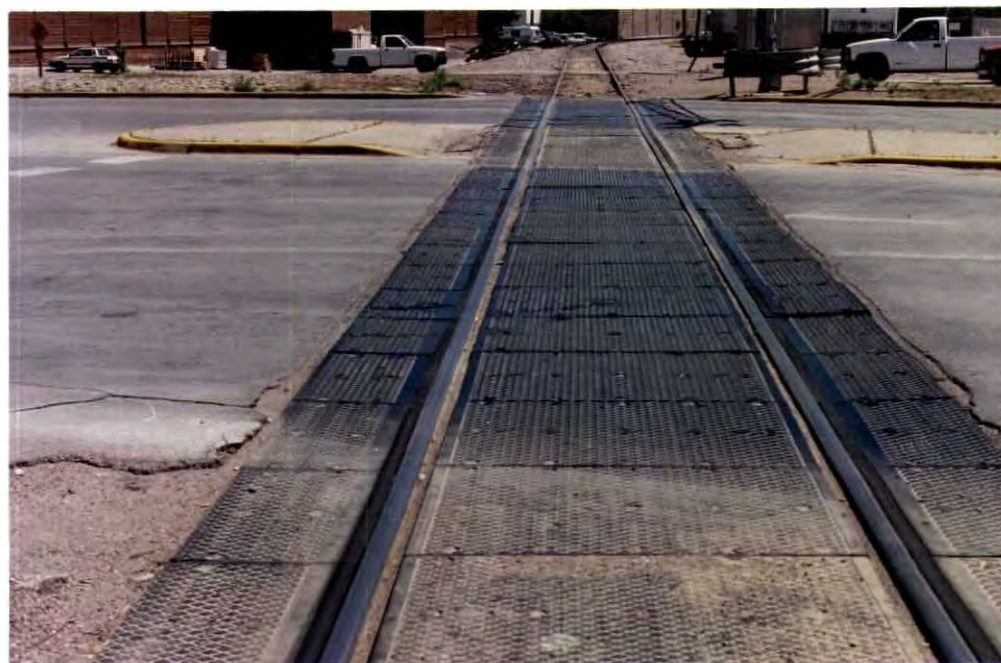
Photo 21. West Boulevard - Mud Filled Track and General View of Panel Unevenness

are worn, however, there is little snow plow damage (See Photo 21).

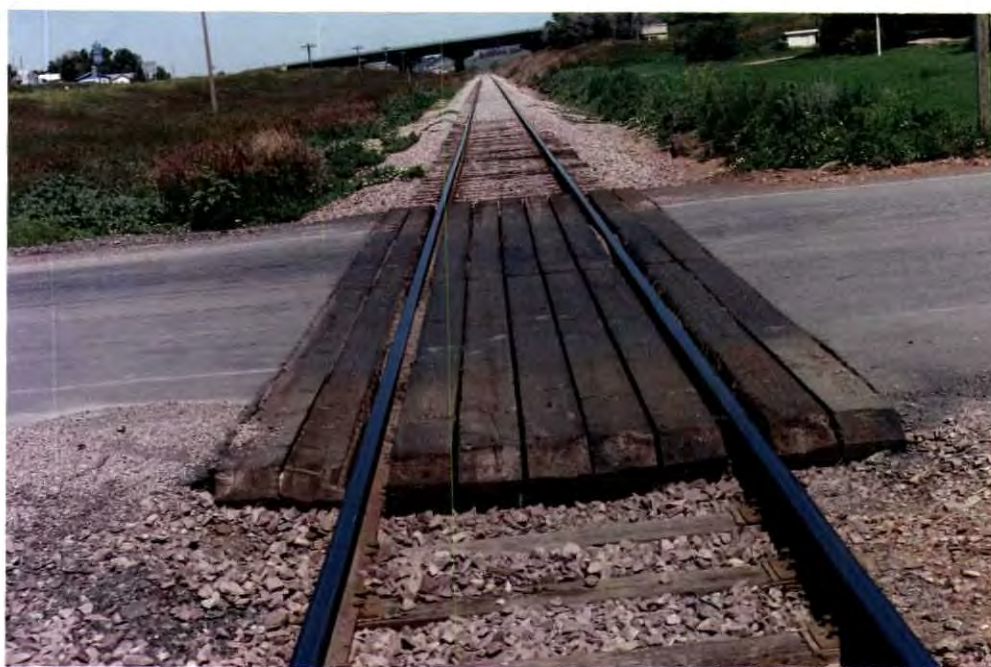
Photo 22. Black Hawk - Overall View and Damaged Timbers Along the Rails

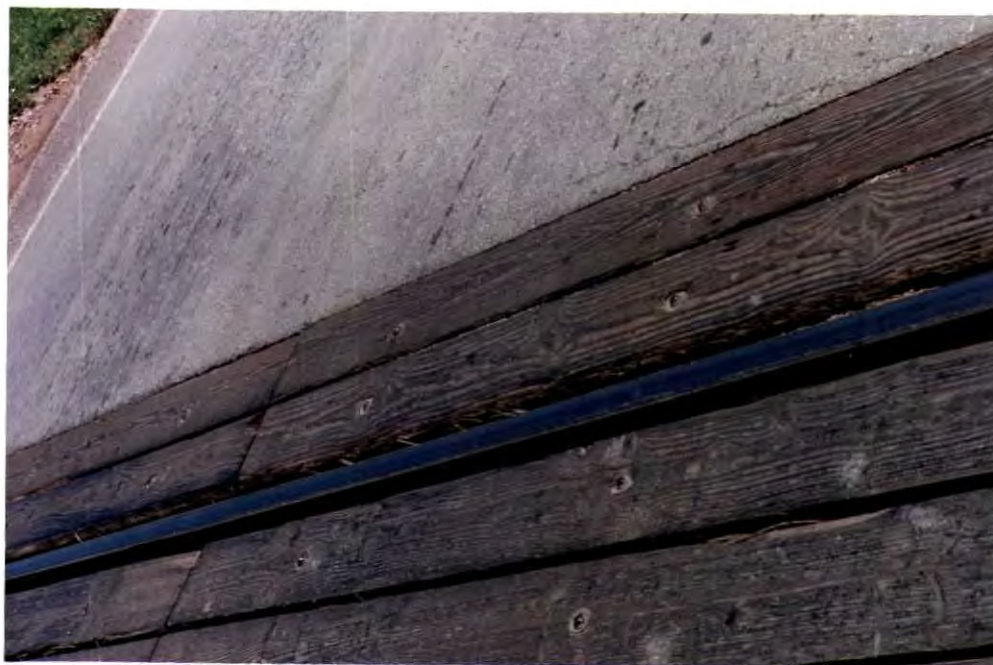
Track movement under railroad loading is evident as the spikes holding the rails have been pulled out of the ties and there is visible damage to the timbers (See Photo 23). The contour map

Photo 23. Black Hawk - Close View of Damaged Timbers and Cracking Along Header

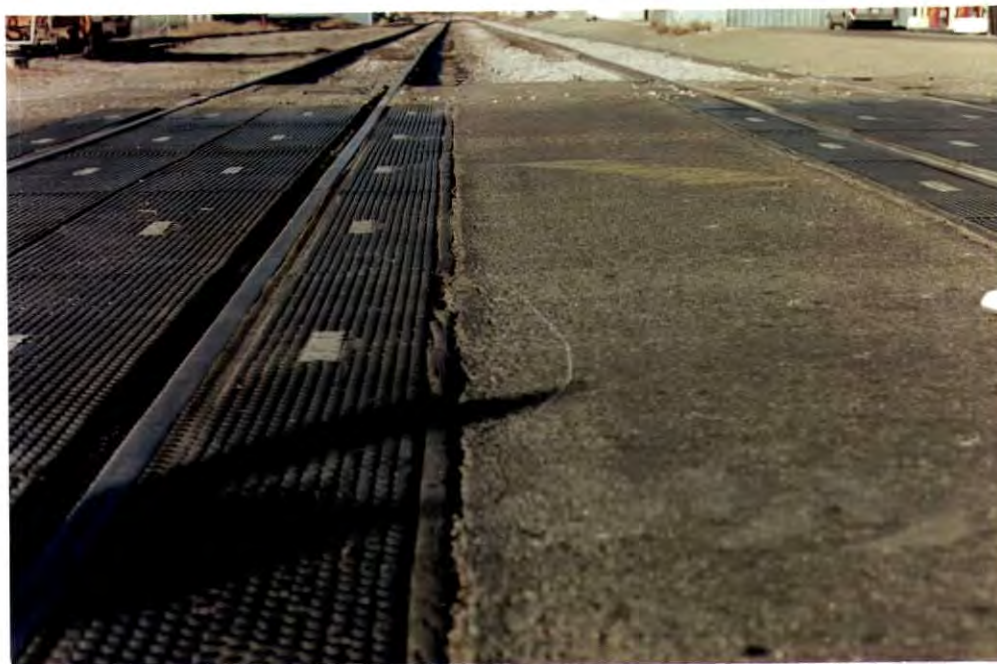
Photo 24. Harrison Avenue - Failed Pavement Where Wood Header Board is Missing or Damaged (Track 1)

The wooden headers are broken up and torn out all along the tracks (See Photo 24). Chipping and cracking of the asphalt can be observed at many points along the headers (See Photos 25 and 26) and loose sand and gravel has collected next to the rail.

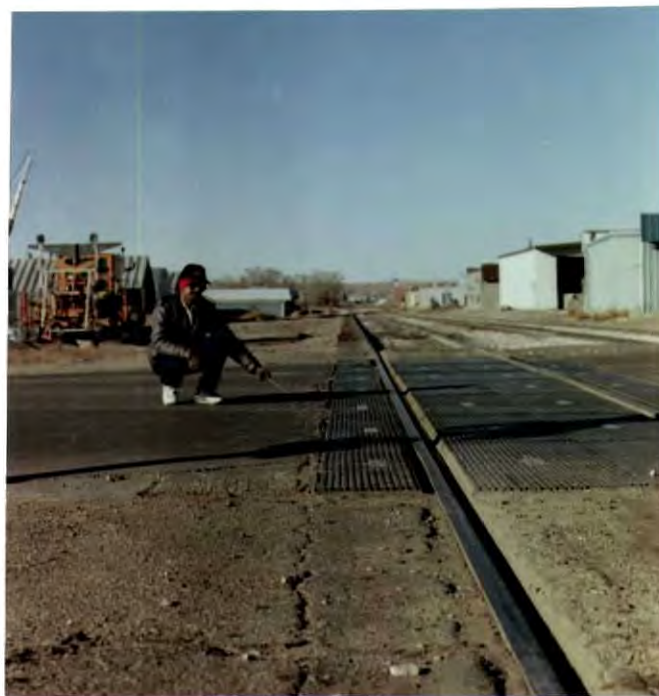
Photo 25. Harrison Avenue - Cracking From Track Movement Under Rail Traffic (Track 2)

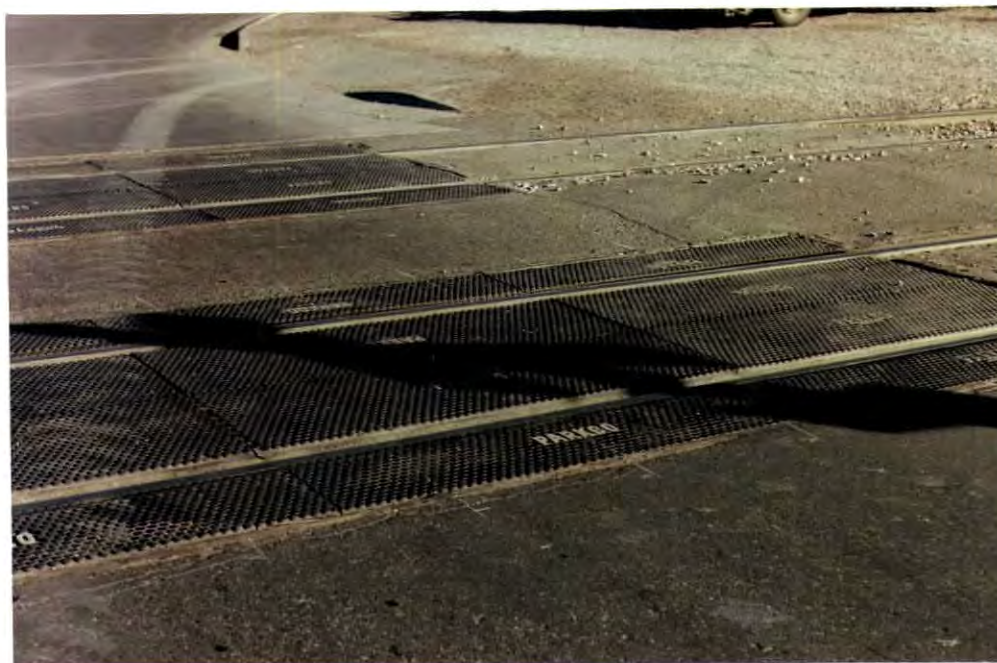
Photo 26. Harrison Avenue - Cracking Along Wood Header Board

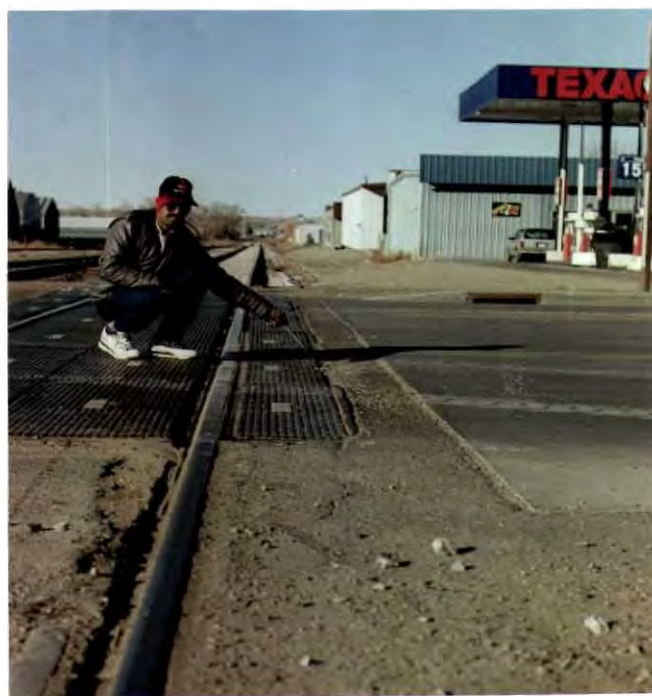
Photo 27. Harrison Avenue - Loose Rubber Panels and Misaligned Pavement and Asphalt Header

Drainage at this crossing appears to be poor. There were no ditches on either end of the crossing and considerable pumping was observed on approaches to the main track (Photo 27).

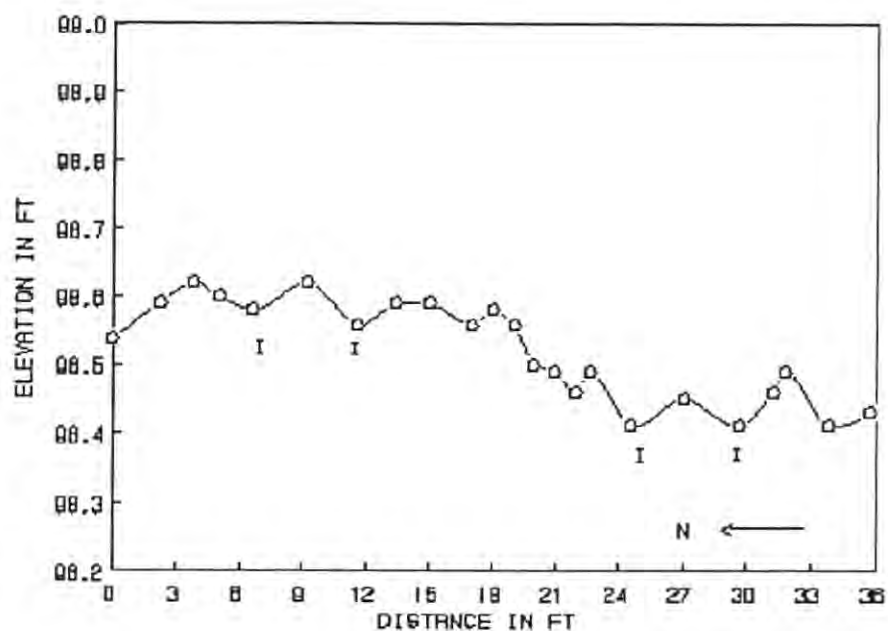
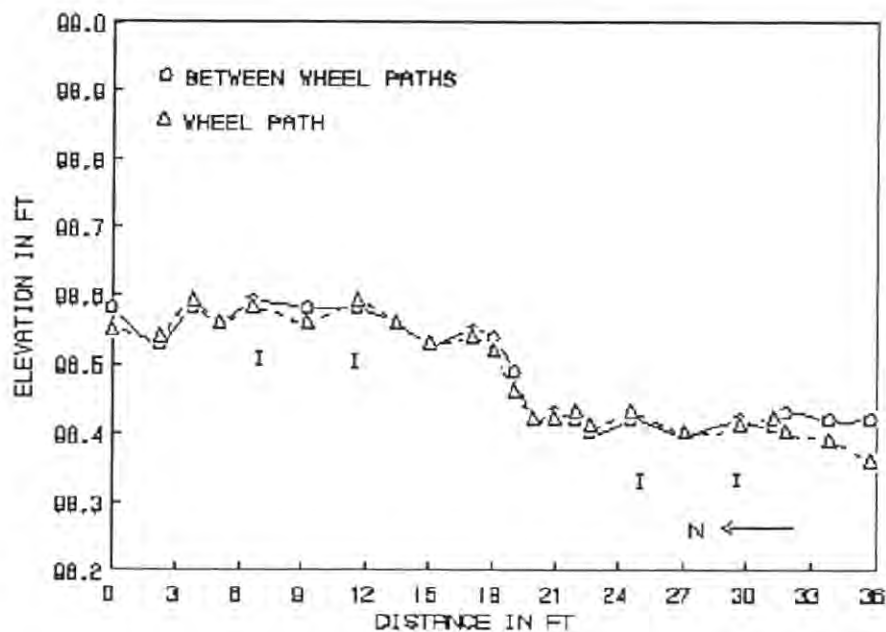
Figure A24 Harrison Avenue, Pierre (Rubber)
Cross section at curb.

Figure A25 Harrison Avenue, Pierre (Rubber)
Cross section taken at wheel path and
between wheel paths.

order of 1/2 inch to 1 inch (See Figures A24 and A25). It can also be seen that there is more panel wear and deformation under the wheel path than in between the wheel paths.

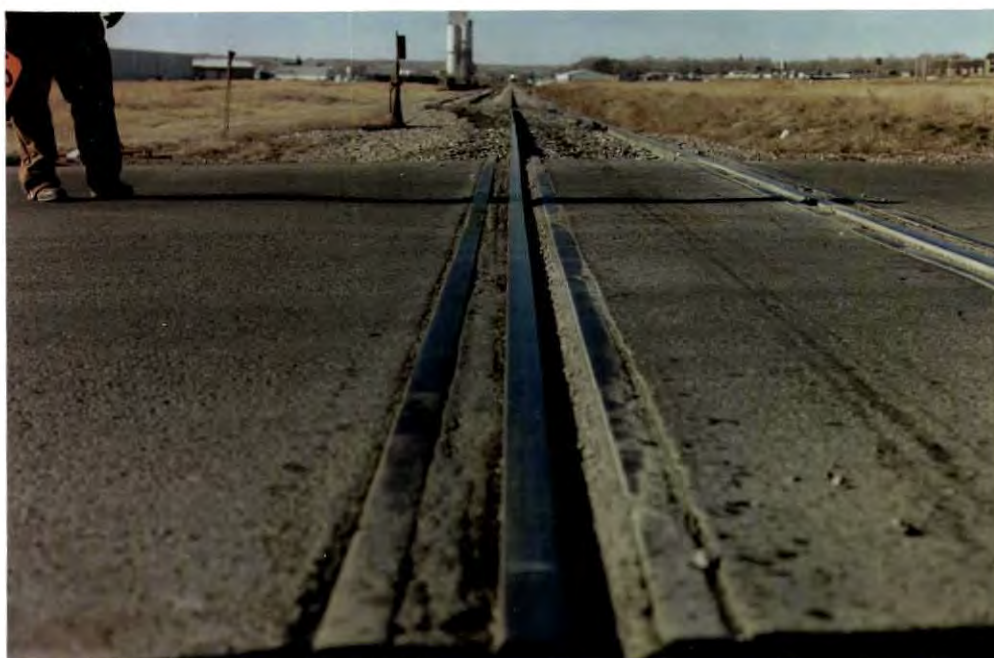
Photo 29. Indian Learning Center - Cracking Along Mud Rails and Settlement of Asphalt in Center Portion of Track

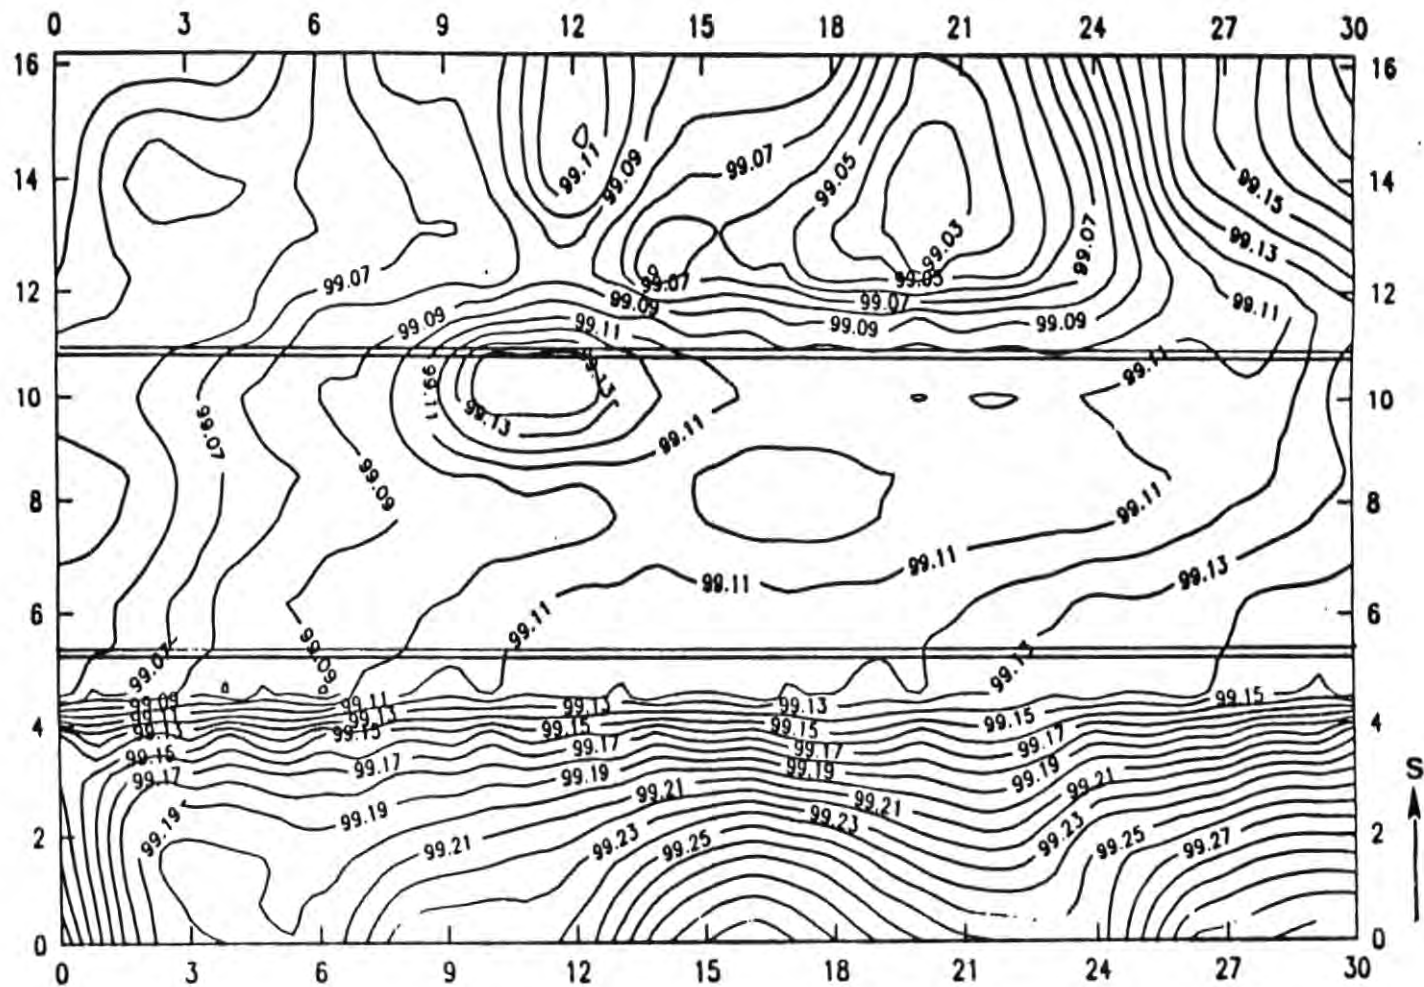
Figure A29 Central Avenue, Pierre (Rubber)

The survey data show that the track has settled up to 1 1/2 inches with respect to the northern approach. This is clearly seen on the contour map (Figure A29), and also in Figures A30 and A31. An half inch high ridge can be seen on the contour map near the south rail on the east side of the crossing, which may be an indication of pumping. The panels are cupped between the rails and have settled more in the center than at the rails. There is little evidence of differential distortion of the panels at the wheel path and in between the wheel paths, but there is considerable rutting on the south side of the crossing (Figure A31 and Photo 30). The wooden header boards are broken on the south side of the crossing (See Photo 30). Panels in between the
