Railroad Crossing Study

Study SD90-14
Volume II: Appendices

Prepared by
Department of Civil Engineering
SD School of Mines & Technology
Rapid City, South Dakota

January, 1992

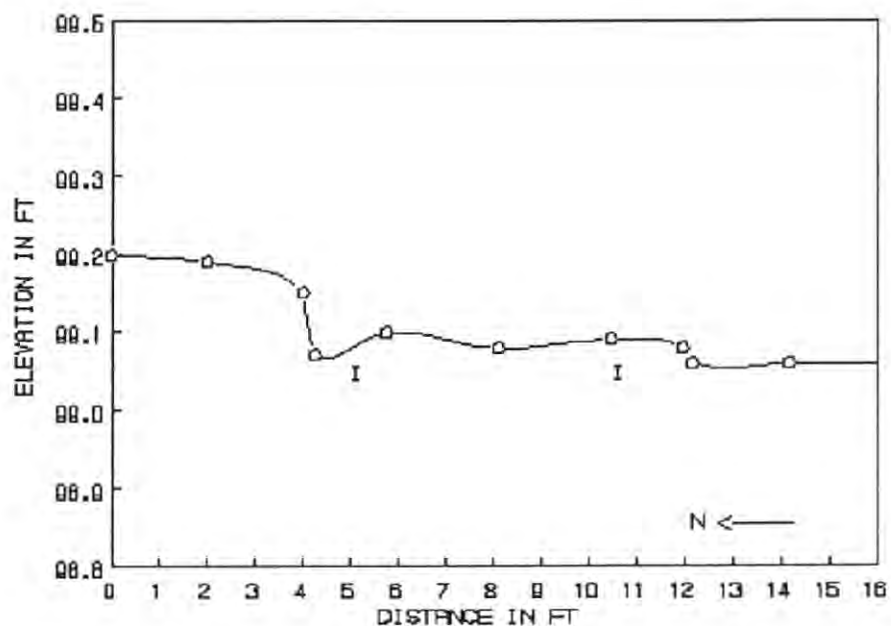
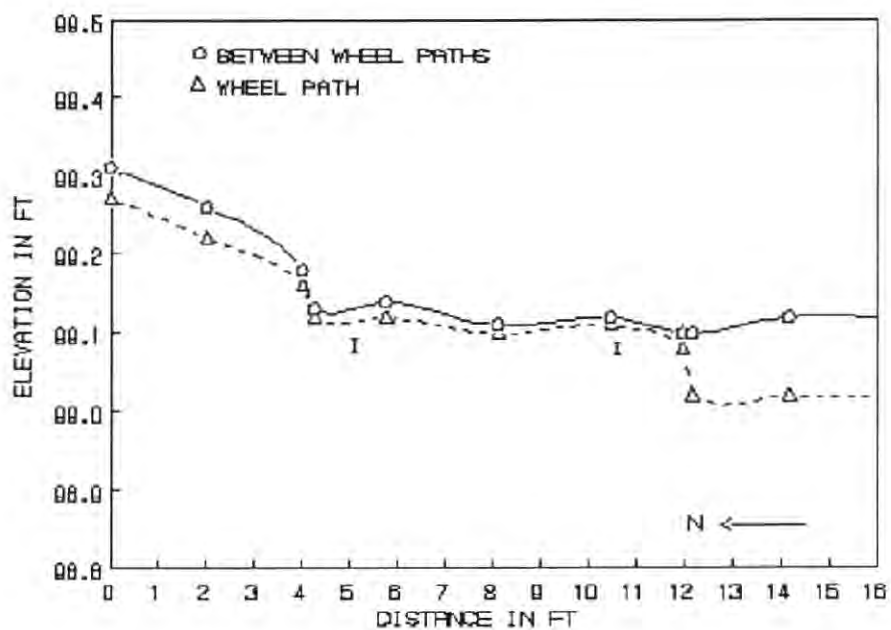
Figure A30 Central Avenue, Pierre (Rubber)
Cross section at curb.

Figure A31 Central Avenue, Pierre (Rubber)
Cross section taken at wheel path and
between wheel paths.

The survey data show that the track has settled up to 1 1/2 inches with respect to the northern approach. This is clearly seen on the contour map (Figure A29), and also in Figures A30 and A31. An half inch high ridge can be seen on the contour map near the south rail on the east side of the crossing, which may be an indication of pumping. The panels are cupped between the rails and have settled more in the center than at the rails. There is little evidence of differential distortion of the panels at the wheel path and in between the wheel paths, but there is considerable rutting on the south side of the crossing (Figure A31 and Photo 30). The wooden header boards are broken on the south side of the crossing (See Photo 30). Panels in between the

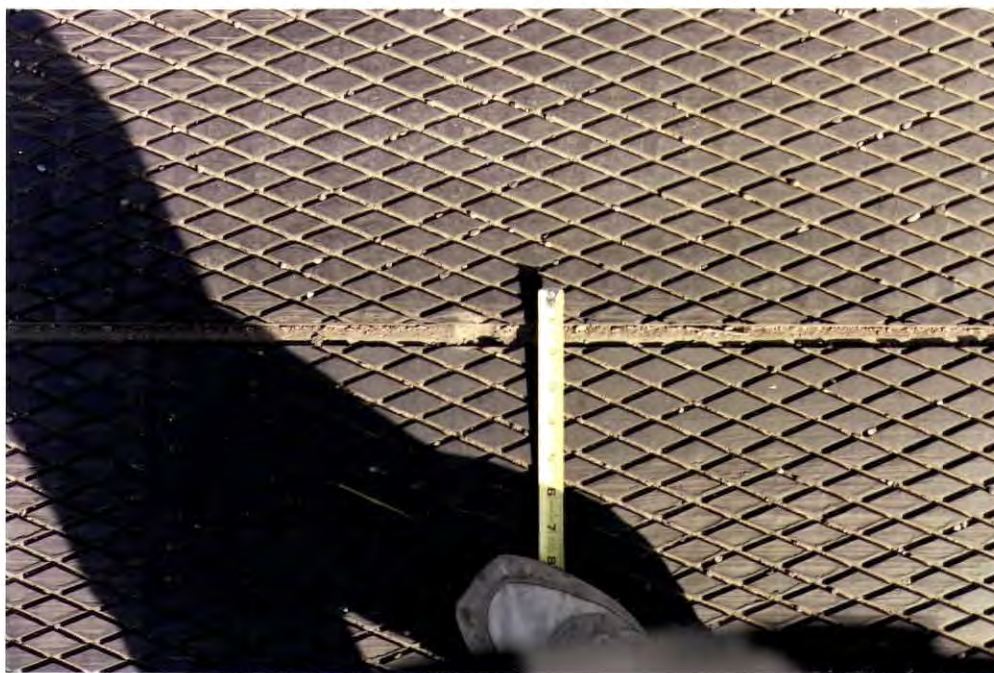
Photo 35. Main Street - Separation of Panels

The Hi-Rail crossing consists of full-depth rubber panels which do not use fasteners. The outer panels are held in place under the ball of the rail and are laterally confined by the pavement. The outer panels are thus subject to lateral movement under traffic and the center panels are subject to movement along the direction of the track. Evidence of such movement can be seen in Photos 34 and 35. Snow plow damage is insignificant.

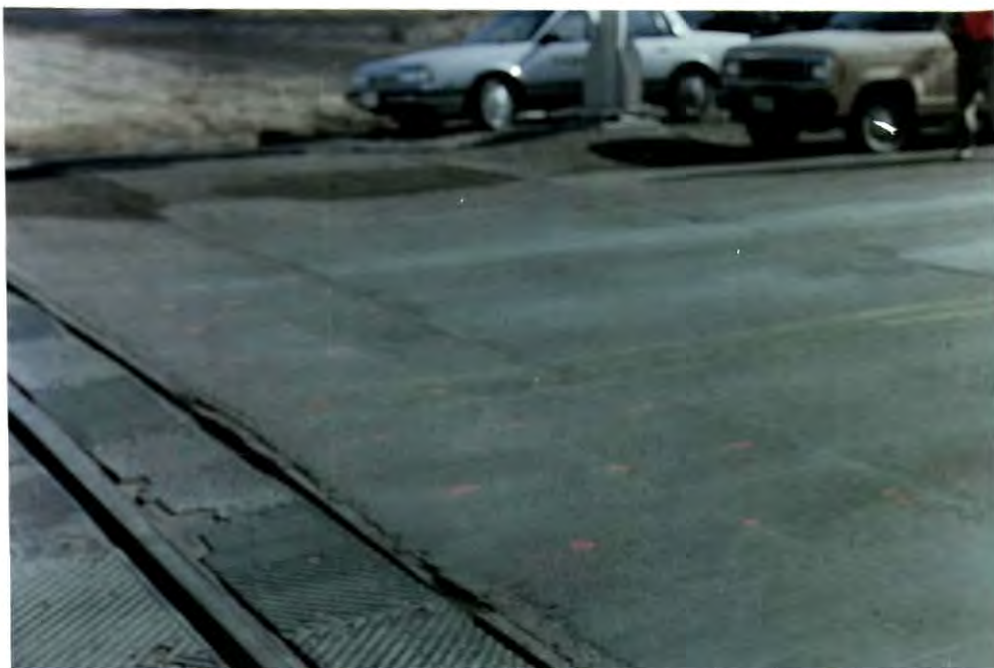
Photo 36. Kline Street - Panel and Header Failure

Photos 36 and 38). Heavy amounts of debris have collected between the rails and the center panels (Photo 37). The panels at this crossing show considerable wear and are distorted (See Photo 37 and 39). Fresh scarring, as would have occurred from snow plow damage, could not be seen.

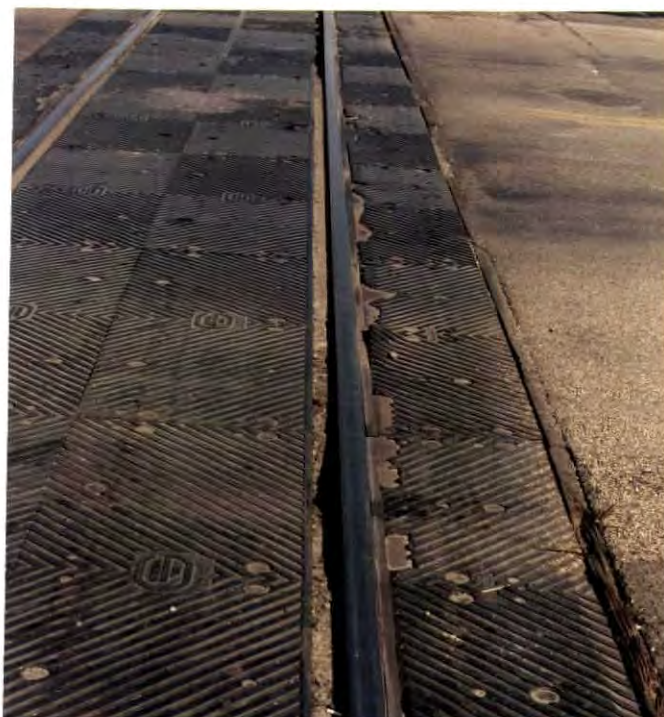
Photo 37. Kline Street - Settlement of Pavement Approach

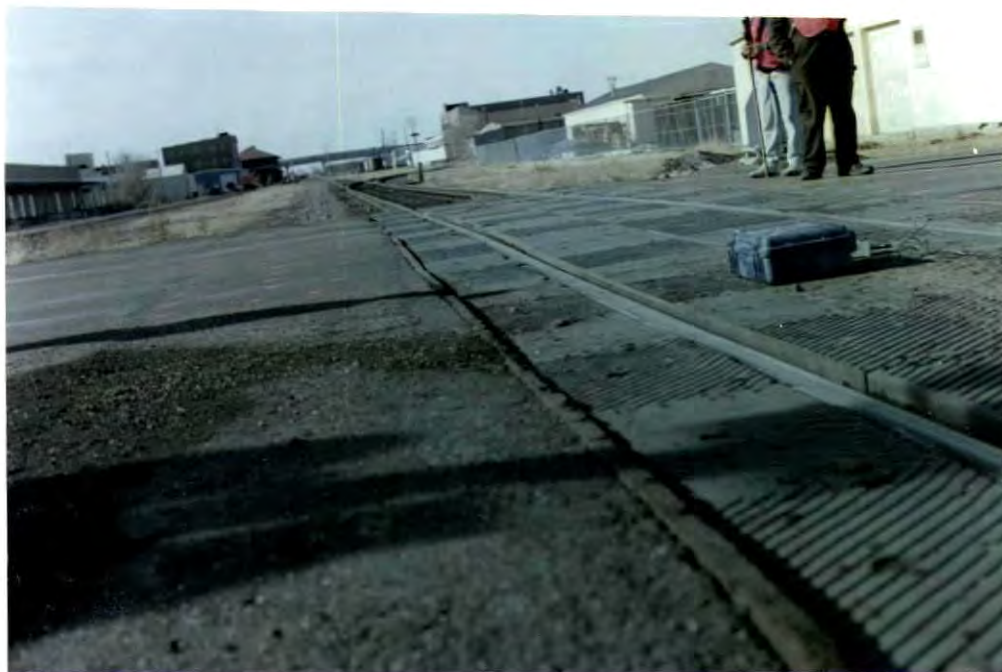
Photo 38. Kline Street - Close-up View of Shoulder Settlement

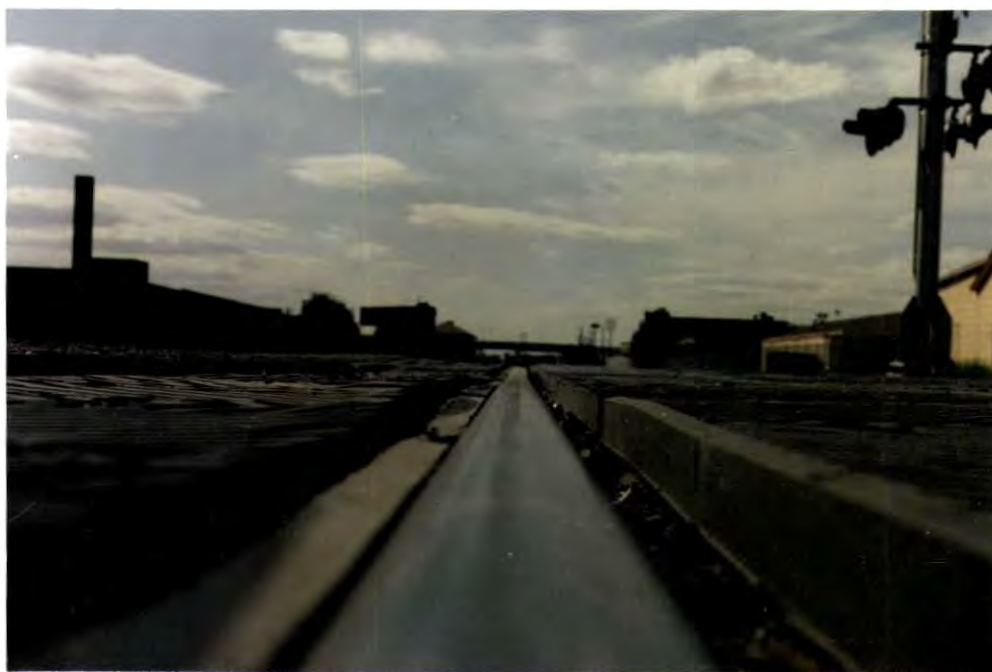
Photo 39. Kline Street - Panel Distortion and Track Settlement.

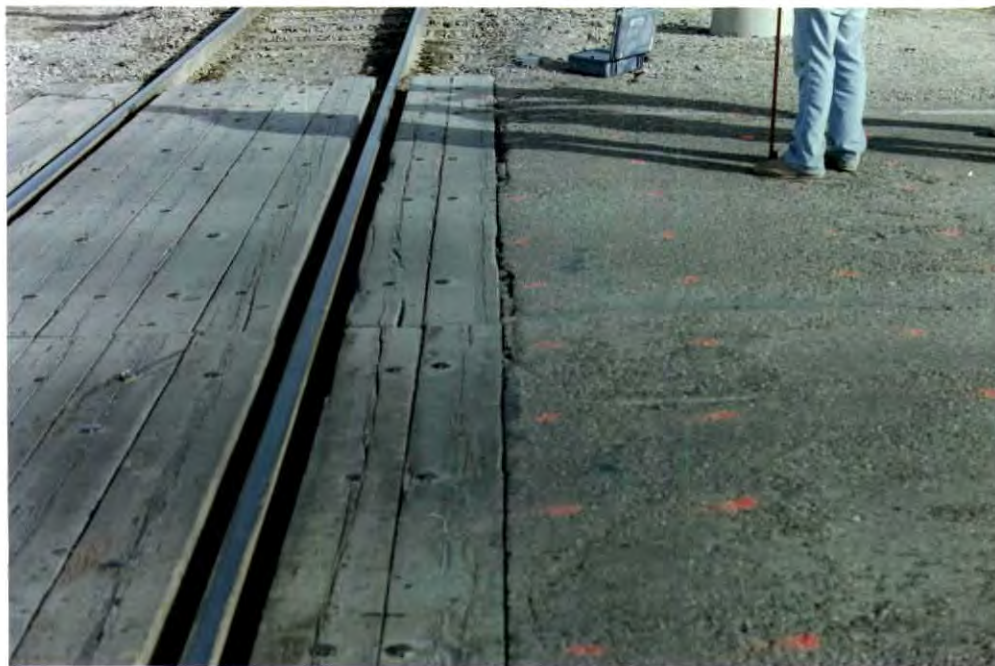
Photo 40. Brown County # 14 - Asphalt Breakdown Next to Timber

Overall views of the crossing are shown in Photos 40 and 41. Photo 40 shows slight breakdown of the asphalt next to the outer timber. Fasteners with large heads were used at this crossing (See Photo 41), and the protruding heads contribute to the roughness of the crossing. There is minor snow plow damage, as some of the timbers are torn as nails have been pulled out (Photo 42).

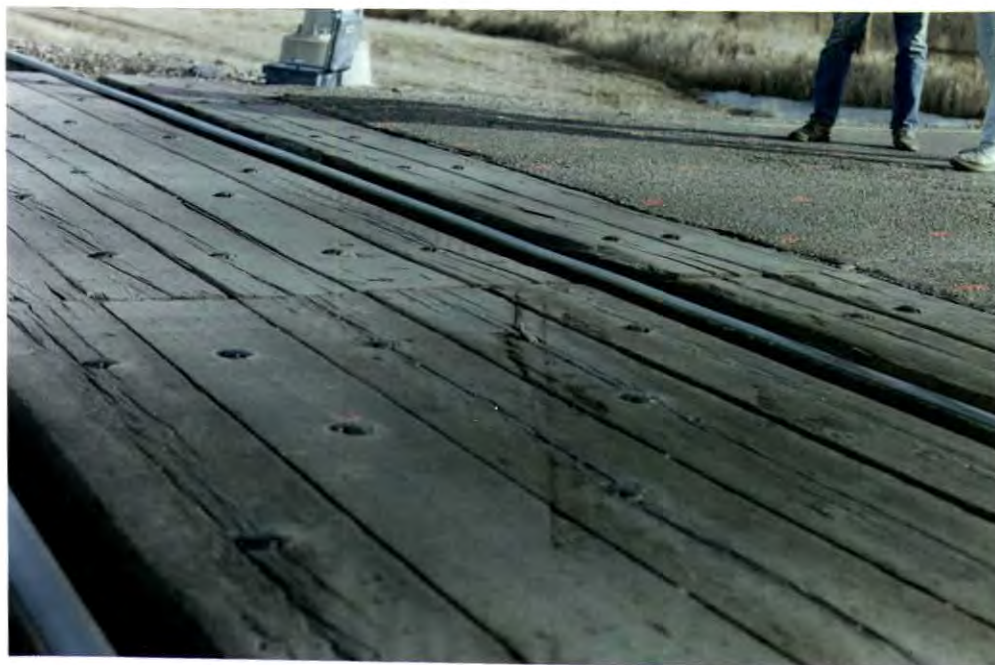
Photo 41. Brown County # 14 - Exposed Nails

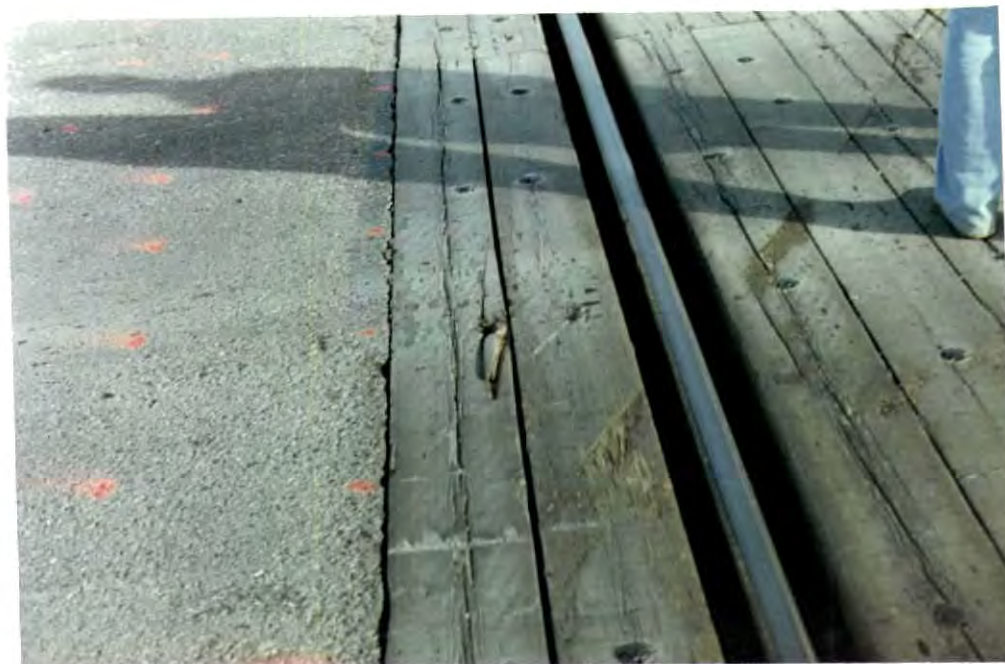
Photo 42. Brown County # 14 - Pulled Out Nail

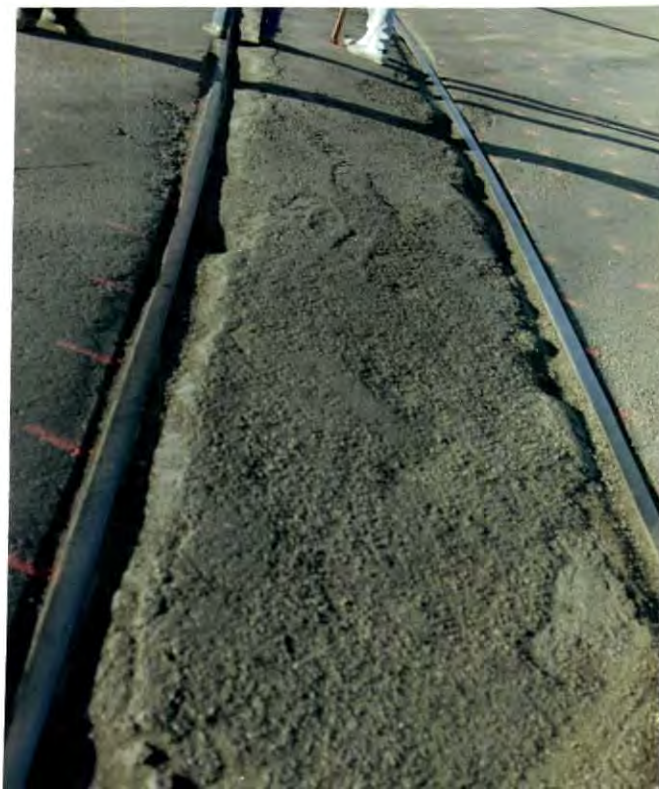
Photo 43. Fifth Street - Overall Condition

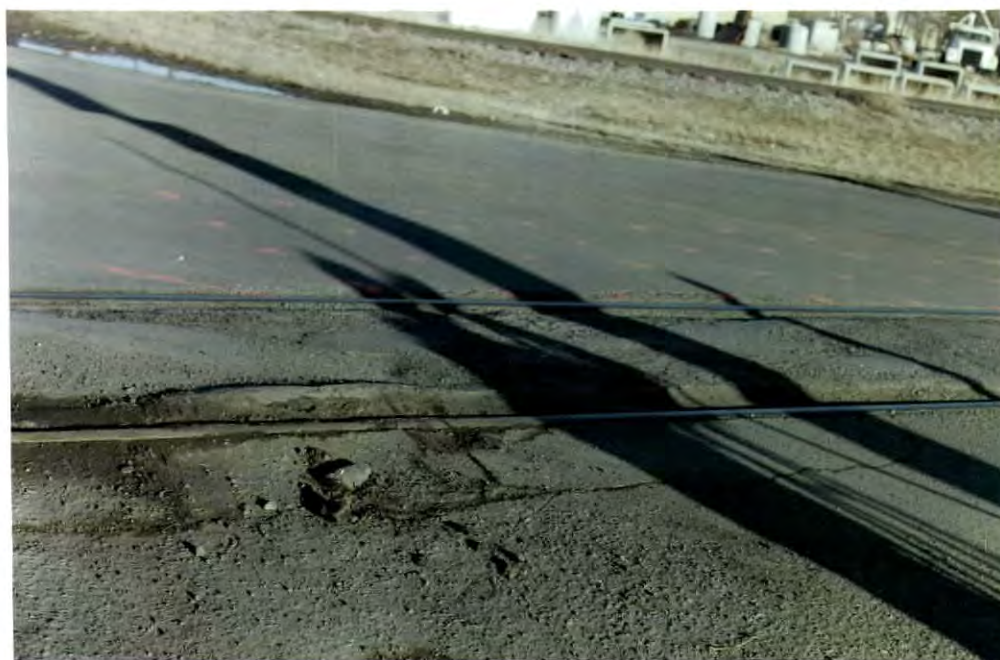
Photo 44. Fifth Street - Pumping

Drainage at this crossing is poor and severe pumping can be seen at the ends of the crossing and between the rails (See Photos 44, 45 and 46).

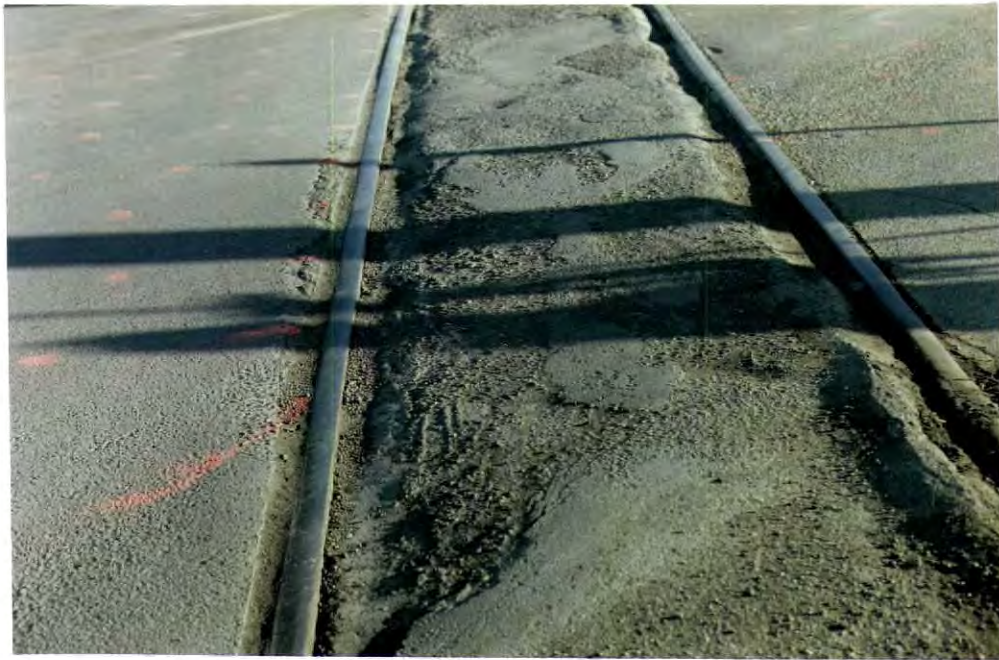
Photo 45. Fifth Street - Close-up View of Failed Asphalt

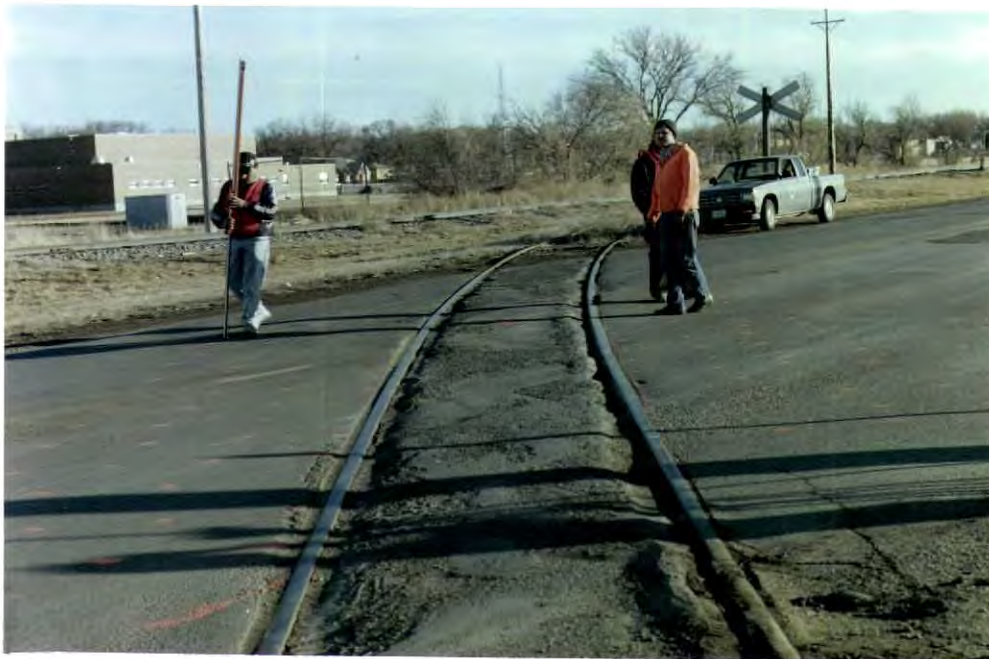
Photo 46. Fifth Street - Cracked Approaches and Failed Center Section

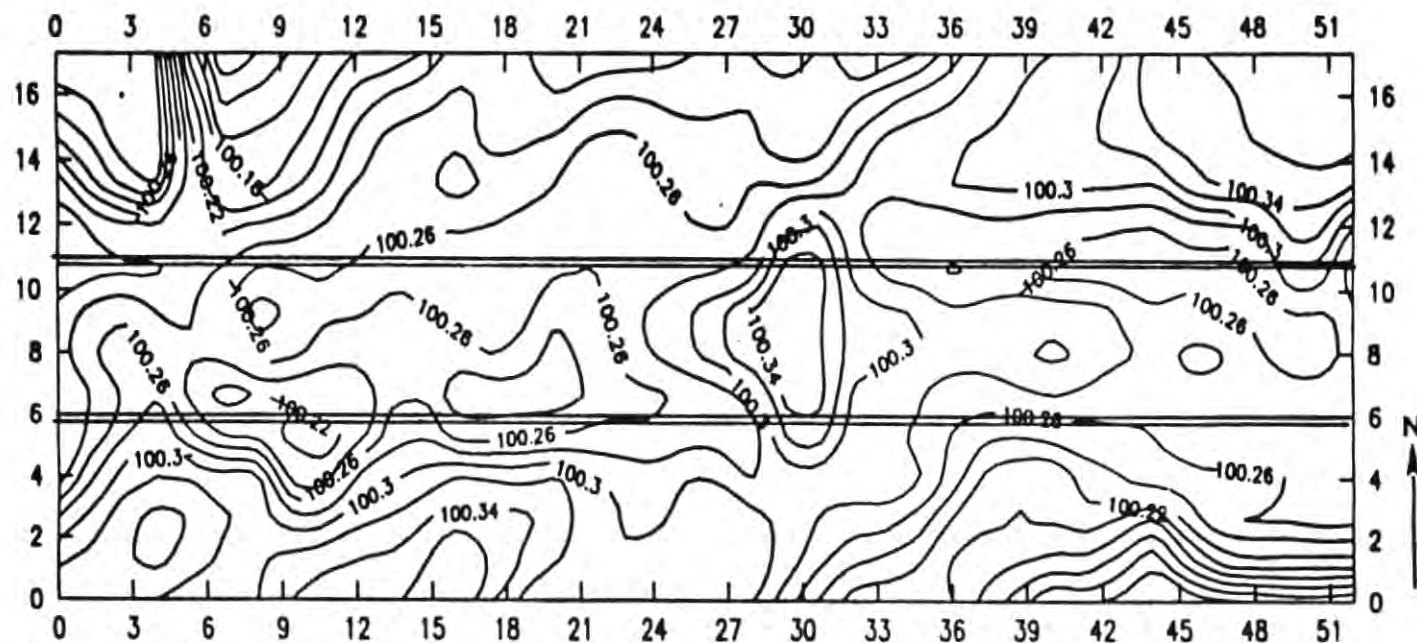
Figure A44 Fifth Street, Aberdeen (Asphalt)

The results of the survey data are presented in Figures A44 through A46 and the condition of the crossing is shown in photos 43 through 46. The contour map shows that the crossing is very

uneven, with differential elevations in excess of one inch over a distance of approximately five feet. The survey shows considerable bulging of pavement in between and outside the rails. Overall, the rails are from 1 to 2 inches beneath the pavement. Figure A45 shows that the elevations of the crossing at the wheel path and in between the wheel paths are vastly different, hence considerable rutting has taken place (Figure A46).

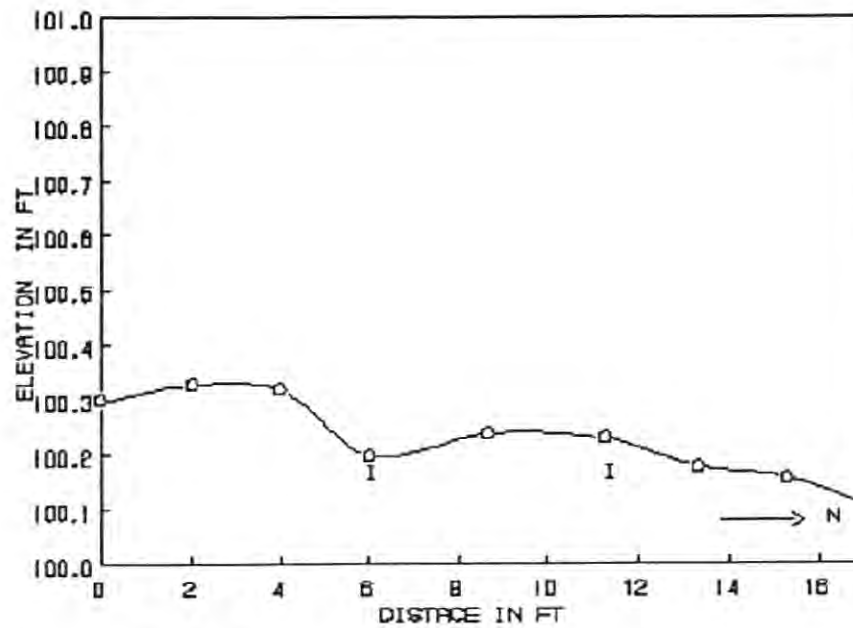
Figure A45 Fifth Street West, Aberdeen (Asphalt)
Cross section at curb.

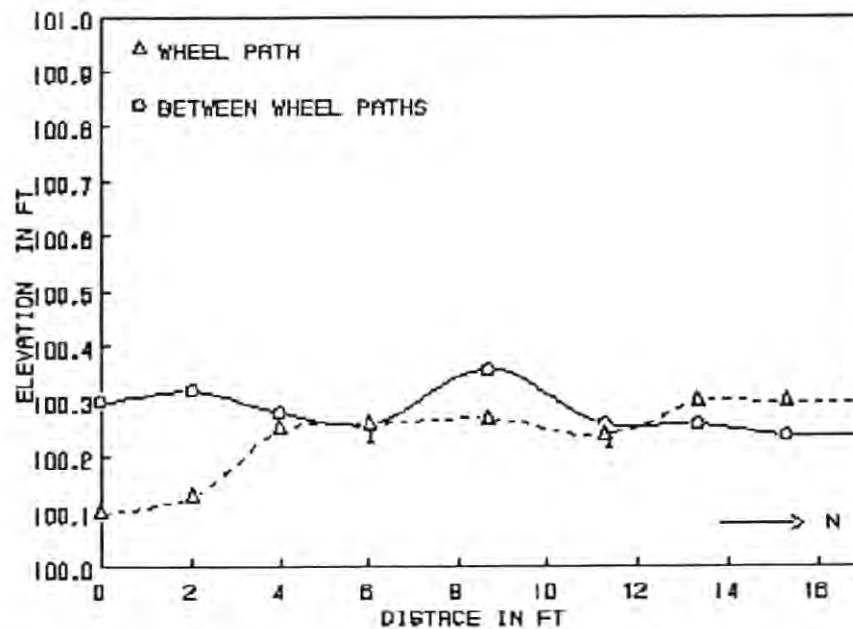
Figure A46 Fifth Street West, Aberdeen (Asphalt)
Cross section taken at wheel path and
between wheel paths.

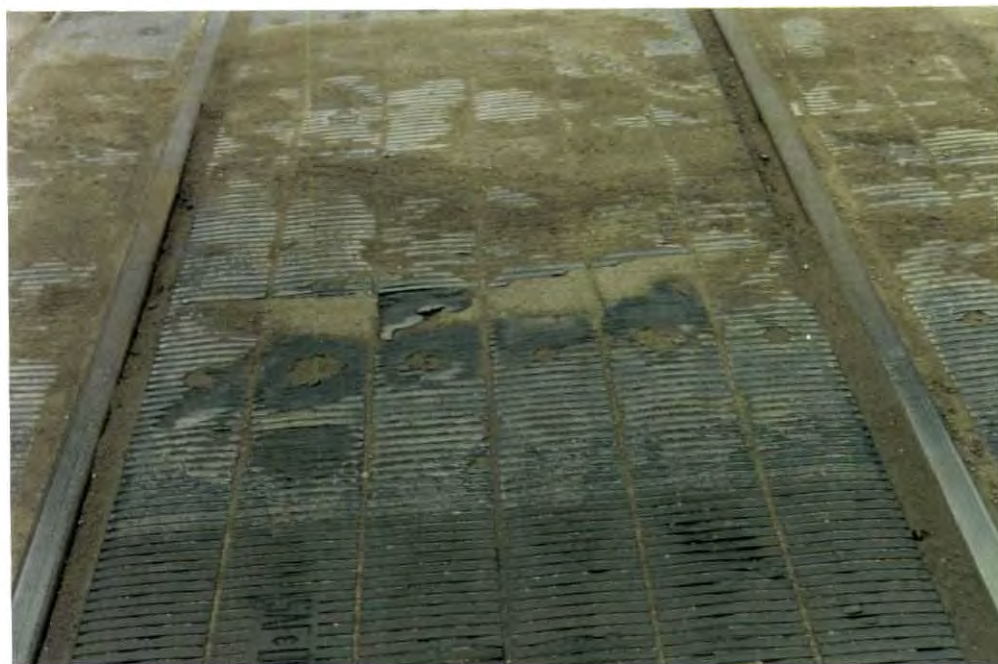
The panels in the crossing are considerably worn and the combination of snow plow damage and wear can be clearly seen in Photos 47 and 48. The space between the rails and the panels is variable and it is likely that some panels are loose (See Photo 50).

Photo 47. North Broadway - Rubber Pad Damage by Snow Plows and Wear

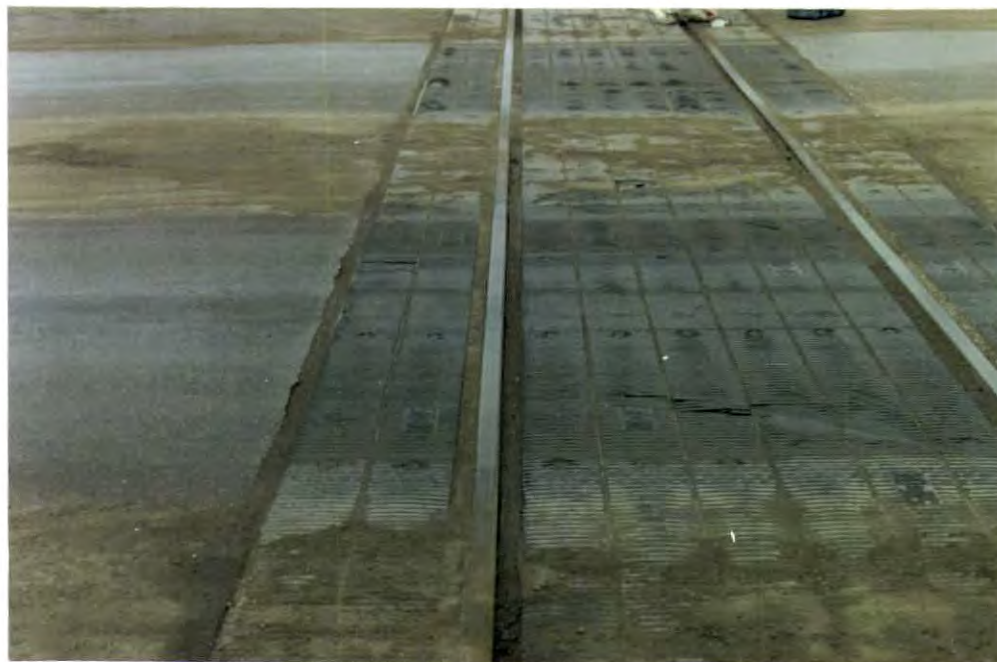
Photo 48. North Broadway - Debris Collection on the Track and Also Next to Rail

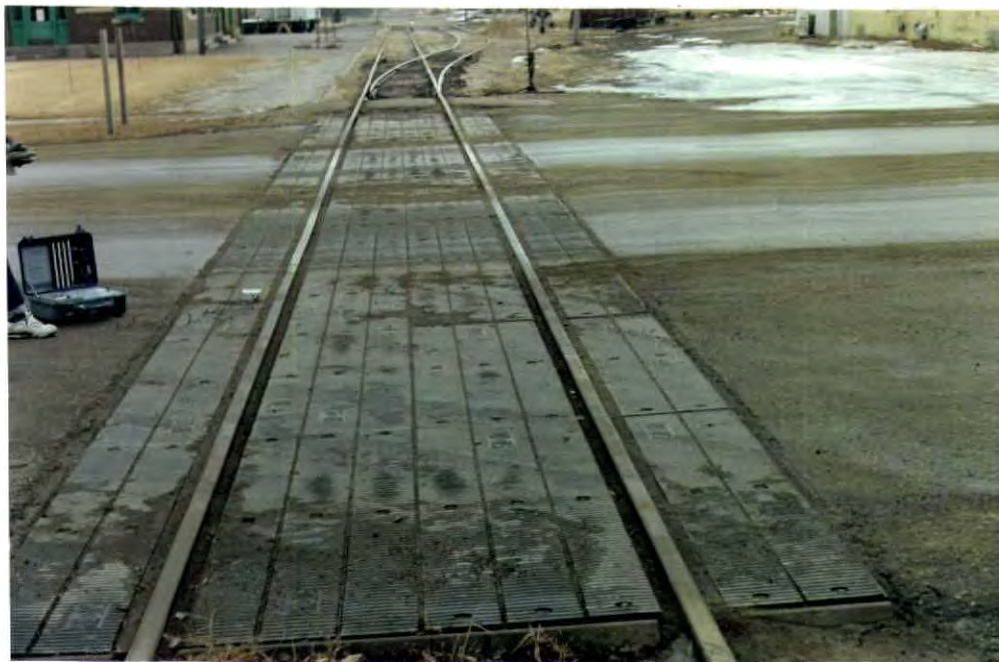
Photo 49. North Broadway - Overall View

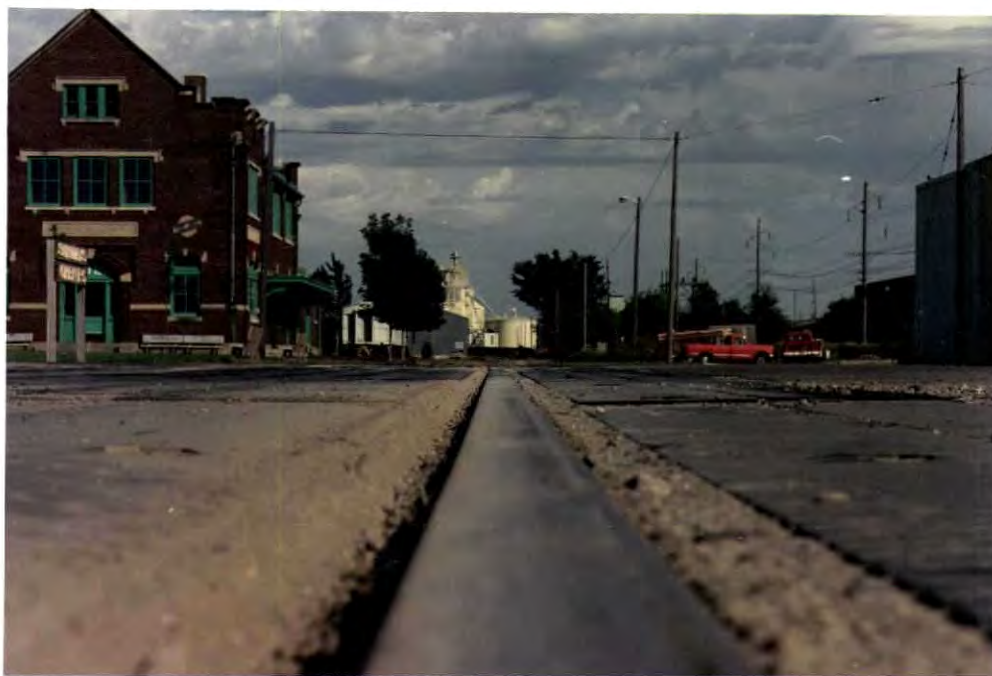
Photo 50. North Broadway - Relative Settlement between Panels

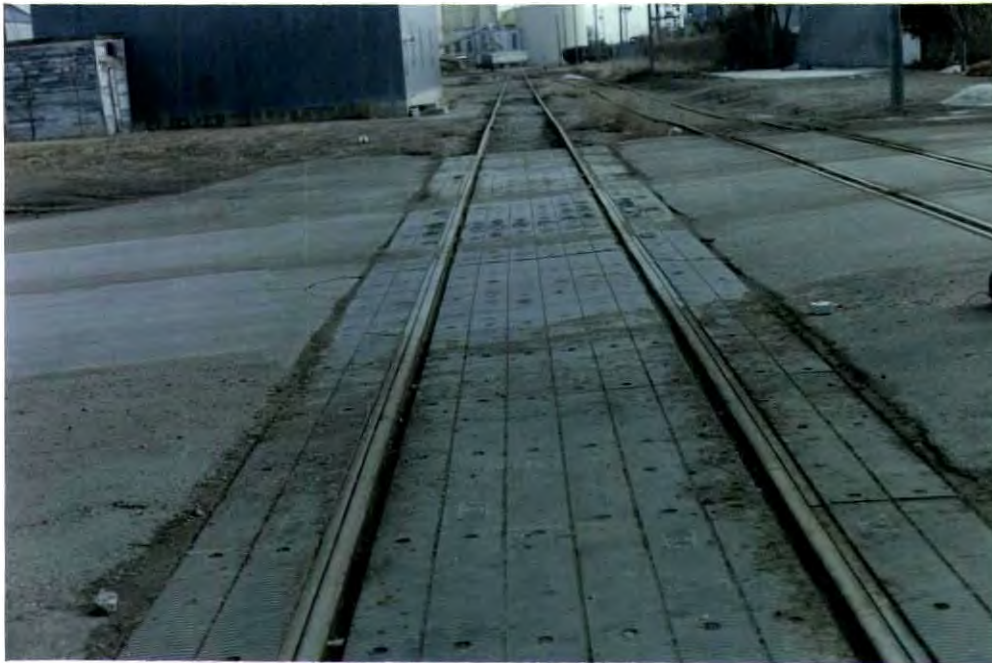
Photo 51. North Maple - Failed Joints (Without Header Board) All Along the Track

The results of the survey are shown in Figures A50 through A52. As can be seen on the contour map (Figure A50), the road is sloping toward the south, however, the main track appears to have settled up to two inches relative to the side spur. This can also be seen in Figures A51 and A52. Rutting at this crossing is insignificant, which can be seen both on the contour map and in the cross section in Figure 52. Elevation differences within the crossings is less than one half inch. The roughness of the crossing can mainly be contributed to the large settlement of the main track and to the rails protruding from the asphalt at the side spur (See Photos 51 and 53).

Damage to the rubber panels was observed in the west lane and on the west side of the east lane. Asphalt chipping can be seen along the entire crossing (See Photo 51), and pavement failures were seen at the south side of the crossing on the east side (See Photo 52). Collection of debris between the rails is evident.

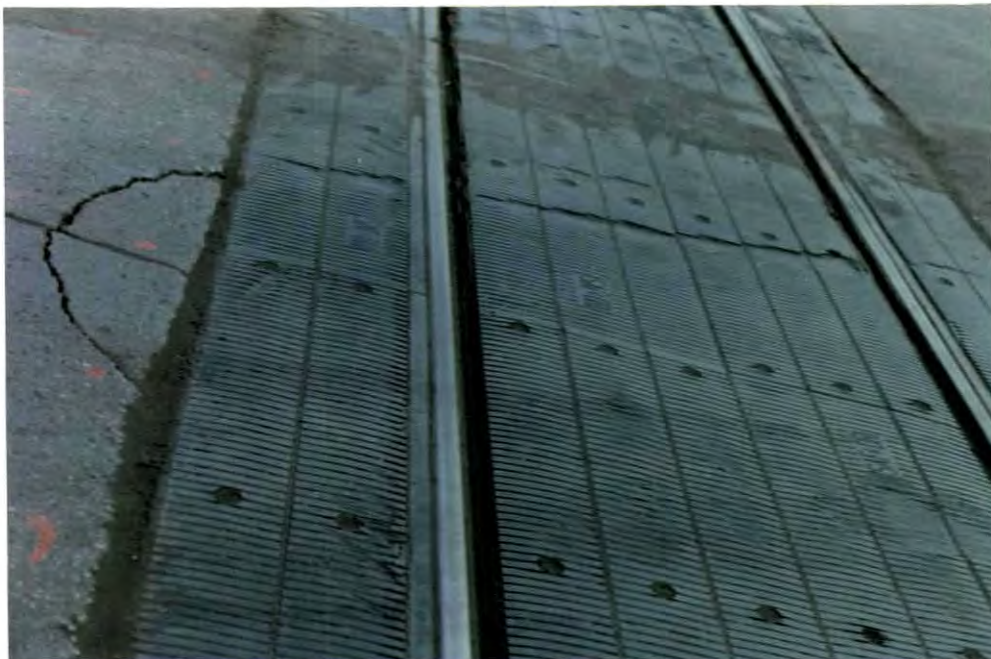
Photo 52. North Maple - Pavement Cracking

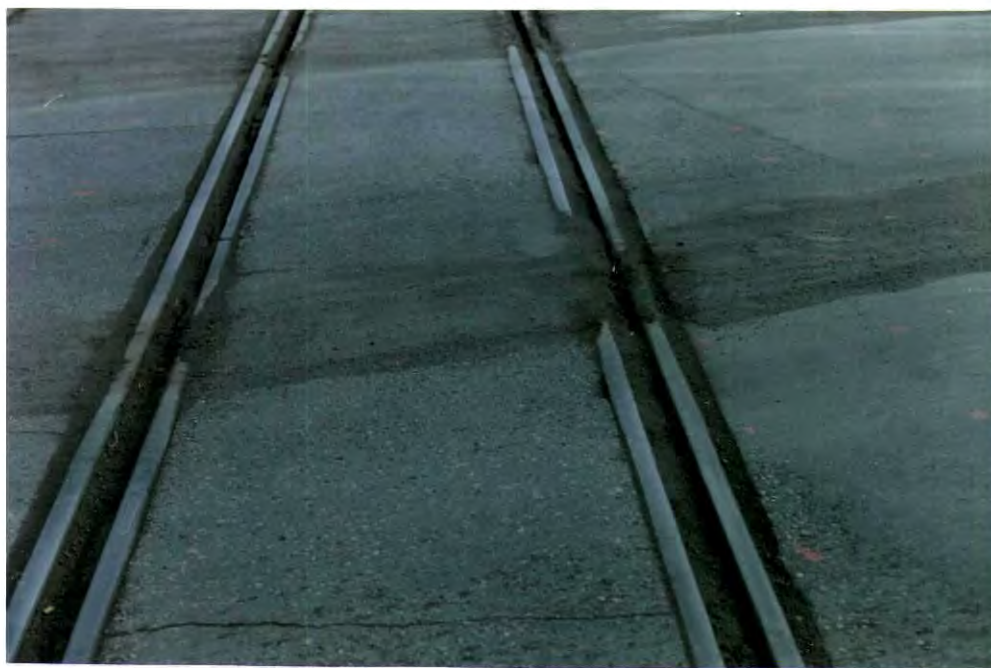
Photo 53. North Maple - Debris Collected on Side Spur

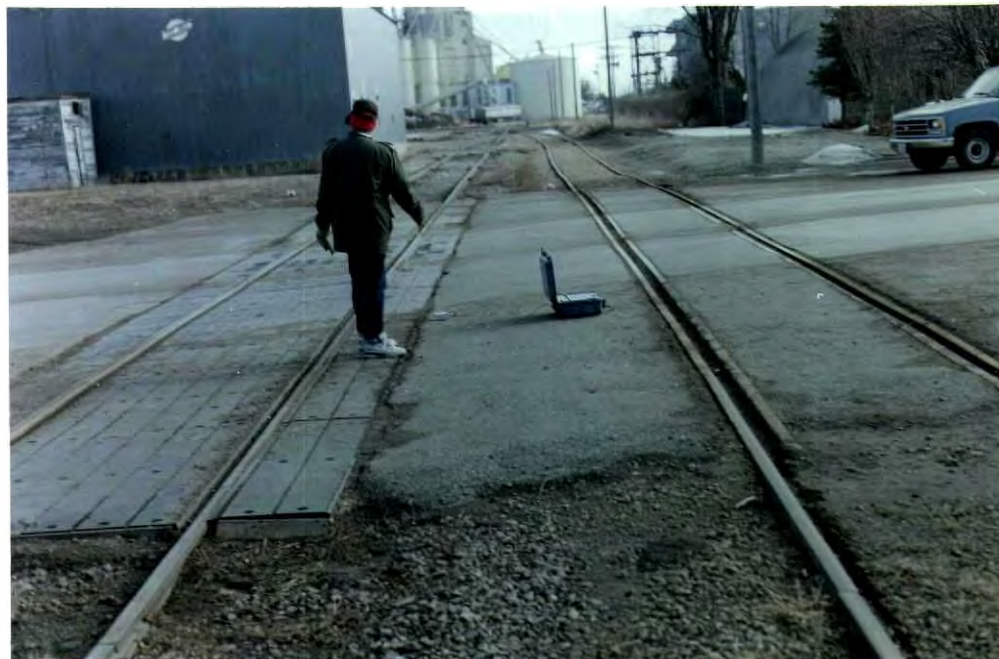
Photo 54. North Maple - Overall View of Main Track and Side Spur

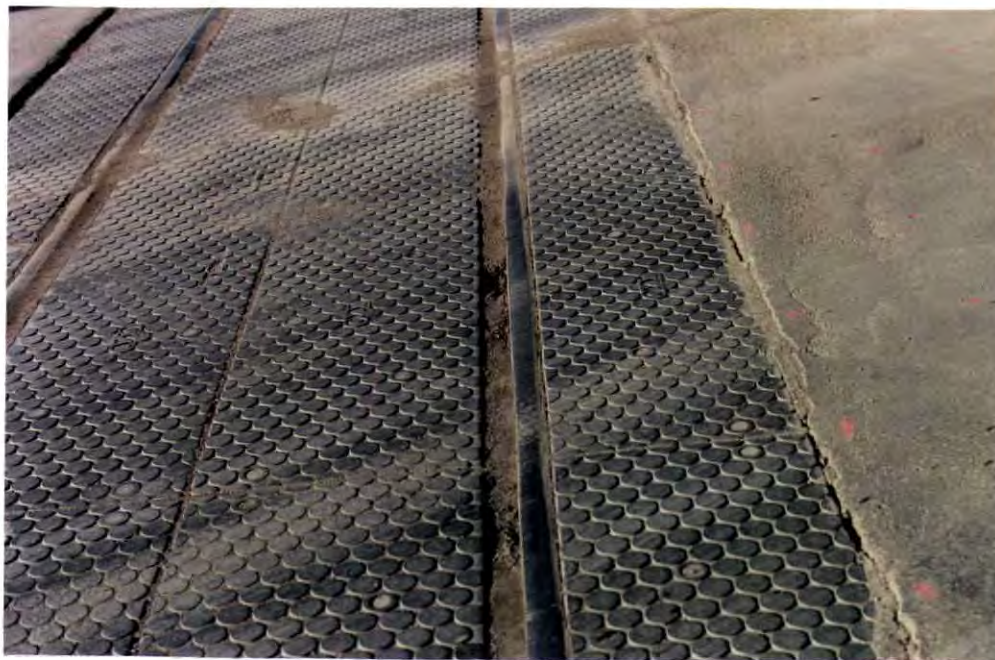
Photo 55. 11th Street - Failed Joint Along Outer Panel and
Debris Collected Next to Rail

The visual inspection of the crossing indicates that there is a sharp drop-off from the pavement to the crossing (See Photos 56 and 57). The abrupt change in elevation was not evident during a second inspection in September of 1991, indicating that frost heave may have occurred at the time of the survey in February of 1991. The inspection also revealed that cracks were opening between the asphalt and the outer rubber panels (See Photo 55). The space between the rails and the panels was also completely filled with mud (See Photos 55, 56 and 57).

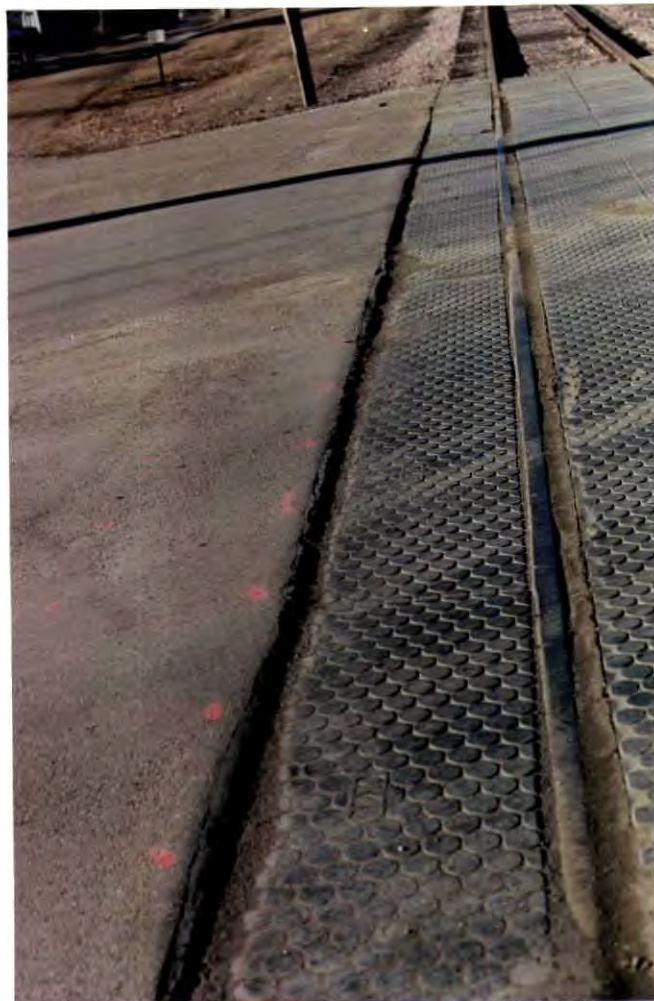
Photo 57. 11th Street - Close-up of Approach Settlement

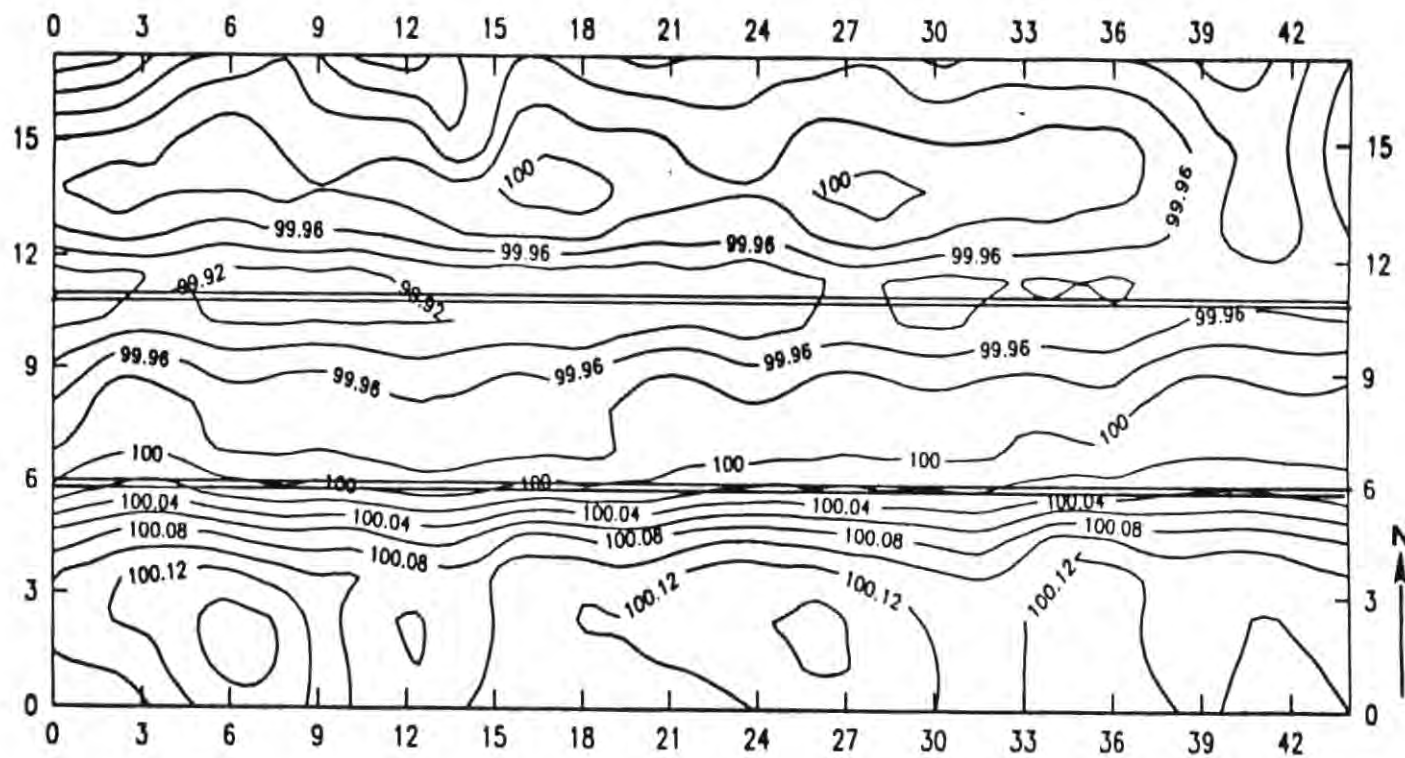
Figure A53 Eleventh Street North, Watertown (Rubber)

The results of the crossing survey are shown in Figures A53 through A55. The street is sloping slightly to the south, with a difference in elevation of two inches from north to south. As can be seen from both the contour map (Figure A53) and the cross sections (Figures A54 and A55), The crossing has settled approximately one inch relative to the approach pavement. The cross-section at the shoulder is slightly less than in the driving lanes. The south rail has also settled between 1/2 and 1 inch relative to the north rail. Rutting in the wheel path is minor, as can be seen both from the contour map and the cross section in Figure A55.

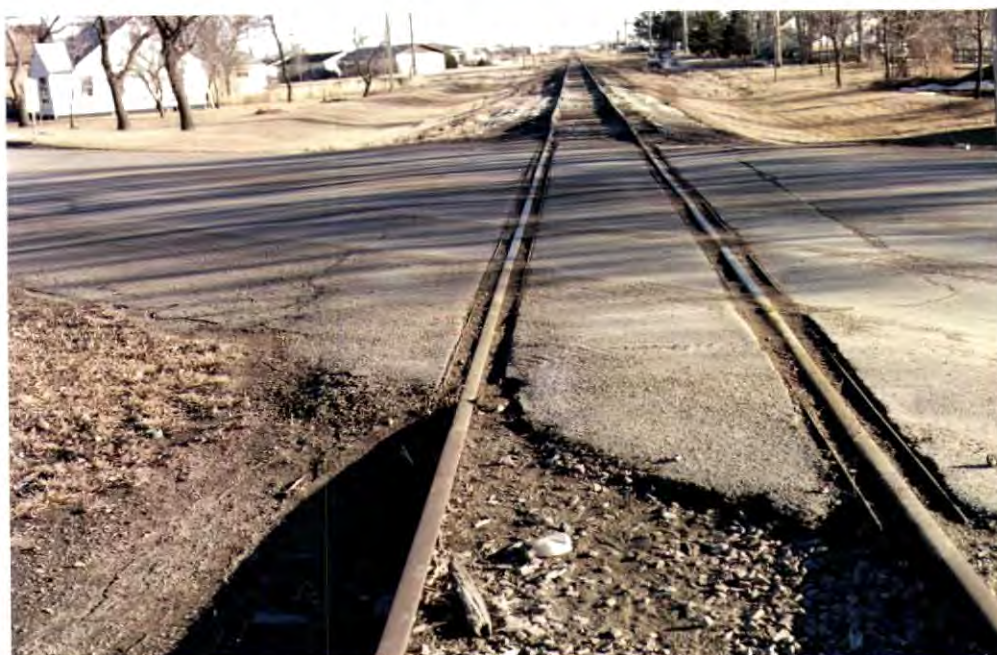
Photo 58. Kemp Avenue - General Condition

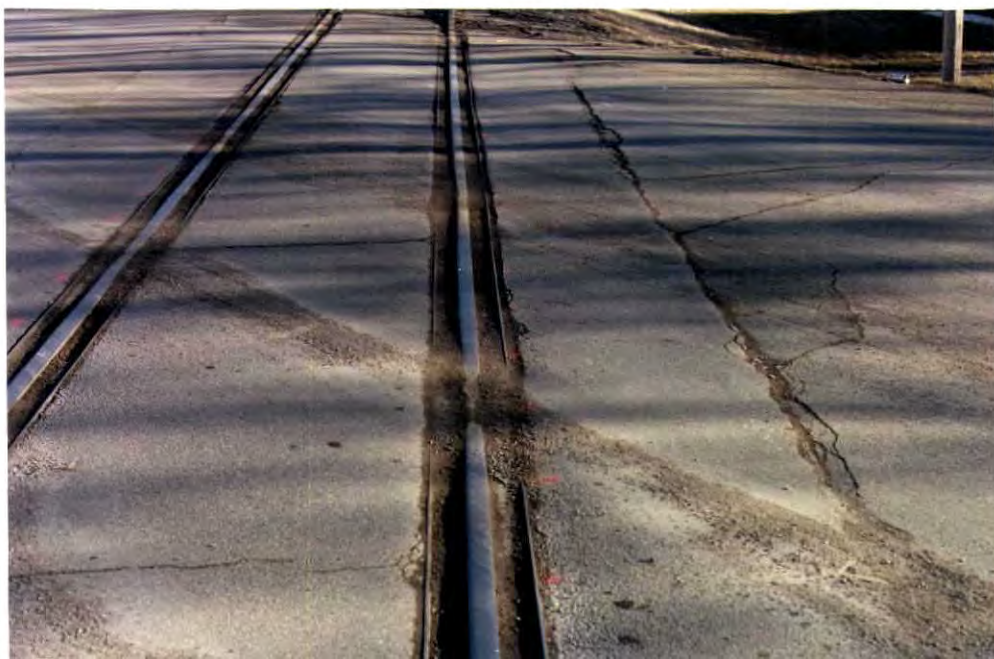
Photo 59. Kemp Avenue - Failed Approach and Asphalt Along Mud Rail

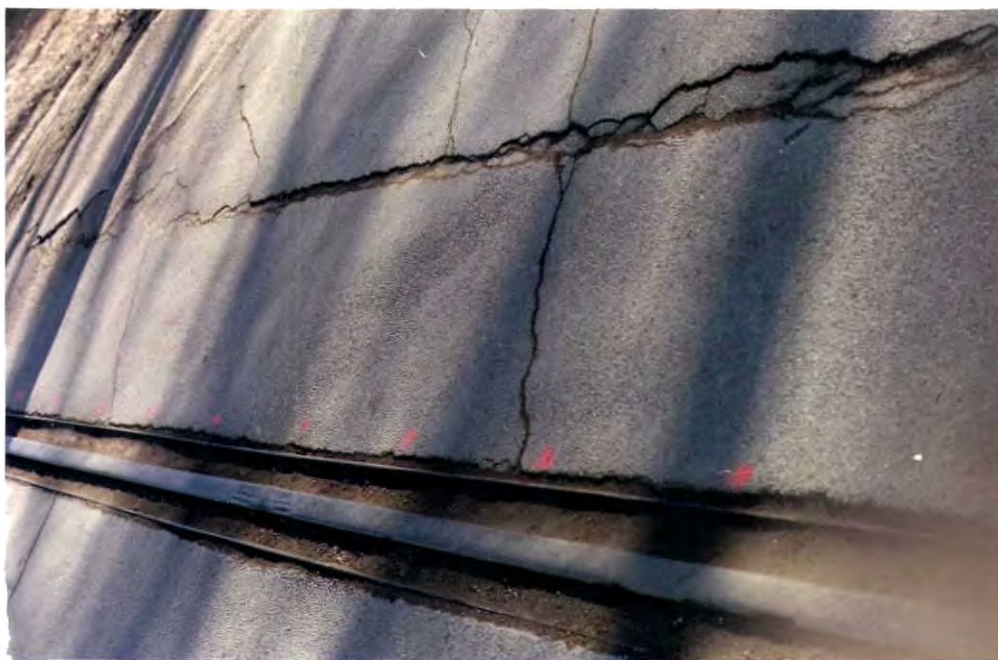
Photo 60. Kemp Avenue - Pavement Failure at End of Tie

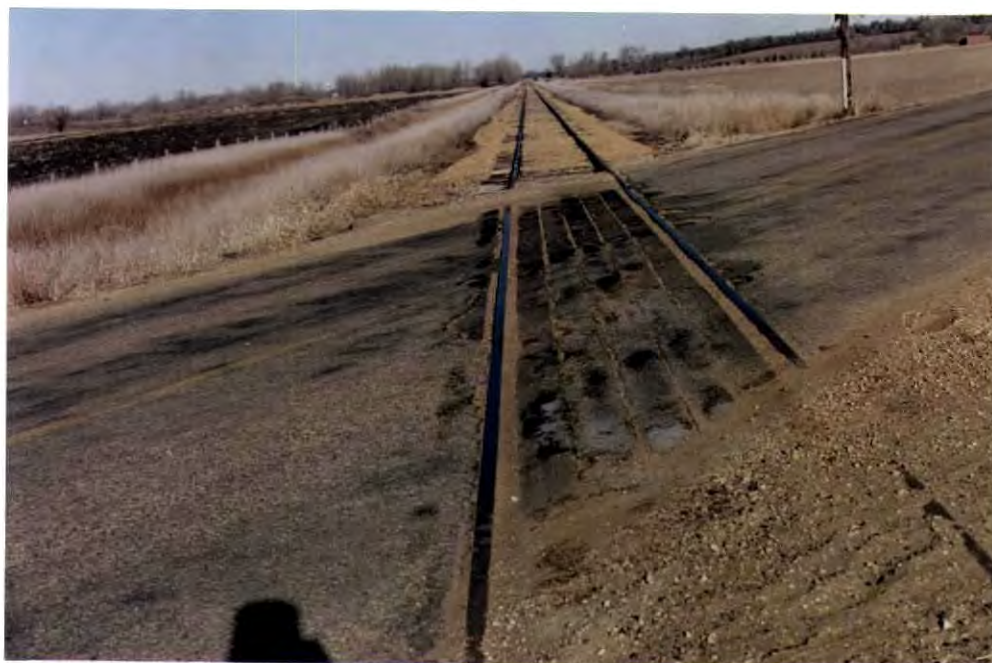
Photo 62. US 212 - Overall Condition With Failed Asphalt Over Header Timber
