Railroad Crossing Study

Study SD90-14
Volume II: Appendices

Prepared by
Department of Civil Engineering
SD School of Mines & Technology
Rapid City, South Dakota

January, 1992

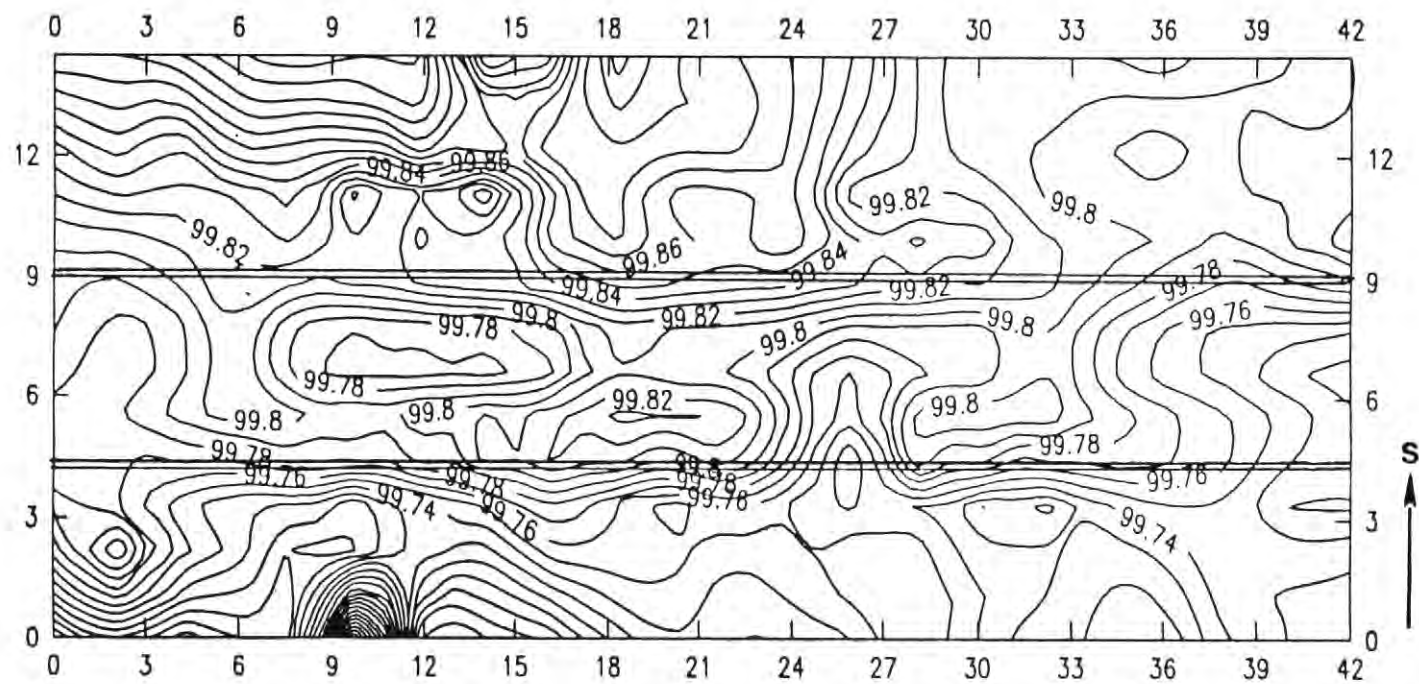
Figure A59 Half Mile East of Watertown,
South of US212 (Timber)

The results of the crossing survey are shown in Figures A59 through A61. The contours of the crossing (See Figure A59) indicate that the crossing is rough, but, the overall settlement relative to the pavement is minimal. The contour map also indicates that the timbers in center portion of the crossing between the rails are worn down as much as one half inch relative to the timbers adjacent to the rails. The rails are also elevated approximately one inch above the timbers in the crossing. The crossing is smoother at the shoulder, indicating that the roughness observed at the wheel paths and between the wheel paths is primarily due to pavement wear and rutting (See Figure A60 and A61).

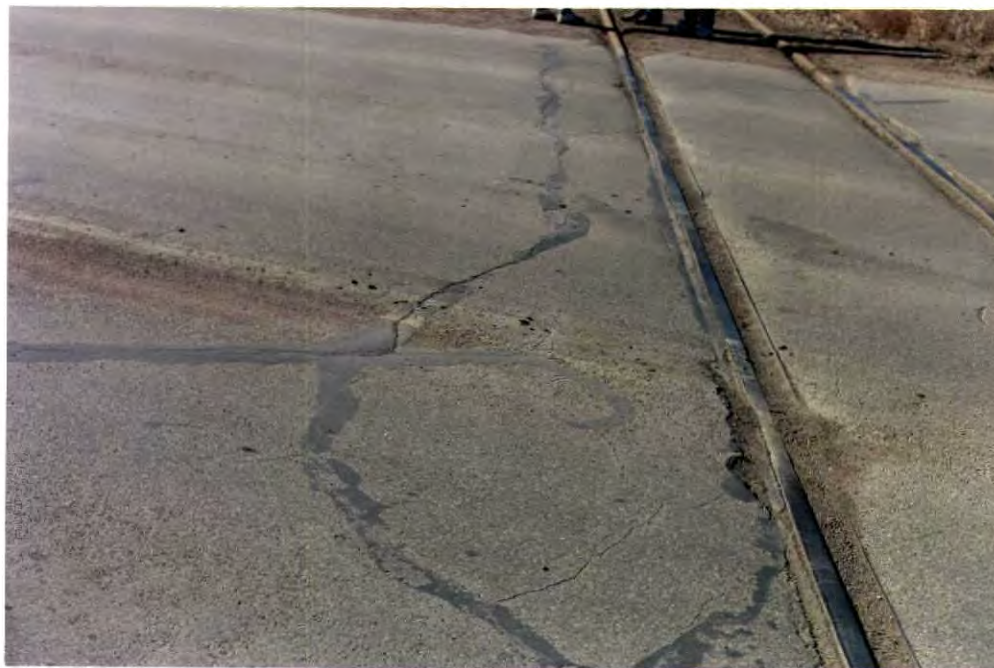
Photo 65. SD 20 and 10th Street West - Cracked Approach and Asphalt Failure at Rail

The photo of the crossing indicates that chipping of the pavement has occurred along the rails. Cracks can be seen at the approach pavement on the south side, extending from the east (See Photos 64 and 65). Significant debris has collected in between the mud rail and the main rail.

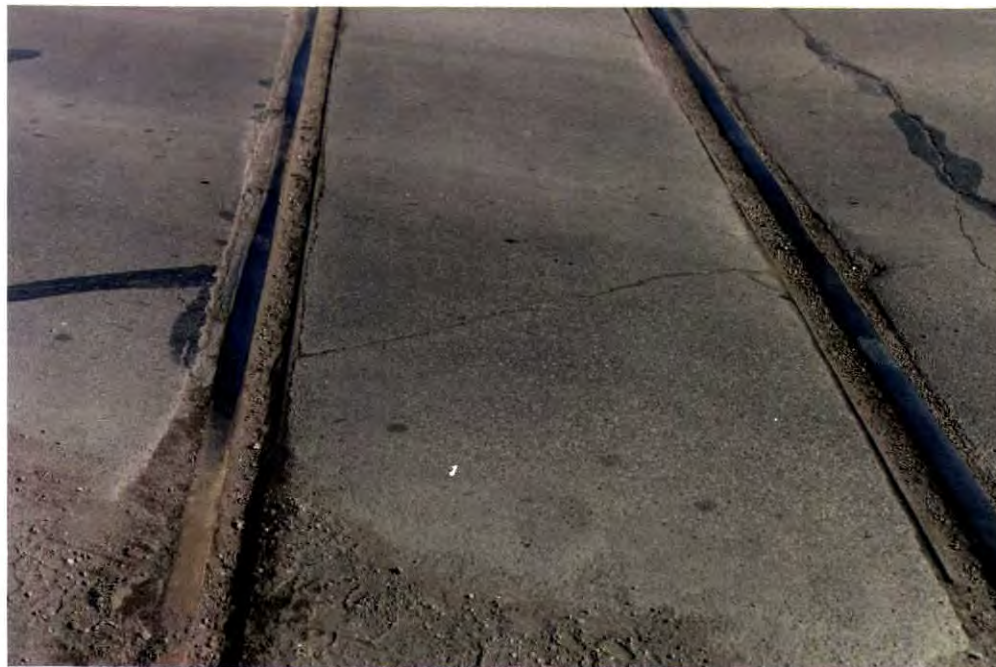
Photo 66. SD 20 and 10th Street West - Cracking of Center Portion

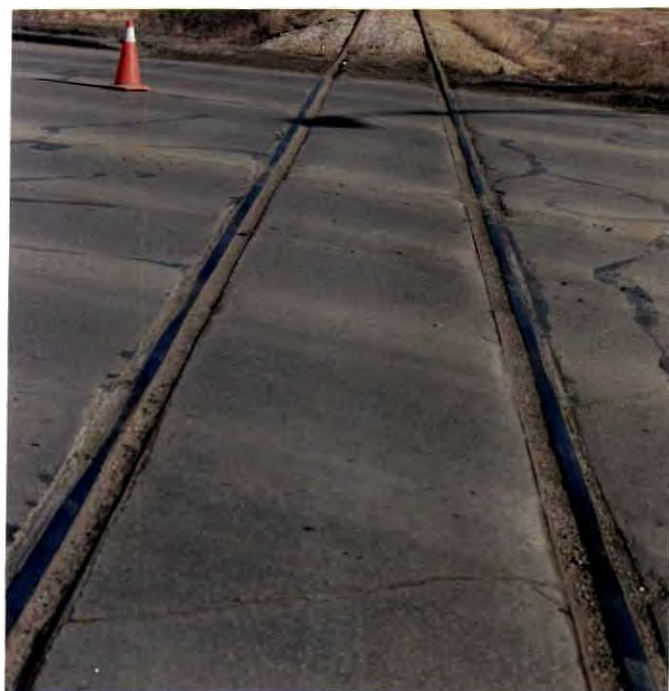
Photo 67. SD 20 and 10th Street West - Overall View

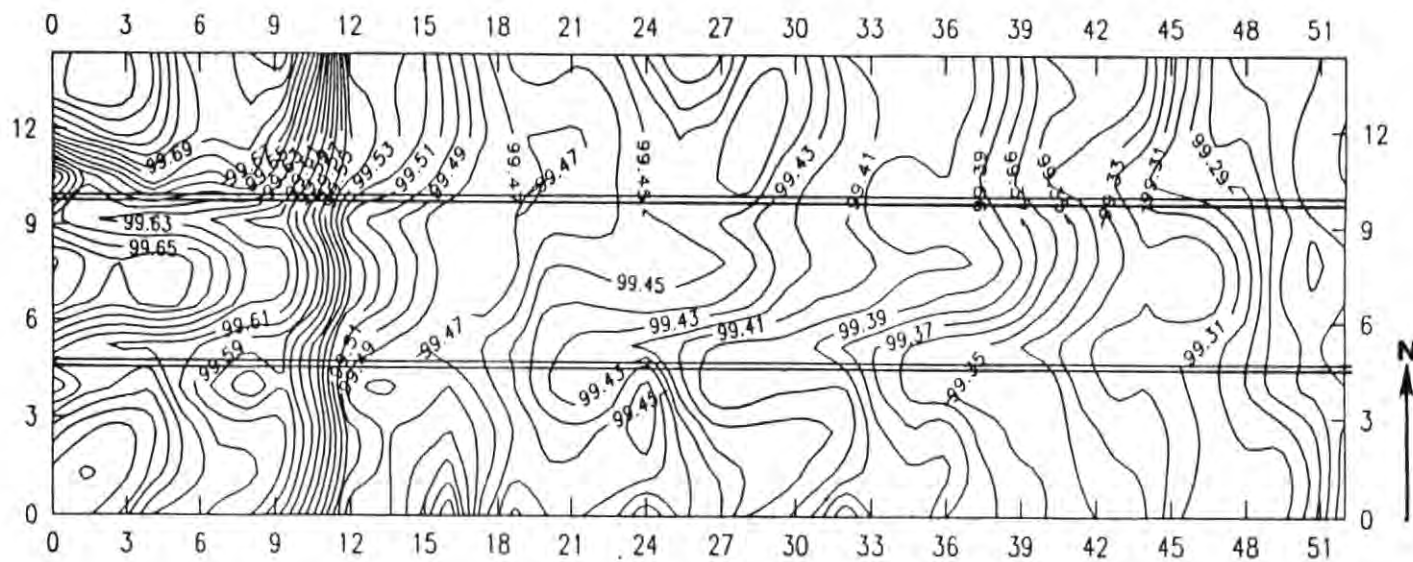
Figure A62 SD20 & 10th Street, Watertown (Asphalt)

The results of the survey are shown in Figures A62 through A64. Based on the topographic map and the cross-sections, the rails have settled approximately one inch relative to the pavement. It should be noted that there is a four inch elevation difference between the east and west ends of the crossing. The cross section in Figure A64 should therefore be analyzed from the overall shape and not on an elevation basis. The cross-section shows that rutting has occurred in the wheel paths, and the crossing is actually smoother at the wheel paths than the area between the wheel paths.

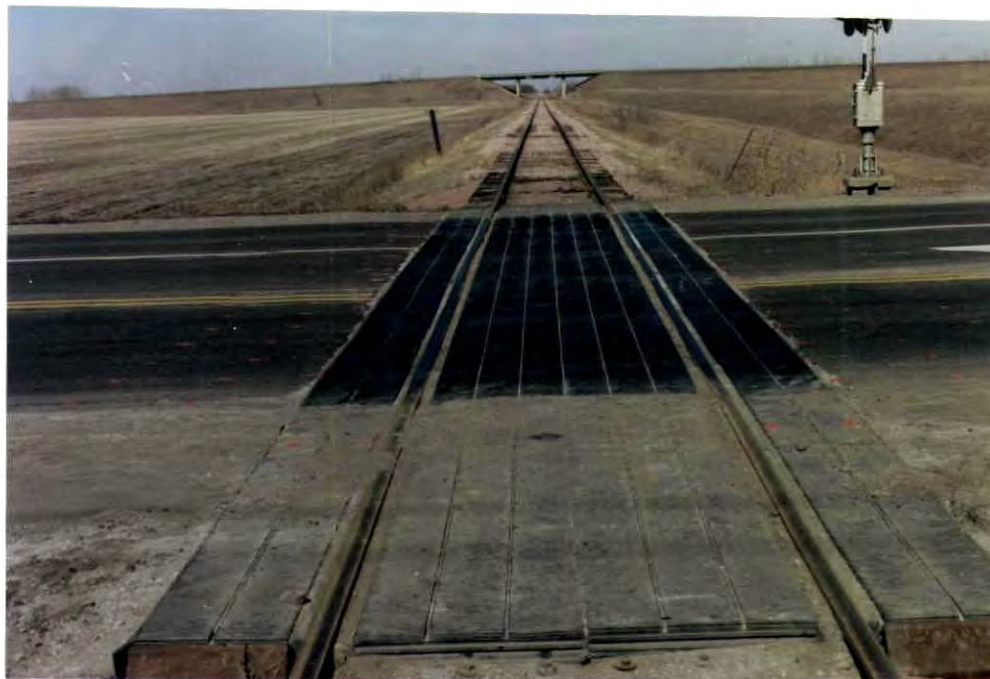
Photo 75. SD 38A - Overall View

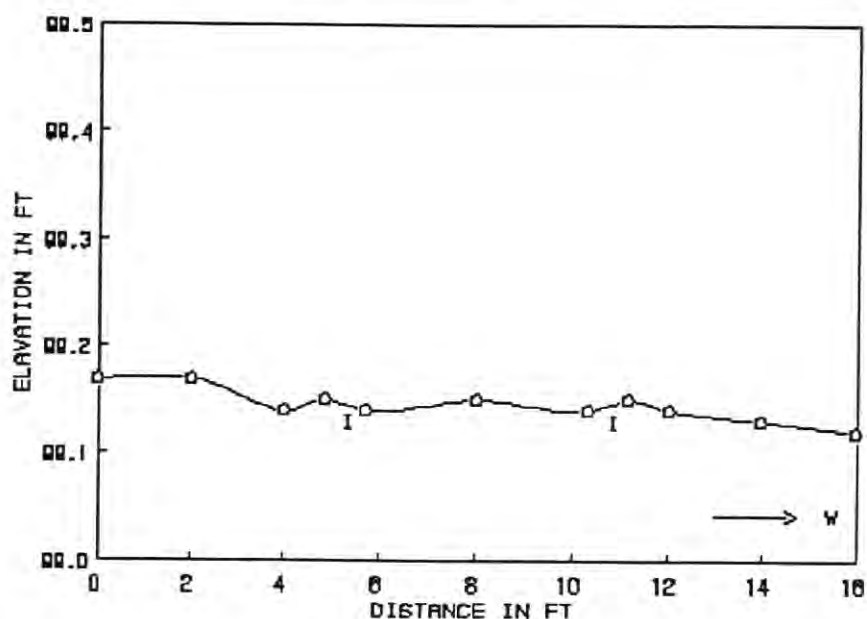
Figure A69 SD 38A North, Sioux Falls (Rubber)
Cross section at curb.

overall settlement is evident (See Figure A69), while the elevations of the approaches at and in between the wheel paths indicate wear and rutting. Evidence of rutting can also be seen in Photo 72. There is significant snow plow damage at this crossing, as can be seen in Photo 73. It is unlikely that the snow plow damage contributes to crossing roughness, but panel wear may be accelerated by the damage. Debris from sanding of the highway is collected in between the panels and the rails and in the grooves of the panels. This can slow surface drainage on the crossing (Photos 74 and 75). The debris does not appear to be periodically removed from the crossing, as the debris was also present during a reinspection of the crossing in July of 1991.

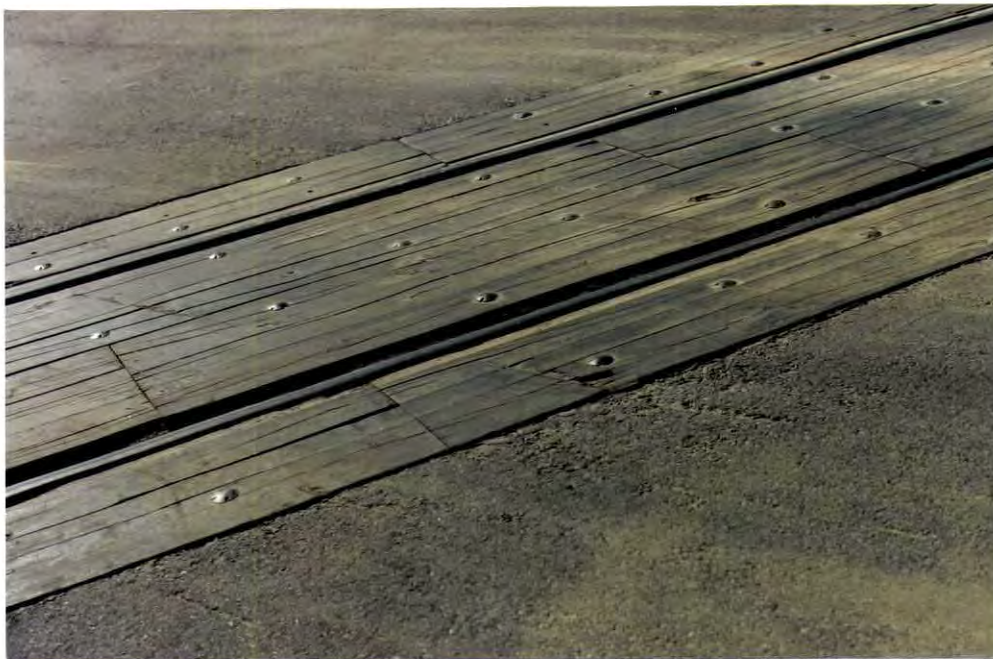
Photo 76. Minnehaha County 131 - Rutted Pavement and Plow Damage

The results of the survey are shown in Figures A71 through A73. The contour map indicates that the track has settled relative to the approaches, however, the crossing is at the low point in a vertical curve, hence the contour tend to overemphasize the actual overall settlement. As can be seen from the cross sections in Figures A72 and A73, the settlement of the track is less than 3/4 inches relative to the approach pavement. The cross-section at the shoulder differs only slightly from the cross-sections in the driving lanes (Figures A72 and A73). Some rutting of the pavement approaches can be seen when comparing the cross-sections at the wheel paths to those between the wheel paths. Evidence of rutting can also be seen in Photo 76.

shoulder sections are cracking (See Photo 79). The spaces between the panels and the rails are mud-filled and may have contributed to shifting of the panels. There is some scarring from snow plows (See Photos 76 and 77), however, overall snow plow damage is insignificant at this time.

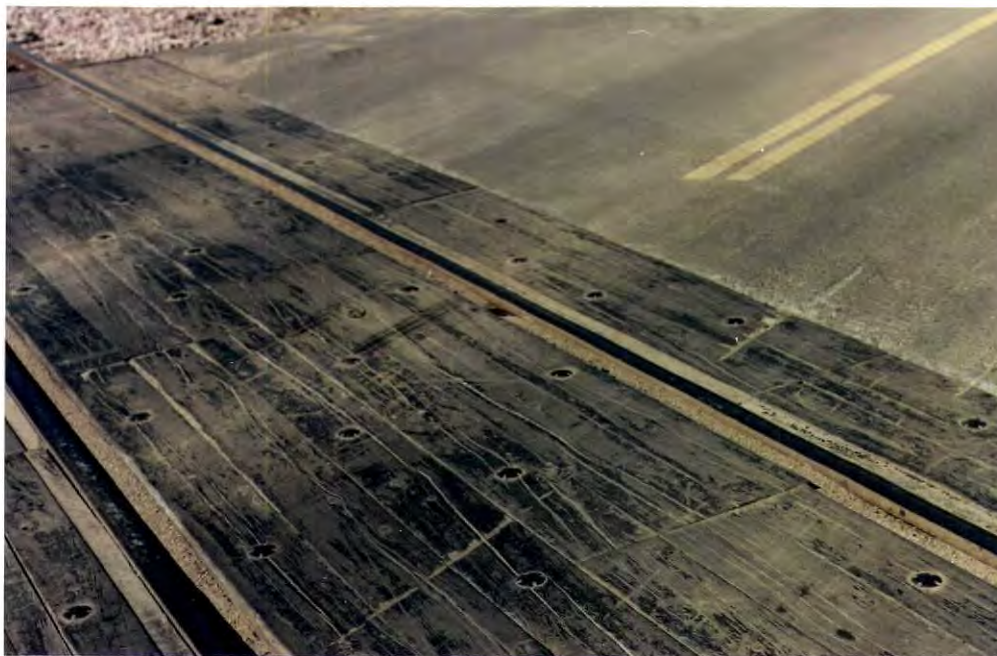
Photo 77. Minnehaha County 131 - Mud Along Rails and Scarring
From Snow Plows

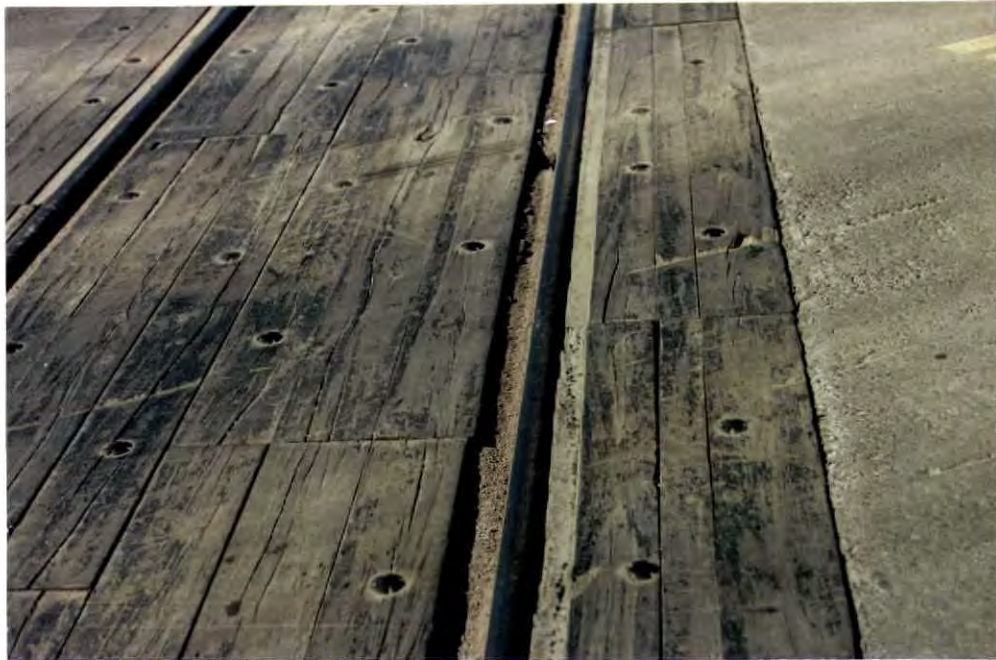
Photo 78. Minnehaha County 131 - Timber Panel Misalignment
(RHS of the Photo)

The panels are showing some signs of deterioration (See Photo 78), as the lamination has failed in some of the panels. Slight misalignment of some of the panels can also be seen. There is evidence of track deflection under rail traffic, as the asphalt

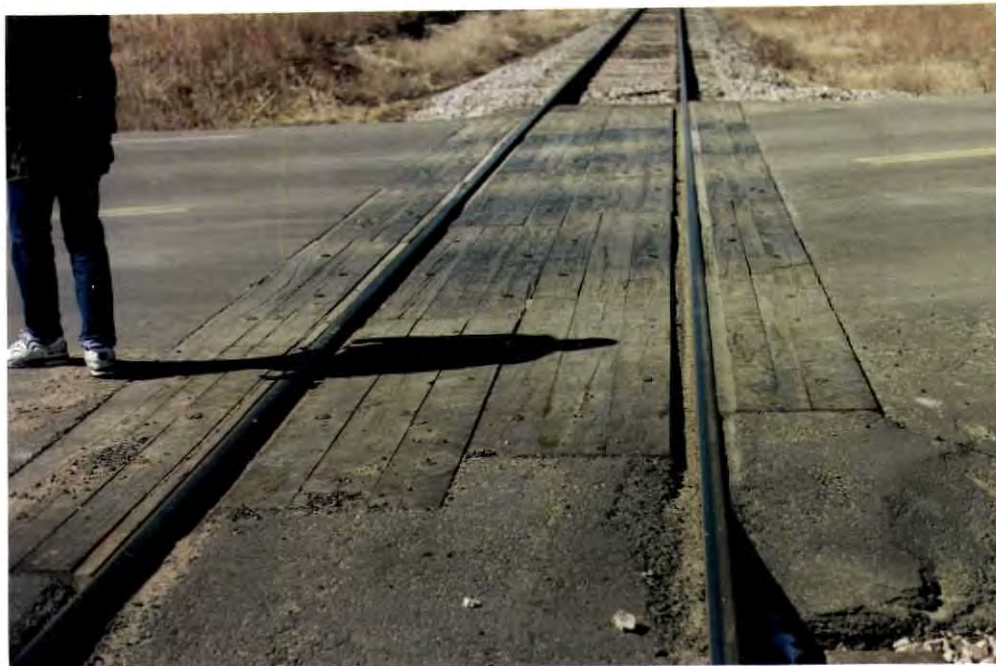
Photo 79. Minnehaha County - Overall View of Crossing

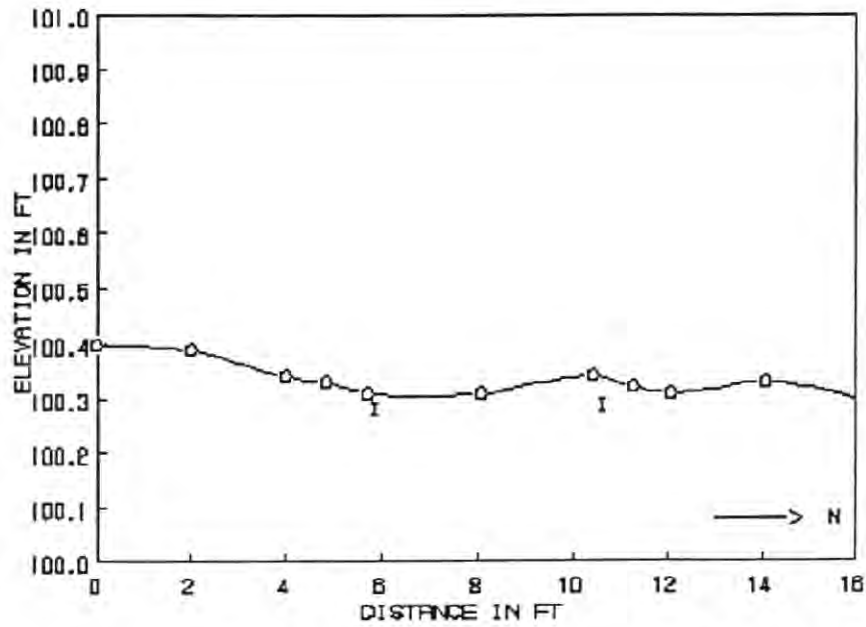
Figure A72 Minnehaha County 131 North of Sioux Falls
(Timber)
Cross section at curb.

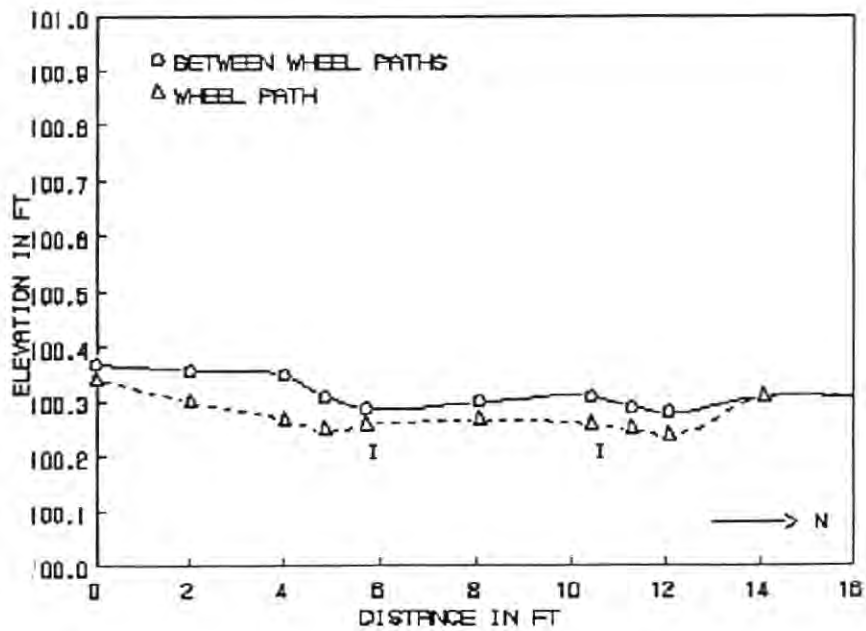
Figure A73 Minnehaha County 131 North of Sioux Falls
(Timber)
Cross section taken at wheel path and
between wheel paths.

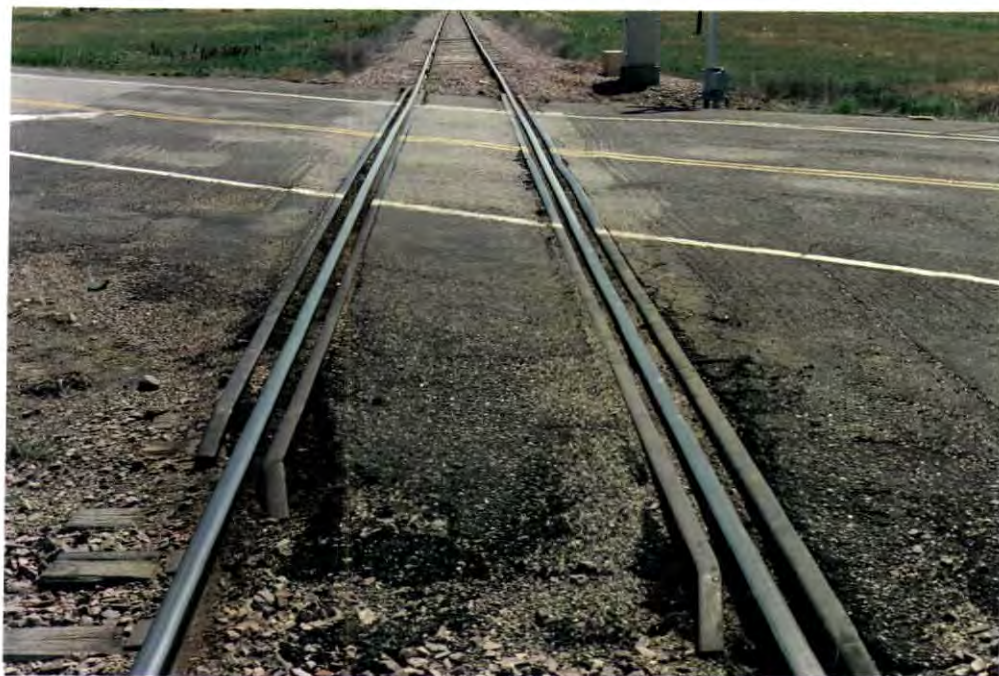
Photo 80. Cottonwood - Shoulder and Road Settlement

similar, indicating that the crossing has settled approximately one inch relative to the approaches (See Figures A75 and A76). There is considerable rutting in the wheel paths, as can be seen when comparing the cross-sections in Figure A76. At some locations the ruts are nearly two inches deep. The rutting and pavement wear can also be seen in Photos 80 and 81.

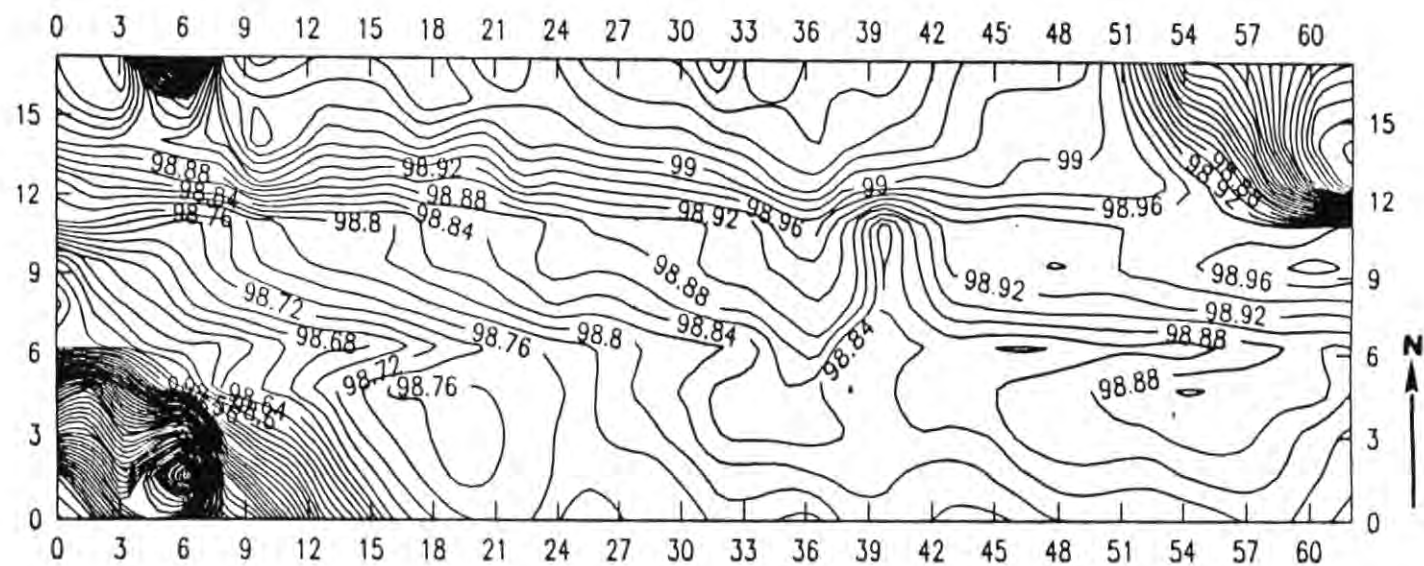
Figure A74 Cottonwood (Asphalt)

The crossing was surveyed in July of 1991 and the results are shown in Figures A74 through A76. The cross-sections taken in the driving lanes and at the shoulder of the highway are quite

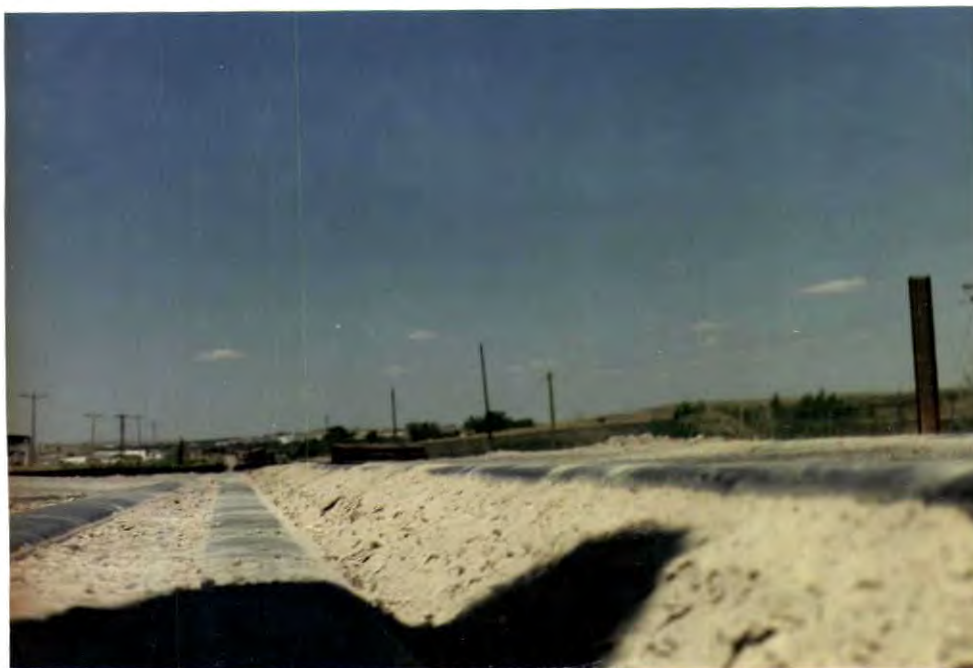
Photo 84. Merillat - Main Track Settlement

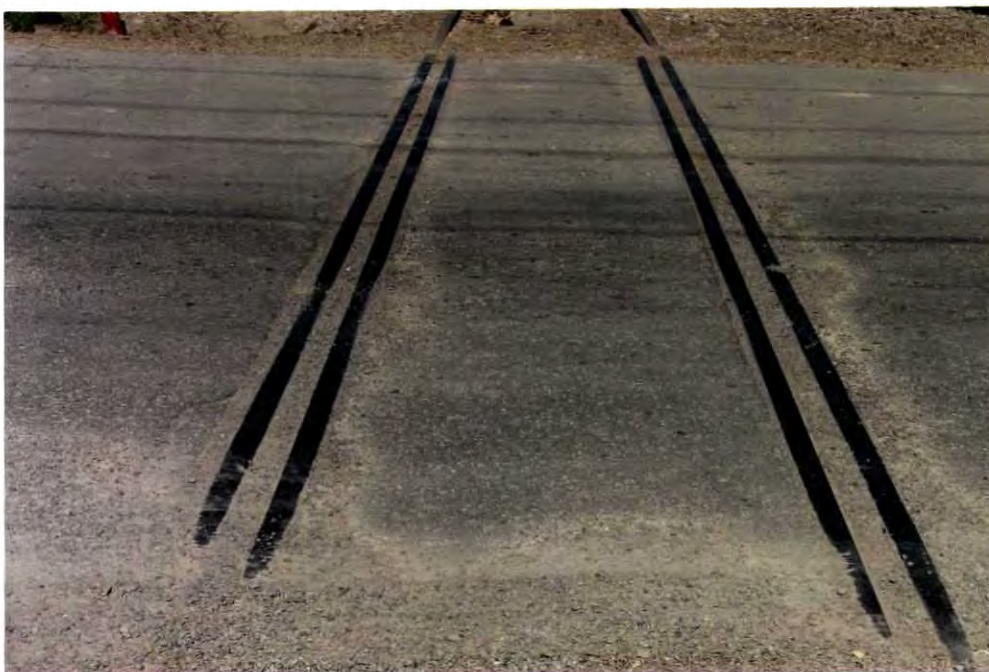
Photo 85. Merillat - Side Spur

well as the main track. Average daily traffic is not known but most of the traffic consists of heavy trucks. Average daily train traffic on the main track is two trains, usually comprised of two locomotives and 40 to 50 freight cars. Traffic on the side track is less than one train per week. At this crossing, the difference between a crossing with a high volume and low volume rail traffic is evident. The main track has settled up to 1.5 inches in relation to the mud rails (See Photo 84), while little or no differential settlement is evident on the side spur (See Photo 85). The inner mud rail also appears to have been pushed away from the main rail. The tracks are mud-filled and it is likely that the mud rails on the main track have been raised by mud being forced under them. The main track also appears to have settled 1.5 to 2 inches in relation to the pavement, and the pavement approaches to the crossing have failed (Photos 85 and 86). There is 115 pound rail throughout the crossing with no bolted joints close to the crossing.

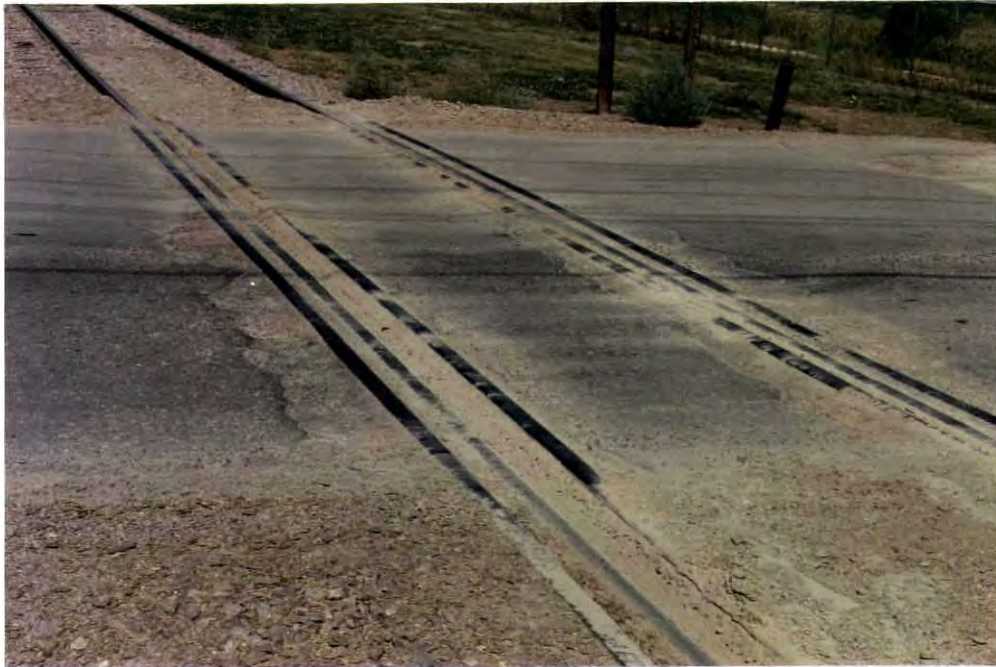
Photo 86. Merillat - Main Track Pavement Approaches

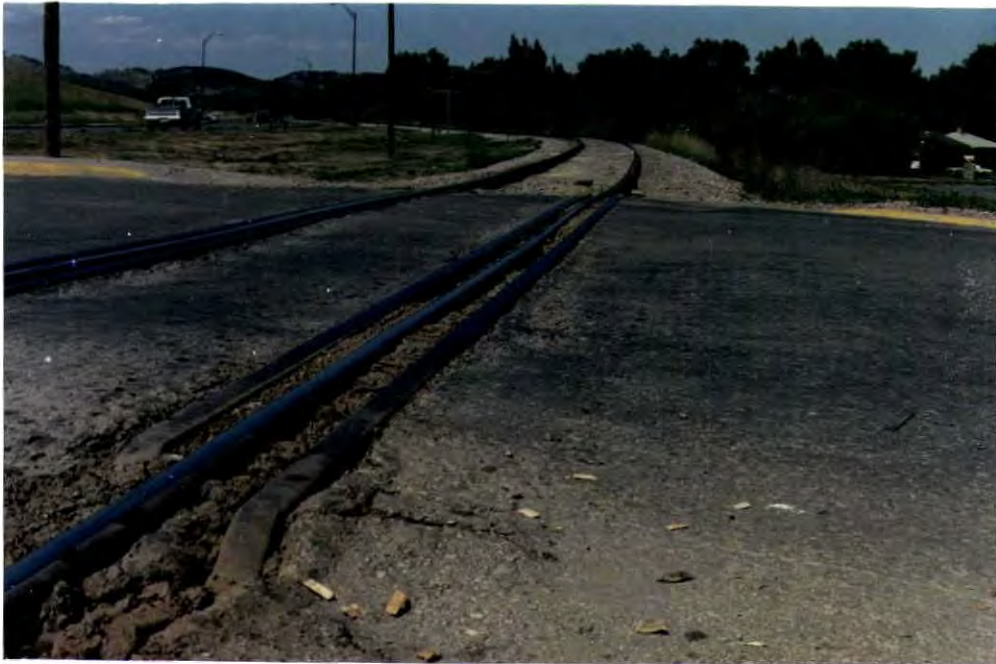
Photo 87. St. Charles Street - Pumping between Rails

This crossing is among the roughest surveyed in the Rapid City area. Based on the information obtained from the condition survey, it is believed that the ties under the crossing are deteriorated. The ballast may also have become infiltrated with fines, as is evidenced by water pooling between the rails and observation of the ballast at the approaches to the crossing.

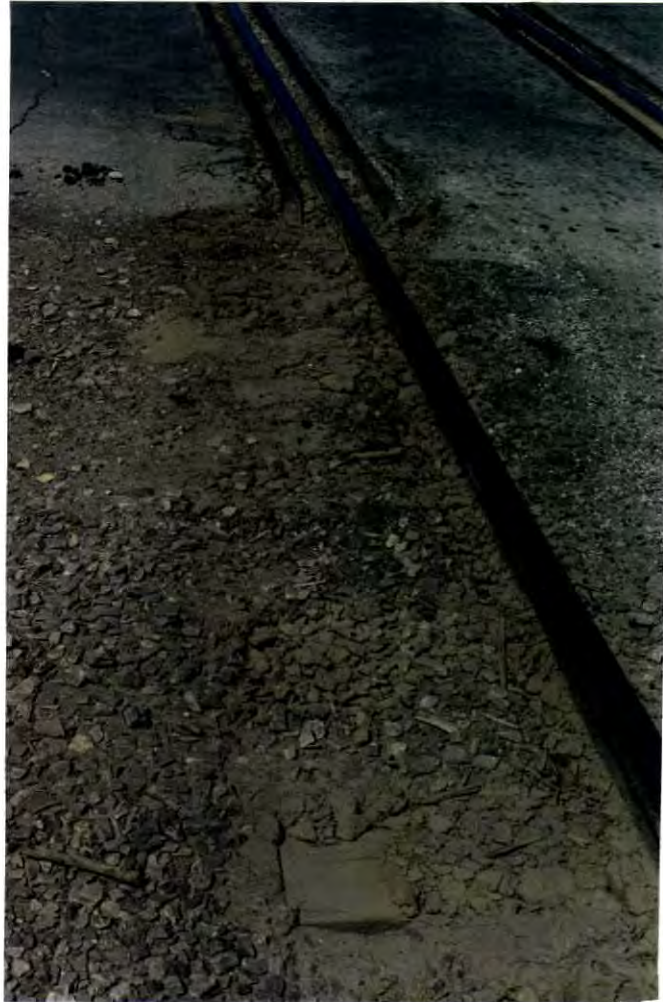
Photo 88. St. Charles Street - Pumping on East Side of Crossing

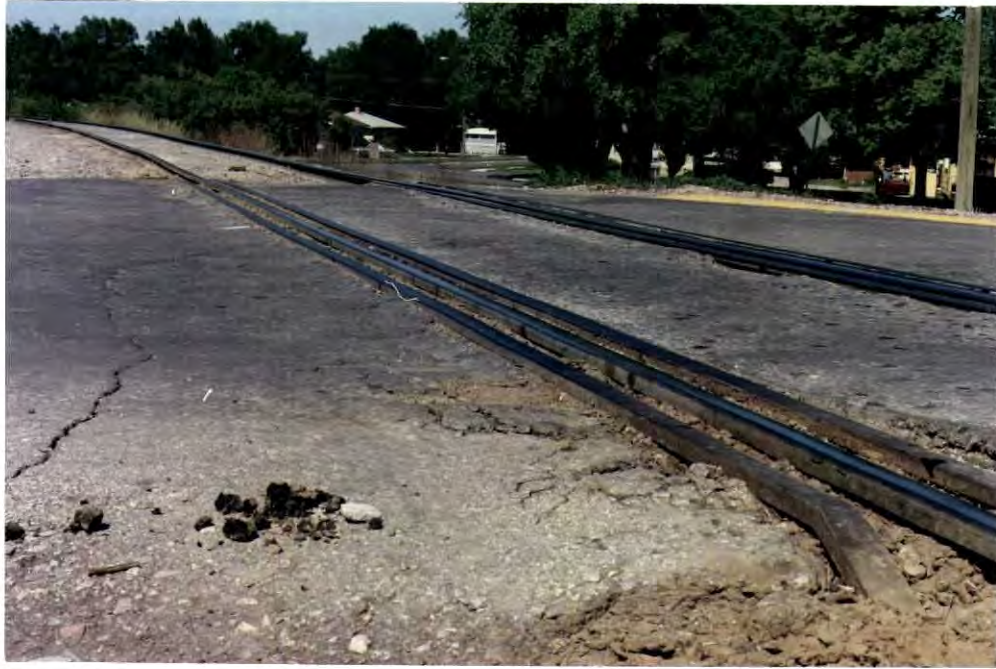
Photo 89. St. Charles Street - Apron and Center Settlement

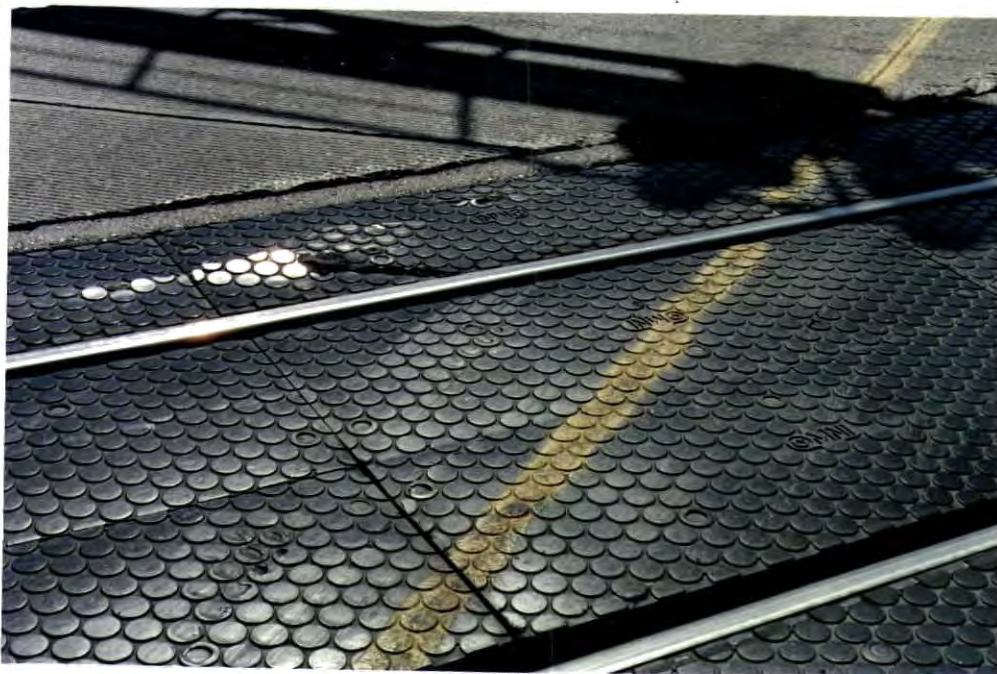
Photo 91. Service Road at DOT - Crossing Settlement

There is some evidence of track settlement and movements, especially at the south rail as the rubber panels are worn down by the railroad traffic (See Photo 90). In addition, minor wear of the rubber panels can be seen along the entire crossing. The entire track section in the crossing has also settled in relation to the pavement, as can be seen by the difference in elevation between the concrete pavement and the headers (See Photo 91 and 92). The differential settlement between the pavement was measured to be between 1/4 to 1.5 inches. The headers are in poor condition (See Photo 93) and should be considered failed in some places. Snow plow damage is locally severe in some places (See Photos 91 and 93), with some panels gouged to depths of more than one inch. The panels have shifted both vertically and horizontally. Vertical misalignment is up to as much as 1/4 to 3/8 inch, while gaps up to 3/4 inch can be seen between panels (See Photo 90). Some of the misalignment may be related to installation and uneven panel thickness. The gaps between the rubber panels and the rails are being filled with sand and gravel (See Photo 90). It should also be noted that the rubber panels appear to be buckling (See Photos 92 and 93). The panels do not appear to be restrained laterally at the ends of the crossing.

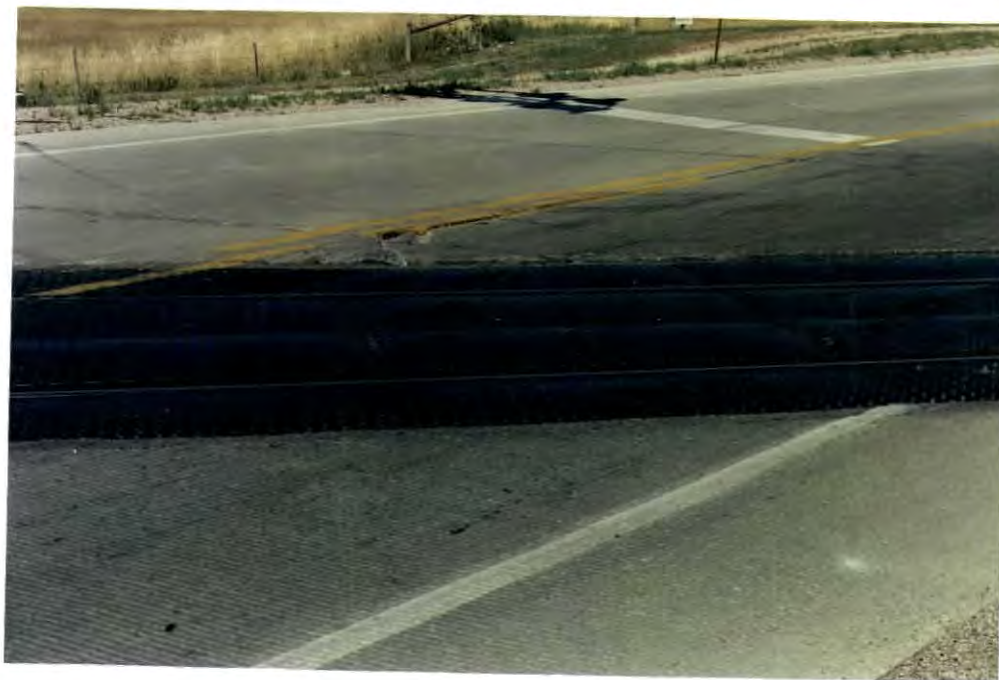
Photo 92. Service Road at DOT - Panel Buckling and Panel Separation

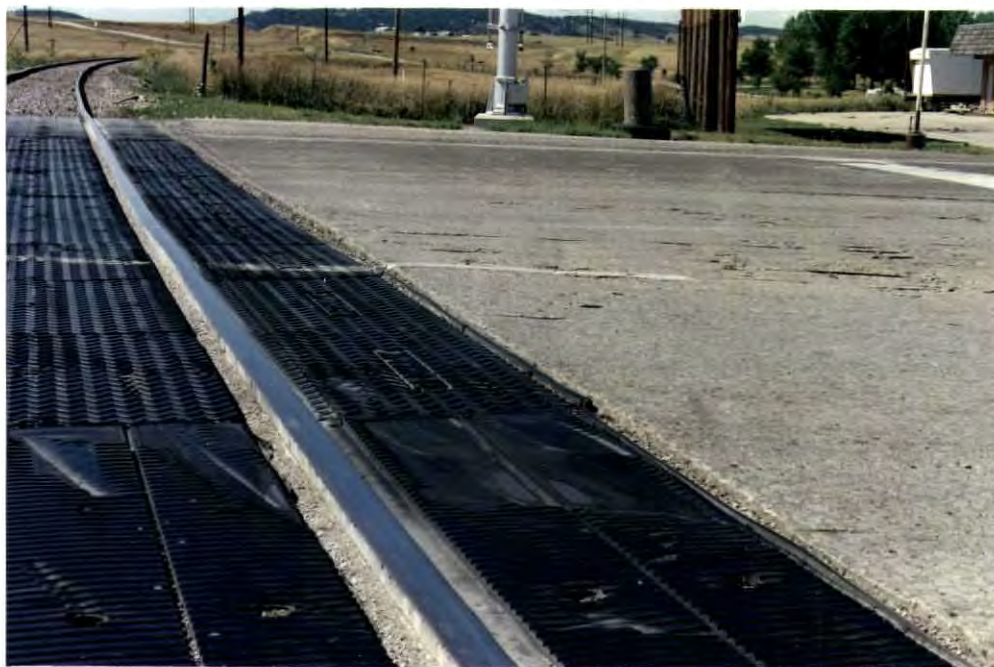
Photo 94. I-90 Loop at Exit 59 - Snow Plow Damage

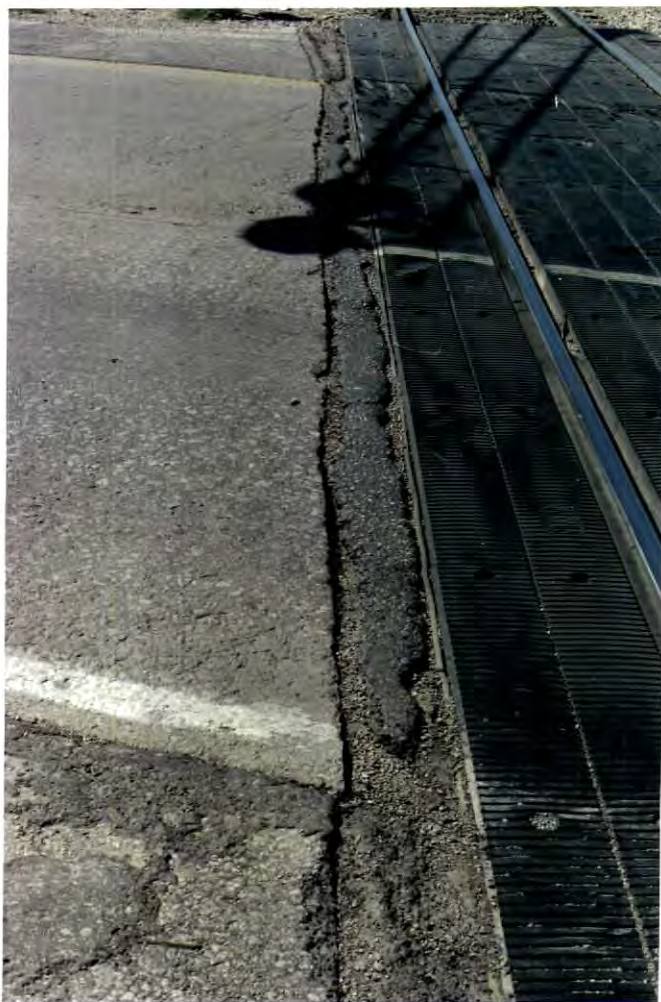
The rubber panels are not full depth but are resting on wood shims attached to the ties. The outer panels are up to one half inch lower than the top of the rails, yet wear from the railroad traffic is still visible. It is therefore likely that up to one half inch of vertical deformation has taken place under railroad traffic. No panel movement is visible under highway traffic. The asphalt headers have failed and have contributed to the considerable roughness in the eastbound lane (See Photos 95 and

Photo 96. I-90 Loop at Exit 59 - Header Failure

96). The headers are also in poor shape in the westbound lanes and the rubber molding is separating from the rubber panels. However, since the headers here are narrower than in the eastbound lanes, roughness is not so severe. Rubber is peeling off of the SAF&DRI panels, not only in areas which have been damaged from snow plows, but also in areas affected by general wear and railroad traffic (See Photo 95). The space between the rail and the center panels is also completely filled with debris and may have contributed to the panel distress. Snow plow damage is severe along the entire crossing but it appears that the SAF&DRI portion of the crossing has been most severely damaged (See Photo 94). The west portion of the crossing appears to have settled the most. As much as 1.5 inches of differential settlement was measured at the north approach in the westbound lanes. The rubber panels in the westbound lanes also showed as much as 1/4 inch vertical separation. Spacing between the panels horizontally was as much as 3/8 inch, with debris-filled panel openings.

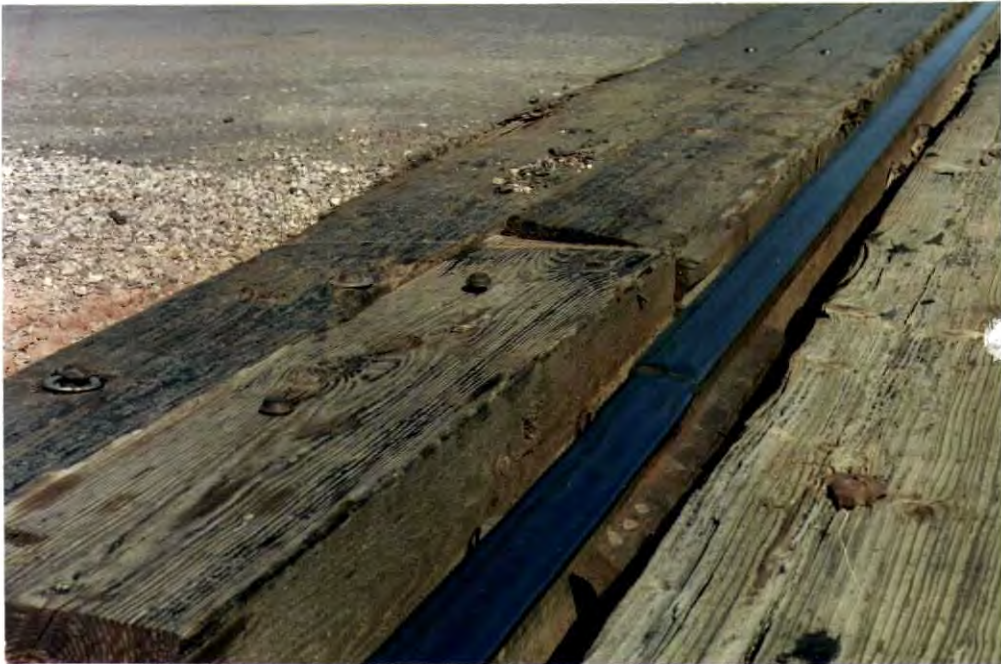
The timbers and the rail are mismatched, with the timbers sitting as much as one inch above the top of the rail (See Photos 97 and 98). Track movement under rail traffic is evident, as the spikes holding the rails have been pulled out as much as one inch. Severe damage to the timbers from the train wheels is also visible (See Photo 99). Several of the spikes holding the timbers in place are loose, as can be seen by loose and missing washers (Photo 98). Some of the spikes appear to have been pulled out by snowplows, as evidenced by damaged spikes and washers. Some of the timbers can be seen moving under motor vehicle traffic. The asphalt approach and asphalt contact with the timbers are good, with little chipping or differential settlements. Some of the timbers are warped (See Photo 98) and

Photo 97. PC L 214 - Mismatched Timber and Rail, and Pulled Out Spike

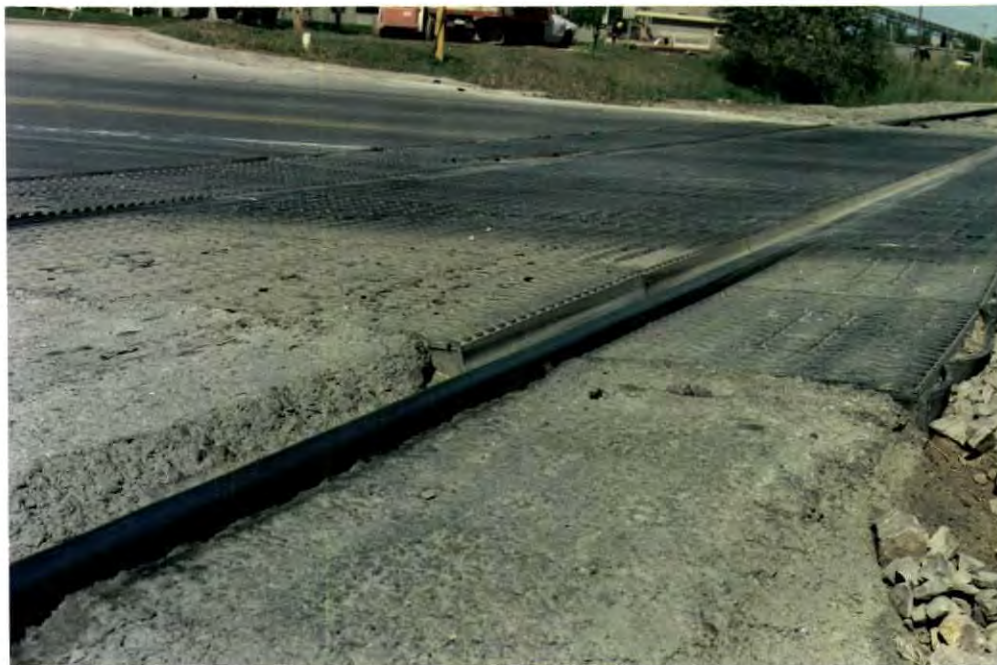
The crossing appears to have settled between 1/2 and 1 inch in relation to the concrete pavement. The outer panels at the south

Photo 100. South Dakota Cement Plant - Outer Panel Settlement

end of the crossing are also up to 1 inch lower than the rest of the crossing (See Photo 100). Evidence of track movement can be seen on the panels, especially at the rail approaches to the crossing. The crossing itself appears to be quite even, with little or no differential movement between the rubber panels. Snow plow damage is severe, as the panels are scarred, and pieces of torn off panel surfaces are laying next to the crossing (See Photos 101, 102 and 103). The concrete pavement approach to the crossing is in good shape, with only minor chipping next to the outer rubber panels.

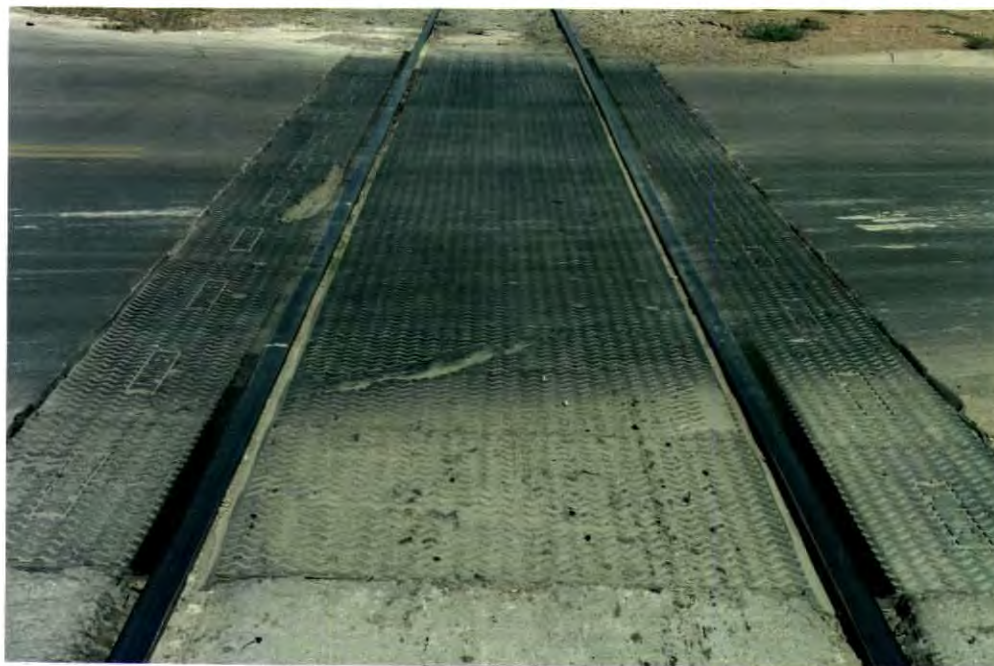
Photo 101. South Dakota Cement Plant - Panel Wear and Crossing Settlement

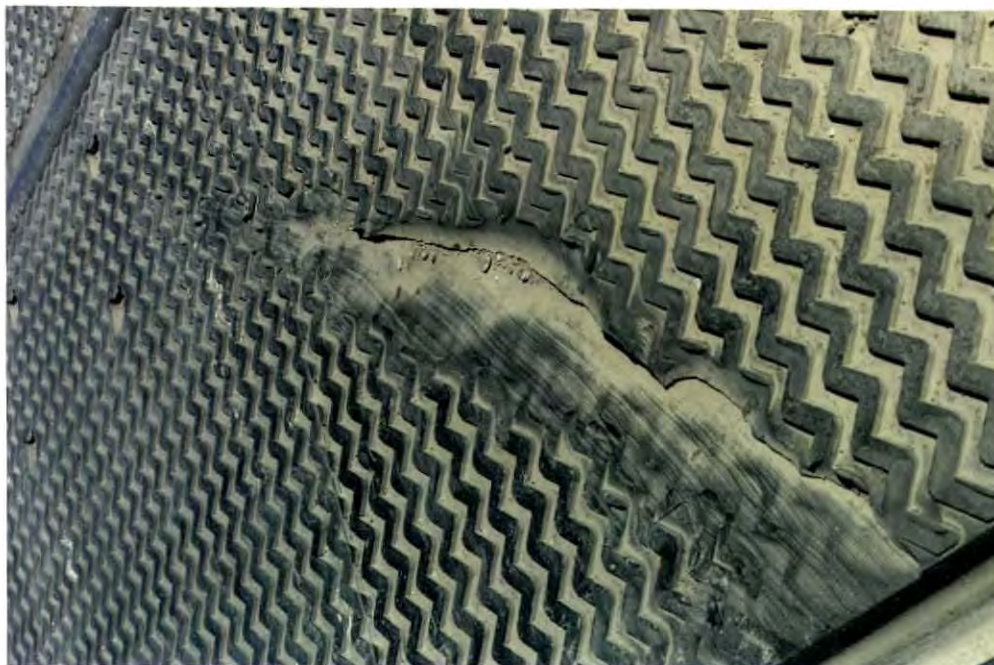
Photo 102. South Dakota Cement Plant - Snow Plow Damage
