Railroad Crossing Study

Study SD90-14
Volume II: Appendices

Prepared by
Department of Civil Engineering
SD School of Mines & Technology
Rapid City, South Dakota

January, 1992

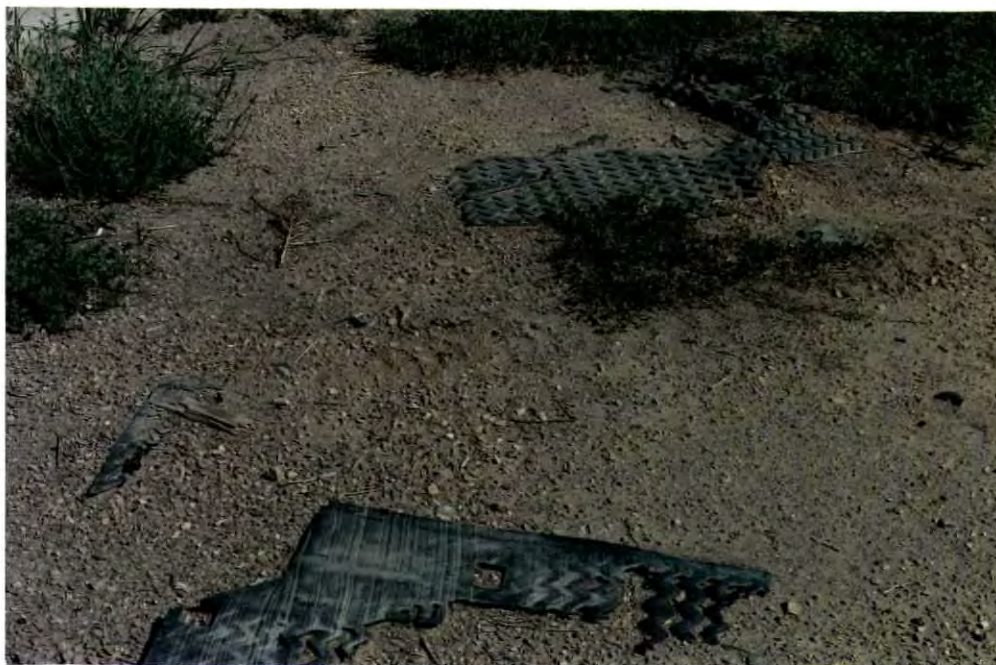
Photo 103. South Dakota Cement Plant - Panels Torn off by Snow Plows

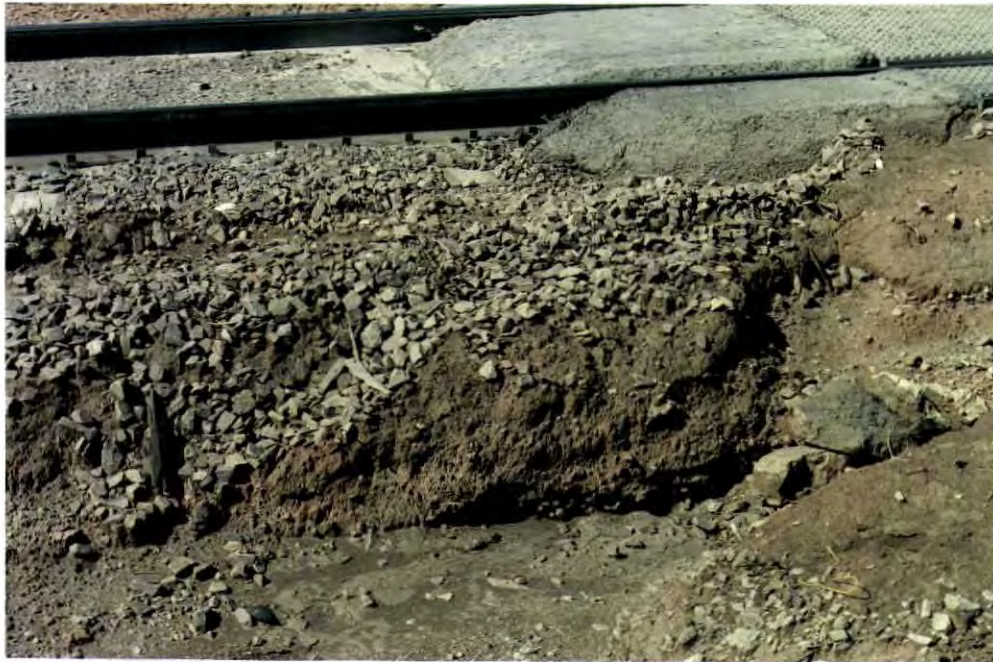
Photo 104. South Dakota Cement Plant - Erosion on the Main Track

Drainage at this location is poor, as can be seen by dried mud in between the rails at both ends of the crossing. At the north end of the crossing, the surrounding terrain is flat with no ditches. On the south side, however, there is a one foot deep gully on the east side of the track. Runoff from the crossing at this location has caused considerable erosion next to the crossing (See Photo 104).

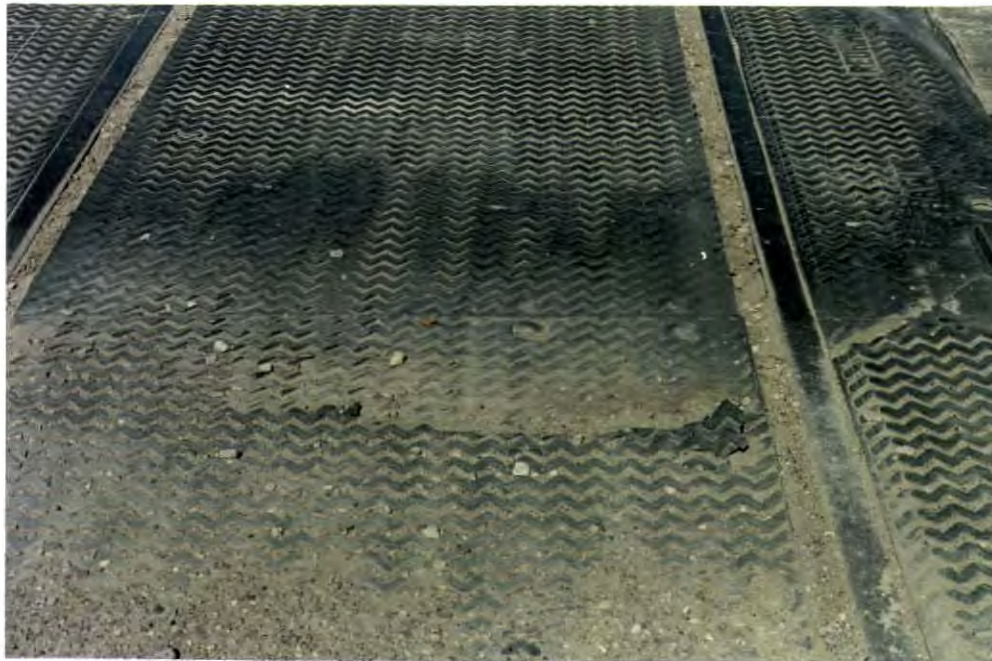
Photo 105. South Dakota Cement Plant - Side Spur

The side spur (See Photo 105) appears to be in good shape, with little or no differential settlement between the concrete approaches and the rubber panels. The spaces between the rails and the inner rubber panels are completely filled with mud and the panels have sustained damage similar to the main track crossing from snow plows.

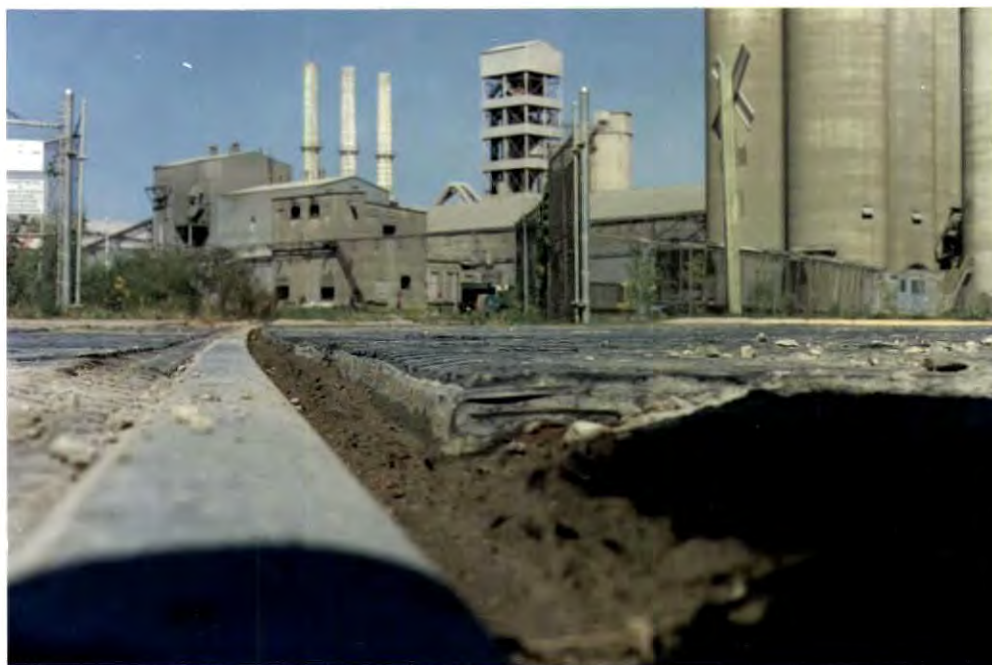
As can be seen by Photo 106, the elevation of the rails is from 1/2 to 1 inch below the rubber panels. The difference in elevation is especially noticeable between the rails and the rubber panels between the rails. The photo also shows that the space between the center panels and the rails is packed with soil. In addition, the outer panels are worn down from 1/4 to 1/2 inch by rail traffic. Settlements between the concrete apron and the outer rubber panels is generally less than 1/2 inch. Snow plow damage is minor, however, some rubber has been peeled off of the panels down to the steel on the east side of the crossing (See Photo 107).

Photo 106. Entrance to Cement Plant - Rail Settlement

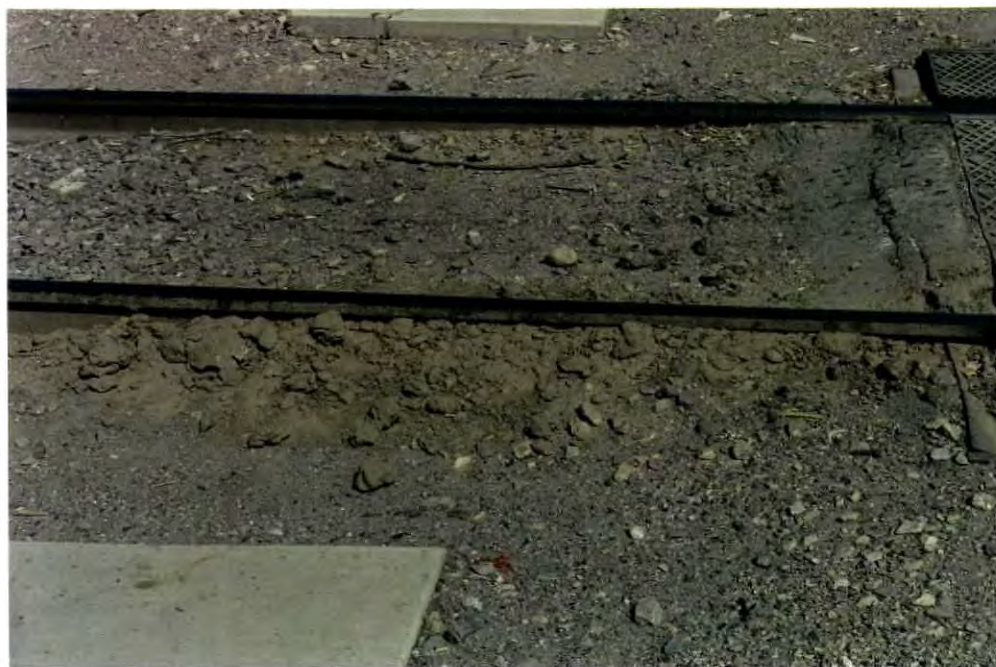
There is evidence of considerable track movement on both track approaches to the crossing. This can be concluded from evidence of pumping at the west end of the crossing (See Photo 108), and from wear on the rubber panels caused by the rail car wheels. The entire crossing has settled from 1 to 2 inches in relation to the pavement (See Photo 109), and there is considerable unevenness within the crossing itself, as the panels are bent and warped and have shifted both horizontally and vertically in relation to each other. The outer rubber panels are nearly flush with the top of the rails, while the center panels are up to one

Photo 108. Mt. View Road - Pumping and Track Movements

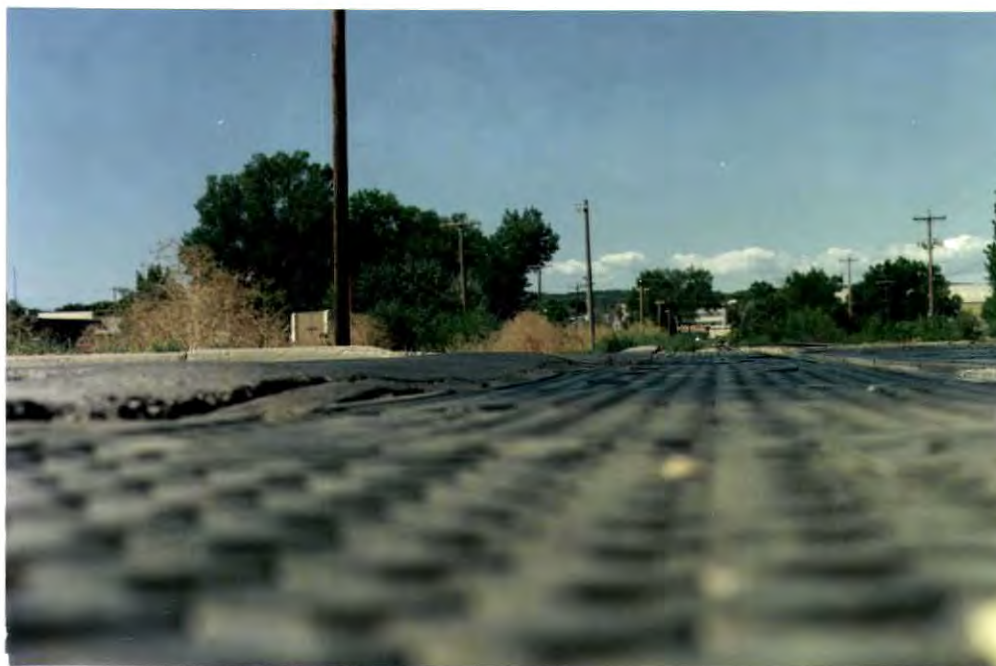
Photo 109. Mt. View Road - Crossing Settlement

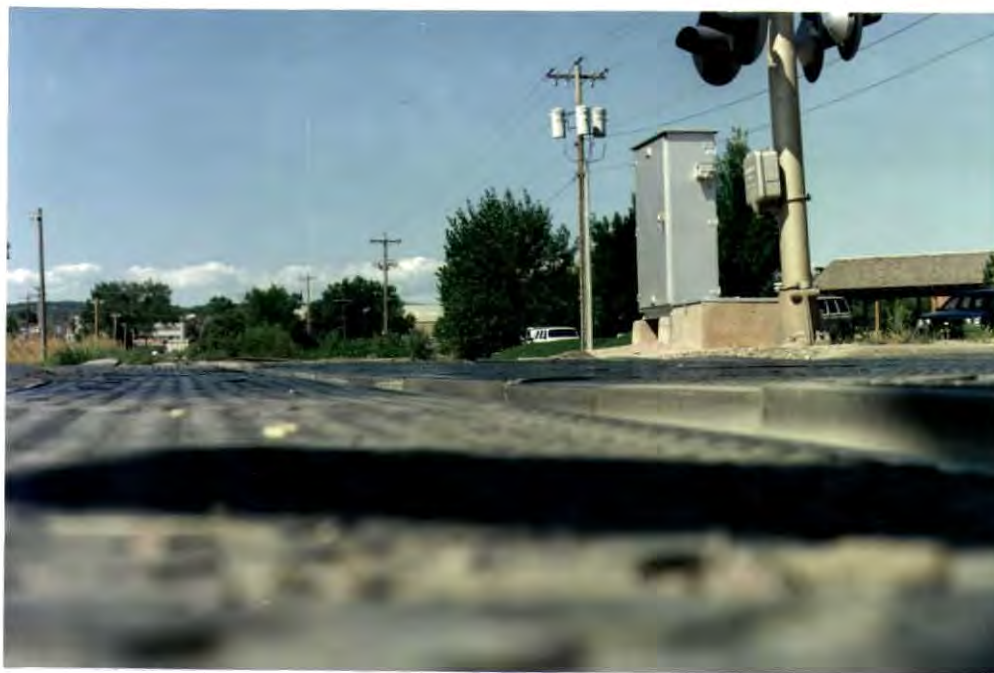
Photo 110. Mt. View Road - Differential Elevation between Center and Outer Panels

inch above the rails (See Photo 110). Since the track is completely mud-filled, the higher elevation of the center panels may be attributed to lifting by mud squeezed down by the rail wheel flanges. The approach aprons are severely cracked parallel to the track and at a distance of 6 to 12 inches from the outer rubber panels (See Photo 112) and considerable patching has been done. The wood headers are worn down or deteriorated. There is some damage from snow plows (See Photo 111). Overall, snow plow damage is not as severe as has been seen on other rubber crossings, however, most fastener protective caps have been torn off, such that the fastener heads are fully exposed to corrosion, wear and snowplows.

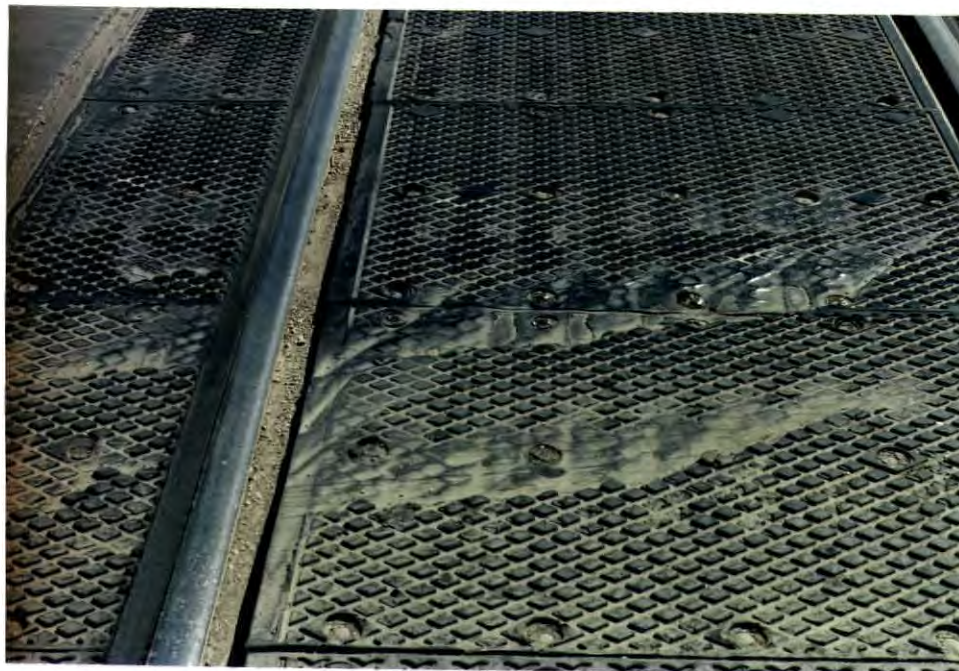
Photo 111. Mt. View Road - Panel Wear and Snow Plow Damage

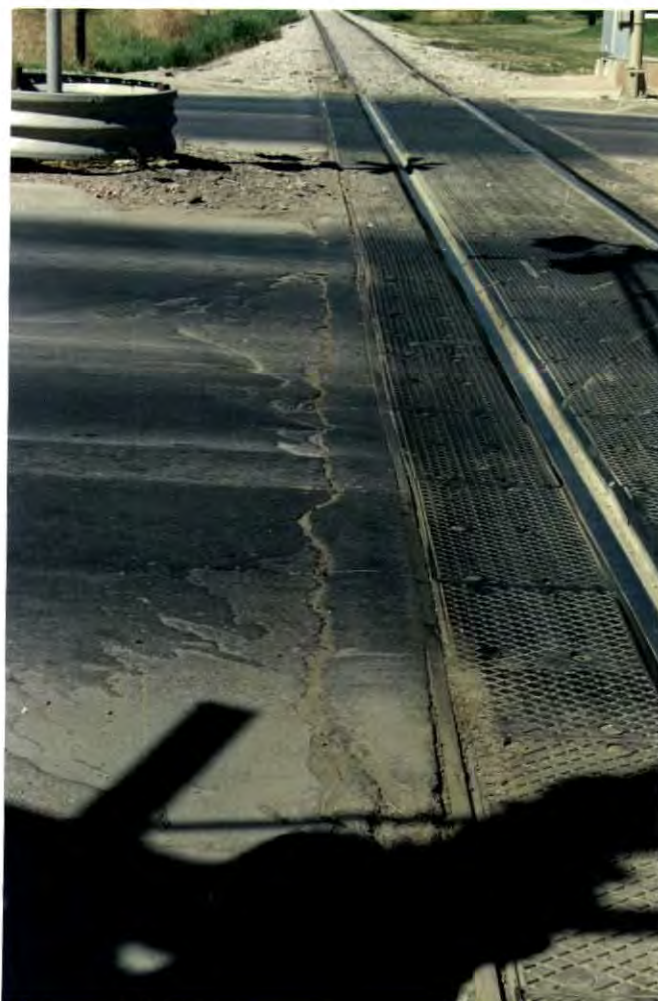
Photo 112. Mt. View Road - Cracking of Apron

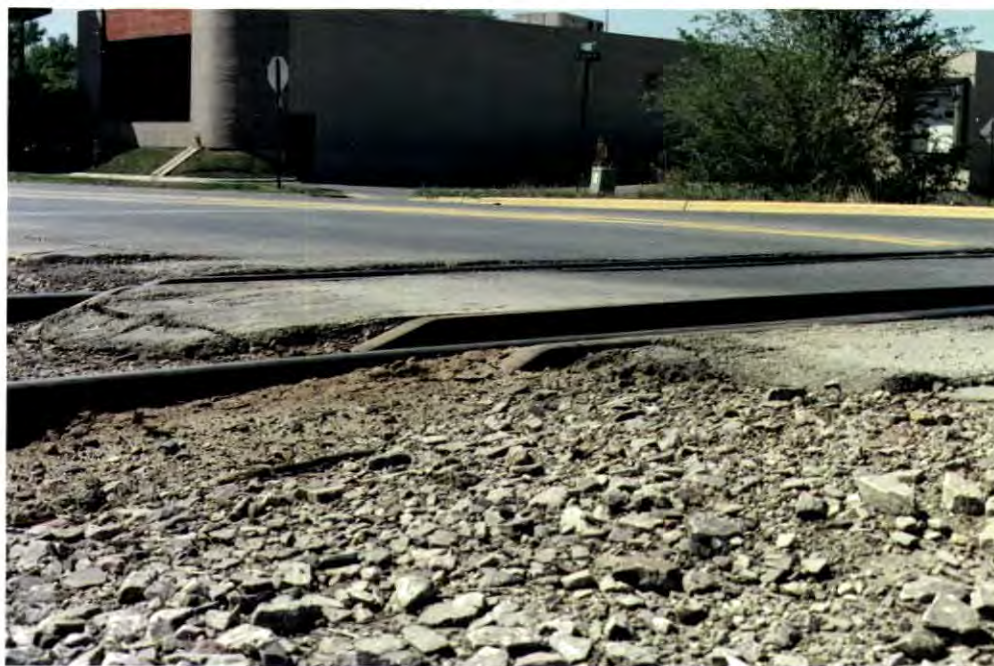
Photo 114. Cross Street - Main Rail Settlement in Relation to Mud Rails

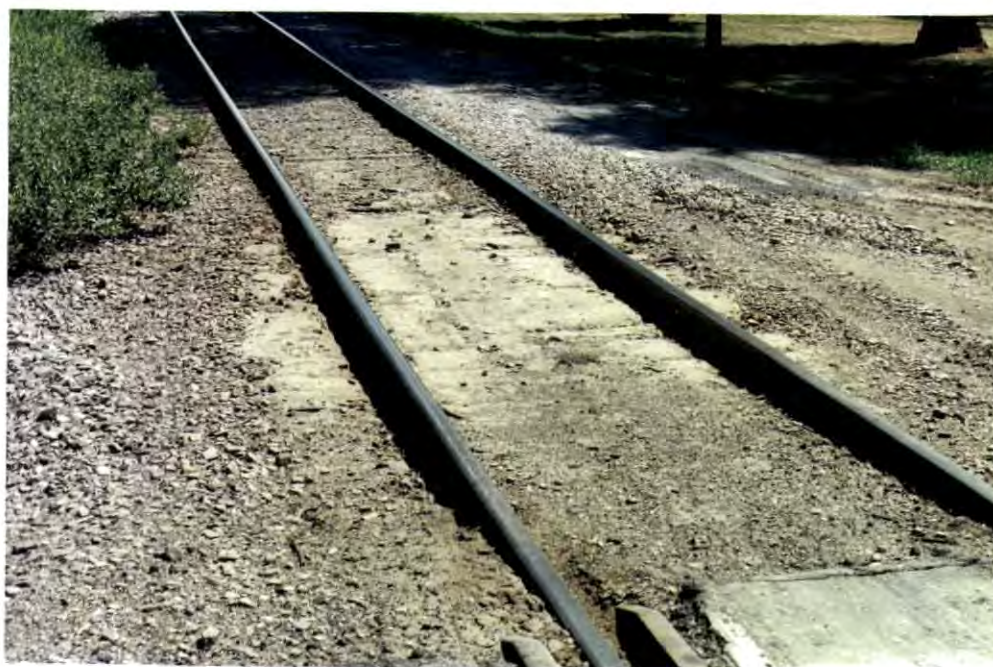
Photo 115. Cross Street - Evidence of Water Pooling between Rails on West End

is evidence of considerable water pooling between the rails at both the east and west ends of the crossing indicating that water is not draining onto the slopes of the embankments at each side of the crossing (See Photo 115).

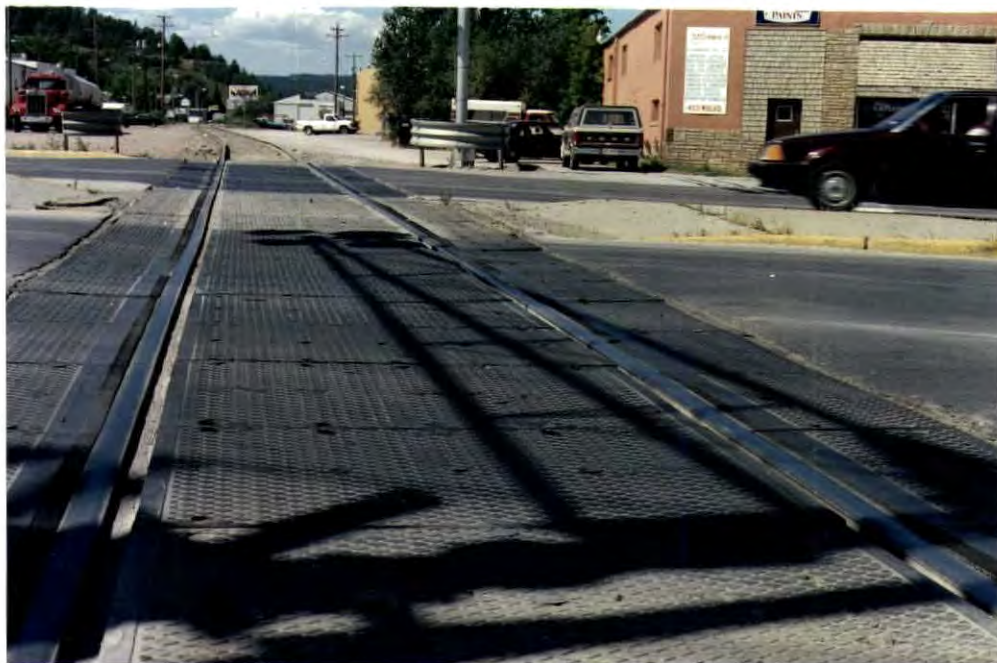
Track movement does not appear to be significant on the west half of the crossing, but considerable wear from the rail traffic can be seen on the east side of the crossing. The crossing appears to have settled from 1 to 2 inches in relation to the pavement aprons (See Photos 116 and 117). The center panels are from 3/8 to 1/2 of an inch above the outer panels at most locations, but

Photo 116. Tenth Street - Apron Tilting and Crossing Settlement

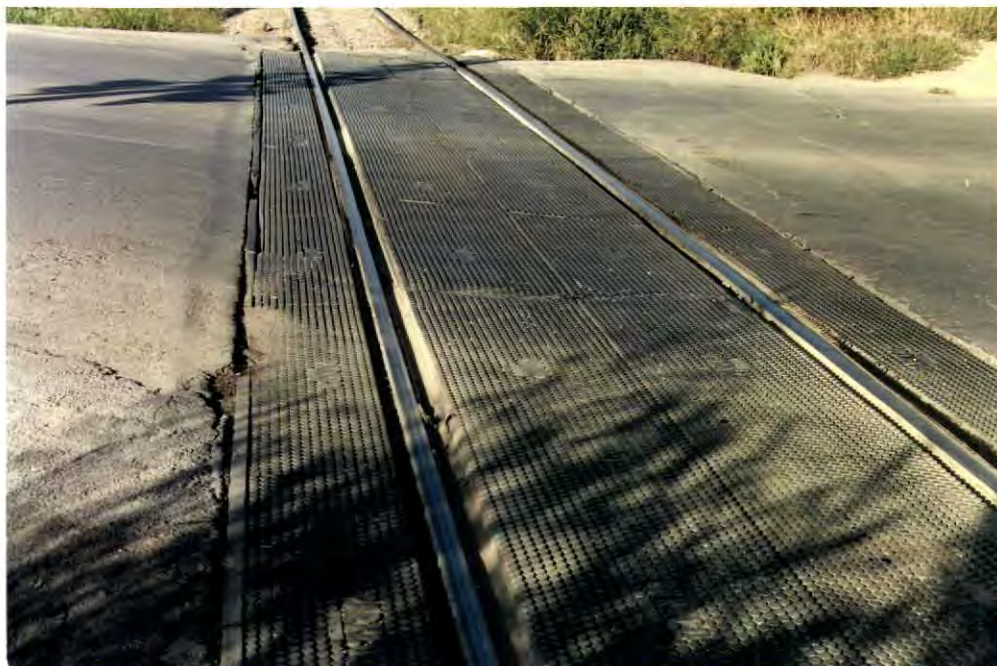
Photo 120. Milwaukee Street - Rubber Panel Wear and Track Settlement

There is evidence of significant track deflection along most of the crossing, as the panels are severely worn by railroad traffic (See Photo 120). Some sand and mud has collected between the center panels and the rails, but this crossing is cleaner than most of those inspected. There are some gaps and vertical displacement between the panels. However, panel displacement at this crossing is on the order of $3/8$ inch or less horizontally and less than $1/4$ inch vertically. The horizontal gaps are filling with debris. There is no evidence of loose panels, as little or no panel deflection or movement could be seen under motor vehicle traffic. Overall settlement of the crossing relative to the pavement is up to 1 inch at the south side of the crossing, but less at the north side. The wood headers are severely disintegrated at most locations (See Photos 120 and 122) and are missing at other locations. The headers have also been raised up to 1 inch above the pavement on the southwest shoulder where they are not exposed to significant traffic.

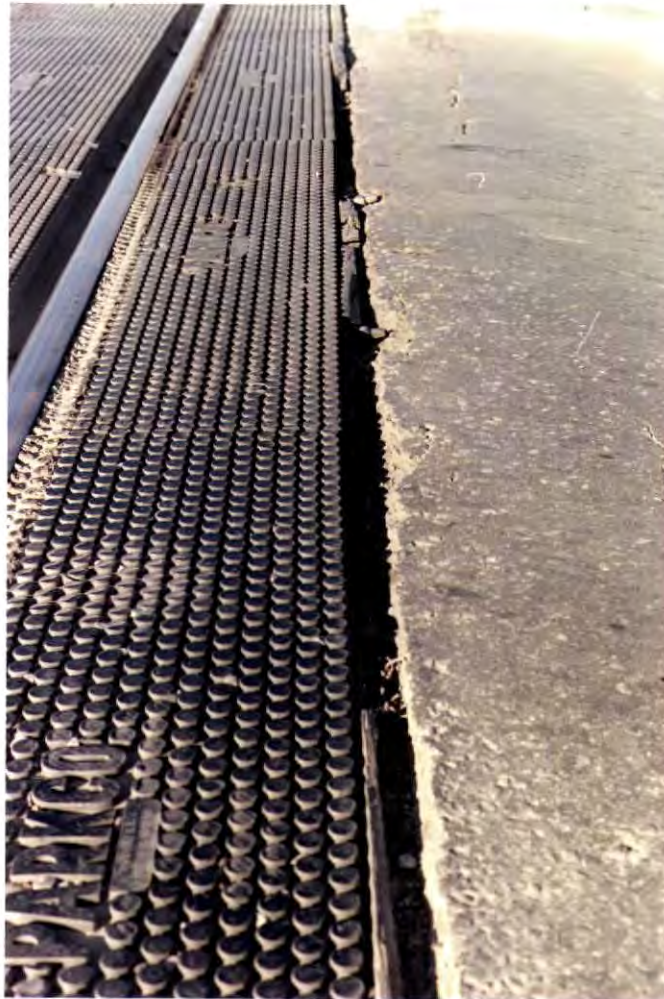
Photo 122. Milwaukee Street - Disintegrated Headers

The asphalt approaches are cracked and are breaking up in the areas where the headers are missing or have disintegrated. The

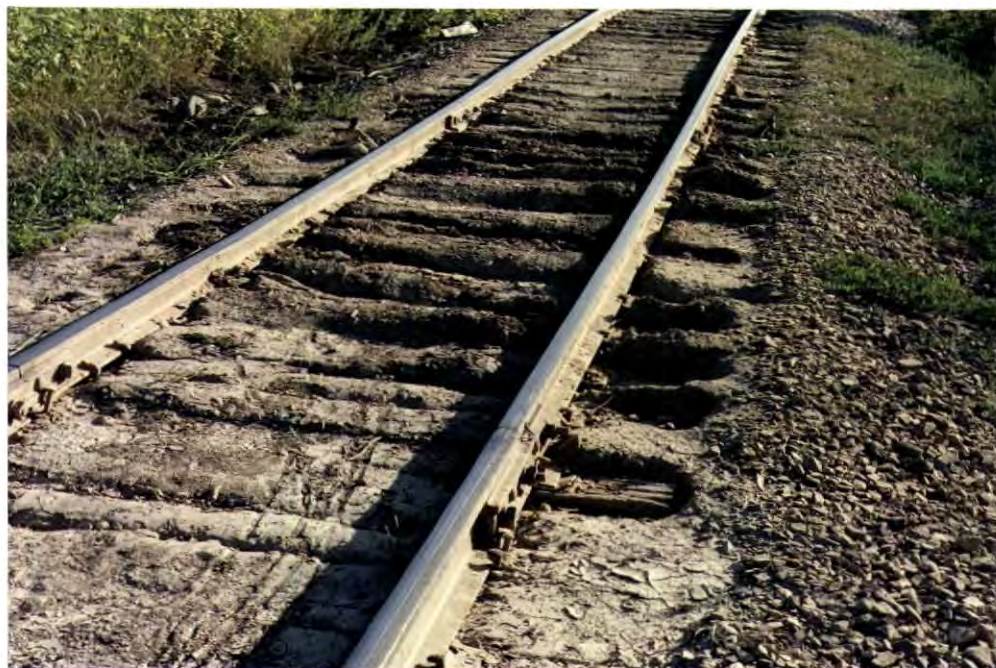
Photo 123. Milwaukee Street - Pumping at East End of Crossing

Drainage at this crossing appears to be poor, although there is one foot deep ditches on both sides of the track at both the east and west ends of the crossing. Nevertheless, there is evidence of water pooling between the rails and along the tracks on both sides of the crossing. Pumping at the east end of the crossing is especially noticeable where the track and ties have settled considerably (See Photo 123).

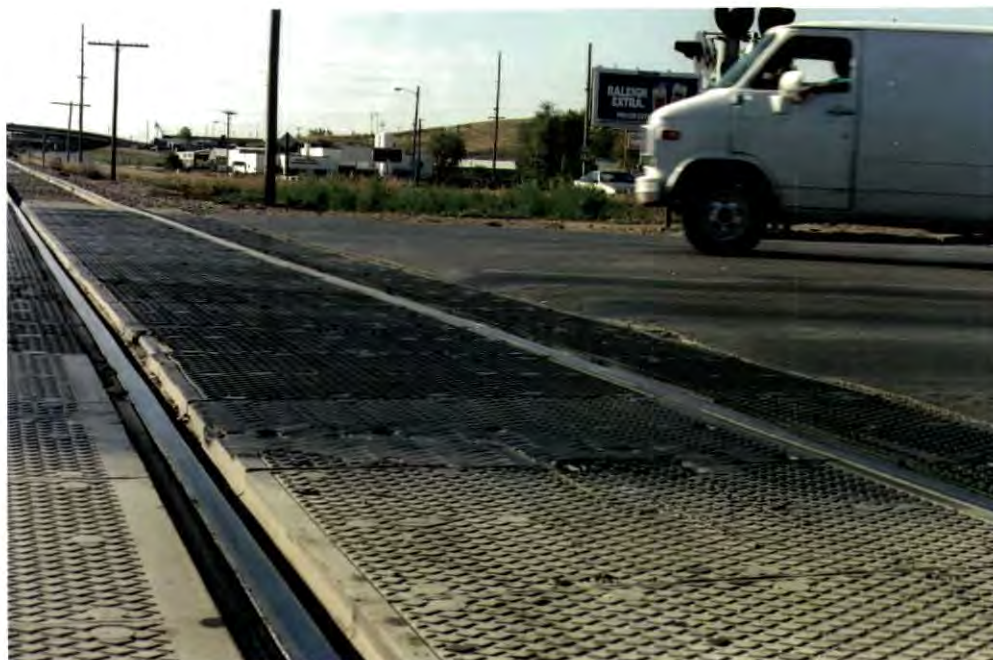
Photo 124. St. Patrick Street - Crossing Settlement on West Side

The crossing appears to have settled from 1 to 1 1/2 inches in relation to the road pavement on the west side of the crossing,

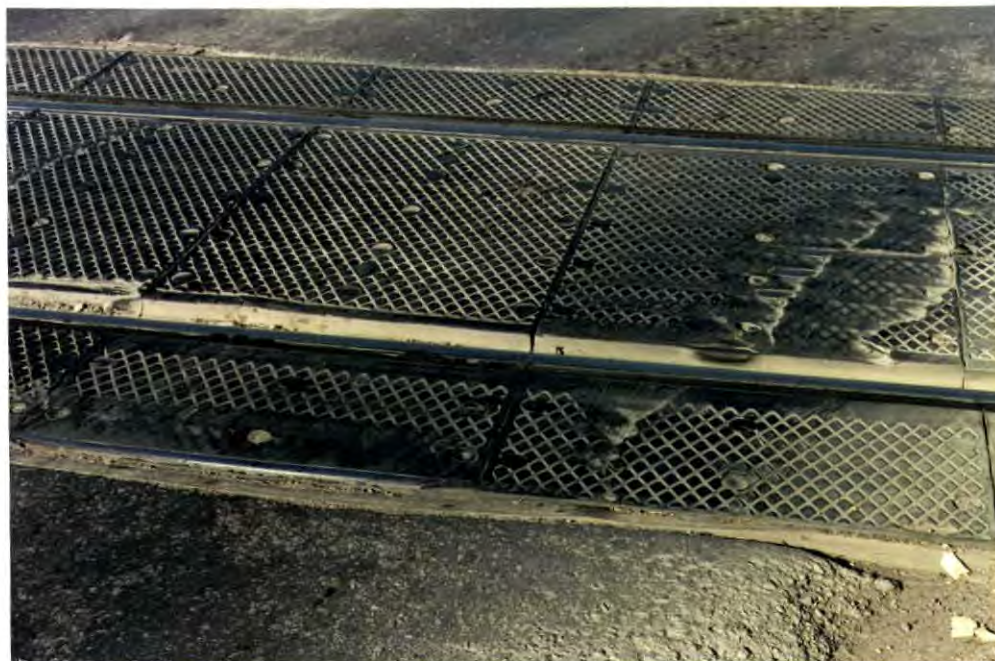
Photo 125. St. Patrick Street - Apron Settlement Relative to Crossing on East Side and Panel Wear

but is from 1/2 inch above to 1 inch below the pavement on the east side (See Photos 125 and 127). Considerable pavement wear is evident on both approaches, especially in the wheel path. There is also evidence of considerable rail deflection under rail traffic, as the outer rubber panels have up to 1/2 inch deep scars along the rails (See Photo 126). The rubber panels are worn down to the steel at several locations (See Photos 125 and 127). There is only minor panel separation and very little vertical shifting between panels. The space between the center panels and the rails contain only small amounts of debris. Snow plow damage is extensive and the combination of plow damage and wear have exposed the steel in the panels at several locations (See Photos 127). A considerable number of fastener protective caps have been lost. The wood headers are badly deteriorated and mud and debris have been forced in between the rubber panels and the headers (See Photo 127).

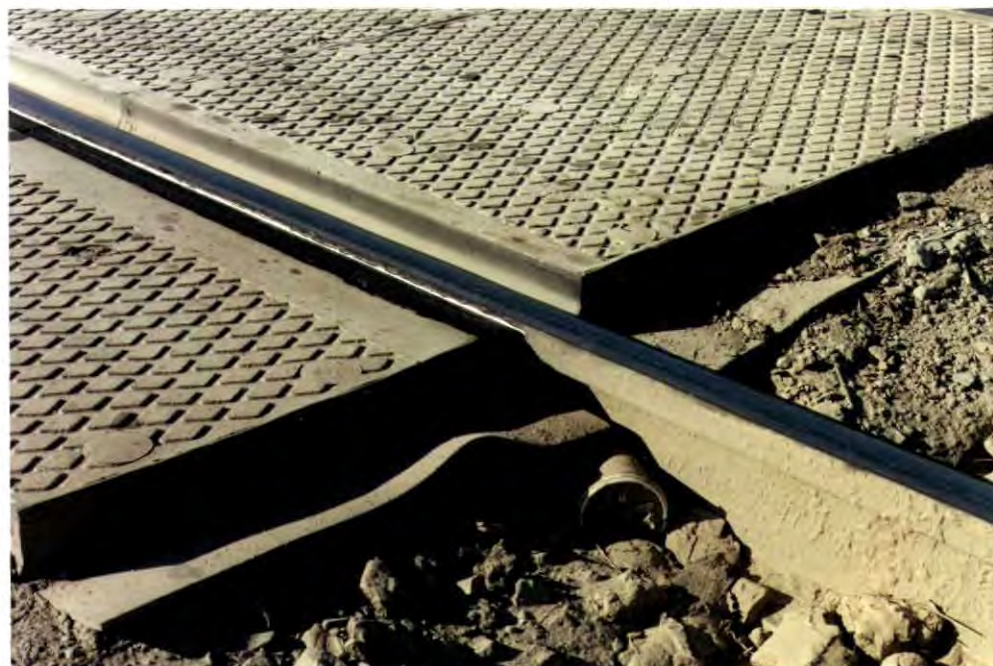
Photo 126. St. Patrick Street - Panel Scarring From Railroad Traffic

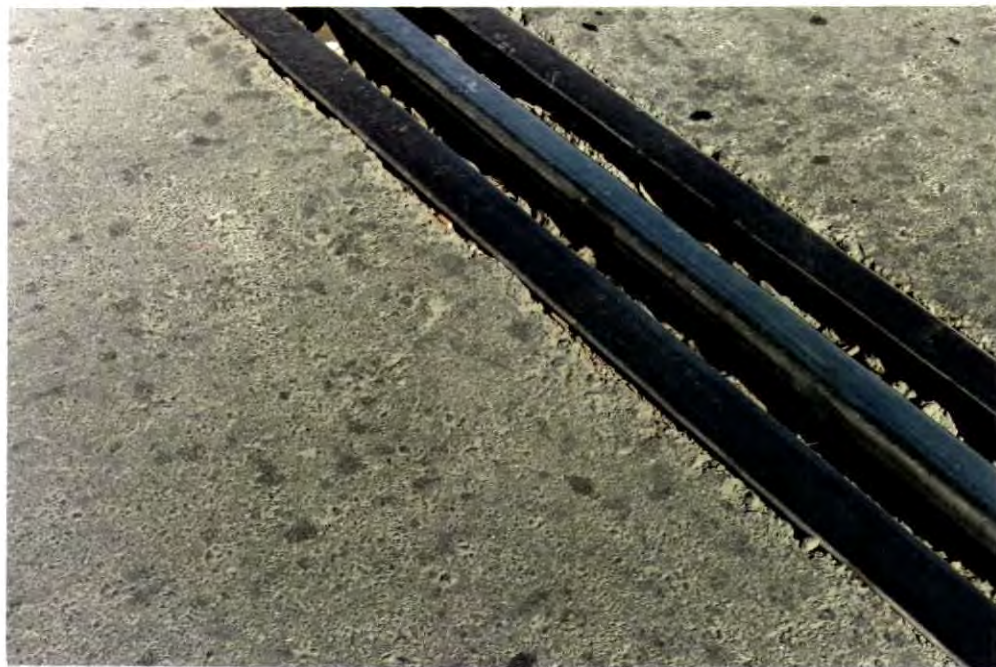
Photo 129. First Street - Asphalt Contact With Mud Rail

There is little evidence of track movement and the mud rails are close to or at the same elevation as the main rail. The asphalt contact with the mud rails is also good, with not more than a 1/4 to a 1/2 inch difference between the elevation of the mud rails and the asphalt contact (See Photo 129). There is no cracking of the apron on either side of the crossing. The spaces between the mud rails and the main rail are filled with loose mud and debris

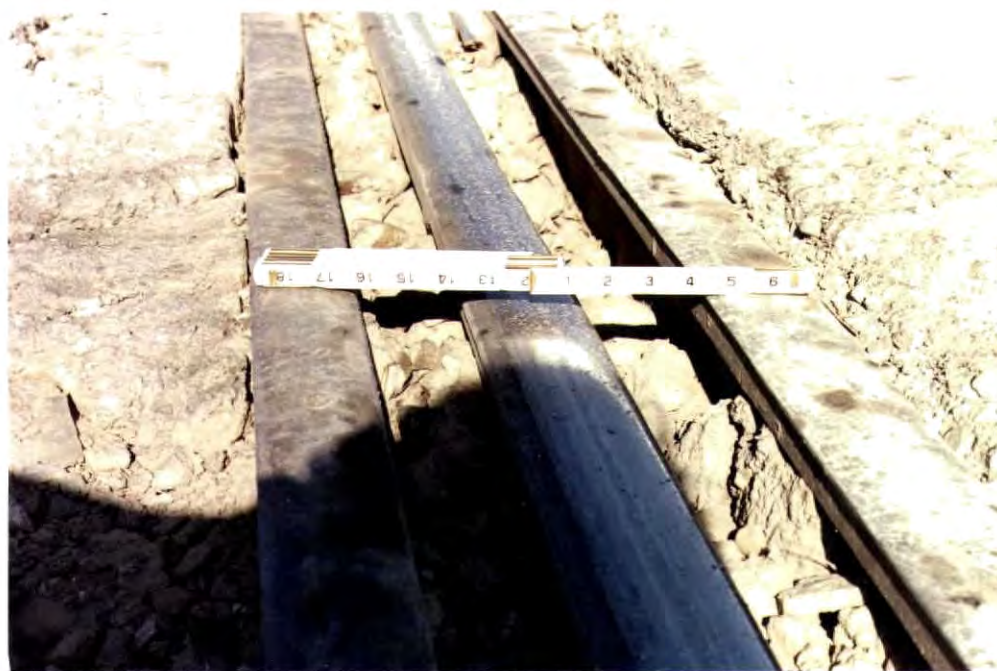
Photo 132. Second Street - Settlement of Main Rail and Mud Rail Below Asphalt

location of the end of the ties. Overall, the crossing is about 1 inch lower than the street pavement level. In addition, the main track is from 1/2 to 1 inch lower than the mud rails (See Photo 132). The asphalt in the driving lanes is rutted and the asphalt between the rails is up to 1/2 of an inch below the mud rails. At the shoulders, however, the mud rails are as much as 2 inches below the asphalt (See Photo 132 and discussion in Chapter IV). The spaces between the mud rails and the main rails are filled with mud and debris.

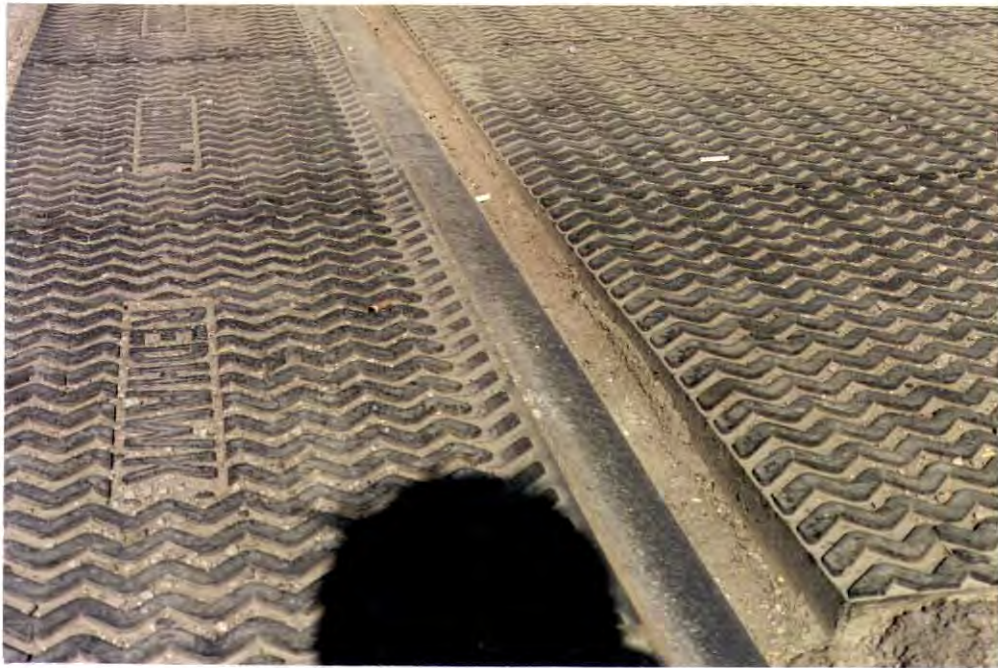
Photo 134. Fifth Street - Mud Packed Space between Rail and Center Rubber Panel

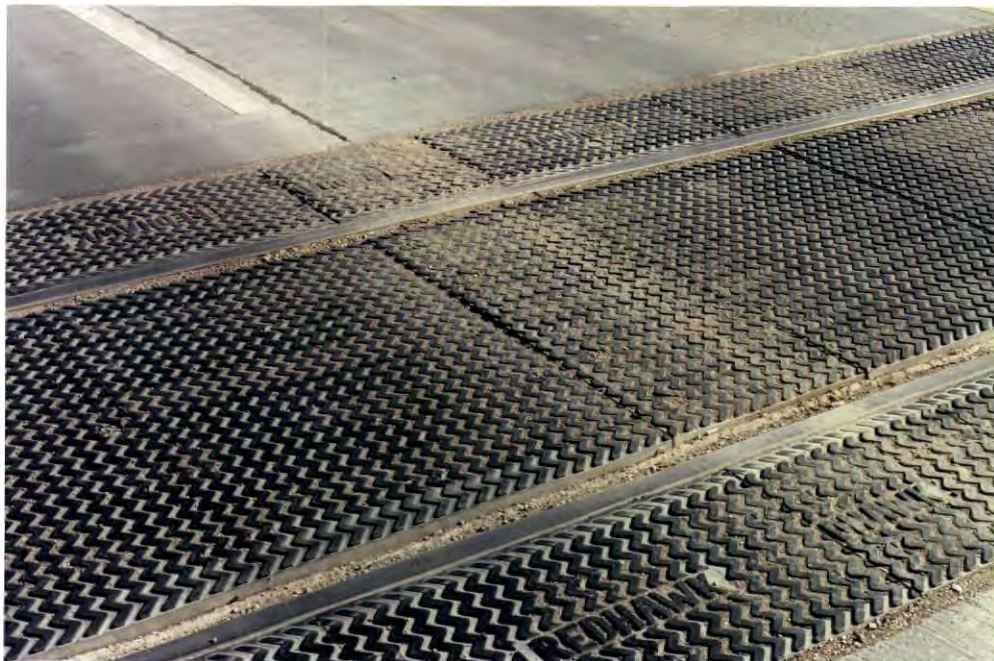
Photo 135. Fifth Street - Vertical Offset between Panels

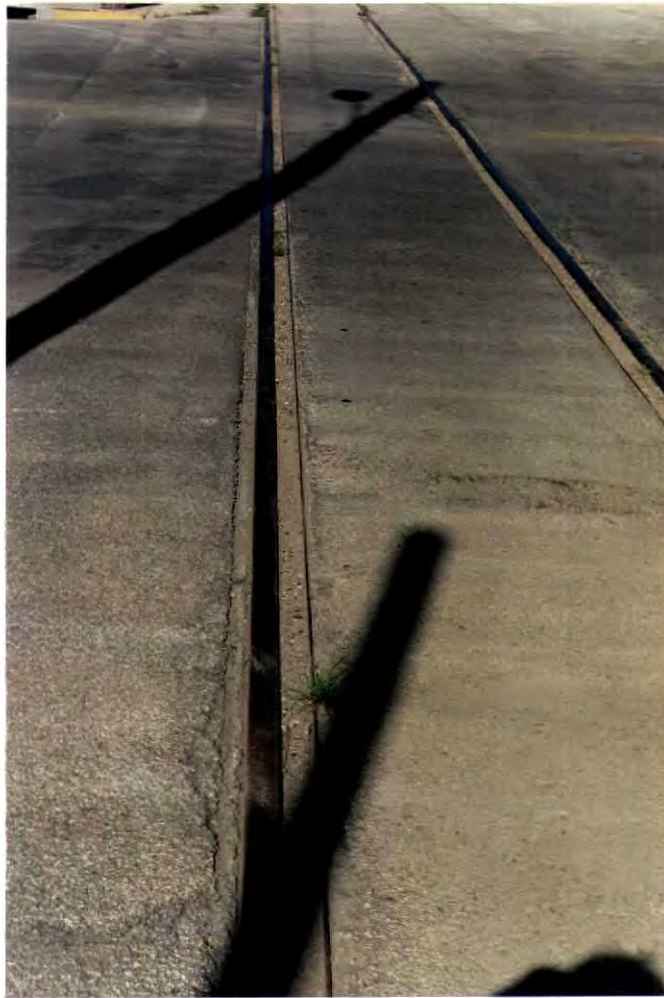
The Seventh Street crossing consists of the main track plus one side spur. The side spur is subjected to very little rail traffic and, at the time of the inspection, it was evident that the side spur had not been used in a long time, as grass was growing between the mud rail and the main rail (See Photo 136). The main track crossing is a ball-up mud rail type with asphalt surfacing. Both inner and outer mud rails are present. The side track has an inner side mud rail only. The pavement consists of asphaltic concrete and there are no headers. The crossing was built before 1979. Seventh Street is a two-lane street serving small businesses and is also a connector street between Omaha and West Main Street. Average daily traffic is 2,252 vehicles, with only a small percentage of these being heavy trucks. Rail traffic at the crossing consists of two trains per day, each with two to five locomotives and 40 to 50 freight cars. Daily switching traffic consists of cross-town hauling of freight cars to and from the train depots. The rail in the crossing is 115 pound weight and continuously welded, with no joints within a distance of 20 feet of the crossing. There is, however, a switch at the east end of the crossing.

Photo 136. Seventh Street - Side Track

The side spur shows little or no distress (See Photo 136). The side spur crossing shows no vertical differential movement between the pavement and the crossing, and the asphalt pavement is at the elevation of the mud rail. There is no cracking of the asphalt at the approaches (at the estimated end of the ties).

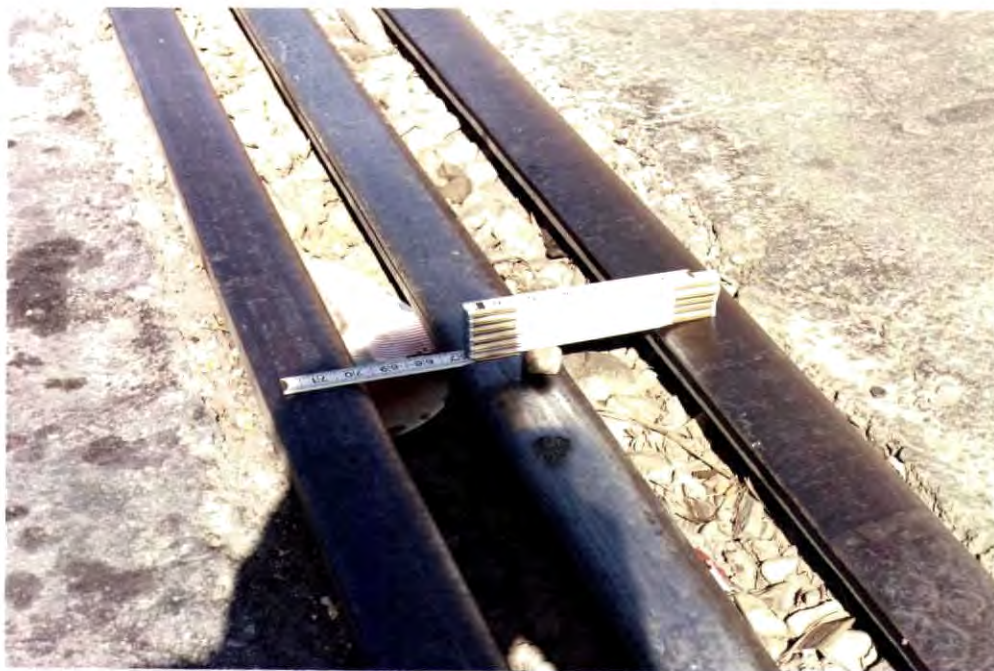
On the main track the main rail is from 1/4 to 1/2 of an inch below the mud rails (See Photo 137). The asphalt between the rails is from 1/2 to 1 1/2 inch below the mud rails. At the outside mud rails the asphalt is up to 2 1/2 inches below the mud

Photo 137. Seventh Street - Main Rail Settled Below Mud Rails

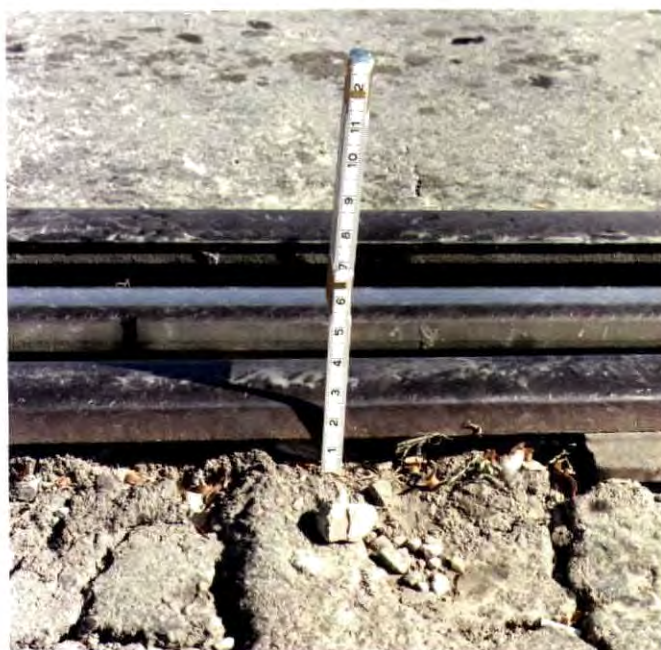
Photo 138. Seventh Street - Asphalt Below Outer Mud Rail

rail (See Photo 138). The approach is failing at a distance of 18 to 24 inches from the rails, which corresponds to the location of the end of the ties (See Photos 139 and 140). The approach is also tilted down towards the rails and it is estimated that the crossing has settled between 1 and 2 inches in relation to the street elevation. The space between the mud rails and the main rail is completely filled with mud and debris.

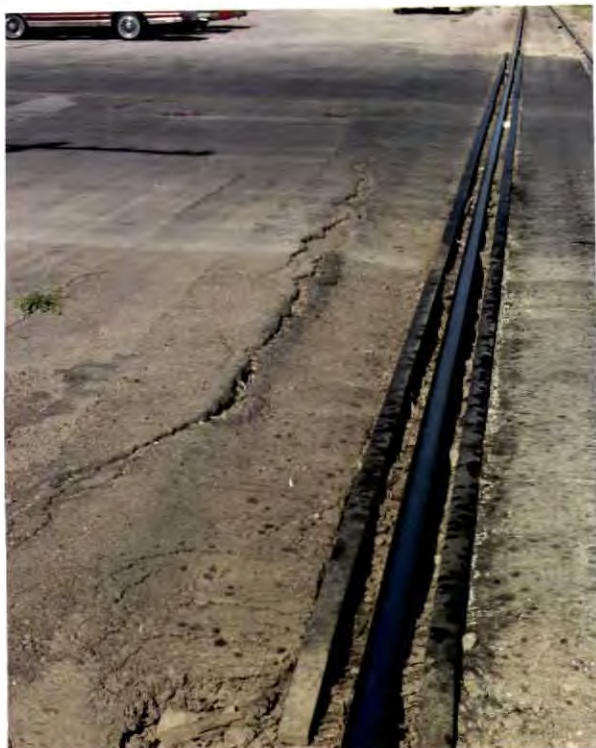
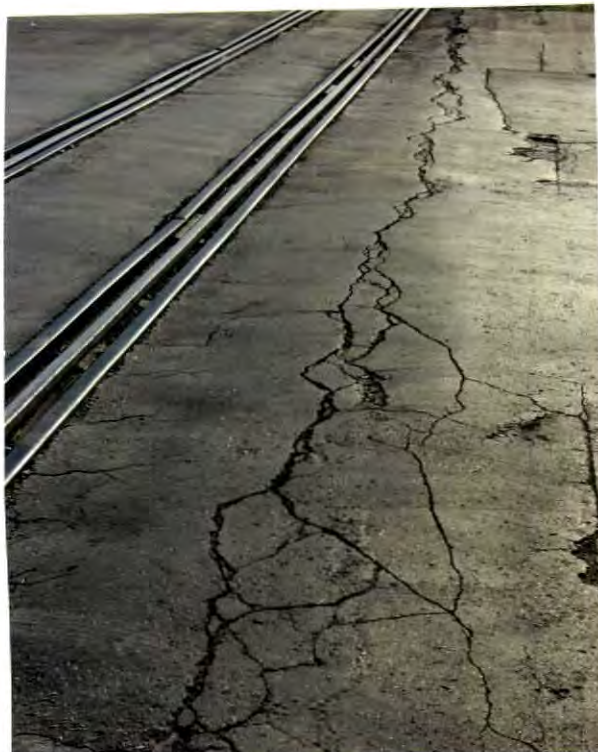
Photos 139 and 140. Seventh Street - Aprons Failing Parallel to Track

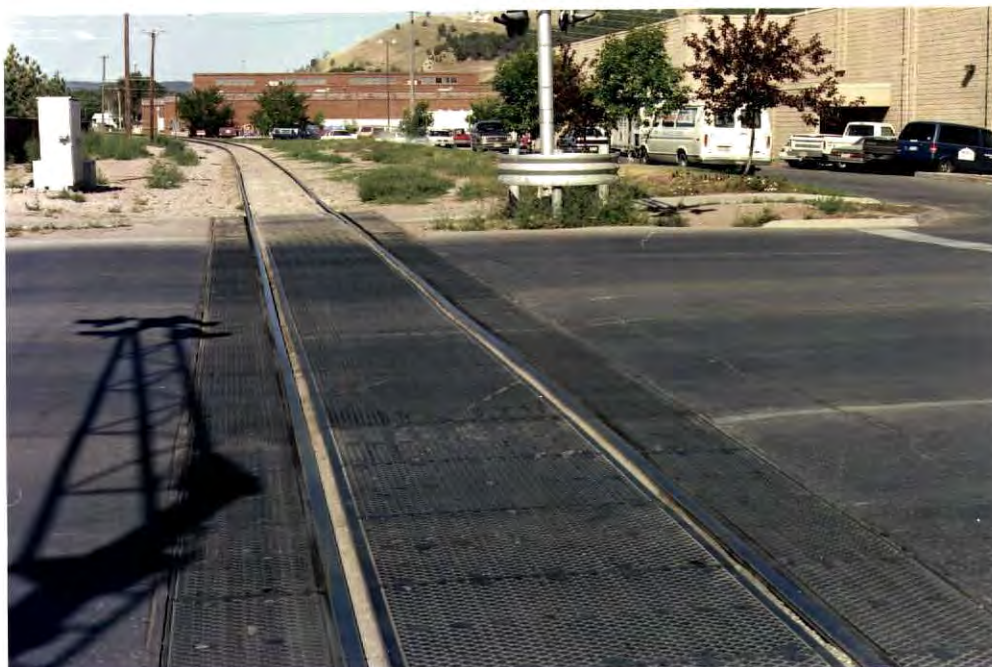
Photo 142. Mt. Rushmore Road - Cracking of Headers, Tilt of Apron, and Dropoff From Apron to Crossing

The crossing is quite even, although significant panel wear can be seen near the rails. Some panels are loose, as they can be seen moving under traffic. The track has settled considerably in relation to the road. Considering the tilt of the apron towards the outer panels and the differential elevation (drop-off) at the headers, total settlement is in excess of 2 inches at some locations. The drop off may be seen at the center left of Photo 142, where the shadow of the mast hits the header and the outer panels. Cracking of the apron is especially evident on both the south and north sides of the crossing, approximately 1 1/2 feet from the headers. Rail deflection under train traffic varies along the crossing, as the outer panels show signs of different levels of wear (See Photo 143). The rail also appears uneven. No portion of the headers are missing, but considerable wear can be seen at some locations (See Photo 143). This photo also shows a sharp drop-off from the approach to the crossing. The space between the headers and the rubber panels is being filled with debris, and the space between the rails and the center panels is becoming filled with hard packed soil. Snow plow damage is

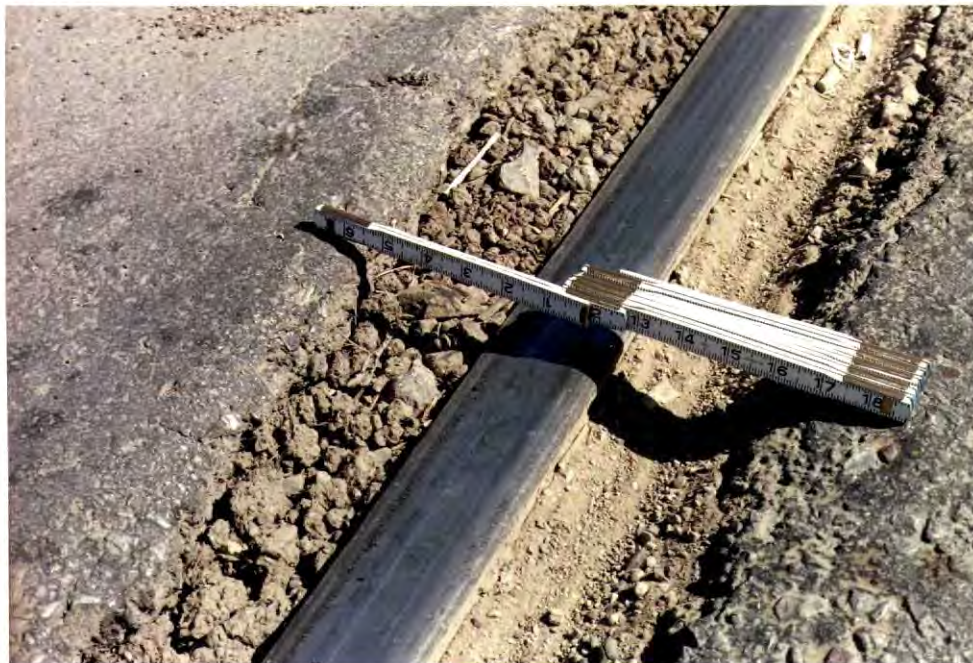
The rails are between 1/2 and 1 inch below the pavement in the driving lanes but have settled up to 3 inches below the pavement on the south shoulder (See Photos 144 and 145). The asphalt on both the inside and outside of the rails is severely broken up (See Photo 146). Settlement of the track under rail traffic is

Photo 144. New York Street - Rail Settlement Relative to Pavement

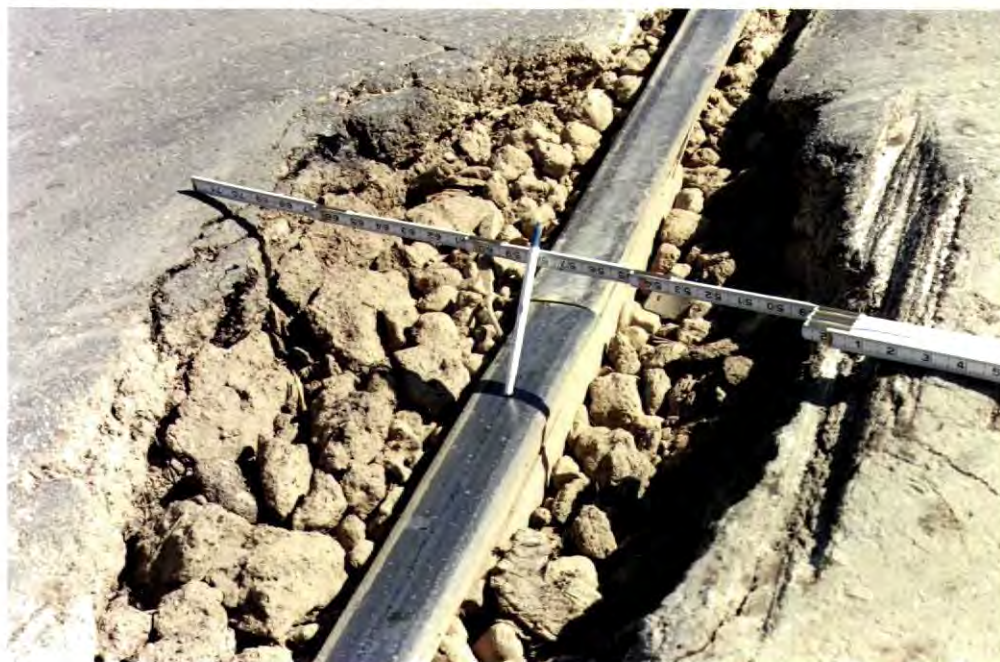
Photo 145. New York Street - Rail Settlement Near South Shoulder
