Railroad Crossing Study

Study SD90-14
Volume II: Appendices

Prepared by
Department of Civil Engineering
SD School of Mines & Technology
Rapid City, South Dakota

January, 1992

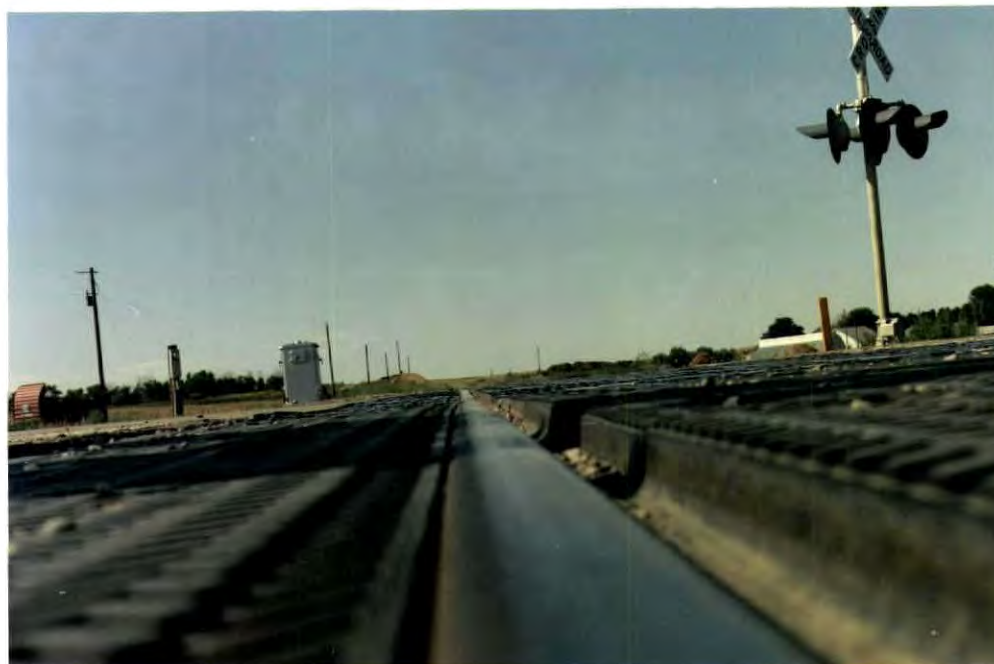
The crossing appears to have settled about 1/2 inch to 3/4 of an inch overall in relation to the pavement, as there is an abrupt drop off from the concrete pavement onto the crossing on both sides. The rail is also from 1/4 to 3/8 of an inch below the center panels along most of the crossing (See Photos 147 and 148). There is considerable amounts of soil and debris between the rail and the center panels which is being forced down between the rail and the panels. Minor vertical displacement between

Photo 147. US Highway 14 at Blunt - Rail Below Center Panels

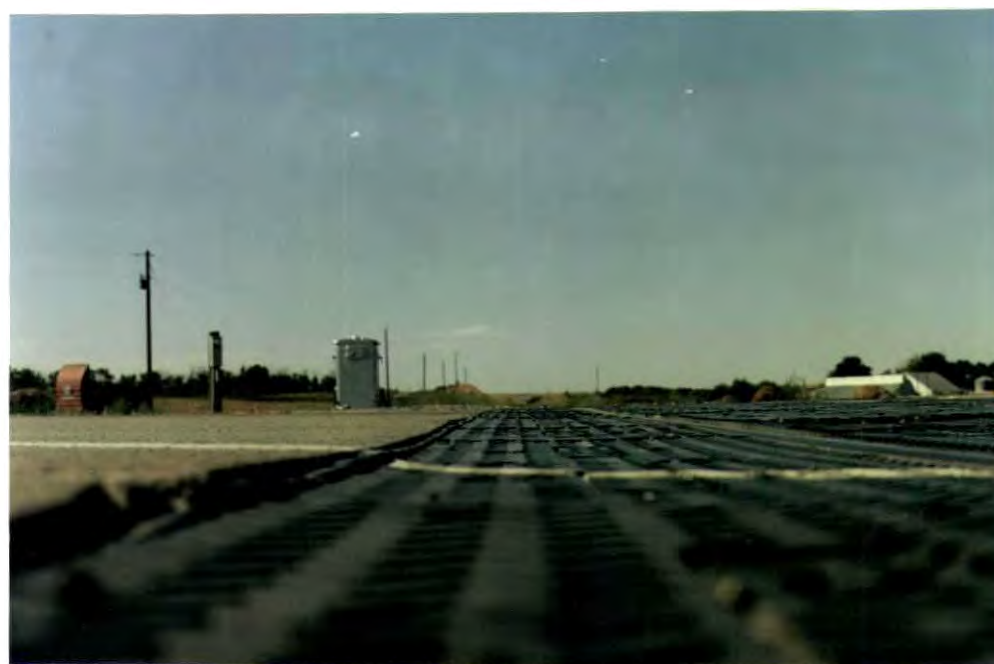
Photo 148. US Highway 14 at Blunt - Settlement at Concrete Apron and Uneven Panels

panels can be seen (See Photo 148), however, shifting of the panels laterally is negligible. The panels show very little wear from motor vehicle traffic. There are no significant signs of rail wheel wear on the outer panels next to the rails, indicating very little deflection of the rail under rail traffic and good rail attachment to the ties. There is minor chipping of the concrete next to the outer panels in the middle of the road on the east side of the crossing. Snowplow damage is severe locally in the eastbound lane where the rubber has been torn off down to the steel (See Photo 149).

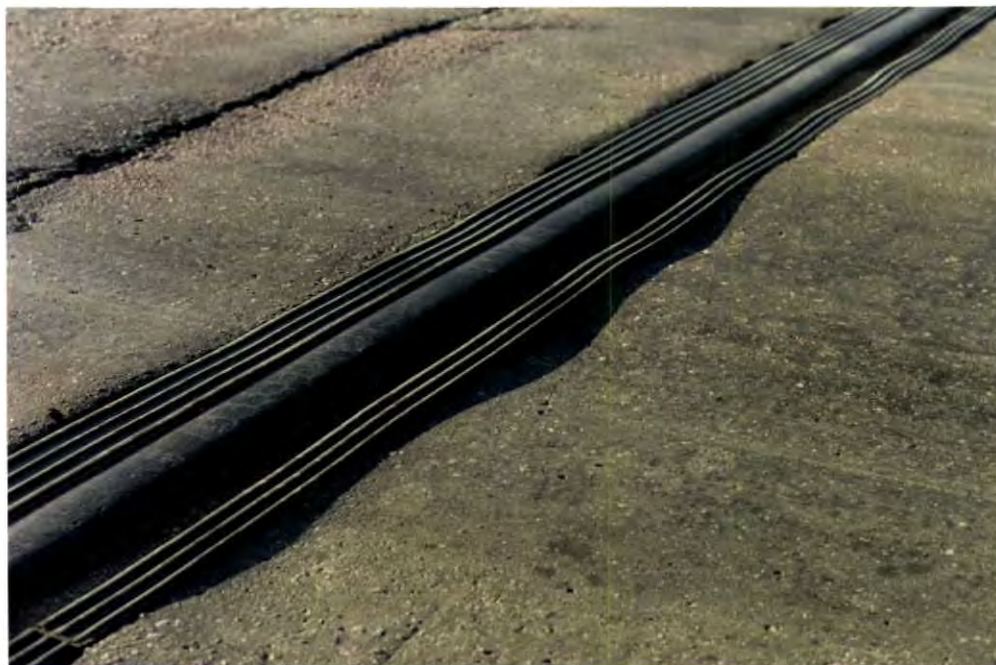
Photo 151. Northville - Rutting between the Rails

The mud rails are not even and are essentially following the surface cross-section of the pavement. In Photo 150 it can be seen that the mud rails generally follow the rutting in the pavement, however, the portion of the pavement between the rails has been rutted to well below the mud rail (See Photo 151). The aprons show evidence of failure (See Photo 152), yet there is very little difference in the elevation of the crossing and the road. The lack of settlement of the crossing in relation to the pavement can be seen in Photo 150, where cracks in the apron are located to the right in the photo. There is no evidence of any track problems on either side of the crossing, neither of water pooling. The spikes on the ties next to the crossing are tight, indicating that the track is deflecting negligibly next to the crossing. There is some gravel in the mud rail although most of the rail is clear.

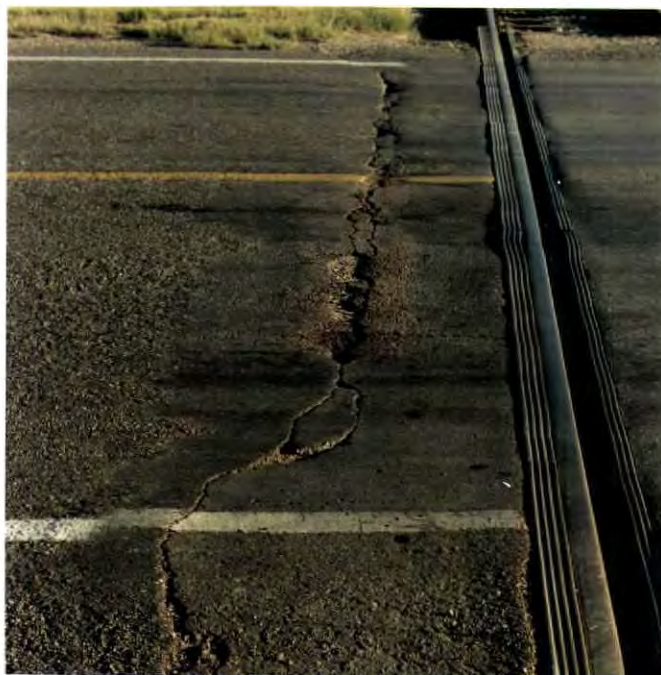
Photo 152. Northville - Cracking of Apron at the End of the Ties

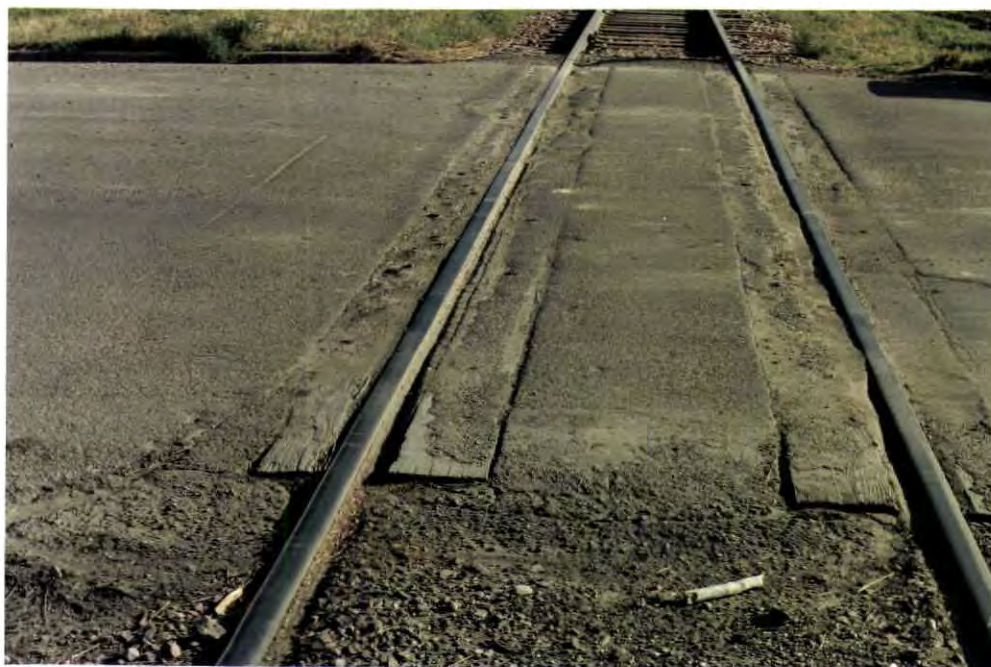
The crossing appears to have been repaired, as the timbers used for headers have been paved over with asphalt, but the asphalt is now spalling off (See Photo 153). The track has settled at least 1 inch in relation to the adjoining street pavement and the timber header/mud rail is tilting towards the rail (See Photo 154). The timbers are getting quite worn (see Photo 155) and the asphalt outside the timber header is failing. The rail is completely mud-filled and is pushing the timbers up on the rail side (See Photo 156). Deflection under rail traffic at the track approach was approximately measured to 1/4 inch and the timbers and rail in the crossing deflected about 1/8 of one inch during rail traffic. Some movement of the timbers could also be seen under heavy motor vehicle traffic.

Photo 153. Aberdeen at 12th Avenue - Asphalt Spalling off Headers

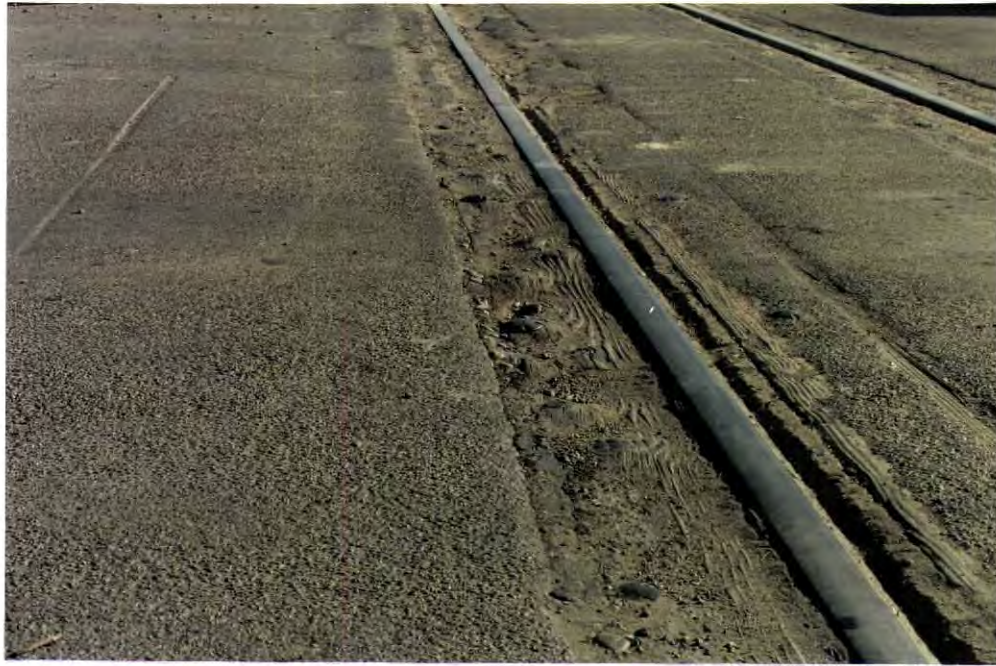
Photo 155. Aberdeen at 12th Avenue - Timber Wear

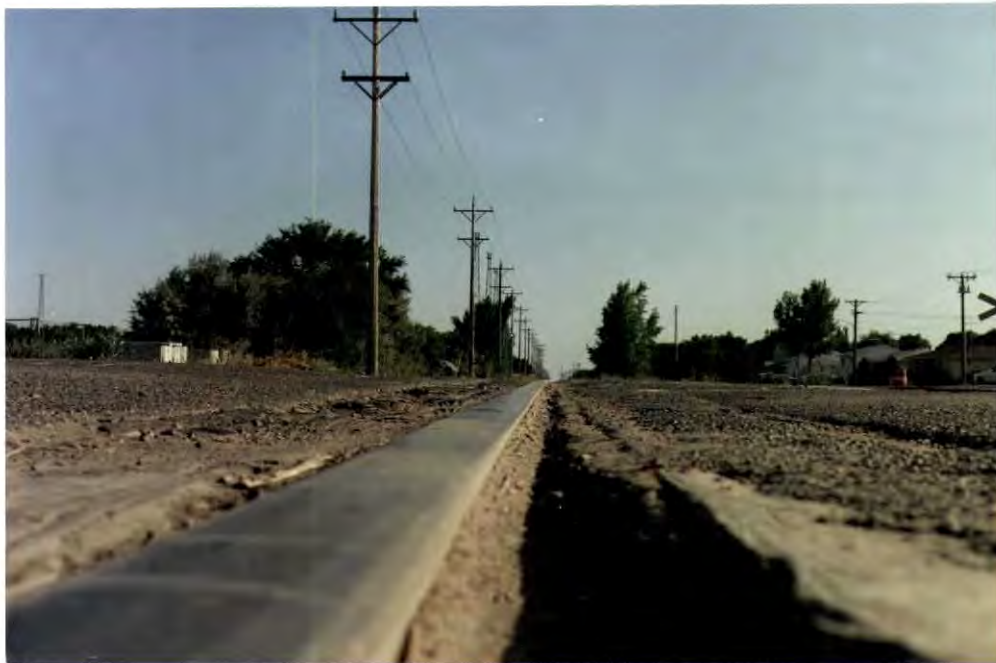
Photo 156. Aberdeen at 12th Avenue - Mud between Rails and Timber

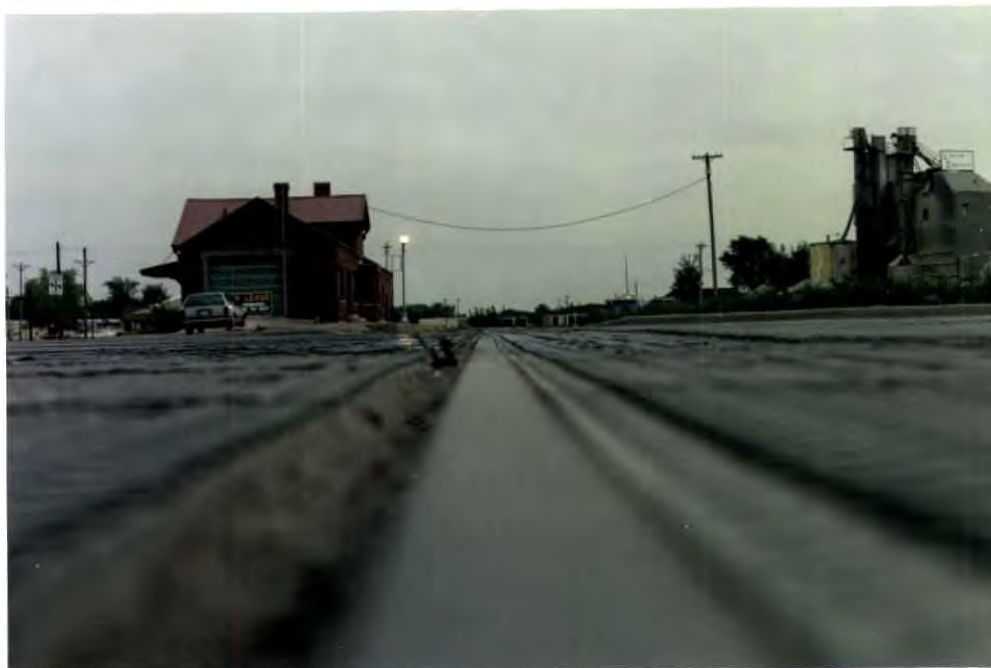
The overall settlement of the crossing in relation to the concrete aprons is less than 1/2 inch (See Photo 157), except for the northwest section where the concrete pavement slab has settled such that it is flush with the rubber panels in the crossing. The center panels appear to be elevated slightly above the rails. The panels also show a slight vertical shifting in relation to each other, as vertical displacement was measured to less than 1/16 of an inch. There is no separation of the panels, at least none that cannot be attributed to installation. The spaces next to the rails are completely mud-filled. There is no sign of wear of the panels from the rail traffic, indicating that there is very little relative movement between the rails and the

Photo 157. Aberdeen at Dakota Street - Crossing Settlement And Center Panels Higher than the Rail

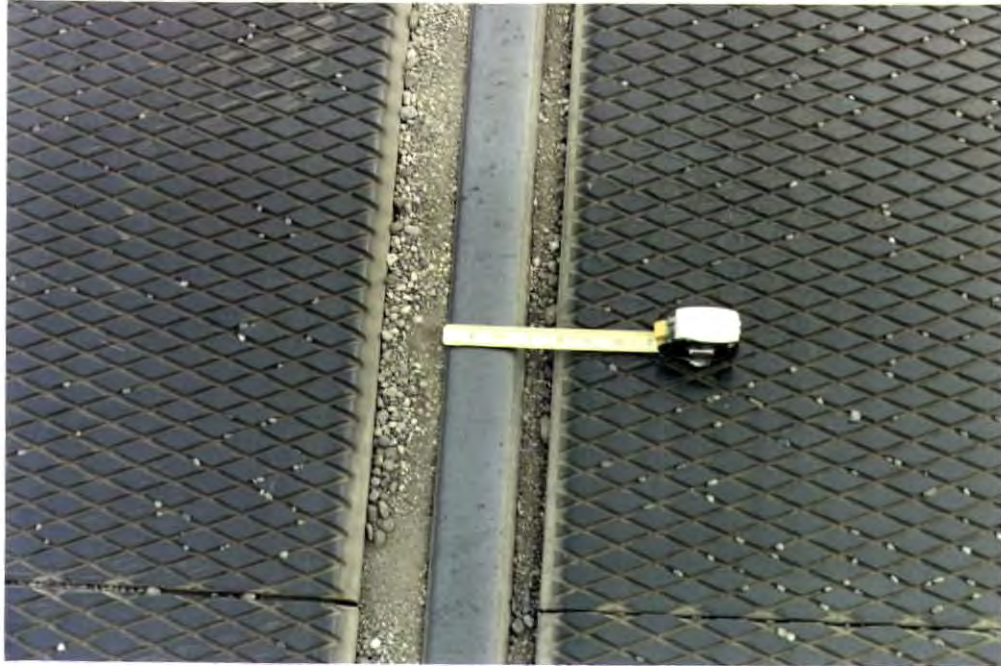
Photo 159. Aberdeen at 8th Avenue - Lateral Displacement of Outer Rubber Panels

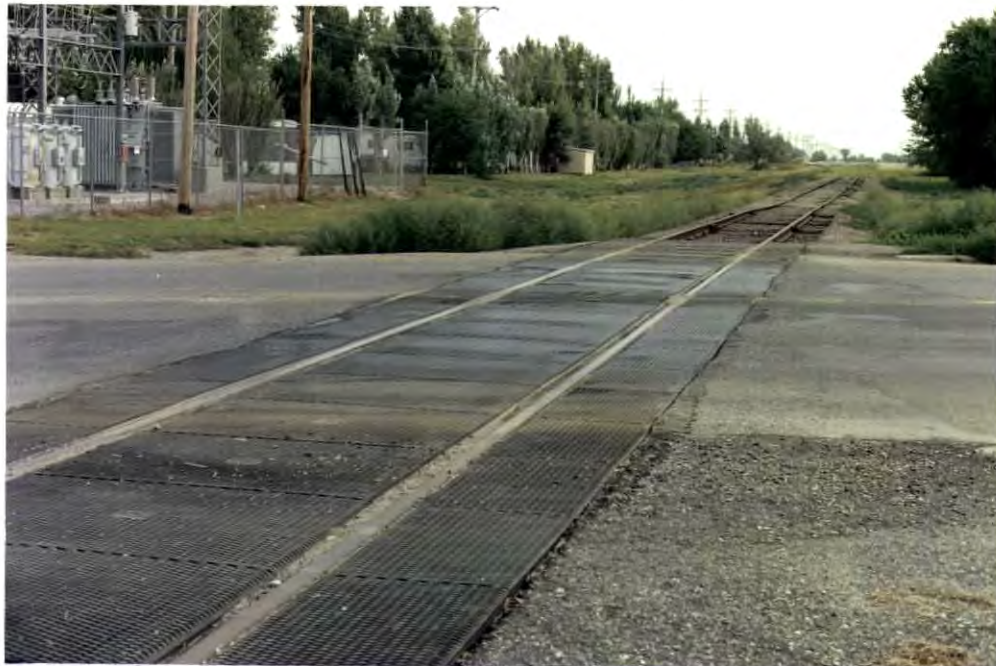
Photo 160. Aberdeen at 8th Avenue - Asphalt Apron Failure at Rubber Panels

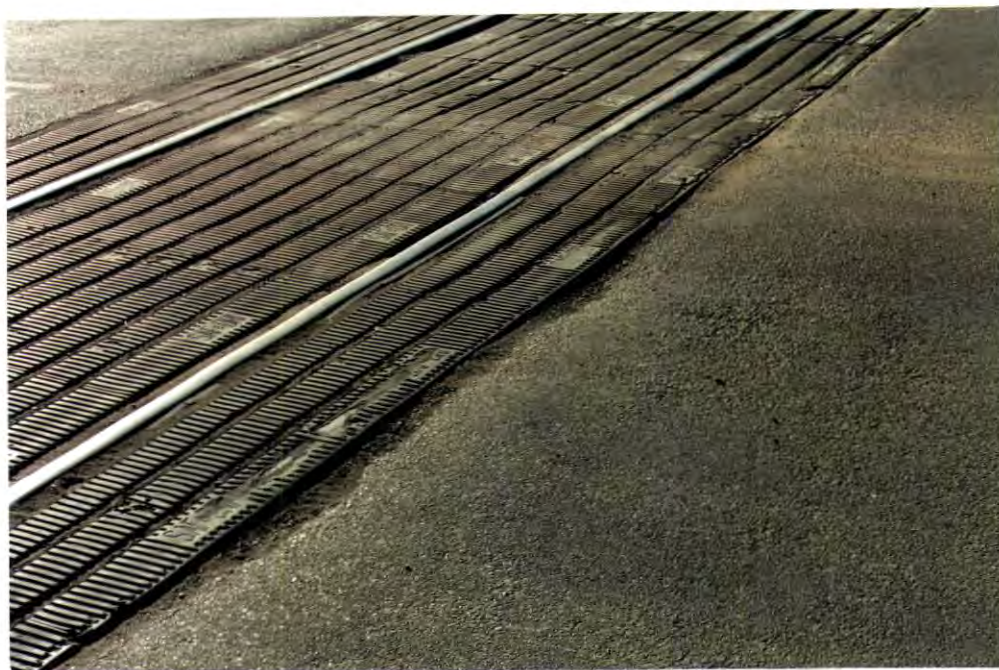
The asphalt approach on the sides of the crossing has settled in excess of 1 inch in relation to the outer panels, although some of the difference in elevation can be attributed to asphalt

Photo 162. US 212 and Highway 281 at Redfield - Asphalt Apron Settlement and Rutting

rutting (See Photo 162). With the coarse grid SAF&DRI crossing it is not possible evaluate track deflections under rail traffic, since there are grooves on both sides of the rail. The rails and the crossing are fairly even but there is some settlement on each side of the crossing. As can be seen in Photo 163 there is considerable panel unevenness and some of the panels are shifted. The spaces between the rails and the inner and outer panels are completely filled with sand. Snow plow damage is local with the most serious damage confined to the outer edges of the outer panels.

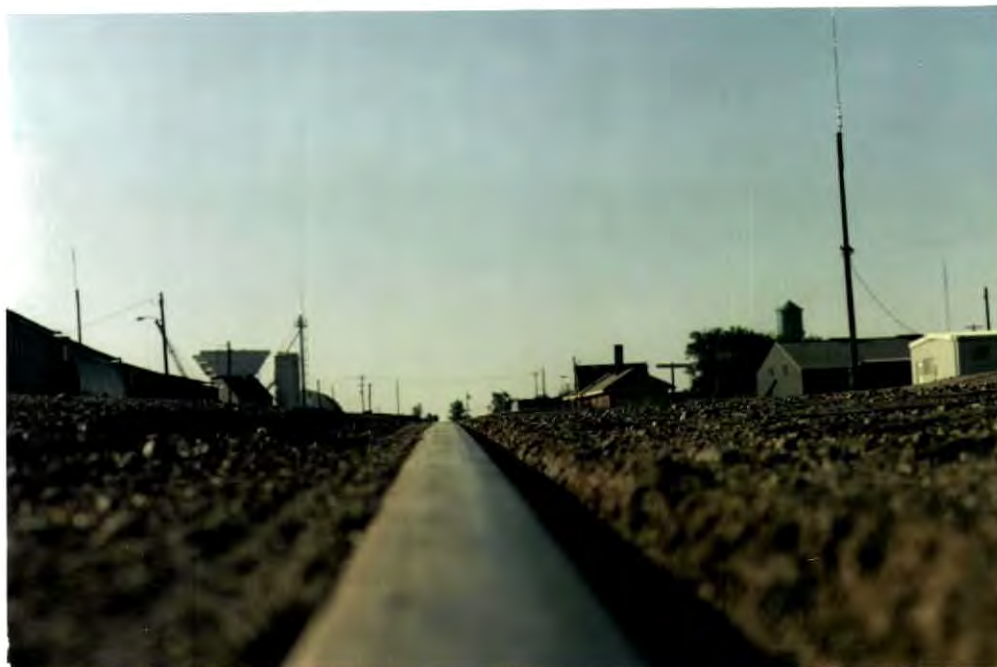
Photo 164. Redfield at 1st Street West - Track and Rail Settlement

The rail has settled up to 2 to 3 inches in relation to the pavement, as can be seen from Photos 164 and 165. The crossing is up to 6 inches higher at the center than the track at the ends. The track is also very uneven, with settlements relative to the pavement varying considerably along the crossing. Evidence of track deflections under train loads can also be seen, as there are scars in the asphalt on the outside of the rails from the railroad cars (See Photo 166). The asphalt is broken up on the aprons and the aprons have settled considerably towards the rails at most locations. The spaces between the mud rails and the main rail are completely filled with soil, yet there is very little difference in elevation between the main rail and the mud rails. There is no evidence of ballast on either side of the crossing for a distance of at least 30 feet.

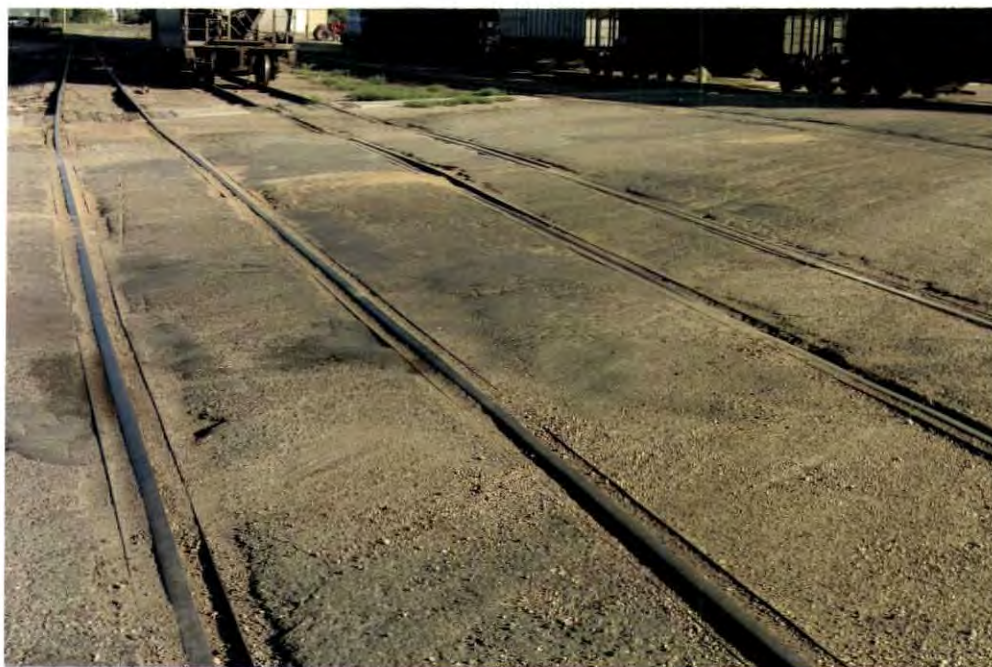
Photo 165. Redfield at 1st Street West - Overall View of Track Settlement and Crossing Condition

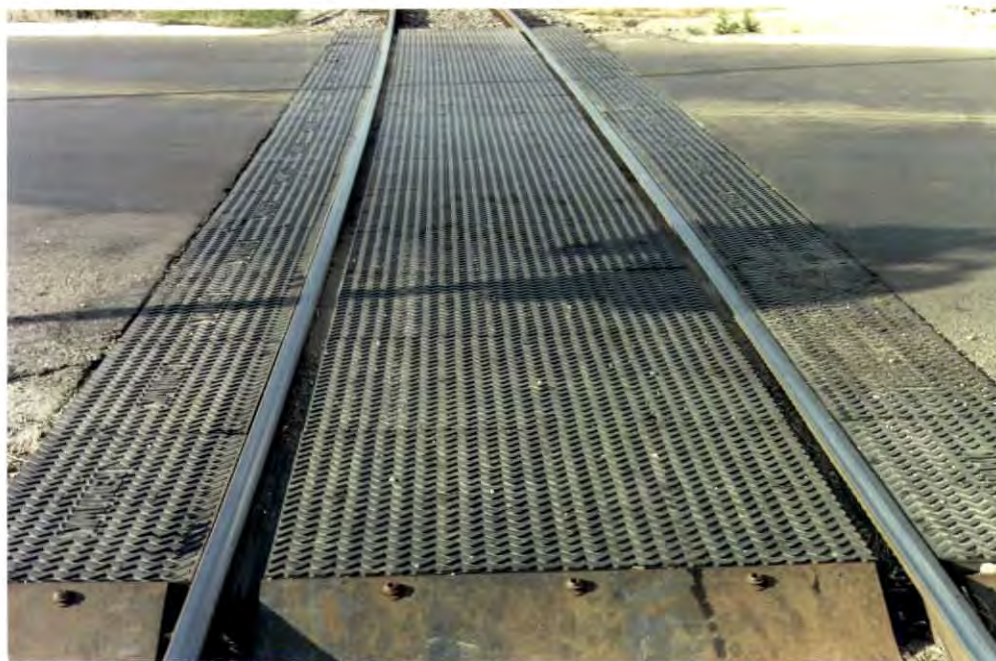
There is no evidence of track deflection under rail traffic, as there are no visible signs of wear on the outside panels next to the rails (See Photo 167). Rail deflections at the ends of the crossing ranged from 1/16 to 1/32 of an inch. The overall settlement of the crossing in relation to the asphalt pavement is up to 1/2 inch on the east side of the crossing and 3/4 inch on the west side, with most of the differential movement in the south (eastbound) lane. Panel separation laterally is up to 1/4 inch and the space between the panels is filled with fine sand. Vertical shifting of the panels is minor and may all be contributed to installation (See Photo 168). The asphalt contact between the rubber panels is good, however, minor breakage can be seen at some locations, especially at the east side of the

Photo 167. Watertown at First Street West - Settlement and Overall Condition

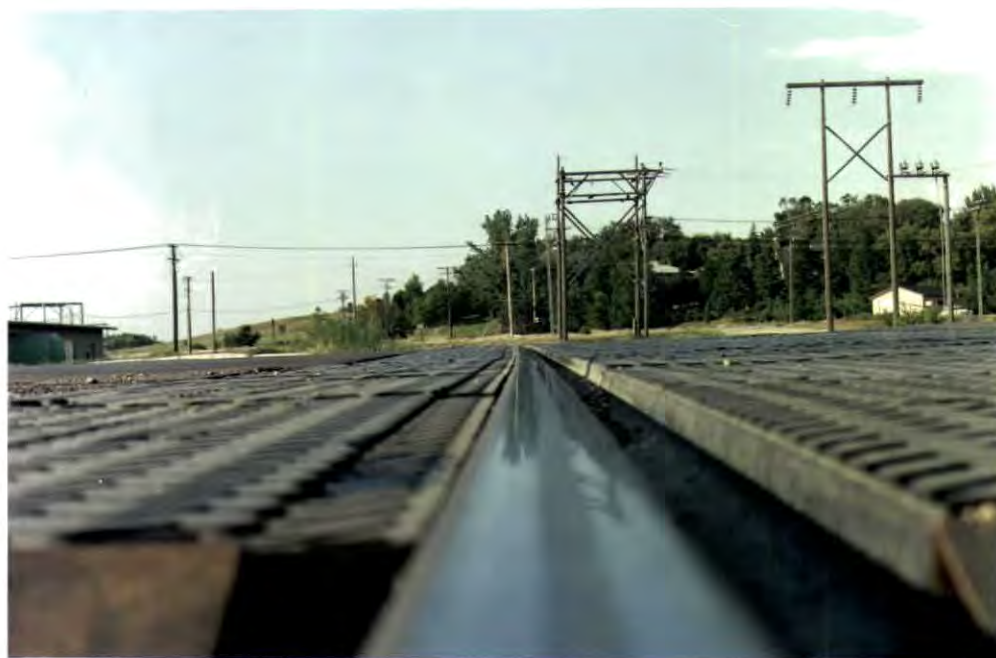
Photo 168. Watertown at First Street West - Minor Vertical Shifting of Panels

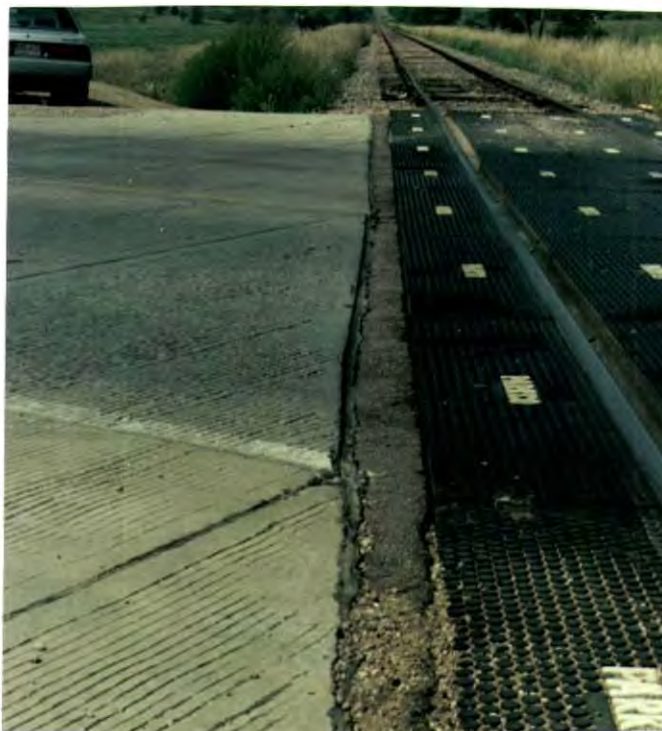
The settlement of the crossing in relation to the concrete pavement is less than 1/2 inch. There is little wear on the rubber panels along the rails, hence track deflection under rail traffic appears to be minor. The headers are failed and appear to have been patched and repaired several times (See Photo 170). Lateral panel separation is less than 1/4 inch and vertical

Photo 170. Highway 38A Northwest of Airport - Failed and Patched Headers

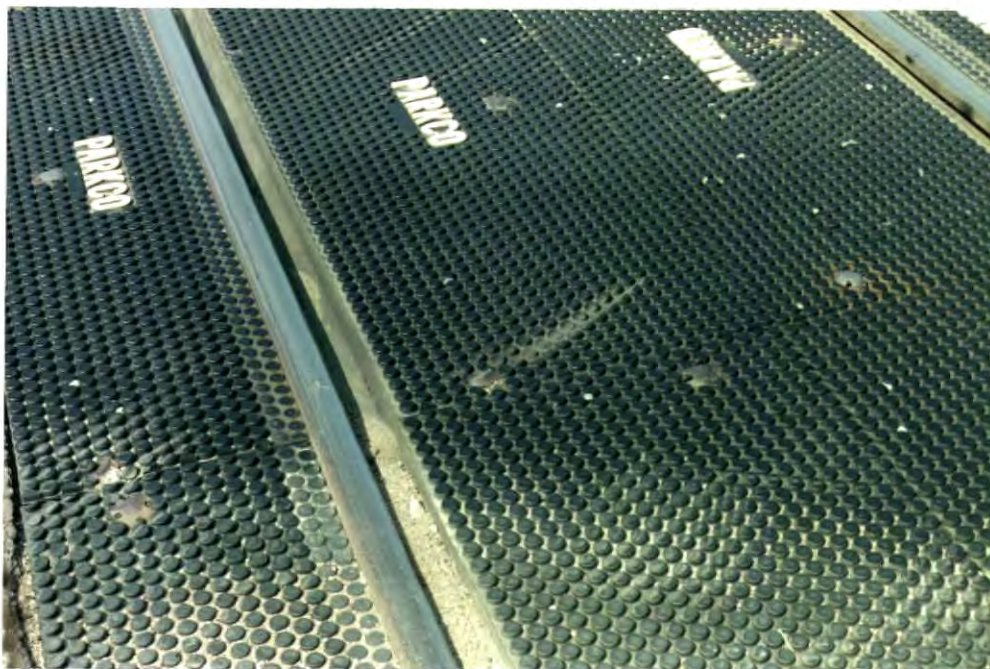
Photo 171. Highway 38A Northwest of Airport - Minor Scarring from Snow Plows

offset between the panels is insignificant. The spaces between the rails and the center panels contain some debris but no hard-packed soil. Snow plow damage is minor and is confined to minor scarring (See Photo 171).

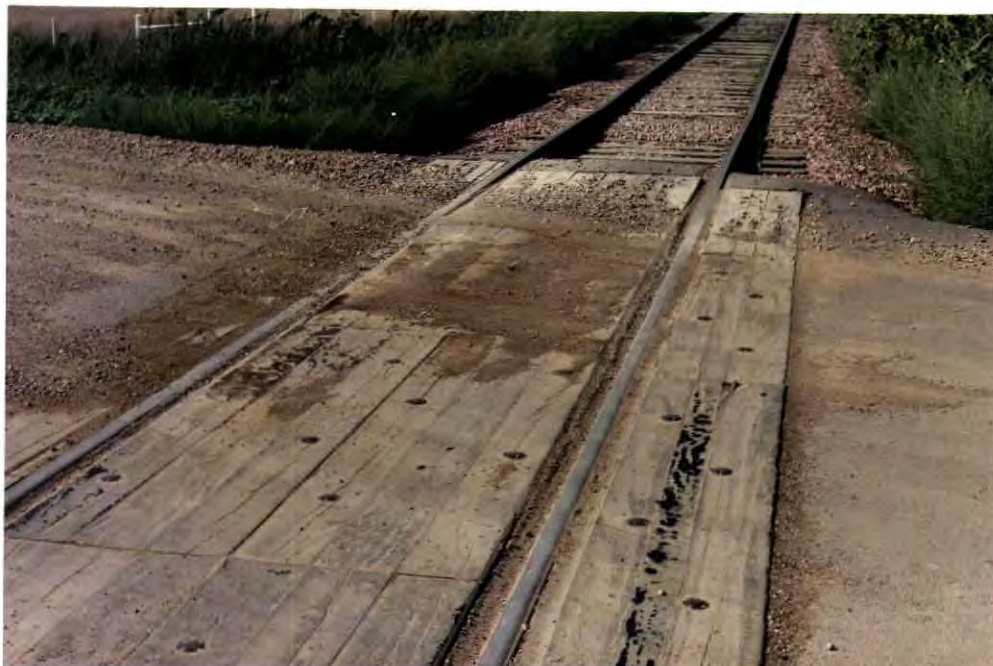
The crossing is on the sloping portion of a hill. On the uphill portion of the crossing the outer timber panels are approximately 3/4 inch lower than the asphalt header, however, the gap is filled with gravel (See Photo 172). On the downhill side of the crossing the pavement is from 1/2 to 3/4 of an inch below the outer timber panels. Thus, overall movement of the crossing

Photo 172. 1/2 Mile East of Minnehaha County 131 - Crossing and Apron Vertical Movements

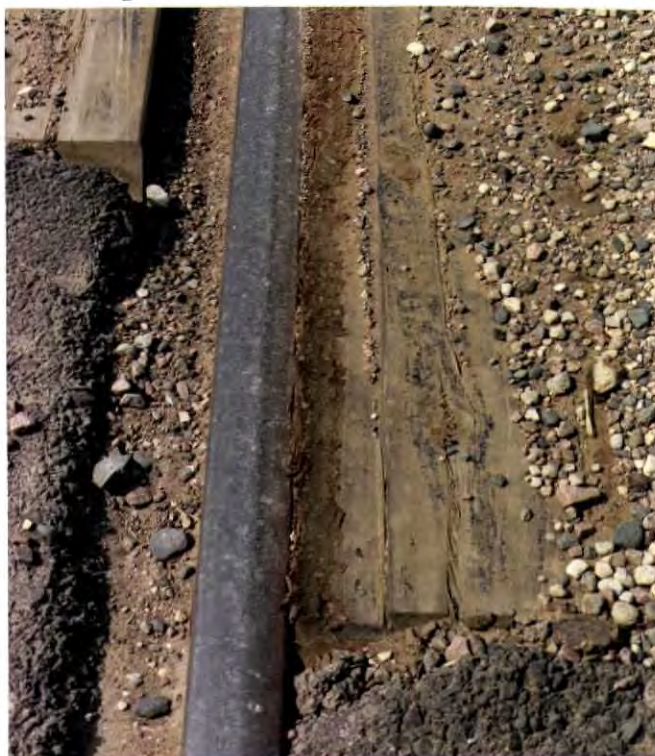
Photo 173. 1/2 Mile East of Minnehaha County 131 - Frayed Timber Panels

relative to the road is difficult to estimate. There is evidence of rail deflections at the approaches to the crossing, as the timber panels have become frayed from the rail traffic (See Photo 173). The timber panels are in good shape although some snow plow damage has occurred (See Photo 174). The track is completely filled with fine sand and silt and some of the inner timber panels adjacent to the rails appear to be slightly higher than the rails and the outer timber panels. This can be seen on in the upper portion of Photo 175.

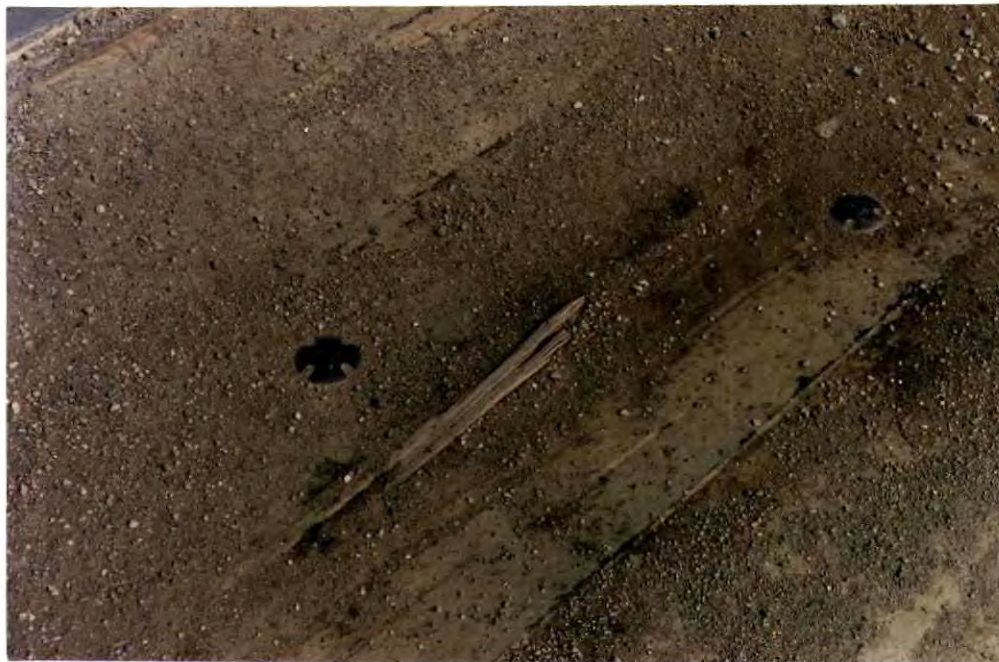
Photo 174. 1/2 Mile East of Minnehaha County 131 - Snow Plow Damage

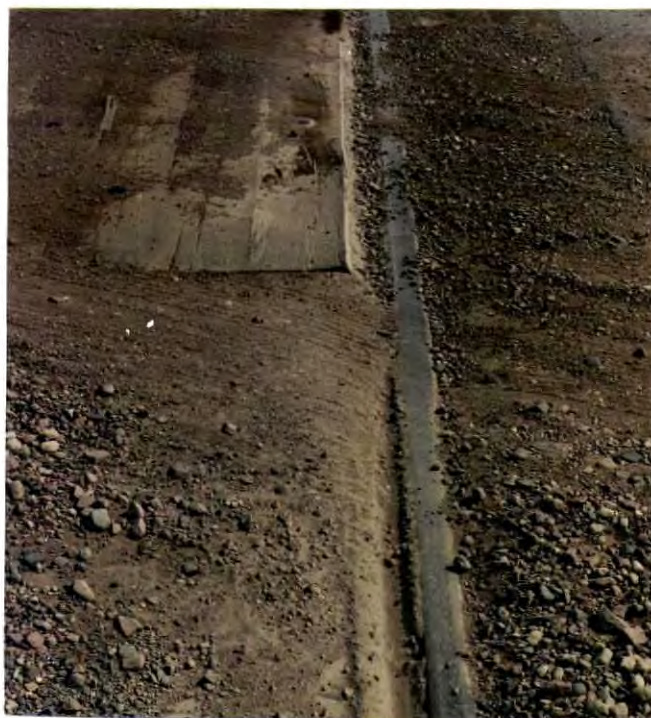
Photo 175. 1/2 Mile East of Minnehaha County 131 - Uneven Timber Panels
