"MAILBOX BRACKET CRASH TESTS"

INTERIM REPORT

RESEARCH STUDY 7-1945

Hayes E. Ross, Jr., P.E.
Study Supervisor
Texas Transportation Institute

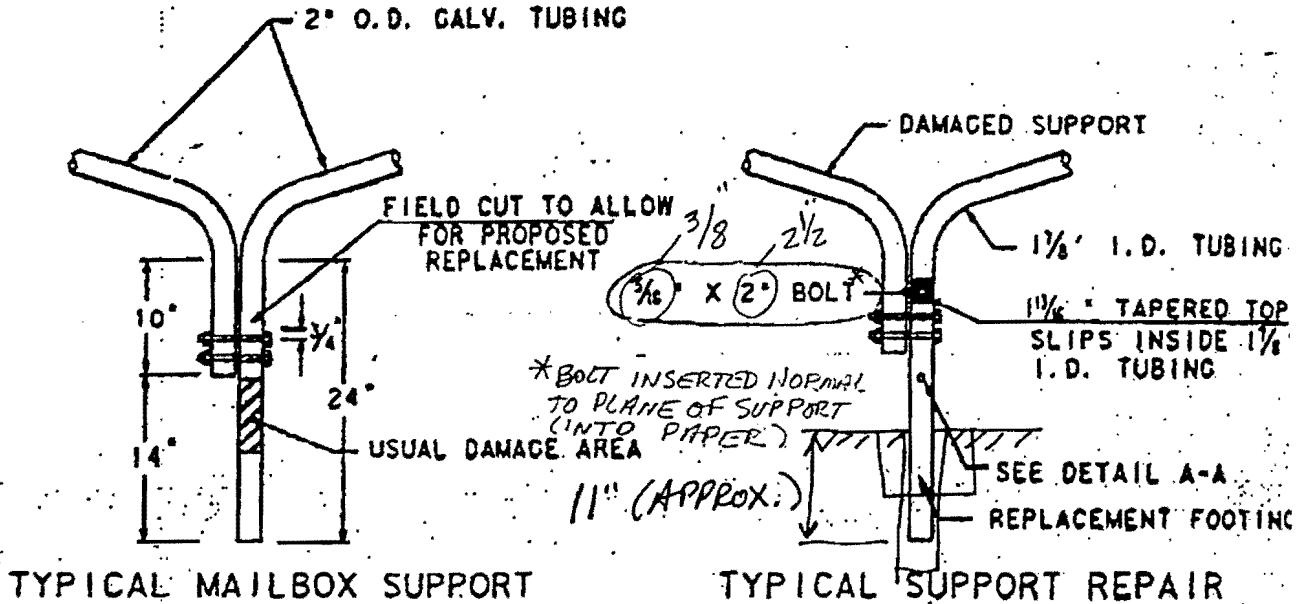
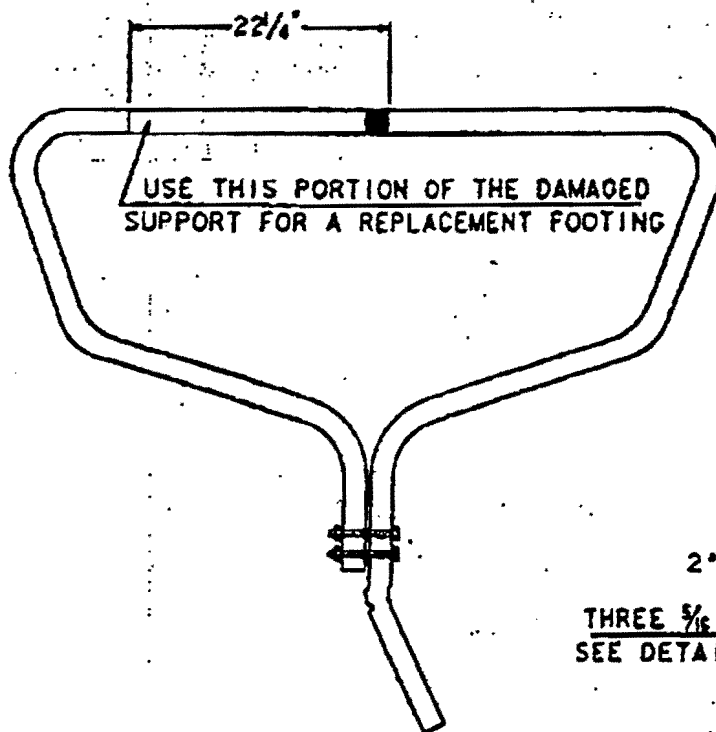
MULTIPLE MAIL BOX SUPPORT REPAIR

TEST NO. 9
 (TEST ARTICLE SAME AS TEST NO. 8 EXCEPT AS SHOWN BELOW)

THREE 5/16" HOLES DRILLED & COUNTERSUNK 2/8" APART

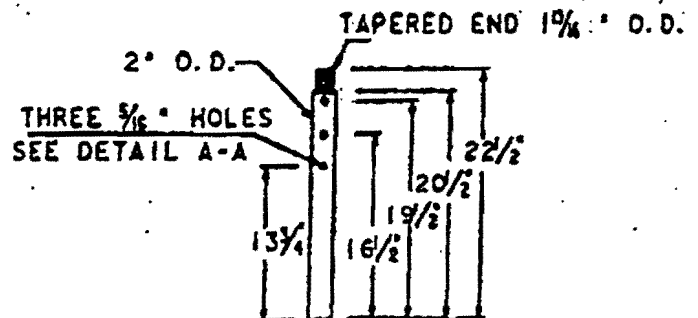
DAMAGED SUPPORT

Upon impact, the support structure deformed, was pulled from the ground socket, and subsequently the upstream mailbox on the support impacted and dished the windshield. Penetration of the windshield did not occur. Two items were identified as probable causes of the differences in behavior of the installation in this test with the two previous tests. First, and likely the dominate reason, the replacement footing in test 1945-9 was inserted approximately 11 inches into the ground socket, whereas the support in tests 1945-7 and -8 were inserted approximately 9 inches. In all three tests the insertion depth was controlled by the 42 inch dimension from the top of the horizontal member of the support structure to the ground. It is believed that the added insertion depth of the replacement footing in test 1945-9 increased the force needed to pull the footing from the socket, which resulted in further deformation of the support structure by the vehicle, and hence contact of the mailbox with the windshield. Secondly, the horizontal distance from the front bumper to the lower edge of the windshield of the vehicle used in test 1945-9 was approximately 2 inches less than the vehicles used in tests 1945-7 and -8.

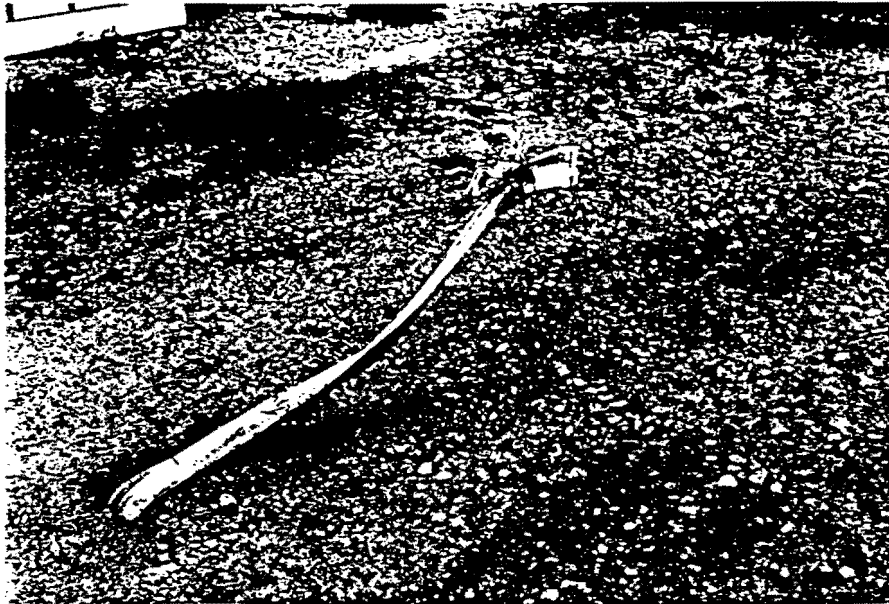
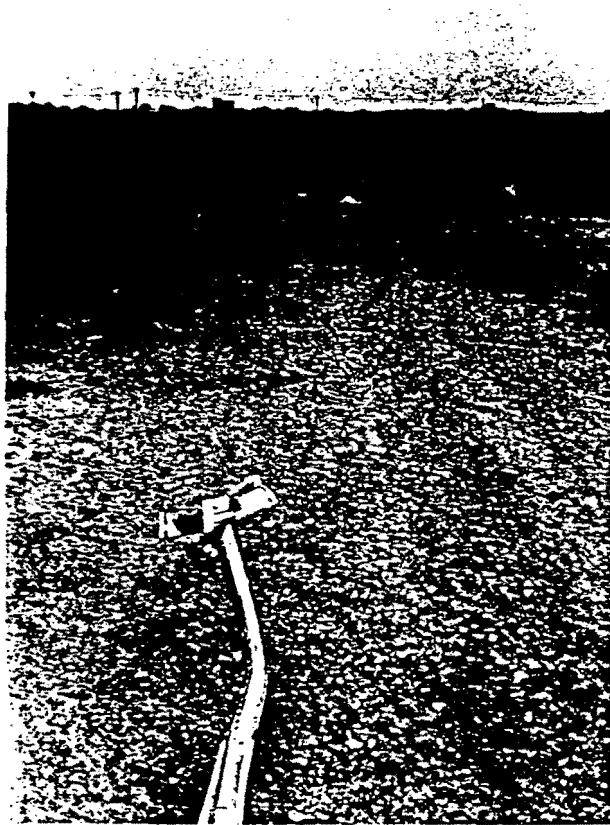
Figure . Test site after test 19452-1.

The installation yielded to the vehicle. The support was displaced over at ground level. The mailbox attachment bracket remained attached to the support. The mailbox components came to rest approximately 72.5 feet (22.1 m) from the point of impact. The vehicle sustained only minor damage to the bumper and hood as shown in Figure ***.

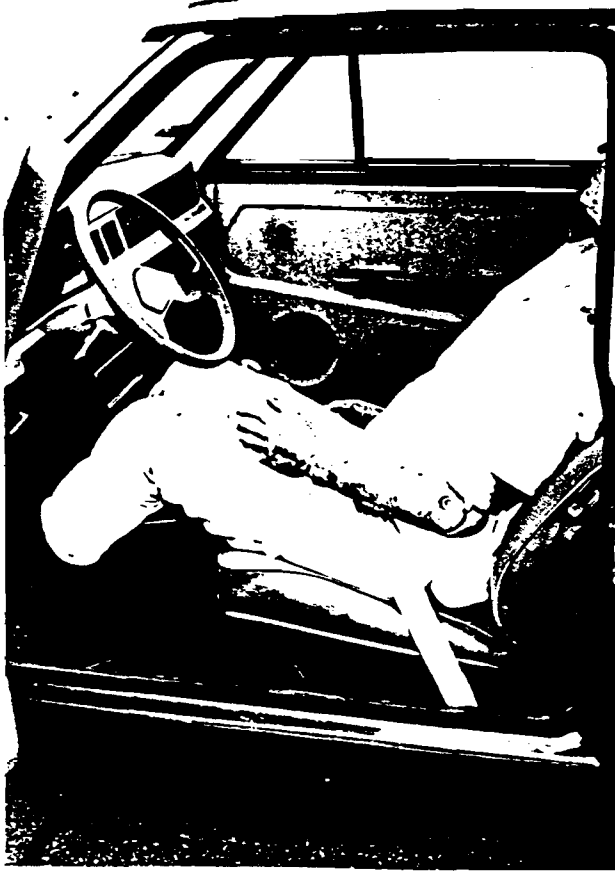
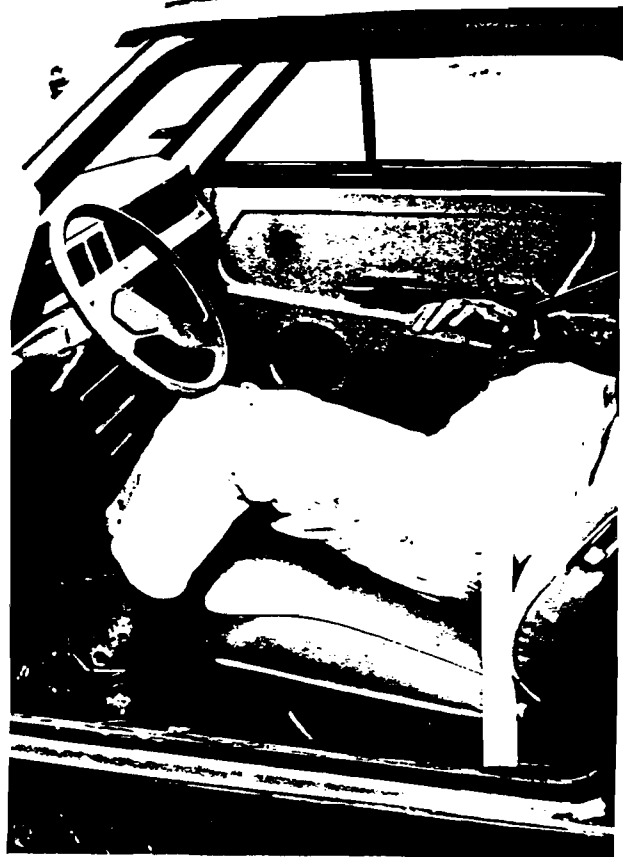
Figure . Anthropometric dummy before and after test 19452-1.

sustained minor damage and did not present undue hazard to other traffic. There was no deformation or penetration into the occupant compartment. There was no occupant contact in the longitudinal or lateral directions. This installation in "strong soil" is acceptable according to the evaluation criteria recommended in NCHRP Report 230.

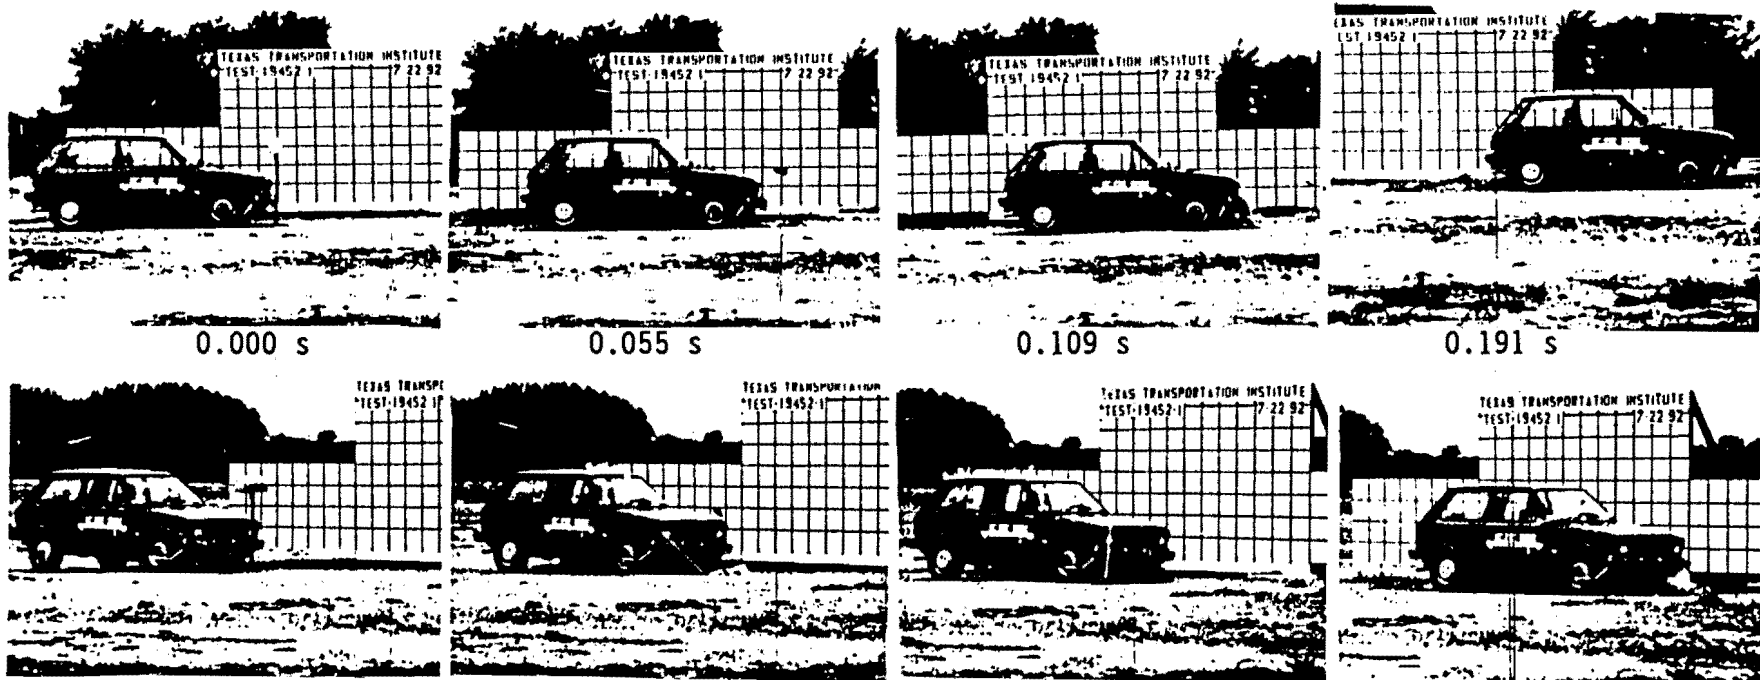
Figure . Summary of results for test 19452-1.

Test No	19452-1.	Impact Speed	58.7 mi/h (94.4 km/h)
Date	07/22/92.	Change in Velocity . . .	1.4 mi/h (2.3 km/h)
Test Article	Single mount, Type 1 Mailbox Installation.	Change in Momentum . . .	114.8 lb-s
Support	Type 4 (2 lb/ft winged channel post)	Vehicle Accelerations (Max. 0.050-sec Avg)	
Embedment	2'-0" driven(strong soil)	Longitudinal . . .	-1.3 g
Vehicle	1988 Yugo GV	Lateral	0.4 g
Vehicle Weight		Occupant Impact Velocity	
Test Inertia	1800 lb (816 kg)	Longitudinal . . .	N/A
Gross Static	1968 lb (893 kg)	Lateral	N/A
Vehicle Damage Classification		Occupant Ridedown Accelerations	
TAD	12-FL-1	Longitudinal . . .	No contact
SAE	12FLEN1	Lateral	No contact

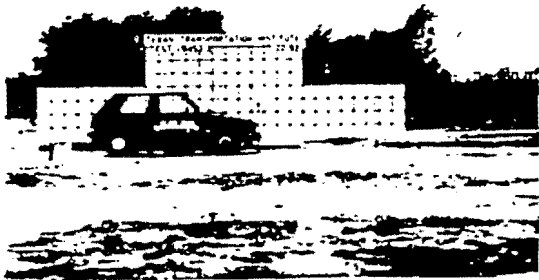
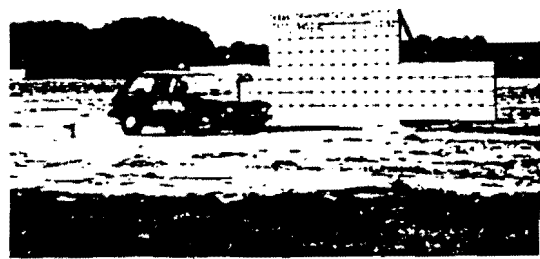
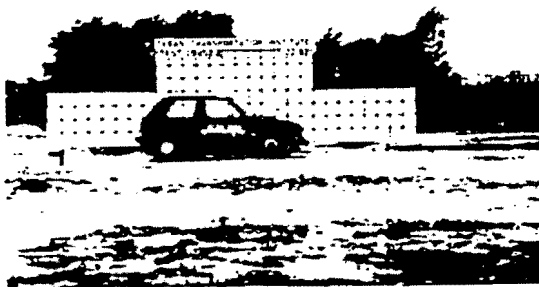
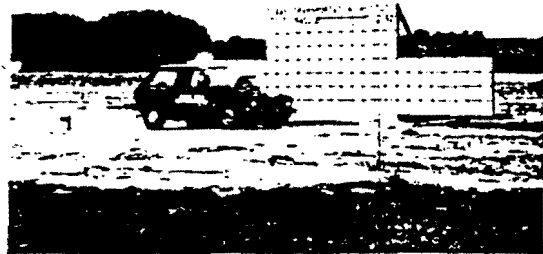
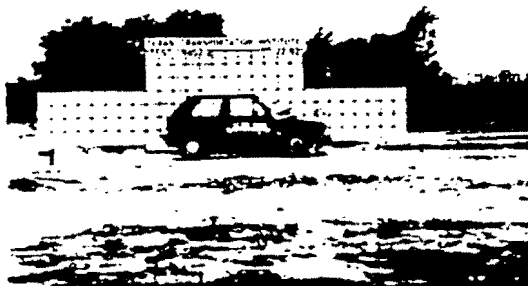
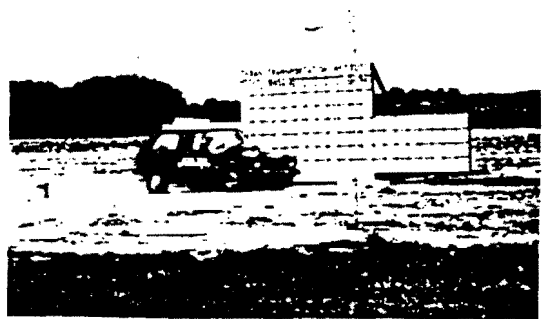
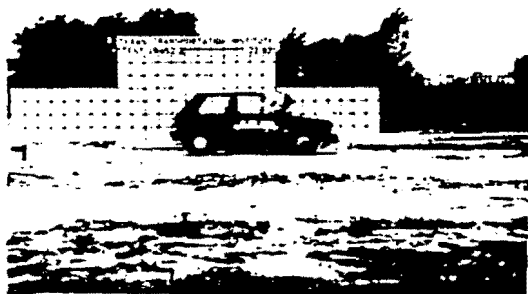
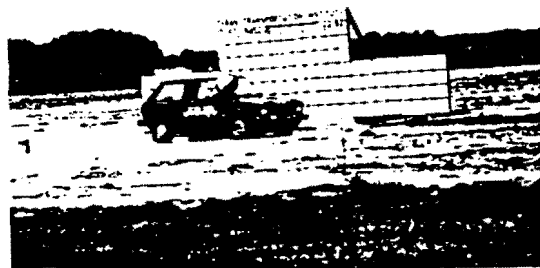
Figure . Sequential photographs for test 19452-2.
(perpendicular and side views)

The installation yielded to the vehicle. The support was displaced over at ground level. The mailbox attachment bracket detached from the support and came to rest approximately 153.0 feet (46.6 m) from the point of impact. In addition, the mailbox components came to rest approximately 101.3 feet (30.9 m) from the point of impact. The vehicle sustained only minor damage to the bumper, hood and windshield as shown in Figure ***.

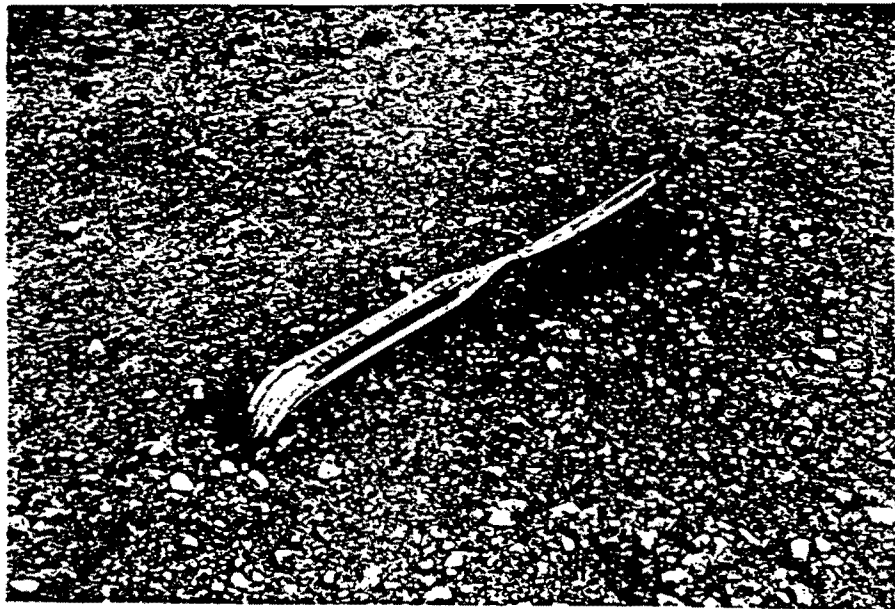
Figure . Test site after test 19452-2.

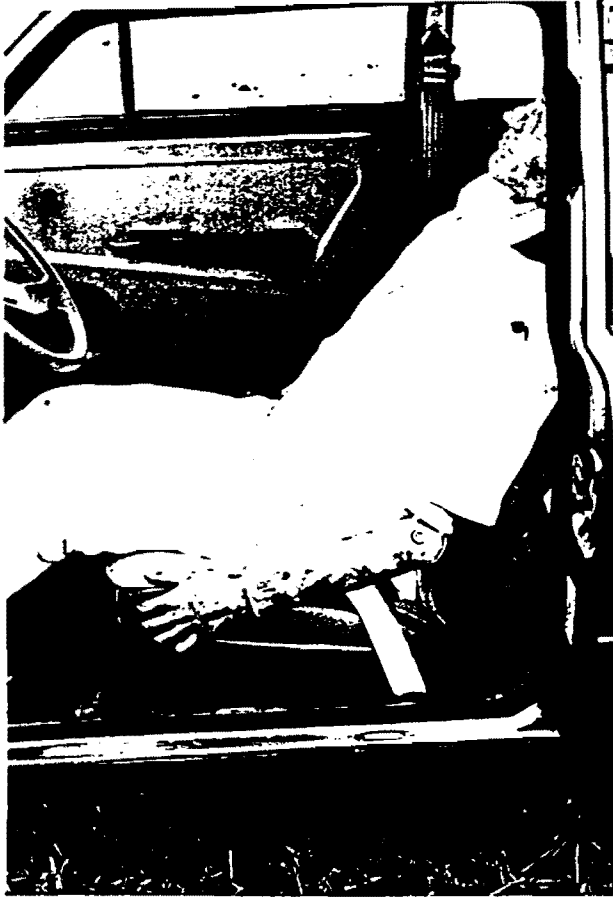
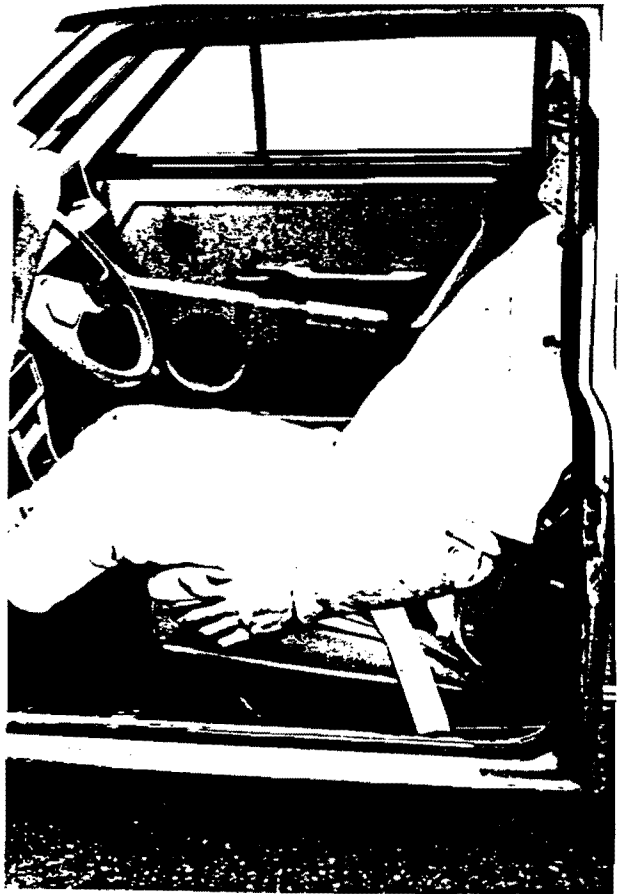
Figure . Anthropometric dummy before and after test 19452-2.

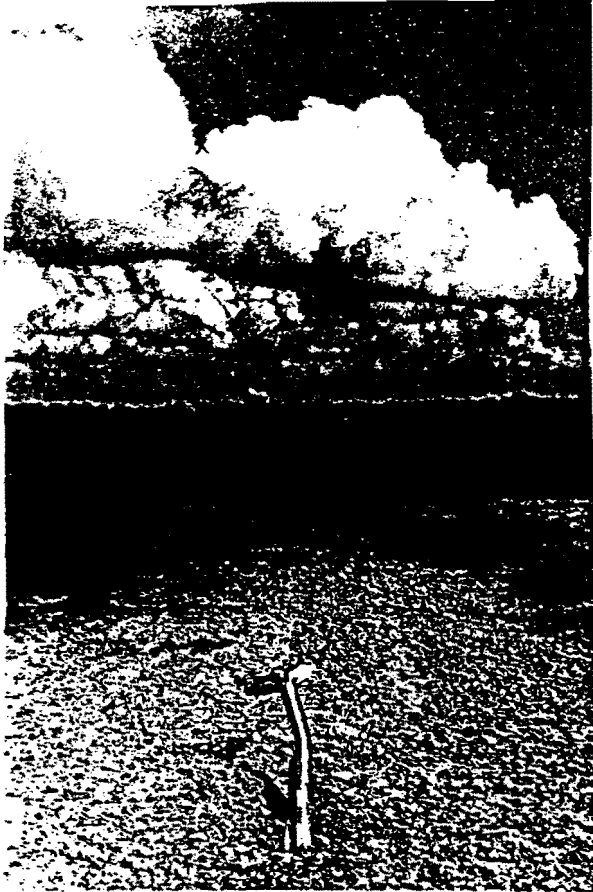
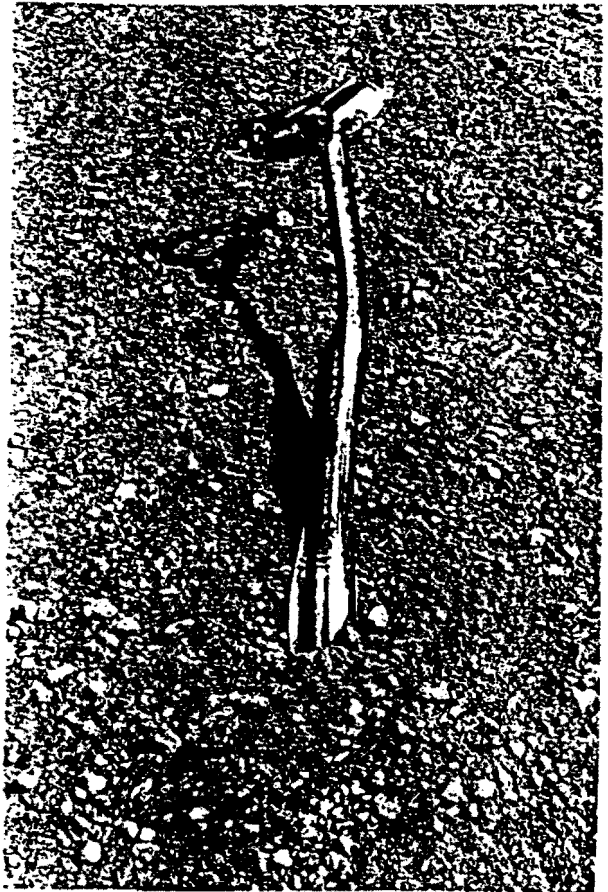
The installation yielded to the vehicle. The support was displaced over at ground level. The mailbox attachment bracket remained attached to the support. The mailbox components came to rest approximately 96.3 feet (29.3 m) from the point of impact. The vehicle sustained only minor damage to the bumper, hood and windshield as shown in Figure ***.

Figure . Test site after test 19452-3.

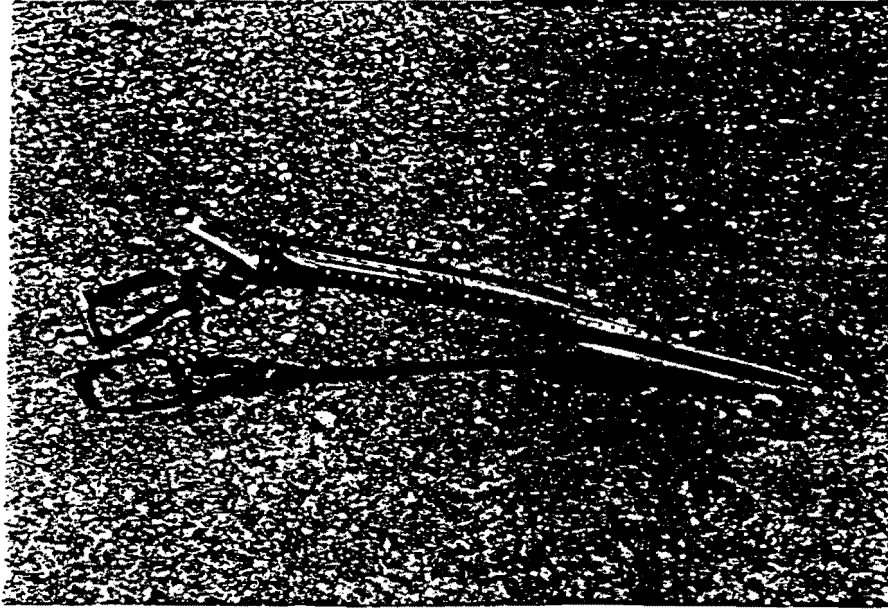
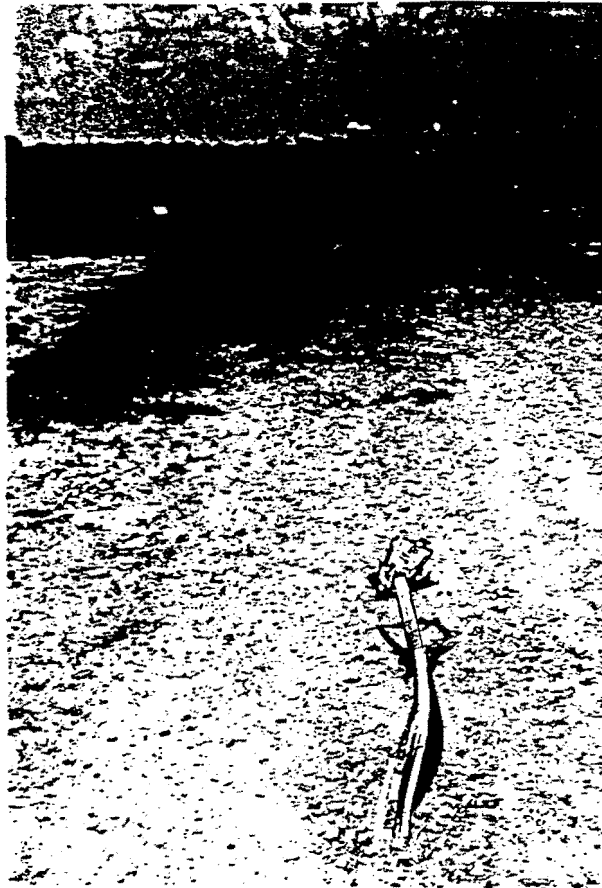
Figure . Test site after test 19452-4.

The installation yielded to the vehicle. The support was displaced over at ground level. The mailbox body came to rest approximately 90.0 feet (27.4 m) from the point of impact. The vehicle sustained only minor damage to the bumper and hood as shown in Figure ***.

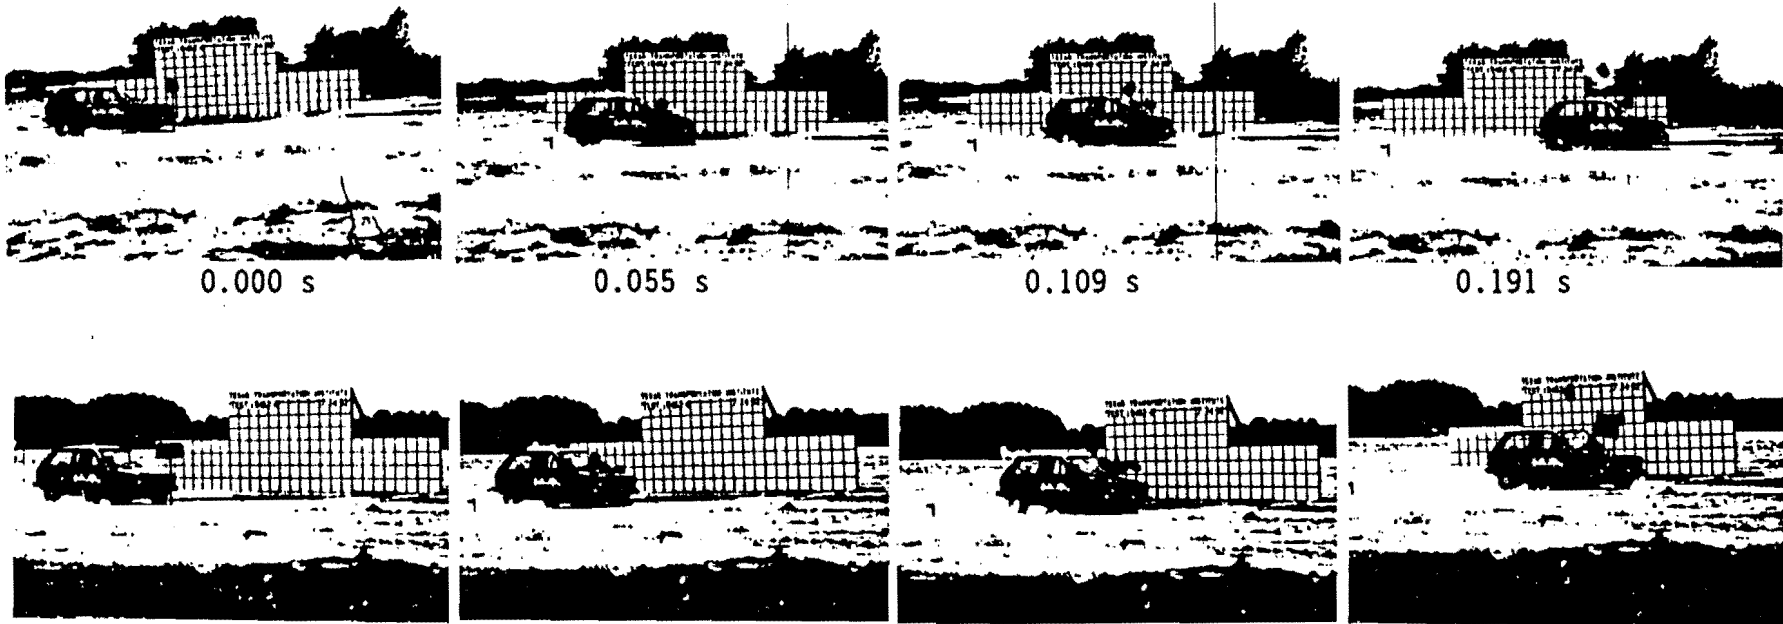
Figure . Summary of results for test 19452-4.

A summary of the test results and other information pertinent to this test are given in Figure ***. The maximum 0.050 second average acceleration experienced by the vehicle was -1.5 g in the longitudinal direction and 0.4 g in the lateral direction. No occupant contact occurred in the longitudinal or lateral direction. Vehicle angular displacements are plotted in Figure *** and vehicle accelerometer traces are displayed in Figures *** through ***. Change in vehicle velocity was 1.5 mi/h (2.3 km/h) and change in momentum was 123.0 lb-s.

Test No	19452-4.	Impact Speed	61.2 mi/h (98.4 km/h)
Date	07/24/92.	Change in Velocity . . .	1.5 mi/h (2.3 km/h)
Test Article	Double mount, Type 1 1/2	Change in Momentum . . .	123.0 lb-s
	Mailbox Installation.		
Support	Type 4 (2 lb/ft winged	Vehicle Accelerations	
	channel post)	(Max. 0.050-sec Avg)	
Embedment	2'-0" driven(strong soil)	Longitudinal . . .	-1.5 g
Vehicle	1987 Yugo GV	Lateral	0.4 g
Vehicle Weight		Occupant Impact Velocity	
Test Inertia	1800 lb (816 kg)	Longitudinal . . .	N/A
Gross Static	1968 lb (893 kg)	Lateral	N/A
Vehicle Damage Classification		Occupant Ridedown Accelerations	
TAD	12-FL-1	Longitudinal . . .	No contact
SAE	12FLENI	Lateral	No contact

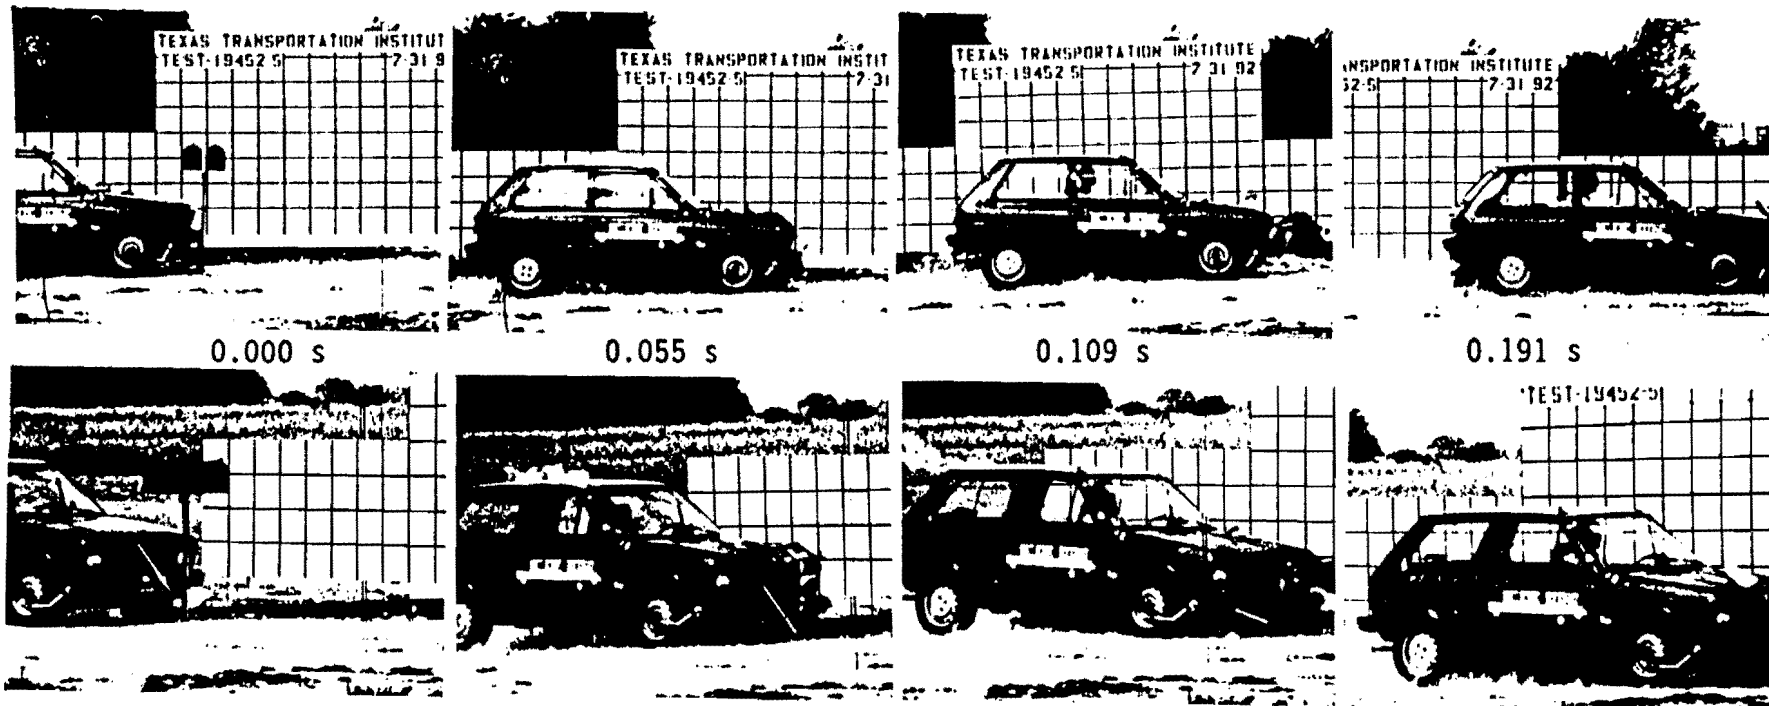
Figure . Summary of results for test 19452-5.

Test No19452-5.	Impact Speed.	62.4 mi/h (100.4 km/h)
Date07/31/92.	Change in Velocity. . .	4.7 mi/h (7.6 km/h)
Test Article	Double mount, Type 1 1/2 Mailbox Installation.	Change in Momentum. . .	385.3 lb-s
Support	Type 4 (2 lb/ft winged channel post)	Vehicle Accelerations (Max. 0.050-sec Avg)	
Embedment.	2'-0" driven(strong soil)	Longitudinal. . .	-2.7 g
Vehicle	1988 Yugo GV	Lateral	0.7 g
Vehicle Weight		Occupant Impact Velocity	
Test Inertia	1800 lb (816 kg)	Longitudinal. . .	N/A
Gross Static	1968 lb (893 kg)	Lateral	N/A
Vehicle Damage Classification		Occupant Ridedown Accelerations	
TAD	12-FL-1	Longitudinal. . .	No contact
SAE	12FLEN1	Lateral	No contact

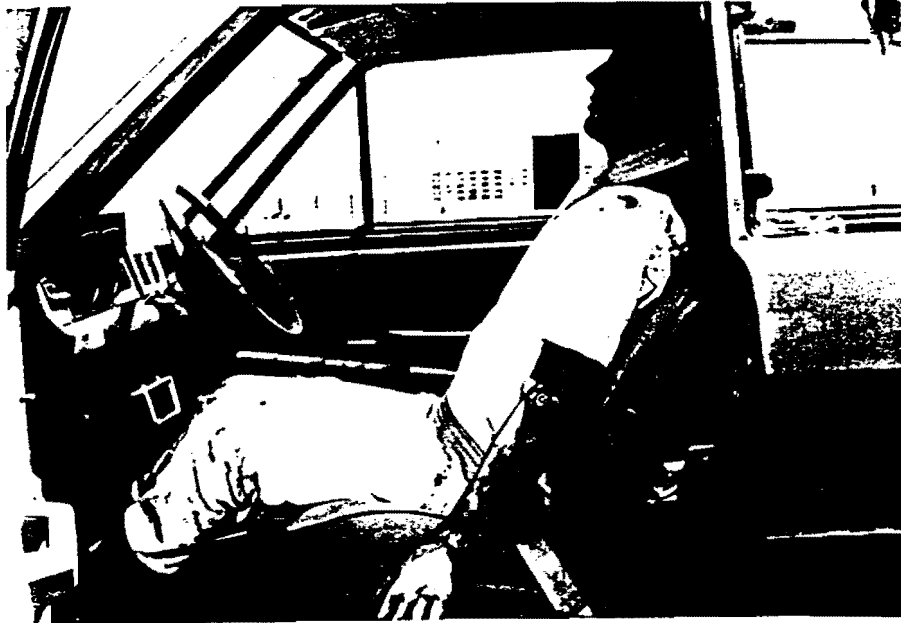
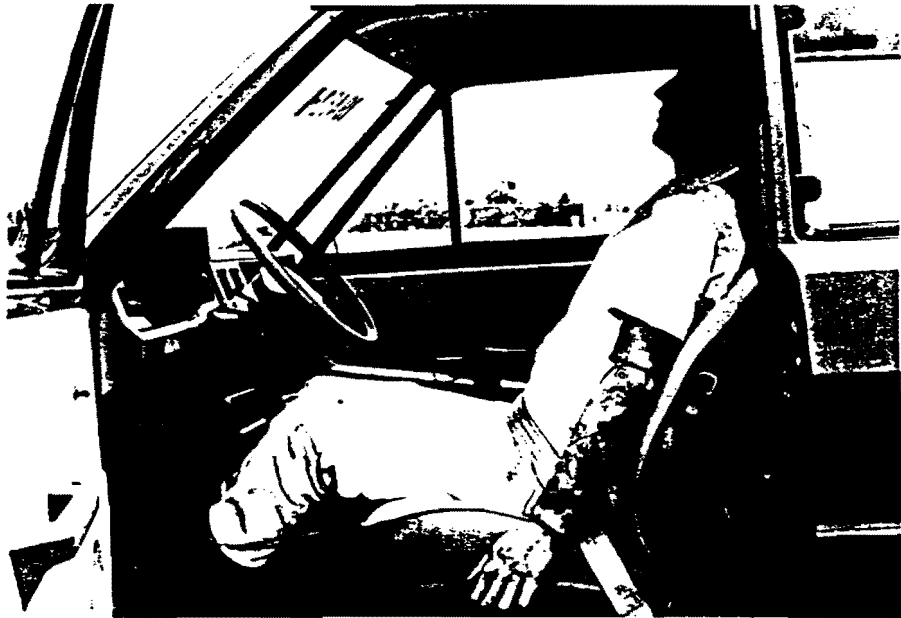
Figure 1 : Anthropometric dummy before and after test 19452-6.

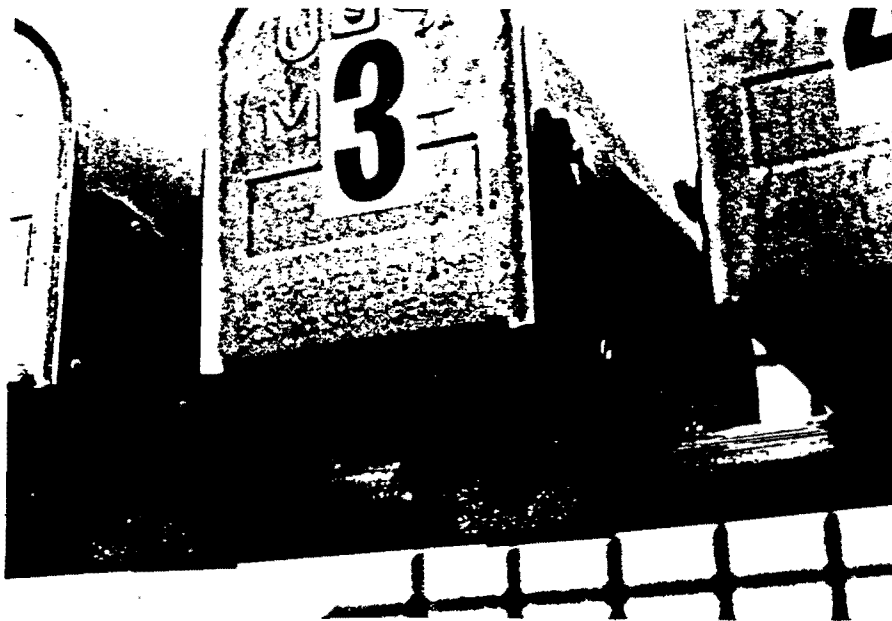
Figure . Mailbox/support connection for installation used in test 19452-7.

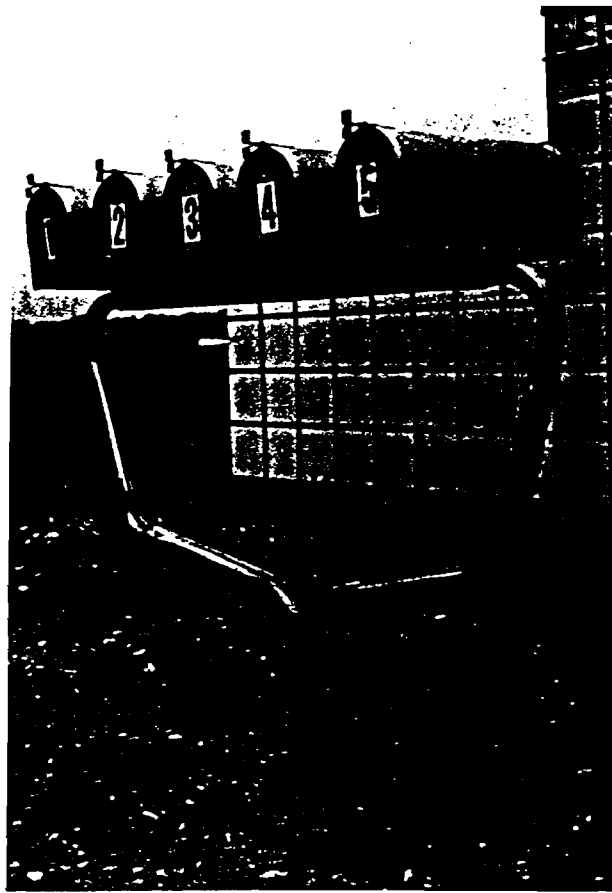
Figure . Mailbox installation before test 19452-7.

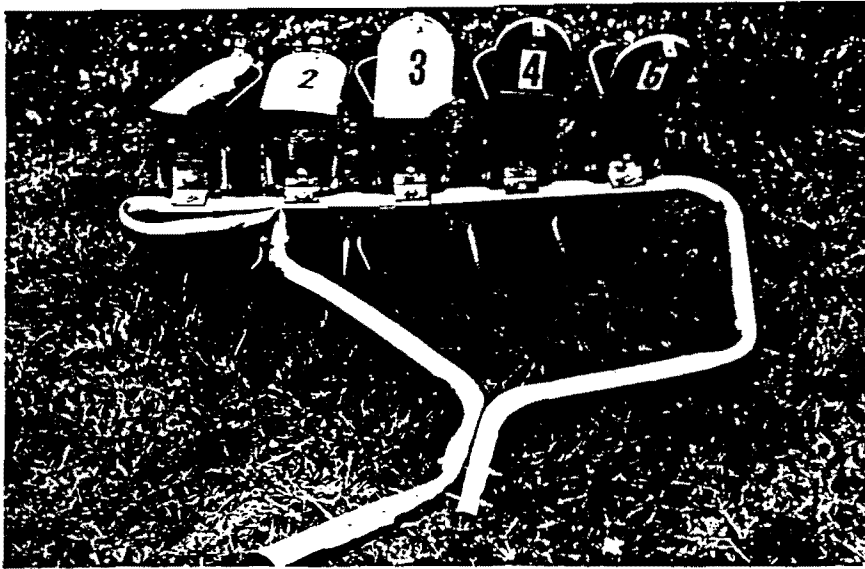
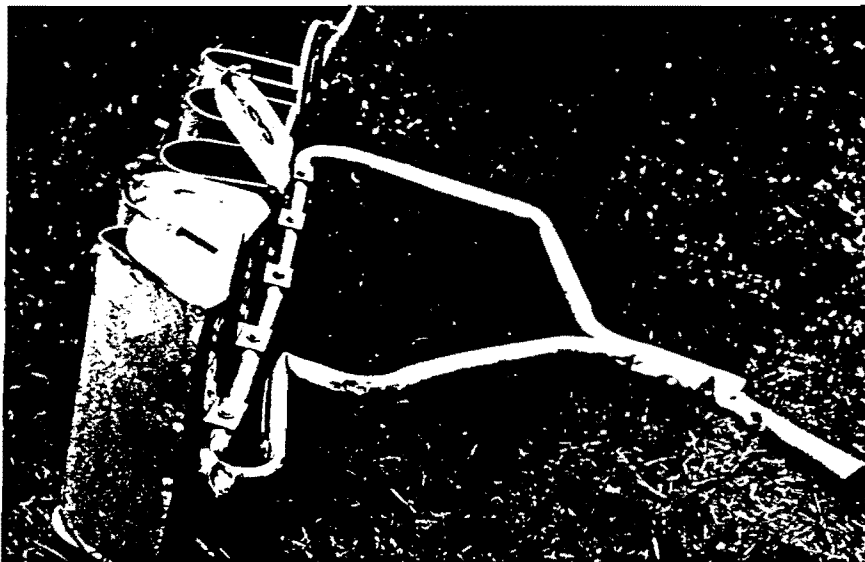
Figure . Mailbox/support and base after test 19452-7.

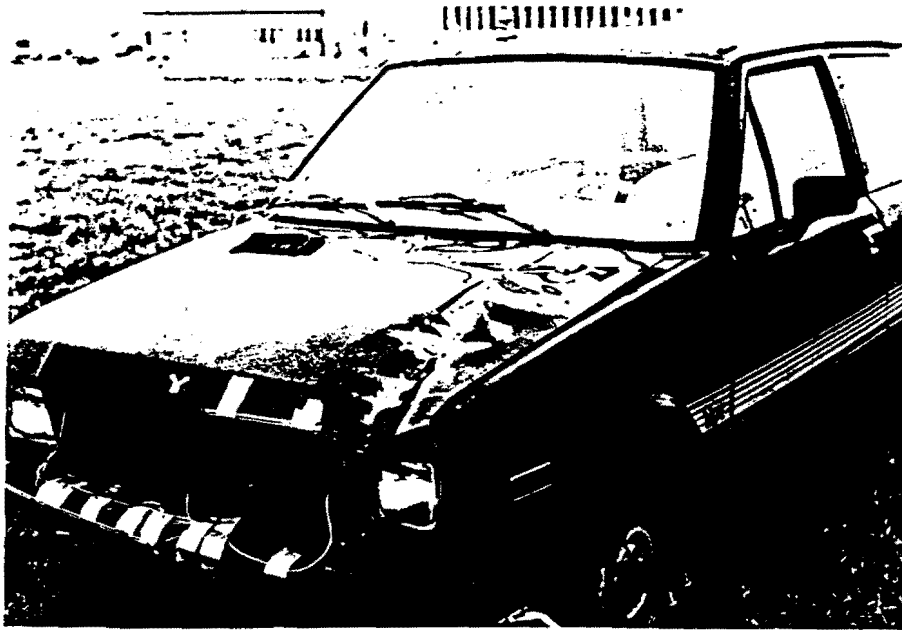
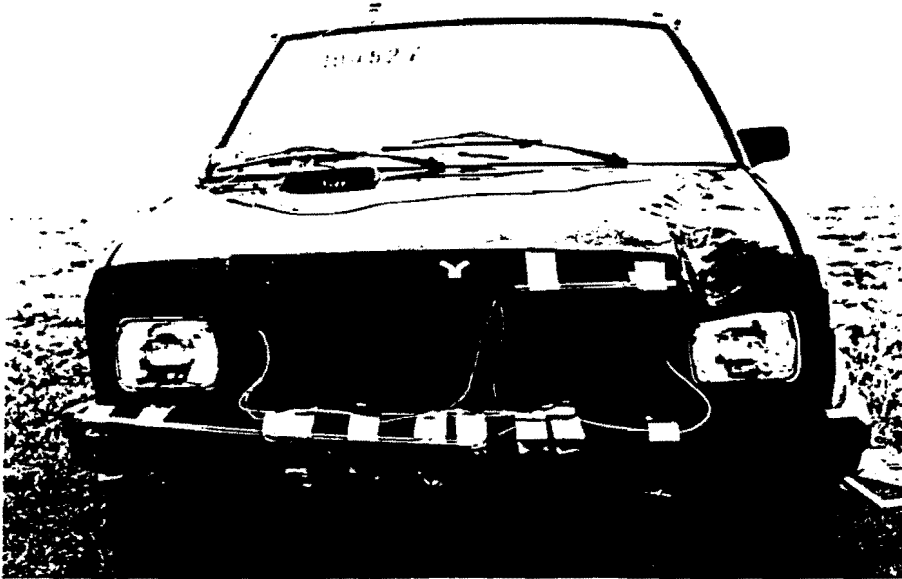
Figure . Vehicle after test 19452-7.

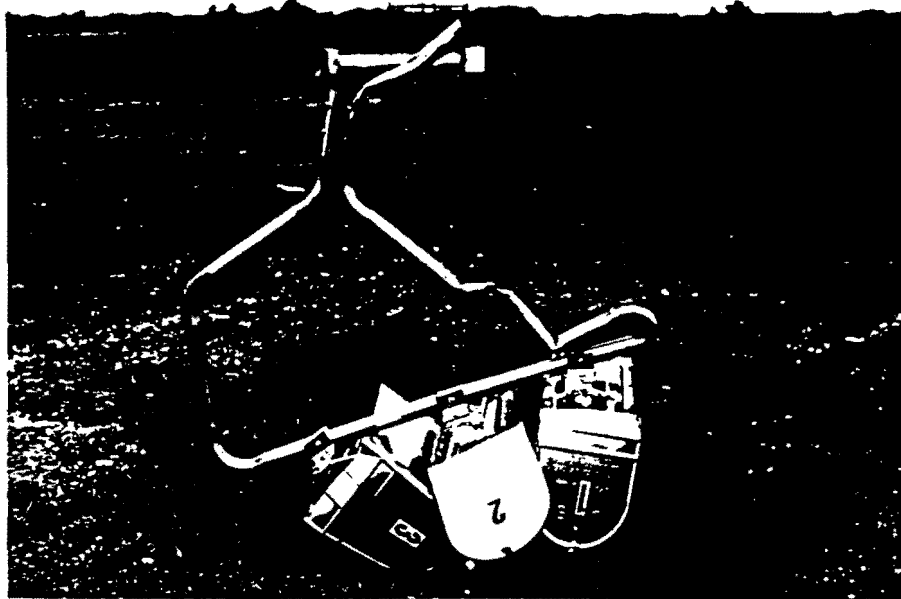
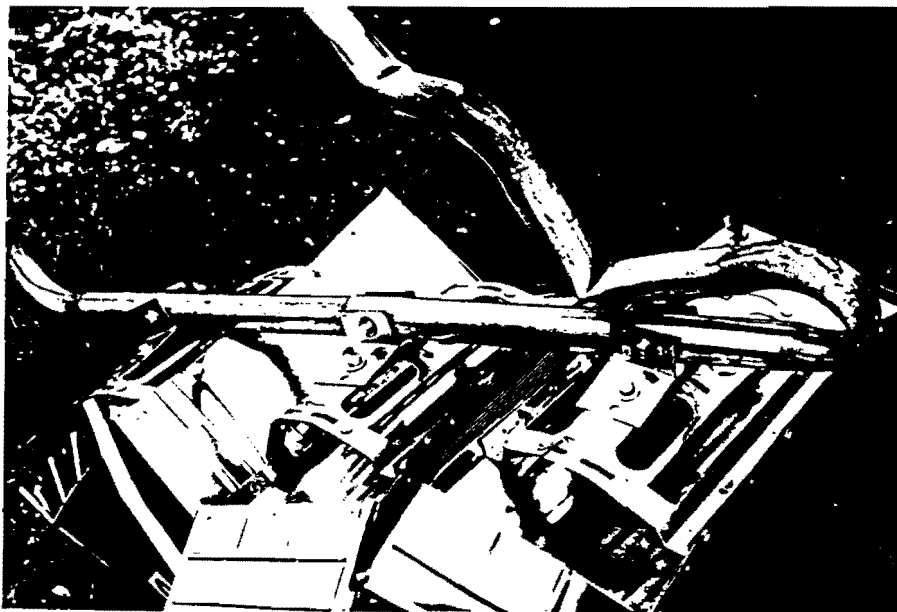
The installation yielded to the vehicle. The support separated from the ground sleeve and the support and mailboxes came to rest approximately 102.0 feet (31.1 m) from the point of impact. All mailboxes remained attached to the support. The vehicle sustained only minor damage to the bumper and hood as shown in Figure XX.

Figure . Mailbox/support after test 19452-8.

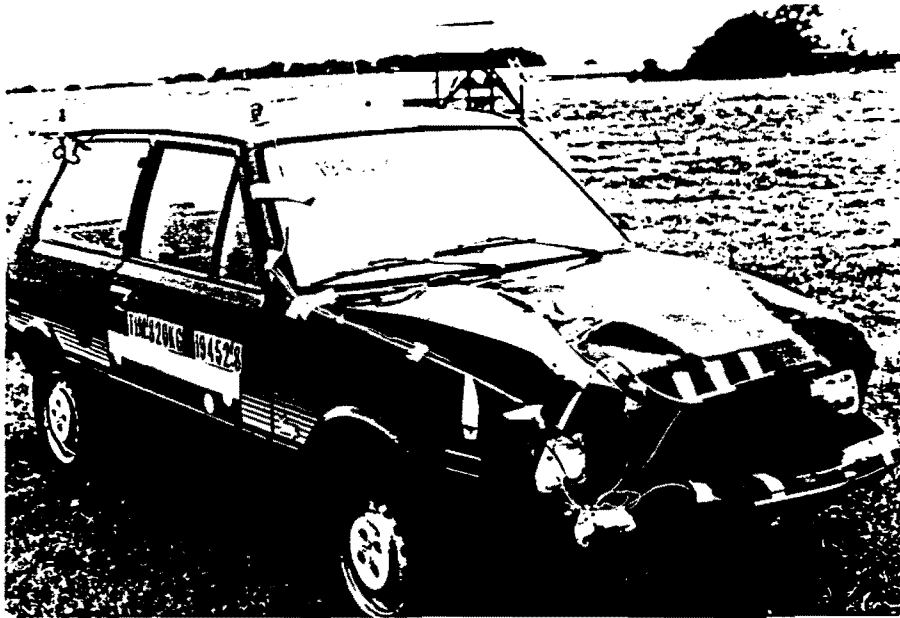
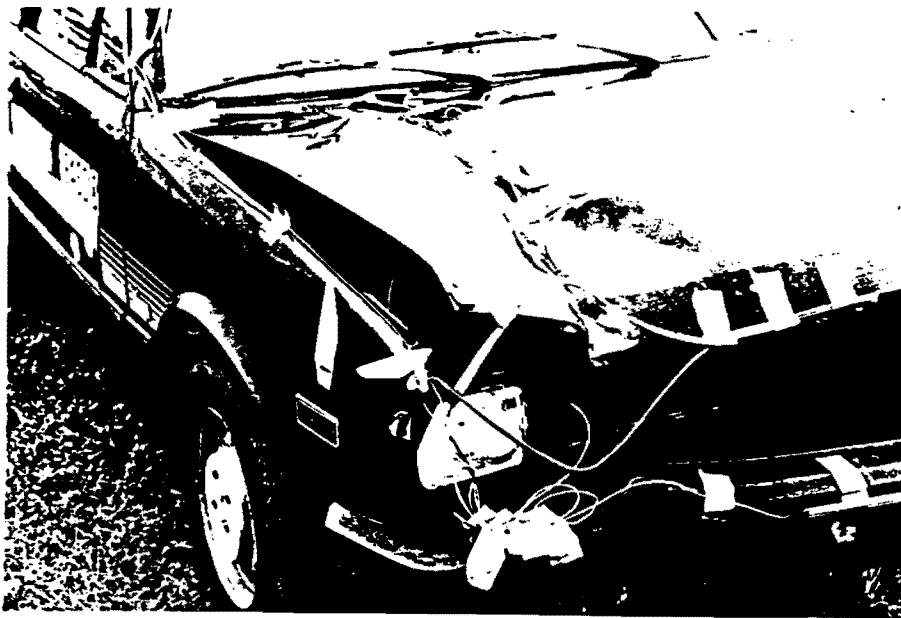
In summary, the mailbox installation safely yielded to the vehicle. The vehicle sustained minor damage and did not present undue hazard to other traffic. There was no deformation and minor penetration into the occupant compartment. The occupant contact velocities in the longitudinal and lateral directions were within acceptable limits. This installation in "strong soil" is acceptable according to the evaluation criteria recommended in NCHRP Report 230.

Figure . Vehicle after test 19452-8.

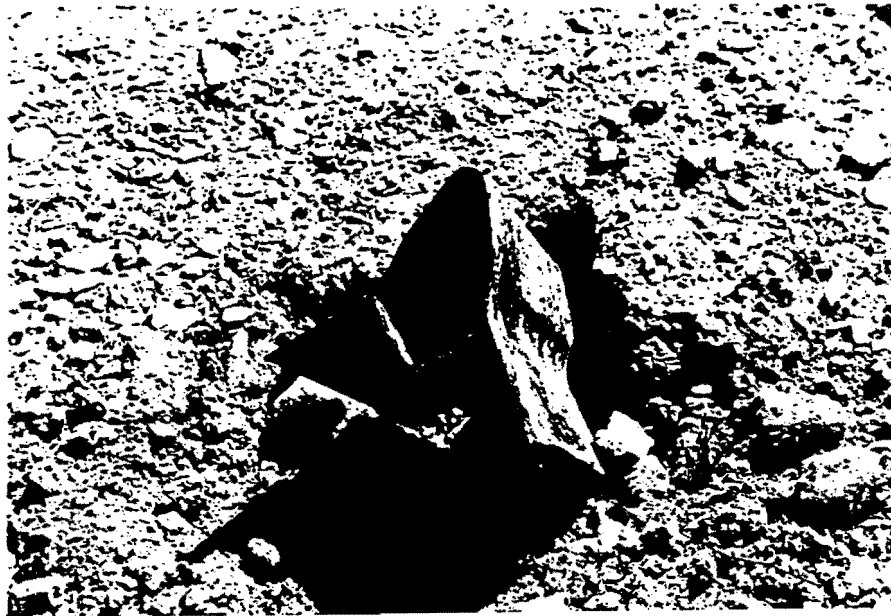
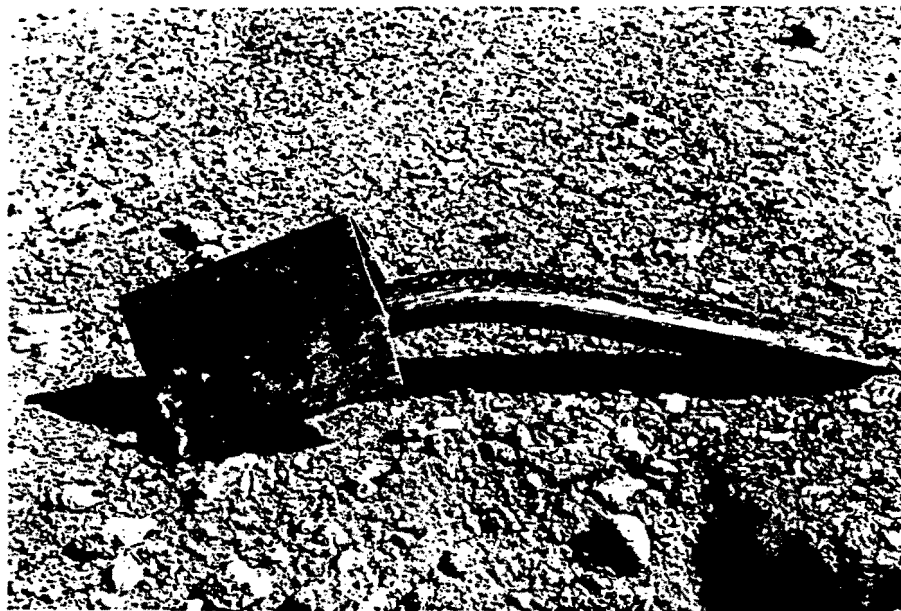
Figure . Flush V-Wing socket after test 19453-9.

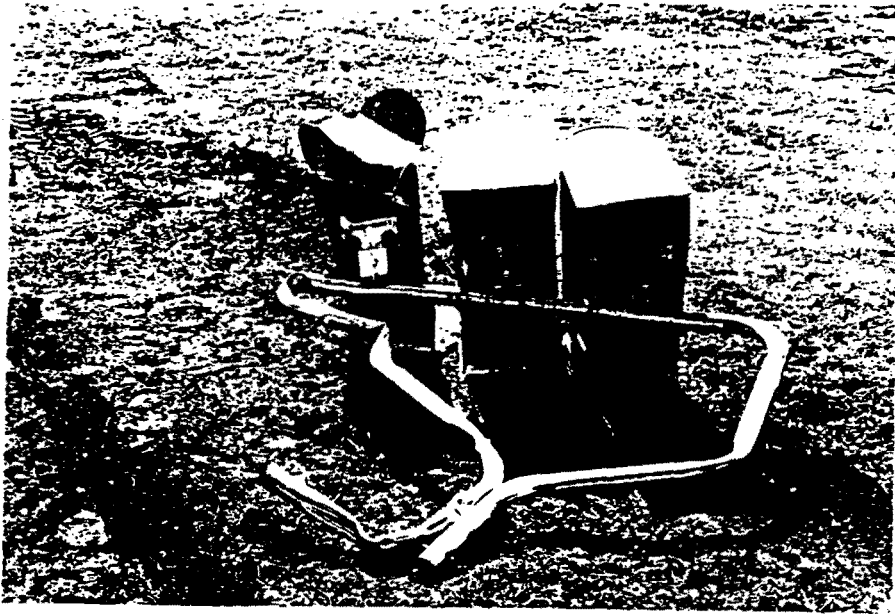
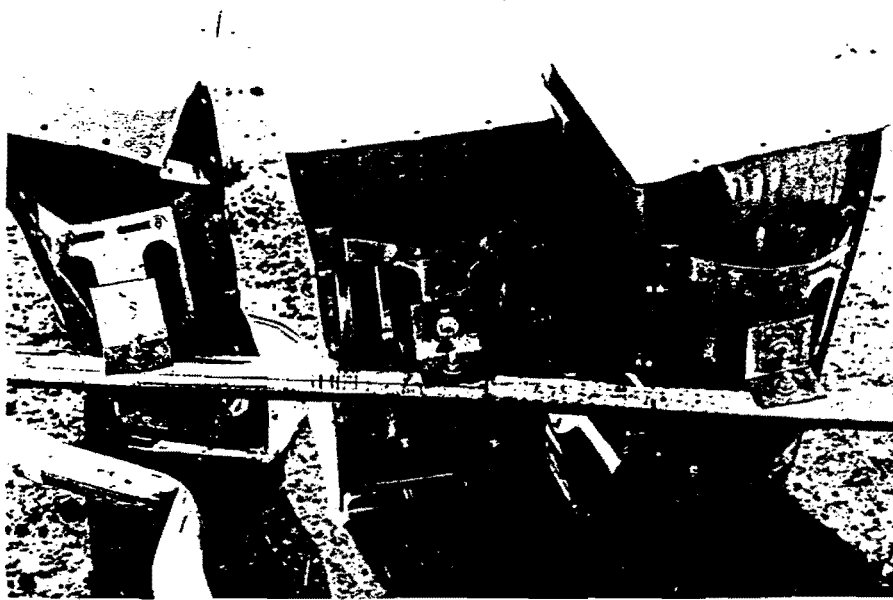
Figure . Mailbox/support after test 19453-9.
