"MAILBOX BRACKET CRASH TESTS"

INTERIM REPORT

RESEARCH STUDY 7-1945

Hayes E. Ross, Jr., P.E.
Study Supervisor
Texas Transportation Institute

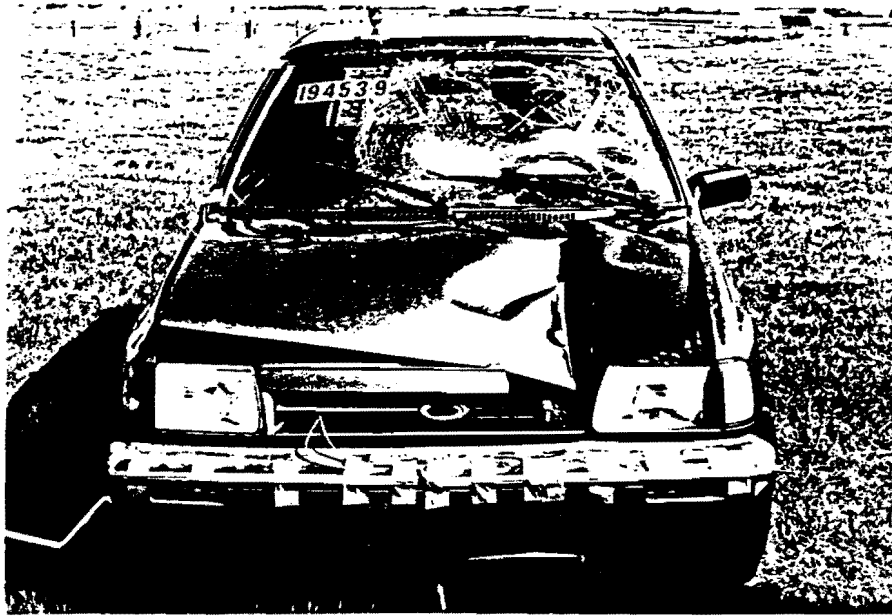
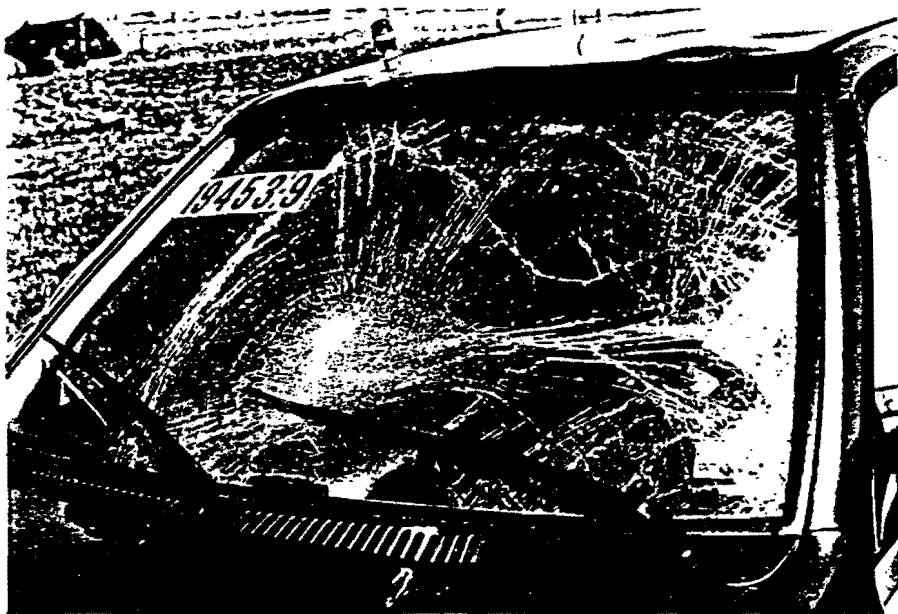
Figure . Vehicle after test 19453-9.
