# Riprap Filters and Stability of Riprap-Covered Slopes: Technical Report

Technical Report 0-7091-R1

TEXAS A&M TRANSPORTATION INSTITUTE  
COLLEGE STATION, TEXAS

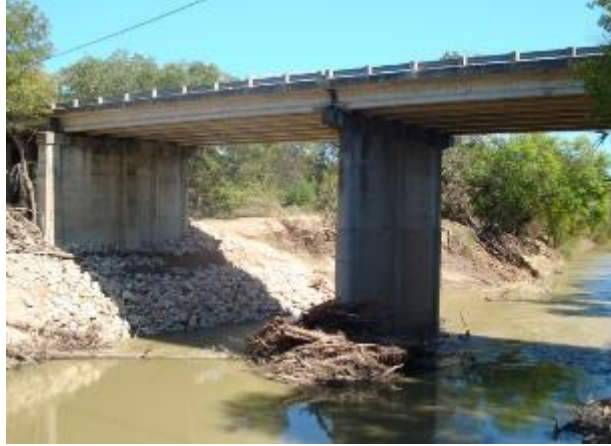
**Figure 66. Site Picture (Briaud et al., 2010).**

The riprap failure occurred in 2010. Now, the northern and southern banks of the main channel downstream of the bridge are experiencing problems due to meandering of the river. The pier in the center of the river shows large accumulations of debris lodged at its upstream nose. Figure 66 and Figure 67 show the riprap failure that was investigated.

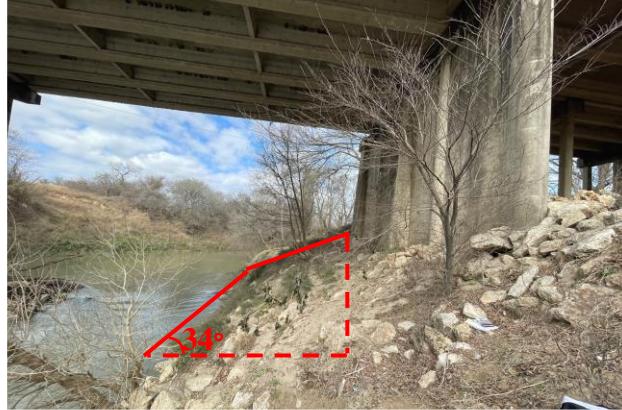
**Figure 68. Riprap-Covered Slope with Two Angles.**

Figure 68 and Figure 69 show a global picture of the site taken on the day of the site visit. Two testing locations were chosen near the top of the slope and slightly downstream of the pier. It was also noticed that a lot of debris had accumulated around the center pier, thus accelerating the flow next to the slope of the main channel. The slope where the riprap was placed had a nonuniform cross section that was steeper at the bottom of the slope and flatter at the top, which seemed to indicate scour at the bottom of the slope. The slope studied was the steeper slope, which had an angle of 34 degrees from horizontal.

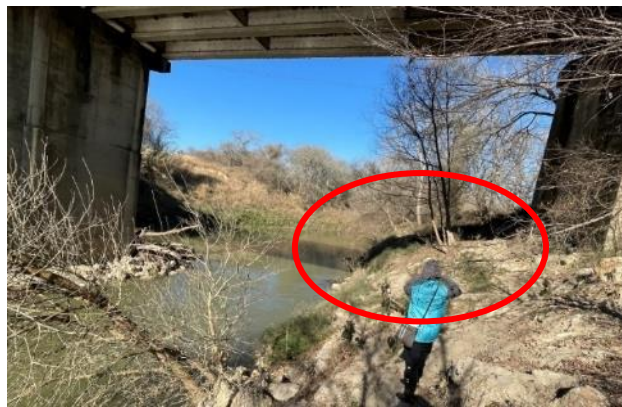
**Figure 69. Riprap-Covered Slope between Main Channel and Flood Plain.**

Considering that the underlying soil is classified as being of high to medium erodibility, the most probable event causing the failure is that abutment scour started to develop at the toe of the slope, which led to a steeper slope angle in the bottom half of the slope. The slope angle may have reached a value that became too steep for the riprap to resist. From previous slope stability analyses, it has been found that the steepest slope to safely place riprap on would be a 2:1 slope. However, the slope angle in this case is 1.4:1, which is not recommended based on previous analysis.

It can be concluded that the failure in this case is due to abutment scour that modified the angle at the bottom of the slope and induced failure of the riprap-covered slope.

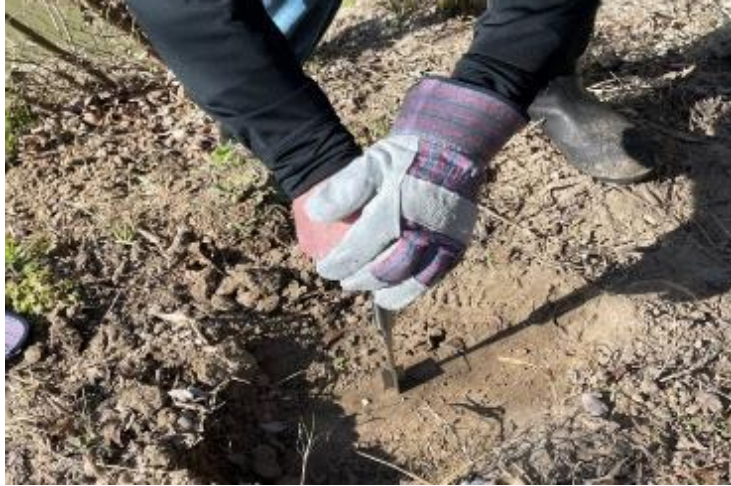
**Figure 70. Shear Vane Test.**

Two locations were chosen to run a vane shear test; all three vanes were used: mini-vane, medium vane, and large vane. Then another vane test was performed 1 m away from the first one using only the medium vane. Figure 70 shows one of the trials.

Table 133 shows the data obtained from the tests. Averaging all the  $S_u$  data obtained, it can be concluded that the average undrained shear strength of the soil measured by the shear vane test was 77 kPa.

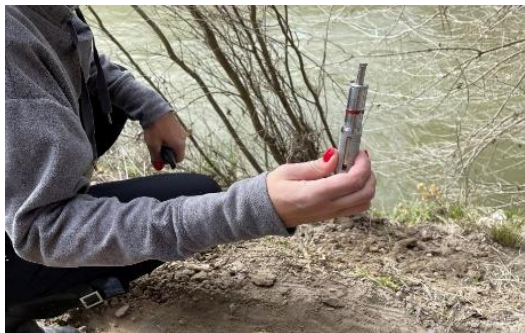
**Figure 71. Pocket Penetrometer Test.**

The PPT is another way to obtain the undrained shear strength in-situ value. It was performed three times (Figure 71). Table 14 shows the data obtained during the test. The average value of these trials was 55 kPa, calculated as 0.3 times the pocket penetrometer reading; this is 28 percent lower than the value obtained by the shear vane test.

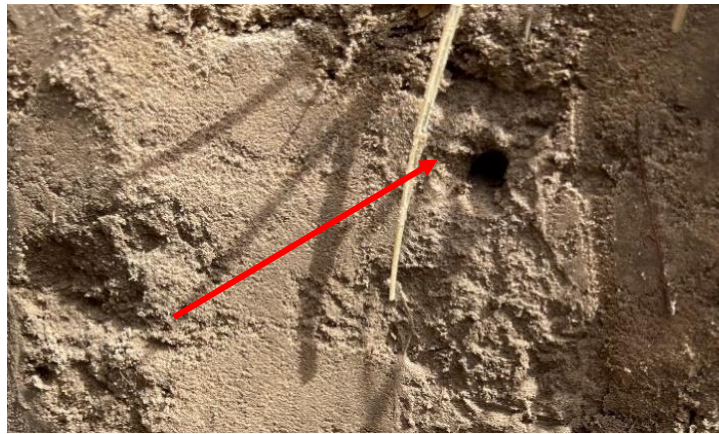
**Figure 72. Pocket Erodrometer Test.**

The PET is a quick in-situ test that helps to quantify the erodibility of the soil being tested by repeated jetting and measurement of the depth of the hole generated (Briaud et al., 2012). Two tests were performed with the PET (Table 15). Figure 72 shows the penetration hole after the PET. A penetration depth of 24.5 mm indicated that the soil is highly erodible.

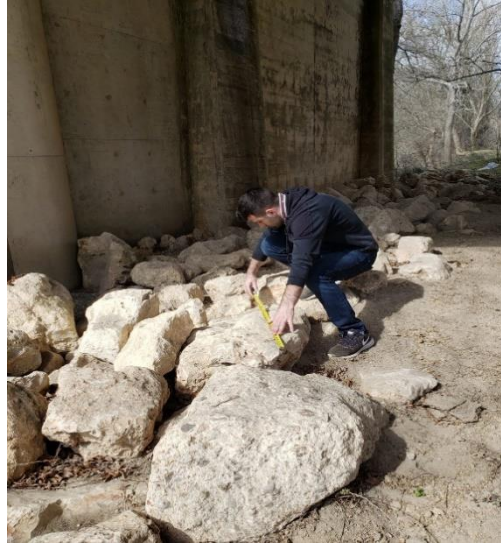
**Figure 73. Riprap Size Measurement.**

Table 16 shows some properties also estimated at the site, including the riprap  $d_{50}$  (Figure 73).

Flow Velocity (m/s)	2.67
Slope Angle (°)	35
Slope	1.37:1
Riprap Size $D_{50}$ (m)	0.45

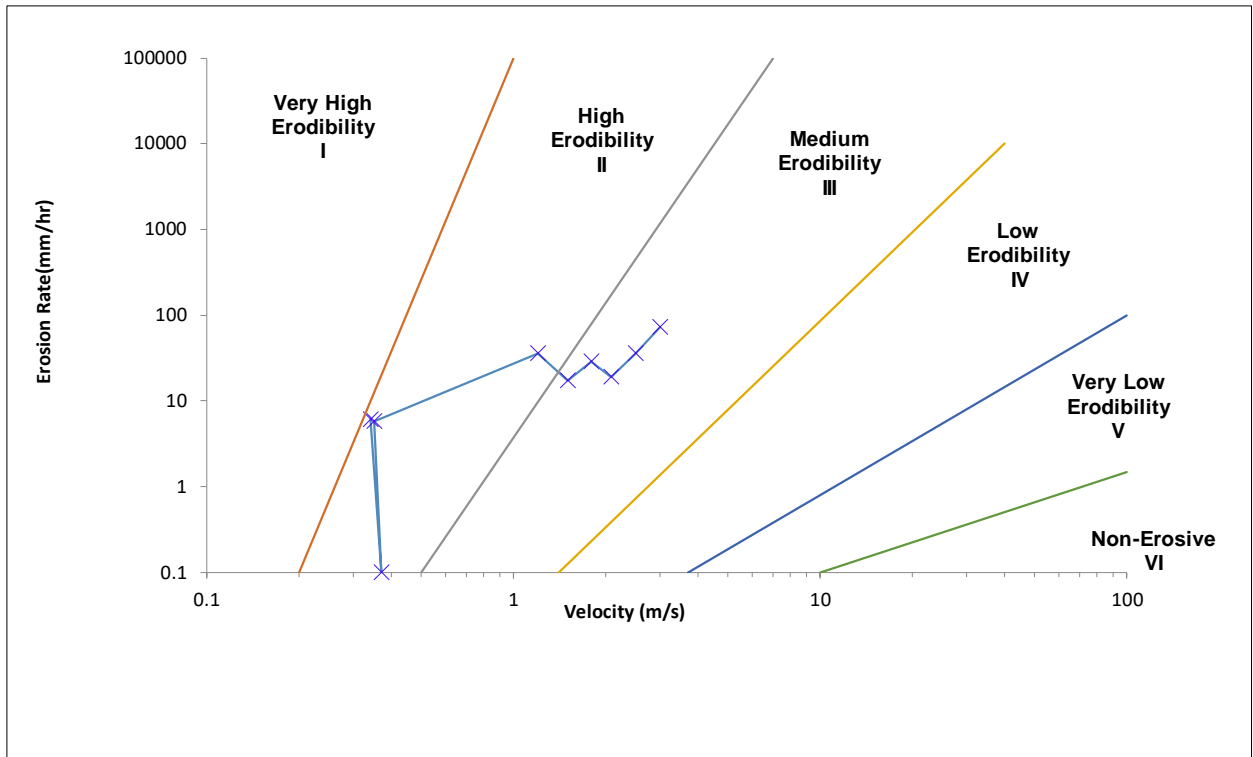
**Figure 82. Erosion Classification in Log-Log Scale (Erosion Rate vs. Velocity).**

In order to assess the erodibility of the soil, a sample was tested in the EFA (Briaud, 2013) (Figure 78 and Figure 79). The results obtained are shown in Figure 80 and Figure 81 and plotted on the Briaud erosion charts in Figure 82 and Figure 83. The soil is in the high to medium erodibility category, which is consistent with the observation at the site that abutment scour took place at the bottom of the riprap-covered slope.

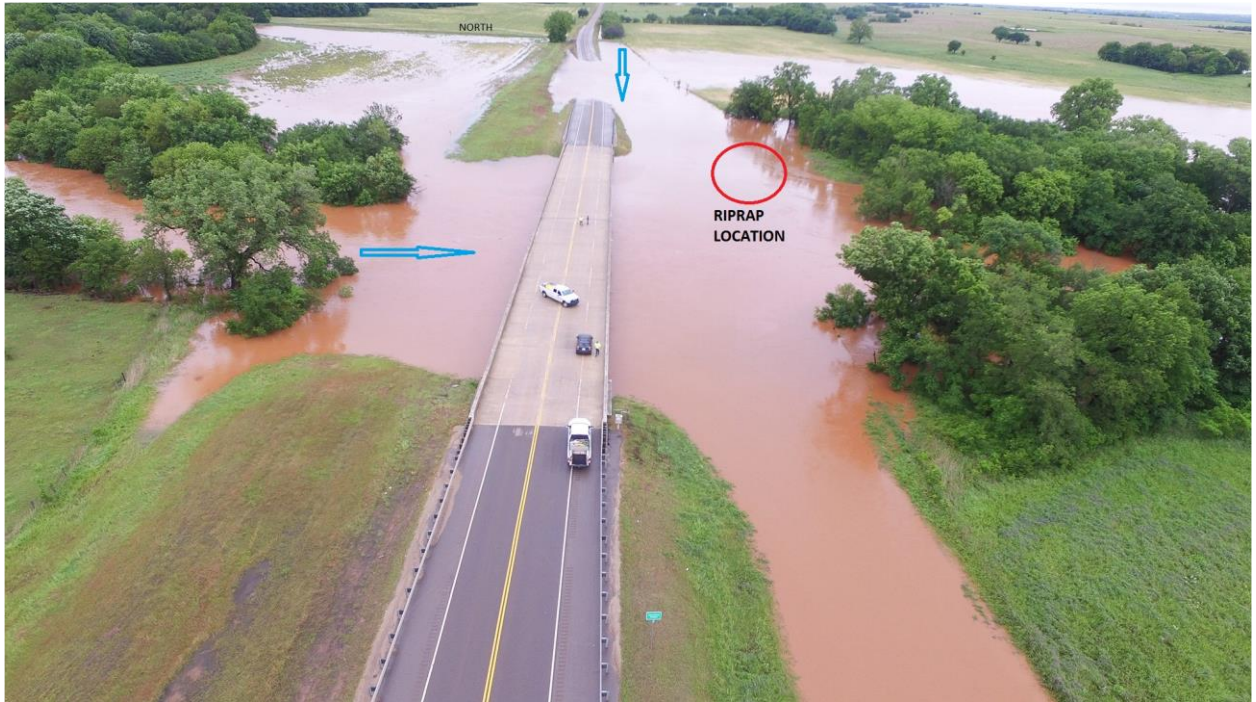
**Figure 84. Flood during 2019 (Courtesy of Oklahoma DOT).**

This case history was obtained from the Oklahoma DOT as part of the distributed survey. During a bridge construction on SH 74 over Skeleton Creek, Oklahoma (7.4 mi north of Crescent, Oklahoma), riprap was placed in order to line the termini of a USGS blue-lined unnamed channel running south into Skeleton Creek. Design plans show riprap thickness to be 0.45 m, with a  $d_{50}$  equal to 12 inches. The riprap was to be installed on top of a 6-inch granular filter. Construction was still underway in May 2015 when heavy rainfall occurred, and the riprap washed away. A site investigation took place after this failure, and it was concluded that the slope was too steep for this high-velocity channel, and this factor caused failure of the riprap (Figure 84 and Figure 85). Therefore, the concerned entity decided to use an alternative solution instead of riprap and lined the embankment with sod and Armormax B2 erosion Control Mat (Figure 86). Monitoring of this solution was regular, and it displayed great performance. In 2019, an extreme flood event took place in Oklahoma, and the countermeasure held well during this event, which corresponded approximately to a 100-year event.

Given that the  $d_{50}$  of the riprap was equal to 12 inches, the critical velocity would be around 4.5 m/s, according to Figure 74 this factor should have been sufficient. However, it may be that the critical velocity of the riprap on that steep slope was not as high as given by Figure 74 for a flat surface. This result indicates that a relationship might exist between the slope angle and the critical velocity of riprap stones for a given  $d_{50}$ . This case history appears to not be a slope stability failure but rather that the riprap on the slope was displaced by high flow velocities.

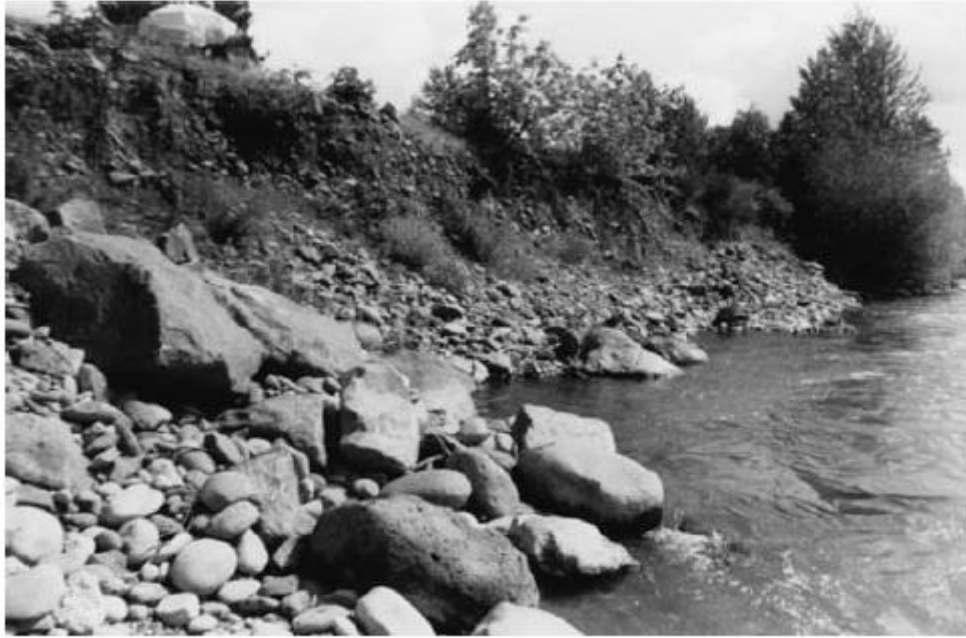
**Figure 94. Willamette Highway over Salmon Creek Riprap Failure (Lagasse et al., 2006).**

This case history was obtained from *Riprap Design Criteria, Recommended Specifications, and Quality Control* (Lagasse et al., 2006). The location is Salmon Creek on the Willamette highway (Route 58), Lane County, Oregon. The riprap failure was attributed to impinging flow that caused undermining at the toe of the slope (Figure 94). The riprap was designed by the USACE Portland District following EM 1110 guidelines. One of the assumptions made during the design was that parallel flow conditions would be occurring. Post-failure analysis showed that the main causes of failure were a combination of the steepness of the slope, the riprap stones being rounded (which reduces the global frictional resistance), and no filter layer being present. Again, the common issue of the steepness of the slope was mentioned in this case history. Moreover, it was mentioned that the failure occurred during turbulent flow conditions, which are not typically taken into consideration in design. Finally, friction is a major contributor to riprap movement resistance, and using rounded stones lowers this resistance because rounded rocks have smaller global friction than angular rocks; indeed, rounded stones do not provide interlocking resistance during shearing.

View upstream of west bank just upstream of Route 58 bridge  
(photographed May 1992)

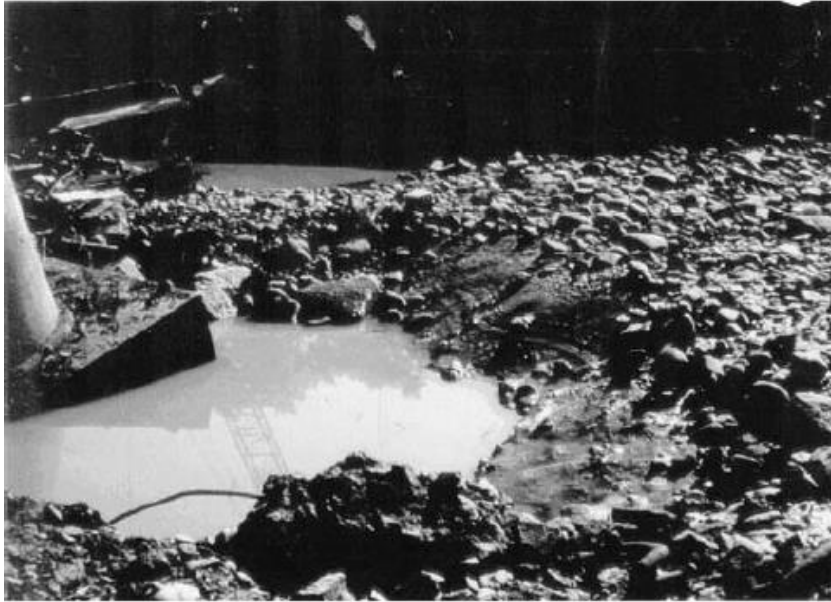
**Figure 96. I-90 Bridge over Schoharie Creek (Lagasse et al., 2006).**

This case history was obtained from *Riprap Design Criteria, Recommended Specifications, and Quality Control* (Lagasse et al., 2006). A major bridge failure occurred in 1987 on the I-90 bridge over Schoharie Creek near Albany, New York, costing 10 lives. The reason of failure was scour at the bridge piers due to riprap failure (Figure 96). The peak flow was  $1,838 \text{ m}^3/\text{s}$ , with a 70- to 100-year return period. The footings were set 1.5 m into the stream bed in glacial till, which was assumed during the design stage to be non-erodible. However, flume studies of samples of the stratified drift showed that some material does erode at a velocity of 1.5 m/s. At a velocity of 2.4 m/s, the erosion rates were high, which called for the need of riprap as a countermeasure. From 1953 to 1987, high-velocity flows were able to displace some of the riprap, which led to rapid erosion of the native soil in 1987. During an inspection in 1979, it was documented that a good portion of the riprap around the pier was missing; however, during another inspection in 1985, absence of the riprap was not detected and led to continuous erosion and failure of the piers. It can be concluded from this case history that another critical variable in the performance of riprap is proper inspection; inspectors must be trained to recognize when riprap has washed away, especially underwater, because this is a critical stage of the failure mobilization, not only in regard to the failure of the riprap but also in regard to the failure of the structure, which could lead to fatalities.

Pier 2 in the foreground with Pier 3 in the background.

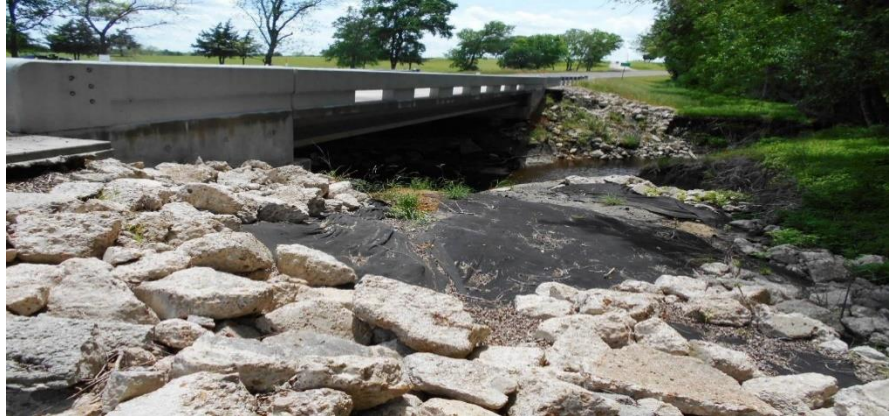
**Figure 98. Geotextile underneath the Riprap (Courtesy of TxDOT).**

This case history was obtained from TxDOT. It occurred in Washington County beside the bridge on FM 1155 over Little Sandy Creek. Riprap was installed on a 3:1 slope (Figure 97) as a scour countermeasure, but then it washed away along the stream. A geotextile blanket was present (Figure 98). One possible reason failure occurred is that the riprap stones used on the site were smaller than the size indicated in the design. When it was replaced by grouted riprap, it worked well. Riprap stone sizing is a crucial parameter for the resistance of the riprap against hydraulic stresses caused by the flow.

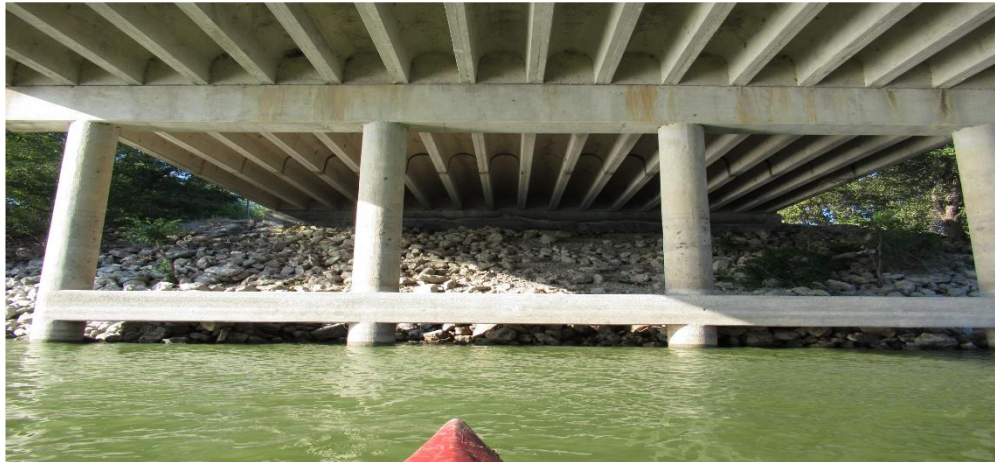
**Figure 99. SH 78 over Price Creek Riprap-Covered Slope (Courtesy of TxDOT).**

This case history was obtained from TxDOT. It occurred in Dallas District and deals with the bridge built in 1972 on SH 78 over Price Creek. The riprap was placed on a 2:1 slope (Figure 99). Failure of riprap occurred when the limestone rock riprap moved downhill (Figure 100) and ended up resting on the interior bents, becoming piled higher around each column as time went on. The recommended action was to reconstruct the north and south banks with large (300 to 500 lb) concrete rubble, or with gabions. The last time it was inspected was September 12, 2019.

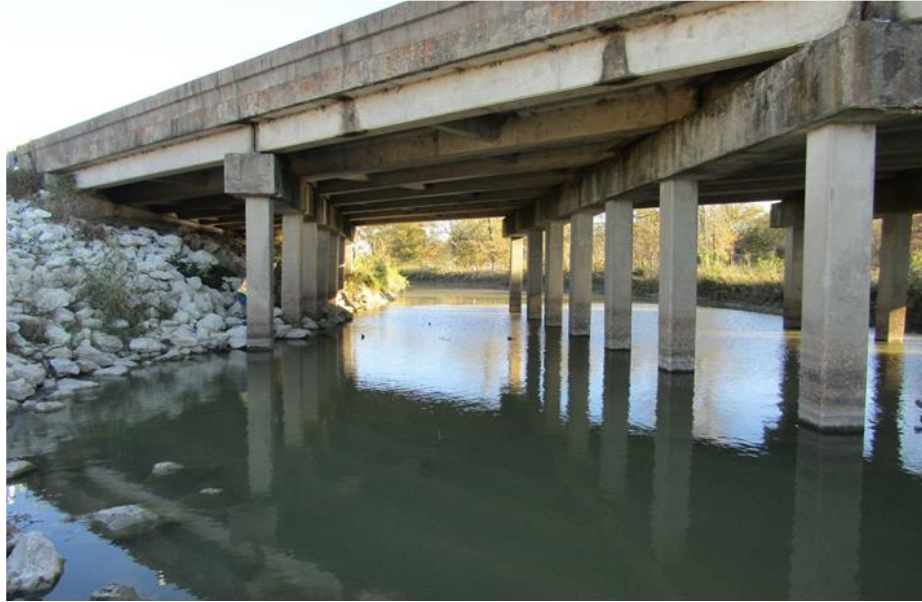
**Figure 105. FM 218 over Cowhouse Creek Riprap-Covered Slope (Courtesy of TxDOT).**

This case history was obtained from TxDOT. It is located in the Waco District and relates to the bridge built on FM 218 over Cowhouse Creek. A concrete cover was installed on the 3:1 slope. This countermeasure was undermined, and the concrete riprap failed in 2007. It was replaced by stone riprap in the form of crushed rock up to 6 inches in size that was used to fill all the voids caused by scour (Figure 105). This stone riprap also failed, and it was repaired by re-installing stone riprap. The exact failure mechanism is not known, but a 3:1 slope does not typically lead to slope stability problems; however, undersized riprap stones might be a potential issue triggering the failure of the riprap when subject to water flow.

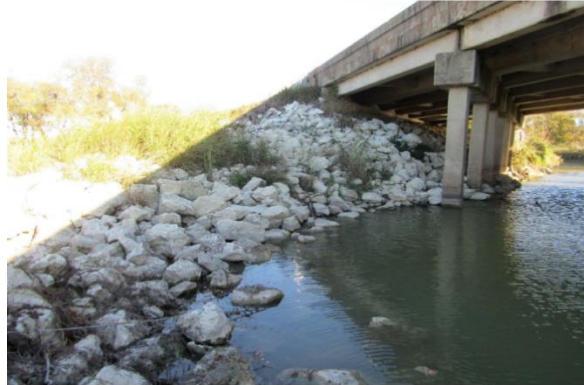
**Figure 107. US 84 over Navasota River E Relief Riprap-Covered Slope (Courtesy of TxDOT).**

This case history was obtained from TxDOT. It occurred in the Waco District and relates to the bridge built on US 84 at Navasota River. Concrete riprap was installed on a 2:1 slope. The concrete riprap failed and was replaced by stone riprap (Figure 107). However, the riprap stones were too small and did not stay in place.

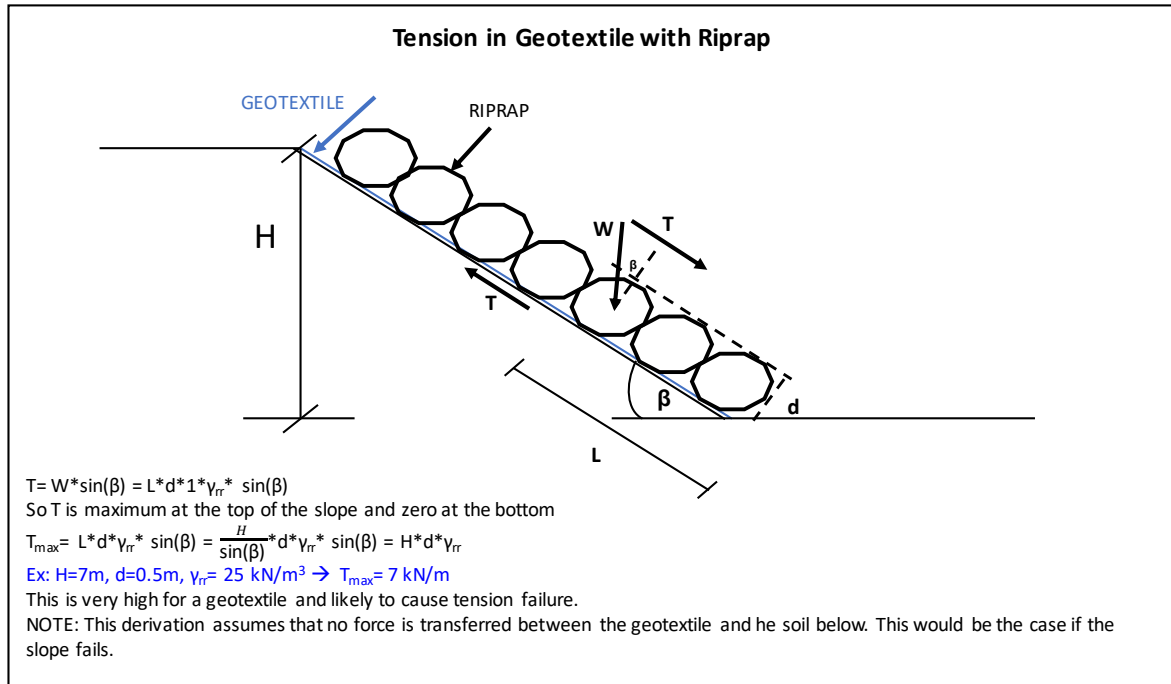
**Figure 108 Geotextile Tension Failure Derivation**

No case histories were reported on geotextile failure in tension and potential sliding plane; however these two scenarios are theoretically possible and should be taken into consideration.

First, when the geotextile is loaded with riprap, tension forces will develop in the geotextile, especially when the geotextile is anchored. Figure 28 shows how these tension forces are generated and how to estimate their magnitude.

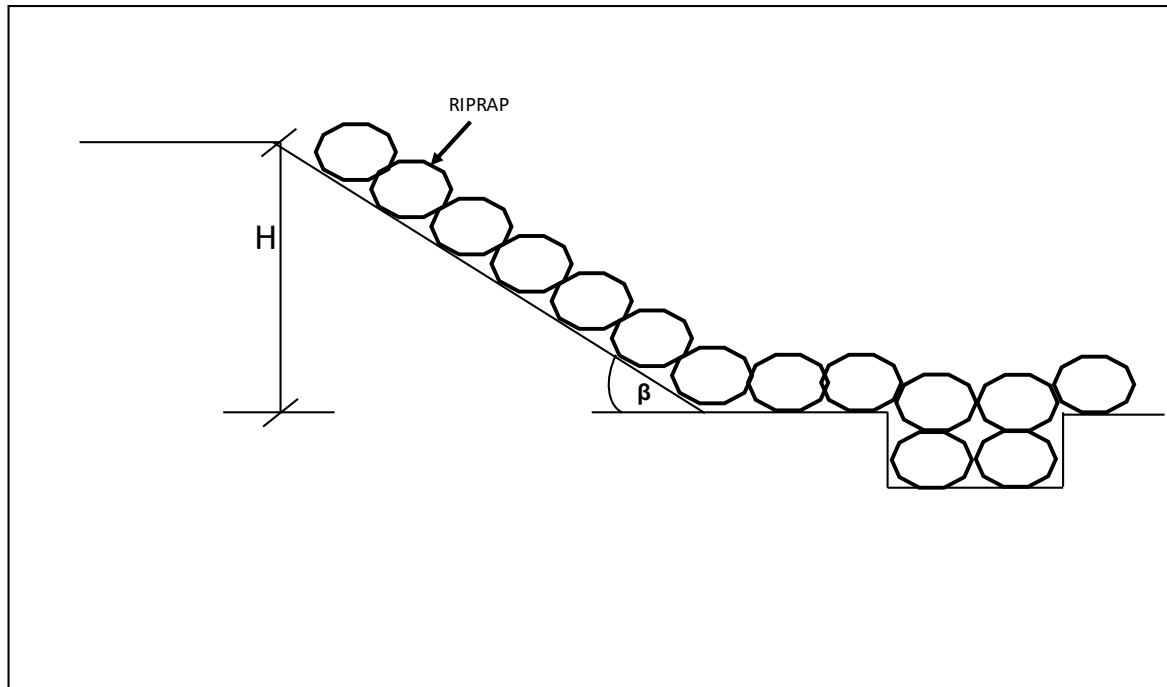
**Figure 109 Riprap Sliding Stability Countermeasure**

Second, the riprap stones can slide along the geotextile or the geotextile can slide over the soil of the embankment fill ; this was also mentioned by some survey responders as one of the drawbacks of using geosynthetic filters instead of granular filters. There are two interfaces: the riprap to geotextile interface and the geotextile to embankment soil interface. Both interface friction forces would have to be checked to ensure that a proper factor of safety is satisfied. One problem is that the friction coefficient for both interfaces is not well known and tests have to be conducted to ensure reasonable values. Figure 109 shows a possible solution to minimize such a failure mechanism.

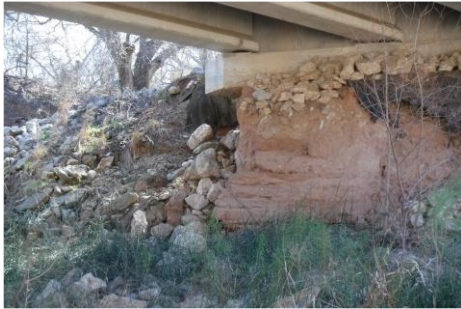
43	TxDOT	FM 667 Cobb Hollow - Wichita Falls	Riprap Washed away
