# Field Evaluation of Reinforced Concrete Repairs Using Hydrodemolition, Galvanic Cathodic Protection, or Impressed Current Cathodic Protection

**Final Report VTRC 25-R22**

Virginia Transportation Research Council  
(A partnership of the Virginia Department of Transportation  
and the University of Virginia since 1948)

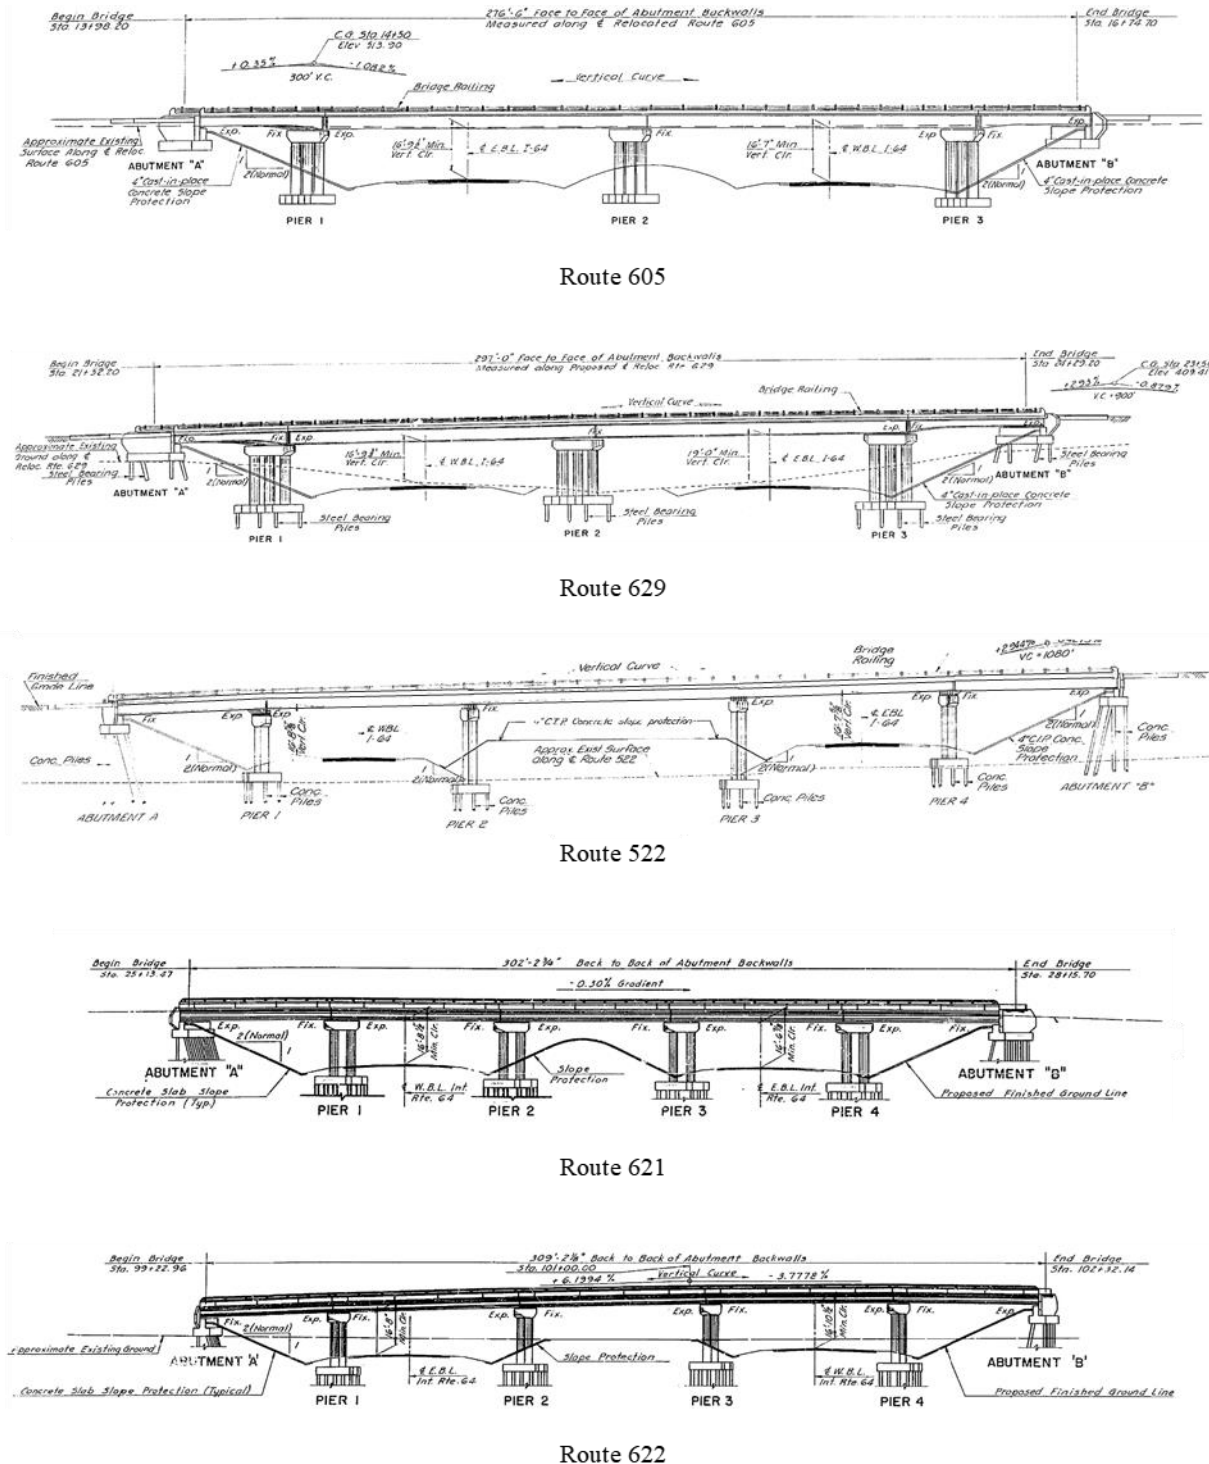
Figure 2. Elevation Views of the Five Structures Repaired along the I-64 Corridor in the Richmond District

The bridge elements selected for testing were all adjacent to the travel lane of the east or westbound lanes of I-64. They were selected because of the high salt exposure due to salt spray from vehicles and leaking joints allowing salt water to reach the pier caps and columns. Figure 2 shows the five bridges.

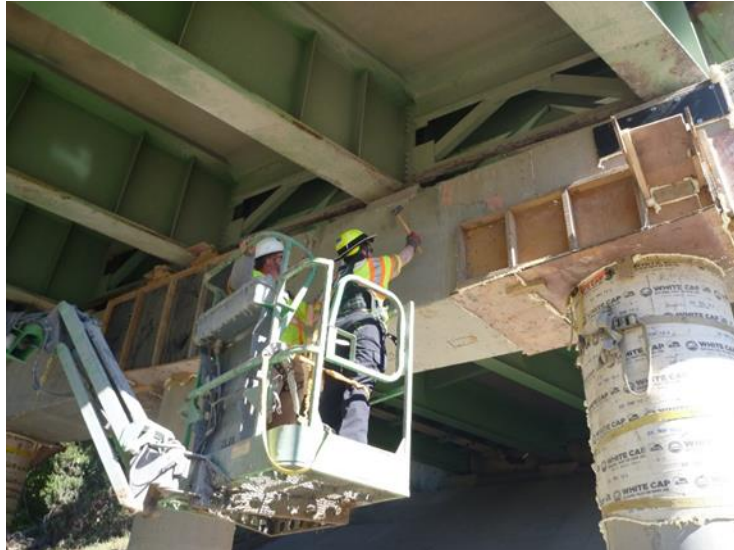
Low-permeability SCC concrete was placed in formwork (Figure 25). The soundness of these repairs was determined by tapping them with a hammer. Most SCC repairs had smooth surfaces; however, some blemishes were noticeable (Figure 26). The contractor ground the surface blemishes so the repair was aesthetically pleasing.

**Figure 25. Route 605 Bridge over I-64 (Columns and Pier Cap along Westbound Lane). After the removal of forms, the area was tapped with hammer to determine if the repairs were sound.**

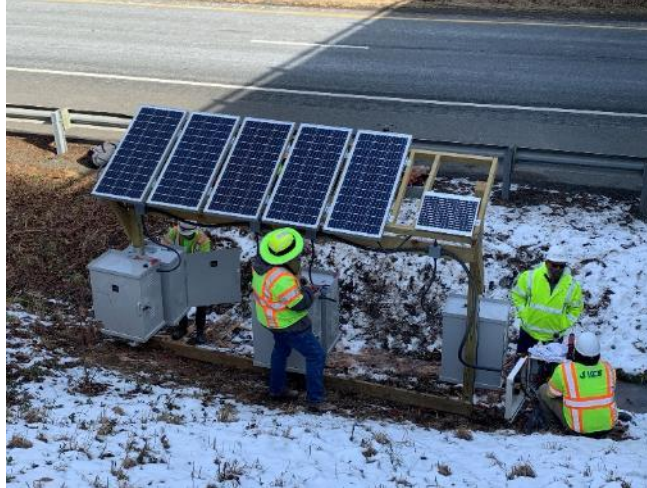
Each GCP and ICCP system is powered using solar panels (Figure 29). The five larger panels supply enough energy to provide CP current and charge the batteries, so that the system can mitigate corrosion day and night. The smaller solar panel provides power to the RMU and charges the battery for data to be collected and periodically transmitted.

**Figure 29. The Five Larger Solar Panels Supply Electricity for the Cathodic Protection System and the Smaller Solar Panel Powers the Remote Monitoring Unit**

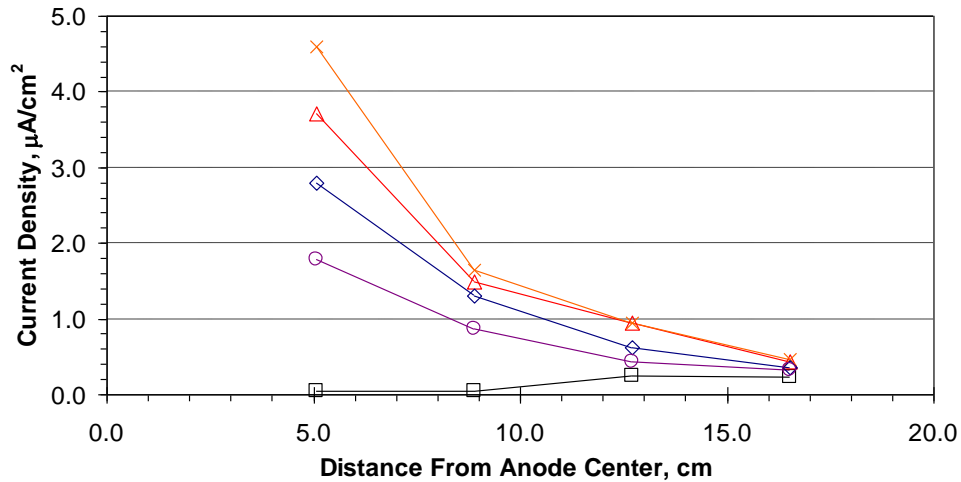
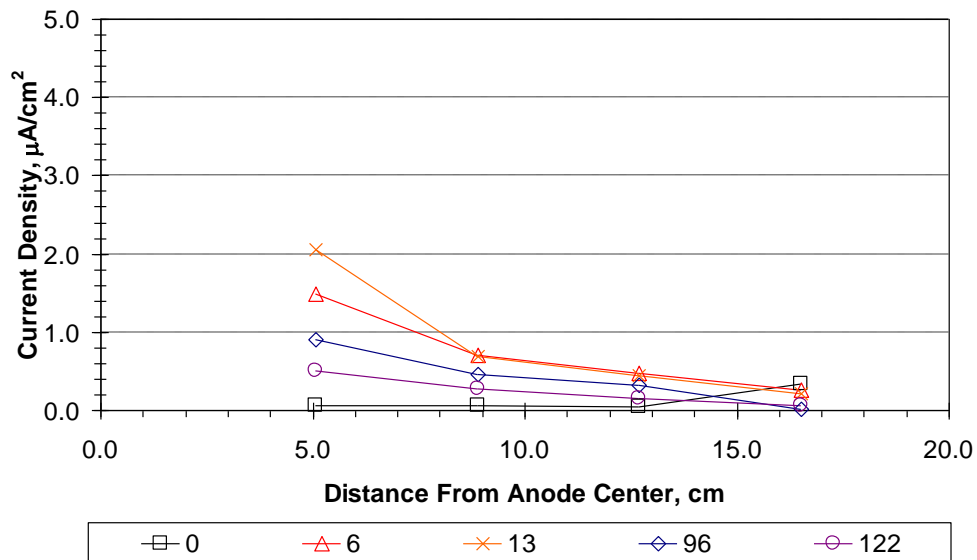
The three substructures were repaired with and without anodes to determine the life expectancy of each. The anodes used were provided by three different companies, so the anodes had distinct differences that were reported to improve efficiency. In some areas, anodes were placed with an embedment mortar to facilitate current flow to prevent corrosion of the reinforcement in the unrepaired areas. The nondestructive testing showed that anodes with or without embedment mortar had minimal effect on the corrosion protection. The unrepaired areas next to the patches started showing distress that would inevitably need repairs. Controlled laboratory studies have also indicated that the influence of the anodes on the reinforced concrete element and the benefit of using them are sensitive to both exposure time and concrete resistivity, which directly influence the projected anode life. Work by Dugarte and Sagüés (2014) concluded that "... throwing distance in likely application scenarios may seriously degrade within a few years of operation." Similar behavior has also been observed in the VDOT elements repaired with these types of anodes in the field. For example, the current flow through the different steel bars first increases but then decreases with time (Figure 33), with most of the current going to the steel in closest proximity to the anode.

**Figure 33. VTRC 05-R25 Current Density Measurements from Sacrificial Anode Sensors Placed in (a) Pier 1 and (b) Pier 12. The numbers in the legend indicate the number of days that have passed since activating the anode.**

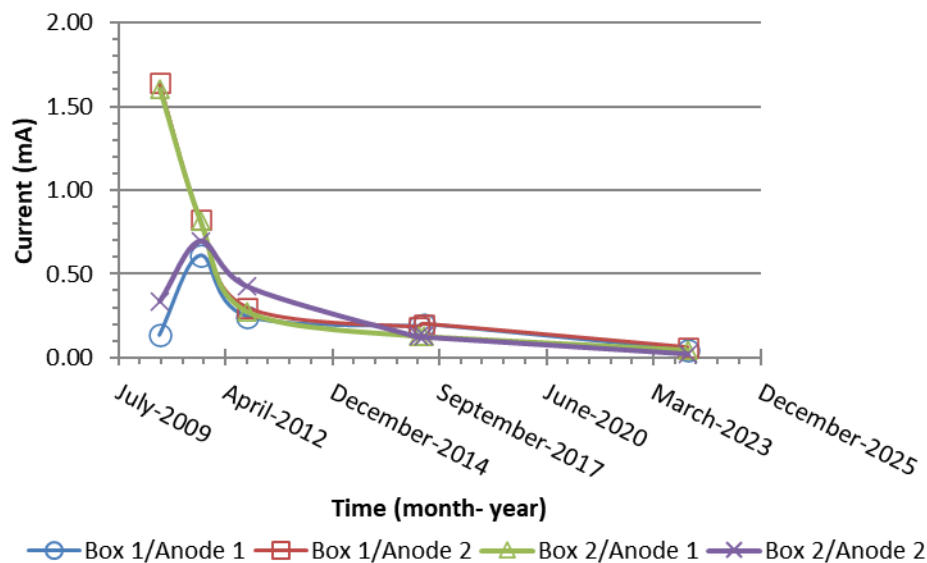
**Figure 34. Measured Current Values on Route 712 Bridge**

Furthermore, Trocónis de Rincón et al.'s (2008) work on concrete samples subjected to different humidity levels concluded that high concrete resistivity due to low humidity led to poorer performance of the anodes compared with concrete that has lower resistivity because of higher humidity levels, which is also consistent with what was observed in Figure 34. This observation shows that as VDOT concrete increases in resistivity as the permeability decreases with age, the current flow decreases, with most of the decrease in current occurring within the first 3 years. Conventional VDOT concrete repair materials are designed to exhibit high resistivity—at times an order of magnitude greater in the repair area compared with the unrepaired concrete—and the recent field measurements confirm it is true. The observed resistivity and current measurements also demonstrate that the sacrificial anode's current flow will be restricted by the high resistive repair material when these types of anodes are embedded

in the low-permeability concretes. Use of embedment mortars did not make a noticeable difference in the performance.

Thus, the technical assistance report concluded from field measurements of the current over time that most of the current flow occurs within 3 years of concrete placement. Field measurements also demonstrated that the distance the anode current extends from the center of the anode indicates that most of the current flows to the closest reinforcing steel bar. Both findings were not surprising because VDOT intentionally uses high resistivity concrete repair materials. The use of high resistivity concrete repair materials in patch repairs, with or without embedment mortar, limits the effectiveness of the DGP anodes. Therefore, the nearby unrepaired areas demonstrate the halo effect and show signs of corrosion-related distress within a few years of completion of the repair. Therefore, for long-term protection of the steel reinforcement, mitigating corrosion required either (1) total removal of the deteriorated concrete to below the reinforcement and replacement with a quality low-permeability concrete that naturally exhibits high resistivity, but without the DGP anodes, or (2) leave some of the deteriorated concrete in place and install an ICCP or GCP system to mitigate future corrosion on the whole element.
