Rail Passenger Equipment Accidents and the Evaluation of Crashworthiness Strategies

David C. Tyrell
Volpe National Transportation Systems Center
U.S. Department of Transportation

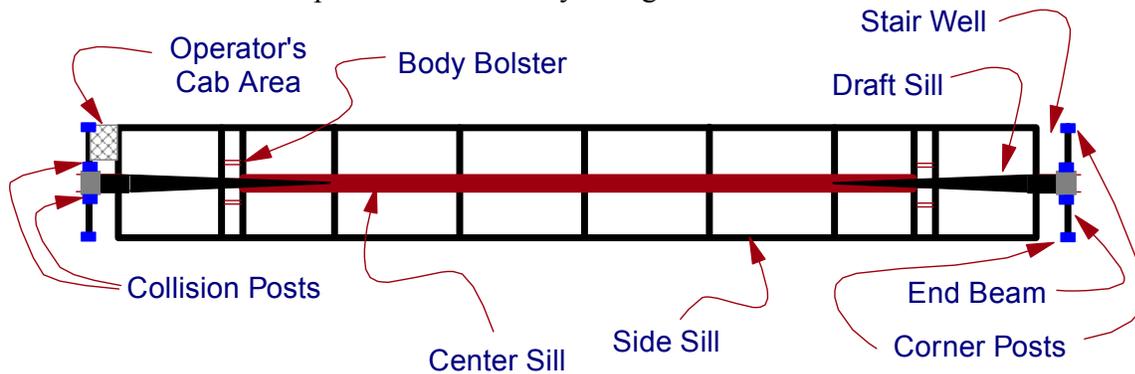
Figure 14. Schematic of typical cab car structural members, plan view.

The typical North American passenger cab car structure consists of an underframe, an end structure and a body shell. The underframe consists of four longitudinal members: the center sill, draft sill and two side sills, and two body bolsters, which laterally connect the center sill, draft sill, and two side sills. The end structure consists of an end beam (or buffer wing), two vertical collision posts and two vertical corner posts. The structural members with the largest cross-sectional areas are the center sill, the draft sill, and the body bolster. The main cab car structural members are depicted schematically in Figure 14.

The main structural elements (i.e., body bolster, center sill, draft sill) of the cab car in the Secaucus collision remained essentially intact. The structural damage consisted principally of crushing of one side of the vehicle, from the end beam to the body bolster longitudinally, and from side sill to the roof plate vertically. There was significant damage to the impacted corner post, end beam and side sill. The end beam failed near the base of the collision post. Figure 15 schematically illustrates the structural damage to the frame of the cab car.

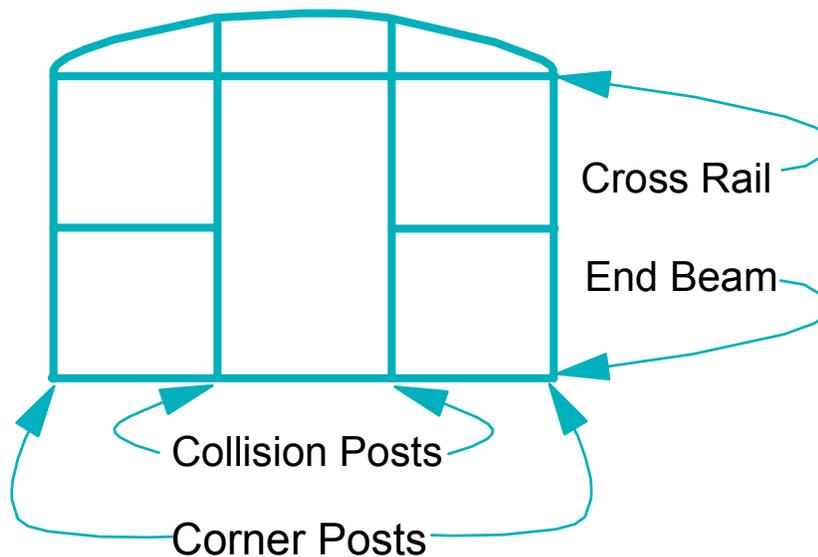
Figure 21. Schematic illustration of cab car end frame structure.

The end frame of the cab car is schematically shown in Figure 21. In cross-section, the collision posts have an I-beam shape. These posts were fabricated from sheet steel, and the widths of the two flanges are different. The collision post webs also included doublers, which extended from the base up to a point approximately 762 mm (30 inches) above the floor.

The coil struck one of the cab cars collision posts and it fractured. The fracture occurred near the impact point, which corresponds to the location where the doublers on the flanges ended. The fracture of the collision post is shown in Figure 22.
