## **A Management Plan for Historic Bridges In Virginia: The 2024 Update**

**Final Report VTRC 26-R03**

**A MANAGEMENT PLAN FOR HISTORIC BRIDGES IN VIRGINIA:  
THE 2024 UPDATE**

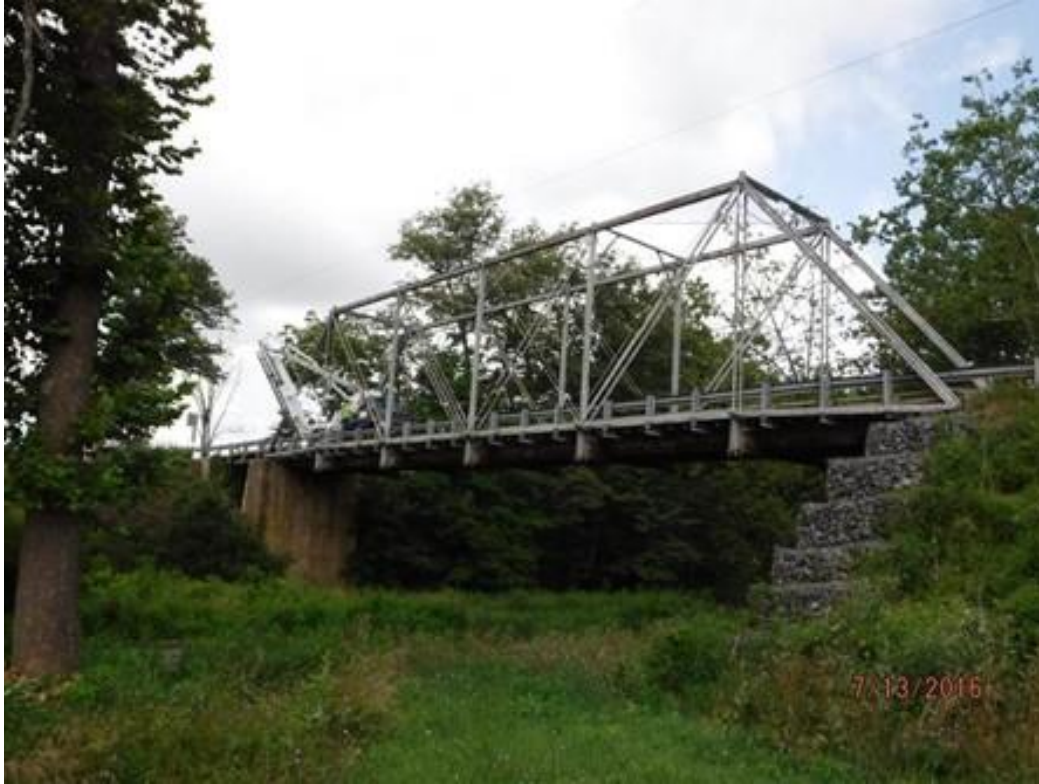
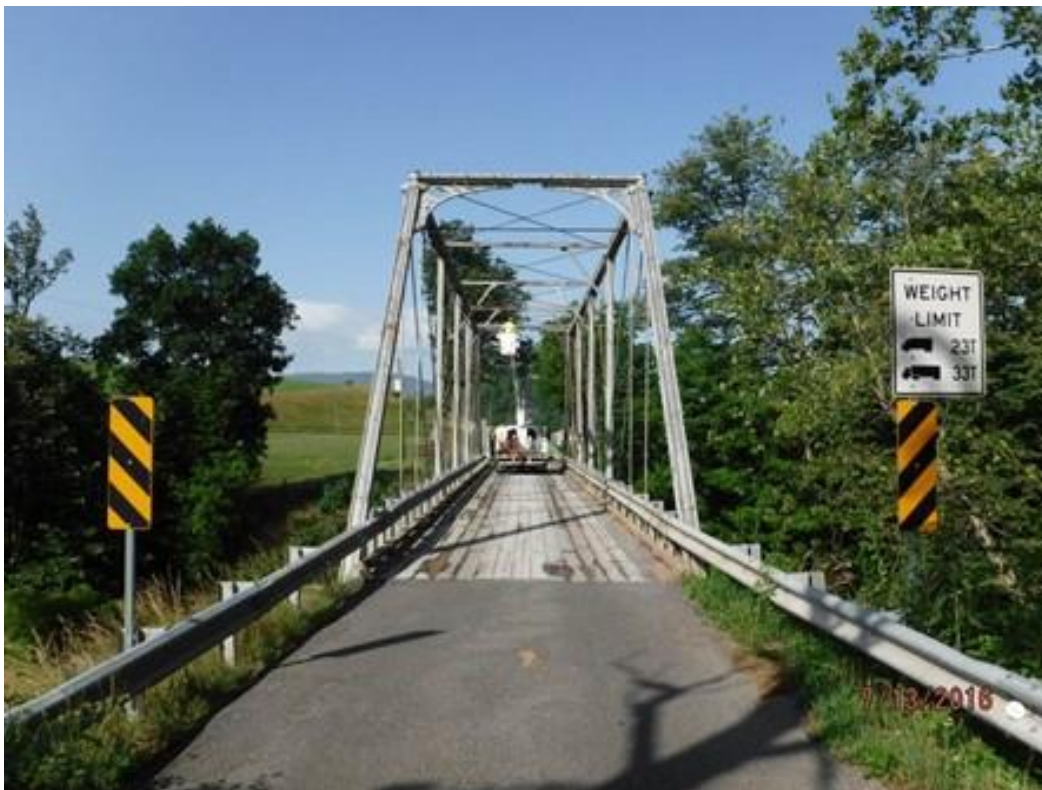
**Figure B7. Wythe County Structure No. 6016**

- The structure is closed to traffic [the rating in the 2017 report was 6-4-5].
- Rehabilitation planning, including environmental and cultural resource review, has been completed. The planned rehabilitation work is in accordance with the Recommended Treatment in the 2001 Management Plan.

*Current Historic Structures Task Group Observations and Recommendations:* This structure was not considered for task group recommendations in the current Management Plan update because of the current rehabilitation project. However, the task group supports the planned rehabilitation of this bridge.

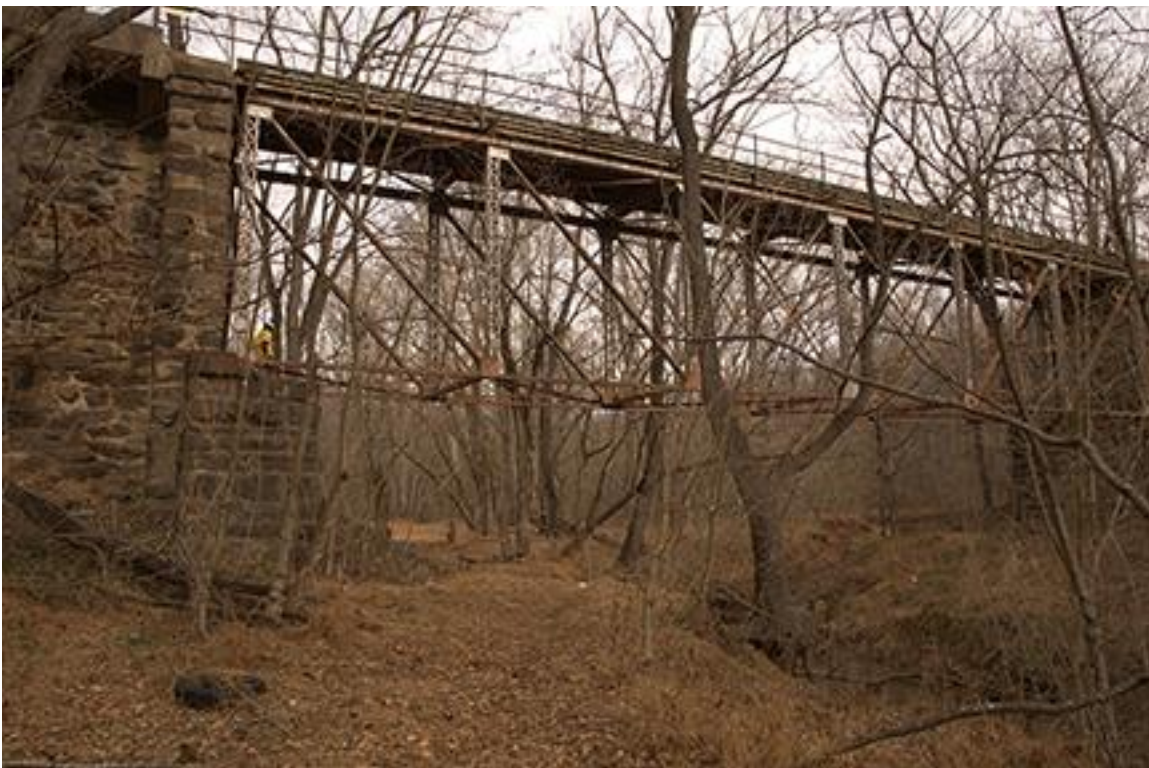
**Figure B9. Bedford County Structure No. 6087**

*Condition:* The current inspection report indicates that this structure is in fair condition. The truss members and rivets exhibit areas of corrosion, pack rust, and section loss. Much of the paint topcoat is gone. Large trees have fallen in the creek, and there is a large accumulation of debris on the bearing seats. There are sections of broken and deteriorated decking boards. There is vegetation on and near the structure.

*Current Historic Structures Task Group Observations and Recommendations:* The current inspection report indicates that this structure is in poor condition. Previous repairs are in accordance with Recommendation 1 in the 2001 Management Plan. The task group defers further recommendations pending the results of the consultant’s evaluation.

- The consultant's evaluation of the structure, as noted in the 2017 update, was completed. The results indicated that it is feasible to rehabilitate the structure. The deck truss will be fully rehabilitated, and the stone masonry abutments will require only minor repointing. Rehabilitation planning, including environmental and cultural resource review, has been completed. This project is scheduled for advertisement in late 2024.
- This work would be in accordance with Recommendation 1 in the 2001 Management Plan.

1. Repair and maintain for vehicular use on-site, with subsequent preventive maintenance as needed. With repairs, the structure can stay in service as long as the traffic demand does not increase. The condition problems of this structure need to be addressed, particularly the deterioration of the gusset plates. The abutments should be cleaned off; debris should be cleaned from the bridge (via pressure washing). Much of the paint topcoat is gone, and the primer is lead-based. The primer should be tested; if it is in good condition, the structure would benefit from a topcoat, and this would extend the life of the truss; spot painting and zone painting could also be considered. A deck membrane and overlay should be considered. Vegetation should be removed from on and near the structure.

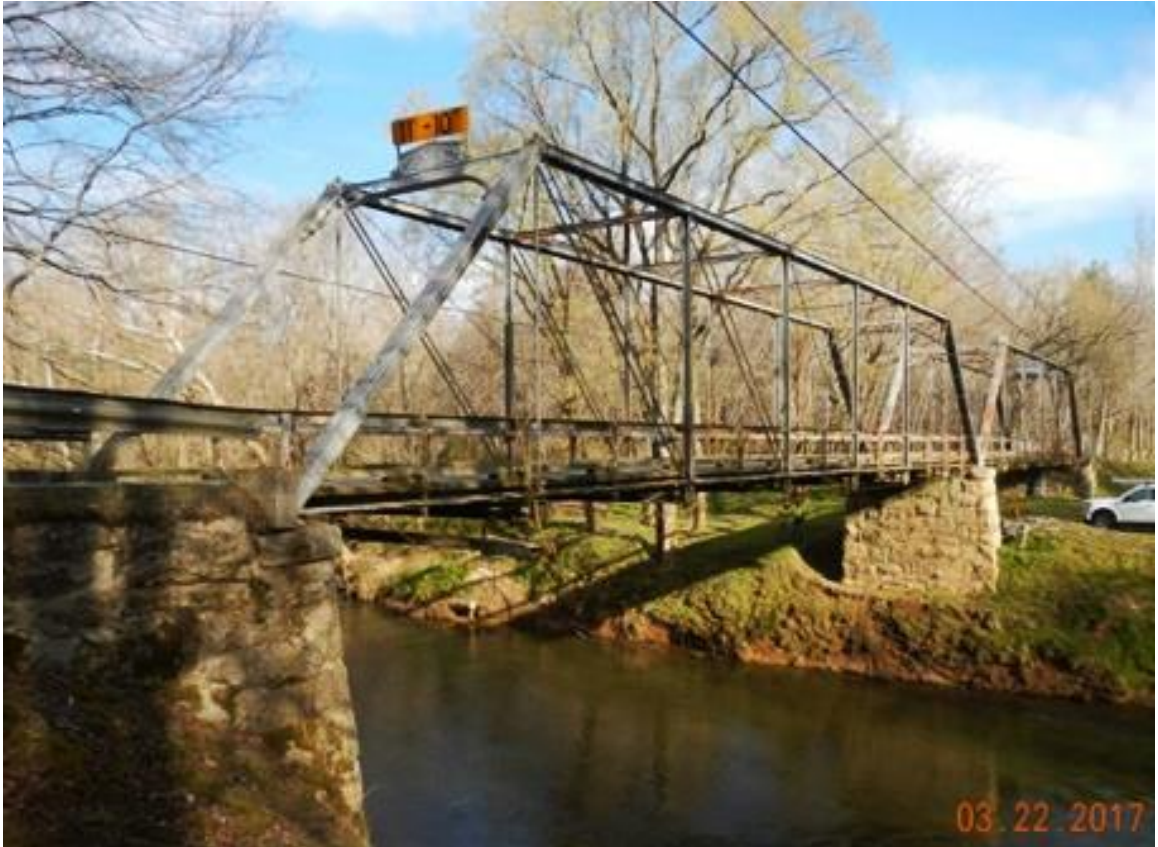
**Figure B15. Brunswick County Structure No. 6104**

- The bridge has been closed since 2021 [the rating in the 2017 report was 8-5-7; this was prior to the extensive damage in September 2021].
- The bridge has been closed since 2021 [the ADT in the 2017 report was 760; this was prior to the extensive damage in September 2021].
- Rehabilitation planning, including environmental and cultural resource review, has been completed. The district anticipates that the project will be advertised in late 2024.
- This is a wrought iron bridge. Given the age and structure of the bridge, vehicle use of the bridge should be limited. Posting reportedly will be kept at 3 tons after rehabilitation.

*Current Historic Structures Task Group Observations and Recommendations:* This structure was not considered for task group recommendations in the current Management Plan update because of the current rehabilitation project. However, the task group supports the planned rehabilitation of this bridge.

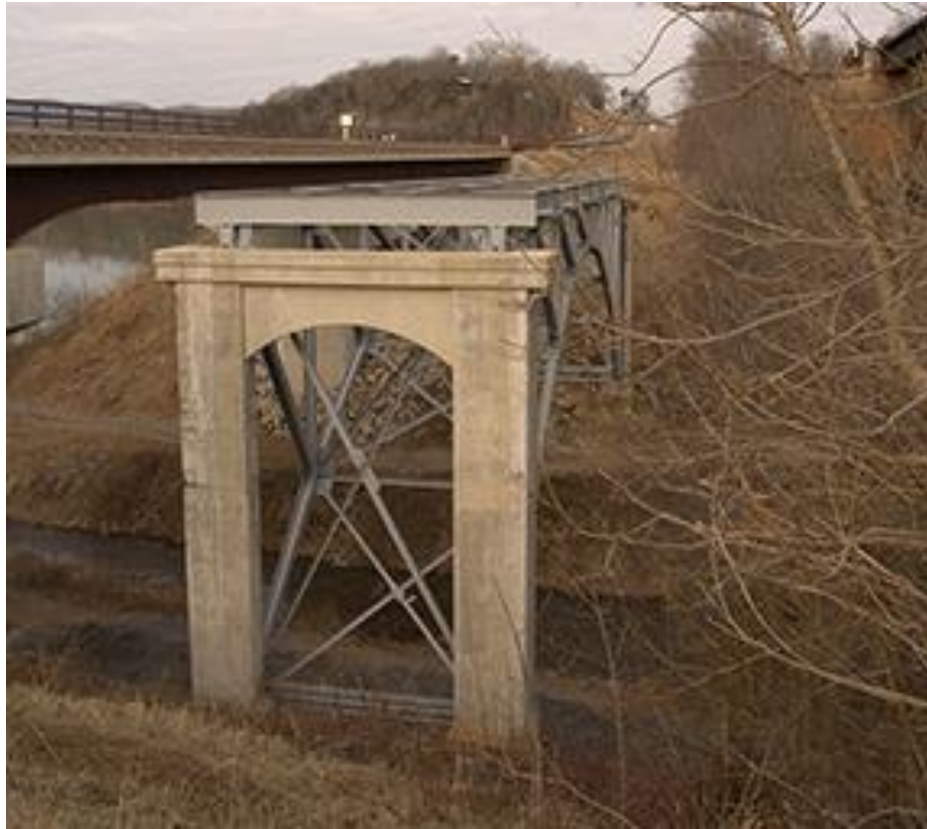
**Figure B18. Page County Structure No. 9001 (Formerly No. 1990)**

- The rating is N-3-4 (reflecting the fact that the deck has been removed); previous post-closure inspection data reflected the bridge's 2007 rating of 4-3-4.
- The structure is closed to all traffic/public access.
- Per the original and amended Memoranda of Agreement, the structure is still preserved in place as a landscape feature and historical exhibit, and is still utilized for paint system evaluation by the district structure and bridge office. It remains closed to all traffic/public access.

*Current Historic Structures Task Group Observations and Recommendations:* Currently, the original and amended memoranda of agreement are being followed. Along with its use as a landscape feature and an historical exhibit, the bridge is still serving an additional purpose in paint system evaluation. The task group continues to support the fulfillment of the memoranda of agreement and the continued use of the structure for paint system evaluation.

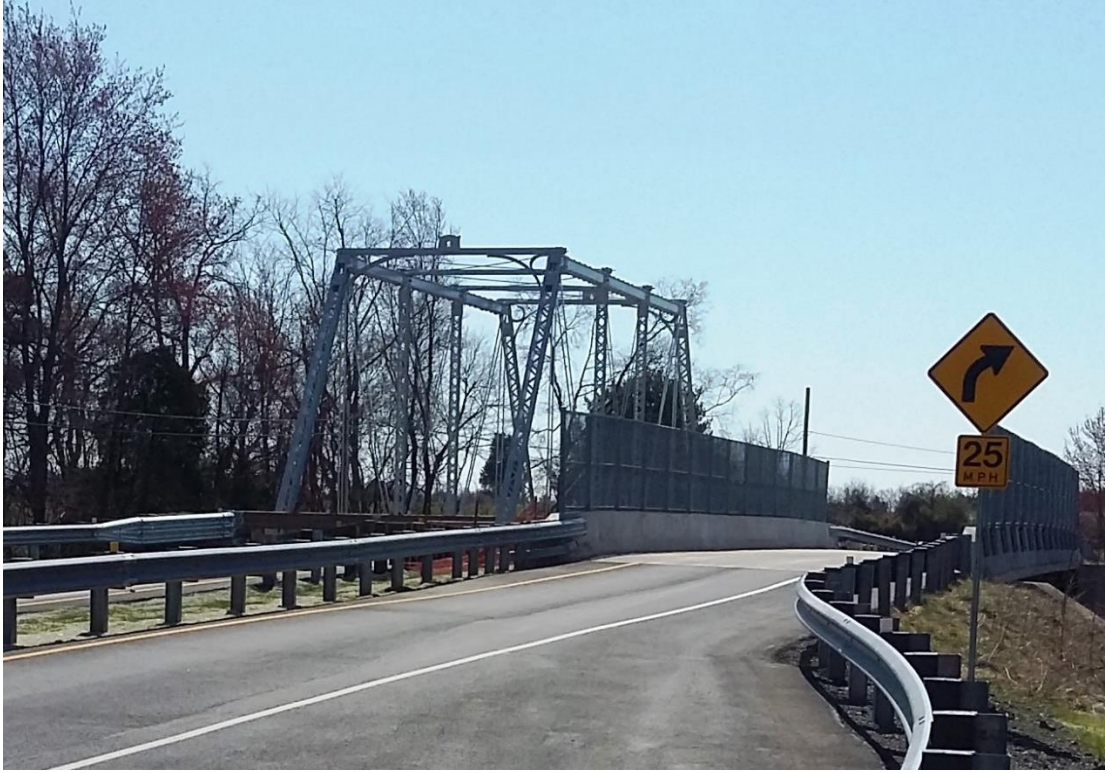
**Figure B21. Prince William County Structure No. 6023 (After Reconstruction, with a New Parallel Span)**

- The rating is 8-7-7 [effectively, this rating relates to the beam structure; per the inspection report, the “Truss that is present is cosmetic and carries no load” and the structure is now considered a “stringer multi-beam girder.”; the bridge had been closed and was disassembled at the time of the 2017 update].
- ADT: The current ADT is 2769 [the bridge had been closed and was disassembled at the time of the 2017 update].
- The inspection report does not identify any major points of concern.

*Current Historic Structures Task Group Observations and Recommendations:* The current inspection report indicates that this structure (including the old truss components) is in good condition. The recent rehabilitation was in accordance with the Recommended Treatment in the 2001 Management Plan (this structure was not considered for task group recommendations in the 2017 Management Plan update because of ongoing Section 106 review). The task group recommendation is to continue maintenance and repairs if needed for vehicular use, with subsequent preventive maintenance as needed.

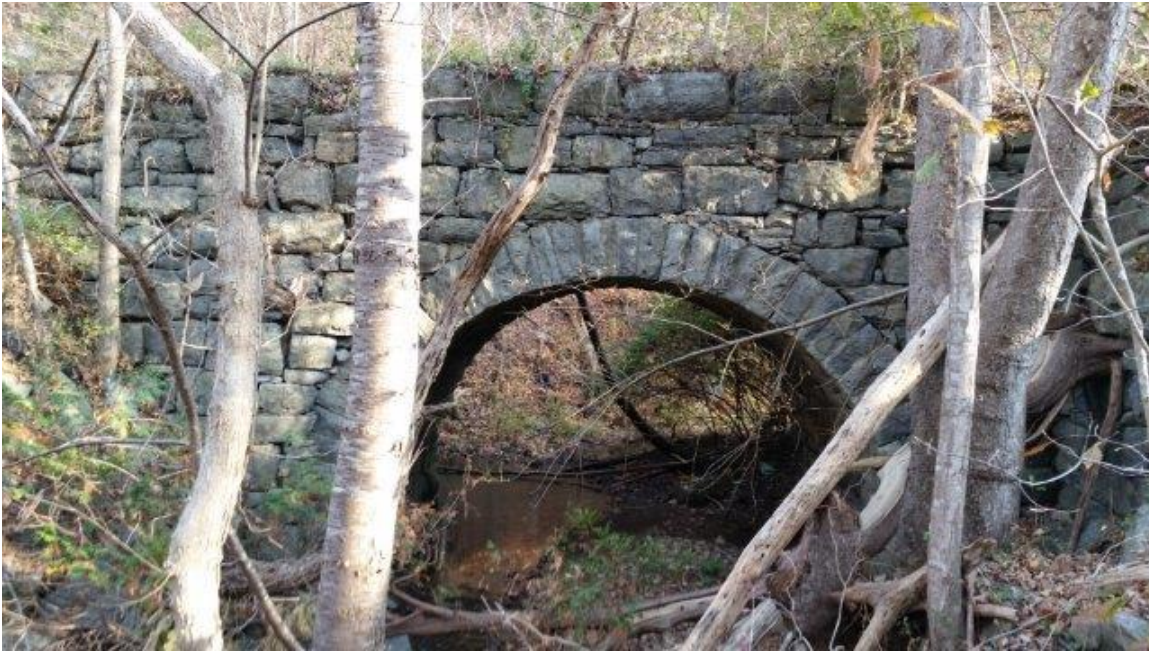
**Figure B23. Southwestern Turnpike Company Bridge, Wythe County**

- The district structure and bridge office is also monitoring vegetation on the bridge. Small trees and other vegetation encroaching on the bridge are being removed as needed to prevent these from damaging the structure.
- The district structure and bridge office reports no condition or repair updates.

*Current Historic Structures Task Group Observations and Recommendations:* The task group reiterates the recommendations of repair and maintain for adaptive use, with subsequent preventive maintenance as needed, in the 2001 Management Plan.

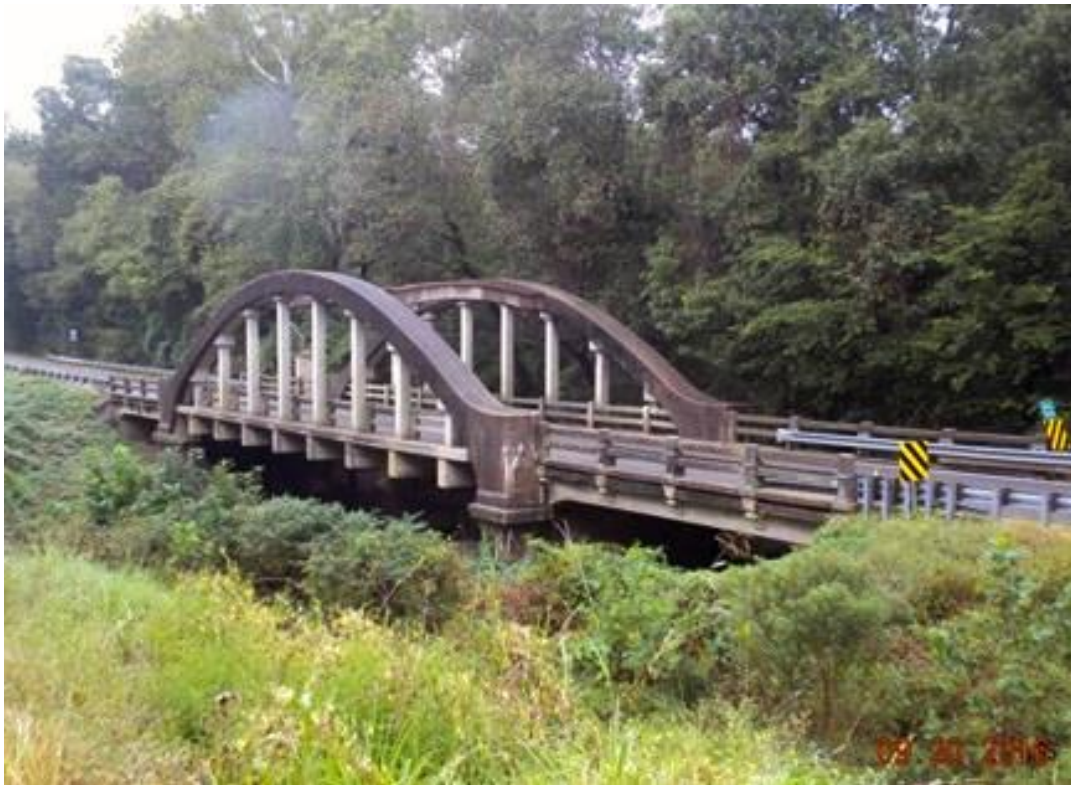
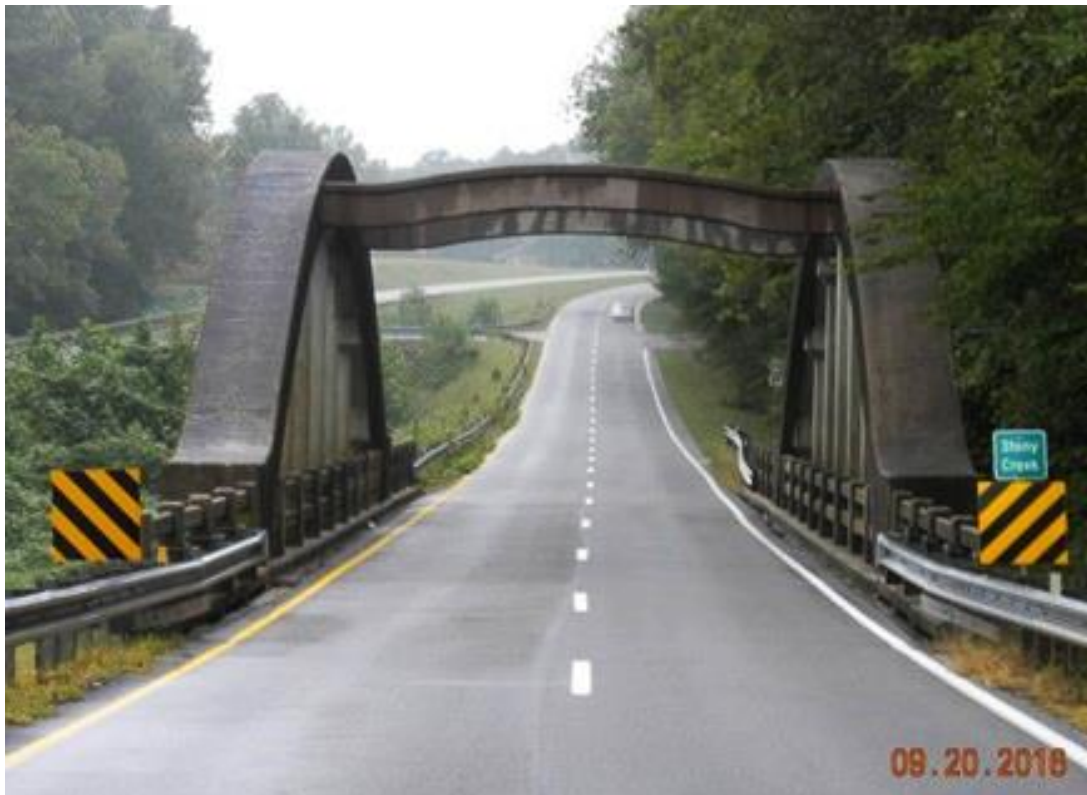
**Figure B26. Dinwiddie County Structure No. 1005**

*Current Historic Structures Task Group Observations and Recommendations:* The current inspection report indicates that this structure is in fair condition. Previous repairs are in

accordance with Recommendation 1 in the 2001 Management Plan. The task group reiterates the recommendations of (continued) repair and maintain for vehicular use, with subsequent preventive maintenance as needed, in the 2001 Management Plan.

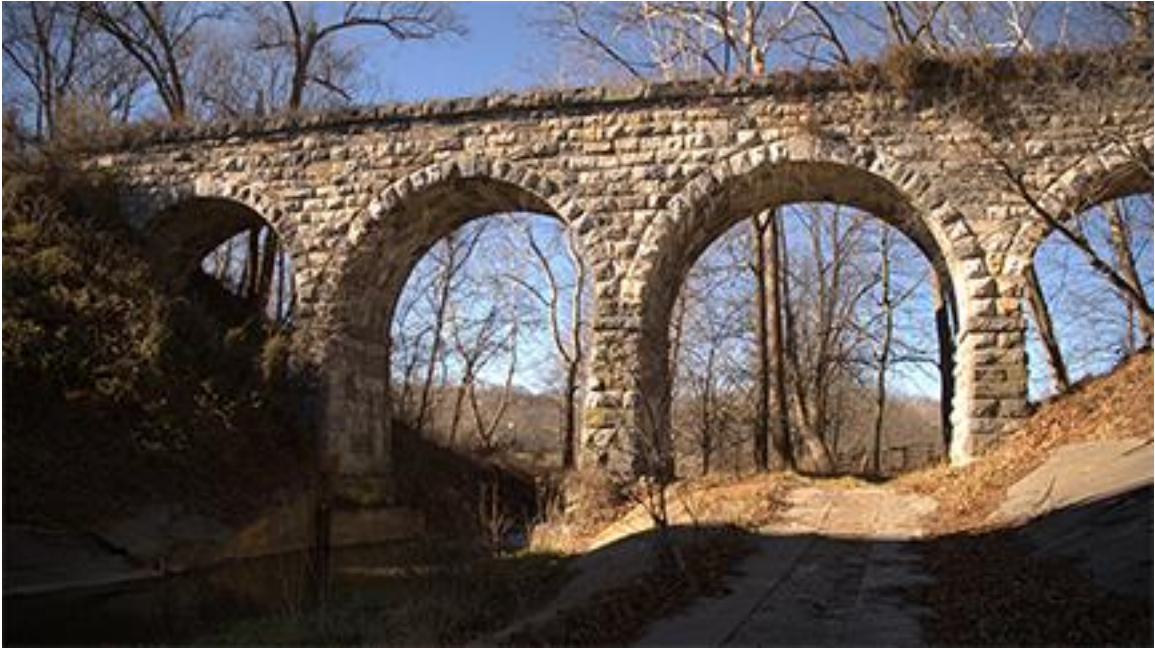
**Figure B29. Augusta County Structure No. 6997 (Valley Railroad Bridge)**

- The structure remains as a landscape feature within the I-81 right of way and is closed to all traffic. There is no public access allowed onto the bridge.
- There still is a need for increased drainage, and to relieve the weight of saturated soil, on this structure. Additionally, the cracks in the masonry require repair or monitoring.
- The district structure and bridge office is exploring drainage and masonry repair issues on this structure.

*Current Historic Structures Task Group Observations and Recommendations:* The task group reiterates the majority of the Recommended Treatment (excluding the recommendation to pursue a transportation enhancement grant) in the 2001 Management Plan. The task group defers further recommendations pending the results of the district structure and bridge office's further assessment of drainage and masonry repair issues for this structure. However, the task group notes their strong support for maintaining this structure in good condition.

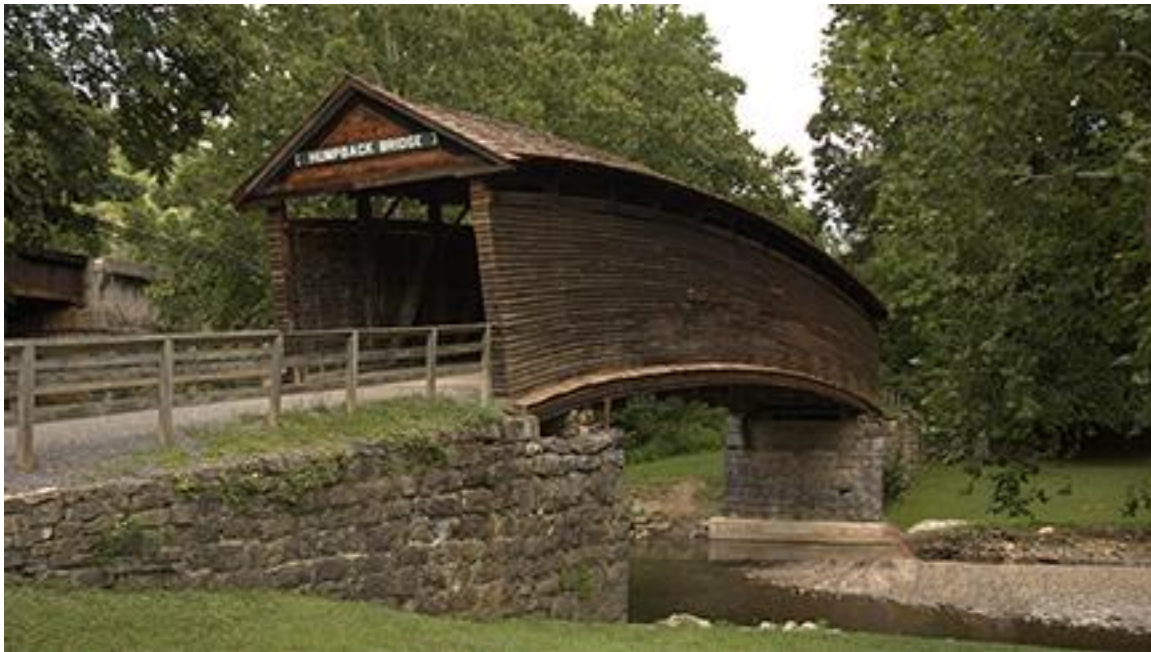
**Figure B34. Alleghany County Structure No. 9007 (Humpback Bridge)**

- Vegetation encroaching on the bridge needs to be removed.
- The cracking and mortar loss on the stone masonry of abutments A and B needs to be monitored.
- The channel scour and embankment erosion at abutments A and B needs to be monitored.

*Current Historic Structures Task Group Observations and Recommendations:* Previous rehabilitation and repairs are in accordance with Recommendation 1 in the 2001 Management Plan. The task group reiterates the recommendations for (continued) repair and maintenance for continued adaptive use, with subsequent preventive maintenance as needed, in the 2001 Management Plan.

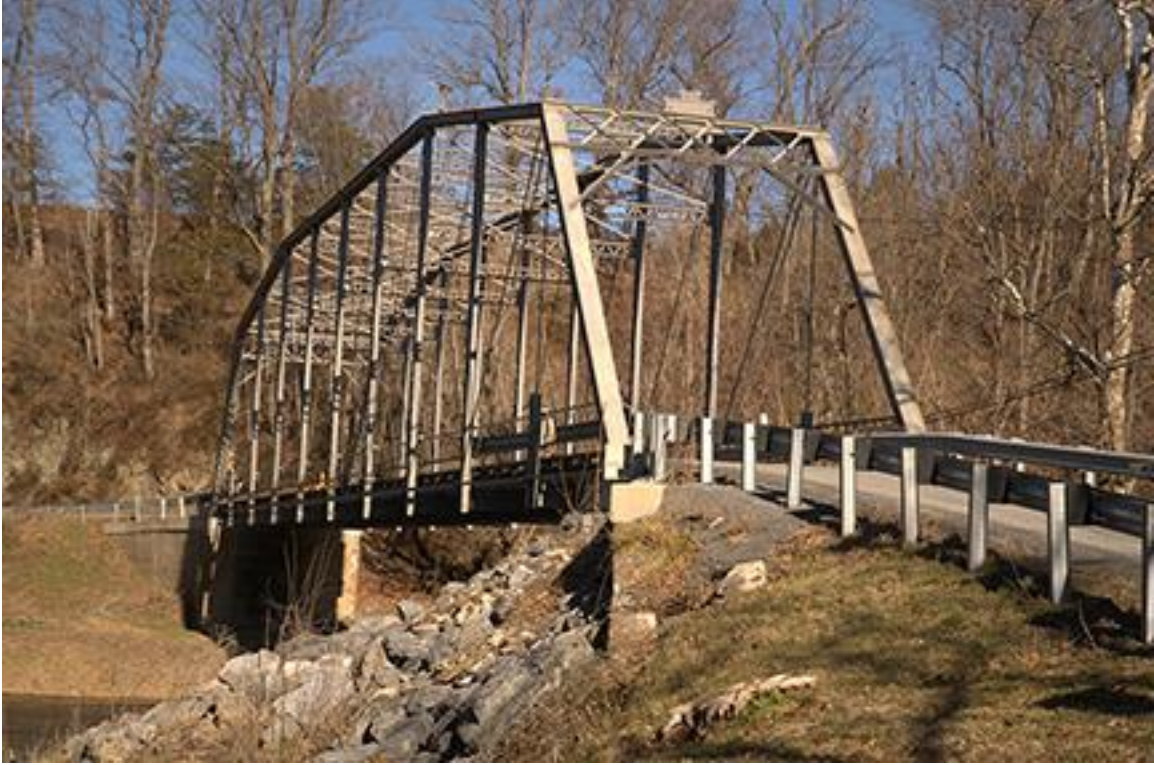
**Figure B38. Augusta County Structure No. 6149**

- Following evaluation of the structure by the district structure and bridge office, the district structure and bridge engineer made the decision that further repairs and rehabilitation were not feasible, and the bridge was permanently closed to vehicular traffic in February 2024.
- The bridge is currently in Section 106 review.

*Current Historic Structures Task Group Observations and Recommendations:* This structure was not considered for task group recommendations in the current Management Plan update because of ongoing Section 106 review.
