1. Report No. TX-99/2966-2	2. Government Accession No.	3. Recipient's Catalog No.	
4. Title and Subtitle FLY-ASH BASES IN THE ATLANTA DISTRICT: EVALUATION OF SURFACE TREATMENT BOND AND YEAR-TWO FIELD PERFORMANCE EVALUATIONS		5. Report Date December 1998

**FLY-ASH BASES IN THE ATLANTA DISTRICT:
EVALUATION OF SURFACE TREATMENT BOND
AND
YEAR-TWO FIELD PERFORMANCE EVALUATIONS**

Report 2966-2
Project Number 7-2966
Research Project:
Durability of Surface Treatments as the Wearing Course
Placed on Crushed Fly Ash and Long-Term Performance
of Crushed Fly Ash for Flexible Base

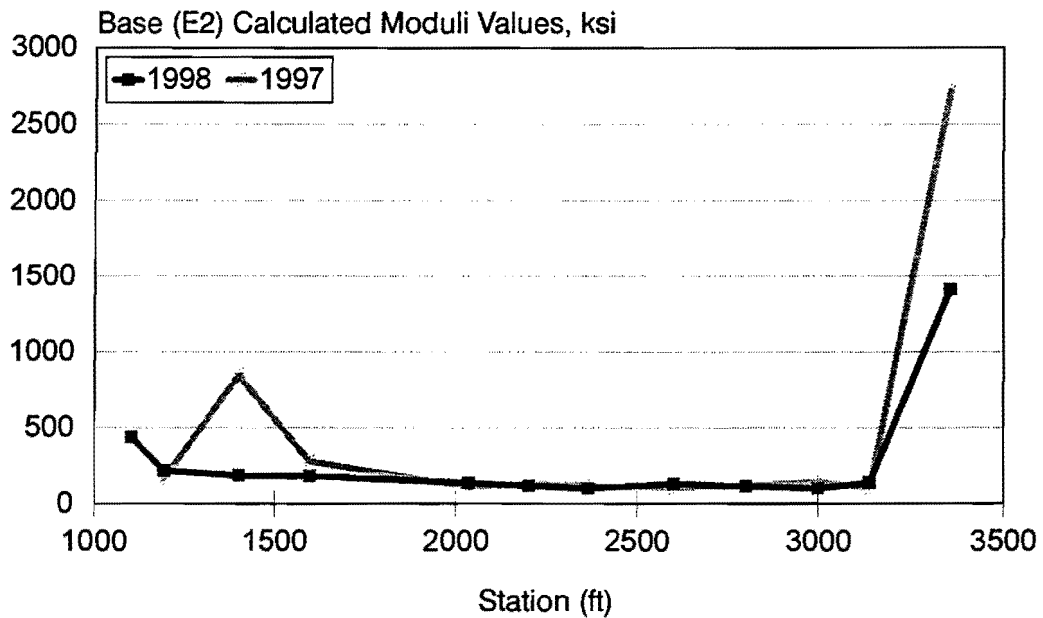
Figure 8. Base Moduli Values for IH 20 Frontage Road

Three cores were obtained from this pavement as shown in Figure 6. Last year, this pavement exhibited the highest compressive strength but there was a loss in strength as noted with the cores taken in 1998. However, there doesn't seem to be an appreciable difference in the base moduli values from 1997 to 1998 (Figure 8). Note in Figure 8, that the last data point may coincide with the beginning of a different type of pavement section.

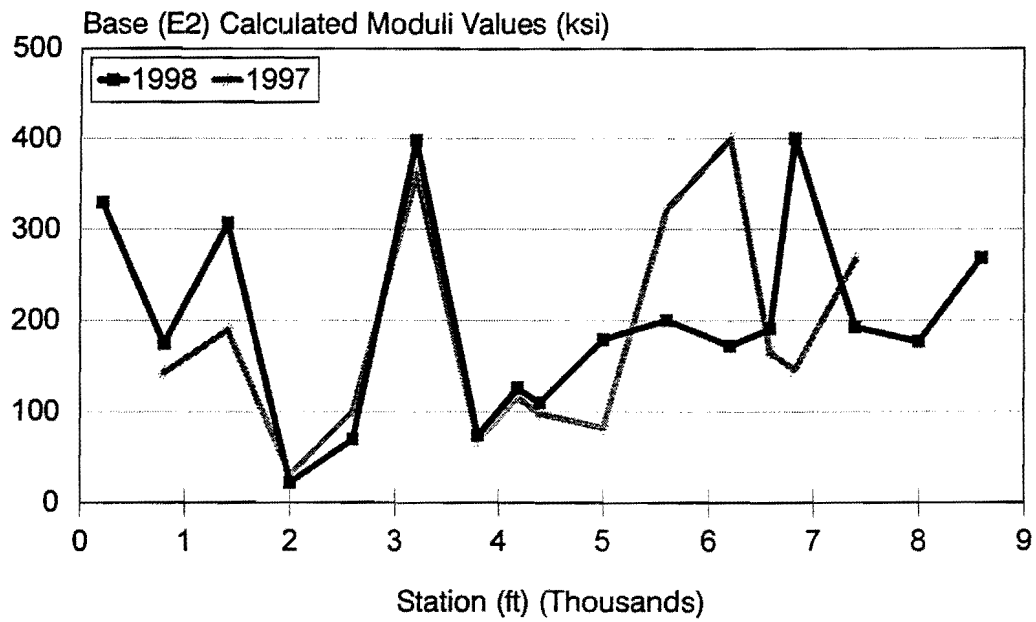
Figure 11. Base Moduli Values for FM 1520

Three cores were obtained from FM 1520 and two of the three cores showed a significantly greater compressive strength than the previous year. FWD data (Figure 11) on this pavement indicates that there is no significant change between 1997 and 1998.

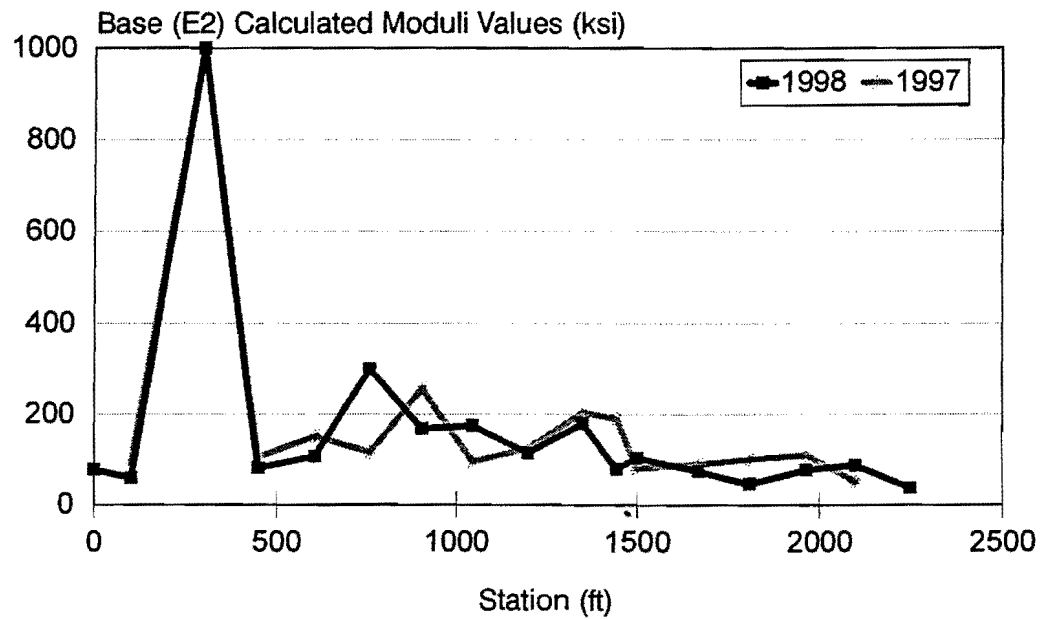
Figure 12. Base Moduli Values for FM 560.

All three cores obtained from FM 560 had a higher compressive strength than the cores obtained the previous year. The base on this pavement has two different thicknesses along its length: 9 inches and 16 inches. Because of the difference in thicknesses, two separate FWD analyses were performed as shown in Table 14. Results from both analyses, however, were combined for Figure 12. Moduli values for this pavement do not appear to be as variable as on some of the others; however, the values are lower than the desired minimum of 145,000 psi. Also, however, there seems to be little change in moduli values between 1997 and 1998.
