# **FRA/Volpe Center Task Force Observation of Operations at TVE Transrapid Test Facility, Addendum**

**April 5 to June 4, 1993**

DOT-VNTSC-RR493-PM-93-1A  
December 1993

Prepared by the Federal Railroad Administration/Volpe National Transportation  
Systems Center High Speed Guided Ground Transportation Safety Task Force

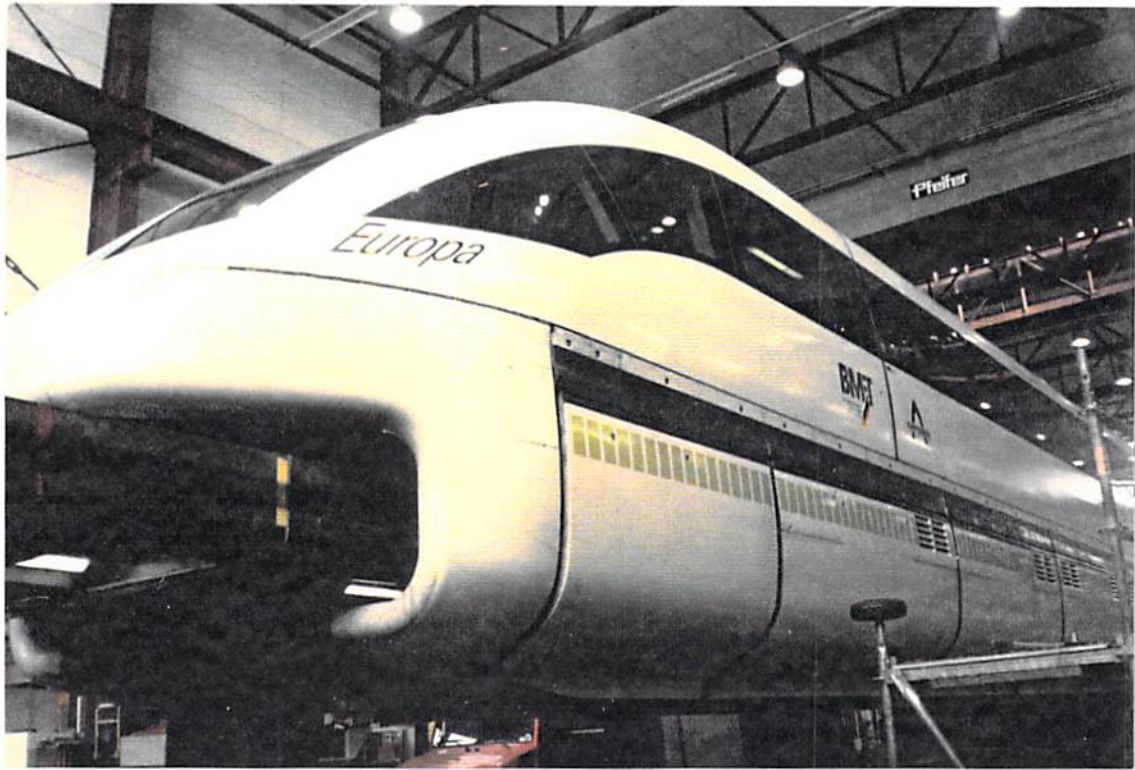
Figure 1. TR07 Vehicle with BMFT Logo

Figure 1 shows the TR07 vehicle with its new BMFT logo, replacing the Transrapid logo. New front magnets with new gap sensors and sloped leading edge have been installed, as shown in Figure 2. The new magnets have improved the vehicle's ability to detect and avoid any loose stators along the guideway. Replacement of all of the remaining magnets is planned for late this year. All of the stators in the guideway have now been examined, and the southern loop is fully operative. However, a better way to attach the "nutstein" to the guideway, using various mechanical devices, is being studied; two options are shown in Figure 3.

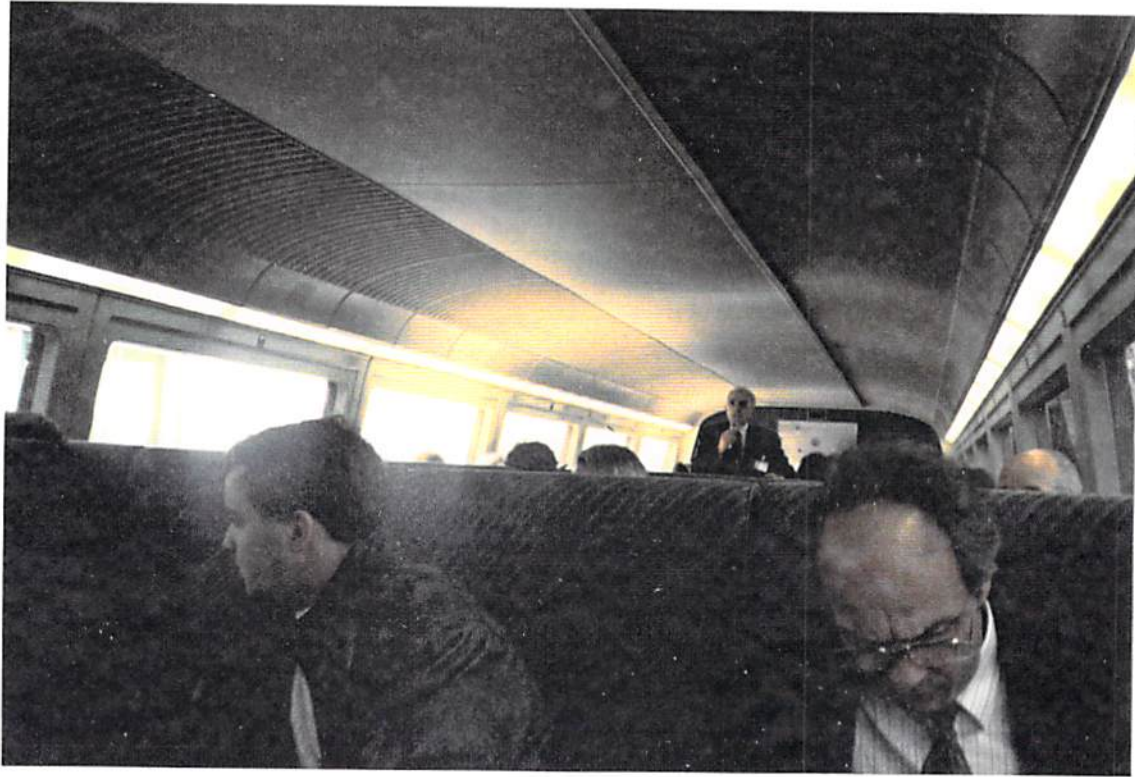
Figure 4. Interior of TR07 Passenger Section

The Task Force observer rode the TR07 vehicle twice with other visitors, including the Mayor of Frankenberg-Parchim, several DB-Rhine employees, and Dr. and Mrs. Scott Phelan of the Massachusetts Institute of Technology (MIT). Dr. Phelan worked on maglev concept and design with Dr. Thornton of MIT. (Figures 4 and 5 show the interior of the vehicle.) The vehicle accelerated very fast and reached about 300 km/h at the end of the curve on the northern loop and reached its maximum speed of 400 km/h for a few seconds on the straight Kanalstrasse section of the guideway before slowing down for the southern loop. The ride was rough in the beginning, but became smoother at the top speed. It was very noisy at higher speeds.

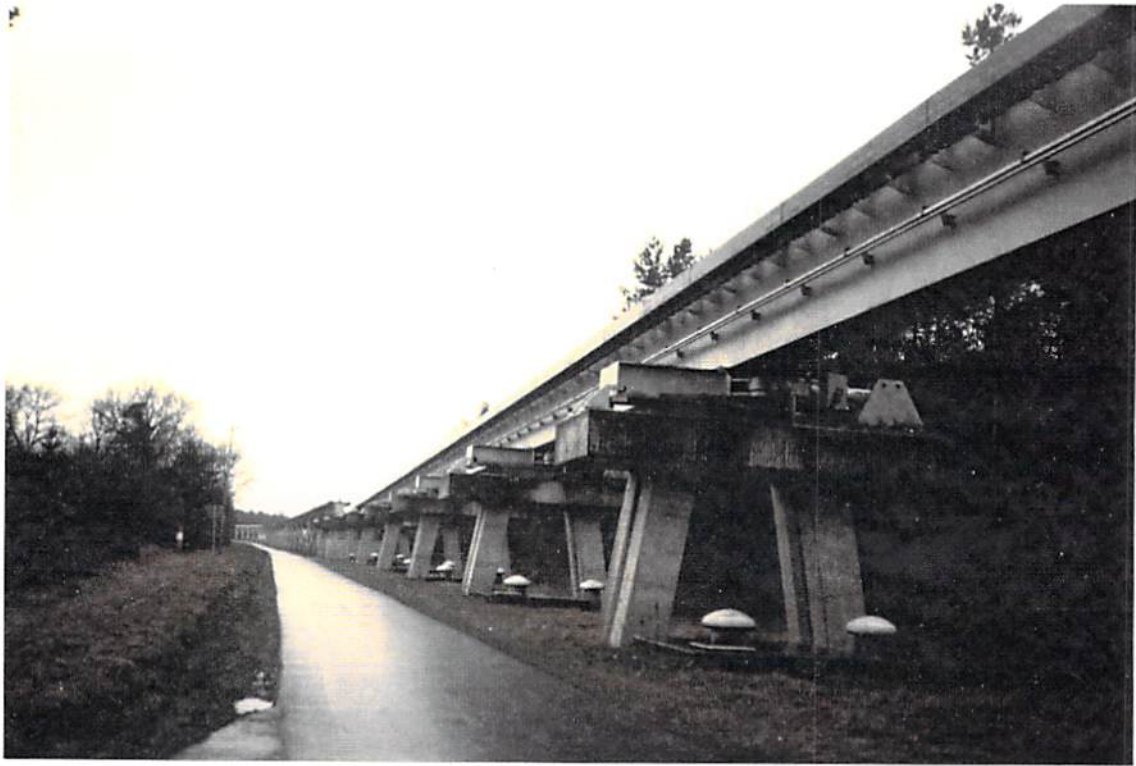
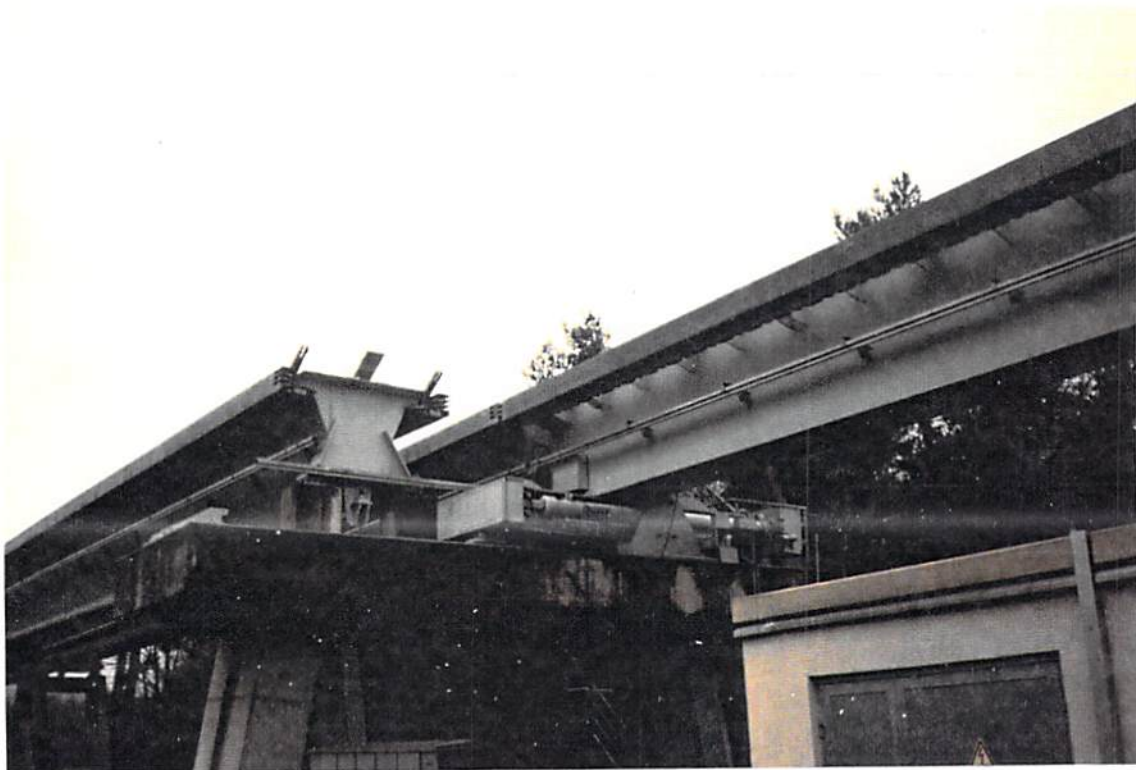
Figure 6. Switch 3 (Two Views)

Mr. Wiedenmann pointed out the various guideway structures. Two views of the hydraulic high-speed Switch 3, at the southern loop, are shown in Figure 6. The steel span being tested for application in Florida is shown in Figure 7. The three double-span sections being tested near the northern loop are shown in Figure 8. The emergency towing vehicle used to "lubricate" the track before set-down tests is shown in Figure 9.

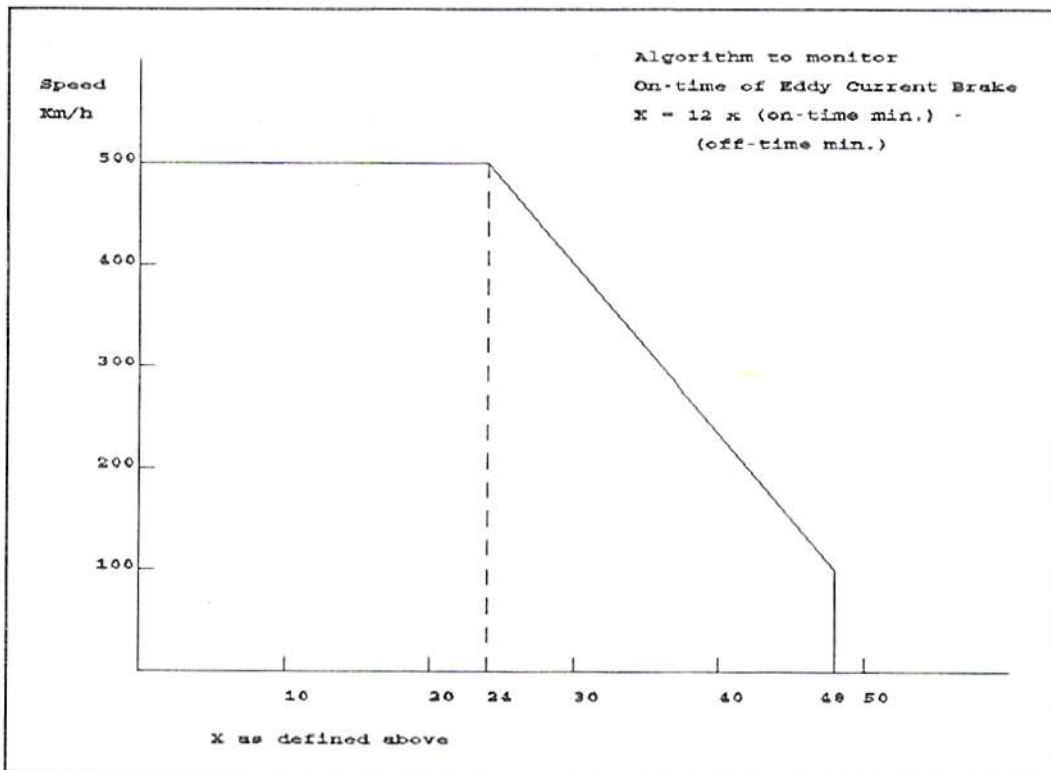
Figure 10. Algorithm for Computing On-Time for Eddy Current Brakes

In the afternoon, travel tests using the entire guideway were performed to verify the efficacy and safe performance of the eddy current brake, wirbelstrombremse (WSB). Five roundtrips of the guideway were completed. The objective was to verify that the BLF speed profile in the BLT II is reduced by continual prolonged cycling of the WSB. The OCS is designed to prevent the vehicle speed from increasing beyond a certain level between applications of the WSB during excessive cycling, to conserve the WSB so that it remains effective for other emergencies. With this feature working properly, the vehicle would continue at a reduced speed after propulsion was restored following a propulsion failure that forced the vehicle to use the WSB. The amount of the speed reduction would depend on previous use of the WSB. (This is shown by the algorithm in Figure 10.)

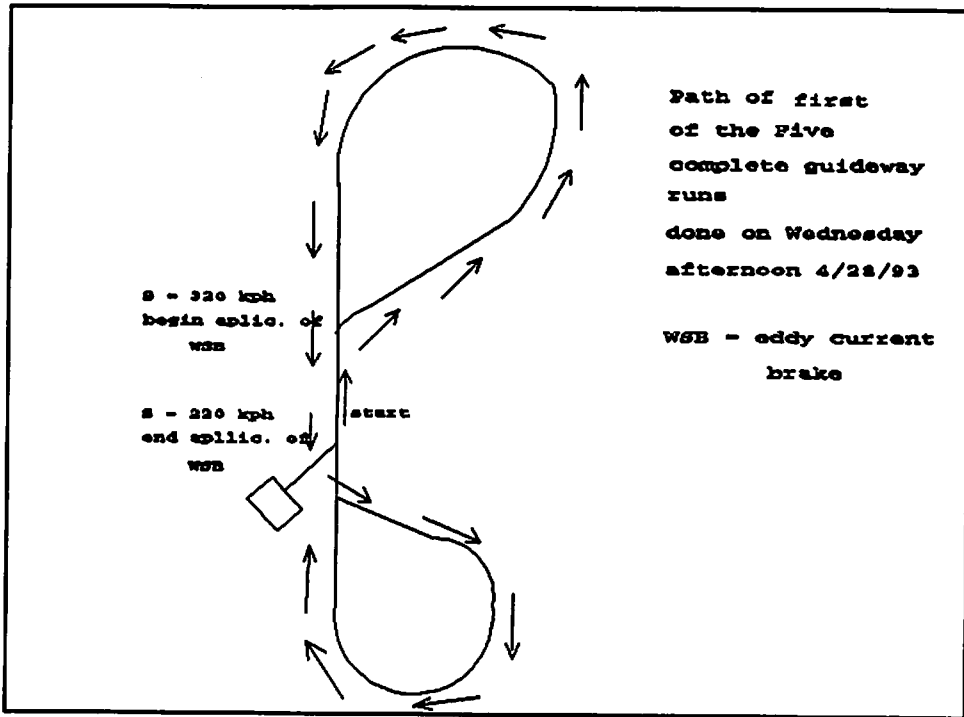
Figure 11. First Complete Loop Around Guideway

The paths taken by the TR07 vehicle during the eddy current brake (WSB) testing are shown in Figure 11. The vehicle traveled north from the station, passed through Switch 2 in turnout (reverse) position, and accelerated as it proceeded around the northern loop. During the first roundtrip, the vehicle reached a top speed of 320 km/h, south of Switch 2. At that point, the WSB was applied. North of Switch 3, the WSB was then released, and propulsion braking was restored to continue to slow the vehicle to the speed needed to pass through Switch 3 in turnout (reverse) position and enter the southern loop. This process was repeated during each of the five roundtrips. During the fifth trip, the speed profile was significantly reduced, allowing a maximum speed of only 210 km/h, as shown in Figure 12.
