Evaluation of Unbonded Jointed Concrete Overlays

ICT Project R27-SP74

September 2025

ICT Series Report No. 25-009

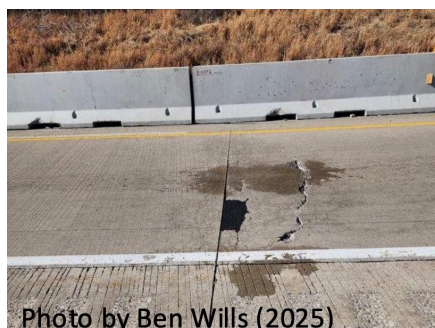
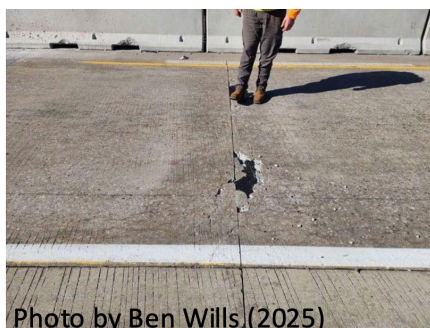
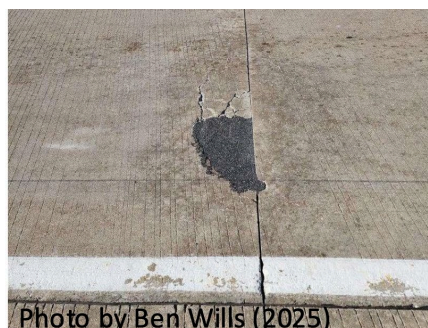
For the southbound JPCP overlay section that was under a counterflow traffic pattern, the distresses shown in Figure 16 (i.e., cracking and spalling near the transverse joint) were reported by an IDOT engineer, Ben Wills. However, the distress development appeared to be a result of the traffic phasing.

Figure 16. Photo. Distresses observed on I-57 southbound lane during head-to-head traffic phasing.

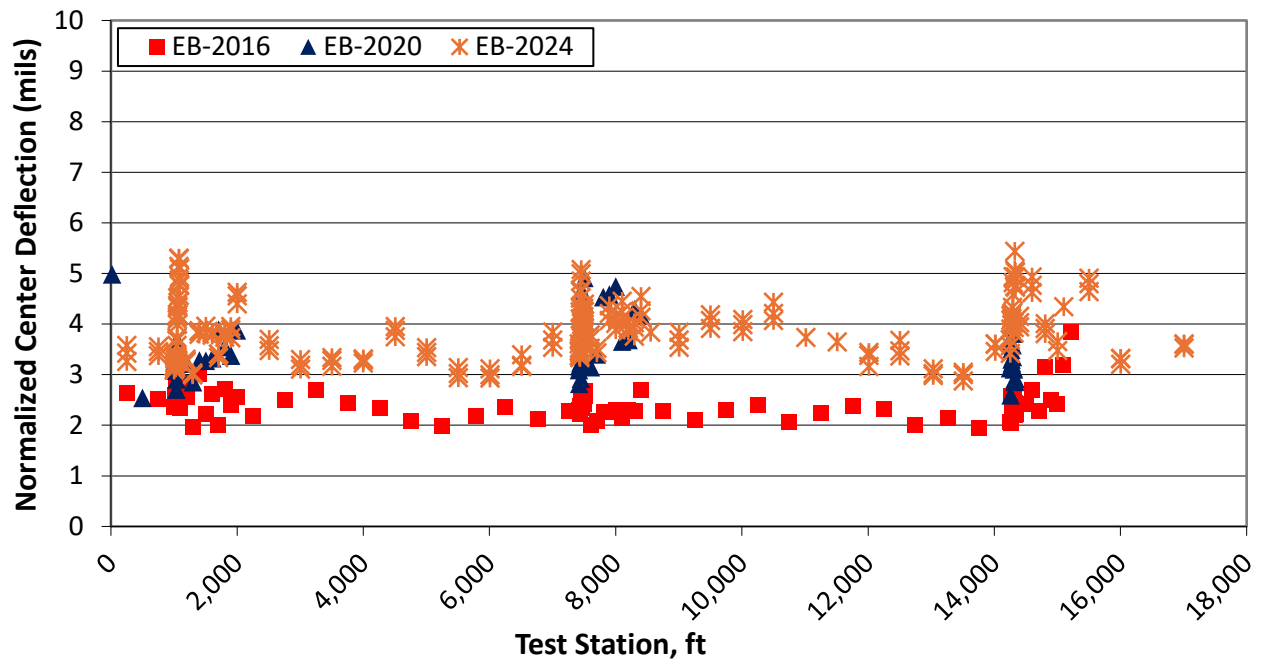
Figure 18 and Figure 19 present the normalized center deflections for various stations in the EB and WB directions, respectively, for the years 2016, 2020, and 2024. Over the span of eight years, normalized deflections increased significantly in both the EB and WB directions, with average increases of 1.45 mil (60%) and 1.18 mil (30%), respectively.

Figure 18. Graph. EB center slab normalized deflections in 2016, 2020, and 2024.

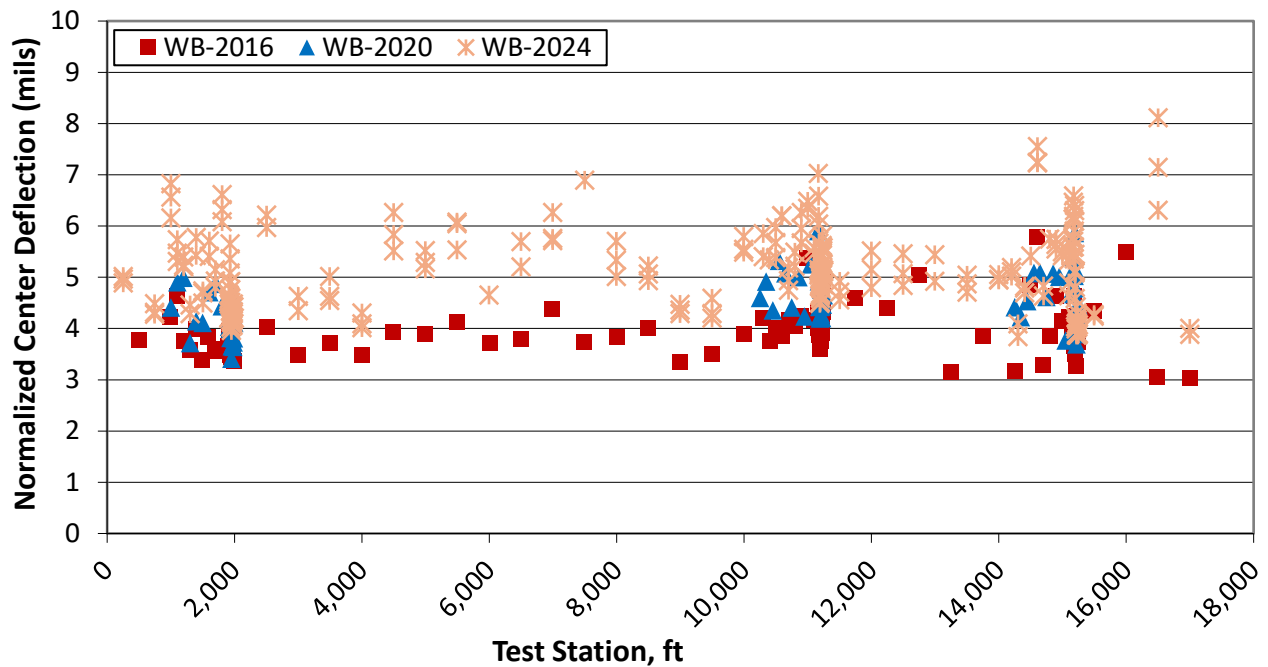
Figure 19. Graph. WB center slab normalized deflections in 2016, 2020, and 2024.

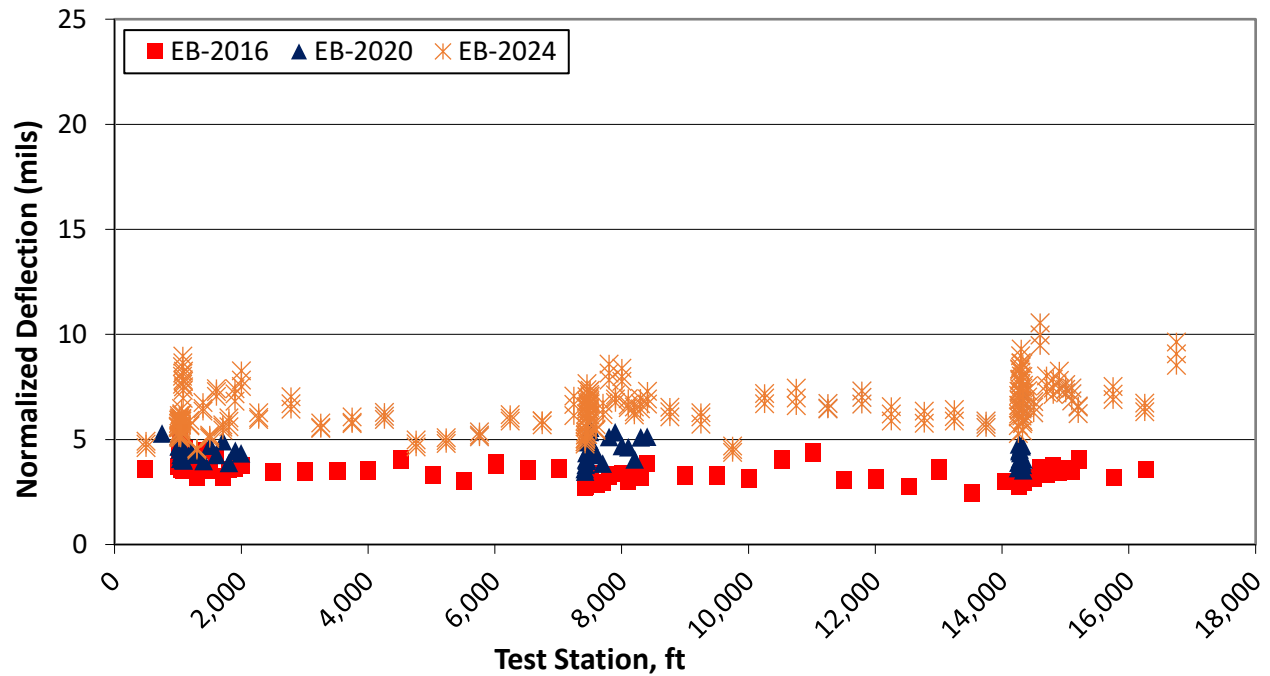
In the EB direction, normalized deflections along the longitudinal lane-shoulder joint peaked between stations 140+00 and 170+00, as seen in Figure 26, but were not always this high or variable. The WB direction showed greater magnitude and variability with deflections reaching up to 24 mils in 2024 (Figure 27). The driving lane-shoulder longitudinal joint exhibited nearly double the normalized deflections in 2024 compared to 2016, with increases of 95% in the EB direction and 84% in the WB direction (see Table 12). Although the percentage increase in deflection is greater for the EB direction, the average WB deflection is more than double the average EB deflection at the lane-shoulder joint. The lane-shoulder longitudinal joint LTE in both directions is shown in Figure 28 and Figure 29. The LTEs declined significantly over the eight-year period, reaching approximately 35% and 26%, respectively, in 2024 (Table 13).

Figure 26. Graph. EB lane-shoulder longitudinal joint normalized deflection (2016, 2020, and 2024).

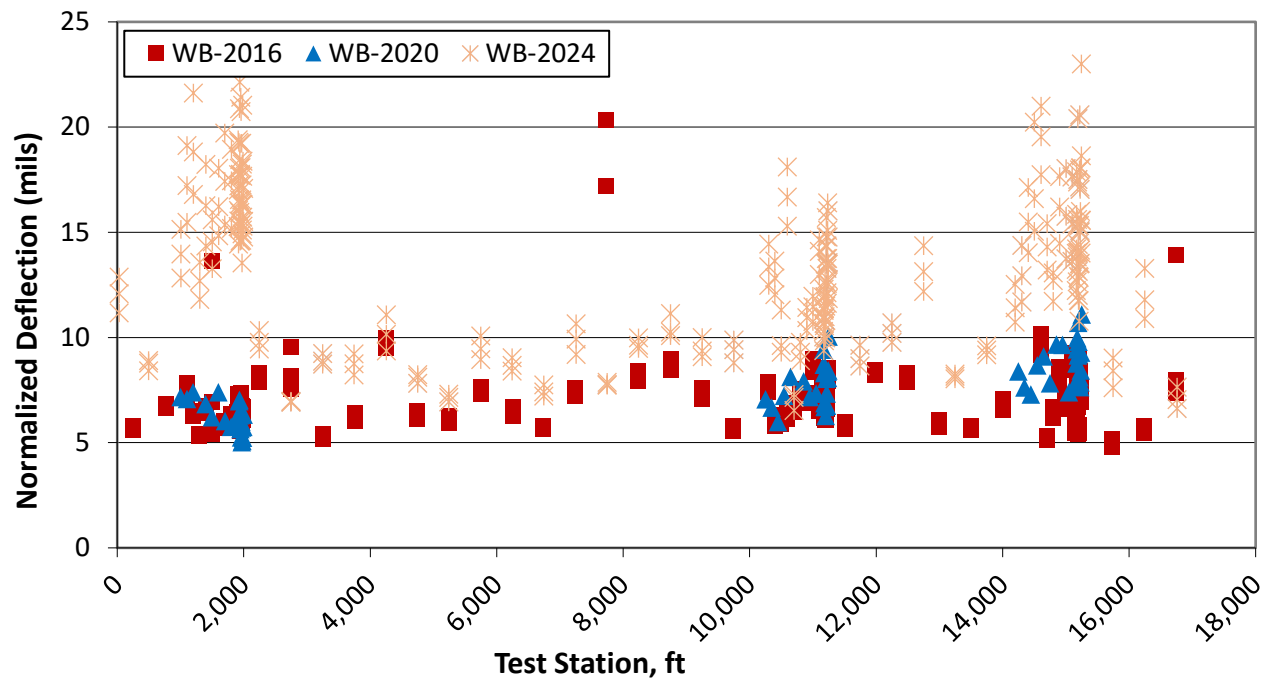
Figure 27. Graph. WB lane-shoulder longitudinal joint normalized deflection (2016, 2020, and 2024).

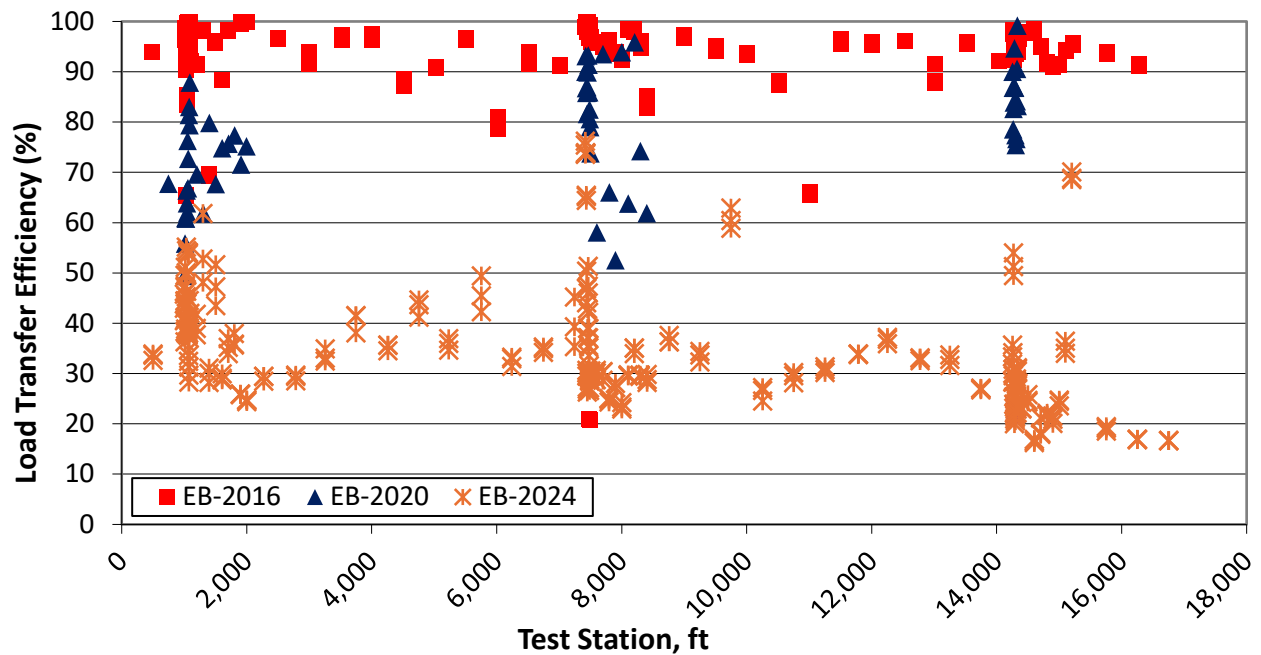
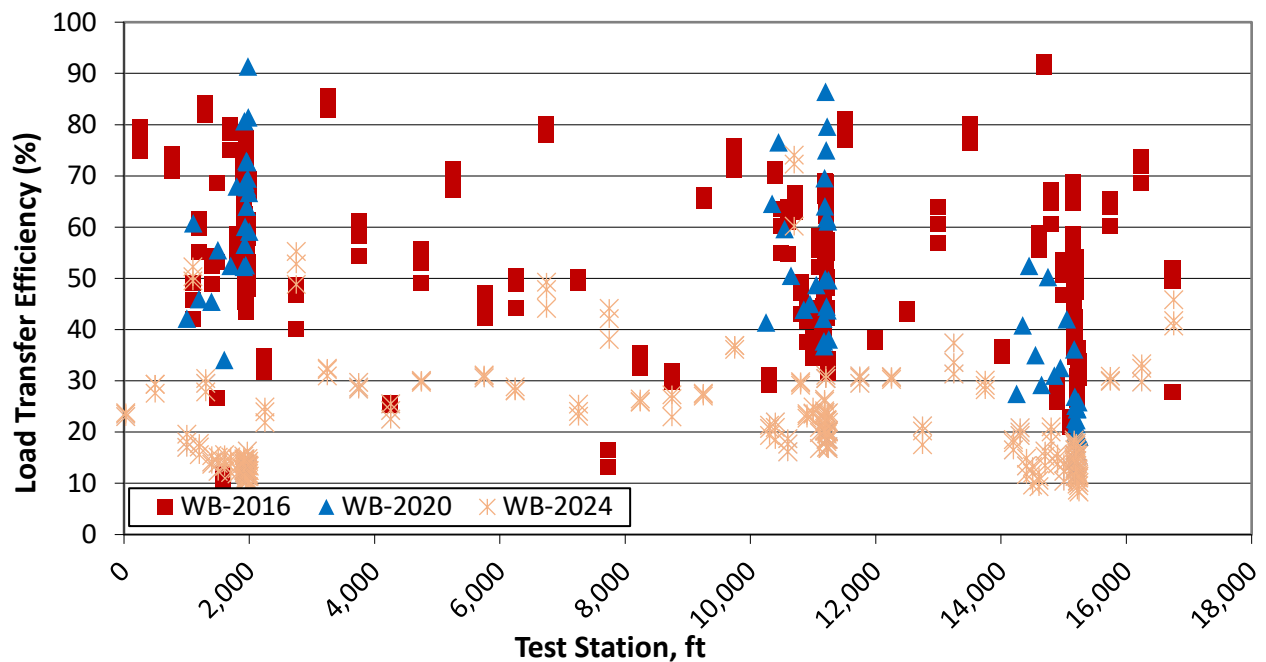
Figure 28. Graph. EB lane-shoulder longitudinal joint load transfer efficiency (2016, 2020, and 2024).

Figure 29. Graph. WB lane-shoulder longitudinal joint load transfer efficiency (2016, 2020, and 2024).

The significant increase in lane-shoulder joint deflection and reduction in the joint LTE in recent years may be indicative of material degradation and erosion occurring at the edge of the driving lane. Stripping and erosion of the HMA interlayer had been noted by DeSantis et al. (2022b) at the lane-shoulder joint while a definitive mechanism had not been determined for the WB lane-shoulder joint deflection increases. Figure 30 and Figure 31 illustrate the relationship between joint LTE and deflection difference across the longitudinal joints. Over time, the data have become increasingly scattered, with LTE showing less sensitivity to deflection differences, particularly at lower LTE values. This weakening correlation is more pronounced in the WB direction, indicating significant progressive deterioration along the longitudinal joints. Notably, this trend is more evident in longitudinal joints compared to transverse joints (Figure 24 and Figure 25), suggesting a greater loss of structural integrity along the longitudinal direction.

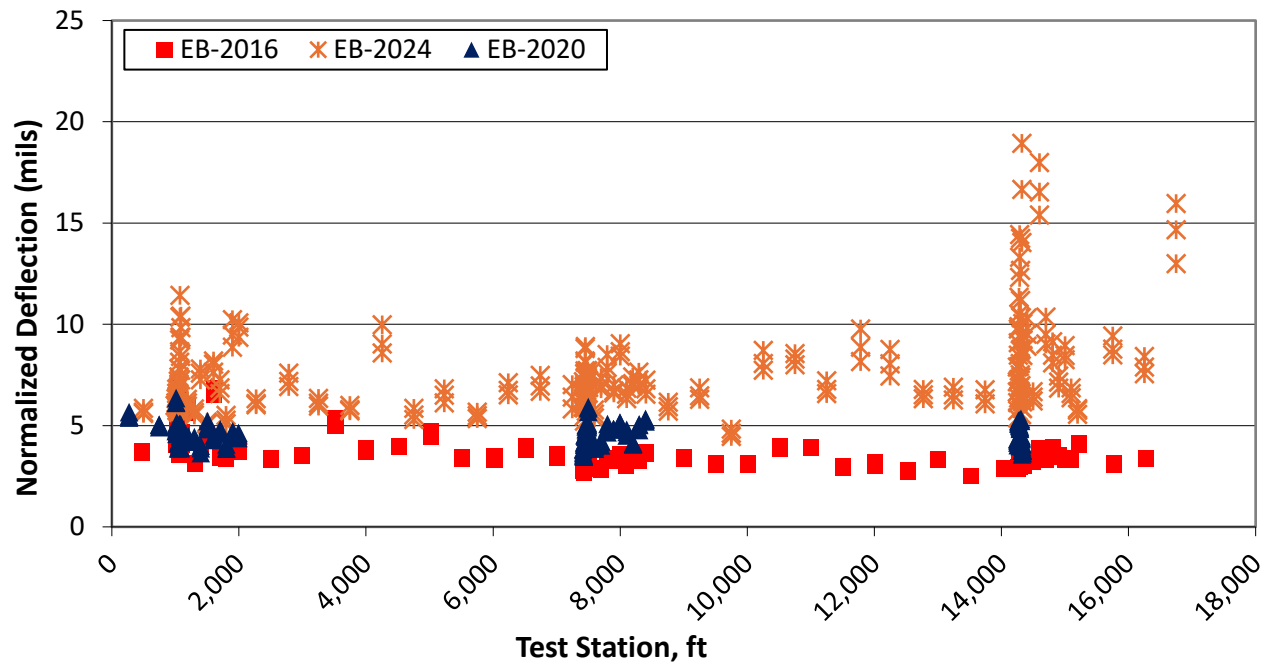
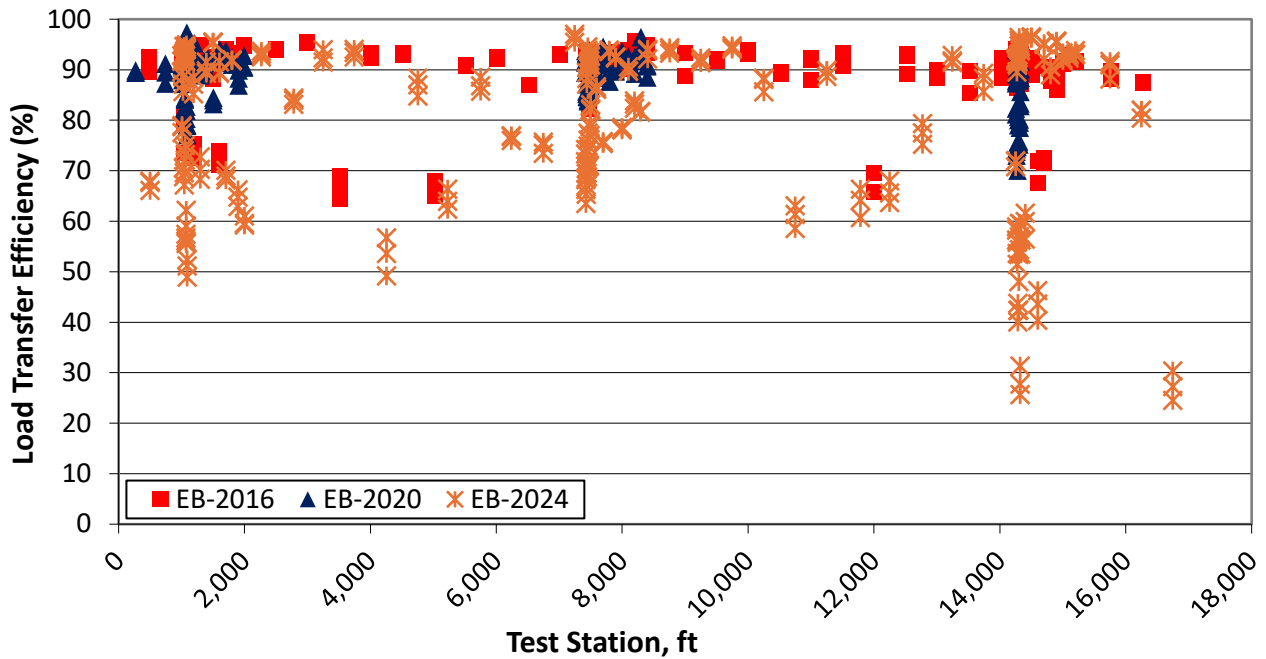
In the EB direction, the slab corners showed the highest normalized deflections and lowest load transfer efficiencies across the transverse and longitudinal joints near the end of the section (i.e., 140+00 ft to 180+00 ft) (see Figure 32, Figure 34, and Figure 36). The WB section exhibited high variability in the deflection and LTE measurements, as seen by the calculated COV values in Tables 14–16, Figure 33, Figure 35, and Figure 37.

Figure 32. Graph. EB leave slab corner normalized deflection (2024, 2020, and 2016).

Figure 34. Graph. EB load transfer efficiency at slab corner across transverse joints (2016, 2020, and 2024).

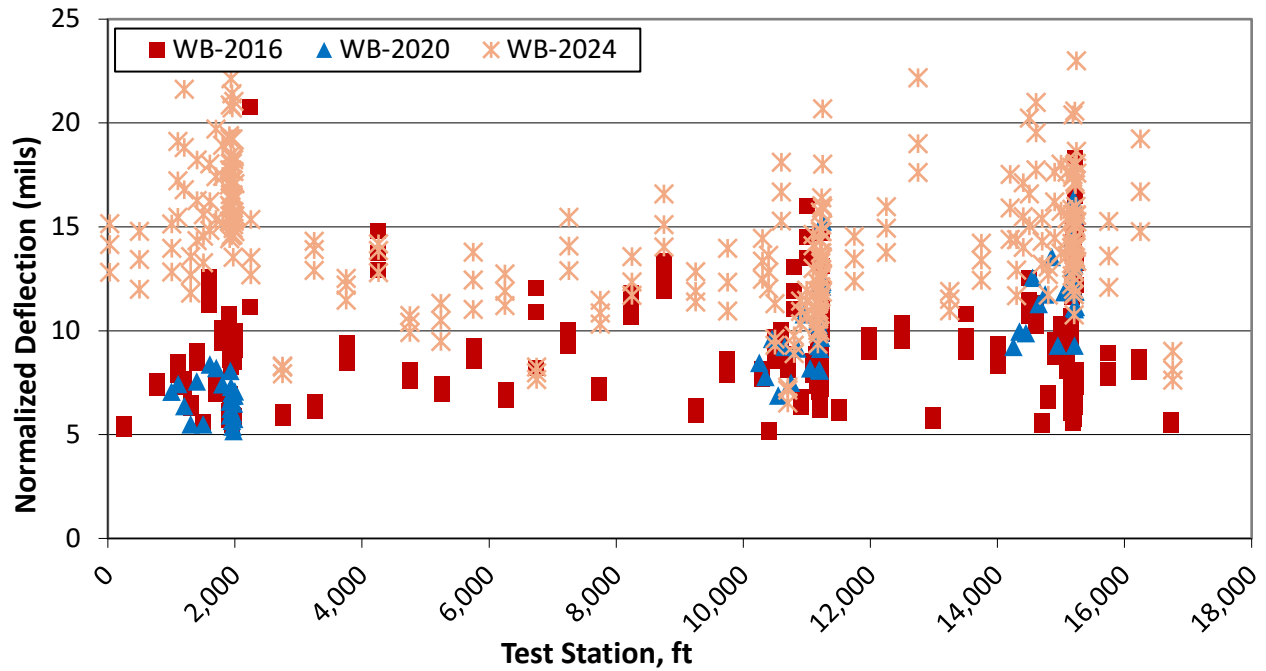
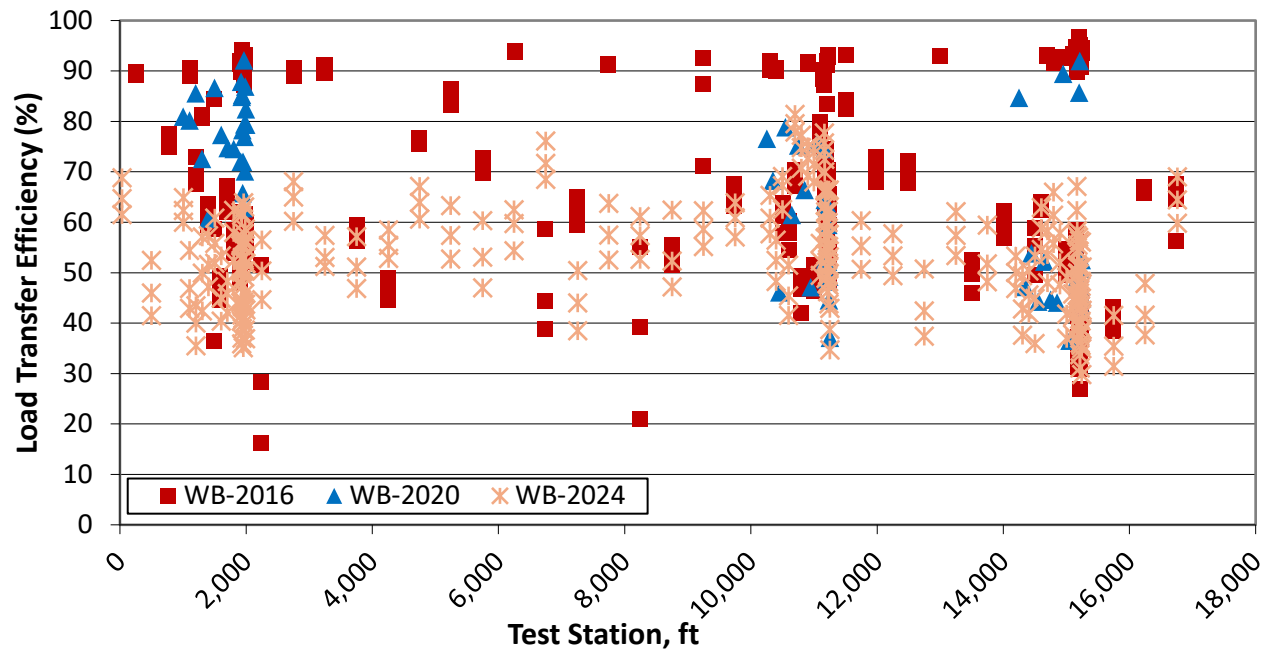
Figure 33. Graph. WB leave slab corner normalized deflection (2024, 2020, and 2016).

Figure 35. Graph. WB load transfer efficiency at slab corner across transverse joints (2016, 2020, and 2024).

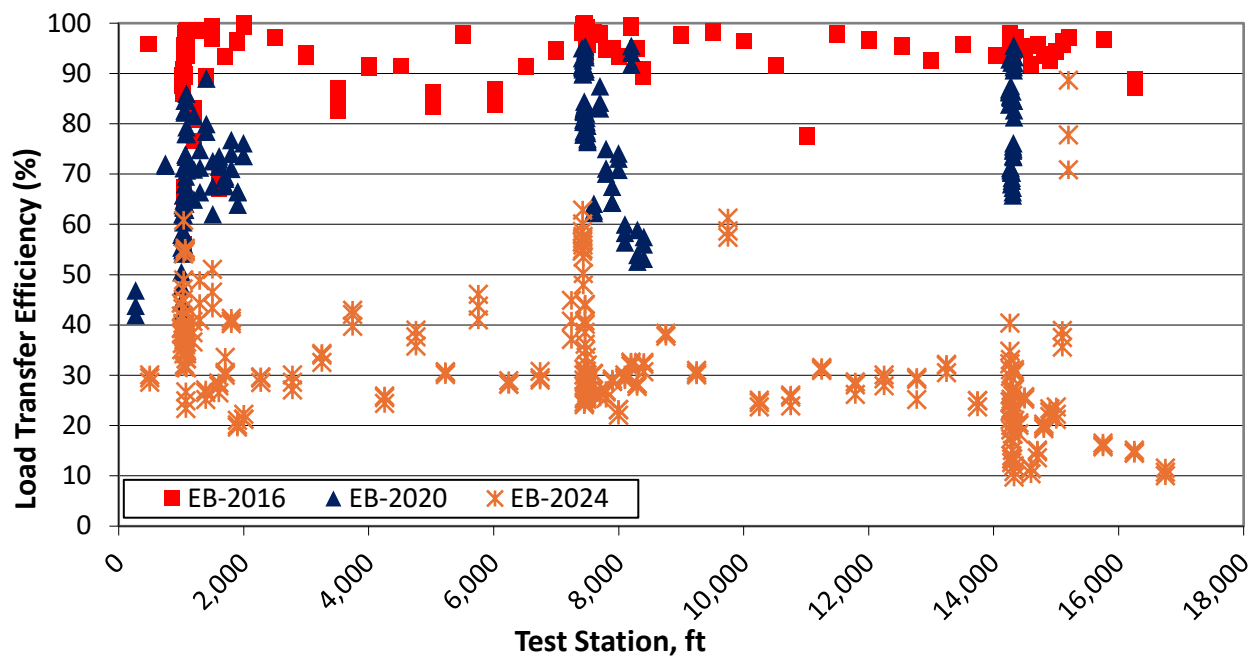
Figure 36. Graph. EB load transfer efficiency at slab corner across longitudinal joints (2016, 2020, and 2024).

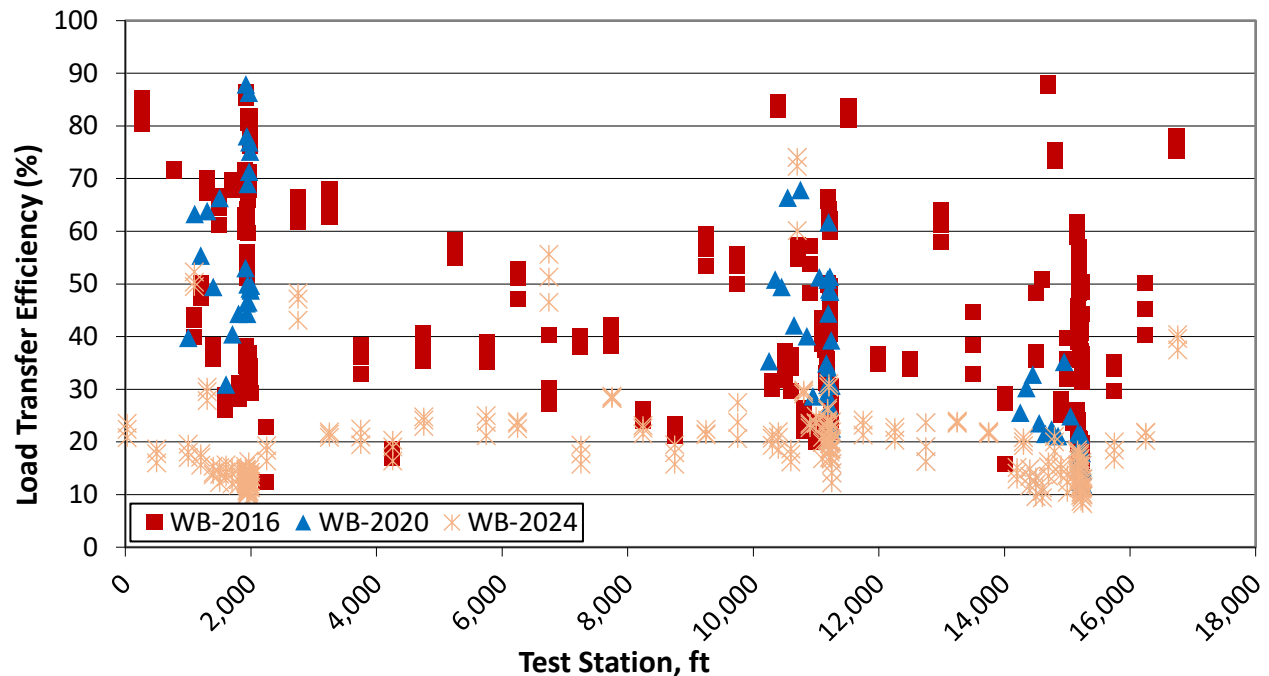
Figure 37. Graph. WB load transfer efficiency at slab corner across longitudinal joints (2016, 2020, and 2024).

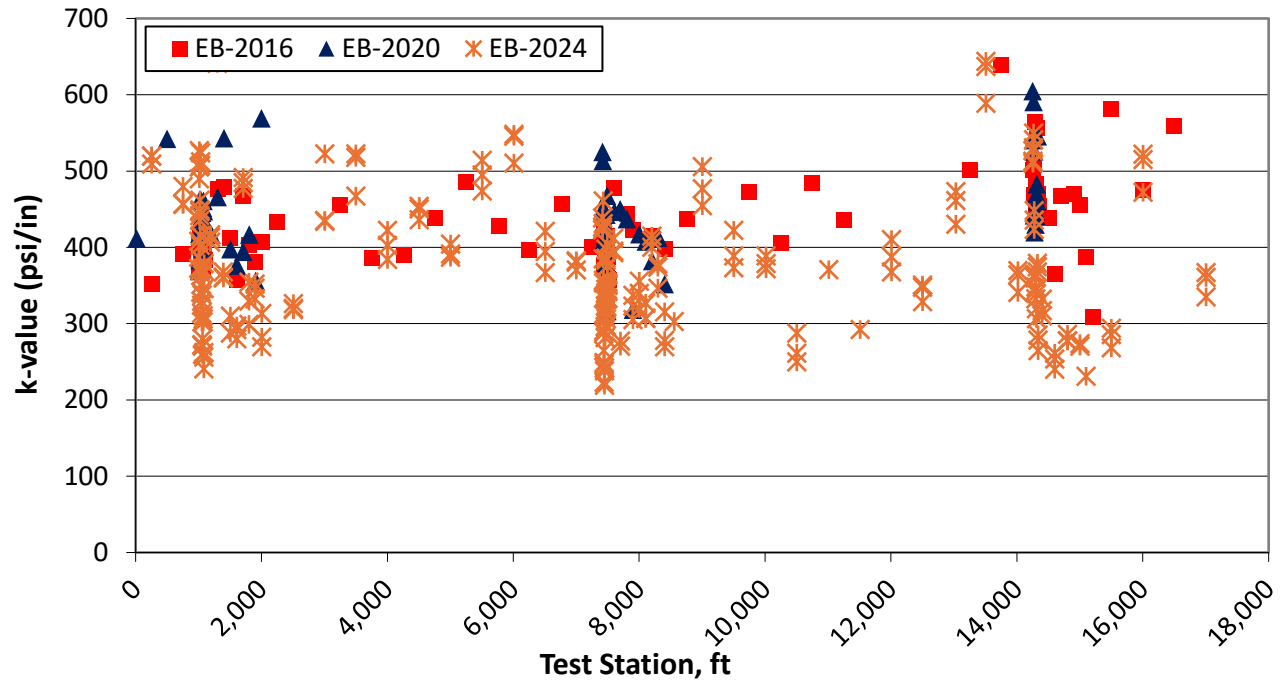
The back-calculated k-values for the EB and WB directions are shown in Figure 41 and Figure 42. At year nine of the test sections (2024), the support is good in each direction (376 vs. 306 psi/in.) as well as the variation within the section. Given most of the changes in the test section have come from loss in LTE and some evidence of HMA interlayer stripping, it is not expected to see significant long-term changes to the support k-value.

Figure 41. Graph. Back-calculated modulus of subgrade reaction for EB direction (2016, 2020, and 2024).

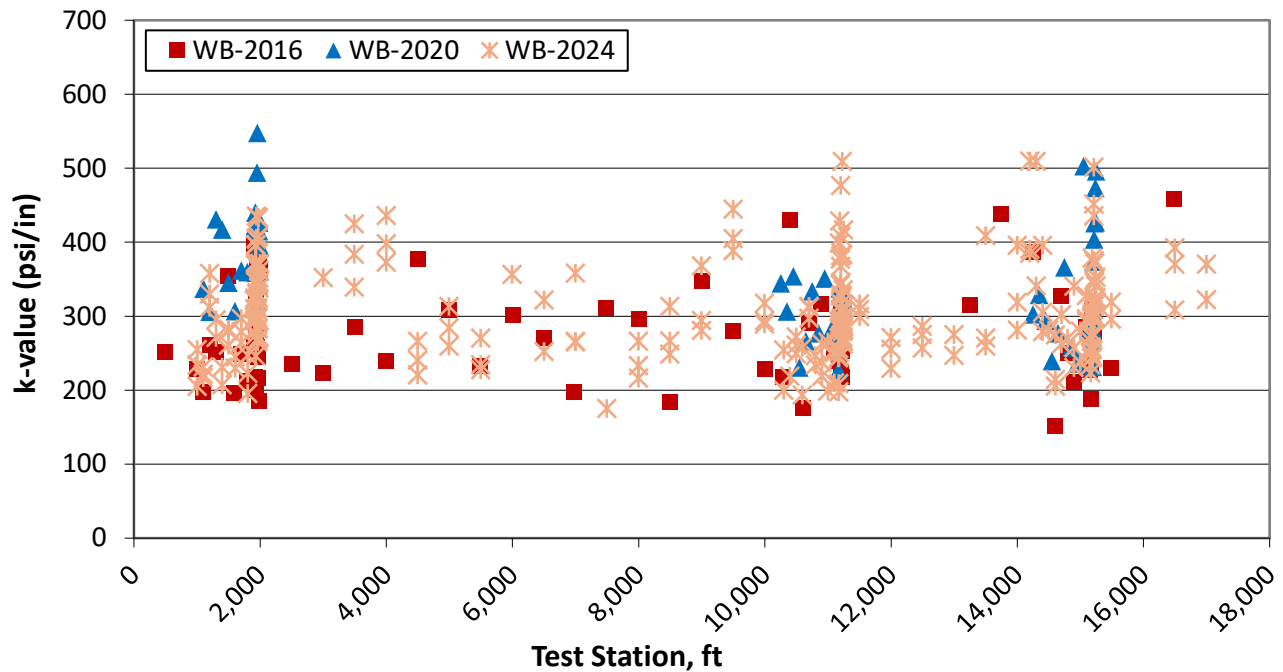
Figure 42. Graph. Back-calculated modulus of subgrade reaction for WB direction (2016, 2020, and 2024).

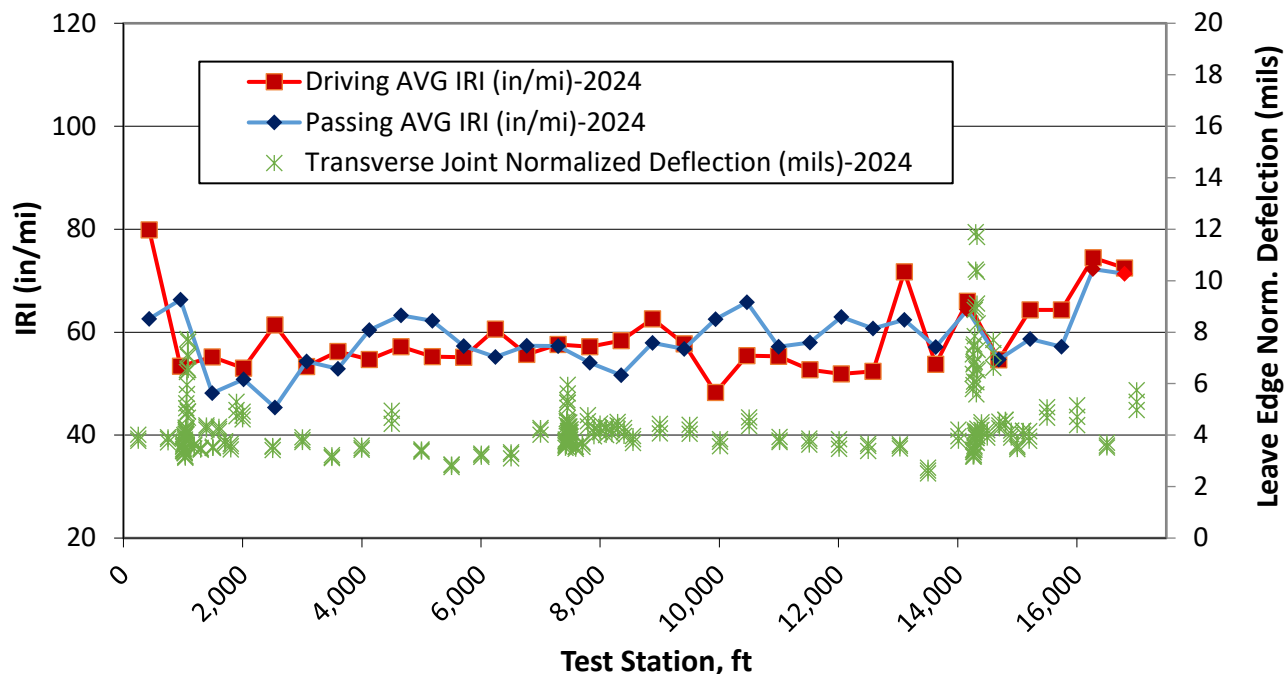
Moreover, IRI values are typically higher at the beginning and end of the section likely because of the beginning and ending of the paving day (Figure 43 and Figure 44). The WB driving lane has particularly high IRI values, reaching up to 120 in./mile (Figure 45 and Figure 46). The FWD deflection data did not strongly correlate to IRI values at individual stations. The higher IRI value for the WB driving lane was likely due to its original high value after construction, which may be related to not having an HMA interlayer to level up the existing CRCP prior to the concrete overlay.

Figure 43. Graph. IRI and normalized transverse joint leave edge deflection along EB direction (fall 2024).

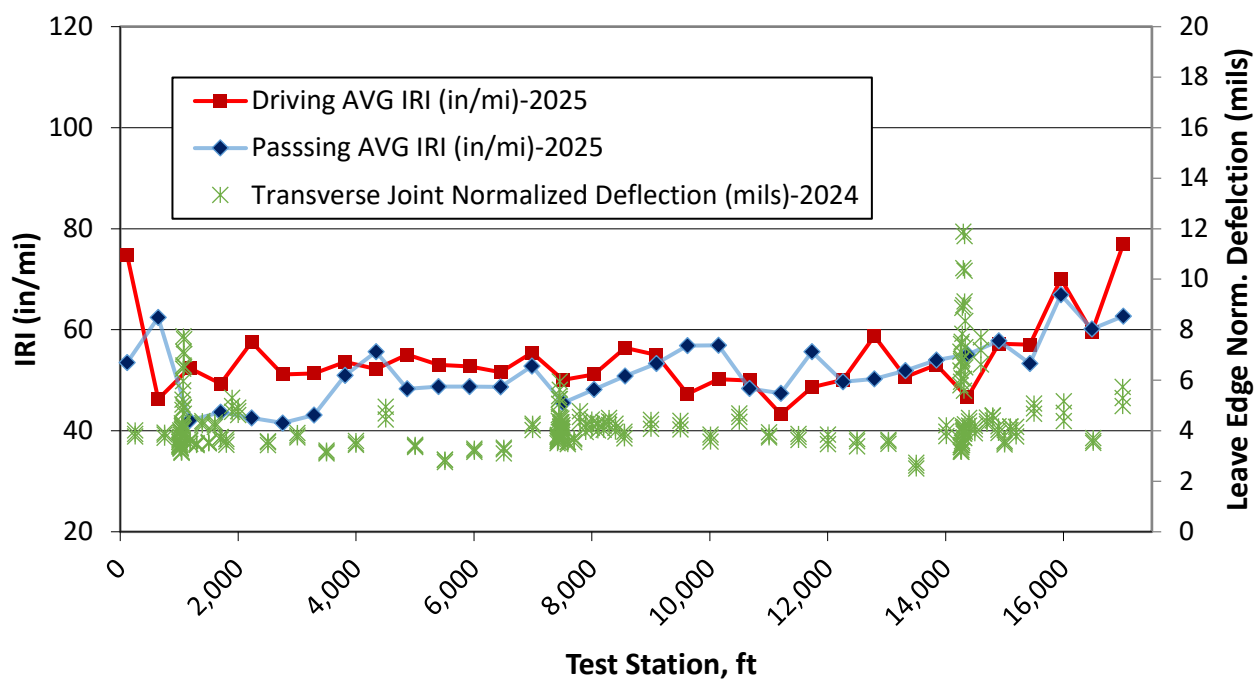
Figure 44. Graph. IRI and normalized transverse joint leave edge deflection along EB direction (spring 2025).

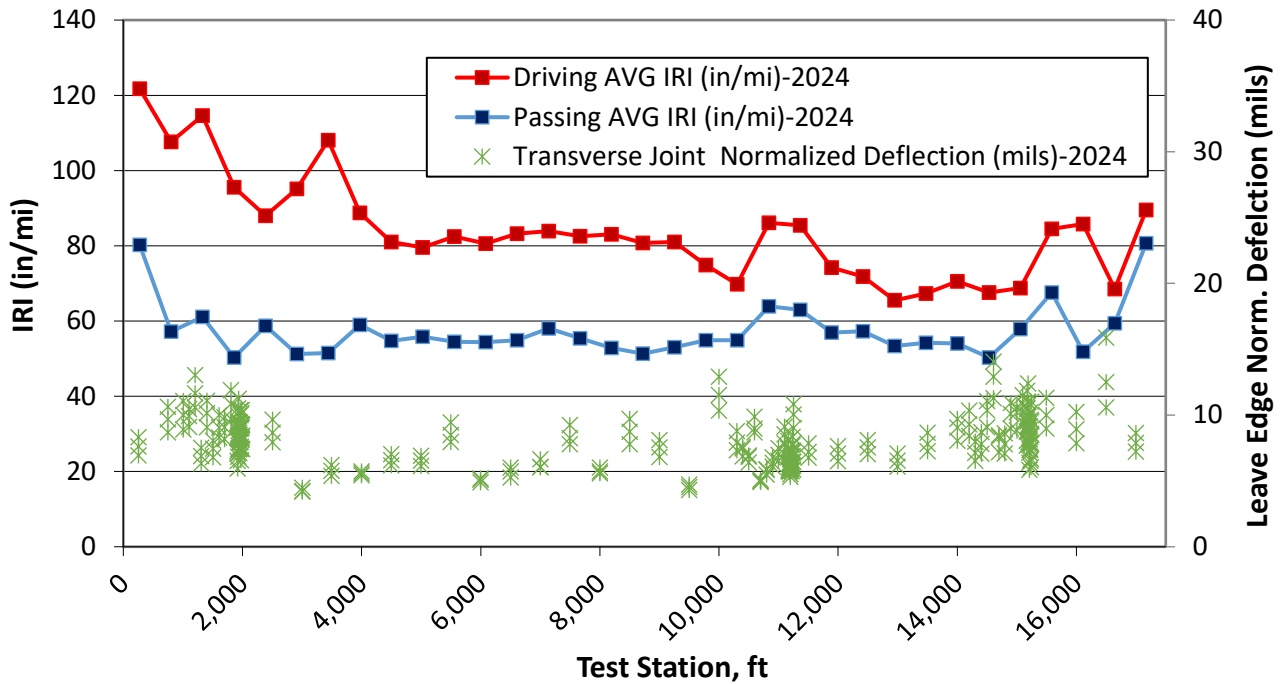
Figure 45. Graph. IRI and normalized transverse joint leave edge deflection along WB direction (fall 2024).

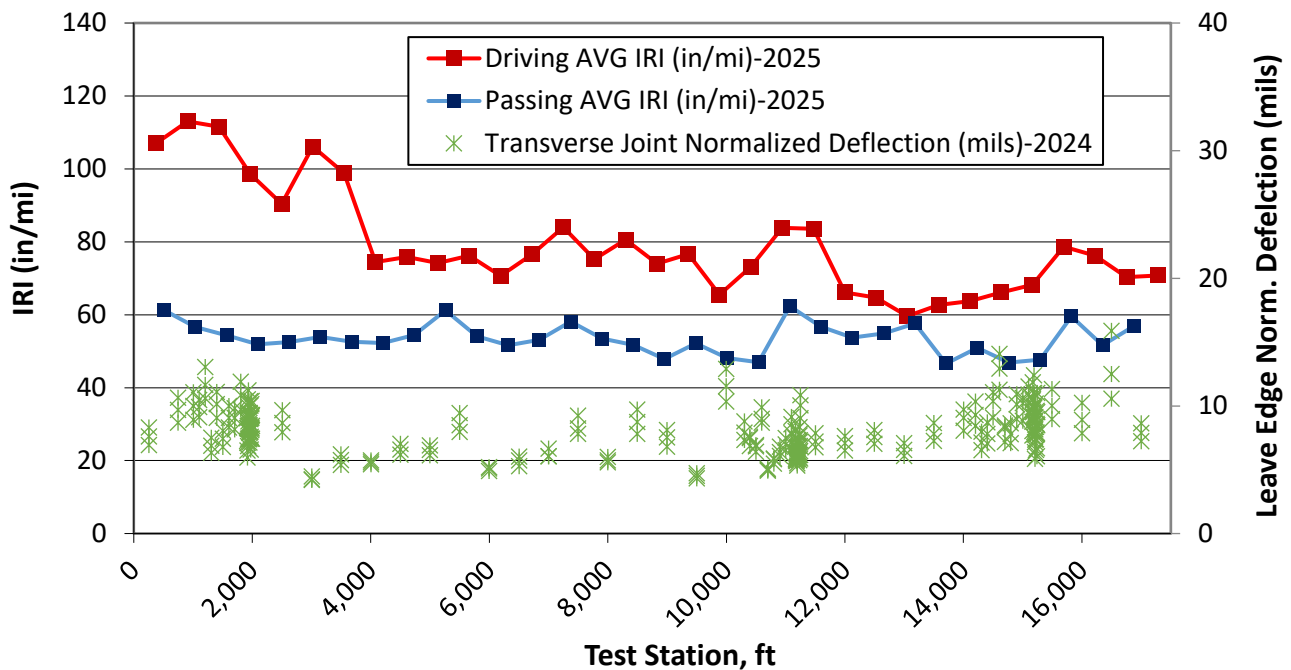
Figure 46. Graph. IRI and normalized transverse joint leave edge deflection along WB direction (spring 2025).

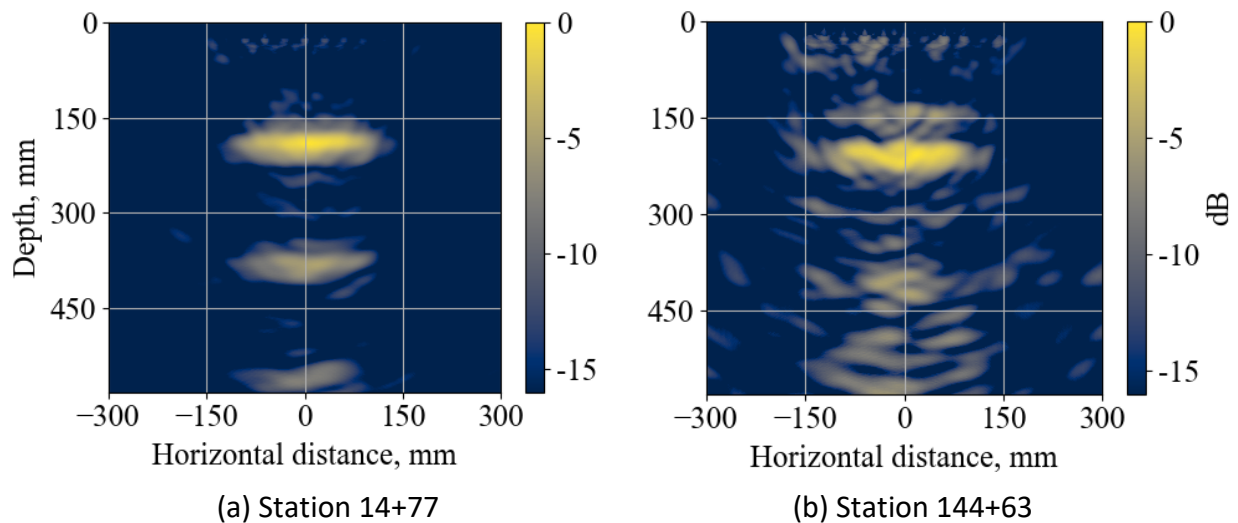
Figure 49 shows two representative B-scan images of shear wave reflections collected at the center of uncracked panels in I-72 EB. Figure 49-a corresponds to station 14+77 and Figure 49-b to station 144+63. In both cases, the dominant thickness reflections appear around 195 mm. Dominant thickness reflection refers to the depth at which the strongest reflection region is visible in B-scans. The average estimated shear wave speed in the center of slabs was 2,605 m/s with a coefficient of variation of 5.7%. Given the expected overlay thickness of 6 in. (152 mm) and HMA interlayer thickness of 1.25 in. (32 mm), this dominant reflection depth aligns closely with the bottom of the HMA interlayer. In some cases (Figure 49-b), an additional reflection is visible near 150 mm depth, suggesting that part of the shear wave energy is being reflected at the concrete overlay-HMA interface. This may indicate partial bonding at the concrete interface and also supports the interpretation that HMA is unbonded from the underlying CRCP layer. While in other locations (see Figure 49-a), B-scans showed no traces of reflections at the concrete overlay-HMA interface. Instead, strong and consistent reflections were observed from the bottom of the HMA interlayer (top of the existing CRCP layer). This pattern suggests the overlay is well bonded to the HMA, but the HMA itself is unbonded to the underlying CRCP, likely indicating a kissing bonding at the HMA-CRCP interface.

Figure 49. Graphs. Example of typical ultrasound-based cross-sectional reconstructions (B-scans) from tests in the center of slabs at (a) station 14+77 and (b) station 144+63.

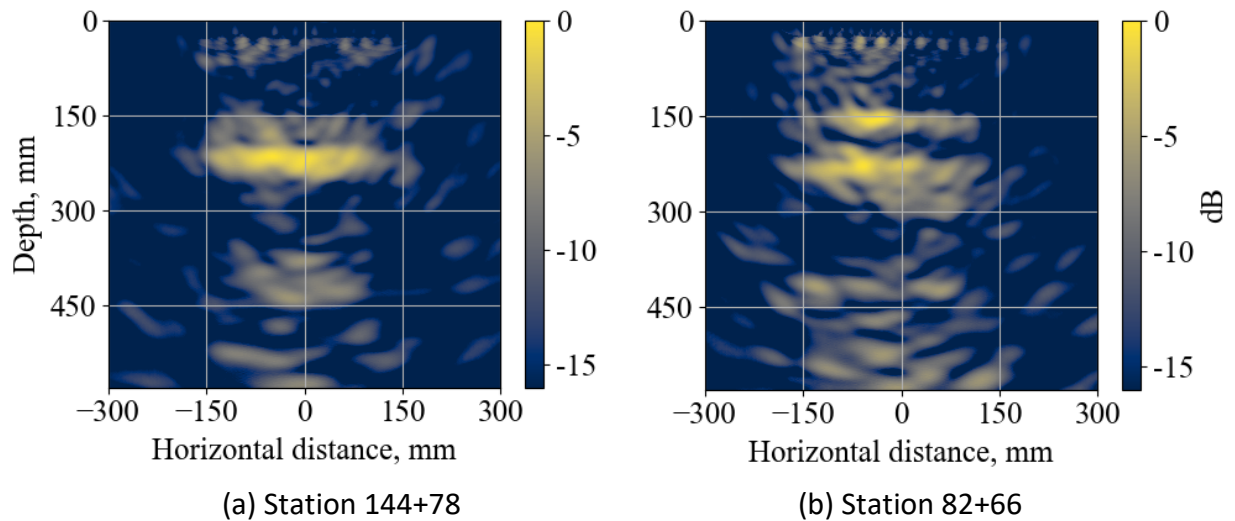
Figure 50 compares B-scan reconstructions at two test locations that are parallel to the transverse joint with station 144+78 containing a visible longitudinal crack and station 82+66 without any cracking, respectively. Both cases exhibit similar reflection behavior, including a distinguishable interface near the bottom of the concrete overlay and dominant reflection from the bottom of the HMA interlayer at about 190 mm, regardless of the surface cracking. No substantial differences in reflection amplitude or continuity are observed between the two conditions, suggesting that the presence of a longitudinal crack at the surface may not always correlate with a significant loss of interfacial contact detectable by shear wave ultrasound. However, this may also indicate that deterioration begins at the bottom of the interlayer, affecting first the bond between the HMA interlayer and the existing CRCP.

Figure 50. Graphs. Example of typical B-scans in locations near (a) transverse joint with longitudinal crack at station 144+78 and (b) transverse joint without longitudinal crack at station 82+66.

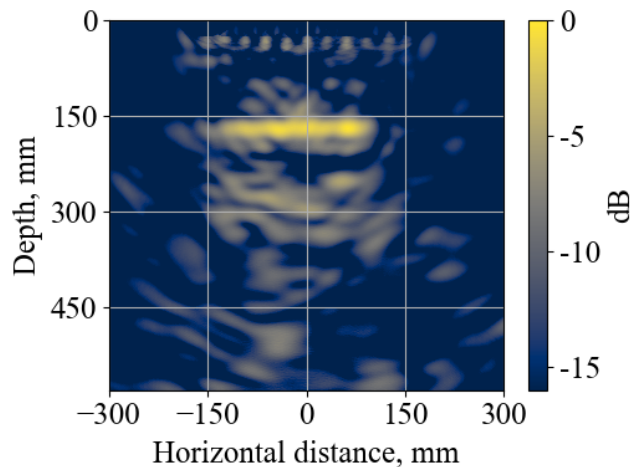
Figure 51 displays an example of the B-scan from a location more than 10 in. from a transverse joint containing a longitudinal crack. In this B-scan the dominant reflection comes from a depth around 6 in. (152 mm), but the lack of echoes from this reflection (e.g., at 304 mm and 456 mm) indicate that the overlay may be partially bonded to the HMA interlayer, which is dissipating shear wave energy in the HMA and CRCP layer.

Figure 51. Graph. Example of the typical B-scan obtained 10 in. offset from a transverse joint with longitudinal crack at station 15+03.

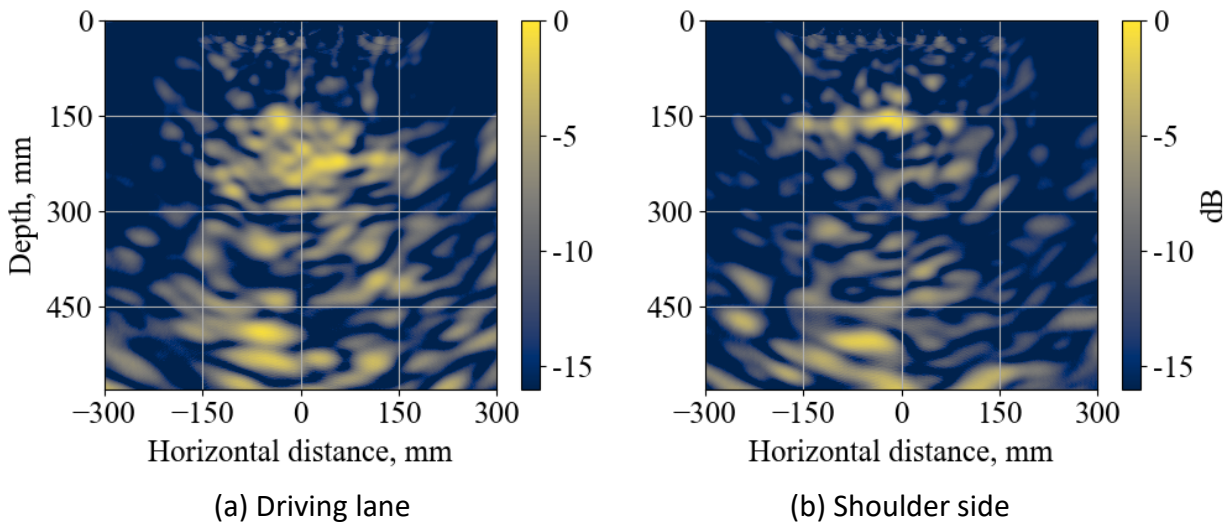
Most of the MIRA tests collected at shoulder-lane locations in I-72 WB resulted in signals with lower signal quality than in the rest of the locations, leading to unreliable C_s estimates and inadequate B-scan reconstructions. On the shoulder side, these findings were attributed to testing with the MIRA device orientated perpendicular to the transverse tining, while on the driving lane, it was mostly attributed to the thickness of the reflective lane markings. These two conditions have a direct impact in the ability of shear waves to propagate across the surface. With these conditions, the proposed approach to reconstruct B-scans at the lane-shoulder joint was to use a representative C_s from all other locations (i.e., 2,672 m/s). As observed in Figure 52-a and Figure 52-b, the B-scans obtained on either side of the lane-shoulder longitudinal joint provide limited reflection traces that differentiated interfaces corresponding to the overlay-HMA or the HMA-CRCP.

Figure 52. Graphs. Example of B-scans obtained parallel to the driving lane-shoulder joint at STA 14+93 on the (a) driving lane and (b) the shoulder side.

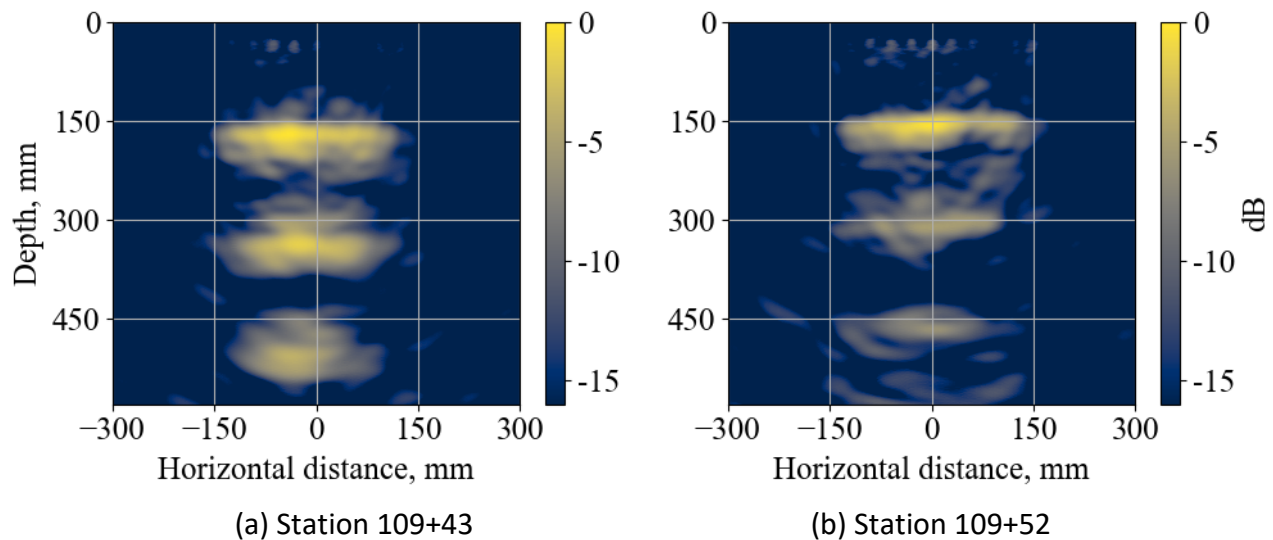
Figure 53 presents representative B-scan reconstructions from MIRA testing conducted on I-72 WB at the transverse joint (Figure 53-a) and at the center of an intact slab panel (Figure 53-b). In both cases, strong and well-defined reflections are observed at depths consistent with the expected overlay thickness (i.e., overlay-NWGF interface). This response was anticipated because of the NWGF interlayer system, which is designed to separate the CRCP and concrete overlay. The NWGF interface acts as a distinct acoustic boundary, producing a dominant thickness reflection at the overlay-NWGF interface. Secondary and tertiary echoes or reverberations of the original shear wave within the overlay are visible at evenly spaced depth intervals. These echoes reinforce the interpretation of a continuous unbonded interface. No additional reflections from beneath the NWGF were observed, further confirming that the wave energy is contained within the overlay layer and not interacting with any deeper pavement layers.

Figure 53. Graphs. Example of B-scan reconstruction in I-72 WB (a) near TJ at station 109+43 and (b) at the center of slab at station 109+52.

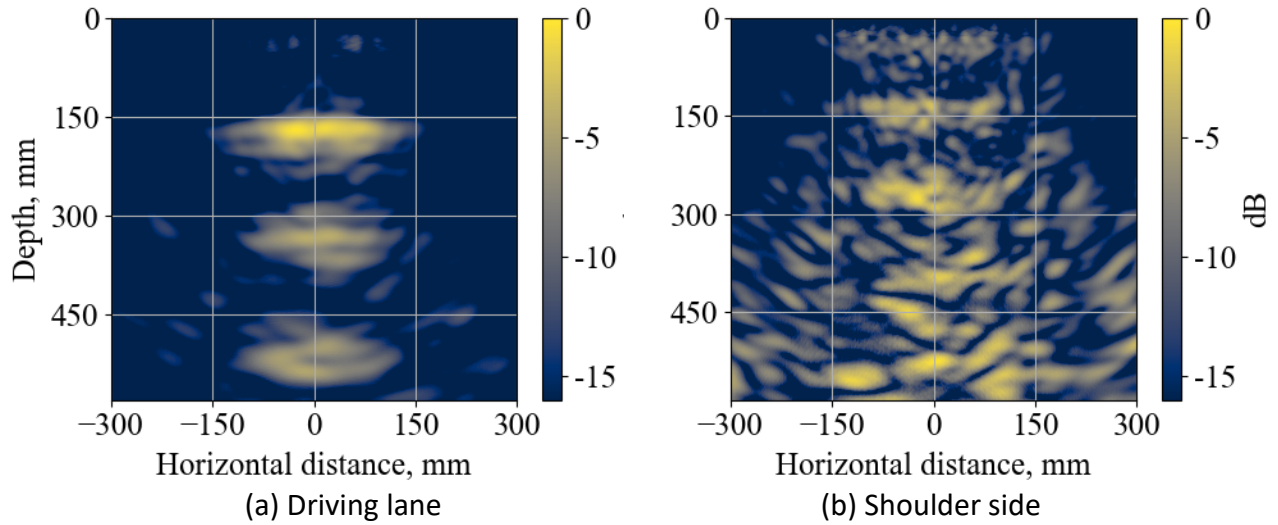
For most of I-72 WB, the MIRA test results collected near the driving lane-shoulder longitudinal joint also displayed low quality signals that were unusable for calculating reliable estimations of C_s . As shown in Figure 54-a, the signal at station 109+66 collected on the driving lane side of the longitudinal joint was the only one that provided clear and consistent waveforms that allowed for a reliable estimation of C_s (2,780 m/s) and reconstruction of the corresponding B-scan. In contrast, the same joint location on the shoulder side (Figure 54-b) produced a poor signal quality, likely because of surface conditions, resulting in an unreliable estimate of C_s (2,160 m/s) and an unrepresentative B-scan. In these cases, where direct estimation of C_s was not feasible, a representative C_s based on the average value from more reliable scans (as discussed in the I-72 EB section) was used for the reconstructions. This allowed for a qualitative assessment of reflection behavior while acknowledging that depth measurements in these locations may be less accurate.

Figure 54. Graphs. Example of B-scan reconstructions across the lane-shoulder joint at station 109+66 (a) on driving lane side with reliable signals (estimated $C_s = 2,780$ m/s) and (b) on shoulder side with unreliable signals (estimated $C_s = 2,160$ m/s).
