Evaluation of Unbonded Jointed Concrete Overlays

ICT Project R27-SP74

September 2025

ICT Series Report No. 25-009

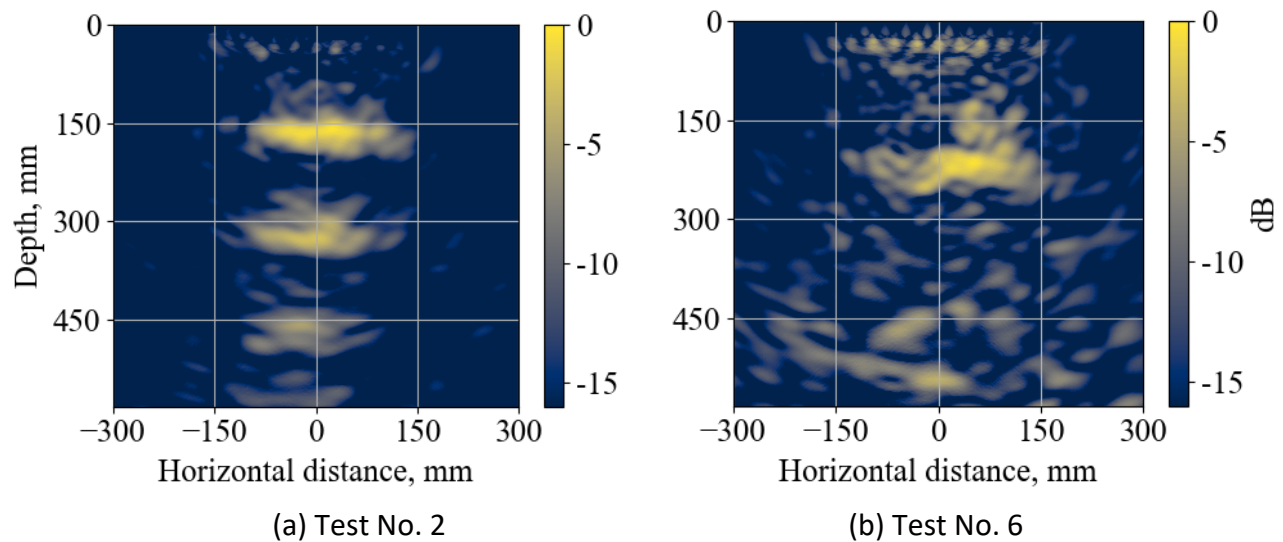
Figure 57 shows representative B-scan reconstructions from the slab center and curb areas. Test no. 2 (Figure 57-a), collected near station 0+06, displays a clearly defined reflection at a depth consistent with the expected overlay thickness of 6 in. (152 mm) and minimal noise, indicating good surface coupling and likely an unbonded condition (kissing bond) at the concrete overlay-HMA interface. In contrast, test no. 6 (Figure 57-b), located near the curb edge at STA 0+54, shows a deeper dominant reflection and more irregular patterns. This can be a result of greater overlay thickness variation or, more likely, a reflection from the bottom of the HMA layer, which is thicker at the edge due to past pavement widening. Moreover, this deeper dominant reflection can be associated with the existing thicker HMA section near the curb applied for lane widening.

Figure 57. Graphs. Example of B-scan reconstructions in East Grand Road at (a) test no. 2 (station 0+06) in slab center with a C_s of 2,413 m/s and an overlay thickness of 6.2 in. (157 mm), (b) test no. 6 (station 0+54) near left-side curb with a C_s of 2,474 m/s and a thickness of 8.2 in. (209 mm).

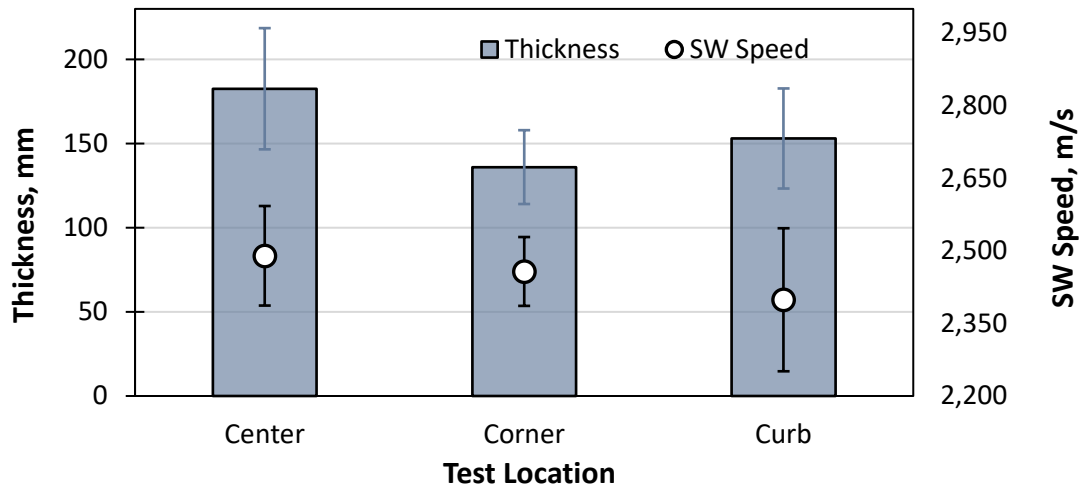
Figure 58 summarized the average surface wave speed, C_s , and dominant reflection thicknesses obtained from MIRA testing throughout 35 locations on East Grand Road, grouped by slab position: center, corners, and curbs. The average estimated overlay thickness at the center locations was 7.2 in. (182.6 mm), compared to 6.0 in. (153 mm) at the curb and 5.4 in. (136 mm) near the corners. Corresponding average C_s values were 2,490, 2,399, and 2,457 m/s, respectively. Approximately 46% of the test locations produced reflection depths within ± 10 mm of the expected design thickness, while the remainder showed deviations that suggest spatial variability in overlay thickness or in the bonding condition at the concrete overlay-HMA interface. This variation is consistent with the construction details shown in the typical section (Figure 5), which specifies variable-depth HMA surface removal prior to overlay placement. It is likely that slab interior regions were milled deeper, while areas near curbs and corners may have retained more of the existing HMA.

Figure 58. Chart. Average estimated thickness and surface wave speed from MIRA testing at center, corner, and curb slab locations along East Grand Road. Error bars represent one standard deviation from the mean for each location group.

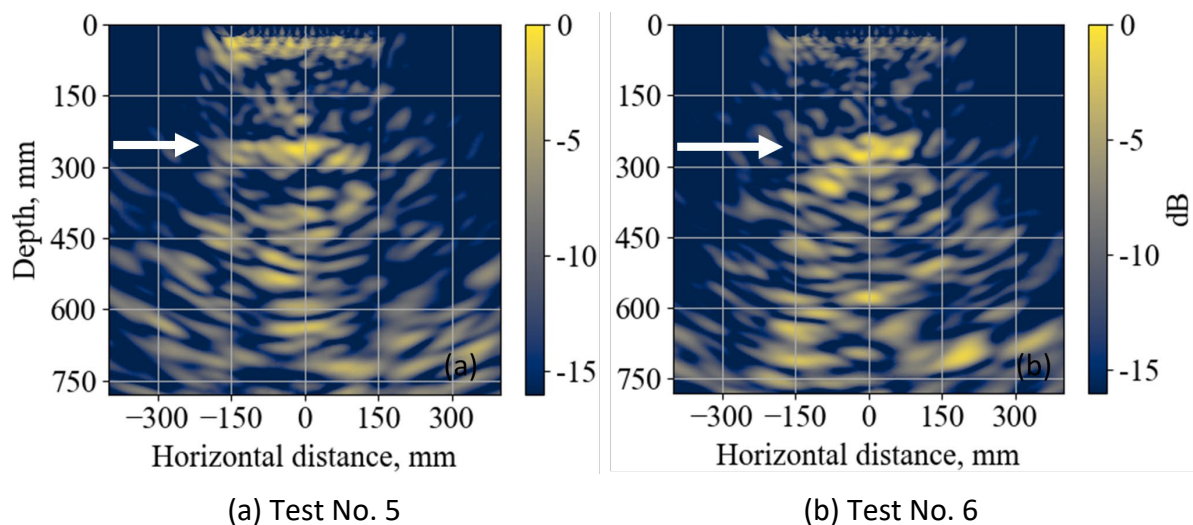
Testing on I-57 was limited because of traffic control constraints, allowing only six exploratory MIRA tests near station 276+90 in the northbound direction. The B-scan reconstructions offered a preliminary view of the concrete slab-HMA interlayer interface, but there were insufficient tests for drawing conclusions. Figure 59 shows two representative reconstructions where the estimated dominant reflection depth approximates the design concrete overlay thickness of 10 in. (254 mm). The absence of multiple echo patterns and the presence of relatively weak reflections near the expected overlay depth suggest some adhesive concrete-HMA bonding and dissipation of significant amount of energy in the HMA interlayer and existing JRC layer.

Figure 59. Graphs. Example of B-scan in I-57 northbound near station 276+90 at (a) test no. 5 and (b) test no. 6. Arrow in white indicates the depth of the overlay thickness reflection.

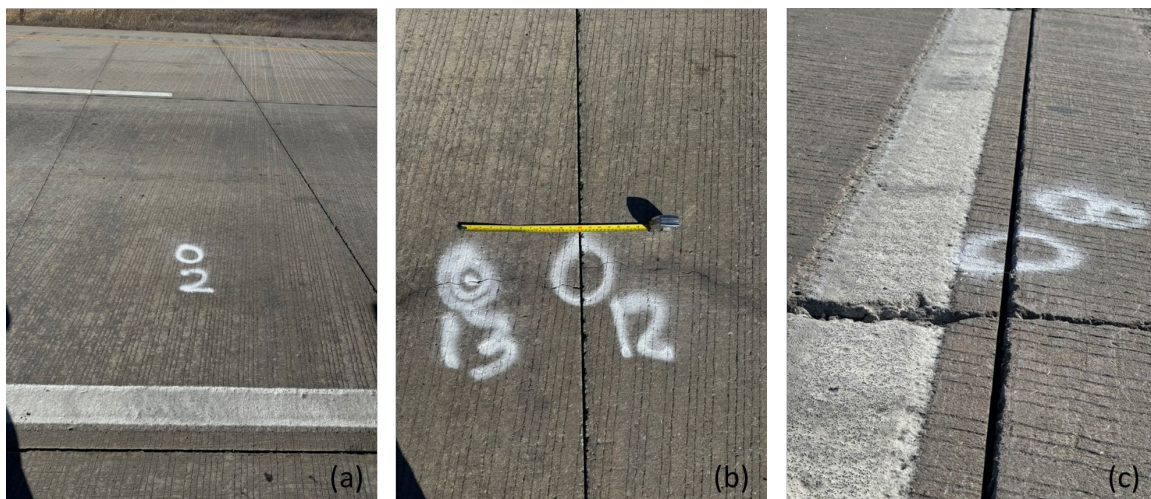
Coring areas were outlined with white spray paint, and reference numbers were added to ensure trackability. Figure 60 displays different locations marked for coring, including a core location in the center of a slab (Figure 60-a), over the transverse joint on a longitudinal crack, 10 in. from the same transverse joint (Figure 60-b) and over the driving lane-shoulder longitudinal joint (Figure 60-c).

Figure 60. Photos. Example of core location markings at (a) slab center, (b) transverse joint with a longitudinal crack, and (c) over the driving lane-shoulder joint.

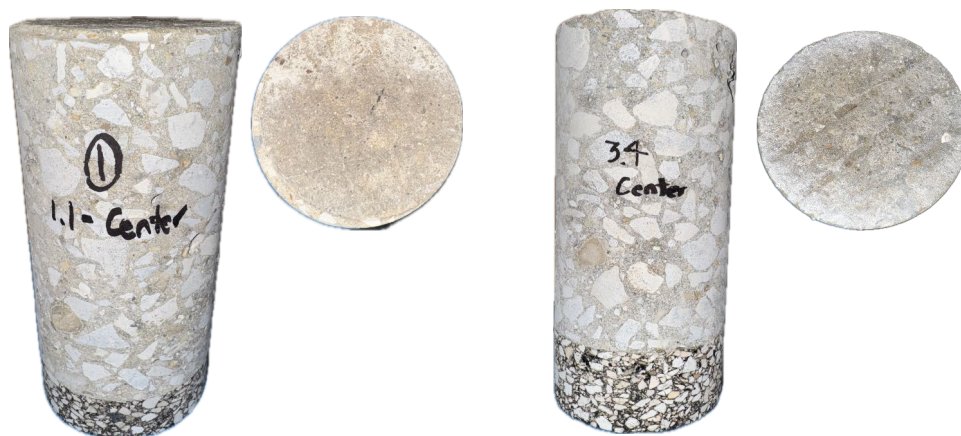
transverse joint with a longitudinal crack, and driving lane-shoulder longitudinal joint. The results of the coring showed 13 out of 14 met the minimum design of 6 in. with an overall average of 6.26 in. The two cores extracted from the EB direction at the slab center displayed a fully bonded condition with the HMA interlayer without signs of degradation in the HMA layer, as seen in Figure 62.

Figure 62. Photo. Side and top view of cores extracted from slab centers.

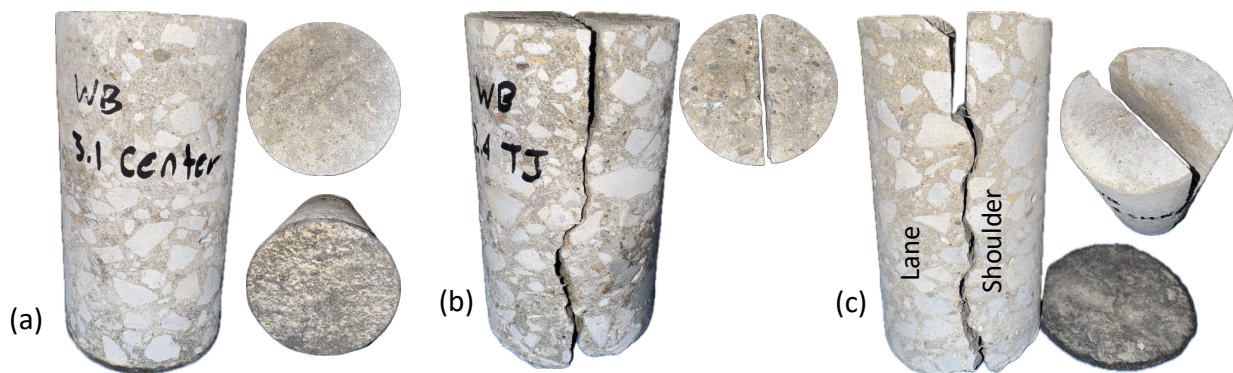
A total of eight cores were taken from the I-72 WB overlay section, covering slab center, transverse joints, and driving lane-shoulder longitudinal joint locations. Representative samples are shown in Figure 67. The extracted cores from the WB had an average thickness of 6.59 in. with all cores meeting the minimum design of 6 in. Only a single core had the NWGF layer still adhered to the concrete overlay (Figure 67-a) after extraction from a slab center. The two cores taken from transverse joints exhibited full-depth joint activation and showed a more pronounced degradation (i.e., wider crack) of the bottom of the core (Figure 67-b). The four cores extracted from driving lane-shoulder joints had the NWGF unbonded (separated), and the joints were activated full-depth with a significant degradation near the core bottom, as seen in Figure 67-c. Additionally, cores from the driving lane-shoulder joint had a higher elevation on the shoulder than the driving lane, and the degradation along the joint crack path seems to follow an upward movement of the shoulder. In some of these cases, the concrete remained together only by a few bridging macrofibers. The wider joint opening reduced the impact of fiber reinforcement across this contraction joint, which was seen in the low LTE across the lane shoulder (average of 24%).

Figure 67. Photo. Examples of cores extracted on I-72 WB at (a) slab center, (b) transverse joint without longitudinal crack, and (c) driving lane-shoulder joint. Each image includes front view (aligned with joint where applicable), top view, and a view of the NWGF as available.

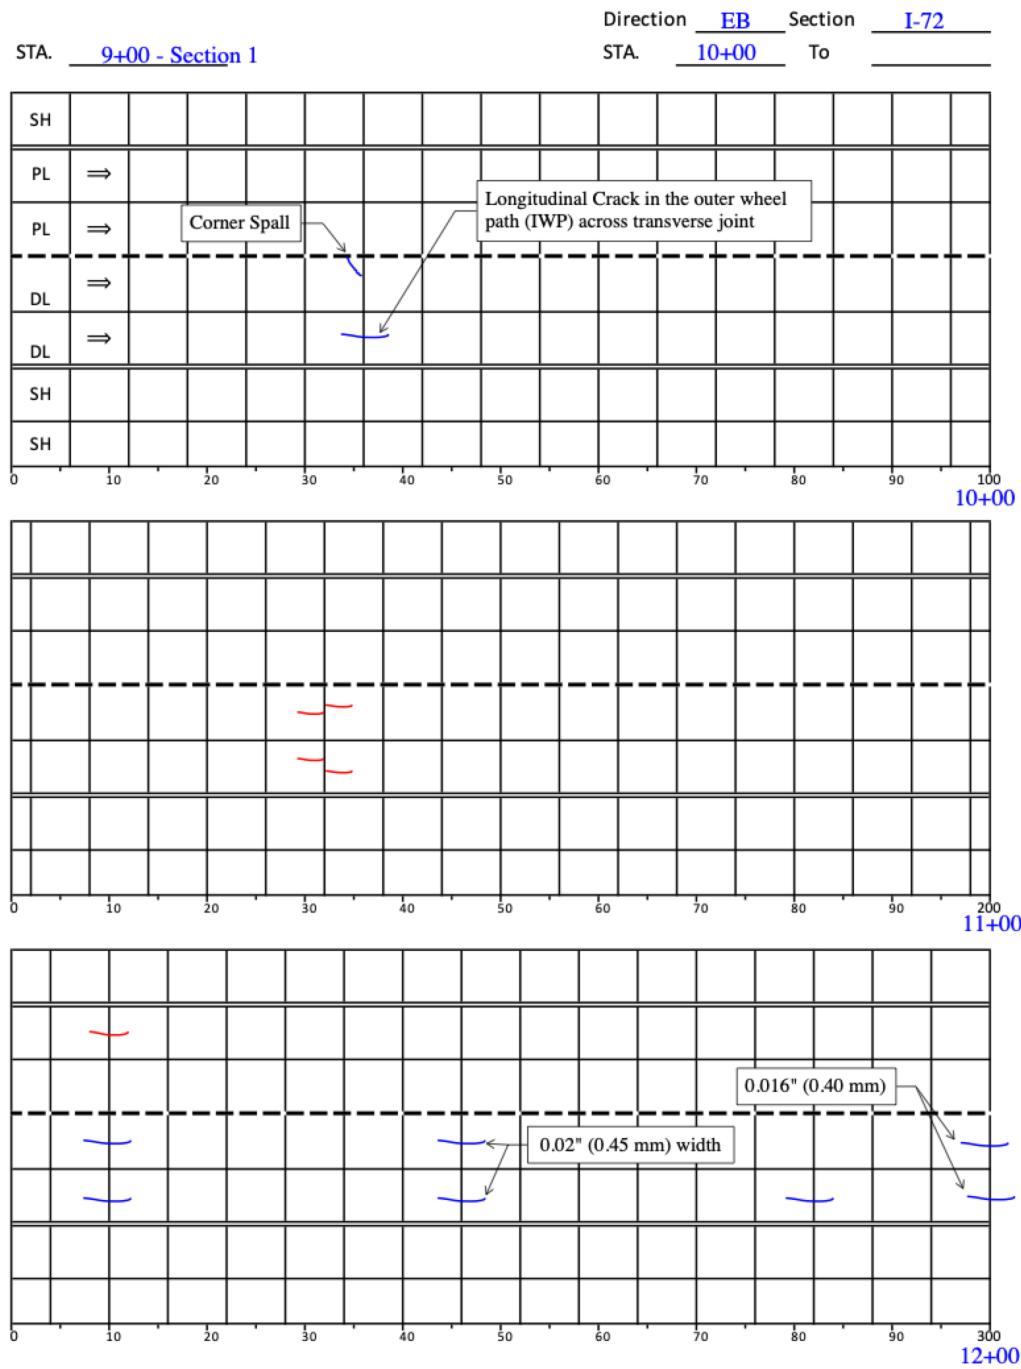
Figure 68. Illustration. Distress survey in I-72 EB at stations 9+00–12+00.

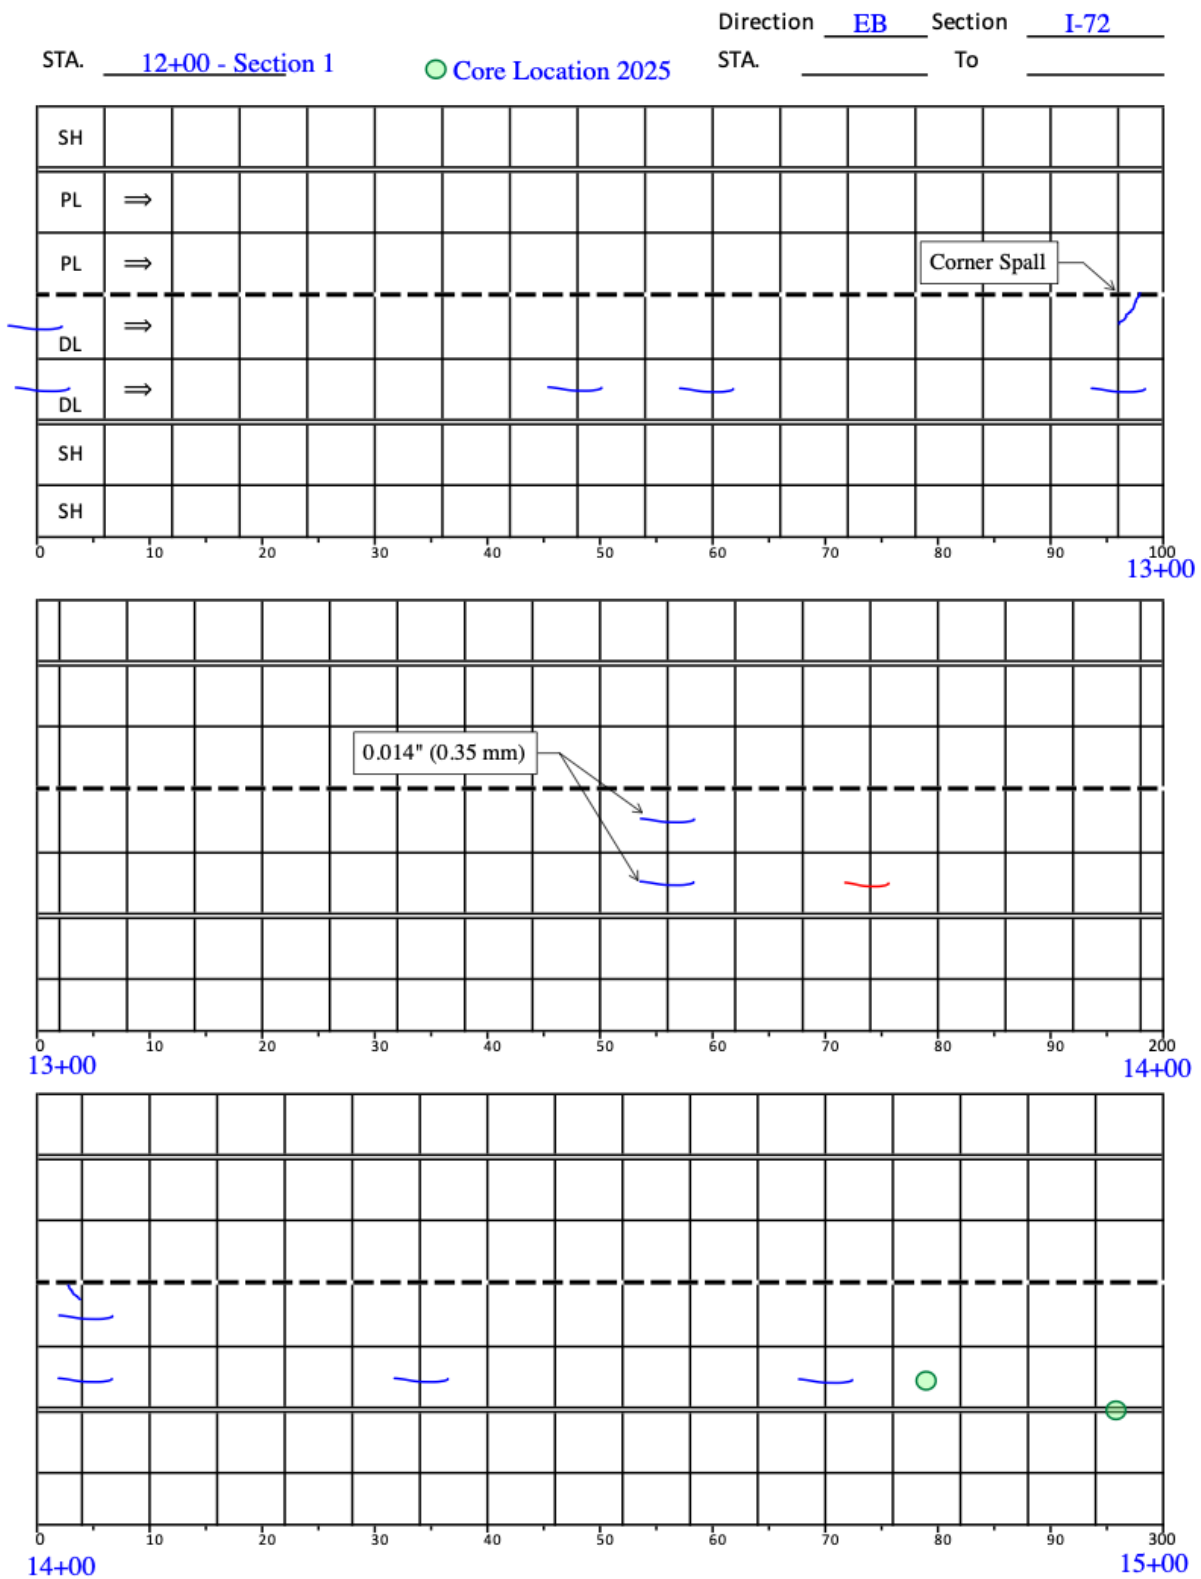
Figure 69. Illustration. Distress survey in I-72 EB at stations 12+00–15+00.

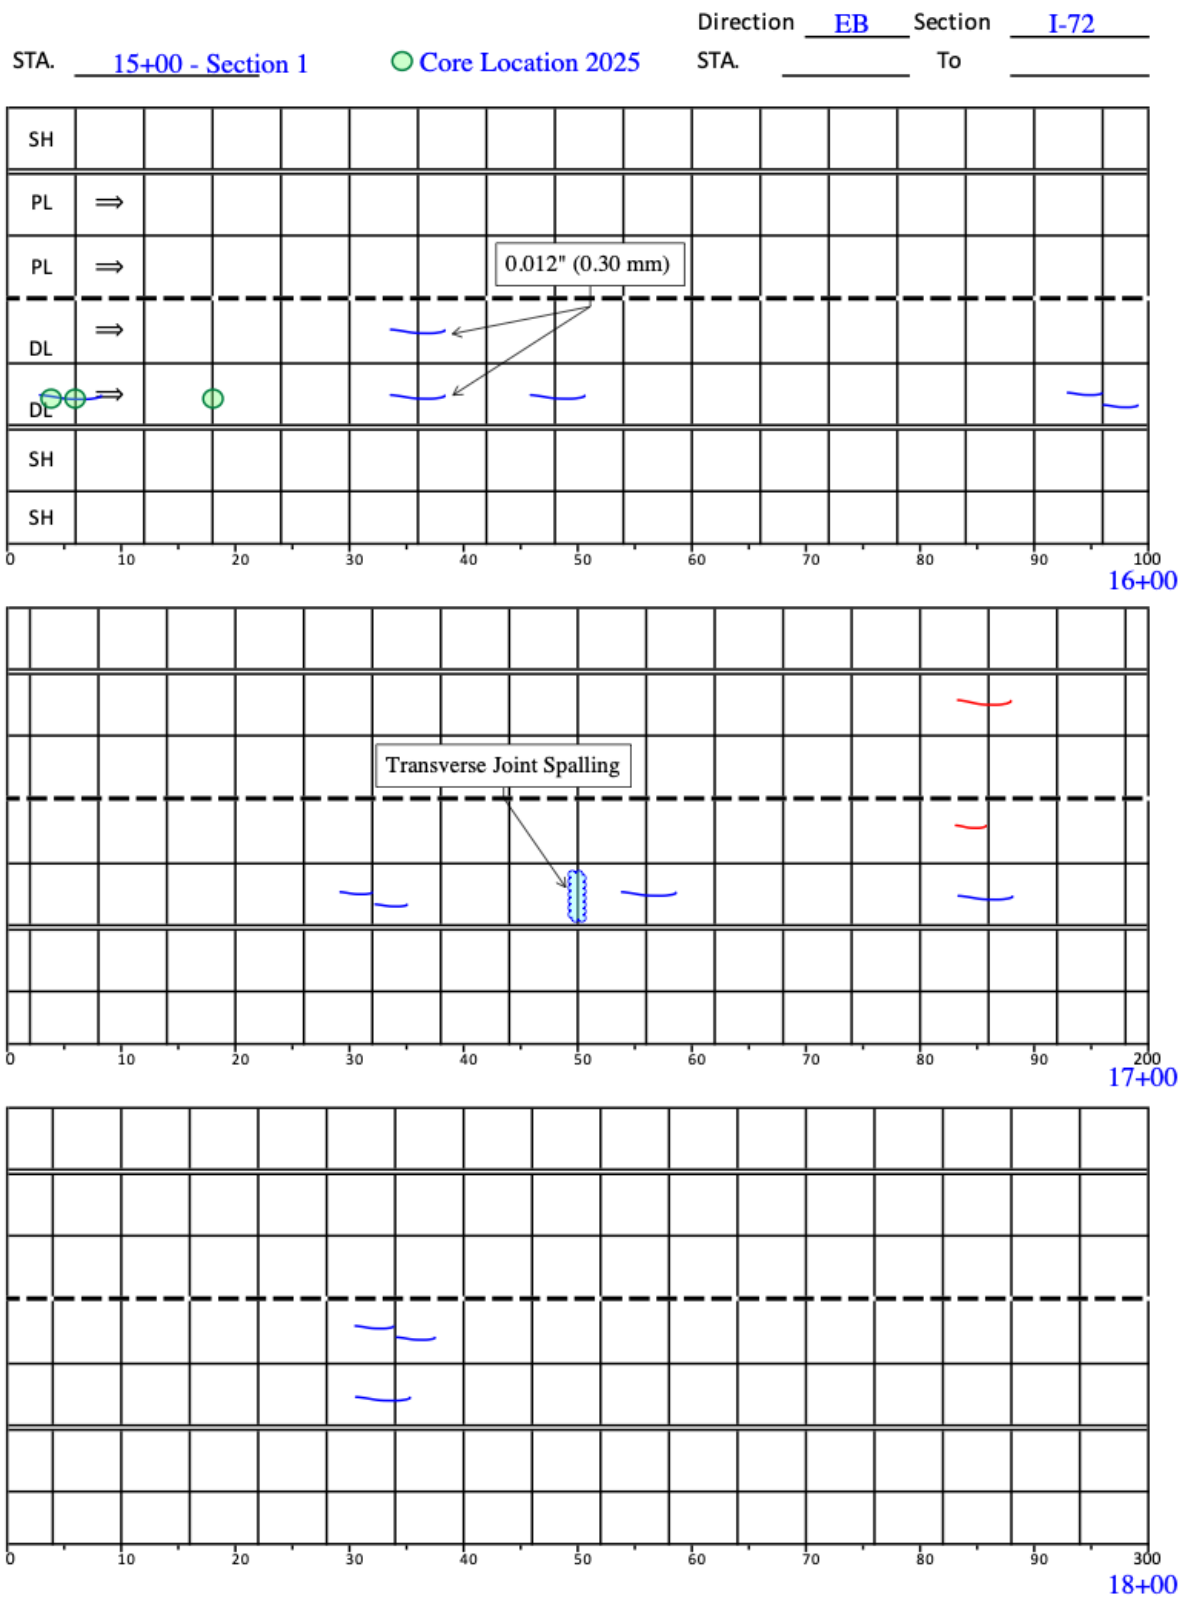
Figure 70. Illustration. Distress survey in I-72 EB at stations 15+00–18+00.

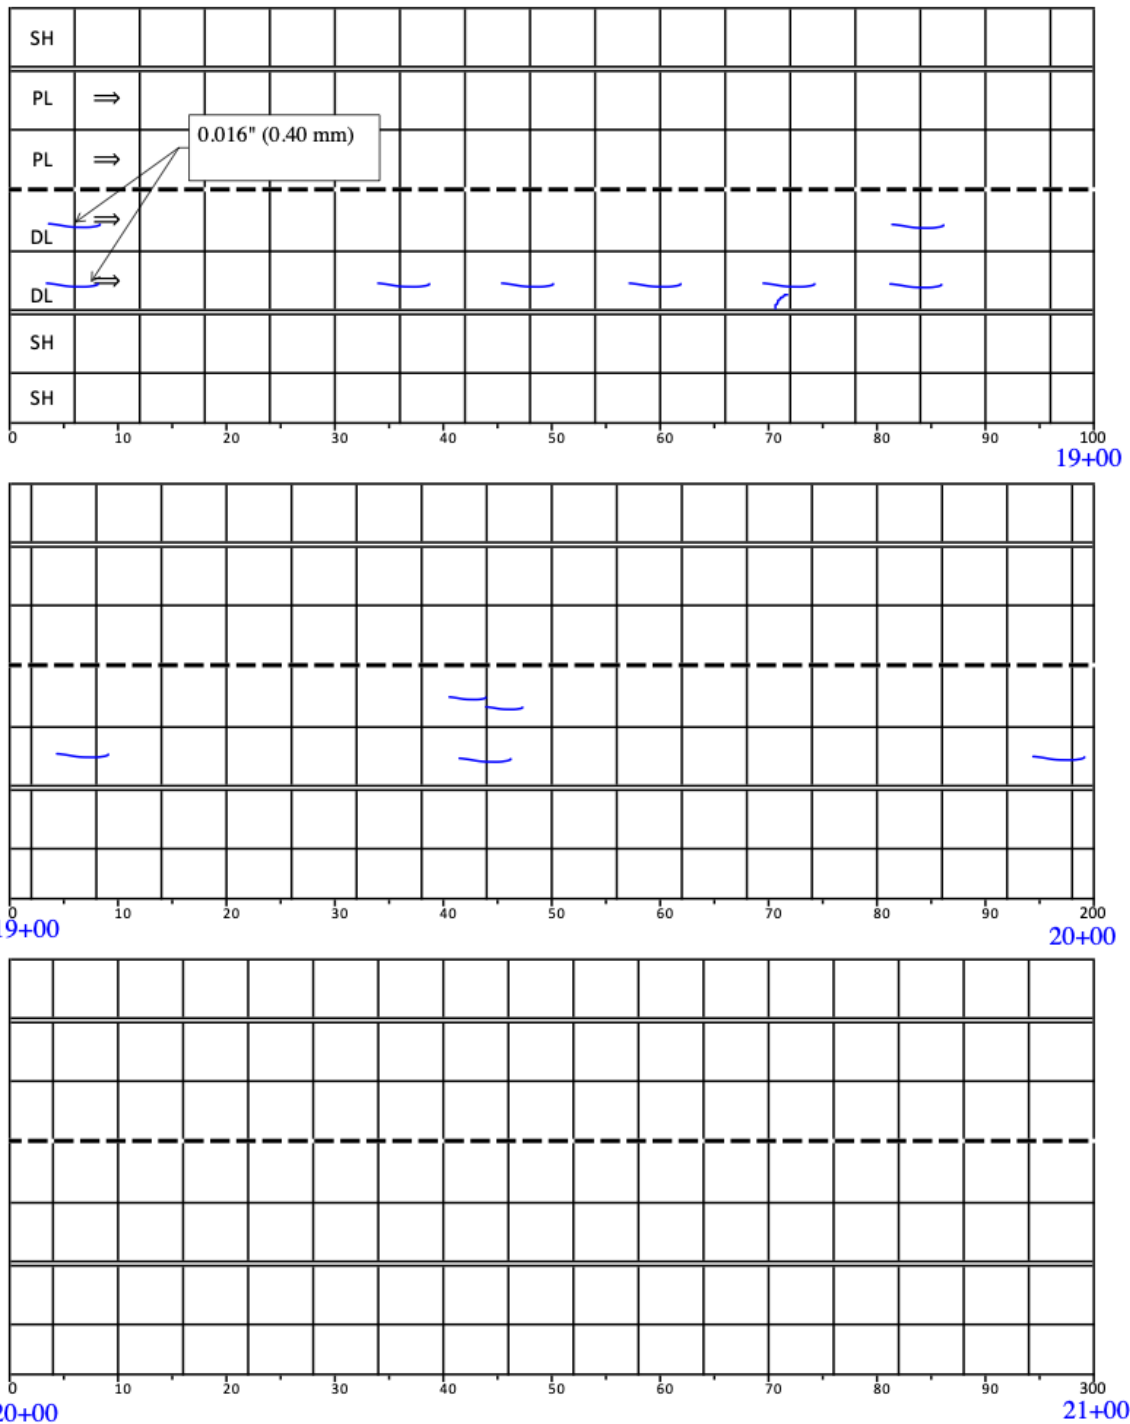
Figure 71. Illustration. Distress survey in I-72 EB at stations 18+00–21+00.

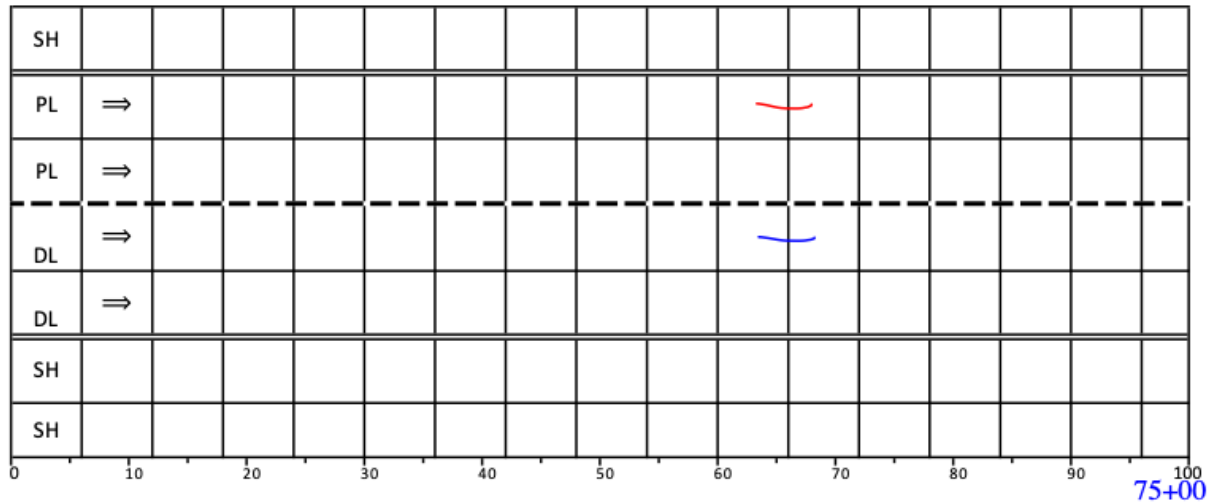
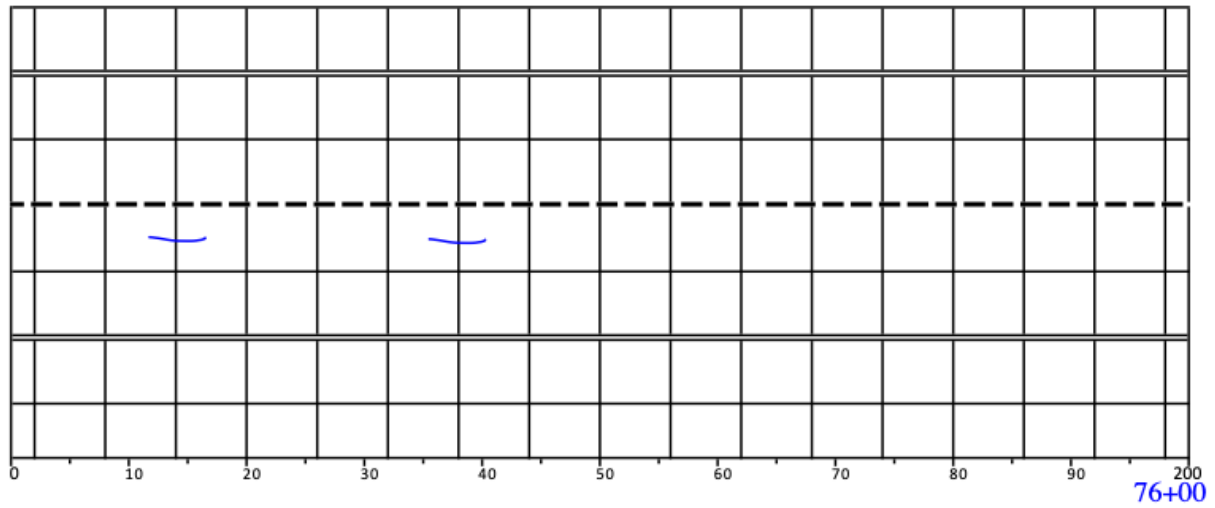
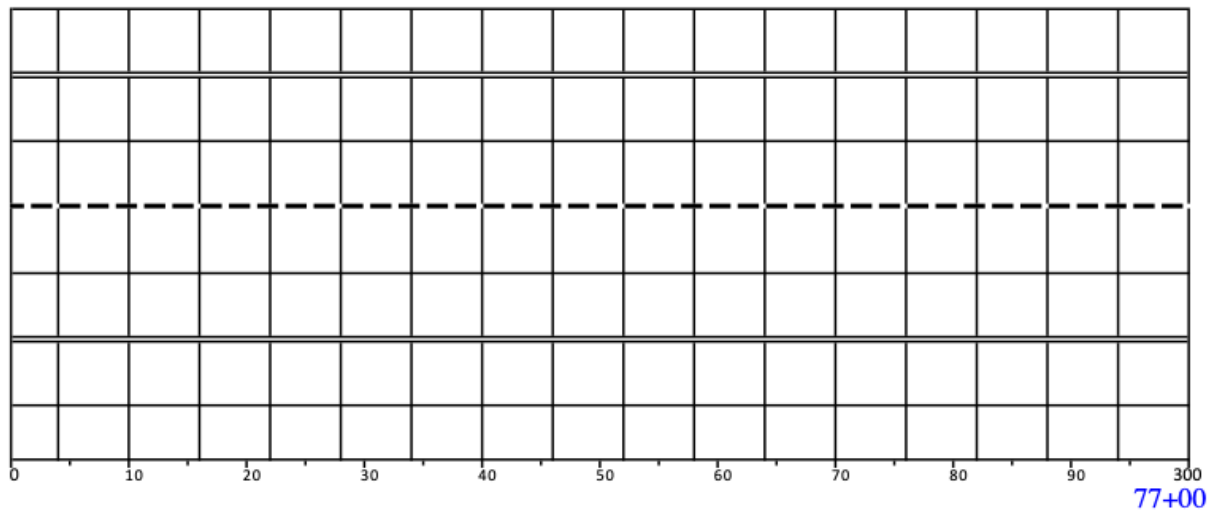
Figure 72. Illustration. Distress survey in I-72 EB at stations 74+00–77+00.

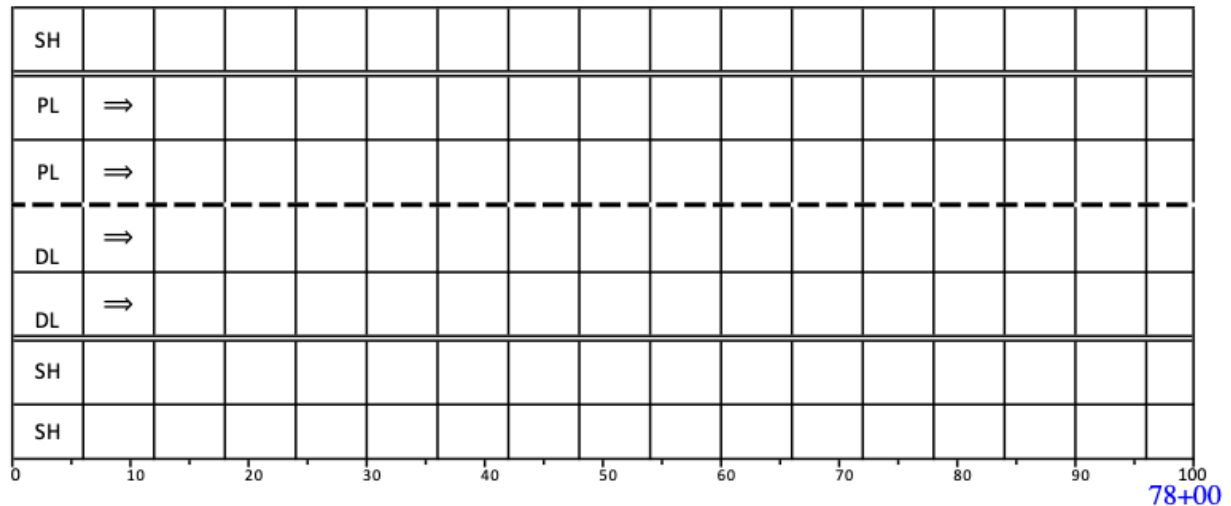
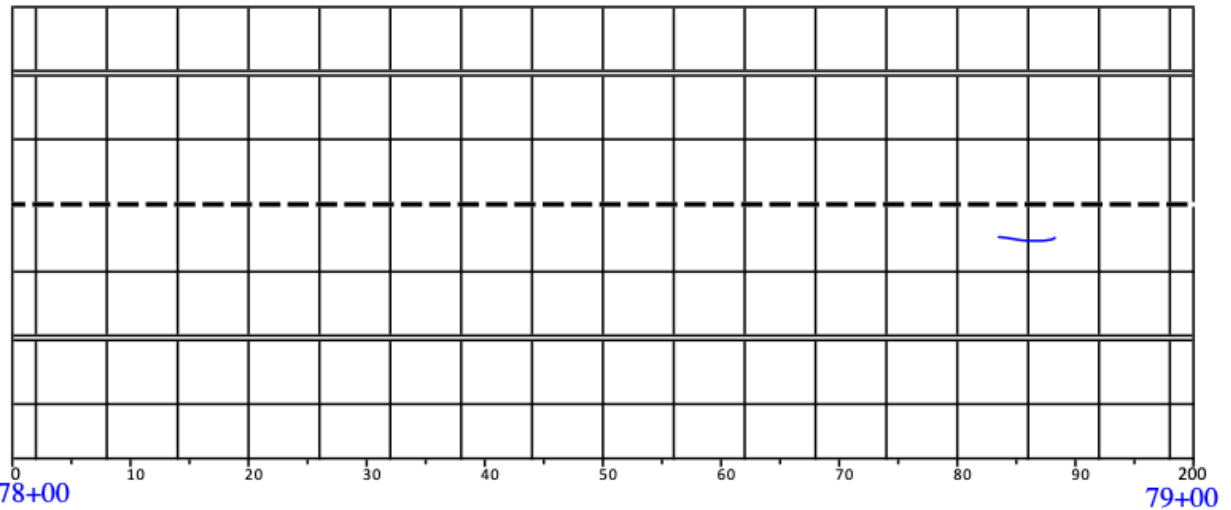
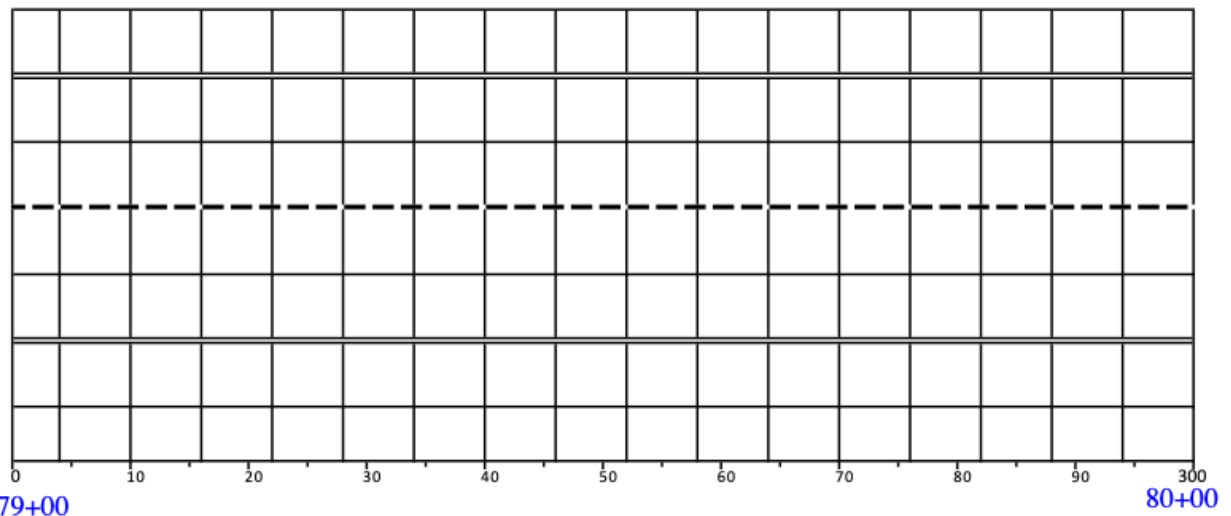
Figure 73. Illustration. Distress survey in I-72 EB at stations 77+00–80+00.

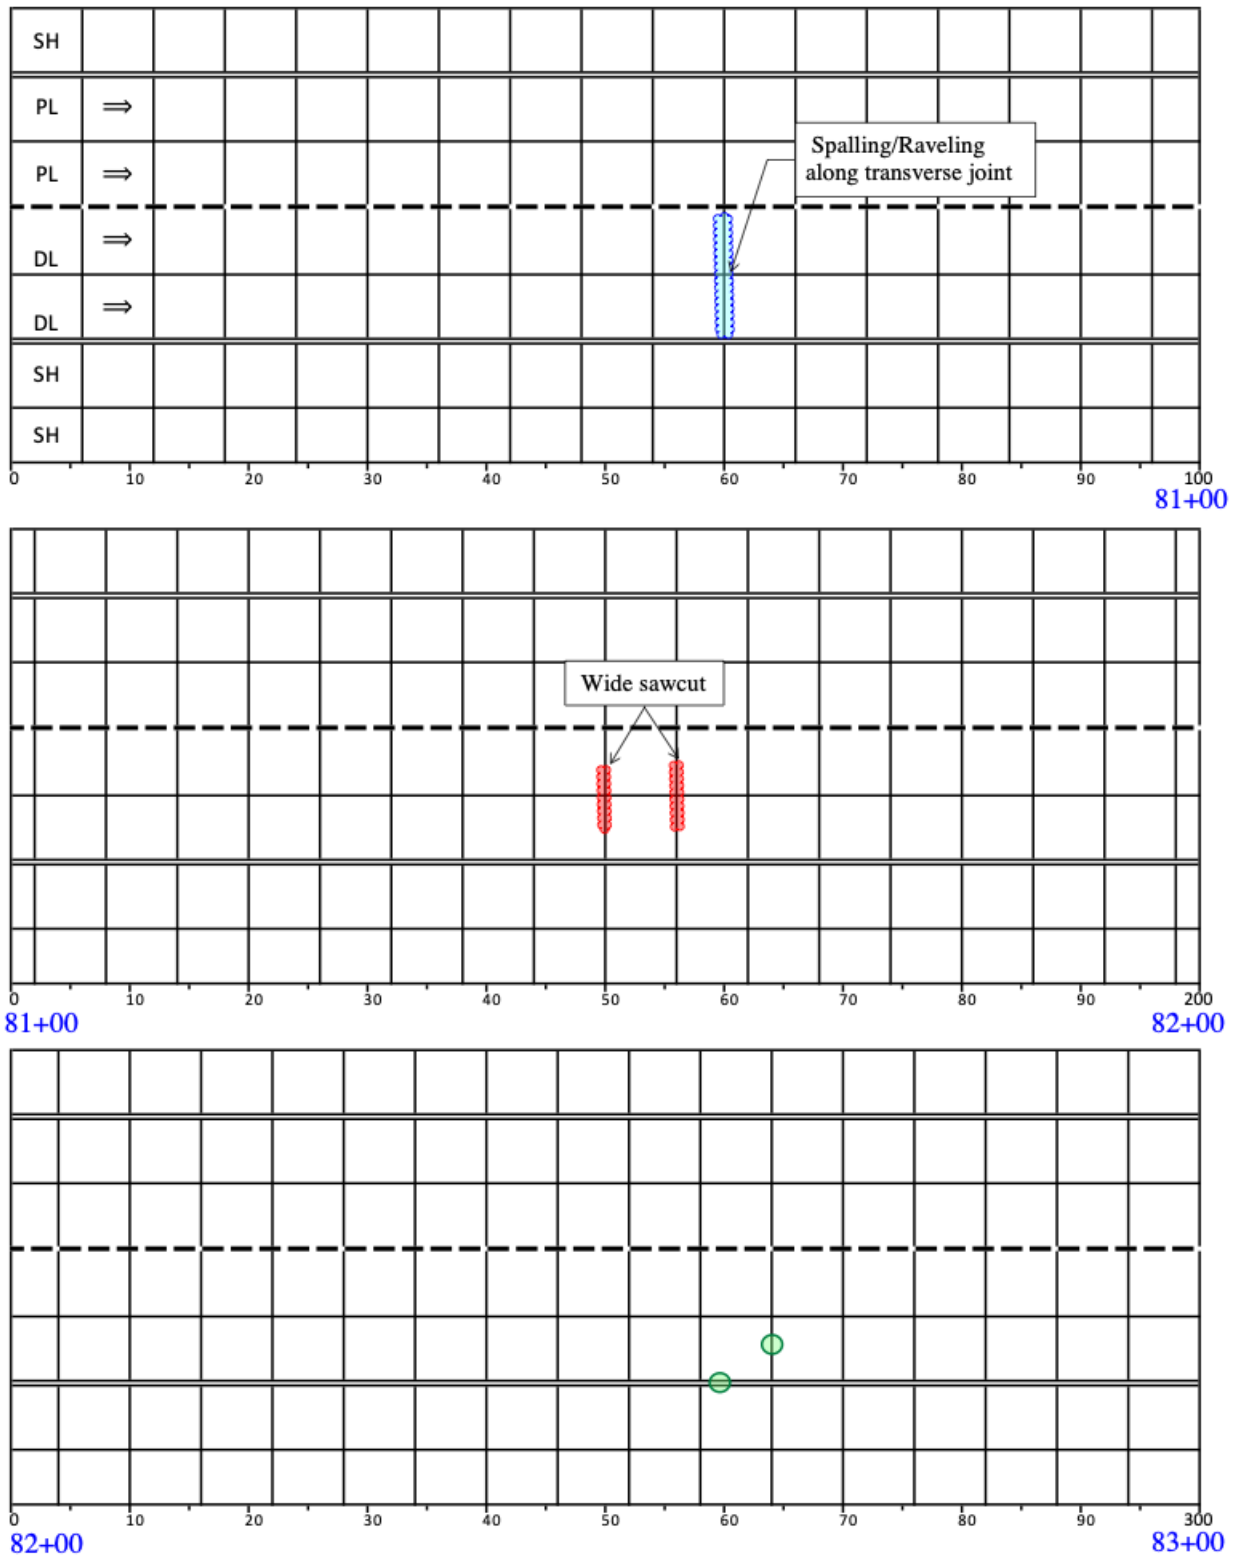
Figure 74. Illustration. Distress survey in I-72 EB at stations 80+00–83+00.

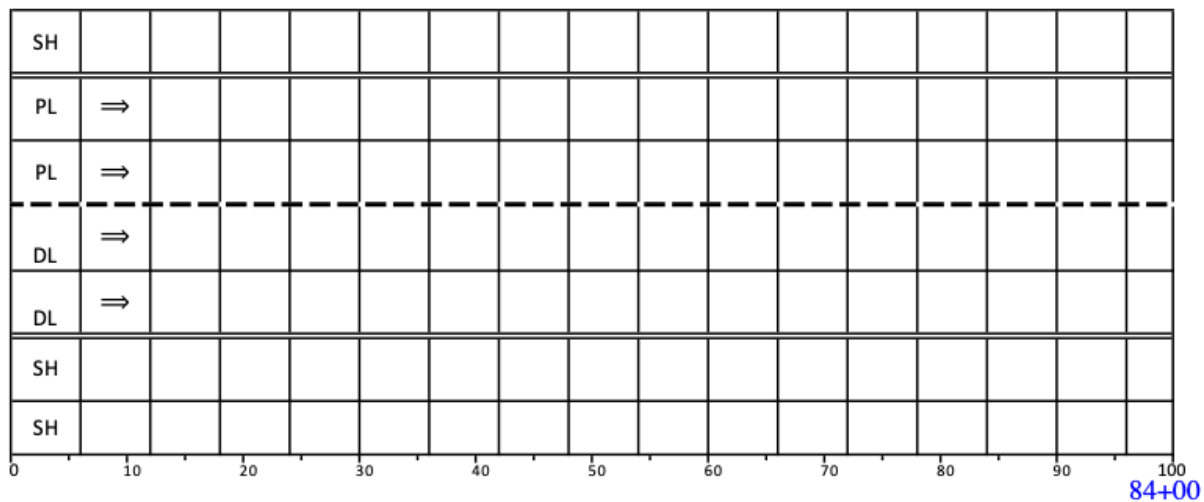
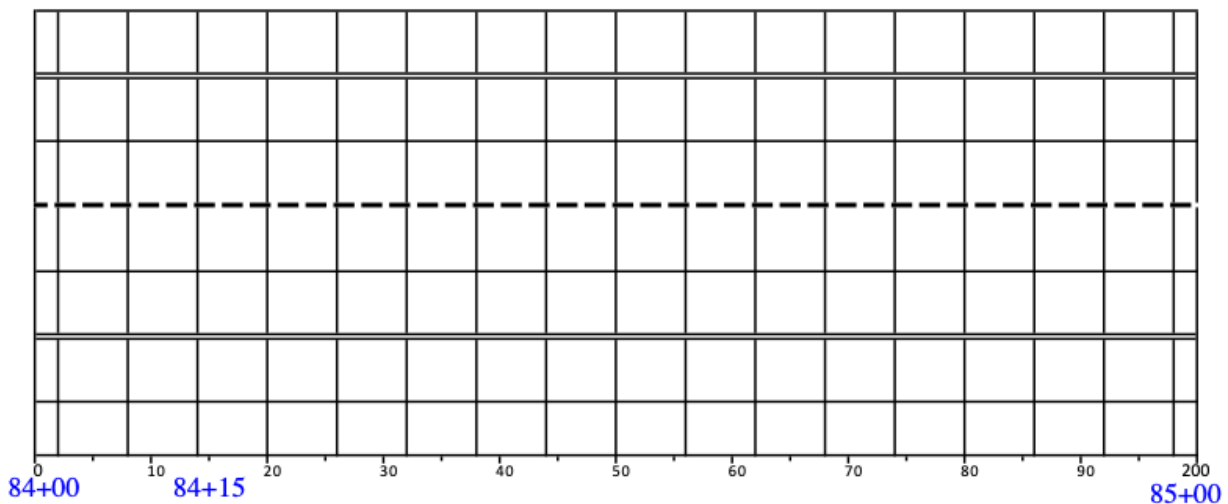
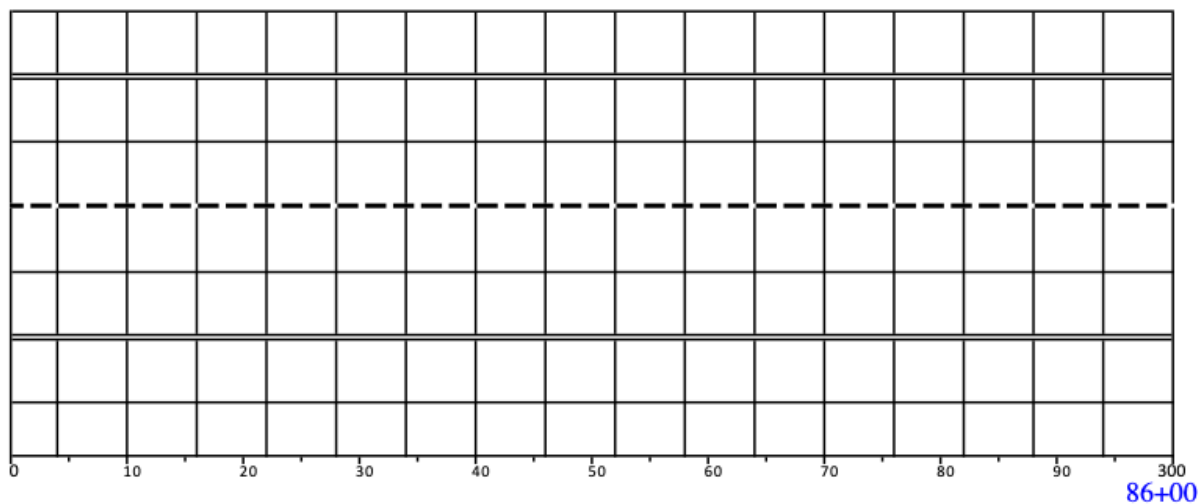
Figure 75. Illustration. Distress survey in I-72 EB at stations 83+00–86+00.

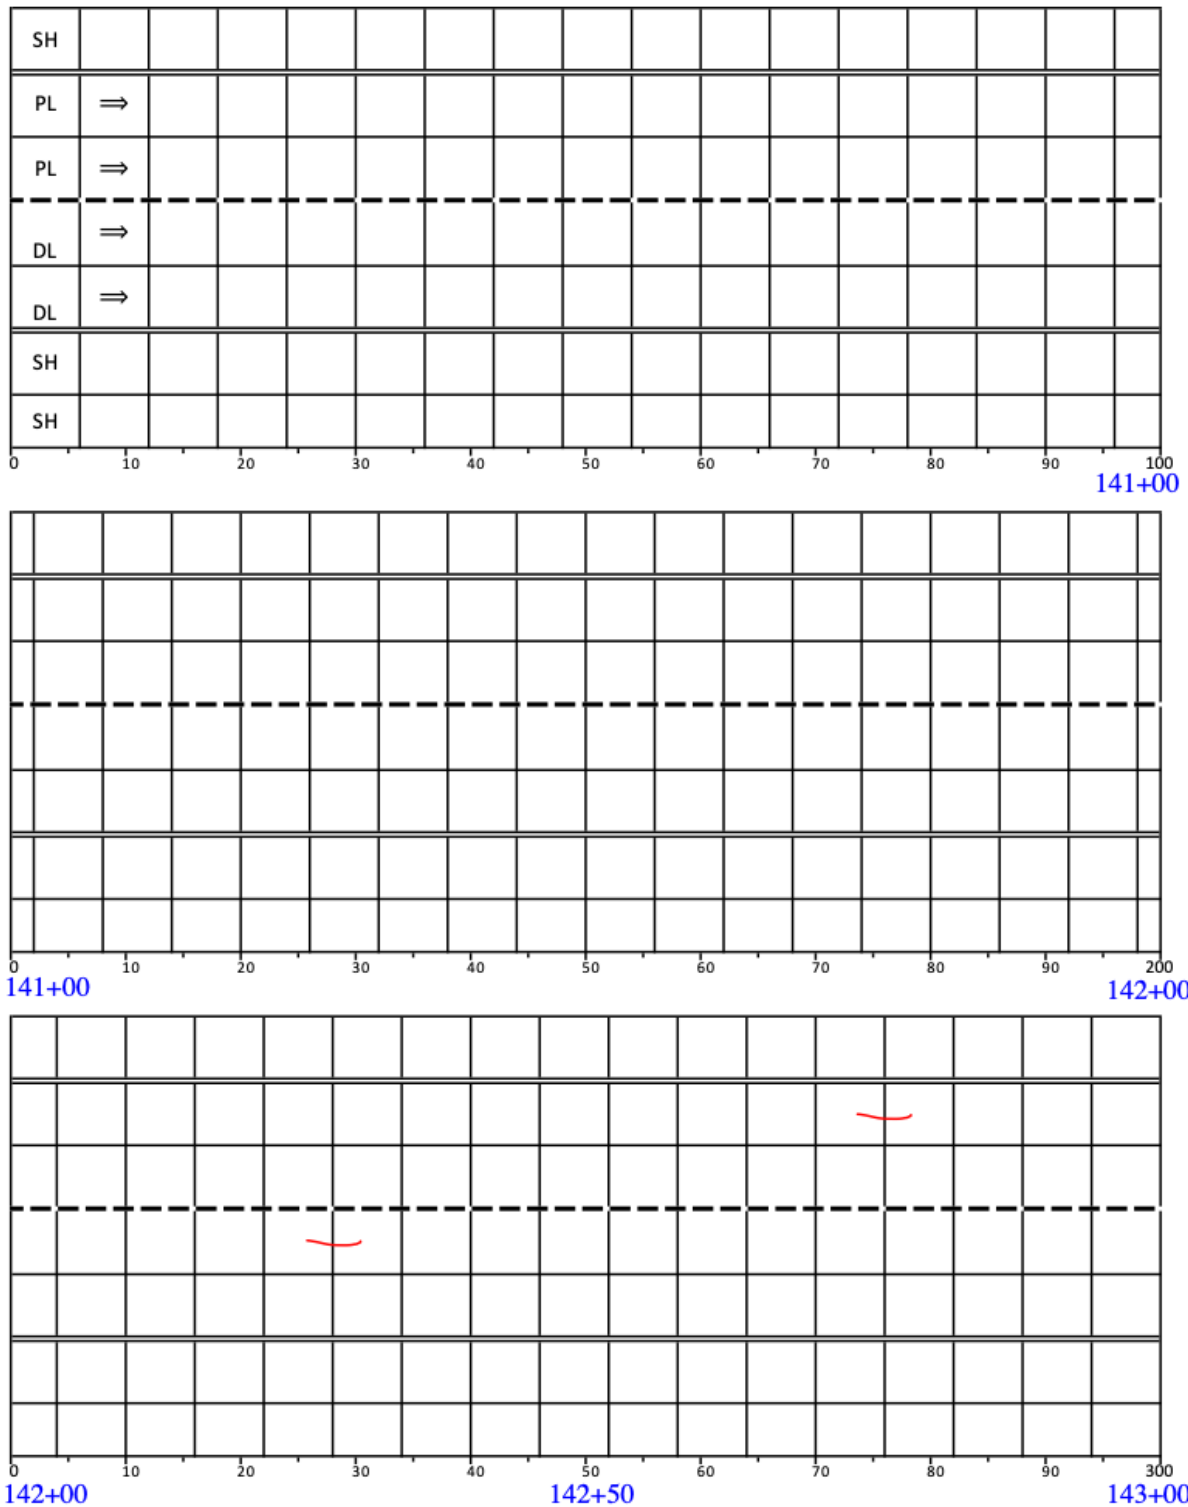
Figure 76. Illustration. Distress survey in I-72 EB at stations 140+00–143+00.

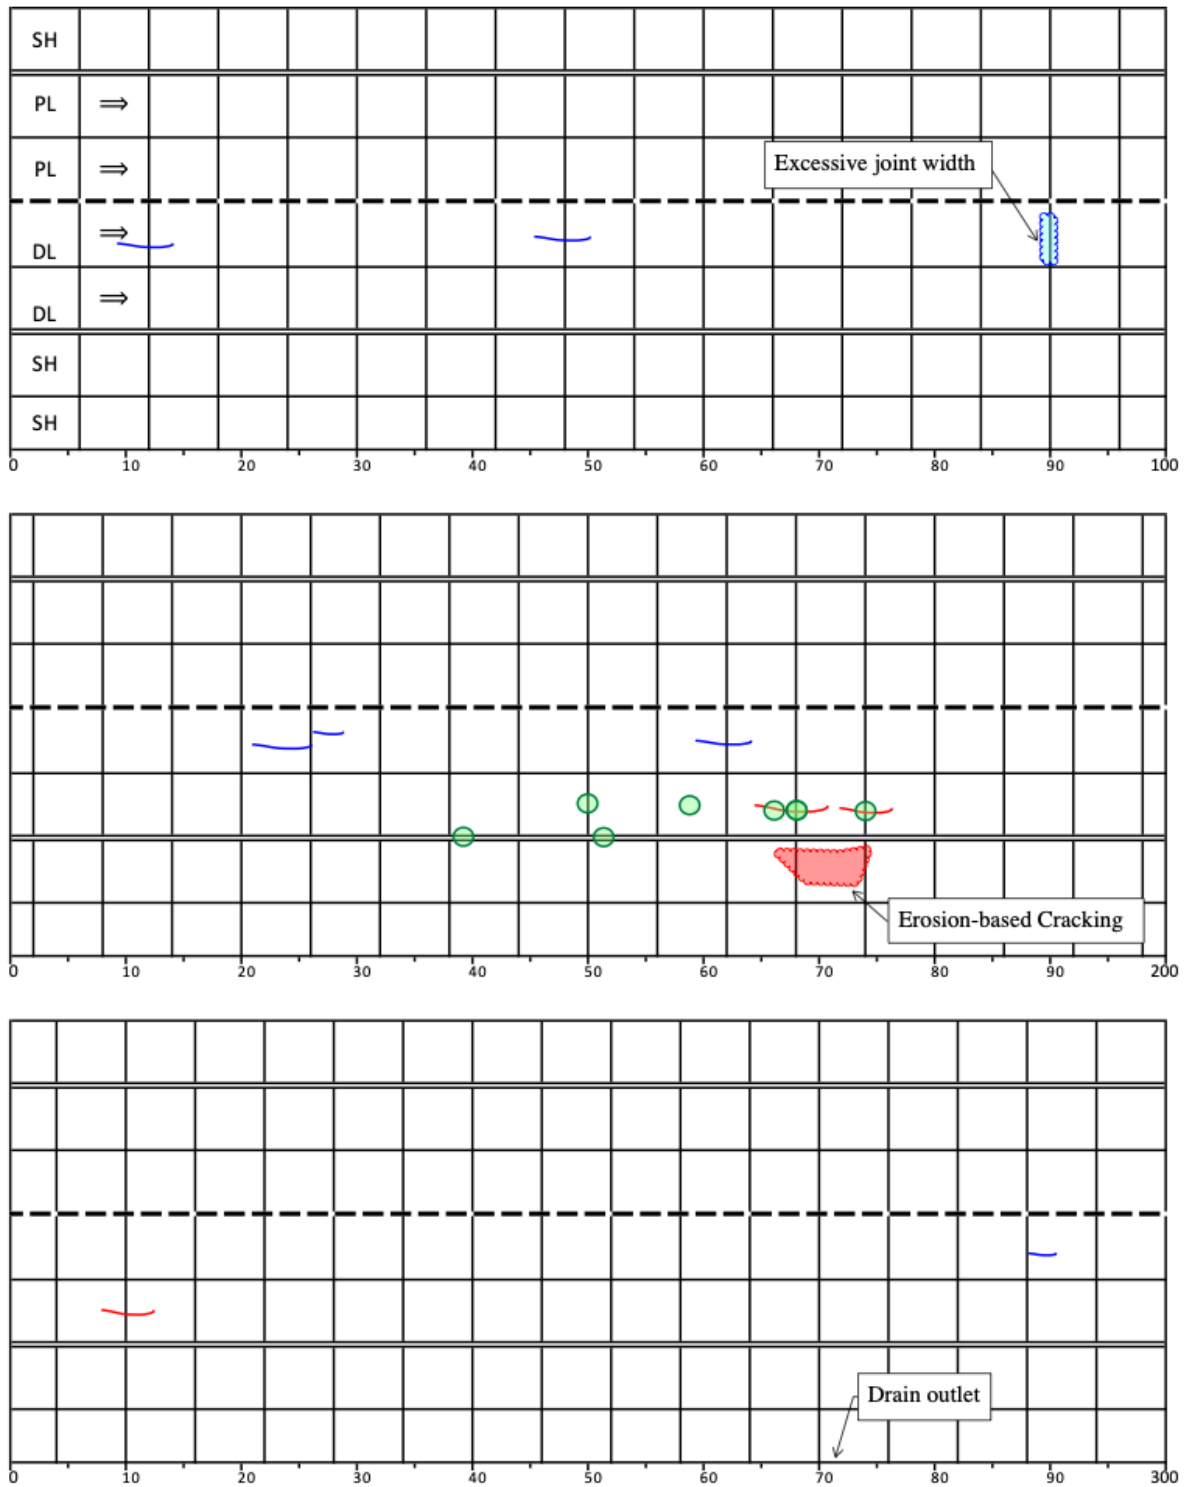
Figure 77. Illustration. Distress survey in I-72 EB at stations 143+00–146+00.
