Evaluation of Unbonded Jointed Concrete Overlays

ICT Project R27-SP74

September 2025

ICT Series Report No. 25-009

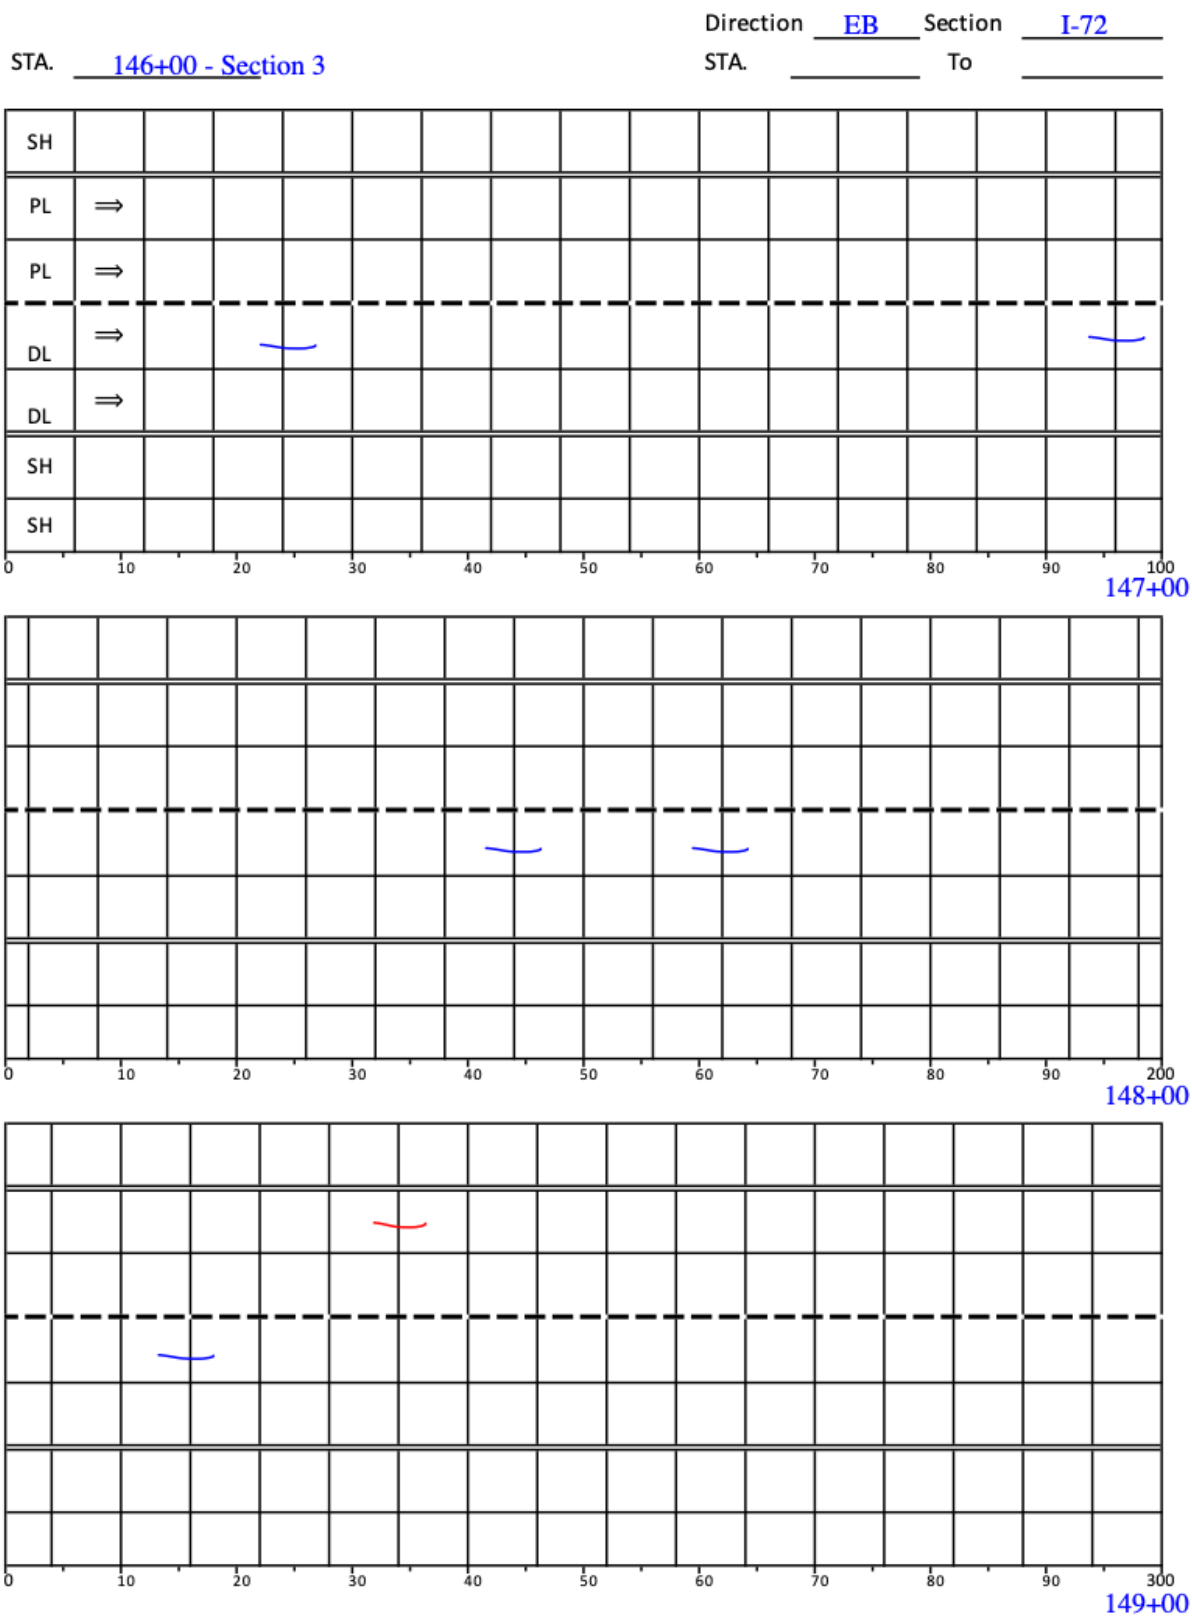
Figure 78. Illustration. Distress survey in I-72 EB at stations 146+00–149+00.

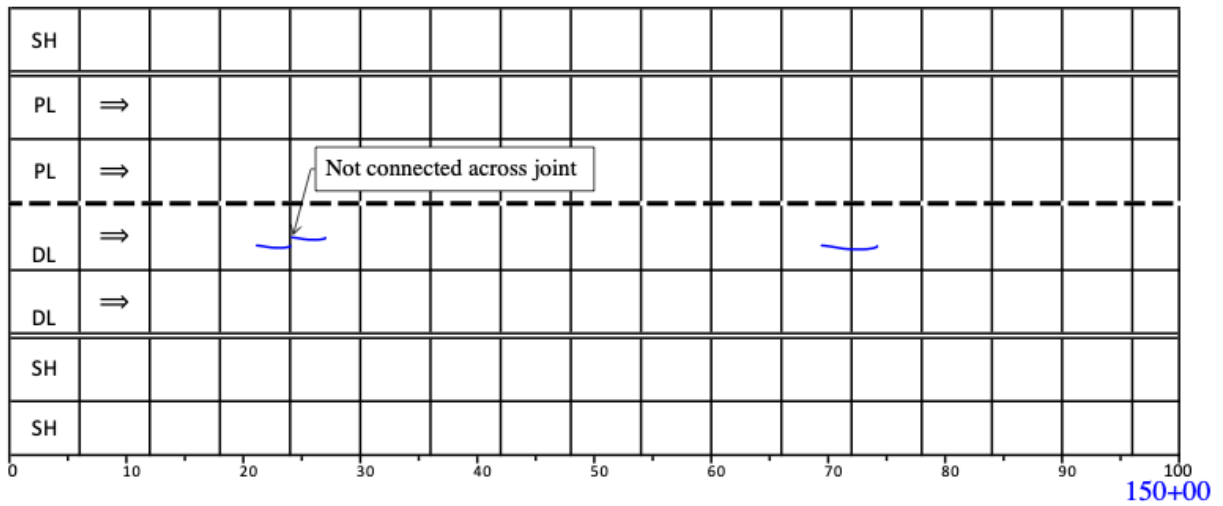
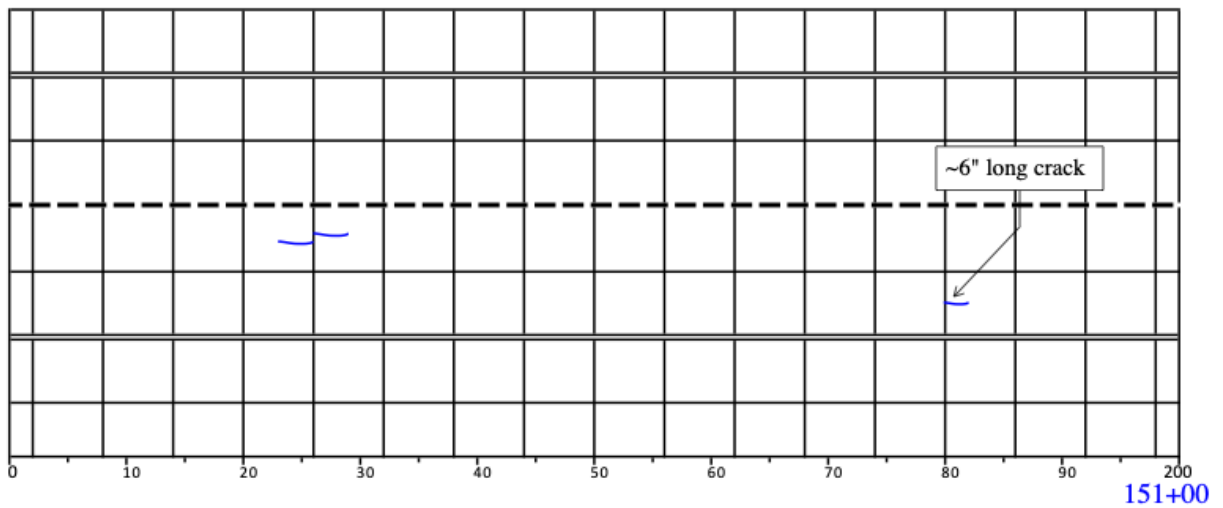
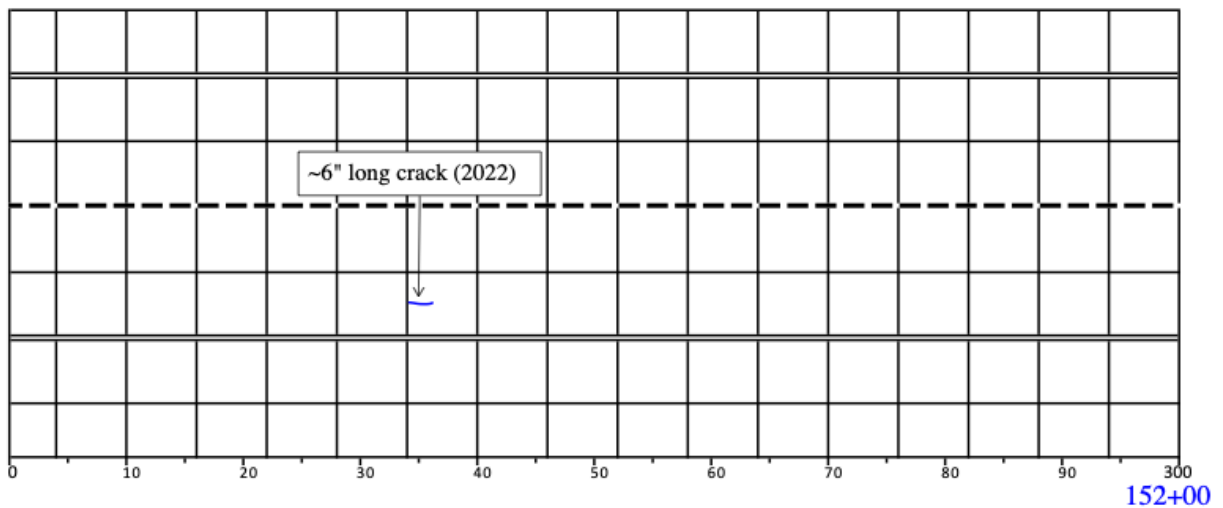
Figure 79. Illustration. Distress survey in I-72 EB at stations 149+00–152+00.

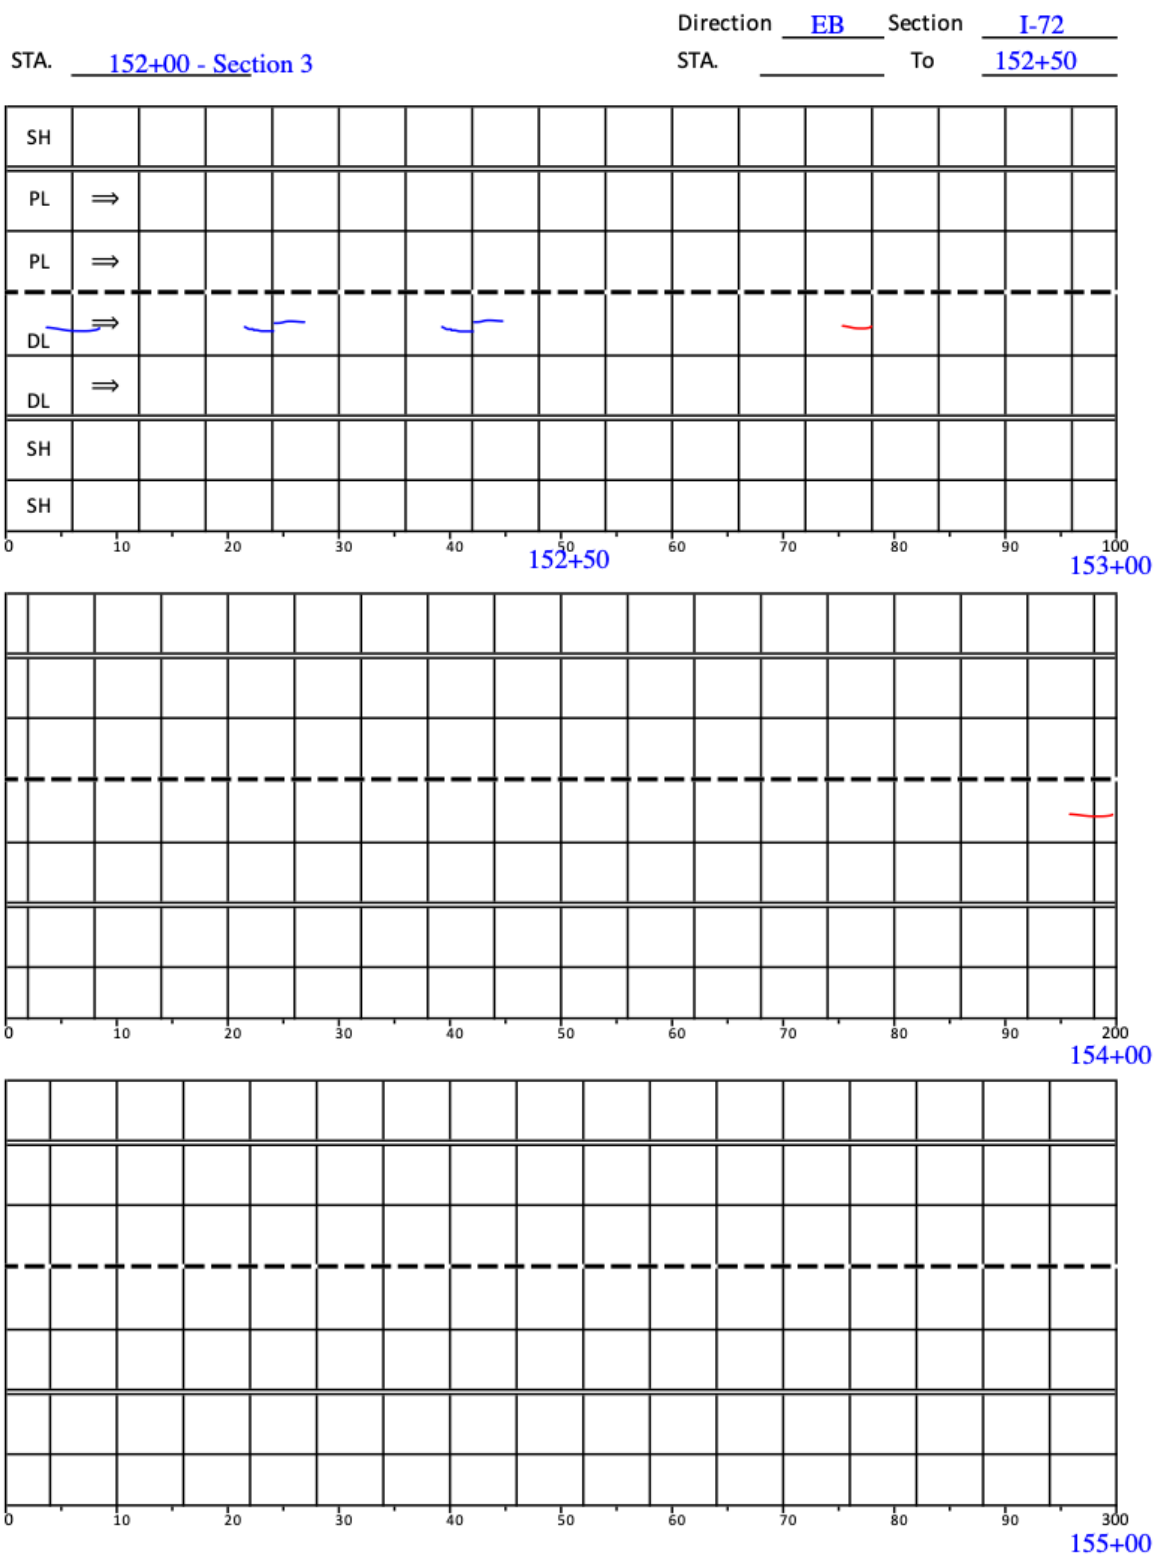
Figure 80. Illustration. Distress survey in I-72 EB at stations 152+00–155+00.

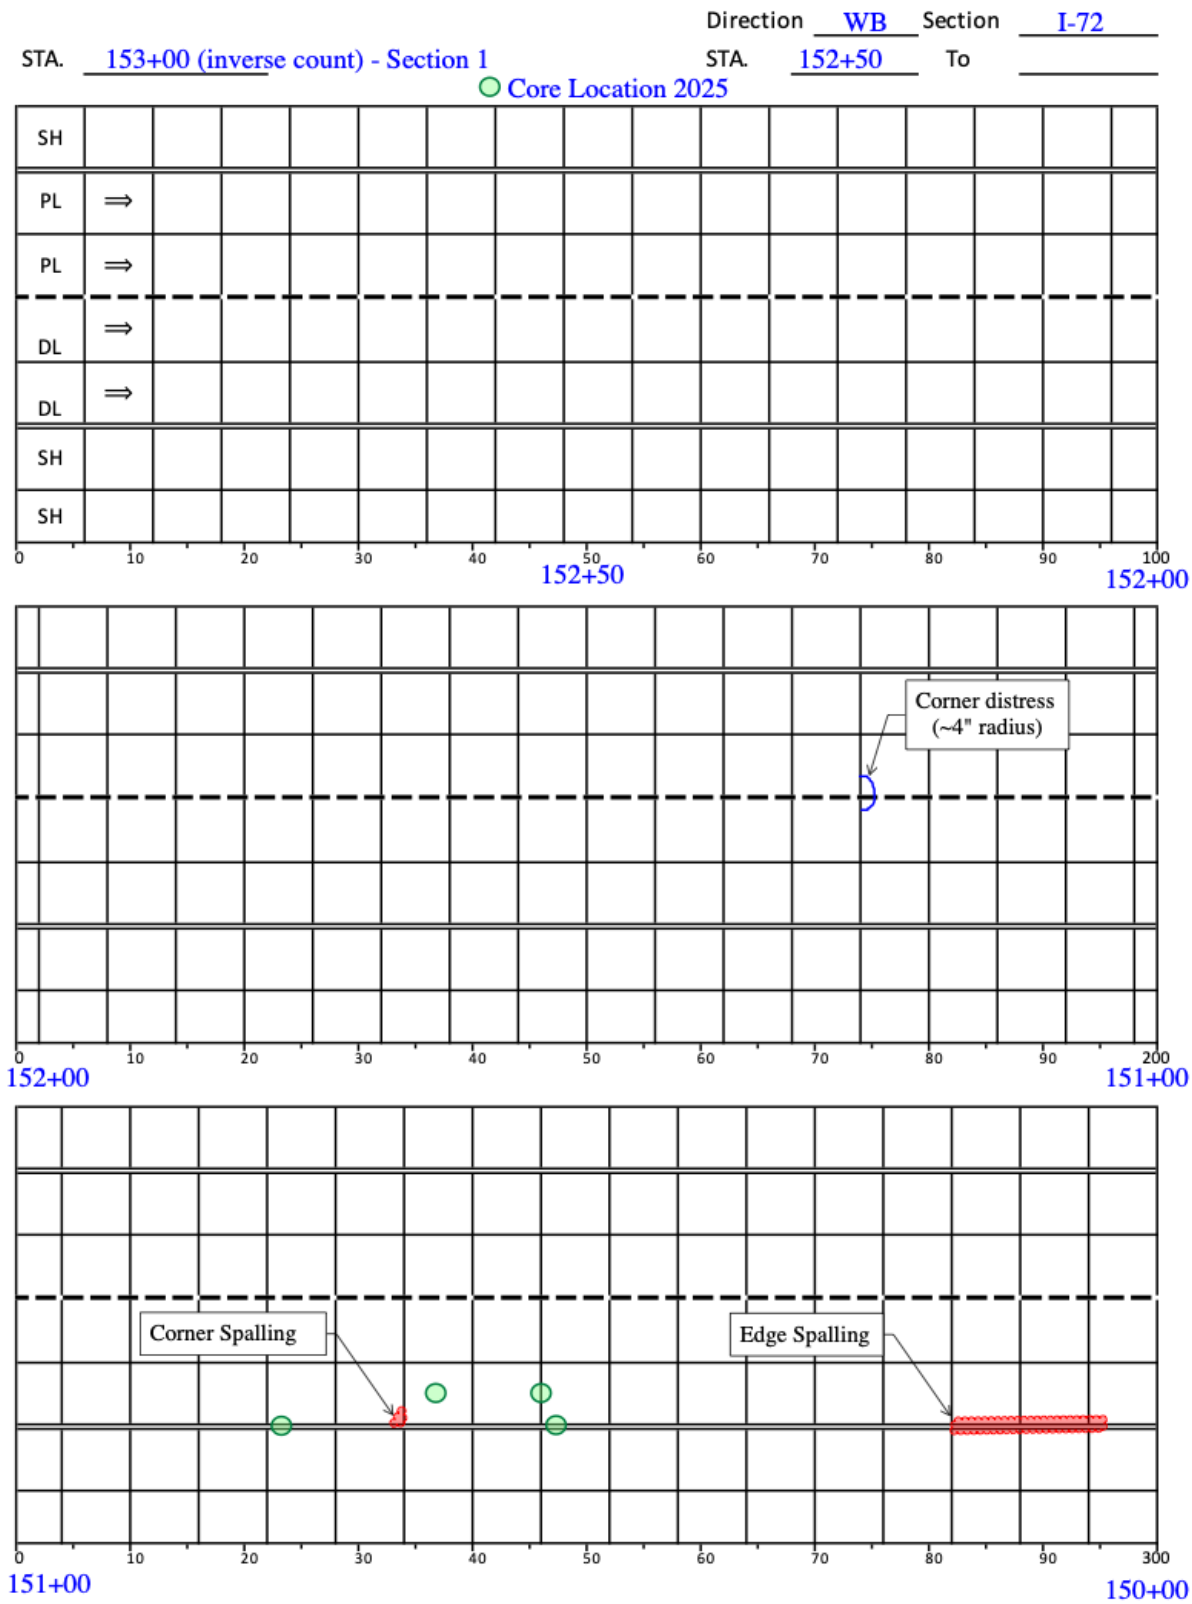
Figure 81. Illustration. Distress survey in I-72 WB at stations 153+00–150+00.

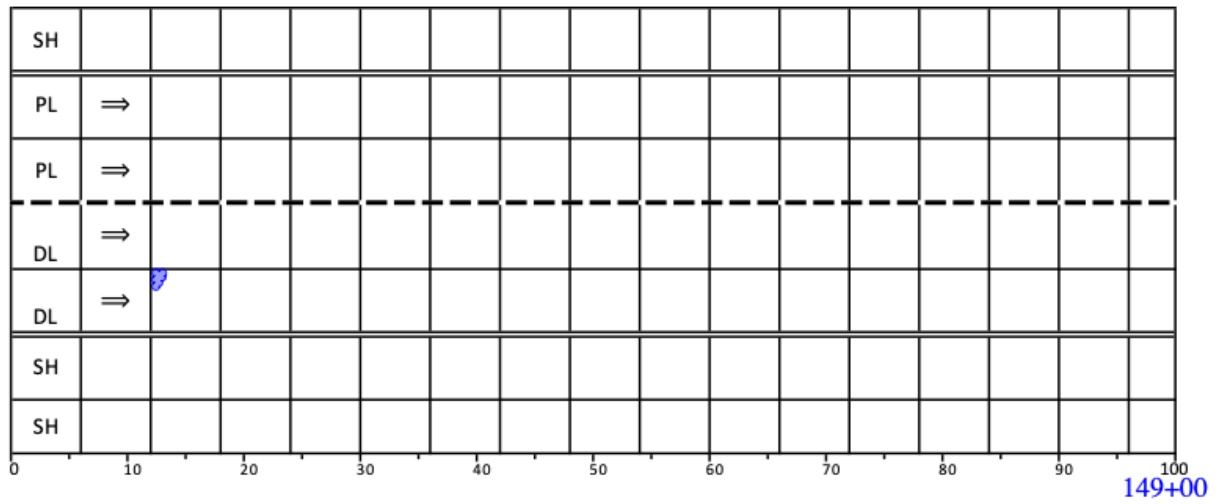
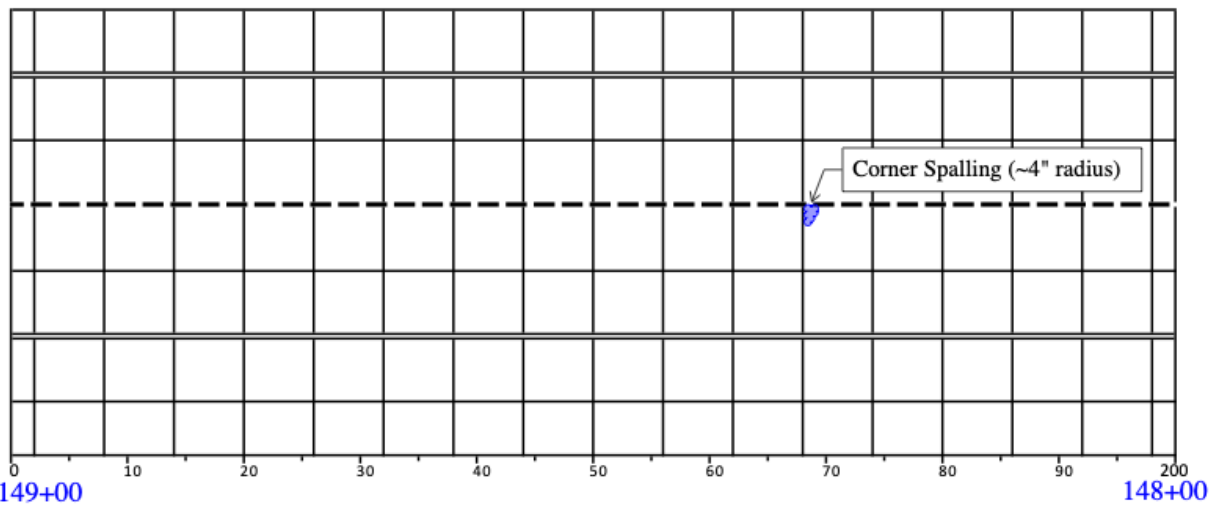
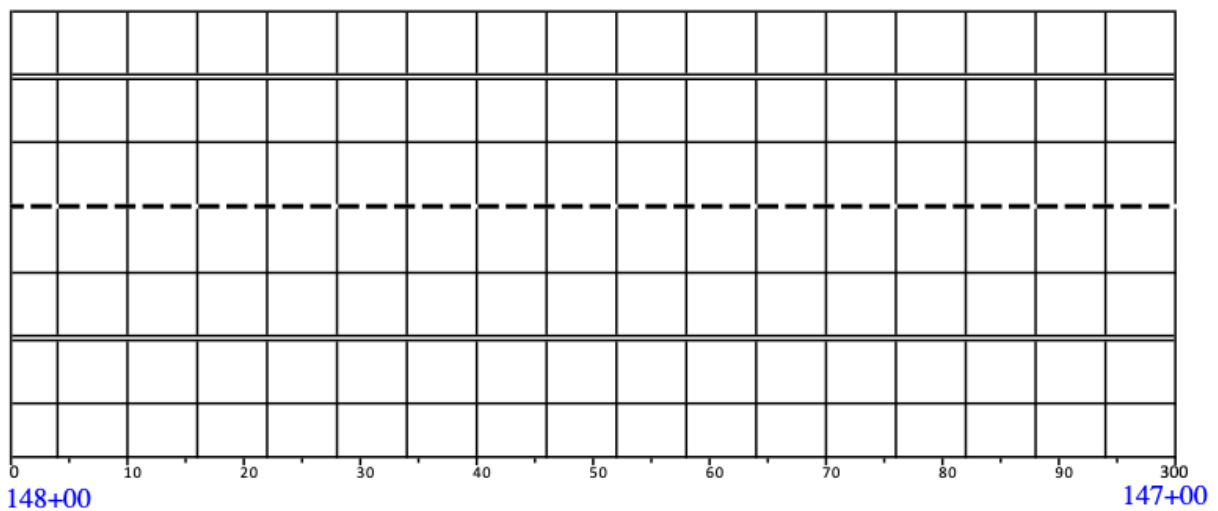
Figure 82. Illustration. Distress survey in I-72 WB at stations 150+00–147+00.

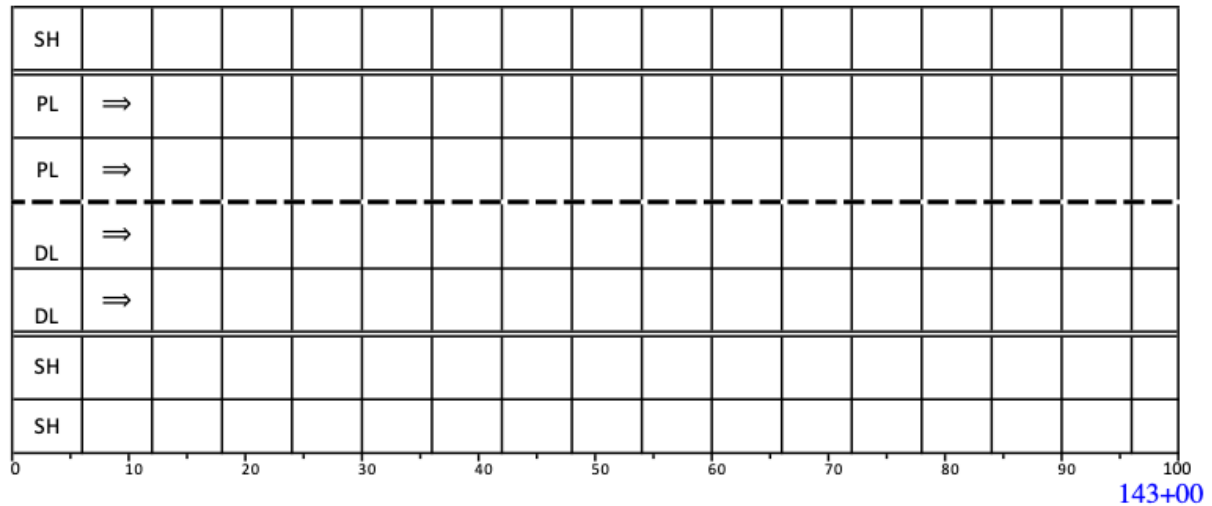
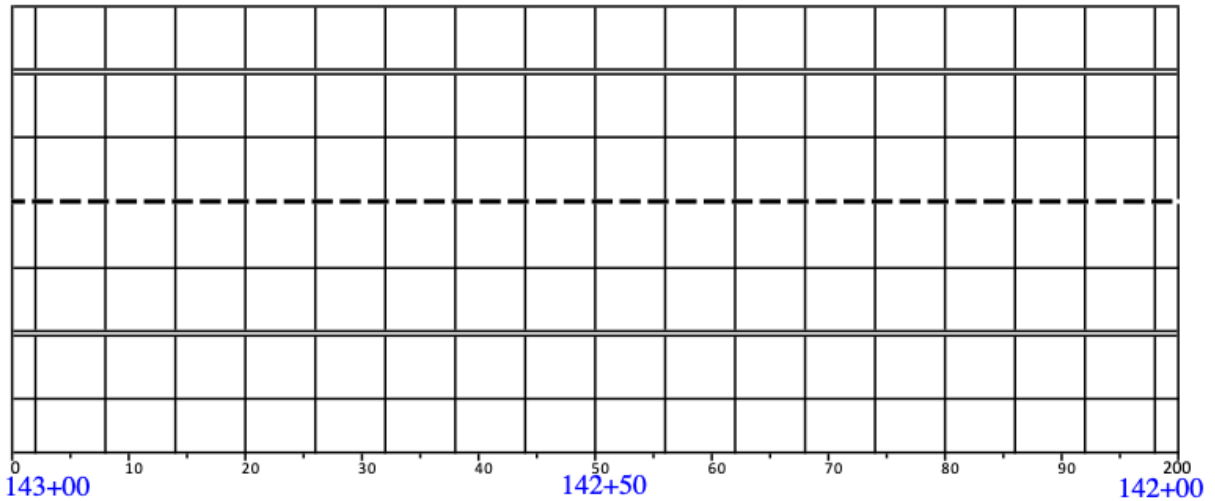
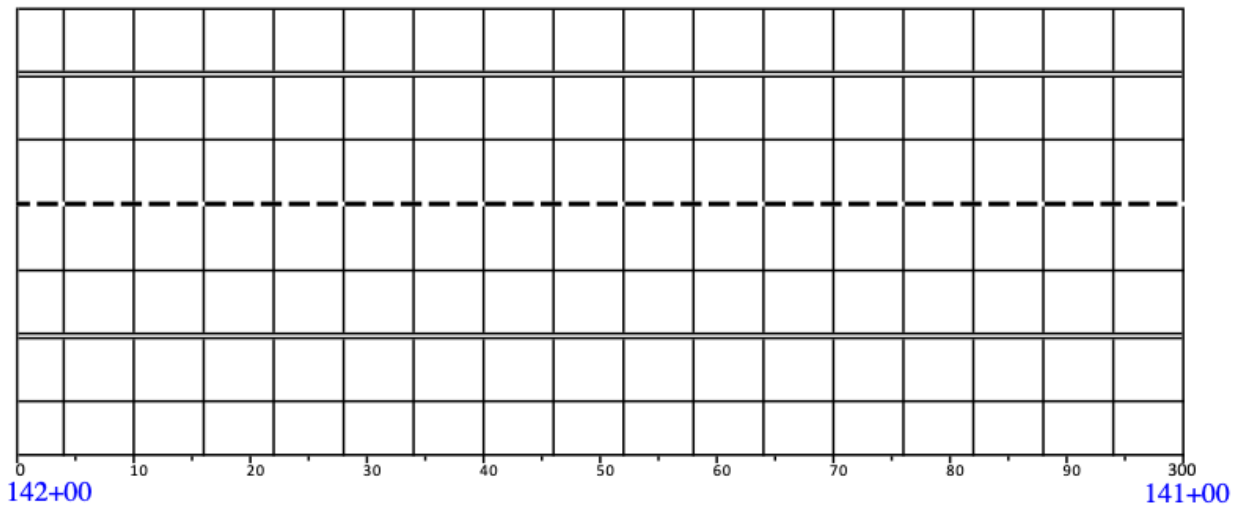
Figure 84. Illustration. Distress survey in I-72 WB at stations 144+00–141+00.

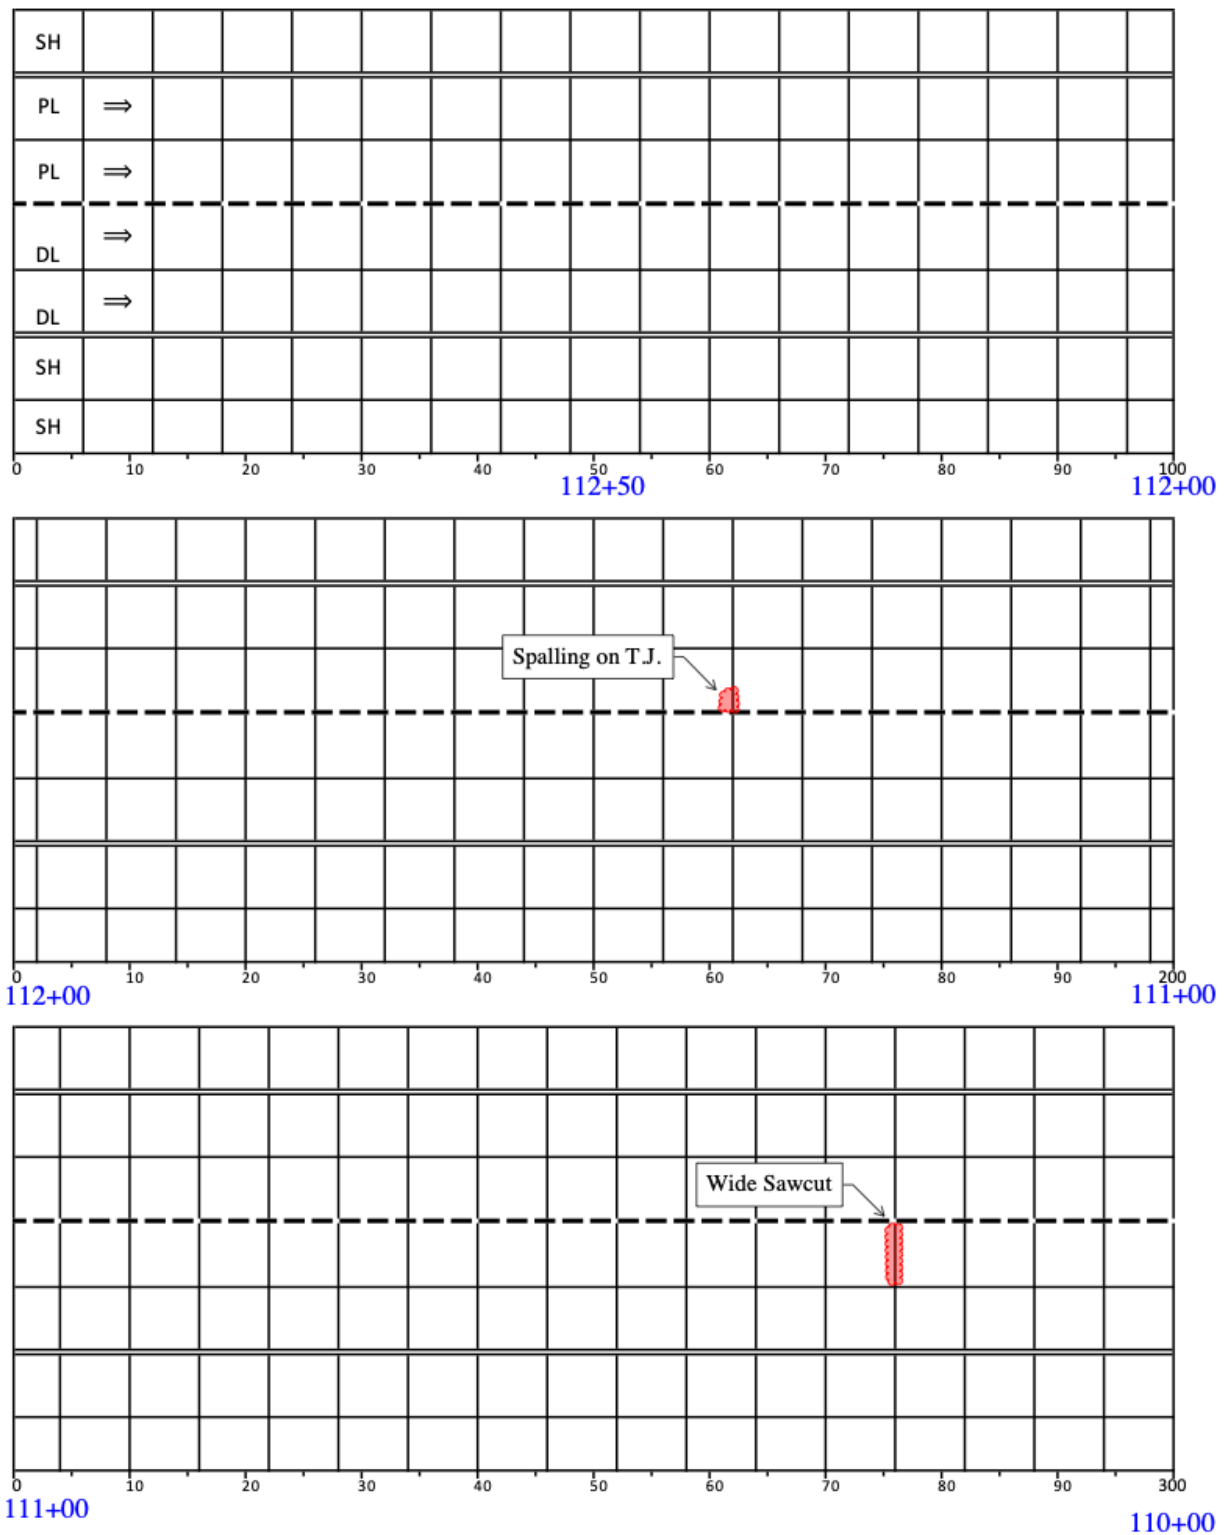
Figure 85. Illustration. Distress survey in I-72 WB at stations 113+00–110+00.

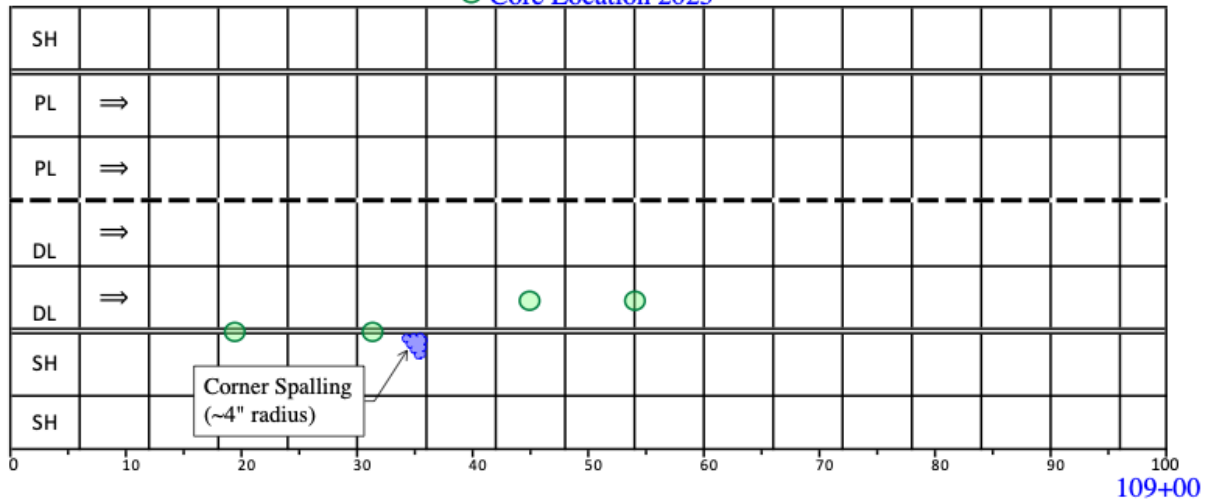
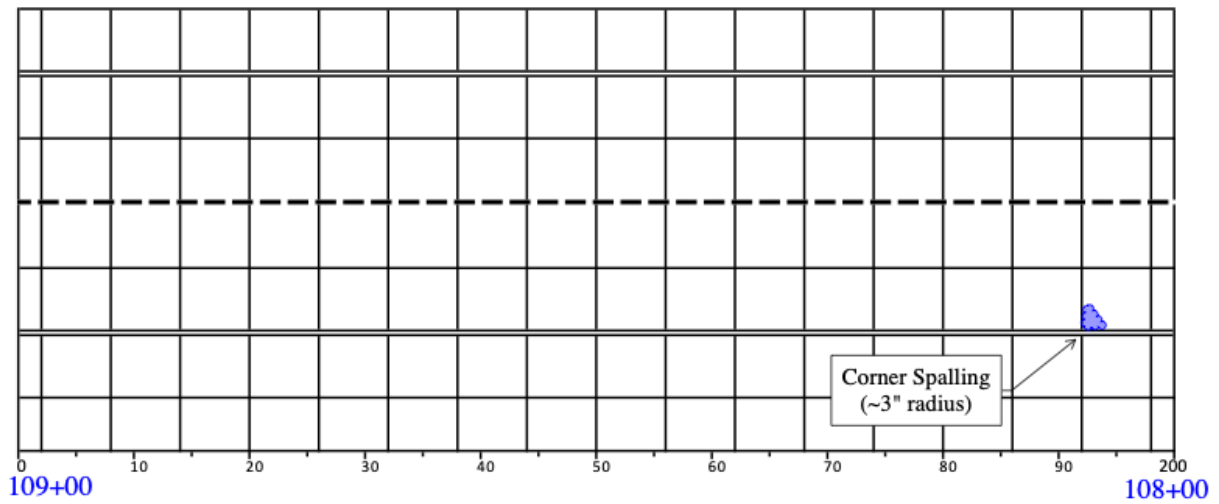
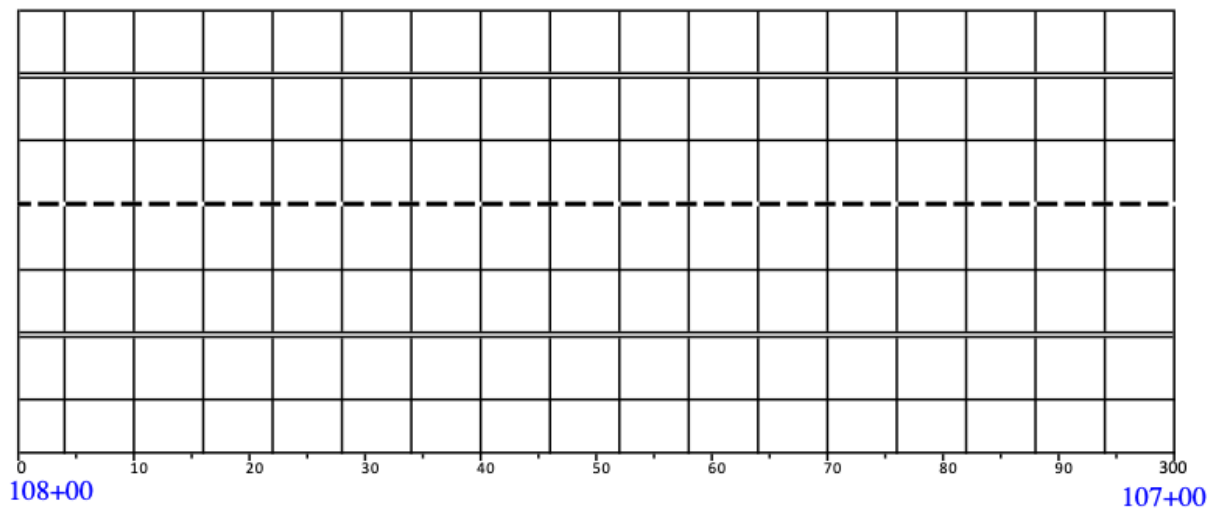
Figure 86. Illustration. Distress survey in I-72 WB at stations 110+00–107+00.

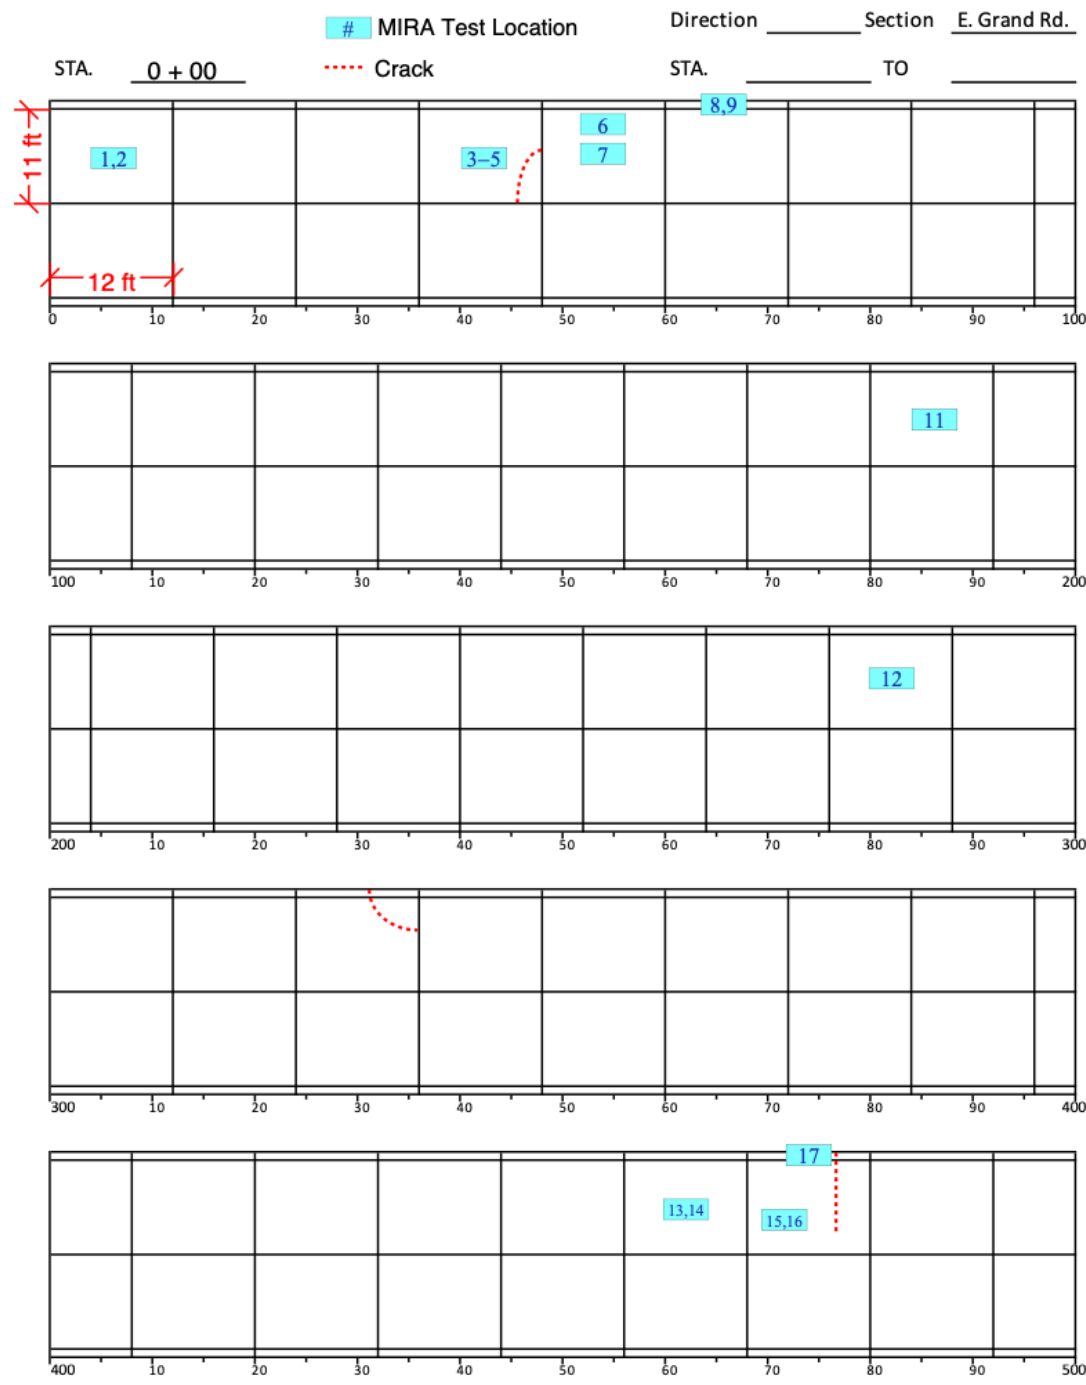
Figure 93. Illustration. Distress survey in East Grand Road at stations 0+00–5+00.

In the distress map the blue lines represent new longitudinal cracks observed in 2021, red lines are new cracks from 2025, and blue boxes are locations for MIRA testing.

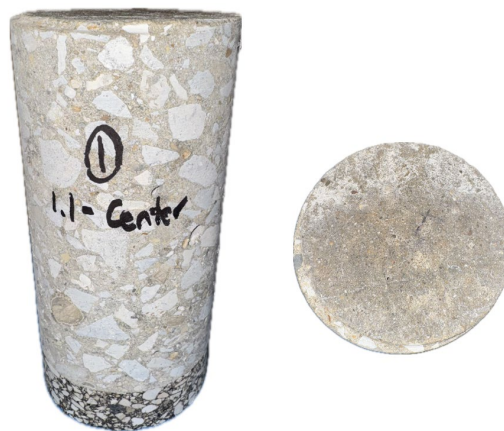
Test No.	Station	Core ID	Overlay Thickness, in.	Diameter, in.	Comment	Interlayer thickness, in.
1	14+77	1.1 Center	6.49	3.70	Completely bonded to HMA. HMA looks intact	1.11
2	14+93	2-3 SH/DL	6.62	3.69	HMA completely unbonded but partially damaged.	1.00
3	15+04	1.3 TJWC	6.61	3.70	HMA completely unbonded but intact. Joint fully activated but still together. Long crack full depth	1.13
4	15+03	1.4 10"-TJWC	6.59	3.71	Completely bonded to HMA. HMA looks intact. Long crack is 32mm deep	1.05
5	15+16	1.5 TJWOC	6.64	3.70	HMA completely unbonded but intact. Joint fully activated but still together	1.25
6	82+61	2.1 SH/DL	6.17	3.67	Deteriorated HMA with only 11mm left. Complete separated and cracked	0.43
7	82+66	2.2 TJWOC	6.15	3.71	Completely bonded to HMA. HMA looks intact. Full-depth activated joint	1.55
8	144+43	3.1 SH/DL	6.11	3.64	Deterioration in the HMA. No HMA in shoulder side	0.31
9	144+55	3.2 SH/DL	6.03	3.61	Deterioration in the HMA. No HMA left on shoulder side	0.36

Figure 99. Photo. Test No. 1: side and top views of core extracted from I-72 EB at station 14+77 at the slab center.

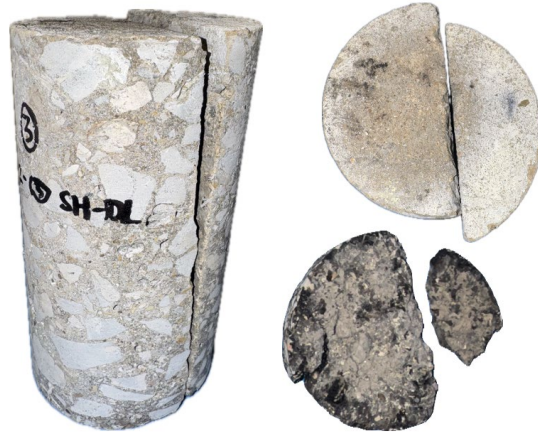
Figure 100. Photo. Test No. 2: side, top and bottom views of core extracted from I-72 EB at station 14+93 at the lane—shoulder joint.

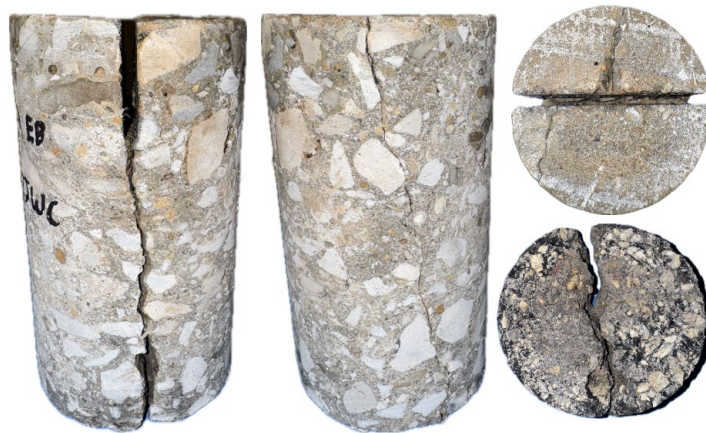
Figure 101. Photo. Test No. 3: sides, top and bottom views of core extracted from I-72 EB at station 15+04 at the middle of a transverse joint with a longitudinal crack.

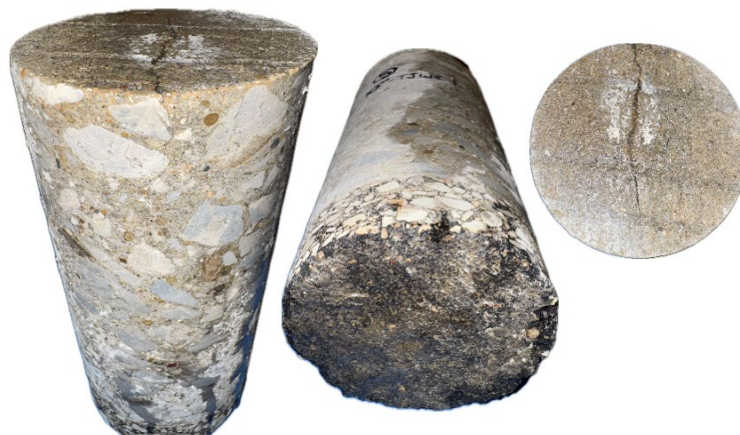
Figure 102. Photo. Test No. 4: side, bottom and top views of core extracted from I-72 EB at station 15+03 at 10" from a transverse joint with a longitudinal crack (on crack path).

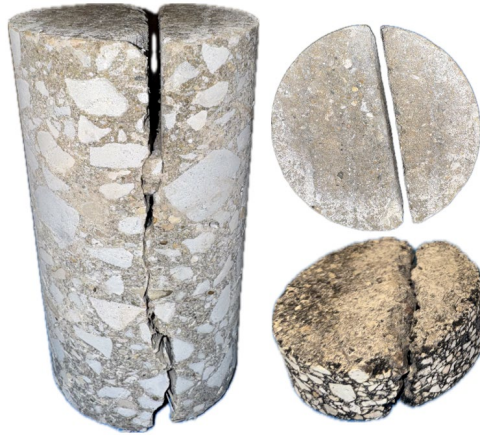
Figure 103. Photo. Test No. 5: side, top and bottom views of core extracted from I-72 EB at station 15+16 at the middle of a transverse joint without a longitudinal crack.

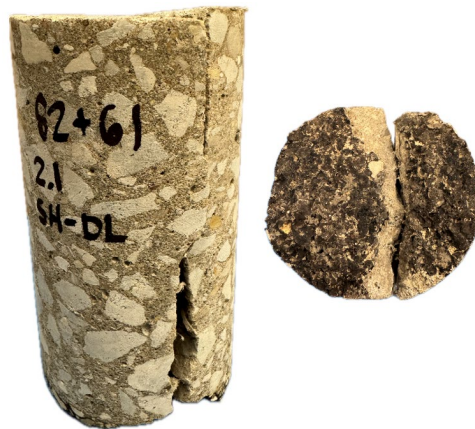
Figure 104. Photo. Test No. 6: side, and bottom views of core extracted from I-72 EB at station 82+61 at the lane—shoulder joint.

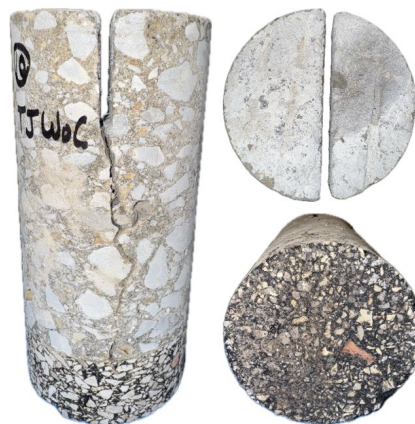
Figure 105. Photo. Test No. 7: side, top and bottom views of core extracted from I-72 EB at station 82+66 at the middle of a transverse joint without a longitudinal crack.

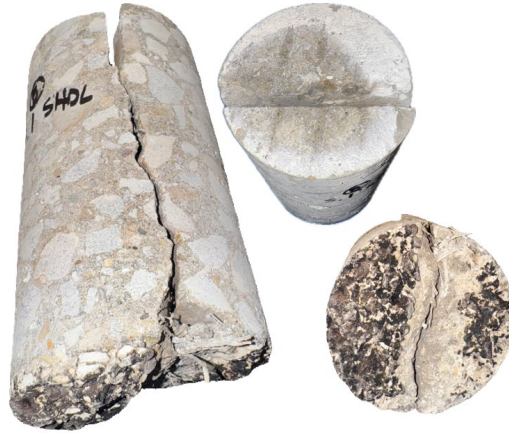
Figure 106. Photo. Test No. 8: side, top and bottom views of core extracted from I-72 EB at station 144+43 at the lane—shoulder joint.

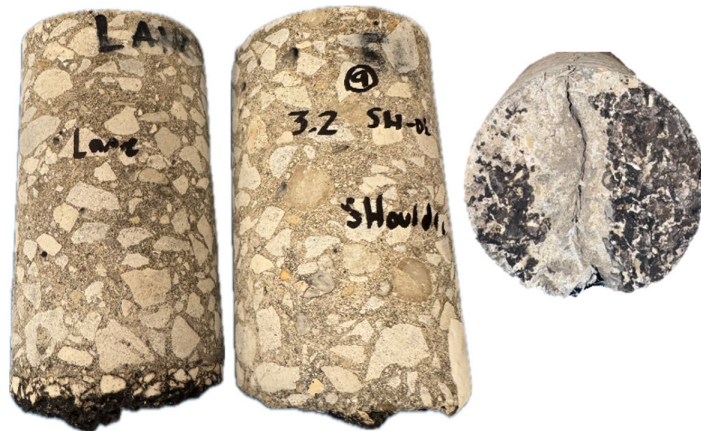
Figure 107. Photo. Test No. 9: sides and bottom views of core extracted from I-72 EB at station 144+55 at the lane—shoulder joint.

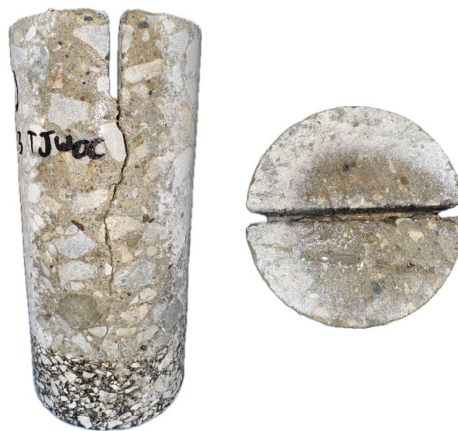
10	144+54	3.3 TJWOC	6.05	3.70	Completely bonded to HMA. HMA looks intact. Transverse joint crack activated full depth.	1.64
11	144+63	3.4 Center	5.97	3.70	Completed bonded to HMA. HMA looks intact. No cracks visible.	1.57
12	144+78	3.5 TJWC	6.07	3.69	Completely bonded to HMA. HMA looks intact. Long crack is only 2" deep. TJ not activated	1.43
13	144+72	3.6 TJWC	6.06	3.70	Completely bonded to HMA. HMA looks intact. Transverse joint crack activated full depth. Longitudinal Crack is ~2-3" deep	1.33
14	144+71	3.7 10in-TJWC	6.06	3.71	Completely bonded to HMA. HMA looks intact. Long crack is only ~ 1" deep	1.34

Figure 108. Photo. Test No. 10: side and top views of core extracted from I-72 EB at station 144+54 at the middle of a transverse joint without a longitudinal crack.

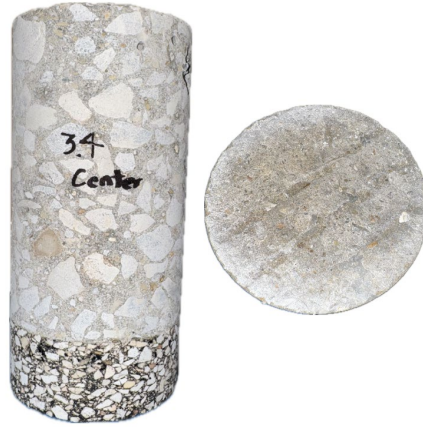
Figure 109. Photo. Test No. 11: side and top views of core extracted from I-72 EB at station 144+63 at the slab center.

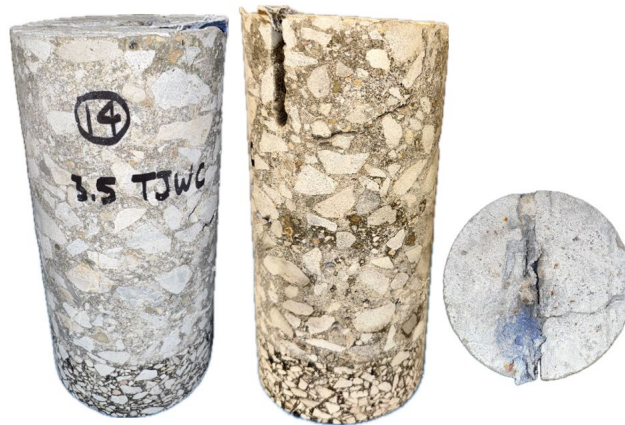
Figure 110. Photo. Test No. 12: sides, and top views of core extracted from I-72 EB at station 144+78 at the middle of a transverse joint with a longitudinal crack.

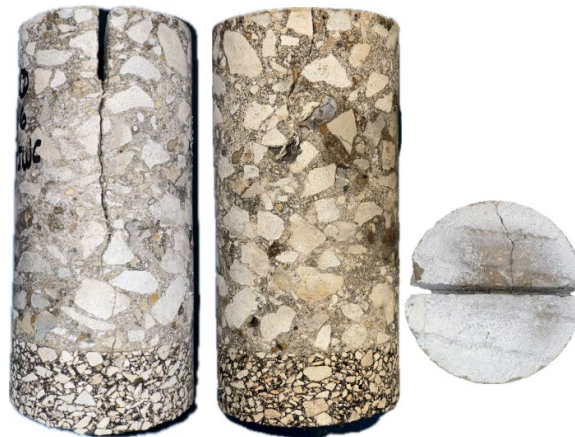
Figure 111. Photo. Test No. 13: sides, and top views of core extracted from I-72 EB at station 144+72 at the middle of a transverse joint with a longitudinal crack.

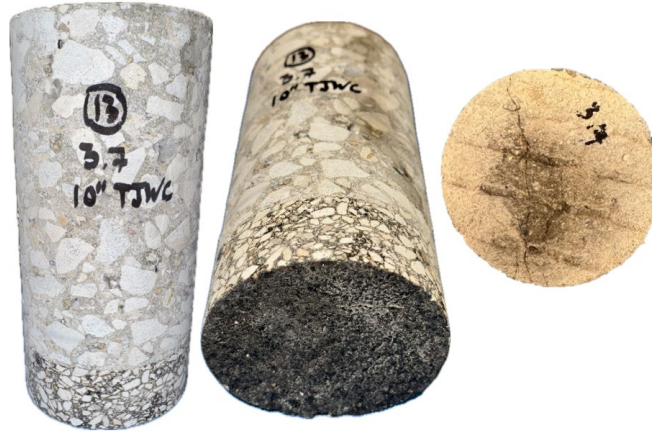
Figure 112. Photo. Test No. 14: side, bottom and top views of core extracted from I-72 EB at station 144+71 at 10" from a transverse joint with a longitudinal crack (on crack path).

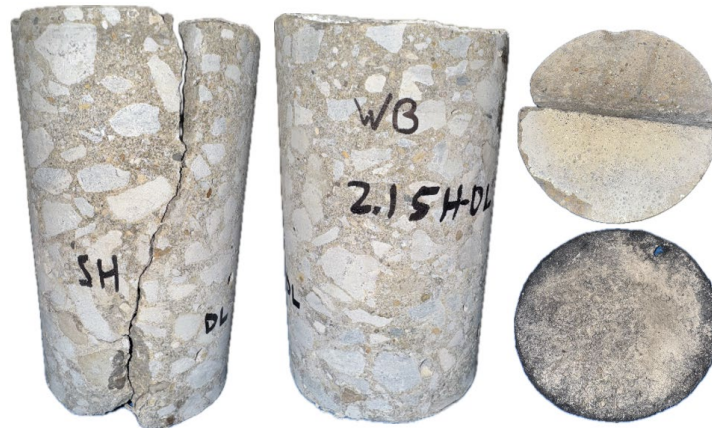
Test No.	Station	Core ID	Overlay Thickness, in.	Diameter, in.	Comment	Interlayer thickness, in.
1	150+68	2.1 SH/DL	6.19	3.69	Fabric unbonded. Fully activated joint. Split core	0.15
2	150+59	2.2 SH/DL	6.55	3.68	Fabric unbonded. Fully activated joint	0.11
3	150+82	2.3 Center	6.21	3.70	Bonded fabric	0.10
4	150+58	2.4 TJ	6.50	3.70	Full-depth activated joint. Split core. Unbonded fabric	0.13
5	109+78	3.1 Center	6.85	3.70	Fabric Bonded to overlay	0.09
6	109+66	3.2 TJ	6.85	3.71	Fully activated joint. Unbonded fabric. Split core	0.14
7	109+52	3.3 SH/DL	6.45	3.68	Fully activated joint. Unbonded fabric	0.12
8	109+43	3.4 SH/DL	7.11	3.66	Fully activated joint. Split core. Unbonded fabric	0.15

Figure 113. Photo. Test No. 1: sides, top and bottom views of core extracted from I-72 WB at station 150+68 at the lane—shoulder joint.

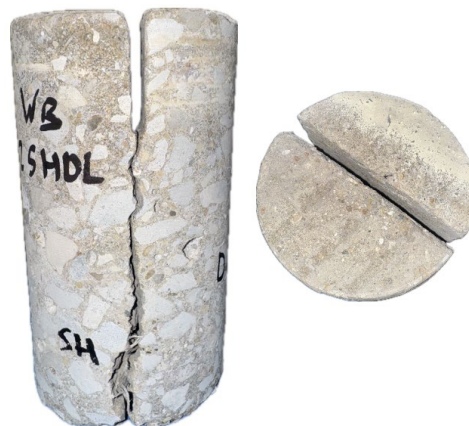
Figure 114. Photo. Test No. 2: side and top views of core extracted from I-72 WB at station 150+59 at the lane—shoulder joint.

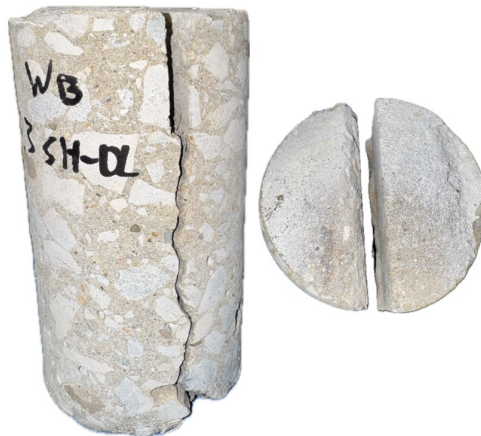
Figure 118. Photo. Test No. 6: side, and top views of core extracted from I-72 WB at station 109+66 at the middle of a transverse joint.

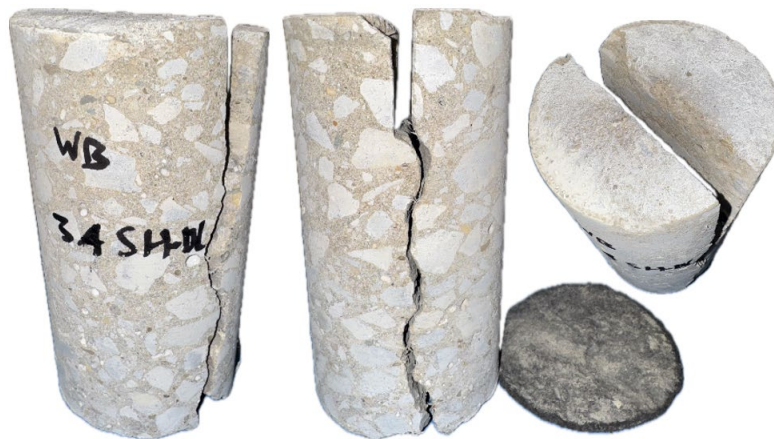
Figure 119. Photo. Test No. 7: side and top views of core extracted from I-72 WB at station 109+52 at the lane—shoulder joint.
