Assessment and Repair of Prestressed Bridge Girders Subjected to Over-height Truck Impacts

September 2025 Final Report Project number TR202011/TPF-5(462)

MoDOT Research Report number cmr 25-013

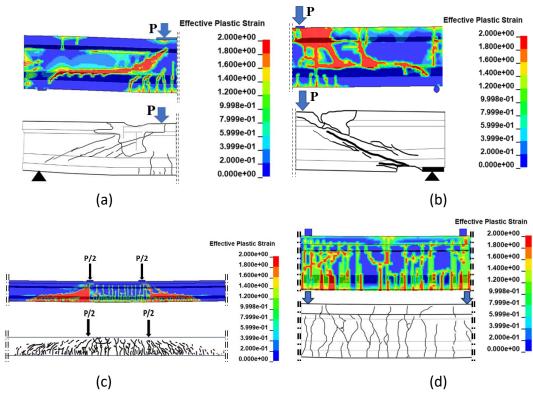
While the FE models did not simulate detailed crack patterns, they accurately identified stress concentration zones corresponding to observed cracking types. Stress concentrations (Figure 3-1) aligned with experimental crack locations, providing reliable indicators of potential cracking behavior:

- Girder G01-Test 1: Shear failure with diagonal plastic strain concentrations matching experimental diagonal cracks (Figure 3-1a).
- Girder G01-Test 3: Similar diagonal stress concentrations in the web, consistent with shear cracks (Figure 3-1b).
- Ultimate Load Test and Control Test: Vertical plastic strain concentrations at the girder soffit correlated with flexural cracks (Figures 3-1c and 3-1d).

Figure 3-1. Static testing and finite element validation: Experimental cracking patterns reproduced from (a) Girder G01 – Test 1 (Chehab et al., 2018), (b) Girder G01 – Test 3 (Chehab et al., 2018), (c) Girder G01 – Ultimate Load Test (Olsen, 1992), and (d) Control Girder – S1 (Ludovico, 2005)

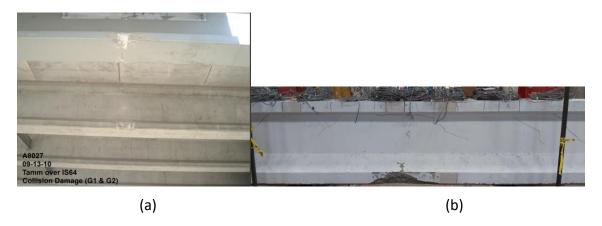
Figure 4-11 shows minor damage to both Girders GO2 and GO4. The same damage level occurred despite the different loading and boundary conditions that were discussed previously. In both girders, concrete spalling was observed over a localized area along the length of the impactor head, spanning approximately 2.5 feet. In Girder GO4, the impact caused the exposure of a single prestressing strand, emphasizing the severity of localized damage. Additionally, both girders displayed shear and torsional cracking extending from the impact zone to the supports. Comparisons between test and real-life damage sustained due to vehicles impacting bridge girders were made (Figure 4-11). These comparisons show the similarities between the two damage cases and the influence of boundary conditions and loading conditions on the damage mechanisms of PC girders.

Figure 4-11. (a) Tamm over I-64 bridge impact (The photograph is courtesy of MoDOT), (b) Girder G02, (c) Bridge 4.3 W. Caldwell, (c) Girder G04 (The photograph is courtesy of Idaho DOT)

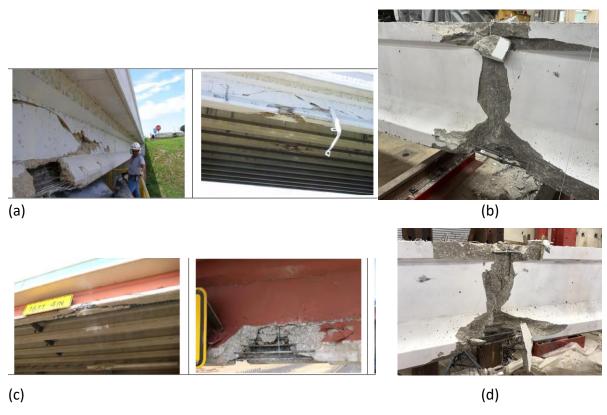
In Figure 4-17a, Girder G01 served as the control girder in the impact test matrix. It was reinforced with 12 prestressing strands as flexural reinforcement and shared identical boundary conditions with Girder G02. The girder was subjected to the highest kinetic energy from the impact bogie, resulting in severe damage. A plastic hinge formed at the mid-span at the point of impact, compromising six strands—four on the impact face and two on the rear—equivalent to

Concrete spalling was extensive, with 52% of the cross-sectional area lost at the top flange, web, and bottom flange. The bottom flange experienced spalling due to concrete crushing, with the impactor penetrating three inches into the girder. Excessive lateral deflection contributed to additional spalling at the web and top flange (Figure 4-17a). Cracking on the impact side extended 17 feet, covering 80% of the span, with inclined shear and torsional cracks ranging from hairline to 0.1 inches in width, decreasing in size further from the impact point. On the rear side, cracks dispersed over a length of six feet, approximately 14% shorter than on the impact side, suggesting plastic shear hinge formation and punching shear failure caused by high shear and inertia forces.

The girder experienced a maximum lateral displacement of 16.3 inches and a residual drift of 2%, along with a vertical residual displacement of 3.5 inches (Figure 4-18). The lateral deflection was the primary cause of strand yielding and concrete spalling. Meanwhile, the increased vertical residual displacement (camber) was a secondary effect resulting from the loss of the concrete section. Based on Harries et al.'s (2012) classification, the damage level was categorized as Severe IV, as the strand loss exceeded 35% and the vertical deflection surpassed 0.5%.

In Figure 4-17d, Girder G06, reinforced with 16 prestressing strands, exhibited a 33% increase in flexural strength compared to Girder G01. Despite this, the girder sustained significant damage under impact, with five out of 16 strands (31%) severely compromised but not ruptured. The strands exhibited sagging, unbundling, and nicking due to direct impact and lateral deflection.

Concrete spalling affected 35% of the cross-sectional area at the impact site, involving the top flange, web, and bottom flange. Spalling at the bottom flange resulted from a 5-inch penetration by the impactor while spalling at the web and top flange was due to excessive lateral deflection. Additionally, the bottom flange exhibited severe cracking and delamination (Figure 4-17d).

Cracking on the front face, where the girder faced the impact bogie, extended 15 feet on either side, covering 73% of the span. These cracks included inclined shear and torsional patterns that diminished in width from 0.1 inches to hairline cracks (less than 0.005 inches) as they radiated from the impact point at a 45-degree angle. The rear face displayed similar crack patterns but with reduced severity (Figure 4-17d).

Girder G06 exhibited a maximum lateral displacement of 15.9 inches and a residual displacement of 5.5 inches, corresponding to a 2.1% lateral drift (Figure 4-18). Excessive deflection was the primary cause of strand damage and concrete spalling. Based on Harries et al.'s classification, the damage to G6 was categorized as Severe III, with strand loss exceeding 25% but remaining below 35%, and vertical deflection exceeding 0.5%.

Figure 4-17. (a) Bridge over US 67, (b) Girder G01, (c) FM 1788 over IH20 AASHTO I-girder, Texas (d) Girder G06 (The photographs were reproduced after NCHRP 20-07/Task 307)

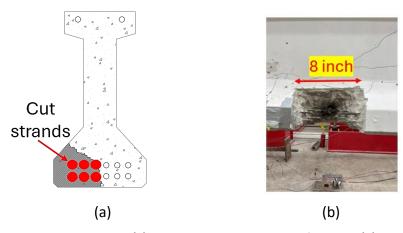
The girder, designated as Girder G04 during the impact test, exhibited significant damage to its prestressing strands, as indicated by internal strain gage data. The collision caused three of the twelve prestressing strands to either reach their yield strength or lose a substantial portion of their initial tension. To achieve the target damage level of 50%, an additional three strands were severed, bringing the total to six severed strands, all located on the same side of the girder (Figure 5-7).

Following the impact test and subsequent strand cutting, the girder retained a camber of 1.38 inches, with minimal lateral (out-of-plane) displacement of 0.125 inches. During the flexural test, initial cracking occurred at a 30-kips load within the constant moment region, which corresponds to a cracking moment of 217.5 kips. ft, extending beyond the fractures induced by the impact. As the load increased, additional bending-related cracks developed, primarily within the constant moment area. These cracks extended into the upper flange at a load of 68 kips, signaling imminent failure.

Figure 5-7. Girder G04, (a) Cross section showing loss of strands, (b) The section along the girder where strands were cut before the flexural test

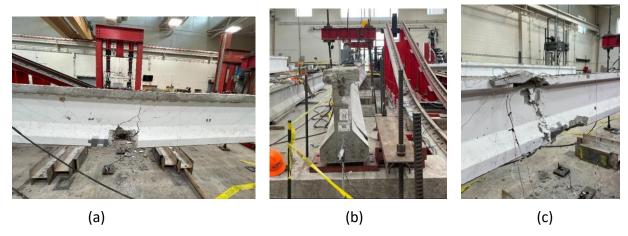
Diagonal shear cracks formed outside the constant moment region at 63 kips, marking the onset of combined flexural-shear failure. The test progressed until the girder deflected 2.1

inches, at which point the load plateaued. At this stage, the combined flexural-shear cracks widened beyond 0.1 inches. Unlike previous specimens, G4 exhibited increased ductility, eventually failing due to out-of-plane deformation caused by eccentric prestressing forces. The girder ultimately failed at a load of 73 kips, corresponding to a maximum moment capacity of 526 kips-ft (Figure 5-8). The flexural capacity was 6.9% lower than the AASHTO LRFD estimate.

Figure 5-8. Failure of the Girder G04 (a) Cracks widening at 70 kips, (b) Out of plane deflection, (c) Failure of the girder

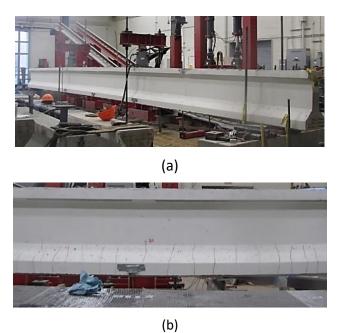
During the flexural test, initial cracking occurred at a 76-kips load, which corresponds to a cracking moment of 551 kips. ft, within the constant moment region (Figure 5-10b). As the load increased, additional bending-related cracks developed, primarily within the constant moment area. These cracks extended into the web at a load of 105 kips.

Diagonal shear cracks formed outside the constant moment region at 155 kips marking the onset of combined flexural-shear failure. The test progressed until the girder deflected 4.3 inches, at which the girder failed. The girder ultimately failed at a load of 190 kips, which corresponds to a cracking moment of 1377 kips. ft. The test flexural capacity of the girder exceeded by 8.4% the estimate by the AASHTO LRFD. The failure mode and location were almost identical to Girder G02, where the failure occurred at the location of the harping point which aligned with the location of the hydraulic jack.

Figure 5-10. Girder G06 (a) Test setup, (b) Cracking at 80 kips

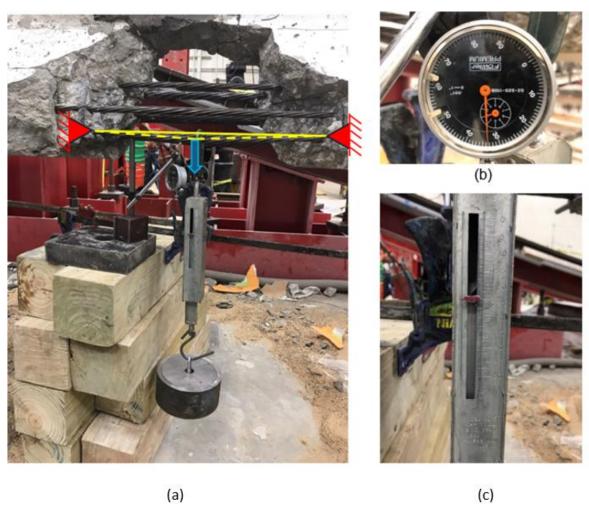
To accurately estimate the flexural strength, determining the effective prestress using a non-destructive testing (NDT) method was essential. The research team devised a technique involving the suspension of a 24.5-lb. weight at the midpoint of each exposed strand, using a scale for precise application. The exact lengths of the strands were measured, and a dial indicator with a precision of 1/10,000 of an inch was used to monitor the resulting deflection, as illustrated in Figure 5-13. By modeling the strand endpoints as hinges under simply supported conditions, the effective prestress force (T) was calculated using the relationship among the sag (Δ), the applied weight (P), and the strand length (L).

Table 5-2 summarizes the NDT measurements and prestress loss calculations. Figure 5-14 shows the number and location of each strand that was assessed using the deflection method. Figure 5-15 shows the implementation of the deflection method for the damaged Girder G06. According to AASHTO LRFD (section 5.9.5.4.2c) the stress in prestressing strands immediately after the transfer is taken not less than 0.55 f_{py} (55% of the strand yield strength).

Figure 5-15. Implementation of deflection method (a) Setup, (a) Dial gage, (c) Weight scale

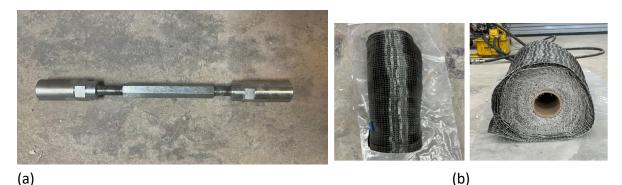
Figure 6-1. Methods used for structural repair (a) Mechanical strand splicing (b) CFRP composite

This chapter investigates the repair of damaged girders using two distinct methods: the mechanical strand splicing technique and externally bonded CFRP composites, Figure 6-1. The primary objective was to restore the girder's flexural strength.

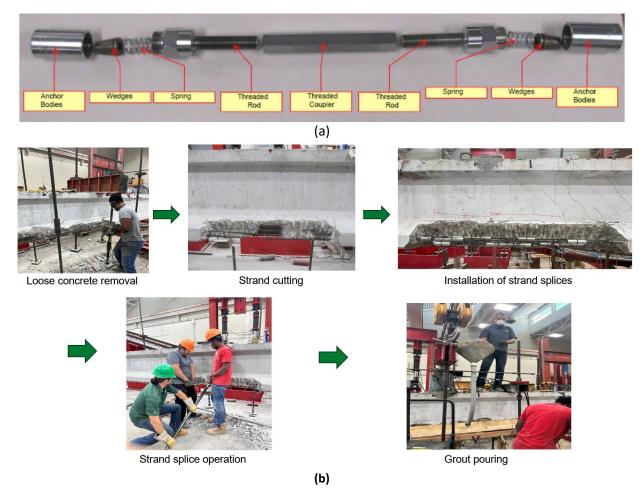
Figure 6-2. (a) GRABB-IT overview (Source: https://www.prestresssupply.com/), (b) Strand splicing repair steps 6.2.5 Test setup and instrumentation

Following the high-strength grout casting and initial curing, a detailed inspection was conducted to identify any cracks resulting from the impact test. Identified cracks were carefully opened and chased using specialized tools to widen their surface and expose their full extent. The cracks were then thoroughly cleaned to remove debris and loose material, ensuring a clean and sound surface for effective treatment, as recommended by ACI PRC-224-01(ACI 224). A Simpson strong-tie low-viscosity epoxy resin was applied under pressure to seal the identified cracks. The process for the mechanical splicing is summarized in Figure 6-2.

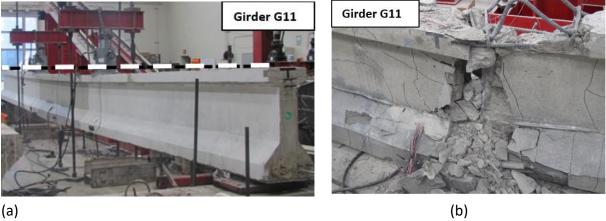
At 118 kips, diagonal shear cracks began to form beyond the constant moment region, near the applied load. Testing proceeded until the girder reached a significant deflection of 5.8 inches. Audible popping sounds were heard at 128 kips, followed by the sound of concrete crushing at 132 kips. The girder reached its structural limit at 132.9 kips, corresponding to a maximum moment of 939 ft-kips (Figure 6-9).

Unlike Girder G10, where the failure occurred at the harping point away from the spliced strands, the failure of Girder G11 occurred at the spliced strand location. This suggests that the failure was initiated by the inability of the spliced strands to sustain the applied load (Figure 6-9a).

Figure 6-9. Girder G11 (a) Deflection of the girder during testing, (b) Failure of the girder

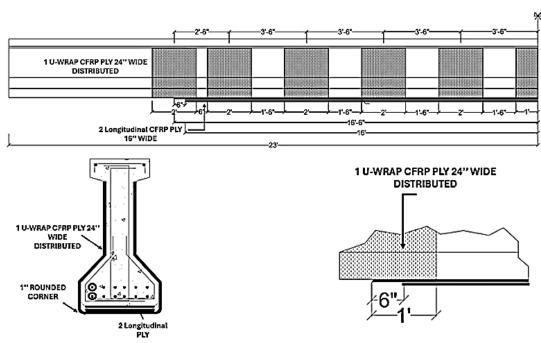
Figure 6-21. Elevation of repair of Girder G07, cross-section and CFRP U-wrap details, and termination details for longitudinal CFRP

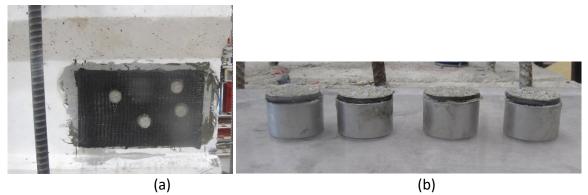
A witness panel was installed during the CFRP application to conduct a pull-off test following ASTM D5722 (Figure 6-23). The test was performed after 72 hours on four specimens, yielding an average failure normal stress of 378 psi—significantly exceeding the ASTM D5722 minimum requirement of 150 psi. The failure occurred in the concrete substrate, which is the preferred failure mode, as shown in Figure 6-23b.

Figure 6-23. (a) Witness panel for pull-off test, (b) Pull-off test specimens' failure

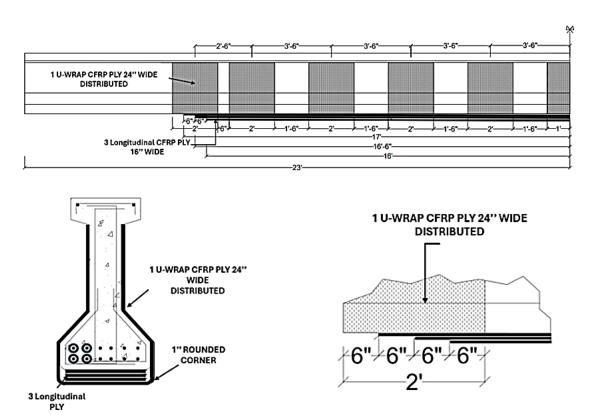
Similar to Girder G07, Girder G08 was repaired using externally bonded CFRP using the manual wet lay-up system. The girder had three strands out of twelve removed from one side, corresponding to a 33% loss of prestressing strands (Figure 6-25). One additional ply was added, for a total of three longitudinal CFRP plies, and all were applied to the girder's soffit following ACI 440.2R-17 guidelines. The same CFRP fabric from the previous repair was used for consistency and fair comparison.

The design estimated a debonding strain of 0.46% for the three CFRP plies. The strain at the soffit was adjusted for the preloading required to straighten the girder before CFRP installation. The goal was to restore the girder's nominal capacity. The same CFRP configuration of the previous repair was implemented in this repair. The longitudinal plies were 33 feet long, with the cutoff length extending after the span at which the bending moment is less than the cracking moment with a value of development length, as per ACI 440 guidelines. The longitudinal plies were terminated six inches from each other (Figure 6-25). U-wraps were spaced at 16 inches, with 5-inch spacing at both ends for proper anchorage. Flexural strengthening details are in illustrated Figure 6-25.

Figure 6-25. (a) Elevation of repair of Girder G08, cross-section and CFRP U-wrap details, and termination details for longitudinal CFRP

Girder G08 also suffered lateral damage due to impact, causing significant cracking. A low-viscosity epoxy resin was injected to seal the cracks and restore structural integrity. Concrete was removed from the bottom flange to access the damaged strands, which were cut and restored with formwork and high-strength non-shrink grout (Sika 428 FS). Concrete cubes were tested at three and five days to confirm strength. Shear dowels (#4 rebar) were used to bond the new concrete to the existing structure.

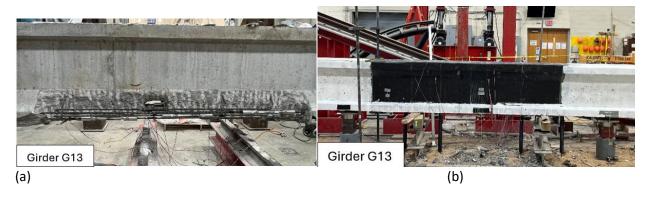
Figure 6-29. (a) Girder being repaired with mechanical strand splice, (b) Photograph of completely repaired girder (hybrid system) with CFRP U-wraps as confinement

The U-wrap was applied continuously over the entire repair area with a 6-inch overlap to ensure complete confinement. Proper surface preparation was essential for maximizing CFRP bond performance. A concrete scarifier was used to ensure that by creating a CSP-3 surface roughness profile. All corners were rounded to a ¾-inch radius with concrete grinders to eliminate stress concentration points.

Before applying the CFRP system, high-modulus epoxy paste was applied to level the concrete surface. The CFRP fabric was saturated with epoxy resin and installed in a U-wrap configuration around the repair zone (Figure 6-29). To verify installation quality, a witness panel was created during the CFRP application process. Following ASTM D5722 guidelines, pull-off testing was conducted after a 72-hour cure period on four specimens. The testing revealed an average failure stress of 528 psi, almost 3.5 times the minimum 150 psi requirement specified by ASTM D5722. The failure mode occurred within the concrete substrate, which is the desired failure mode, confirming optimal bond development.

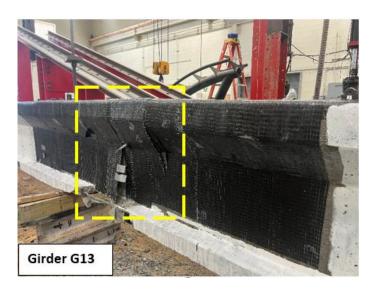
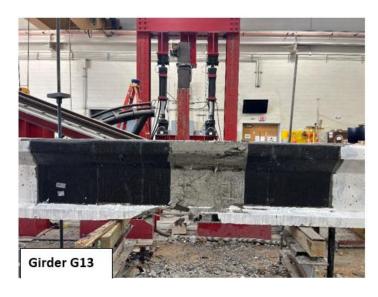
progressed during testing, the girder exhibited significant upward deflection, though notably, no visible cracking patterns developed despite increasing force application. The failure sequence began with audible popping sounds emanating from the CFRP system, followed by the ultimate failure mechanism by debonding of the U-wrap in the central section of the repair (Figure 6-30). Figure 6-31 shows the force-deflection curve where the maximum failure applied load was 121 kips which corresponds to 877.3 kips.ft which represents 75% of the Girder G02 test and 80% of the AASHTO LRFD flexural capacity estimate for Girder G02.

Figure 6-30. Photographs of Girder G13 showing (a) Failure of 50% damage repaired girder at midspan (b) A view of concrete damage behind the u-wrap system

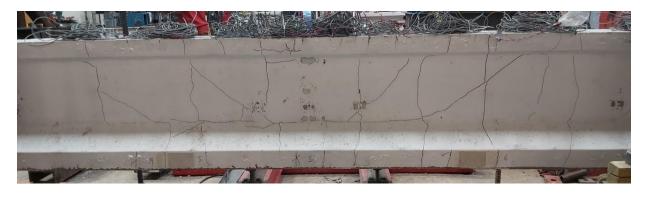
Figure C-37. Damage photographs of Girder G02 impact (a) Impact side, (b) Back side

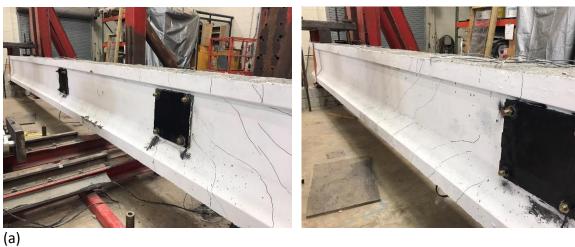
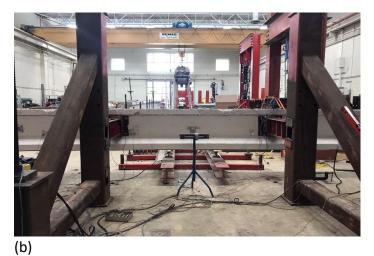
C.1.7 Girder G07

Figure C-46. Damage photographs of Girder G07 with the additional stirrups and intermediate steel diaphragms (a) Impact side, (b) Back side

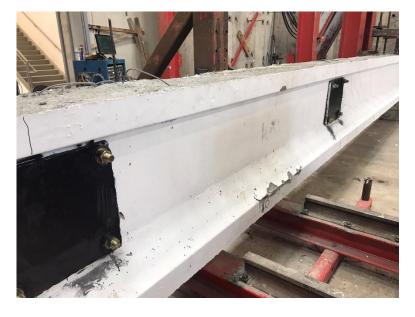
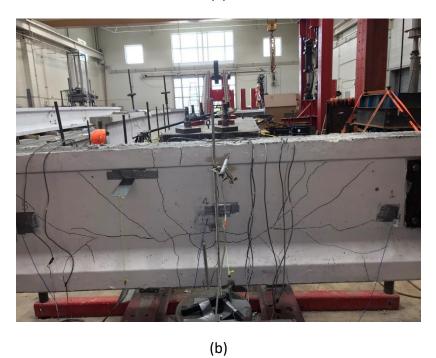
C.1.8 Girder G08

Figure C-47. Damage photographs of Girder G08 with intermediate steel diaphragms (a) Impact side, (b) Back side

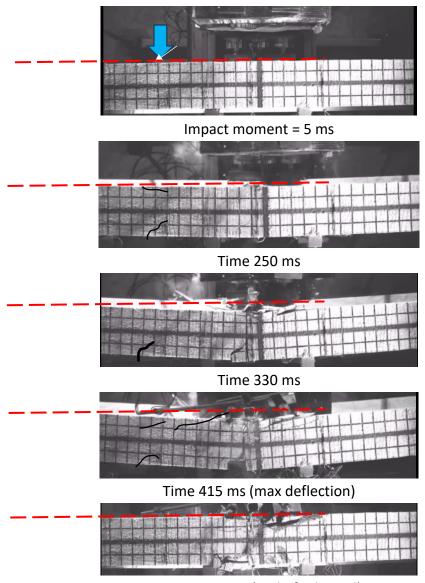
By 250 ms, the top flange began to exhibit cracking, primarily due to the lateral bending moment induced by the applied impact force. These cracks signified the early stages of structural compromise in the girder.

At 330 ms, noticeable lateral deflection was observed in the girder, accompanied by the formation of additional cracks. This deflection caused further distress in the concrete, which began to spall as the material exceeded its tensile strength.

Following this peak deflection, the girder exhibited elastic rebound. By 1165 ms, it completed the rebound phase, leaving a permanent lateral deflection of 4.5 inches. This residual deformation highlighted the extent of the inelastic behavior of the girder under the given impact conditions.

Additionally, global shear cracks were observed on both the front and rear faces of the girder, underscoring the severity of the impact forces. These shear cracks contributed to the overall

damage pattern and emphasized the combined effects of lateral deflection and shear stresses on the girder's structural integrity.

Figure C-30. High speed camera of Girder G01 top view footage

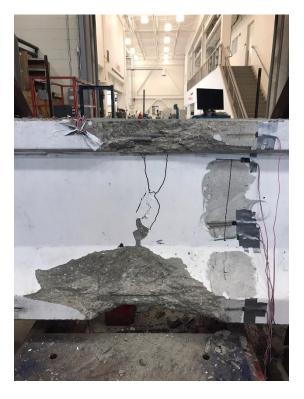
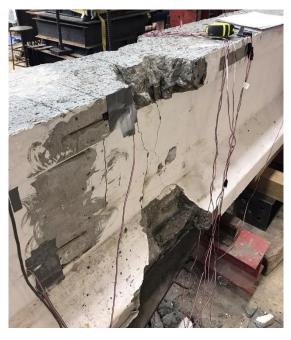
Figure E-3. Damage photographs of Girder G09 from lateral static testing (a) Loading side, (b) Back side of loading, (c) Back side after unloading

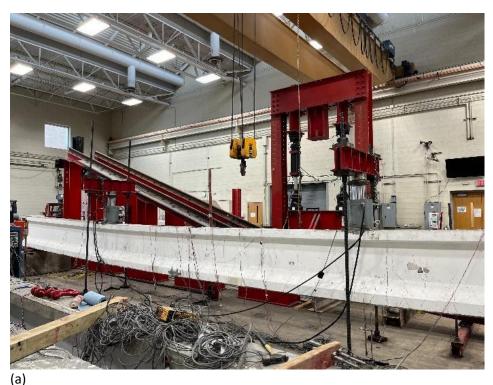
F.1.1 Girder G02

Figure F-3. (a) Deflection of the girder during testing, (b) Failure of girder (c) Close up to the strands at failure

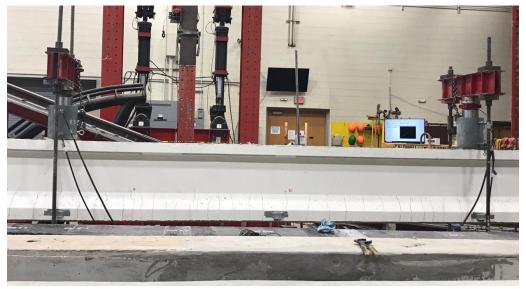
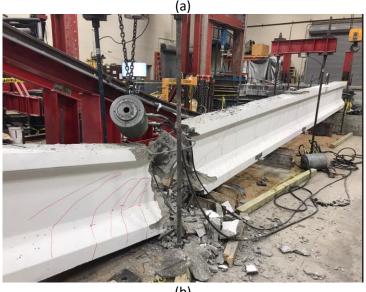
F.1.2 Girder G14

(b)
Figure F-4. (a) Cracking of the girder during testing, (b) Failure of the girder

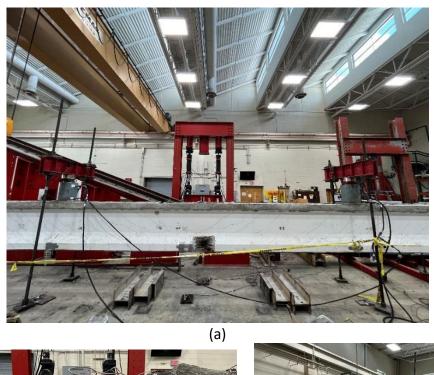
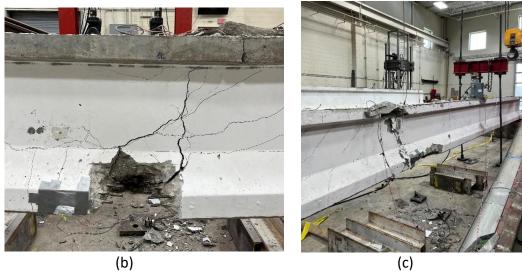
F.1.4 Girder G04

Figure F-6. Residual strength 50% flexural twelve strands (a) Deflection during testing, (b) Severe cracking just before failure, (c) Crushing of the top flange at failure

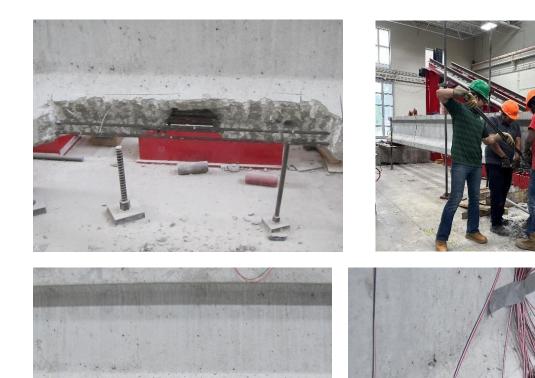
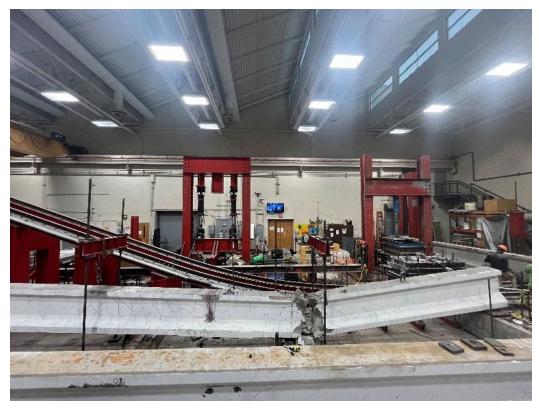
Figure G-10. Testing and failure of Girder G10

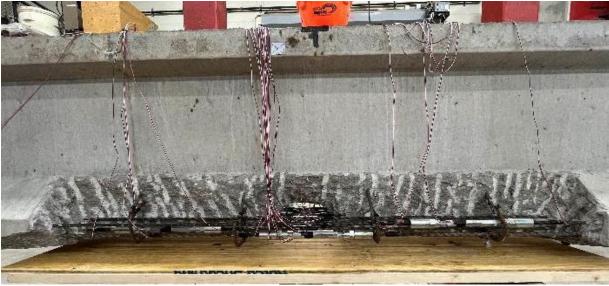
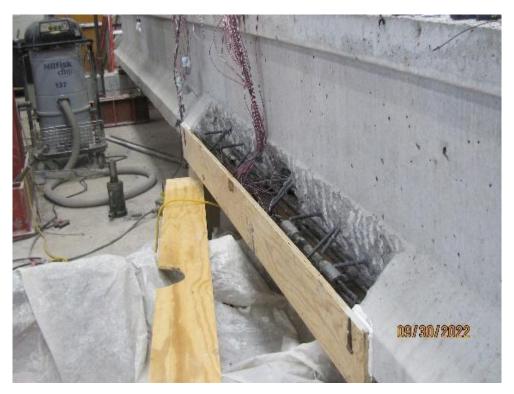
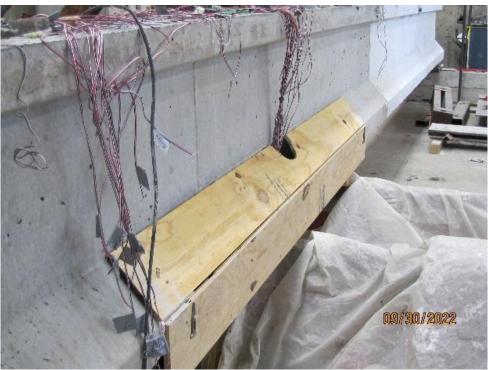
Figure G-11. Splicing and formwork of the spliced 25% (Girder G11)

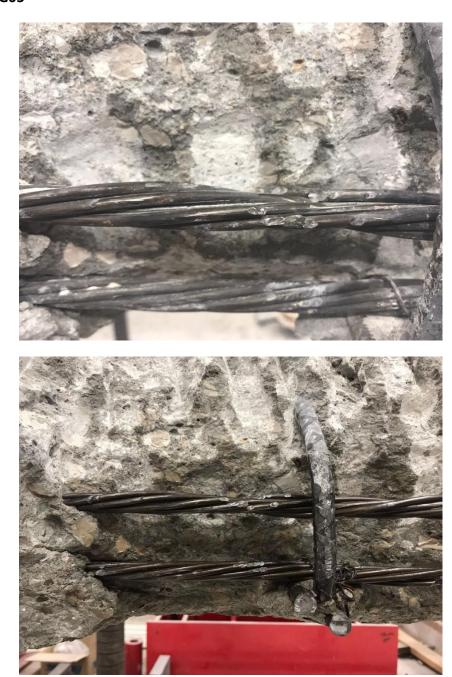
Figure G-12. Strands severed from the second impact of Girder G05 before splicing

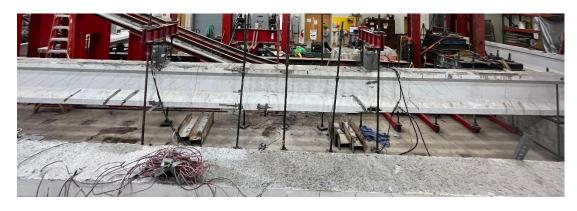
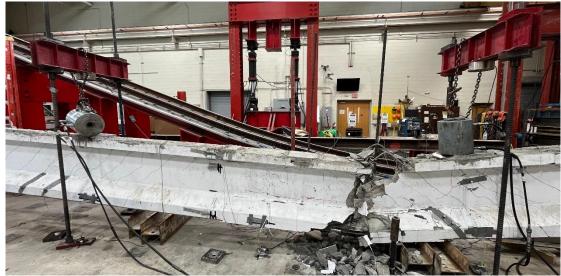
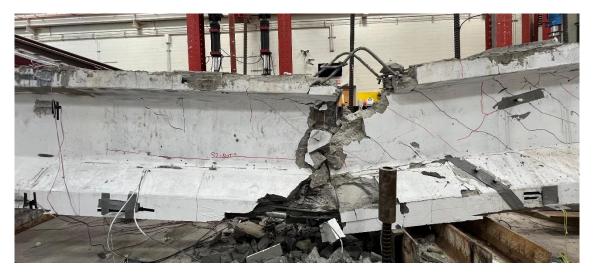
Figure G-15. Testing and failure of the spliced girder

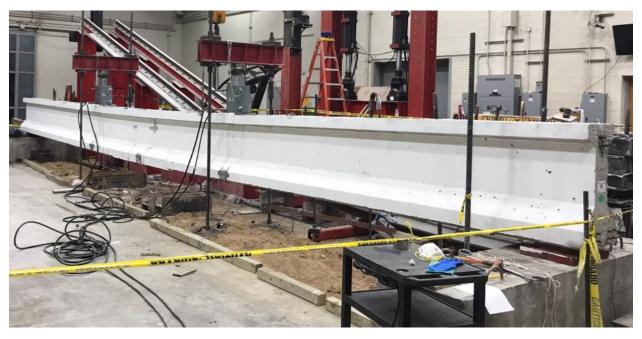
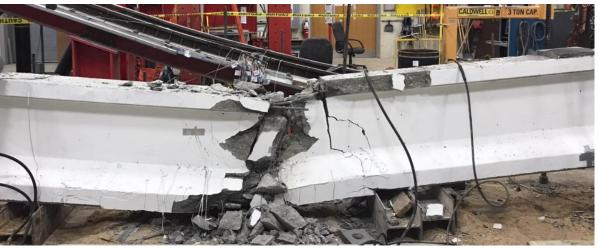
Figure G-17. Testing and failure of the girder

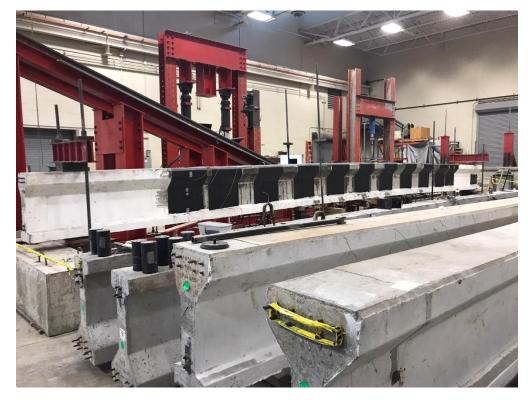
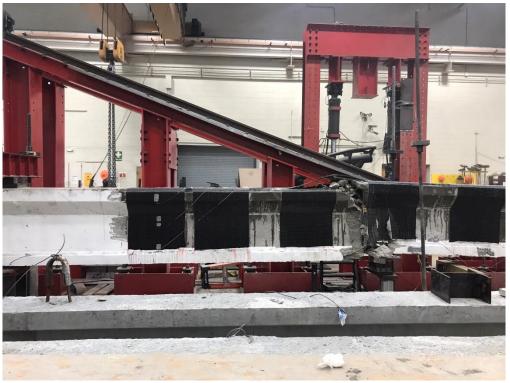
Figure G-20. Girder deflection and failure

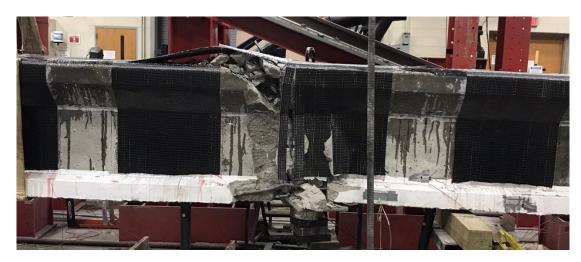
Figure G-21. Rupture of CFRP longitudinal plies

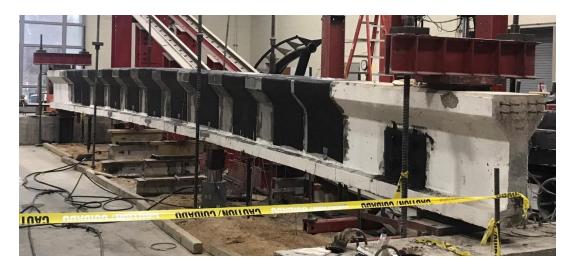
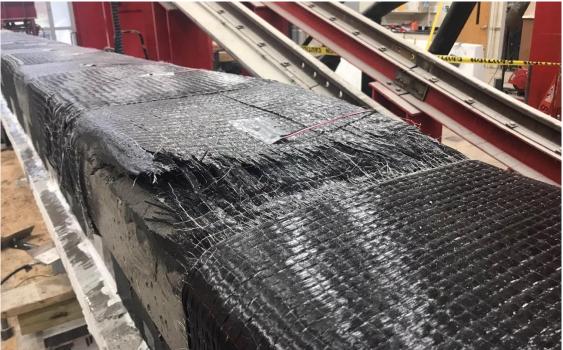
Figure G-25. Testing and failure of the repaired girder

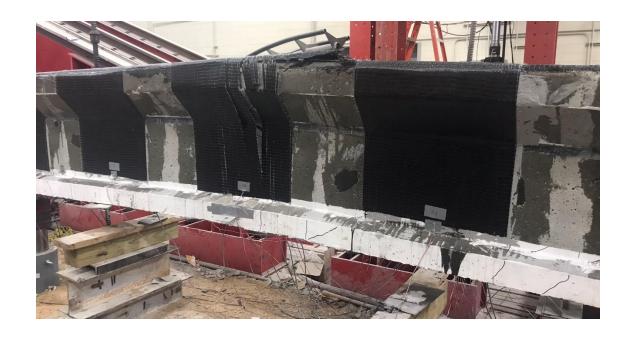
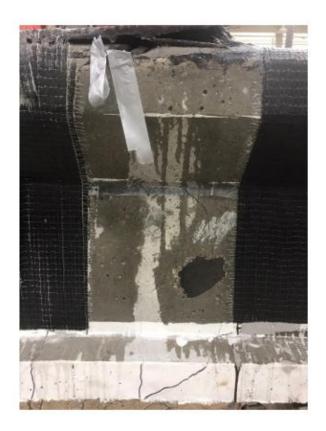
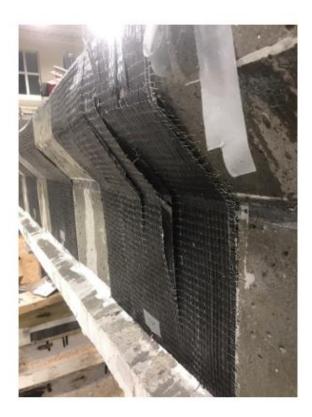
Figure G-26. Failure of the CFRP U-wraps

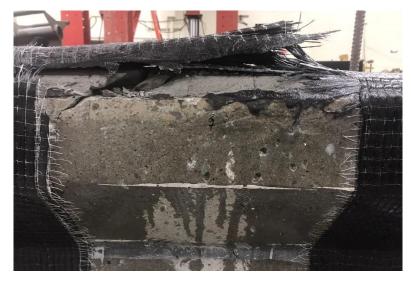
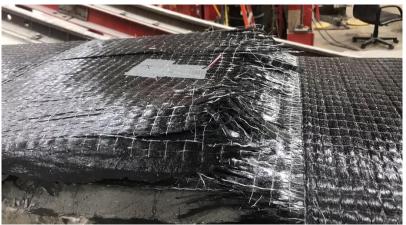
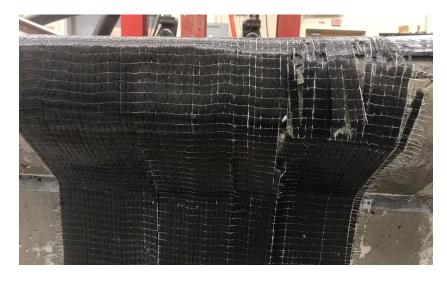
Figure G-27. Rupture of CFRP

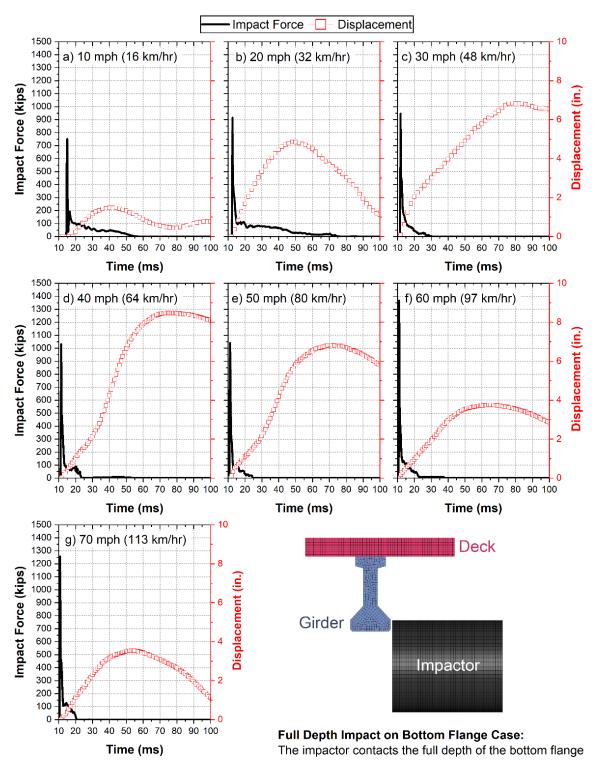
This proportionate increase in kinetic energy leads to a corresponding rise in impact force. As shown in Figure H-44, the impact force increased from 750 kips at 10 mph to 1366 kips, marking an 80% increase at 60 mph. However, at lower speeds, the structural response exhibited more global behavior with out-of-plane deformation, as indicated by lateral displacements ranging from 1.6 in. at 10 mph to 8.5 in. at 40 mph. Beyond 40 mph, the impact became increasingly localized, resulting in limited displacements. For instance, a lateral displacement of 6.8 in. at 50 mph highlights this transition.

Figure H-44. Impact force and lateral displacements at different impact speeds

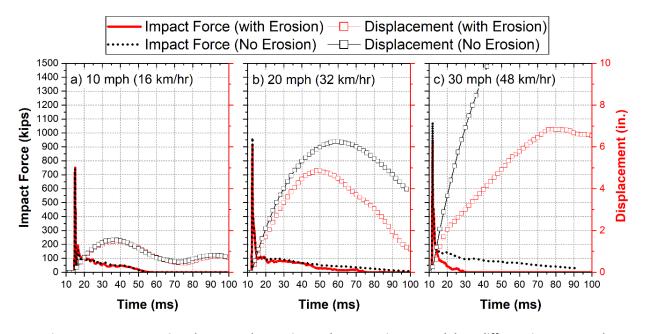
As part of this research, a comparison was conducted between models with and without erosion elements. As shown in Figure H-47, the findings offer unique insights into the predictive capabilities of these models under various impact conditions. At lower speeds, such as 10 mph, both erosion and non-erosion models predicted similar impact forces and displacements (Figure H-14a). However, as the impact speed and energy increased, a substantial discrepancy emerged. Models without erosion tended to overestimate the impact force at higher speeds. Furthermore, displacement predictions in non-erosion models became increasingly unreliable due to the continued deformation of elements beyond their failure limits (Figure H-47b and c).

Notably, the extensive damage simulated in non-erosion models at high speeds rendered them unsolvable, restricting the investigation to speeds below 30 mph. These findings emphasize the importance of incorporating erosion effects to effectively model and understand the behavior of structures subjected to high-velocity impacts.

Figure H-47. A comparison between the erosion and non-erosion FE models at different impact speeds

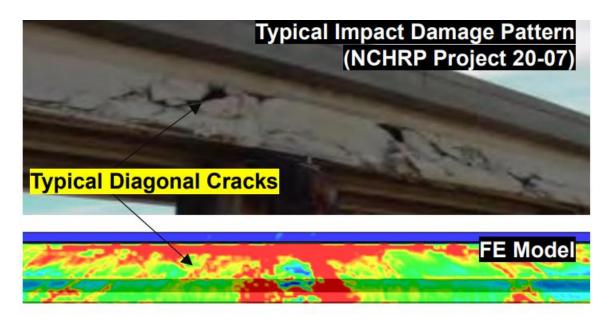
Local and global damage failures were observed in this study. A frequently observed damage pattern, initially identified by Feldman et al. (1996) [28], is the exterior (fascia) girder torsion-induced shear fracture, commonly associated with side-impact incidents. As illustrated in Figure H-48a, this damage pattern was consistently observed in the finite element (FE) models used in this investigation, with the extent of damage varying according to specific impact conditions. Additionally, as the impact velocity increased, the damage pattern evolved into a more pronounced shear push-out, particularly on the rear side of the girder, as shown in Figure H-48b. Another consistent finding was the occurrence of longitudinal cracking at the connection between the web and the girder flange, as illustrated in Figure H-48c.

(a) Typical diagonal cracks of the fascia

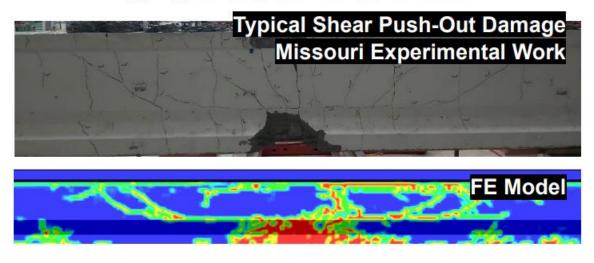
(b) Typical shear push-out damage of the rear side

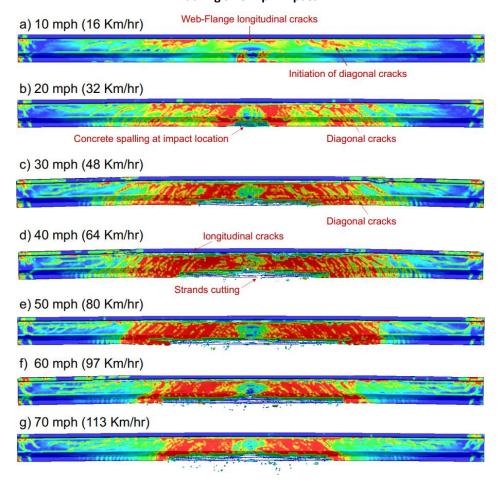
Figure H-50. Damage patterns of the prestressed girders at different impact speeds (front-side view)

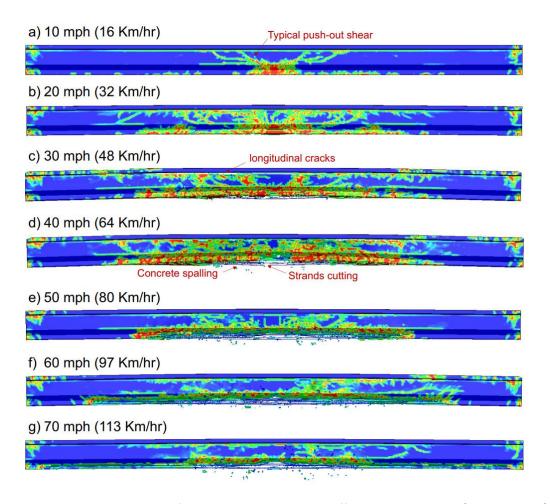
Figure H-51. Damage patterns of the prestressed girders at different impact speeds (backside view)

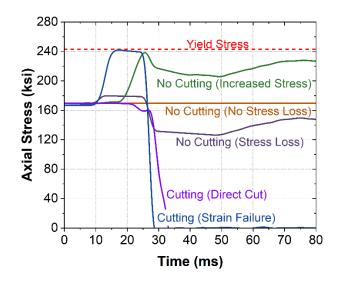
The FE models provided insights into the response of prestressing strands to impact events. As shown in Figure H-52, strands exhibited varying responses under impact loads:

- Some strands remained unaffected and retained their initial stress.
- Others experienced stress loss due to concrete erosion around the prestressing strands and the lateral displacement caused by the collision.
- Some strands experienced a stress increase within their elastic range, avoiding failure.
- Strands exceeding the yield stress and strain limits were cut, particularly those in direct contact with the impactor, which was severed immediately.

Figure H-52. Response of prestressing strands under impact loads

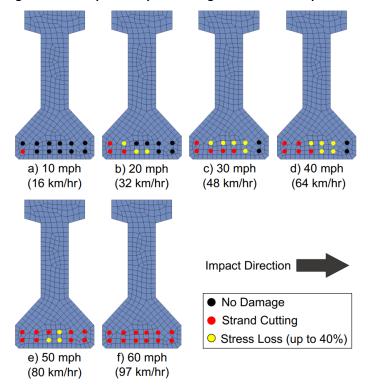
The results showed a significant increase in prestressing strand damage severity as impact energy increased. Figure H-53 classifies strand conditions into three categories: undamaged, up to 40% stress loss, and cut strands. Higher impact speeds corresponded to an increased likelihood of strand cutting and stress loss. Importantly, these findings underscore the need to account for stress loss in strands, as current damage classification methods primarily focus on complete strand cutting (Harries et al. 2012). Even strands appearing to be in good condition may suffer stress loss, compromising the load-bearing capacity of the girders. The results consistently indicated that strand damage was initiated in the first row near the impact location.

Figure H-53. Prestressing strands damage under impact at different impact speeds

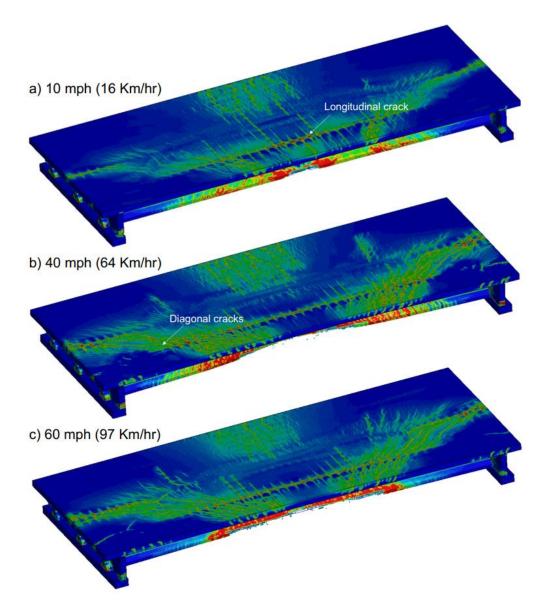
A notable transfer of stresses was observed in the overall response of the bridge to the impact event, particularly at the girder-deck joint contact. The impact load exerted horizontal and vertical load components, both contributing to the formation of longitudinal cracks at the girder-deck joint locations. As the impact energy increased, higher strain magnitudes were transferred to adjacent girders, initiating diagonal cracks, as shown in Figure H-54.

Figure H-54. Overall damage patterns of the prestressed girder bridges at different impact speeds

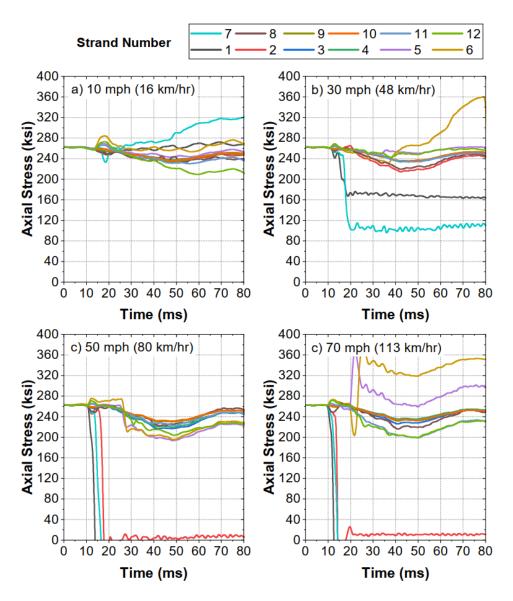
Changes in strand stresses provided valuable insights into the severity of strand damage under the two impact location scenarios. The full-flange impact scenarios, as shown in Figure H-53, resulted in a significant number of severed strands. In contrast, the partial-flange impact scenarios showed a notable reduction in strand severing, with a maximum of only three severed strands observed in the 70-mph scenario, as shown in Figure H-57.

Figure H-57. Variation in the axial stress of the prestressing strands under partial flange impact scenario H.5.5 Intermediate diaphragms
