Traffic Disruption-free Bridge Inspection Initiative with Robotic Systems

September 2025
Final Report

Project number TR202004/TPF-5(462)
MoDOT Research Report number cmr 25-011

Missouri University of Science and Technology

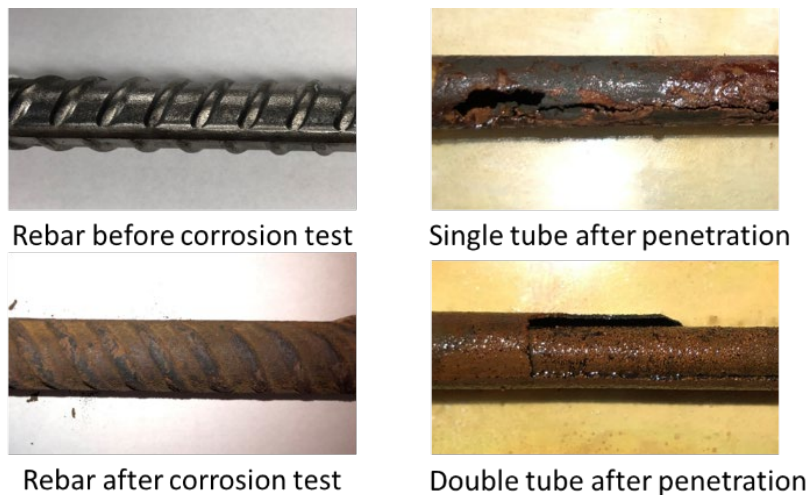
Figure 11. Test Specimen and Corrosion Effects

Visual inspection remains an effective means to understand the condition state of bridge elements as visualized graphically in the *Manual for Bridge Element Inspection* (AASHTO, 2019). Even for the rebar corroded in laboratory tests as shown in Figure 11, visual inspection is critically important to verify test data and help interpret the experimental findings in a specific laboratory. For example, by comparing the rebar sample before and after significant corrosion, a pattern of indicated corrosion areas in terms of ribs and valleys of the deformed rebar can be visually observed. A close examination on the corroded steel tubes for surface irregularity such as cracks and holes can verify their complete penetration in a corrosive environment.

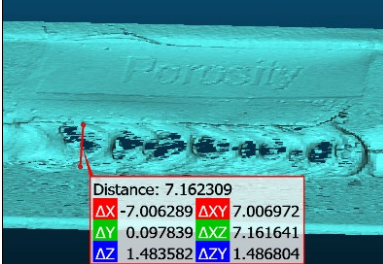
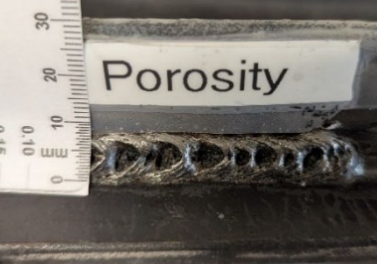
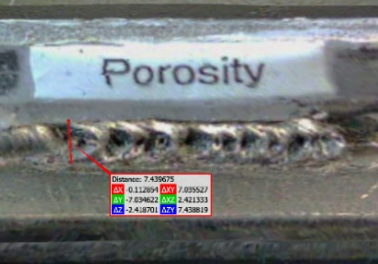
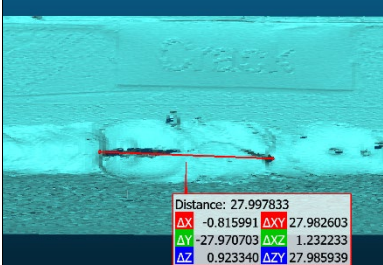
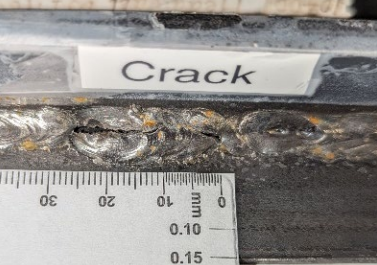
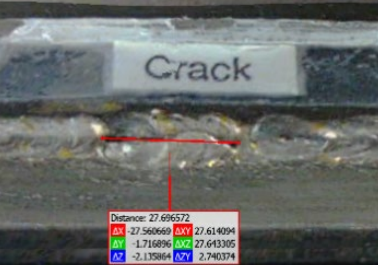
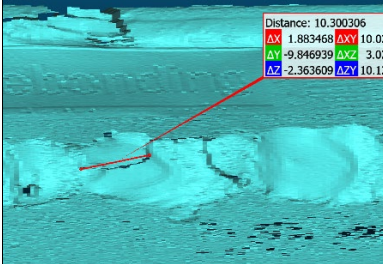
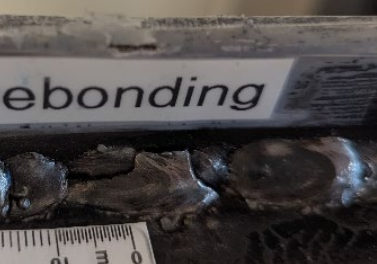
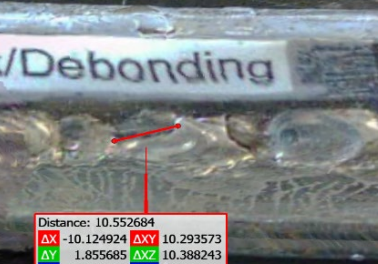
Table 13. Detected Defects from Point Cloud and Ground Truth Measurements

Table 13 compares defect size measurements from the scanCONTROL 3060-50/BL (monochrome point cloud), the SR-Scan Ferret Pro 3D scanner (colored point cloud), and a measure tape. It can be observed from Table 13 that the defect size measurements from the two scanners are consistent with their ground truths in every direction. The maximum difference in cavity, cracking and debonding measurements from the monochrome and colored point clouds is 3.7%. Note that the defect labels on the sample are clearly seen in the monochrome point cloud.

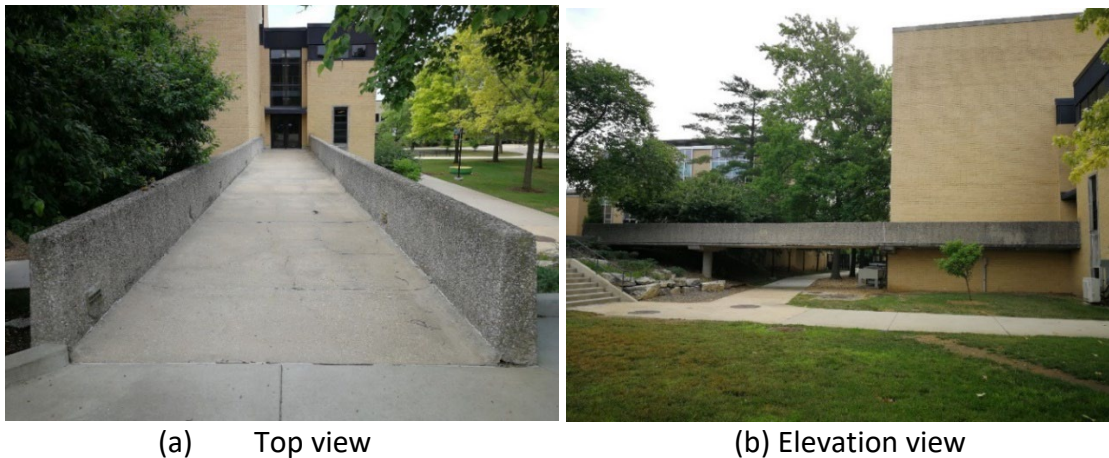
Figure 36. The Pedestrian Bridge on Missouri S&T Campus as a Testbed

Figure 36 shows an overall view and condition of the pedestrian bridge on the Missouri S&T campus. The pedestrian bridge is located between the Computer Science Building and the Engineering Research Laboratory on campus. Built 50 years ago, the bridge deck is 94 ft (28.6 m) long, 11 ft (3.45 m) wide, and 7 to 12 in (18 to 30 cm) thick.

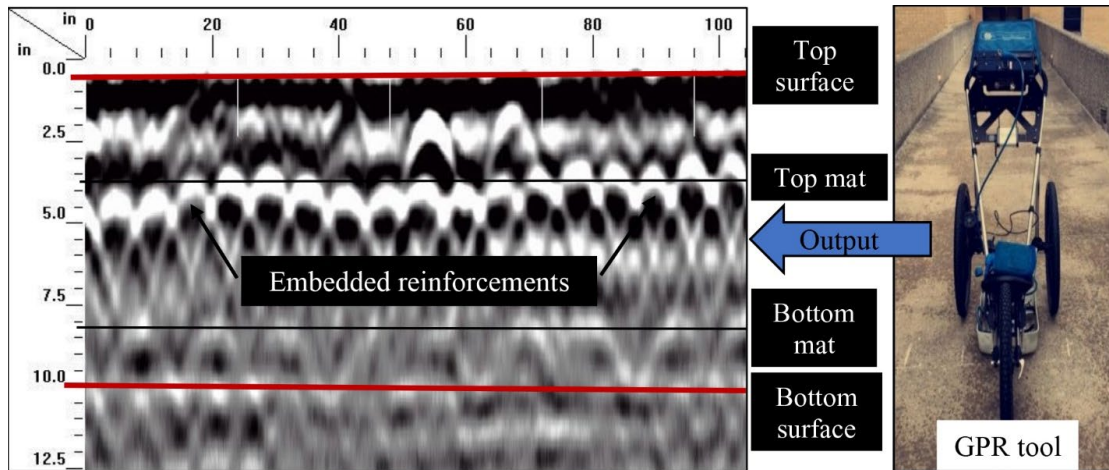
Figure 42. Processed GPR Output Showing Top and Bottom Rebar Mats

The significant inconsistency in apparent depth to the top layer of embedded concrete reinforcement, as illustrated in Figure 42, was observed due to the irregular reinforcement mat, including the potential addition of reinforcement placed during the rehabilitation/repair project. These uncertain factors made the GPR data interpretation a challenge in the bridge deck assessment. As such, further GPR results are not presented in this report.

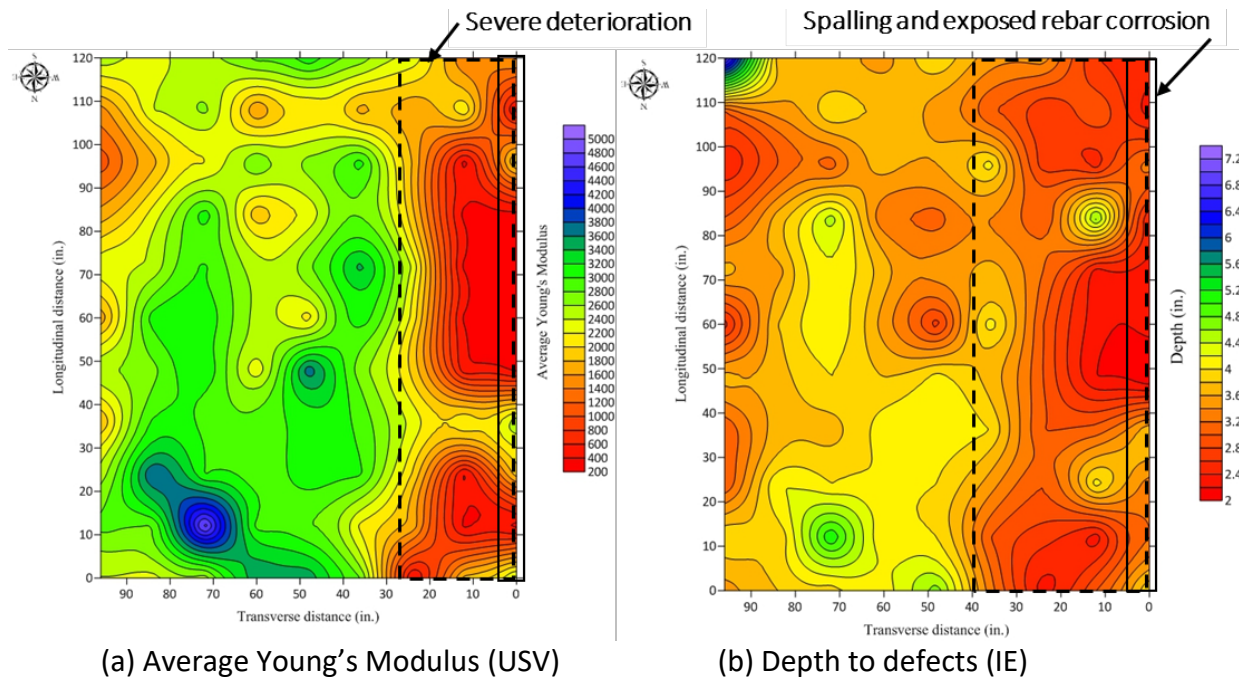
Figure 45. Underside Deck Survey: (a) USV and (b) IE Variation Map

Figures 44 and 45 present the USW and IE variation maps from the topside and underside surveys of the bridge deck, respectively. The dashed box indicates significant deterioration while the solid box represents the location of visually observed exposed rebar and concrete spalling. The two methods (USW and IE) showed corresponding results from the topside and underside deck

surveys. At the top section as shown in Figure 44, areas of high deterioration indicated by a low range of average Young's Modulus, less than 2901 ksi (20 GPa), and a high range of depth to defects 2 – 5 in (5.1-12.5 cm). At the bottom section as shown in Figure 45, areas of high deterioration indicated by a low range of average Young's Modulus, less than 2901 ksi (20 GPa), and a high range of depth to defects 2 – 4 in (5.1-10.2 cm). An extensive deterioration area was observed approximately at the western part of the bottom section near the exposed reinforcement corrosion area.

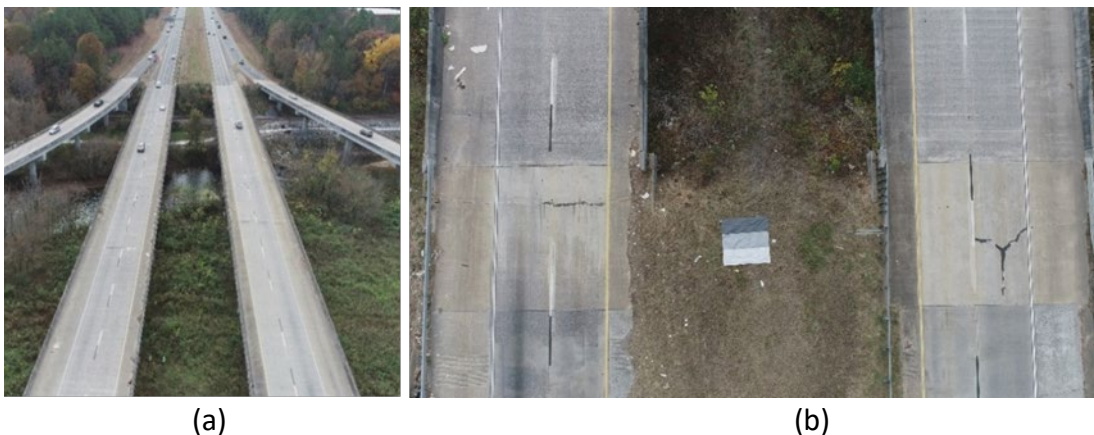
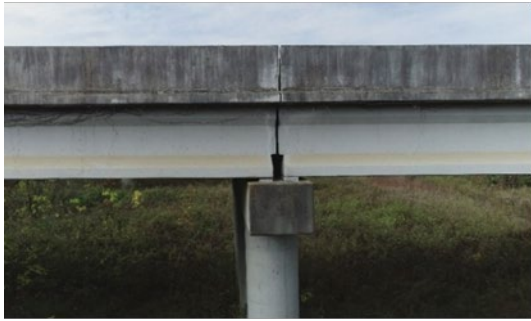
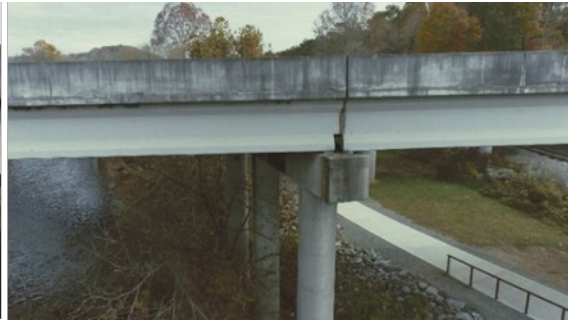
Figure 48. Georgia Bridge 5700510 (Phantom 4)

This subsection presents the representative inspection data for Georgia state bridge 5700510 in the age group of 35-40 years. Figure 48 shows RGB images taken from the Phantom 4. It can be observed that cracks appear on the roadway near the approach spans and the outside of the exterior girders are painted. Figure 49 shows images from the Nikon camera for high-priority inspection areas. Minor spalling, rebar exposure, and drainage water marks can be noticed at the bridge caps. This is further revealed by Elios 2, as shown in Figure 50. Both the inside of the exterior girders and interior girders appear uncoated. Figure 51 shows thermal images from the FLIR camera. The cracks can be noticed on the road before the bridge approach spans. The main bridge span does not reveal noticeable delamination. Figure 52 shows the point cloud explored as one of the digitization approaches for virtual bridge asset management.

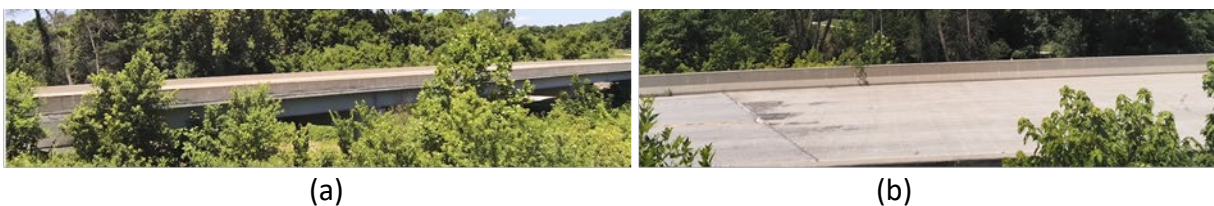
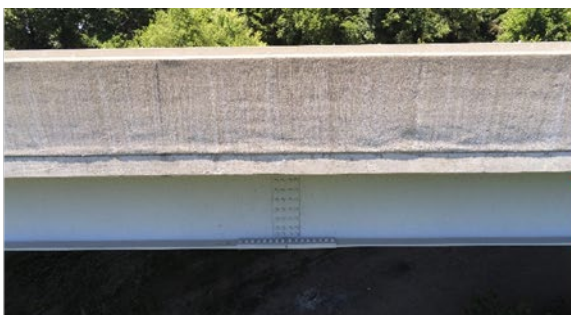
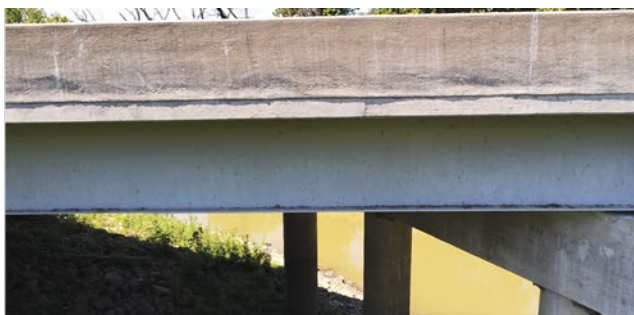
Figure 53. Missouri Steel Bridge A4988 (Parrot Anafi)

This subsection presents the representative results of two Missouri bridges: a steel bridge (A4988) and a prestressed concrete girder bridge (A5805). Figure 53 shows images of the steel bridge A4988 taken from the Parrot Anafi drone, while Figure 54 shows images taken from the Nikon camera. This bridge in the age group of 15-20 years is in good condition. Figure 55 shows images taken from the Elios 2 drone with no major damage observed at the time of the inspection. Figure 56 shows the thermal images taken from the FLIR camera. Joints and road surface patches can be clearly noticed before the approach spans. No major damage is noticed for the deck of the main spans.

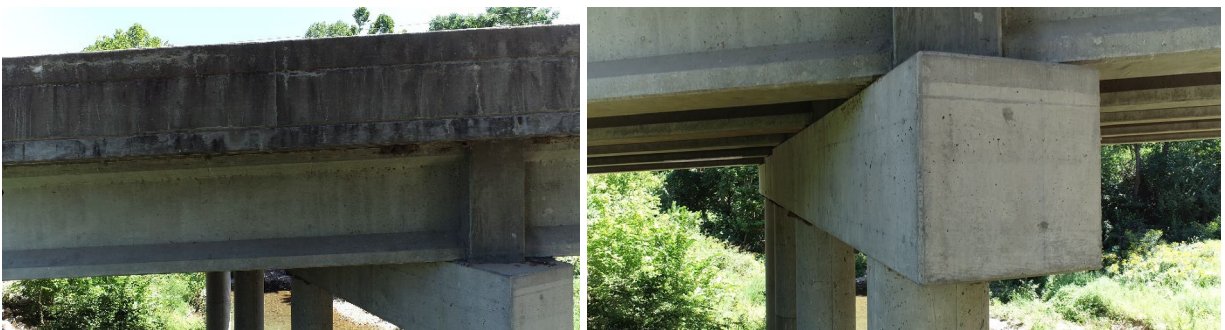
Figure 58. Missouri Prestressed Concrete Bridge A5805 (Phantom 4)

For Missouri bridge A5805 in the age group of 15-20 years, Figures 58-60 present representative images taken from the Phantom 4 drone, the Nikon camera, and the Elios 2 drone. They show no indication of deterioration or damage. Figure 61 shows several thermal images taken above the bridge deck from the FLIR camera. The joints near the approach can be clearly noticed. The main bridge deck shows no key issues. Figure 62 shows the point cloud generated for bridge A5805 explored to digitize bridge assets.

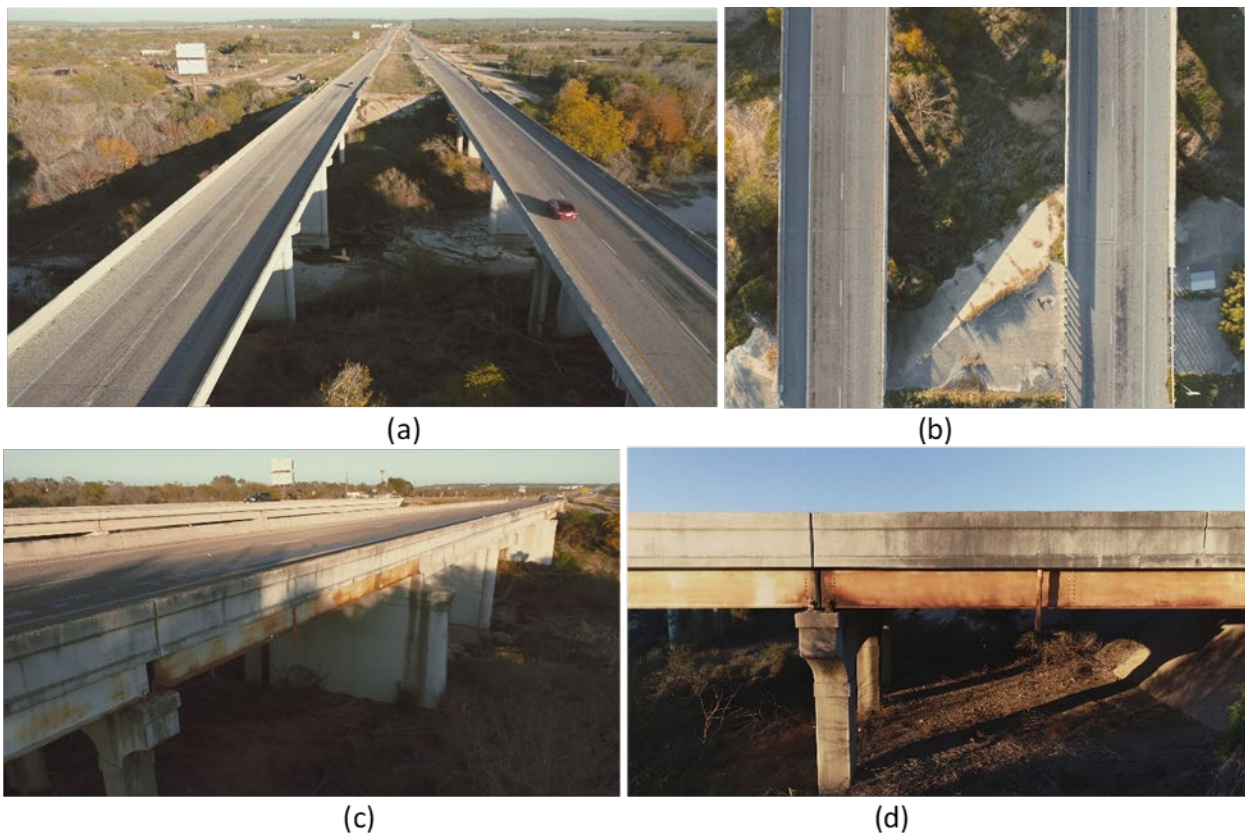
Figure 63. Texas Bridge 151630002405167 (Phantom 4)

This subsection presents example inspection results for Texas bridge 151630002405167 in the age range of 35-40 years. The presented bridge example is a composite bridge with both pre-stressed concrete spans and steel girder spans. Figure 63 shows representative images from the Phantom 4. Some bridge deck surface abrasion can be noticed. Heavy corrosion can also be observed on the girders, especially at the supports. As shown in Figure 64, images from the Nikon camera reveal scouring around foundations of the bridge columns and rain drainage marks at the bridge caps. Misalignment of the deck and bridge cap can also be noticed. Figure 65 shows images taken from the Elios 2, further revealing the drainage issues at the joints. Figure 66 presents thermal images from the FLIR camera. The rough surface and boundary corrugated marks can be clearly noticed. Figure 67 shows the point cloud generated for the bridge as one of the digitization processes of bridge assets.

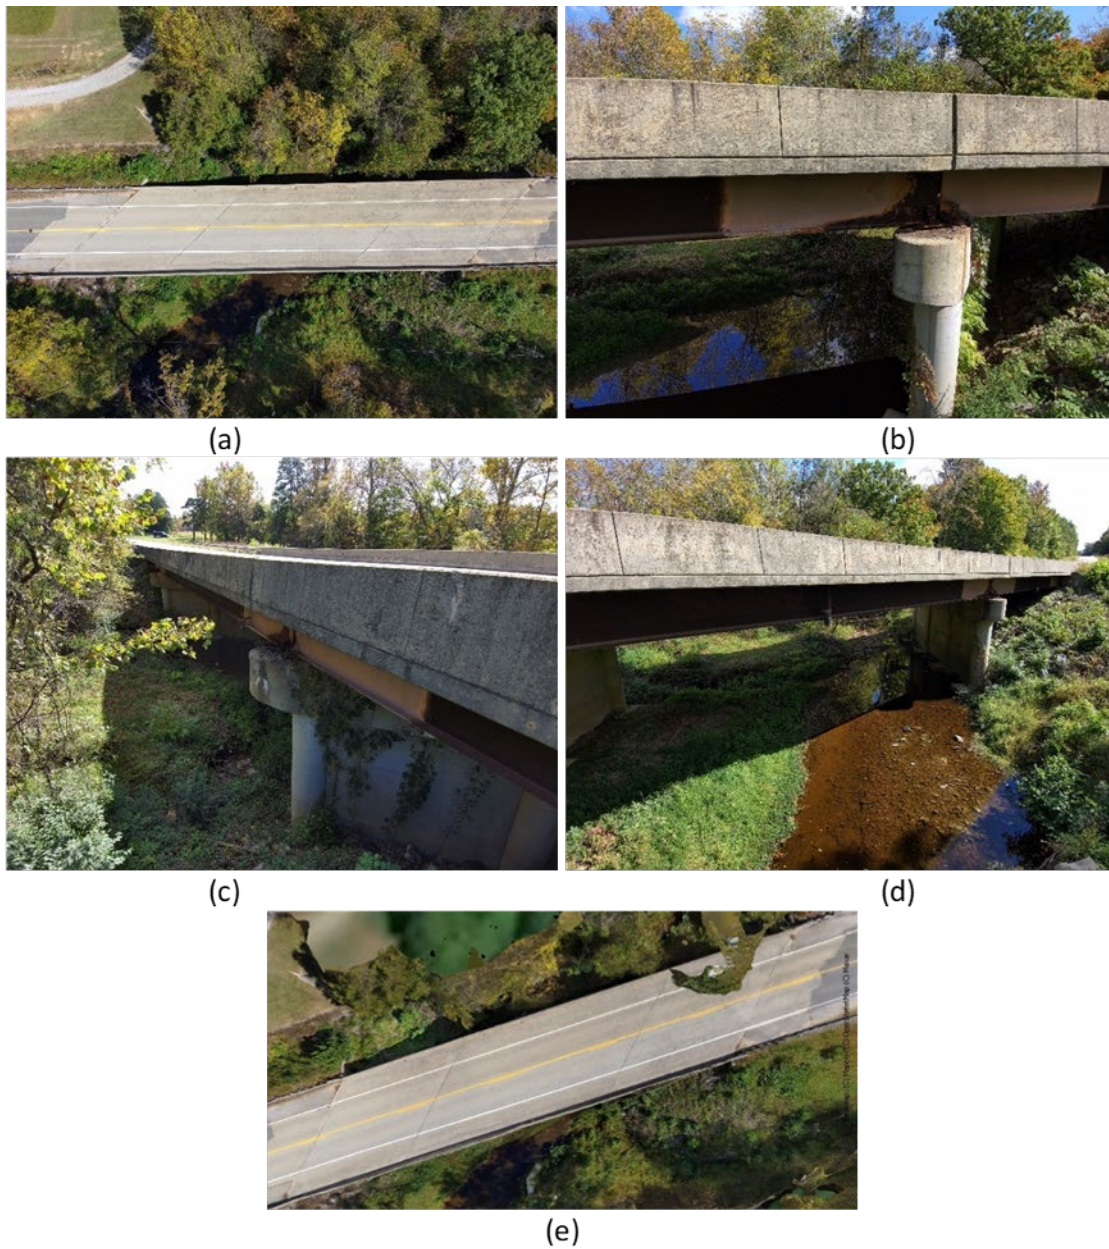
Figure 68. Virginia Bridge 11562 (Skydio 2)

This subsection presents the inspection results for Virginia bridge 11562 in the age group of 35-40 years. Figure 68 presents some of the images taken from the Skydio 2. Specifically, Figure 68(a) shows the overall top view of the bridge with surface changes noticed at the approach spans. Figure 68(b-d) shows the side view of the bridge with corrosion at the support and the middle part of the exterior steel girders, where only partial painting remains near the support. Figure 68(e) shows a 3D model of the bridge generated from Agisoft using individual images and videos. The 3D model enables an overview of the entire bridge from any perspective, potentially enabling virtual inspection of the bridge anywhere and anytime by anyone authorized to access.

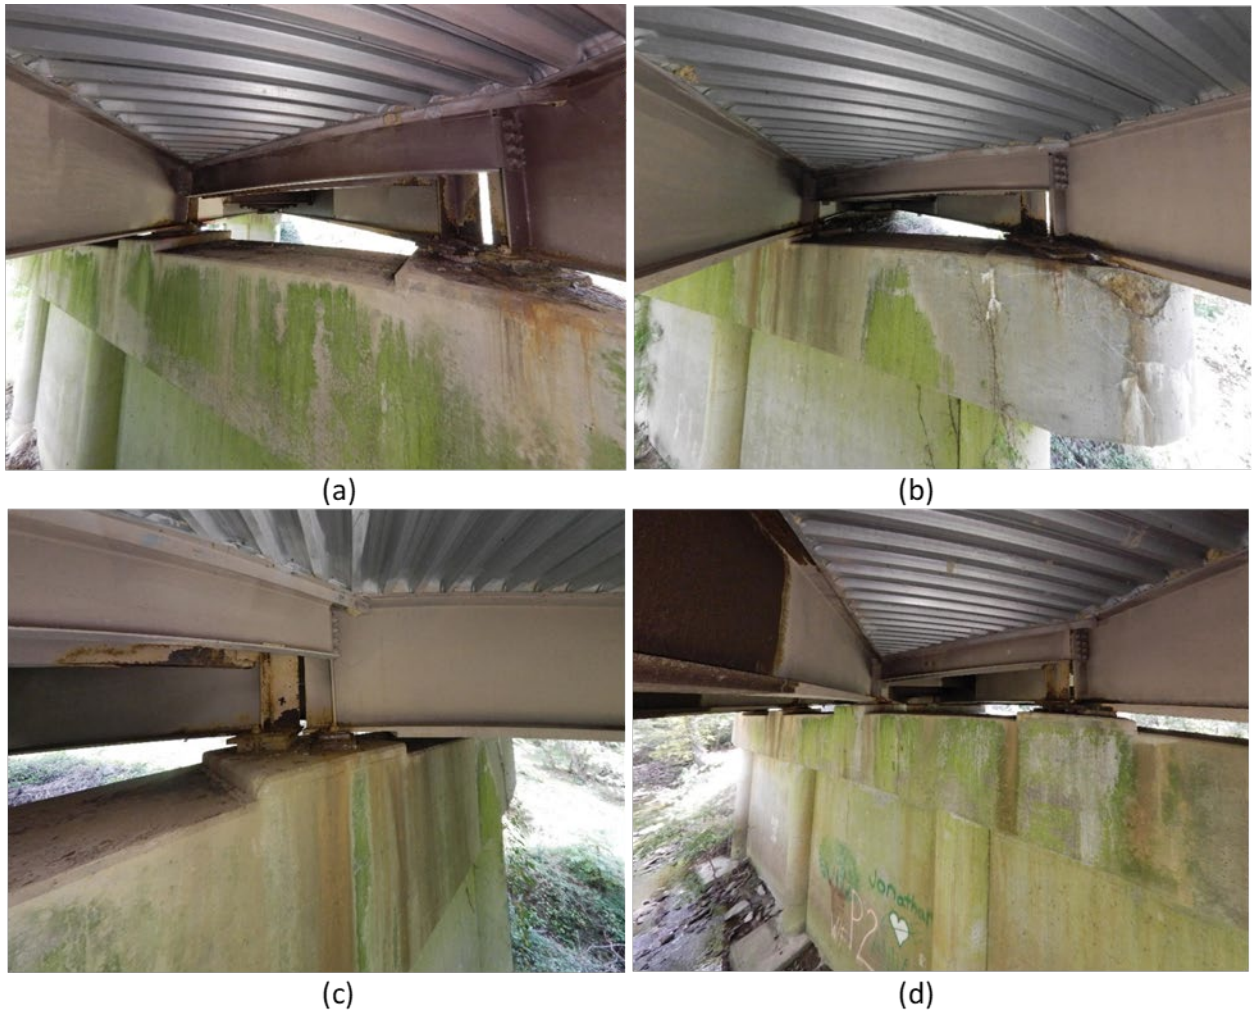
Figure 70. Virginia Bridge 11562 (Elios 2)

Figure 69 shows images taken from the Nikon camera. Corrosion issues and deterioration at the support can be noticed clearly. Spreading of the corrosion on the steel girders can also be noticed, which is consistent with the observations from the Skydio 2 and the Elios 2. Figure 70 shows images taken from the Elios 2. These images further reveal the corrosion issue at the supports, and the drainage issue at the concrete caps which may be a cause for the corrosion. Corrosion patterns can be noticed at the steel girders. The inner side of the exterior girder shows good condition of the paint, while interior girders show rust at the mid-span. In general, bridge supports present a consistent corrosion issue. Figure 71 presents a 3D thermal model of the bridge generated from individual thermal images using photogrammetry. Such a 3D thermal model enables an overview of the bridge from any angle in top view as the DJI M600 drone collects data above the bridge only. Major patch issues and asphalt surface changes can be noticed at the approach spans. Note that thermal imaging is effective for subsurface delamination, but it requires a temperature change. The best time would be 10 am – 2 pm with sunny conditions for rising temperature data collection and after sundown for decreasing temperature data collection.

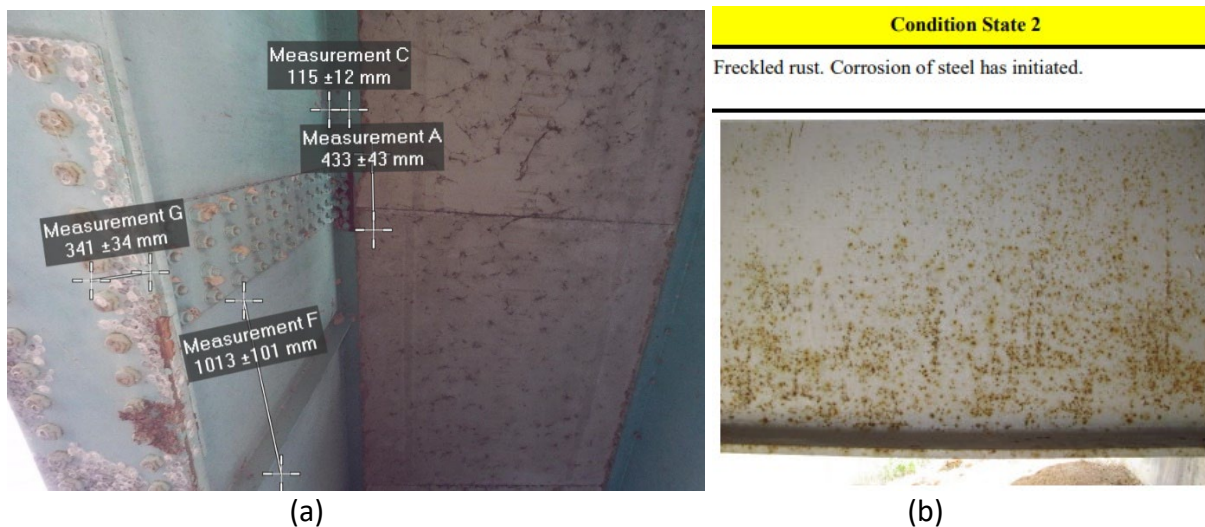
Figure 82. Bridge A4188 Frames vs. AASHTO Reference Photos for Coating Deterioration and Steel Connection Corrosion Assessment (25.4 mm = 1 in)

Figure 82(a) shows the corrosion issue at the bolted connection part of bridge A4188 near Jefferson City, MO. The top beam flange showed a corrosion area of approximately 4.53×17.1 in (115×433 mm), while the bottom flange showed an area of approximately 13.4×39.9 in (341×1010 mm). This corrosion condition may be classified into CS2, in reference to the AASHTO *Manual* as shown in Figure 82(b).

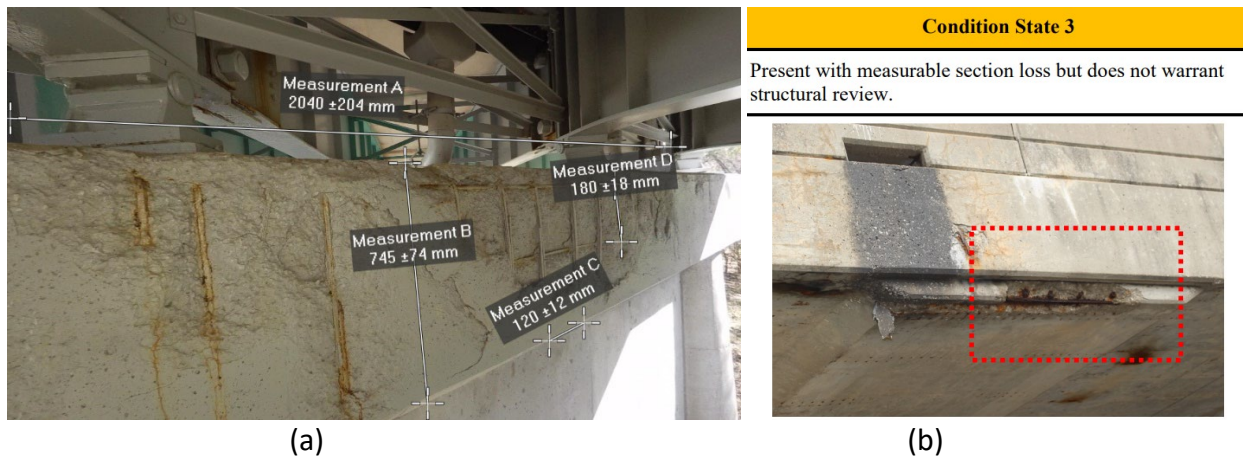
Figure 83. Bridge A4351 Frames vs. AASHTO Reference Photos for Concrete Spalling and Rebar Corrosion Assessment (25.4 mm = 1 in)

Figure 83 shows a severe spalling with exposed rebar on a cap beam of bridge A4351 near Jefferson City, MO. The spalling area was measured to have approximately 29.3×80.3 in (745×2040 mm). Rebar exposure also revealed the spacing of approximately 4.72×7.09 in (120×180 mm) in the middle section. Comparing to the AASHTO reference as shown in Figure 83(b), the defect may be classified into CS3.

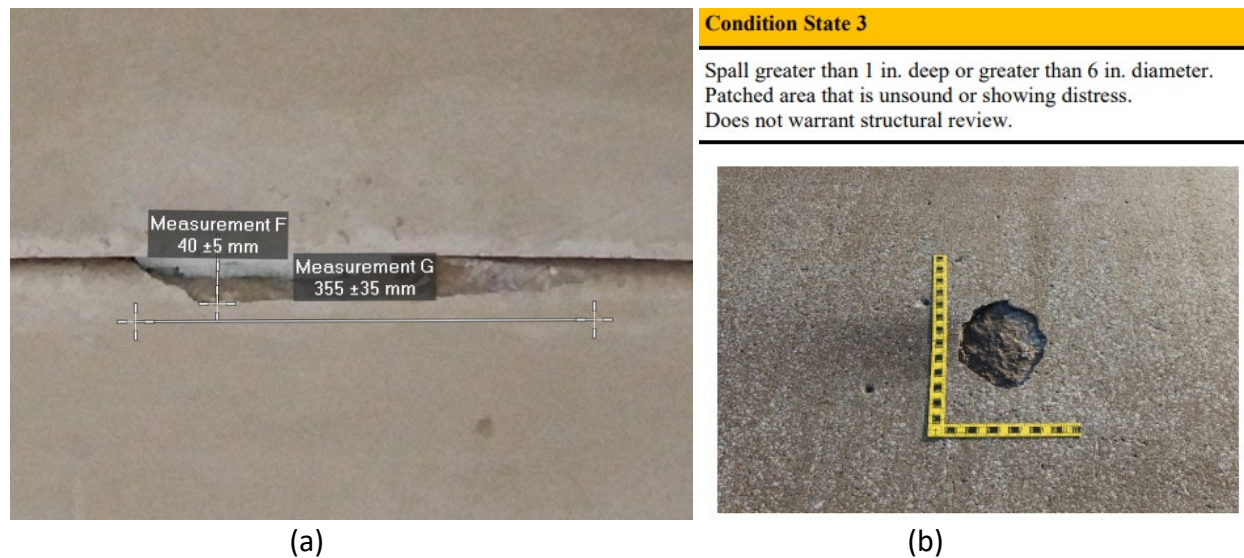
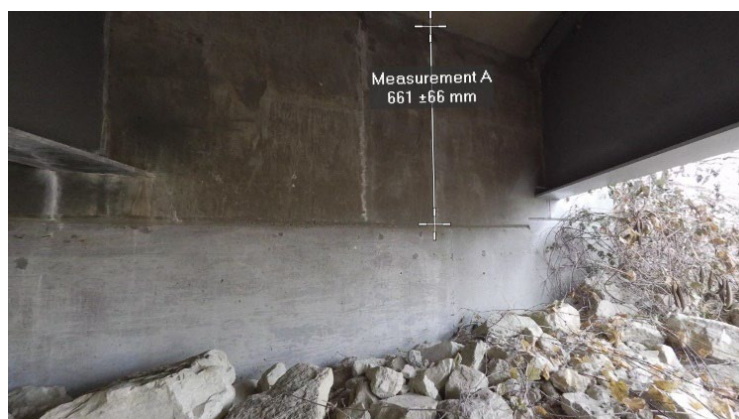
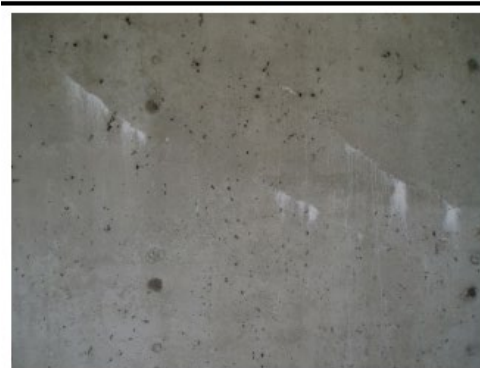
Figure 84. Bridge A4982 Frames vs. AASHTO Reference Photos for Concrete Spalling and Leaching Assessment (25.4 mm = 1 in)

Figure 84 compares the video frames of bridge A4982, including notable defects, with reference photos in the AASHTO *Manual* (AASHTO, 2019) to assign appropriate CS of the bridge elements. Specifically, Figure 84(a) shows the measurement of a spalling area, sizing approximately 1.57 × 14 in (40 × 355 mm), on the underside of the bridge deck. This spalling condition may be categorized into CS2 to CS3 in reference to the excerpted photos from the AASHTO *Manual*, as shown in Figure 84(b). Figure 84(c) shows a 26 in (661 mm)-long leaching trace on the bridge abutment, which may be categorized into CS1 compared to the reference photo in Figure 84(d).

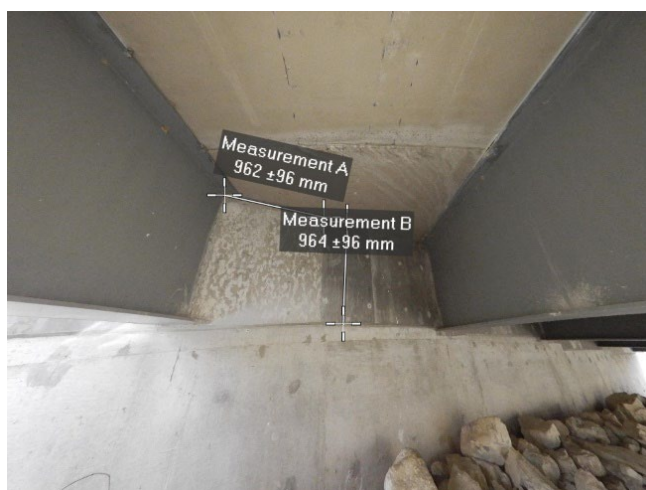
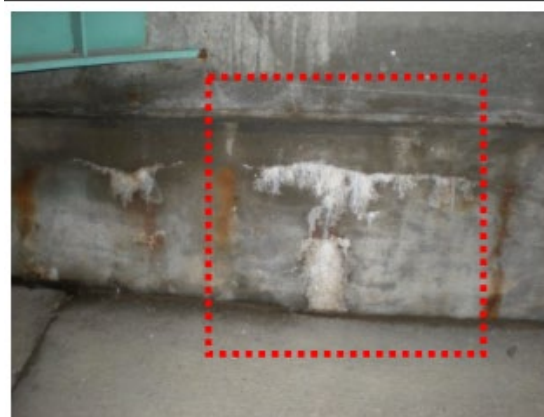
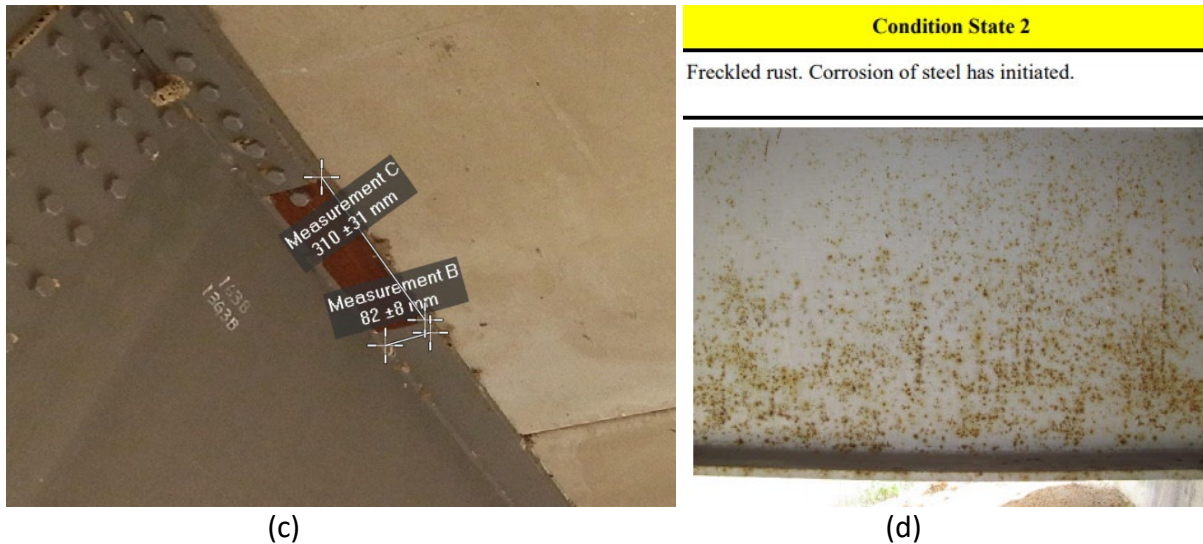
Figure 85. Bridge A4988 Frames vs. AASHTO Reference Photos for Concrete Leaching and Steel Corrosion Assessment (25.4 mm = 1 in)

Figure 85 shows sample defect measurements for bridge A4988. Specifically, Figure 85(a) shows a leaching area of approximately 37.9×38.0 in (962×964 mm) at the abutment of bridge A4988. Compared to the AASHTO reference as shown in Figure 85(b), the defect may be classified into CS2. Figure 85(c) shows the corrosion of a rectangular steel plate sizing 3.23×12.2 in (82×310 mm). Compared to the AASHTO reference as shown in Figure 85(d), the corrosion condition may be classified into CS2. However, further verification is required as the color alone is insufficient to draw a definitive conclusion on the degree of deterioration.

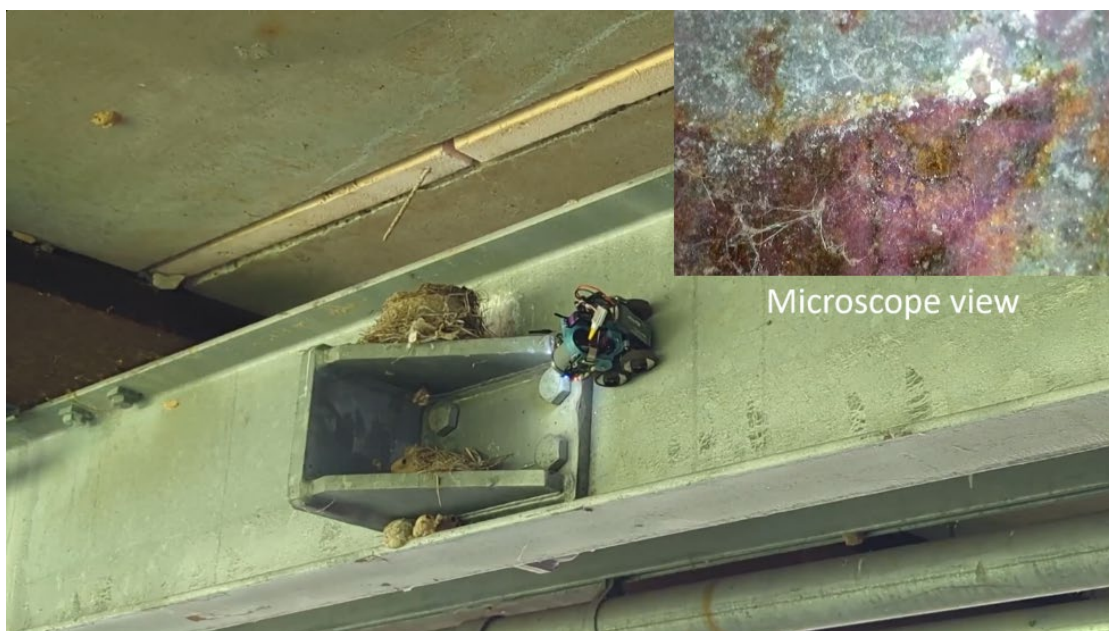
Figure 94. Crawler Access to a Potentially Corroded Area via Microscopic View

As shown in Figure 94, a microscopic imager was used to inspect the bolt connection where bird nests and rust were observed in detail from magnified images. Similarly, the functions of the crawler for bolt and nut inspection and the anchorage area examination were illustrated in Figure 95. While not observable by the operator, the crawler provided a beyond-the-visual-line-of-sight view of rust on the web of the steel girder in Figure 95(b). The presence of trapped water may contribute to rusty conditions.

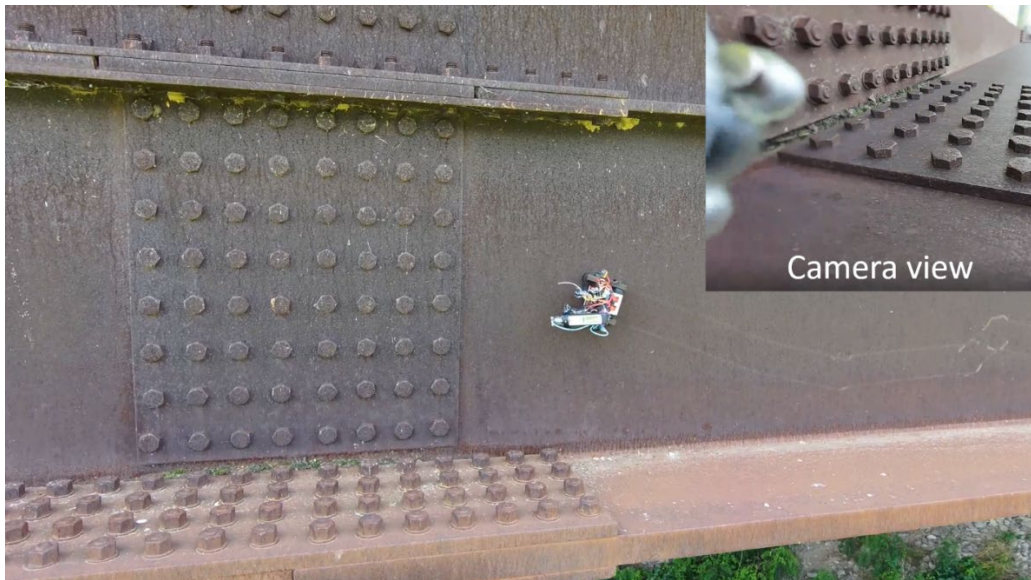
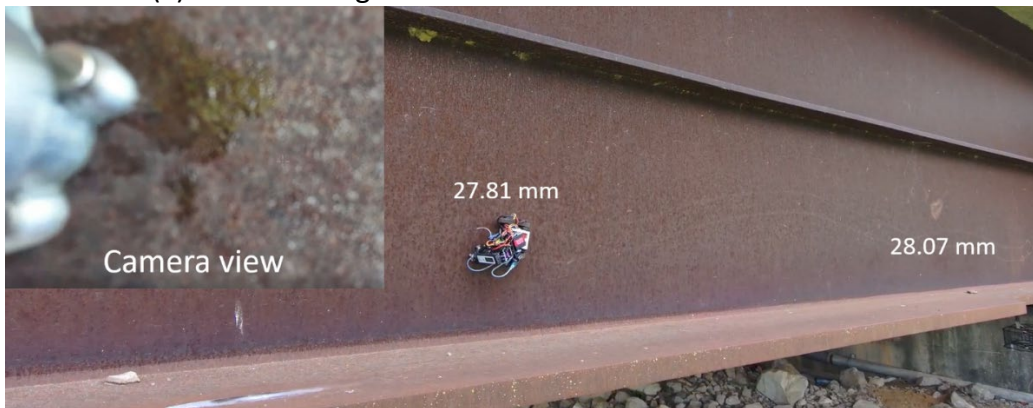
Figure 96. Automated Nondestructive Testing on the Web of a Steel Girder

As demonstrated in Figure 96, an aerial NDT was conducted on the longitudinal steel girder using a structural crawler. The crawler was equipped with an ultrasonic metal thickness measurement device. During operation, the crawler halted at the target inspection site, then the pumping system dispensed the ultrasonic gel, and finally the manipulator deployed the ultrasonic sensor for thickness measurement. The camera view from the crawler included the sensor to help the crawler navigate through the bolt area as shown in Figure 96(a). Once the ultrasonic device was in place, its readings on the thickness of the web of the longitudinal girder were displayed on the screen as illustrated in Figure 96(b).
