A Follow-up Evaluation of the Concrete Pavements (U.S. 58) Rehabilitated in 2012

Final Report VTRC 26-R16

FINAL REPORT
A FOLLOW-UP EVALUATION OF THE CONCRETE PAVEMENTS (U.S. 58)
REHABILITATED IN 2012

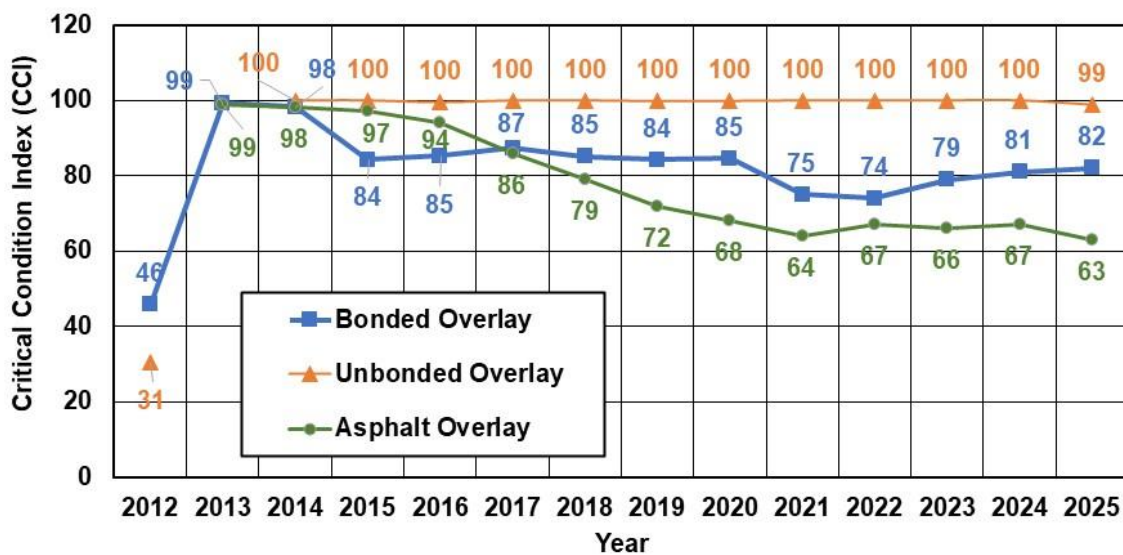
Figure 9. Pavement Condition Index for Three Overlay Sections

Surface distress data were collected from the VDOT PMS for both eastbound and westbound US 58 in Southampton County, Virginia. In addition, researchers visited the section for a visual assessment. Although all sections were CRCP before overlay, their classification has changed after overlay. The bonded section is CRCP, the same as before, but the unbonded section is rated as jointed plain concrete pavement. On the other hand, the asphalt overlay section is now a composite section with an asphalt surface. Therefore, the surface distresses cannot be compared directly with the pre-overlay conditions because the major distress categories have changed. Overall pavement conditions were compared in terms of pavement CCI and IRI ride quality, shown in Figures 9 and 10, respectively. The following section discusses the individual section's surface distresses.

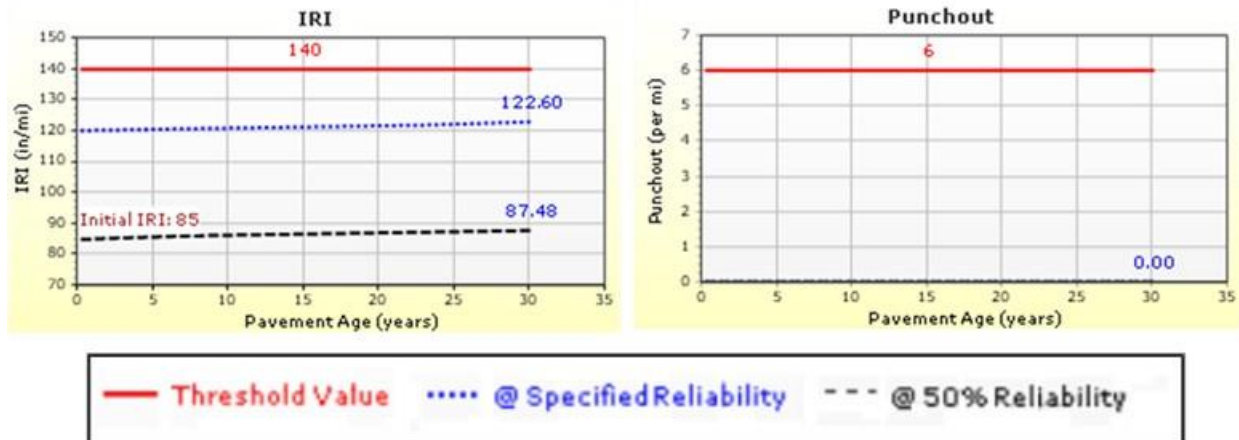
Figure B1. Bonded Concrete Overlay. CRCP = continuously reinforced concrete pavement; CTA = cement-treated aggregate; IRI = international roughness index; PCC = Portland cement concrete.

Distress Type	Distress @ Specified Reliability		Reliability (%)		Criterion Satisfied?
	Target	Predicted	Target	Achieved	
Terminal IRI (in/mile)	140.00	122.60	95.00	99.30	Pass
CRCP punchouts (1/mile)	6.00	0.00	95.00	100.00	Pass

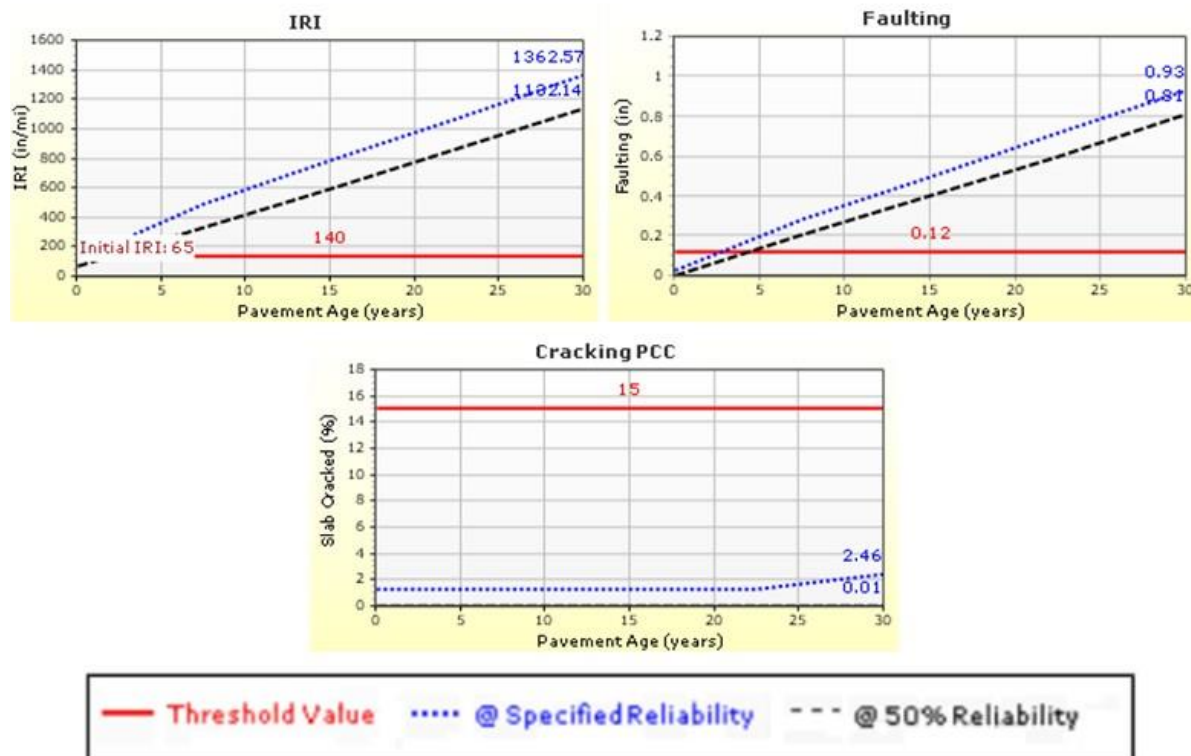
Figure B2. Unbonded Concrete Overlay (No Dowel). CRCP = continuously reinforced concrete pavement; CTA = cement-treated aggregate; IRI = international roughness index; JPCP = jointed plain concrete pavement; OGD = open-graded drainage layer; PCC = Portland cement concrete.

Distress Type	Distress @ Specified Reliability		Reliability (%)		Criterion Satisfied?
	Target	Predicted	Target	Achieved	
Terminal IRI (in/mile)	140.00	1362.57	95.00	0.00	Fail
Mean joint faulting (in)	0.12	0.93	95.00	0.00	Fail
JPCP transverse cracking (percent slabs)	15.00	2.46	95.00	100.00	Pass

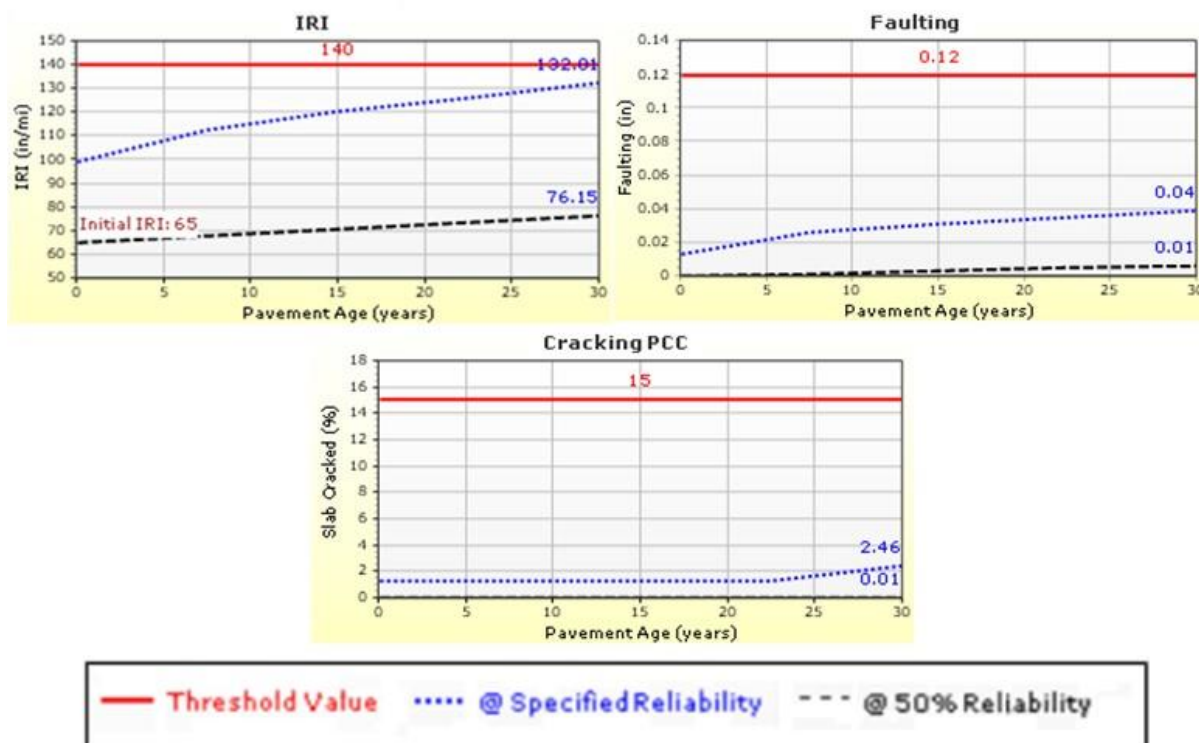
Figure B3. Unbonded Concrete Overlay (With Dowel). CRCP = continuously reinforced concrete pavement; CTA = cement-treated aggregate; IRI = international roughness index; JPCP = jointed plain concrete pavement; OGD = open-graded drainage layer; PCC = Portland cement concrete.

Distress Type	Distress @ Specified Reliability		Reliability (%)		Criterion Satisfied?
	Target	Predicted	Target	Achieved	
Terminal IRI (in/mile)	140.00	132.01	95.00	97.00	Pass
Mean joint faulting (in)	0.12	0.04	95.00	100.00	Pass
JPCP transverse cracking (percent slabs)	15.00	2.46	95.00	100.00	Pass

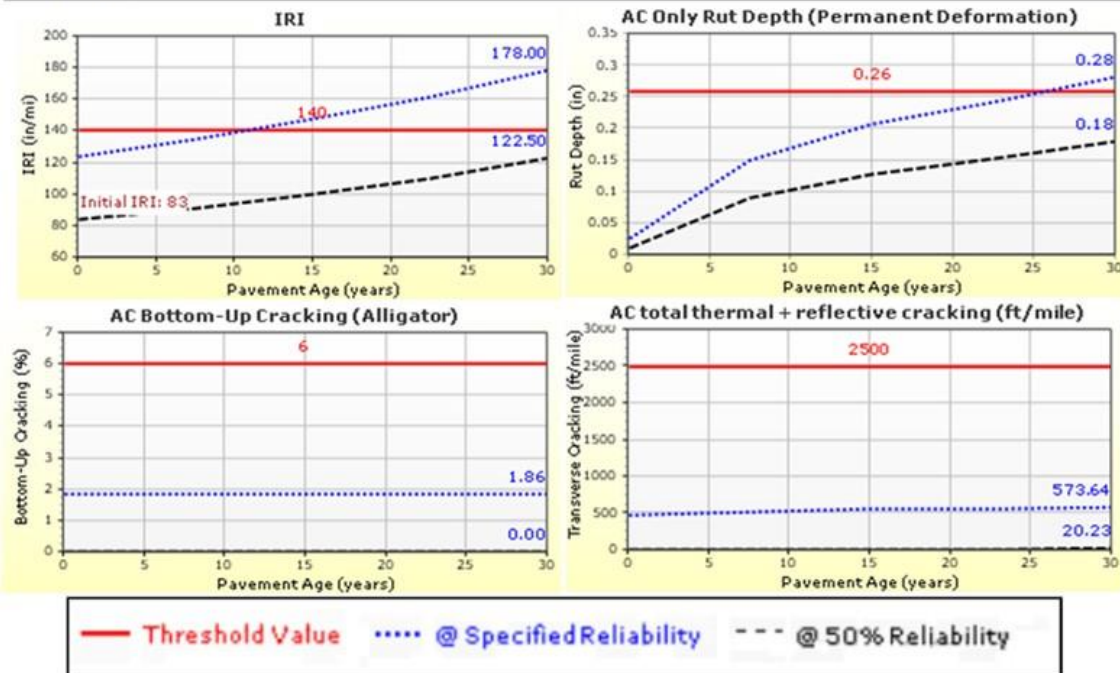
Figure B4. Asphalt Overlay. AC = asphalt concrete; CRCP = continuously reinforced concrete pavement; CTA = cement-treated aggregate; IM = intermediate mix; IRI = international roughness index; OL = overlay; PCC = Portland cement concrete; SM = surface mix.

Distress Type	Distress @ Specified Reliability		Reliability (%)		Criterion Satisfied?
	Target	Predicted	Target	Achieved	
Terminal IRI (in/mile)	140.00	177.99	95.00	69.81	Fail
Permanent deformation - AC only (in)	0.26	0.28	95.00	90.26	Fail
AC bottom-up fatigue cracking (% lane area)	6.00	1.86	95.00	100.00	Pass
AC total transverse cracking: thermal + reflective (ft/mile)	2500.00	573.64	95.00	100.00	Pass
AC thermal cracking (ft/mile)	1000.00	1.00	50.00	100.00	Pass
AC top-down fatigue cracking (ft/mile)	2000.00	347.84	95.00	100.00	Pass
CRCP punchouts (1/mile)	6.00	0.00	95.00	100.00	Pass
Chemically stabilized layer - fatigue fracture (% lane area)	25.00	0.26	-	-	-
