Evaluation of Bridge Fiber Optic Sensor Systems

NM12SP-07-012

EVALUATION OF BRIDGE FIBER OPTIC SENSOR SYSTEMS

Final Report
July 15, 2016

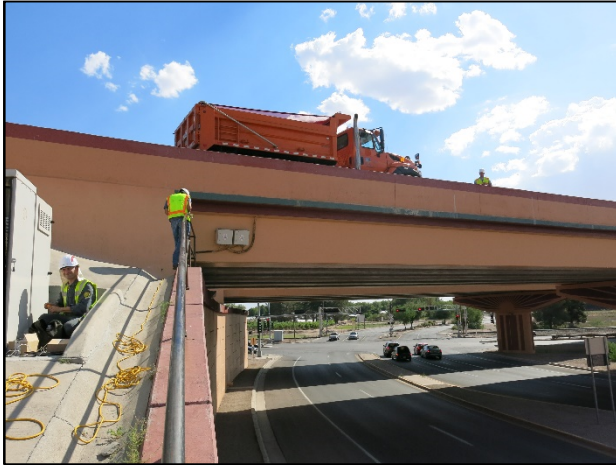
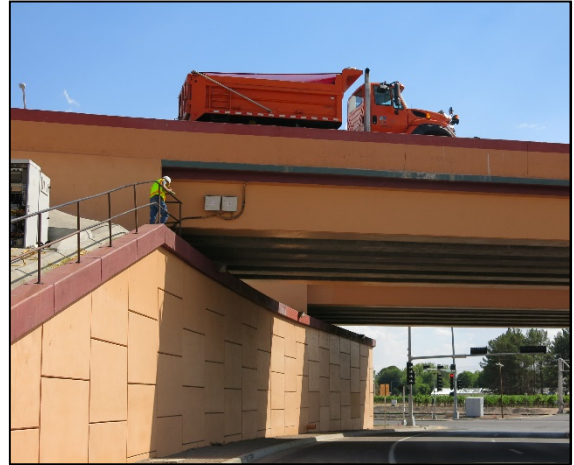
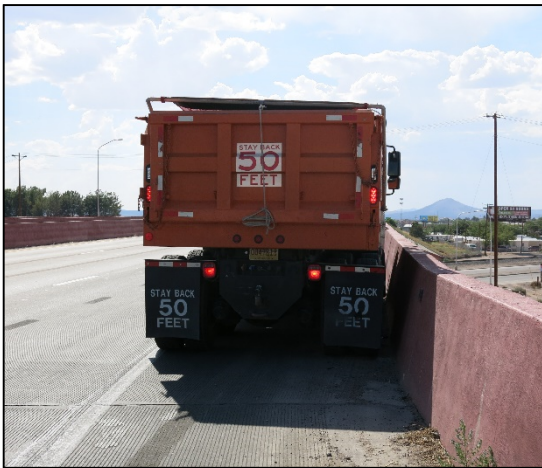
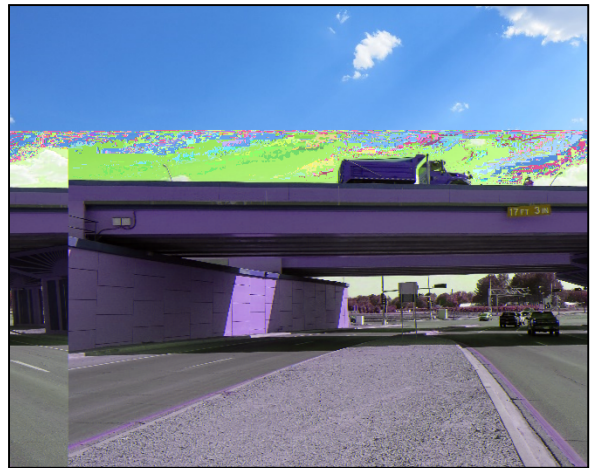
Figure 13 shows pictures during the evaluation including pictures of the junction boxes and central monitoring tower. Additionally, Figure 14 shows pictures from a modified load test. Due to traffic remaining on the bridge, further investigation is needed; however, data was collected under load to potentially investigate the behavior of the bridge particularly in the shear region. Bridge 9266 has a significant number of large shear cracks (see Figure 15). Further data collection

and analysis could provide insight into the behavior of the bridge leading to formation of the shear cracks.

Figure 14: Bridge 9266 load test – (a) and (b) shear region; (c) truck location; (d) near midspan.

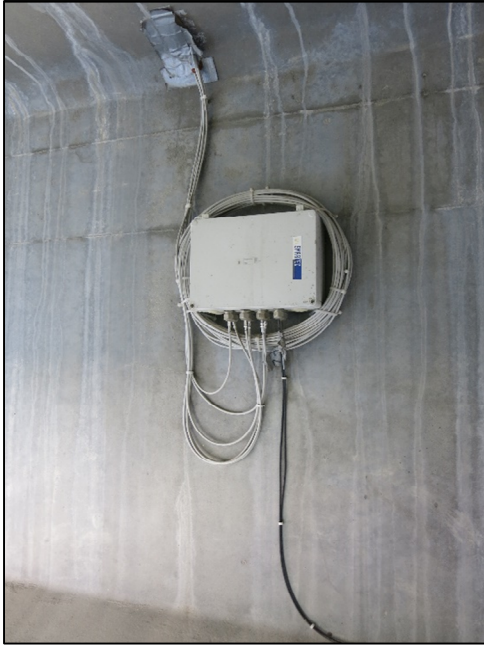
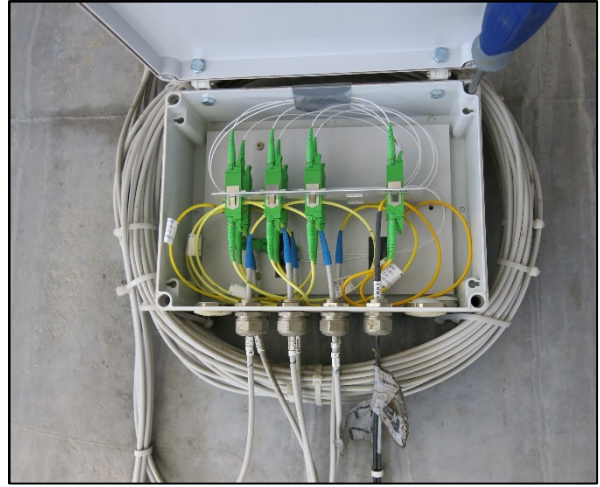
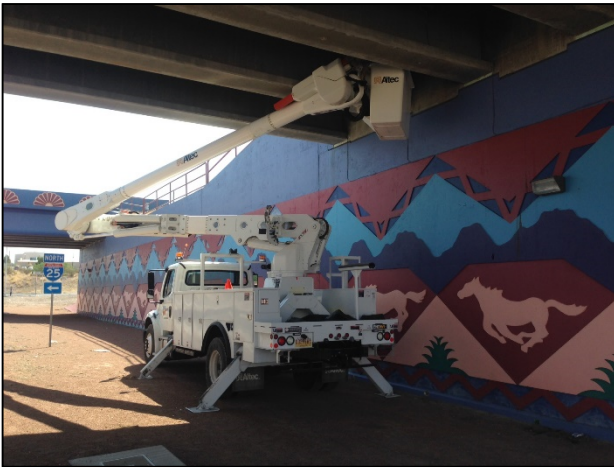
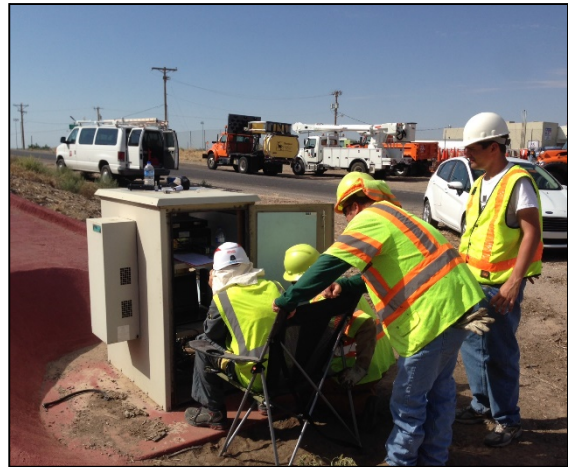
Figure 23 shows pictures during the evaluation of Bridge 9336. Due to the state of the sensor systems, minimal repair work had to be done. Figure 24 shows picture from the load tests performed on Bridge 9336.

Figure 23: Bridge 9336 evaluation – (a) typical junction box; (b) inside junction box; (c) under-bridge access unit; (d) NMDOT personnel examining data.

- Repair heating / cooling unit on the central monitoring housing unit.
