# **Investigation of Rack and Pinion**

## **Alignment of the Cass Street**

### **Movable Bridge in Joliet, Illinois**

**Physical Research Report No.129**

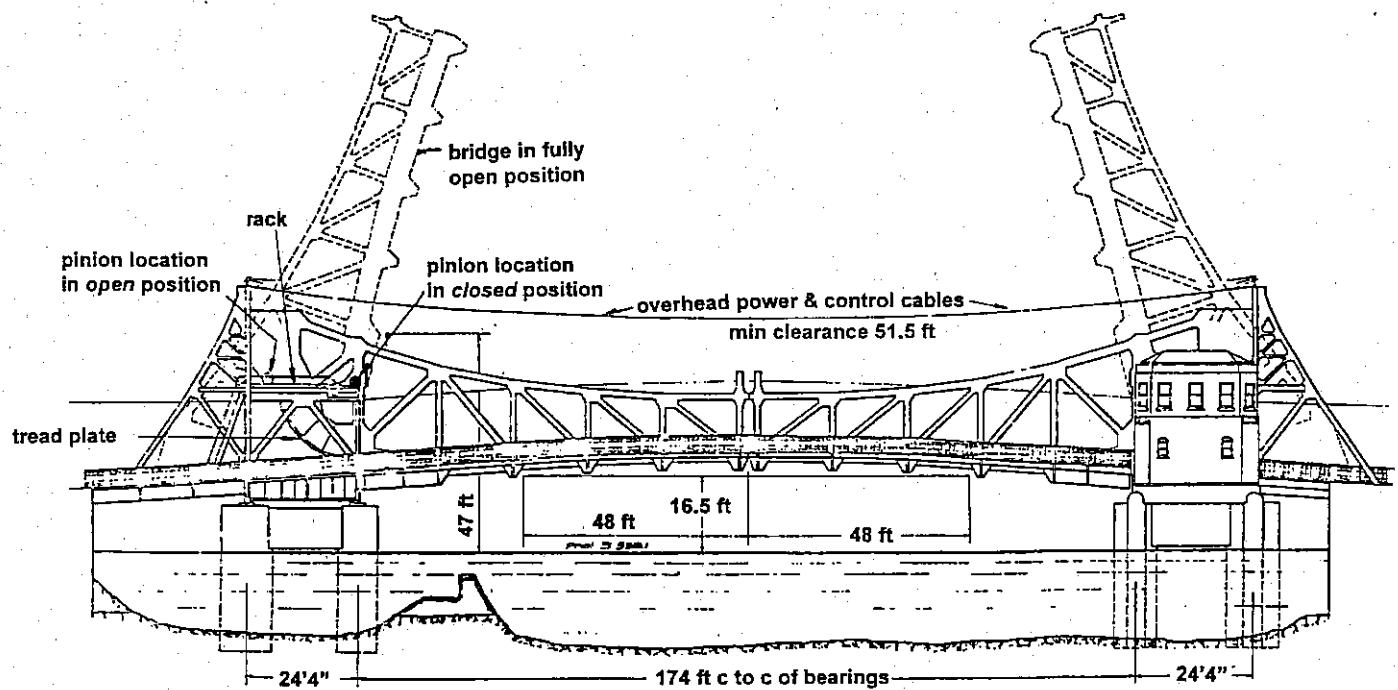
*Figure 1.* Elevation view of the Cass St. Bridge over the DesPlaines River, Joliet, Illinois, showing general lift span dimensions and overall geometry. Locations of the pinion on the fixed rack in the open and closed positions are shown. Adapted from original 1931 plans.

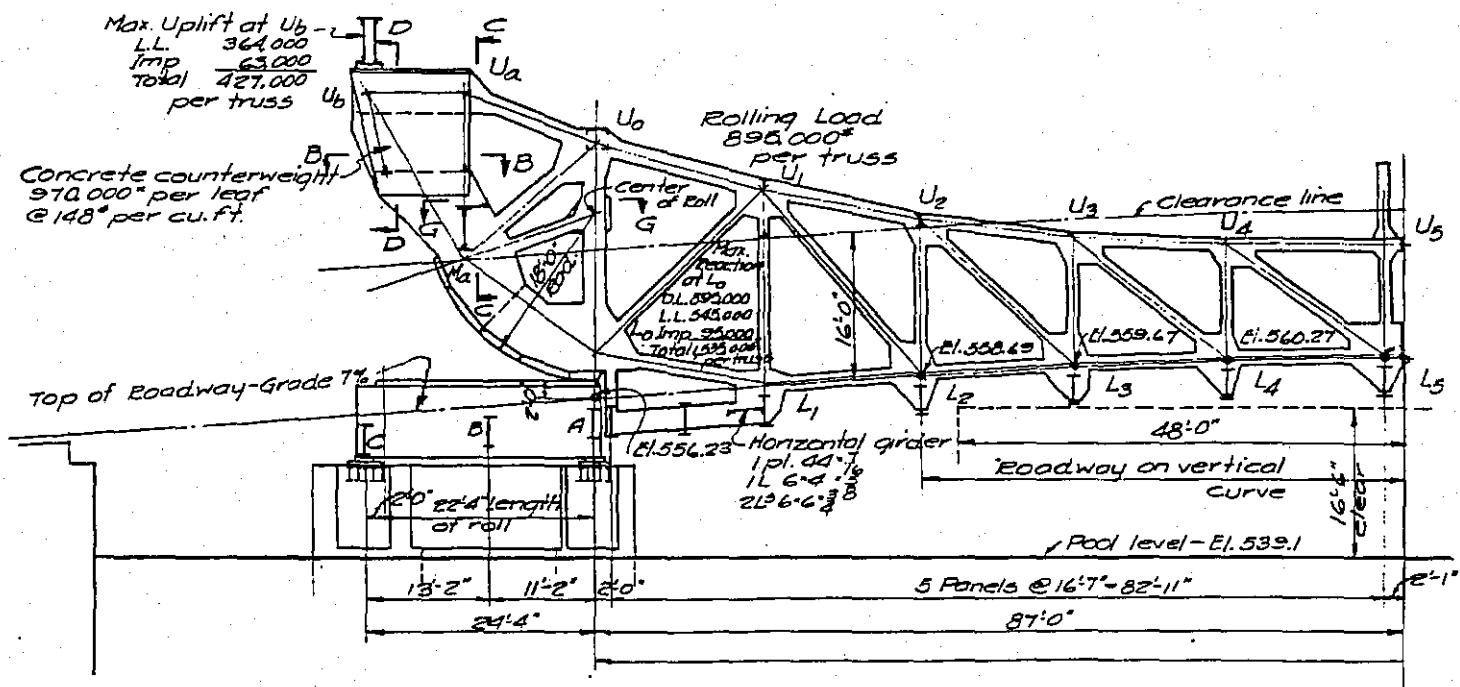
Figure 2. Sectional view of the Cass St. Bridge rolling lift bridge, showing counterweight, tracks, tread and 1/2 span. Adapted from original 1931 plans.

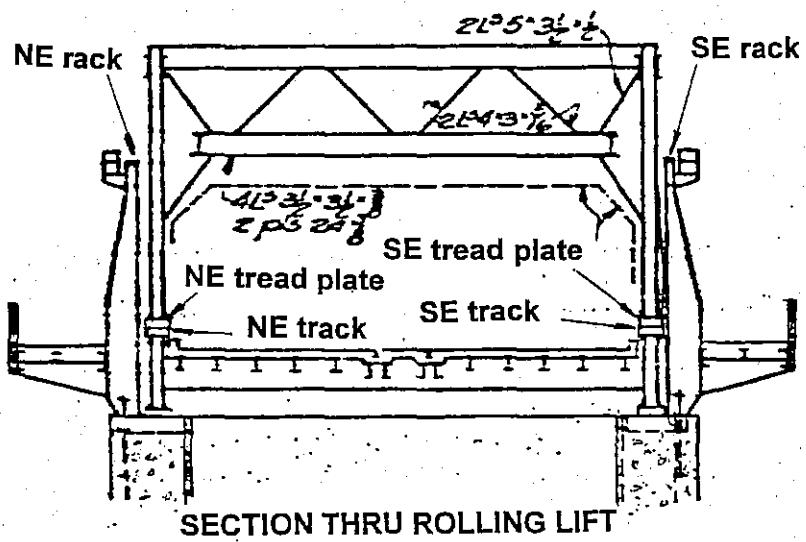
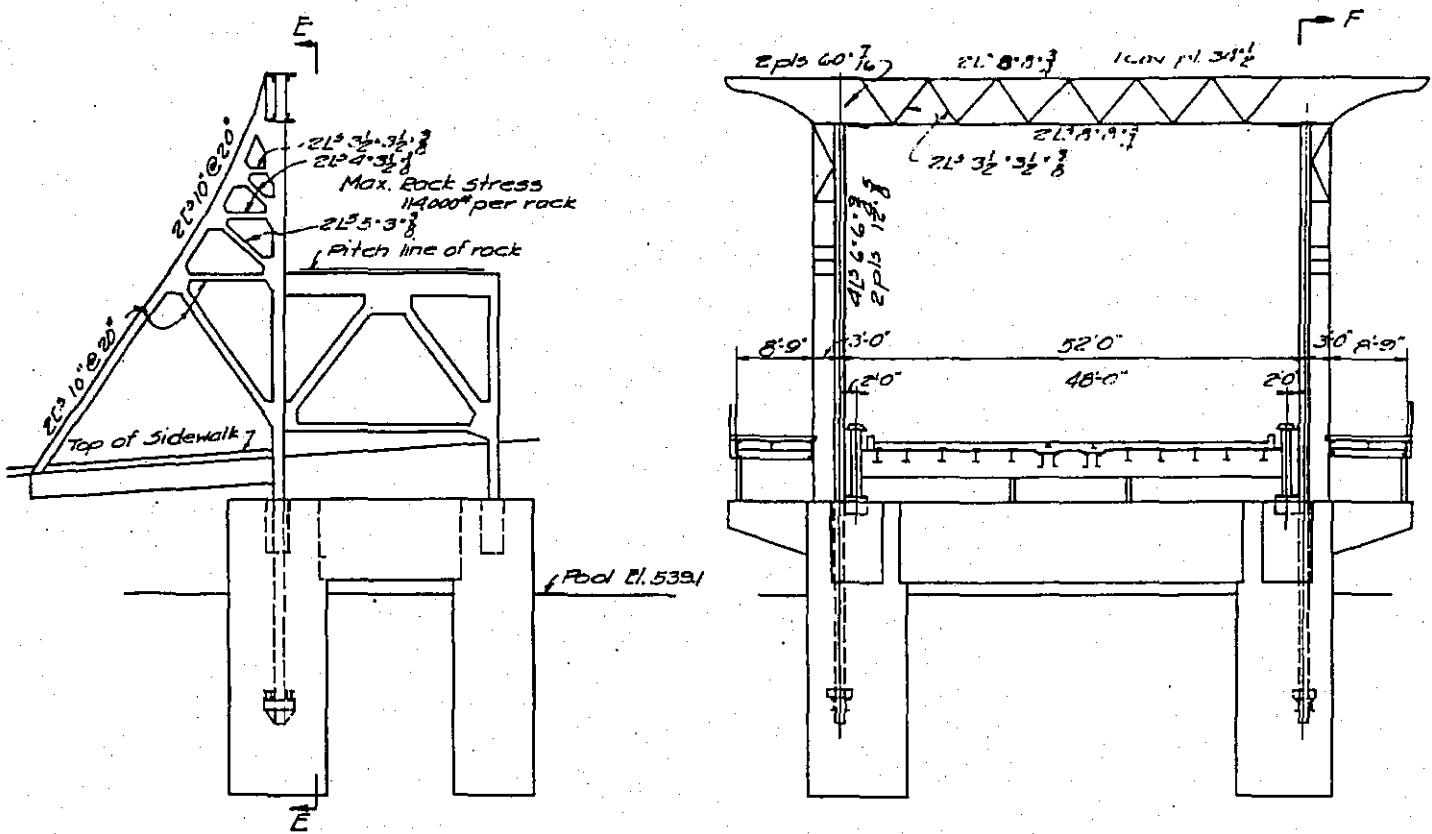
**Figure 3.** Rack and track supports and anchorages, and respective locations of tread plates, racks and tracks on the abutment end of the Cass St. Bridge. Adapted from 1931 plans.

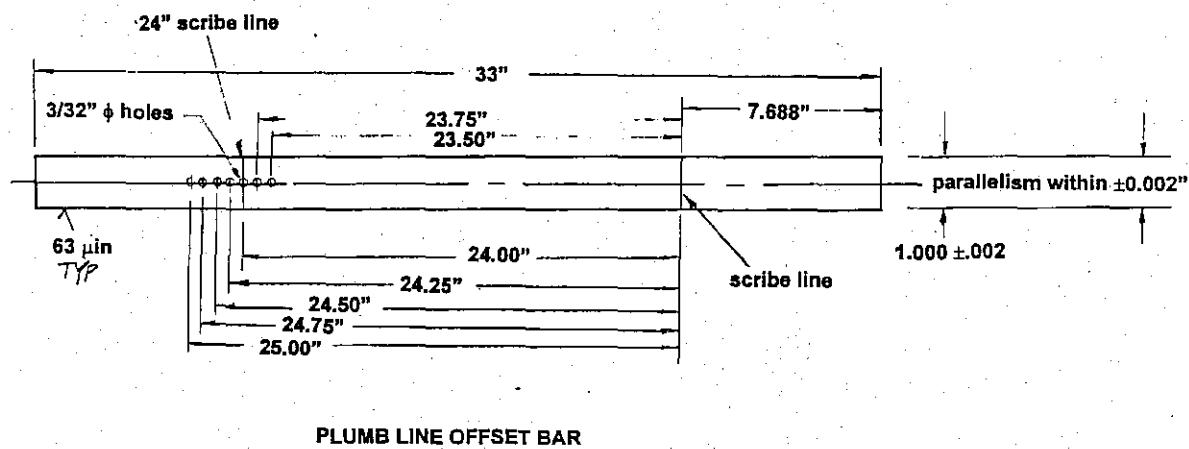
**d. Parallelism of Racks and Tracks.** A third survey was performed to check the parallelism of the track with respect to the upper rack. Measurements were made by use of a flat, calibrated bar with a small hole drilled exactly 24.00" from the center line of the rack plate, as shown in *Figure 7*. With this offset, the bar was clamped to the rack base plate, and aligned with the rack center line. A line was then sent through the drilled hole which held a heavy plumb bob. The accuracy of a plumb line in still air is approximately  $\pm 0.015"$ . The measurements indicated that the eastern side track was offset  $24.00" \pm 0.125"$  from the rack center line. Plumb bob measurements on the rearward portions of the northeast and southeast tracks were within  $0.125"$  of the center line of the track plate.

However, measurements of the 24" offset on the river side of the track proved to be difficult. First, there was no means of attaching the calibrated bar to the rack, since the supporting base plate for the rack terminates flush with the forward rack element. Even after clamping the offset bar to the rack, structural elements on the bascule span interfered with the drop of the plumb line. In addition, traffic must be halted to obtain this measurement. Because the riverside measurement was not made, an extension bar should fastened to the track to make this measurement in the future.

**Figure 7.** Dimensions of the calibrated offset bar used in the gravity method to verify the required rack-to-track offset of 24 inches.

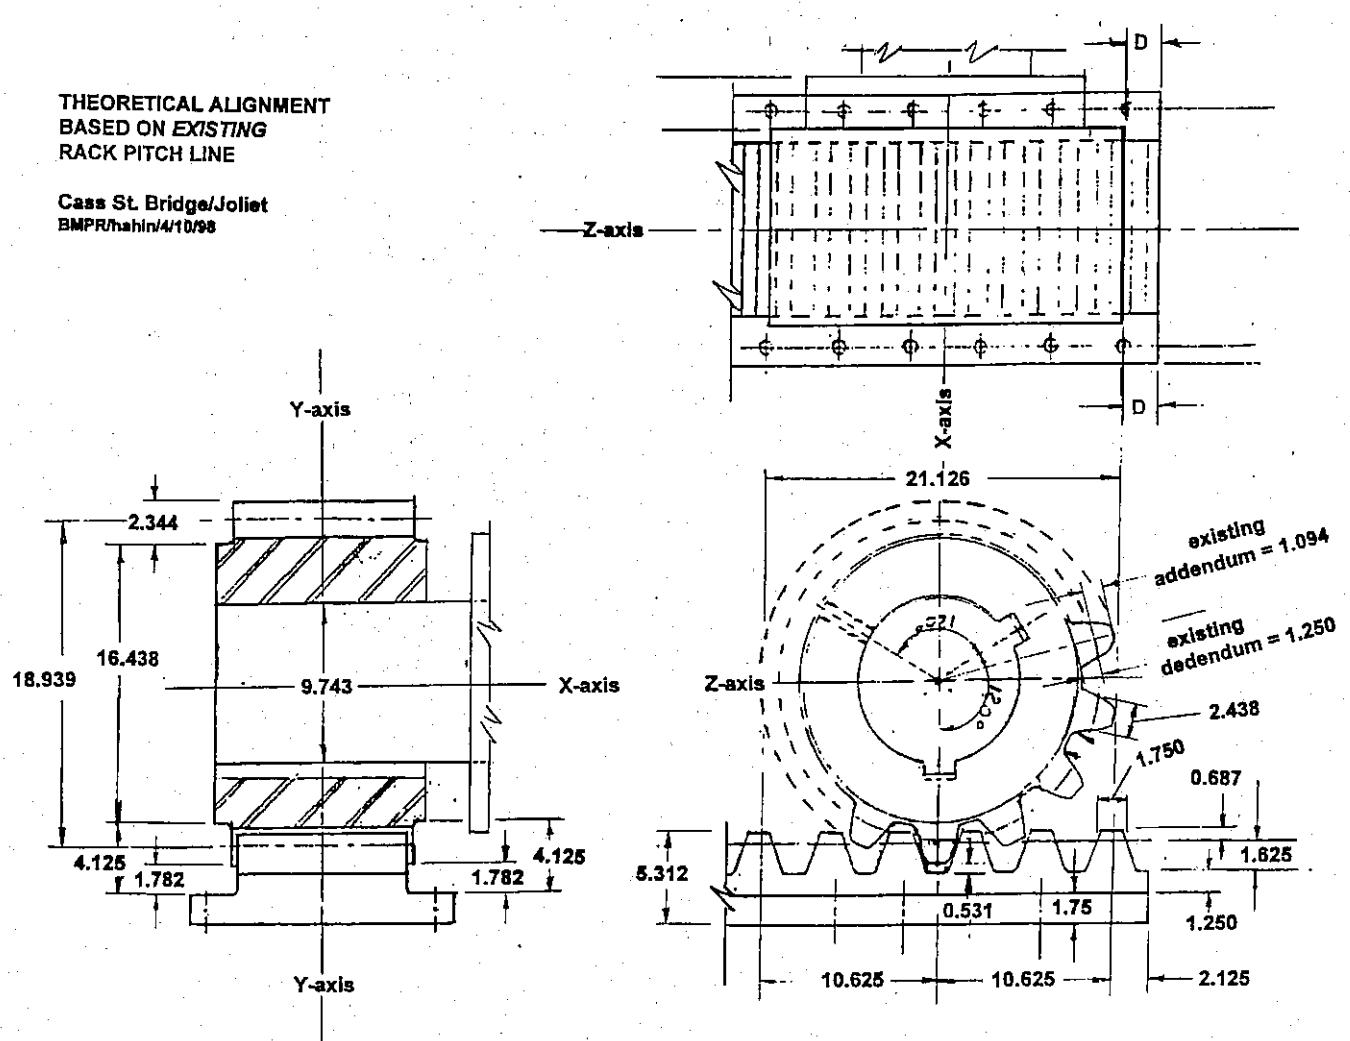
The orientation of the X, Y and Z axes for the rack and pinion are shown in *Figure 9*. The observed wear pattern appears to indicate that the pinion shafting axis is tilted with respect to the X-axis, and is also rotated a few degrees, placing the pinion's transverse plane out of alignment with respect to the Z-axis.

The pinion alignment may have been reasonably close after the retrofit work of 1986. However, continual lifting and closure of the bridge has resulted in a change in load transfer pathways. Proper load transfer should be from the collar to the structural plate. Due to loss of bolt preload and hole expansion, load transfer has shifted from the collar bolts to the structural plates they bear against. Because of lack of spot-facing on the bearing collar, there is a high probability that the bolts were eccentrically loaded. Spot-facing is a machining procedure to locally flatten the areas of direct contact, such as at collar, bolt, washer or nut contact surfaces. Moreover, the 1984 plans had no burr relief specified for the bolt holes in the structural plates. Burr relief attenuates localized stress concentrations under a tightened bolt head.

**Figure 9.** Orientation of the X, Y and Z-axes for alignment of the pinion and levelness of the rack, and other general dimensions. Reference dimensions are the clearance between the rack and pinion teeth; rack pitch line and pinion pitch line alignment; levelness of the pinion, and "D" distance equality on both sides of the rack and pinion.

The 9.75" diameter pinion shaft is so massive in comparison to the collar bolts that they cannot effectively transfer loads if misalignment is present. After the alignment shims fell out, replacement bolts were refitted in 1997. However, the pinion was seriously out of alignment and abnormal wear resulted in a short period of time.

**c. Interim Alignment Procedure.** The proposed alignment procedure in this report assumes that the rack is a reasonably proper reference base for the alignment of the pinion until more permanent changes to the track can be made, including changing button diameters to 8.44" and re-centering & reboring button holes. *Figure 9* is the reference drawing for interim pinion alignment.

(c) *Z-axis* and *X-axis* pinion inclination is determined by the "D" distance shown in *Figure 9*. Distance "D" should equal be on both sides of the rack within  $\pm 0.004"$  when the face of a precision  $90^\circ$  angle plate is affixed parallel to the rack teeth.
