# Whitetopping Performance in Illinois

**FINAL REPORT**  
**PHYSICAL RESEARCH REPORT NO. 148**  
**JANUARY 2005**

**Illinois Department of Transportation**

# Final Report

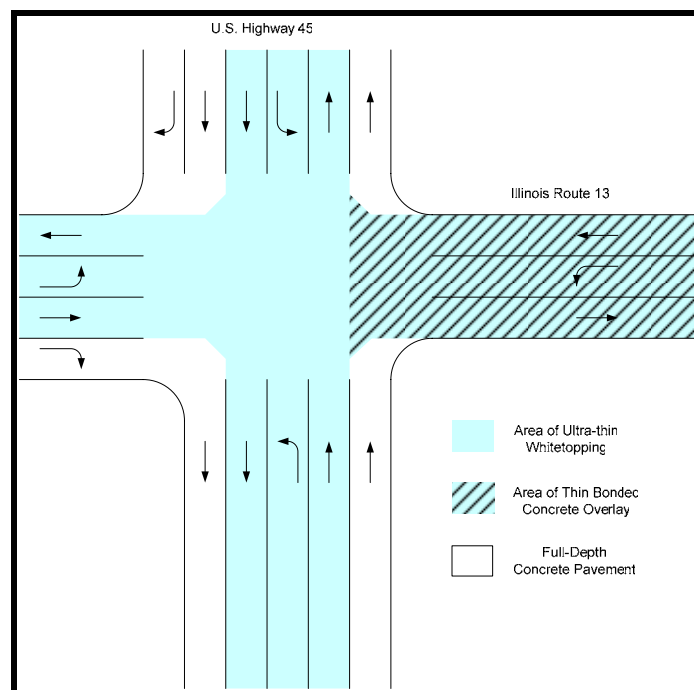
Figure 11  
Harrisburg Project Layout

Transverse cracking, rutting, and shoving of the HMA overlay, were evident in all four legs of the intersection prior to this rehabilitation. Evidence of the rutting may be seen in Figure 10 below. The original pavement cross section consisted of a portland cement concrete pavement overlaid with a nominal 4.5 inches of HMA. This overlay was not present for the driving lanes of U.S. Highway 45 or the eastbound right turn lane on Illinois Route 13. These lanes were added to widen the intersection and consisted of full-depth concrete pavement. The complete layout of the Harrisburg project may be found in Figure 11.

Traffic was detoured away from this intersection for a period of six days to allow for all construction activities. Construction began with the milling of 3.0 inches of the old HMA

inlay within the highlighted areas of Figure 11. Following the milling operation, the pavement was cleaned with high pressure water and compressed air. Two by four lumber was used to form the construction joints and control the grade of the 3.0-inch inlay as it was placed.

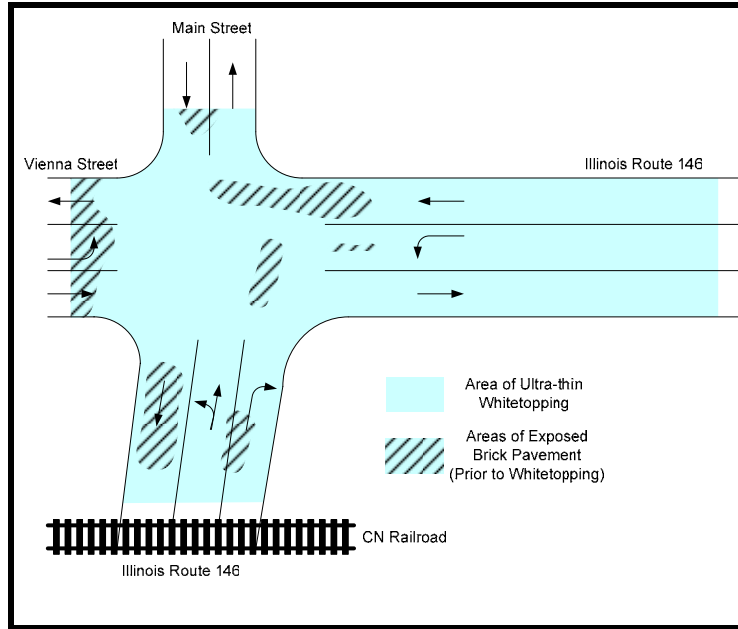
Figure 15  
Anna Project Layout

The second additional research project was constructed in June of 2001 at the intersection of Vienna and Main Streets along Illinois Route 146 in Anna. This rehabilitation included all of the trafficked lanes within the intersection. This project is unique, in that it is a combination of ultrathin whitetopping and a bonded concrete to brick inlay. The areas of exposed brick were not very well defined; however, their approximate locations may be seen in Figure 15 along with the project layout.

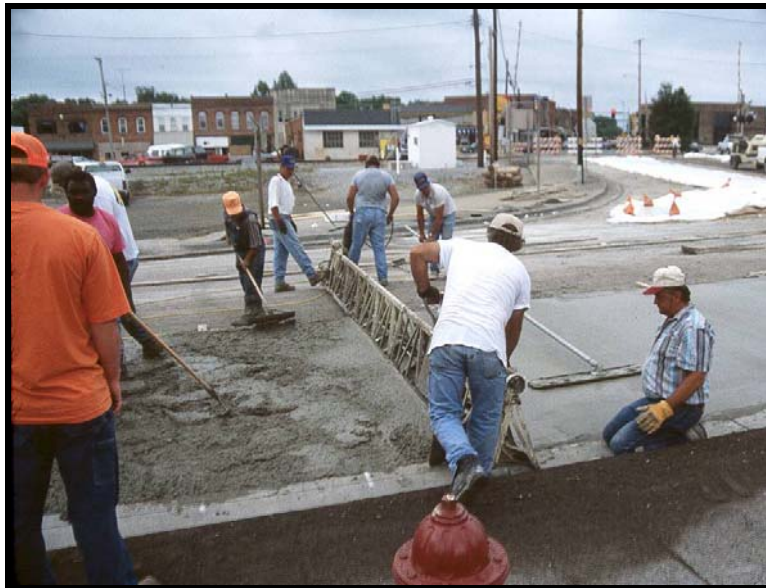
Figure 17

Two by four lumber was used to form the construction joints and control the grade of the 3.0-inch inlay as it was placed. The concrete was placed by hand and finished with a single vibratory screed, straightedges, floating, and some hand finishing as shown in Figure 17. The surface was textured with a coarse broom prior to the application of a white curing compound. The concrete inlay was constructed in three stages.

#### Anna Concrete Placement
