**EVALUATION OF HIGH PERFORMANCE  
CONCRETE BRIDGE DECKS  
AND  
OTHER EXPERIMENTAL BRIDGE  
DECKS THROUGHOUT ILLINOIS**

**PHYSICAL RESEARCH REPORT NO. 166  
December 2017**

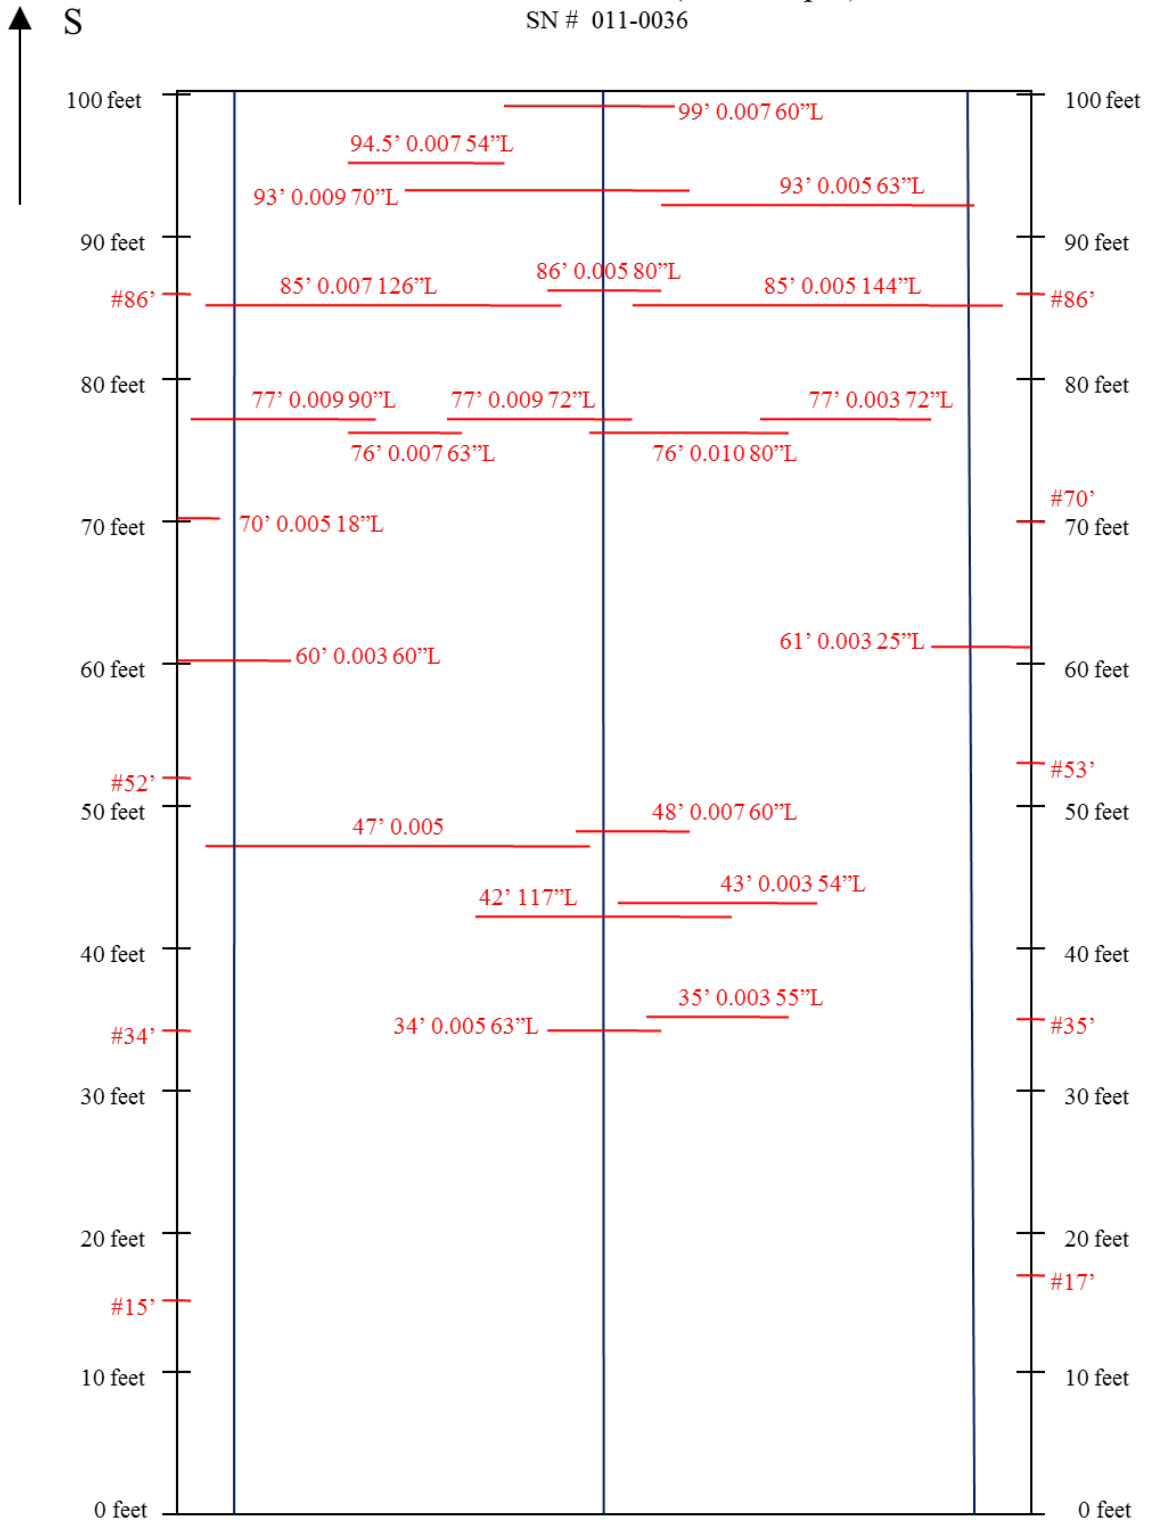
Figure 2.1-2

Christian County – SN#011-0036 – Surveyed 9/16/2003

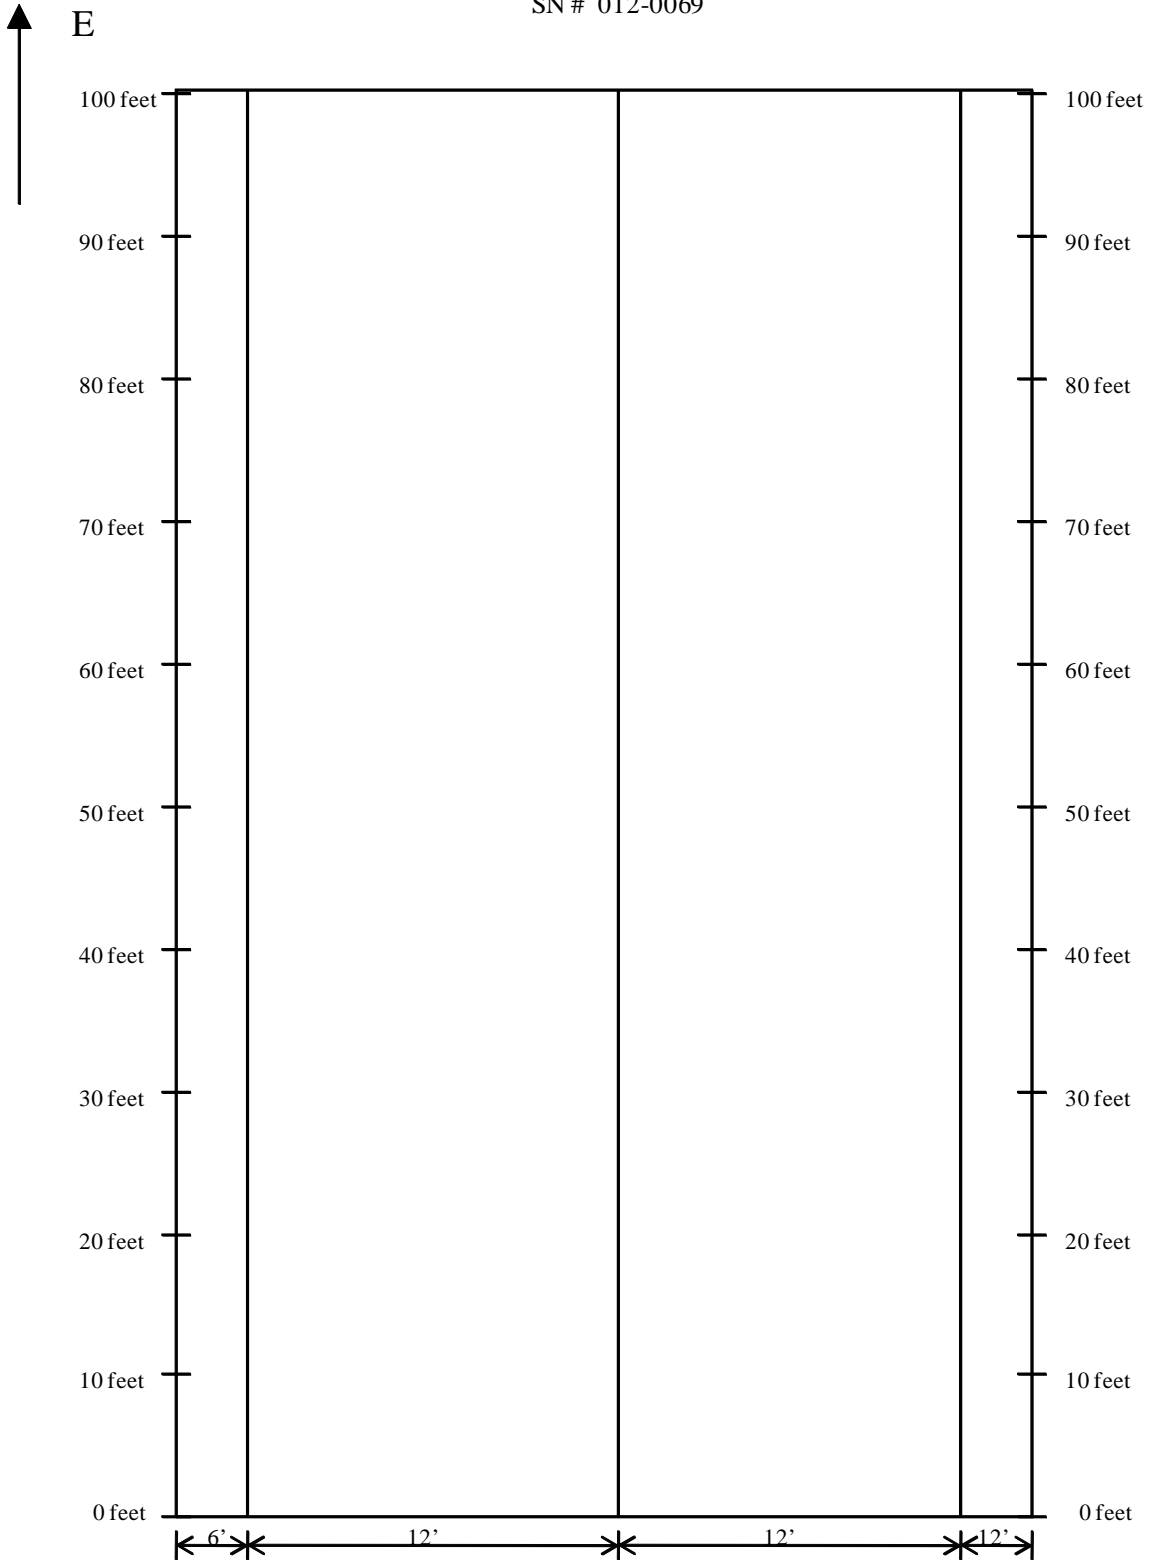
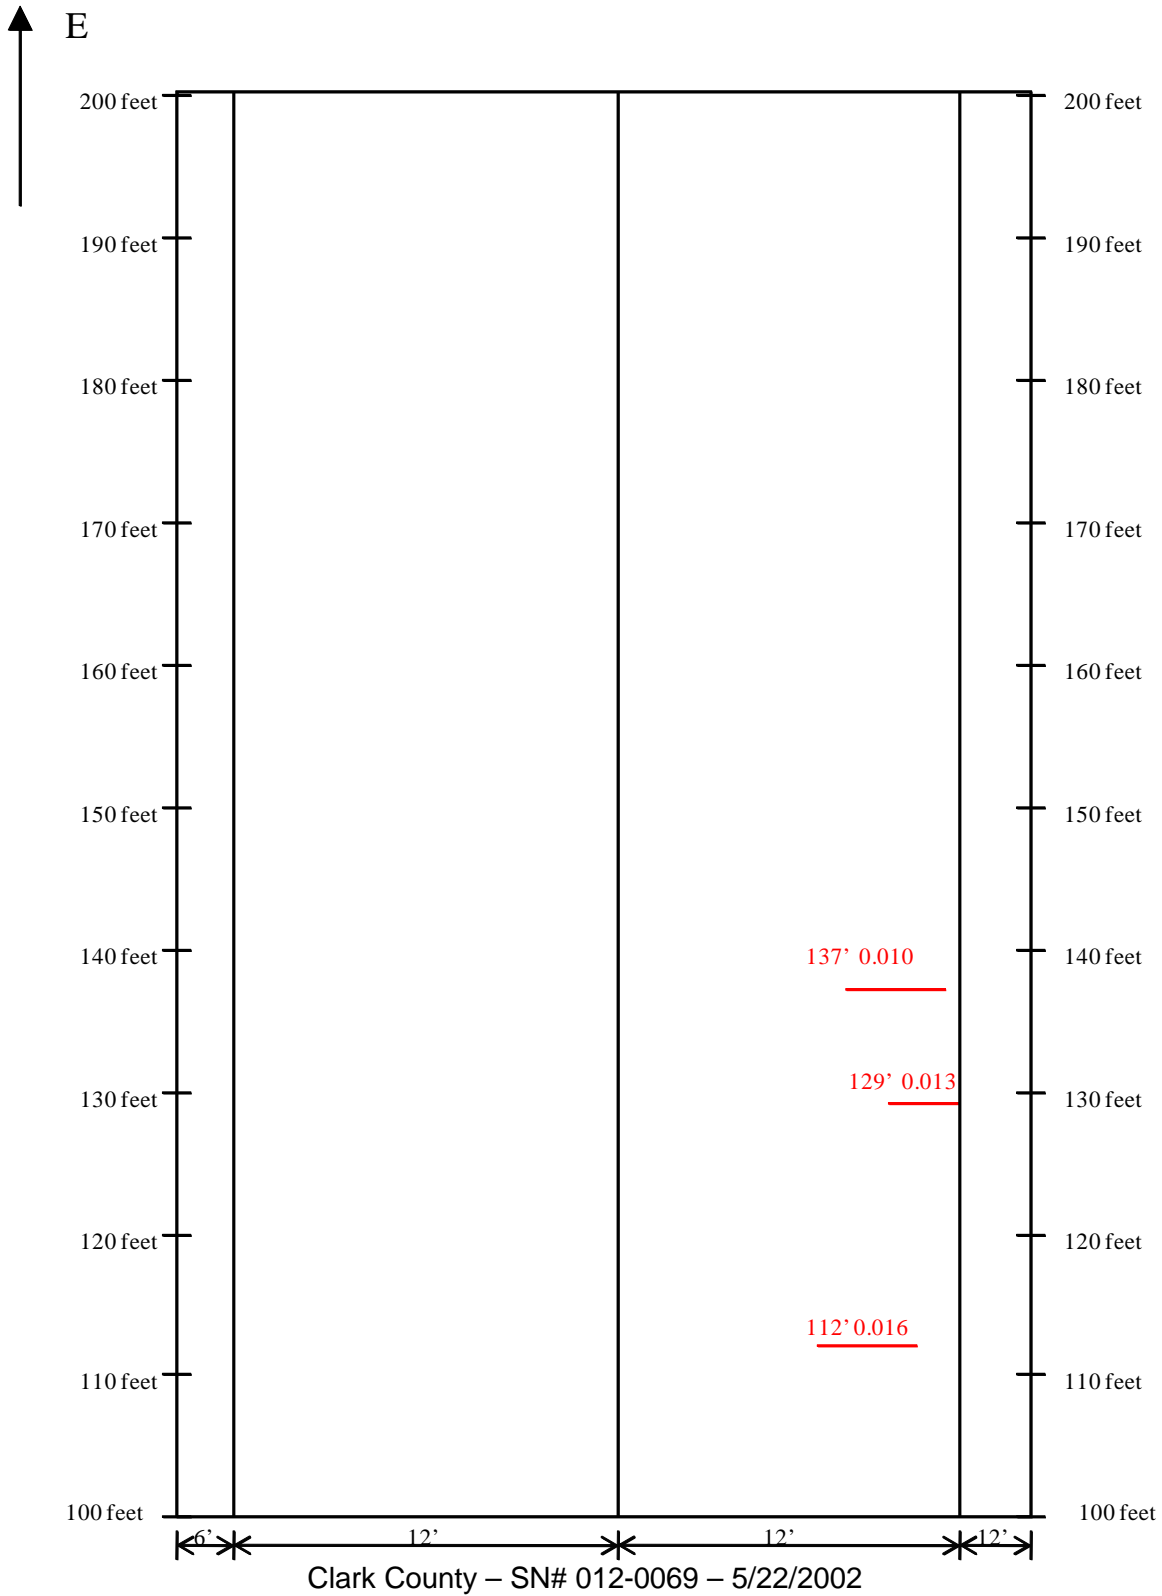
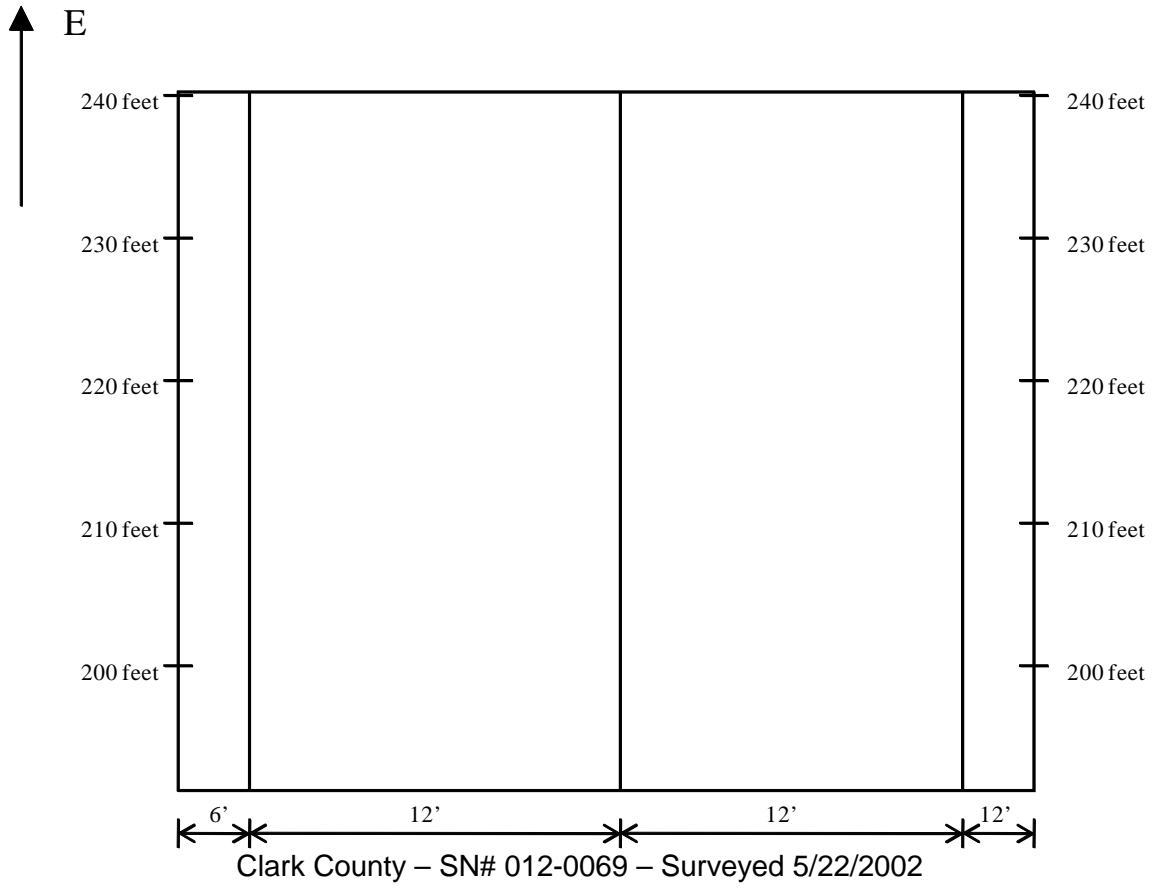
SN # 012-0069

Clark County – SN# 012-0069 – Surveyed 5/22/2002

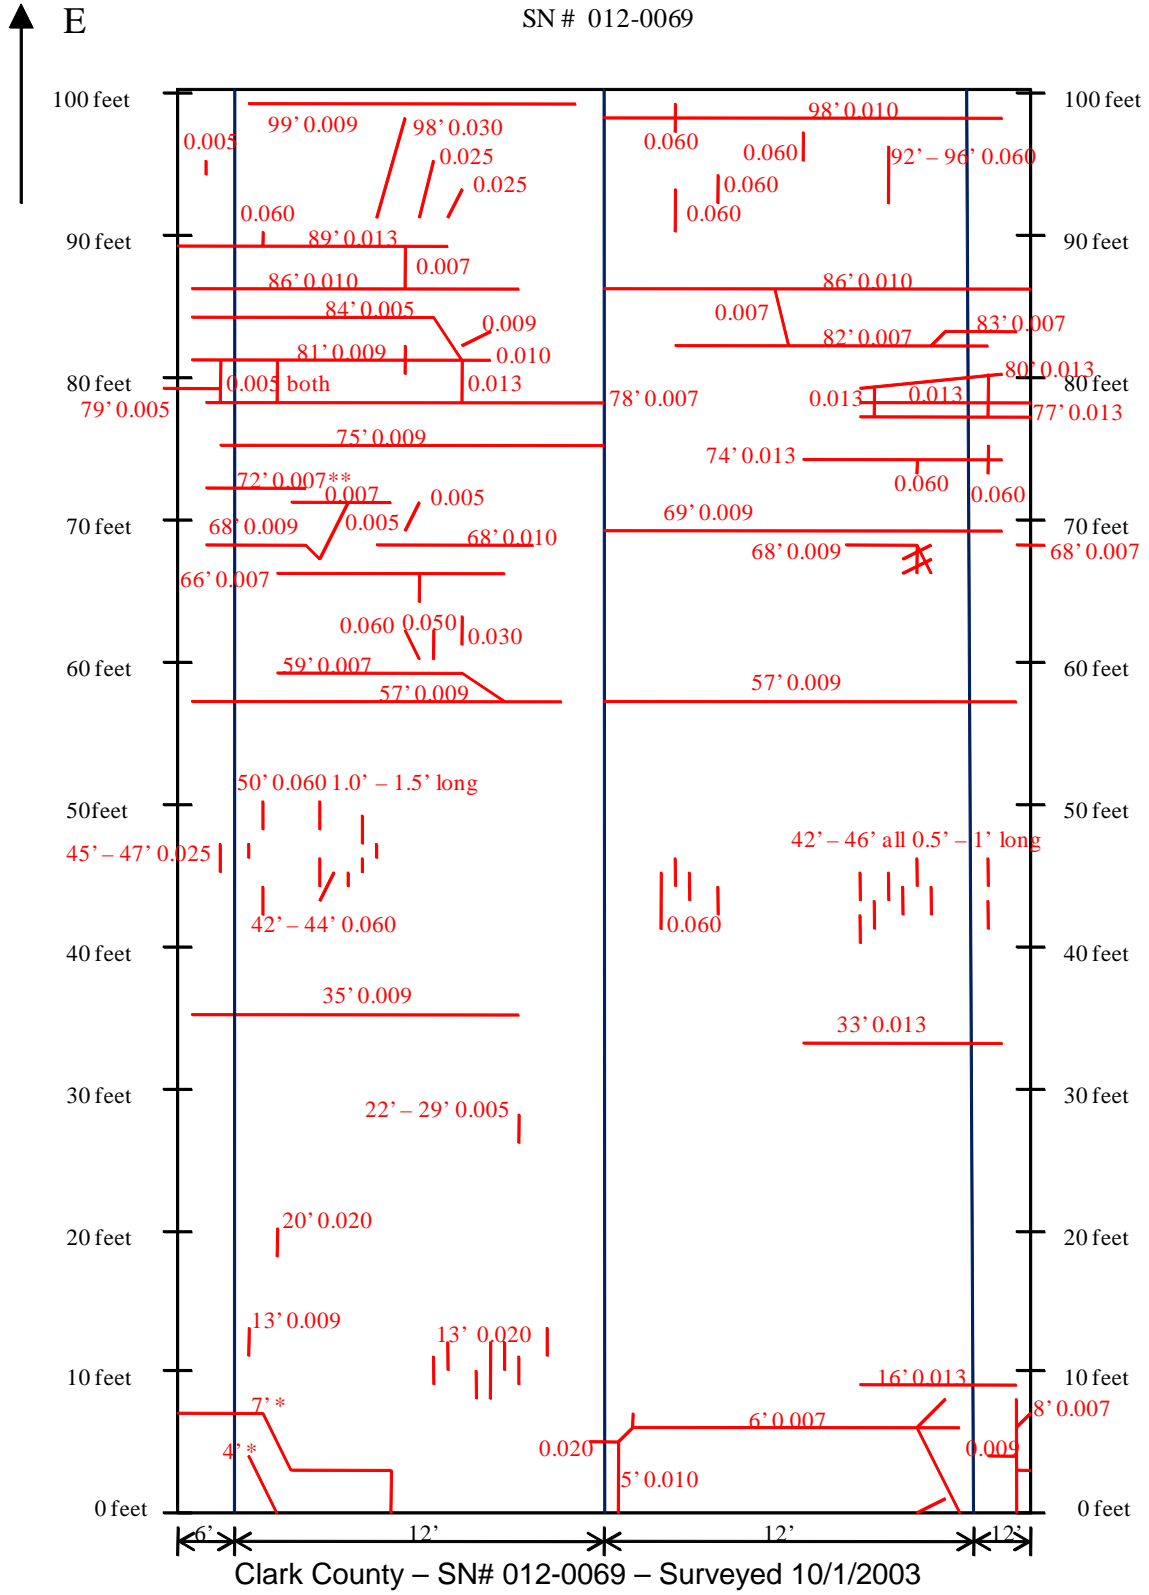
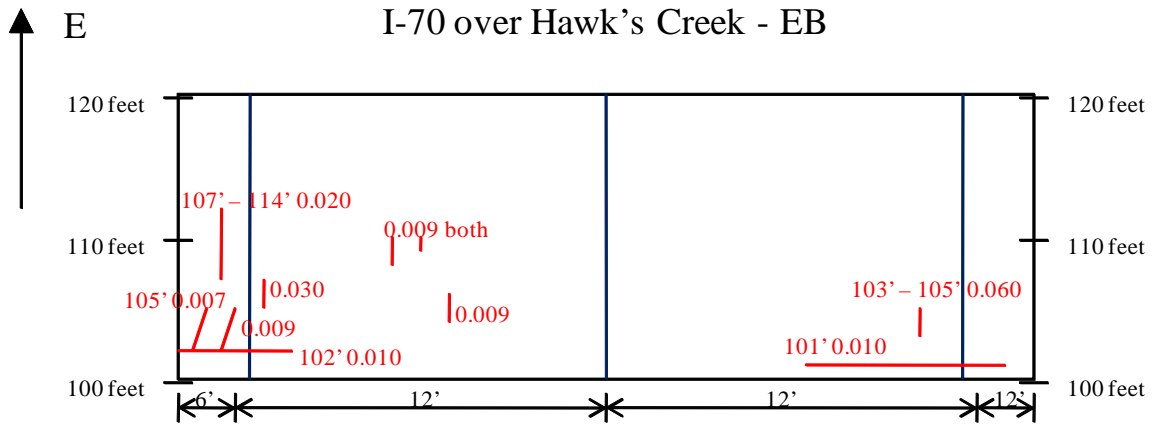
I-70 over Hawk's Creek – EB  
 SN # 012-0069

Clark County – SN# 012-0069 – Surveyed 10/1/2003

This is a partial deck survey due to time constraints and traffic safety concerns.

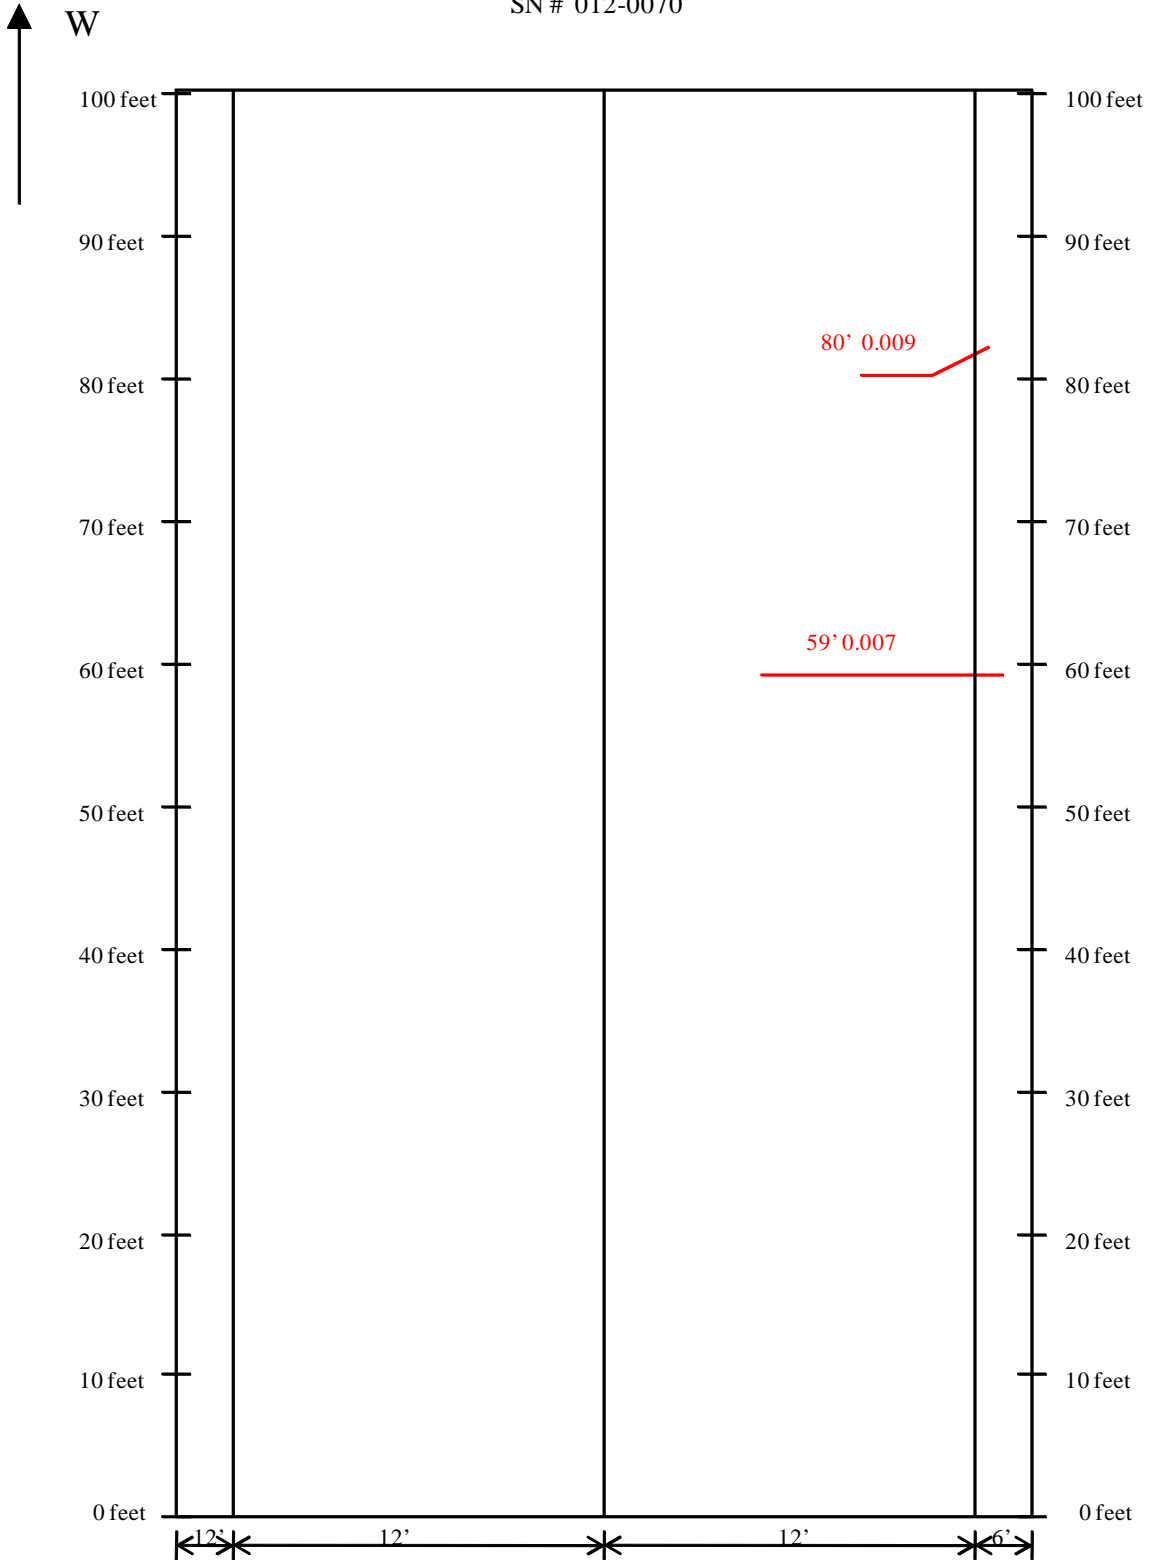
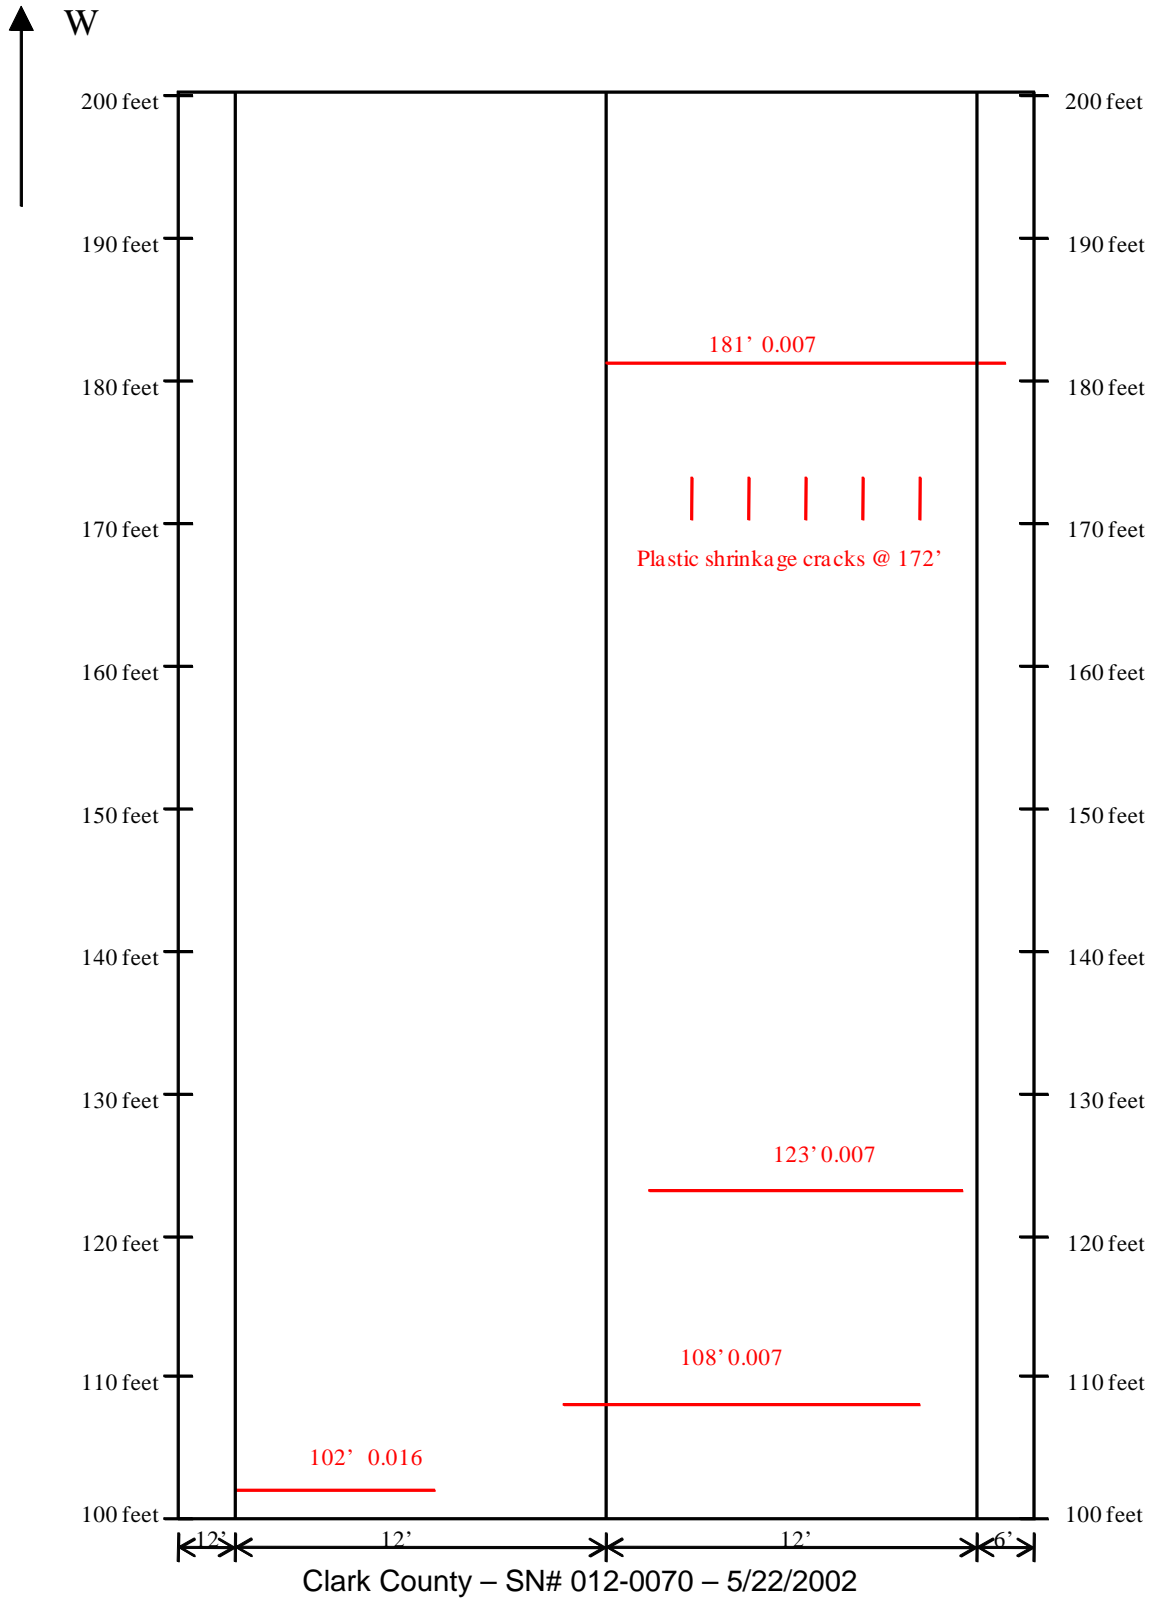
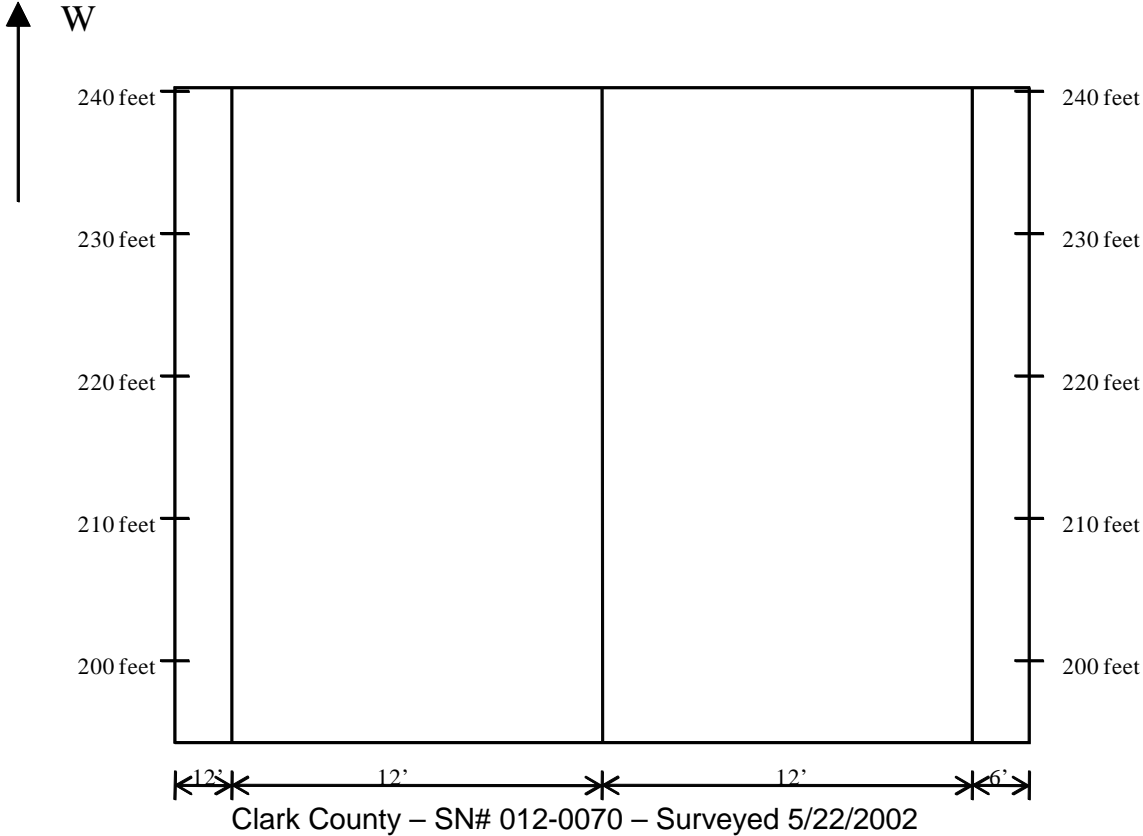
SN # 012-0070

Clark County – SN# 012-0070 – Surveyed 5/55/2002

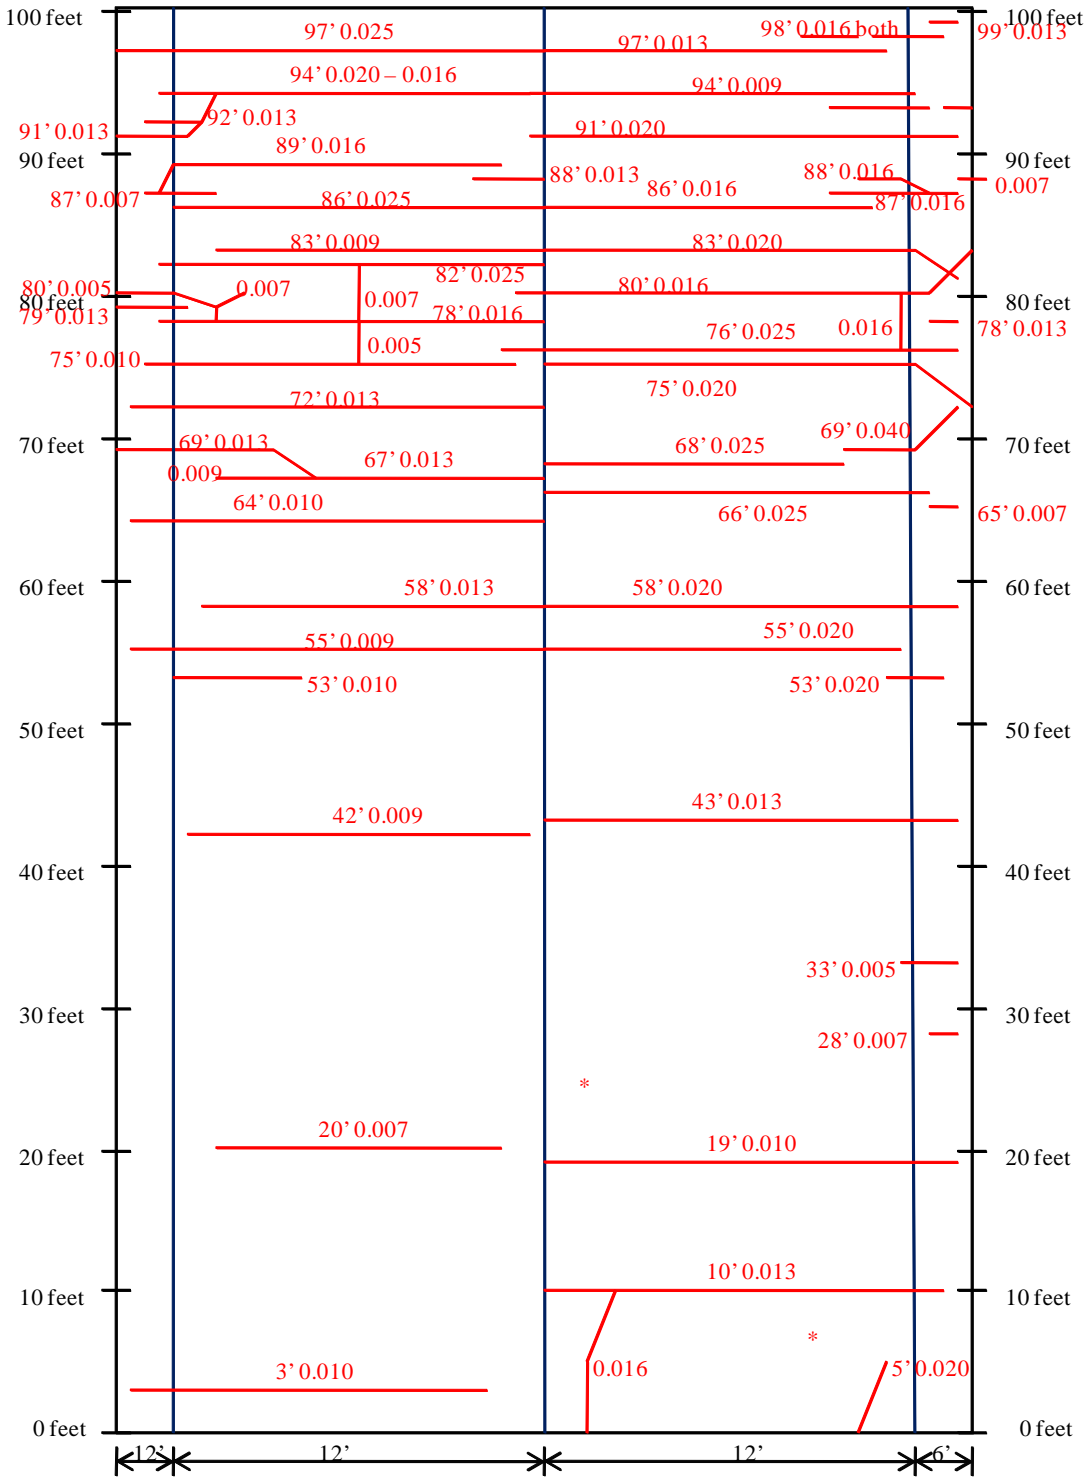
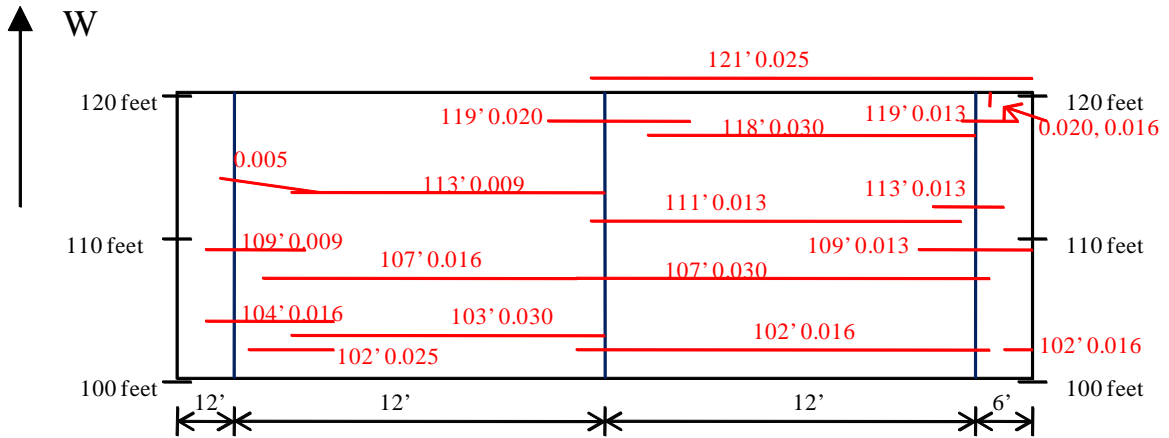
I-70 over Hawk's Creek – WB  
 SN # 012-0070

Clark County – SN# 012-0070 – Surveyed 10/1/2003

This is a partial deck survey due to time constraints and traffic concerns.

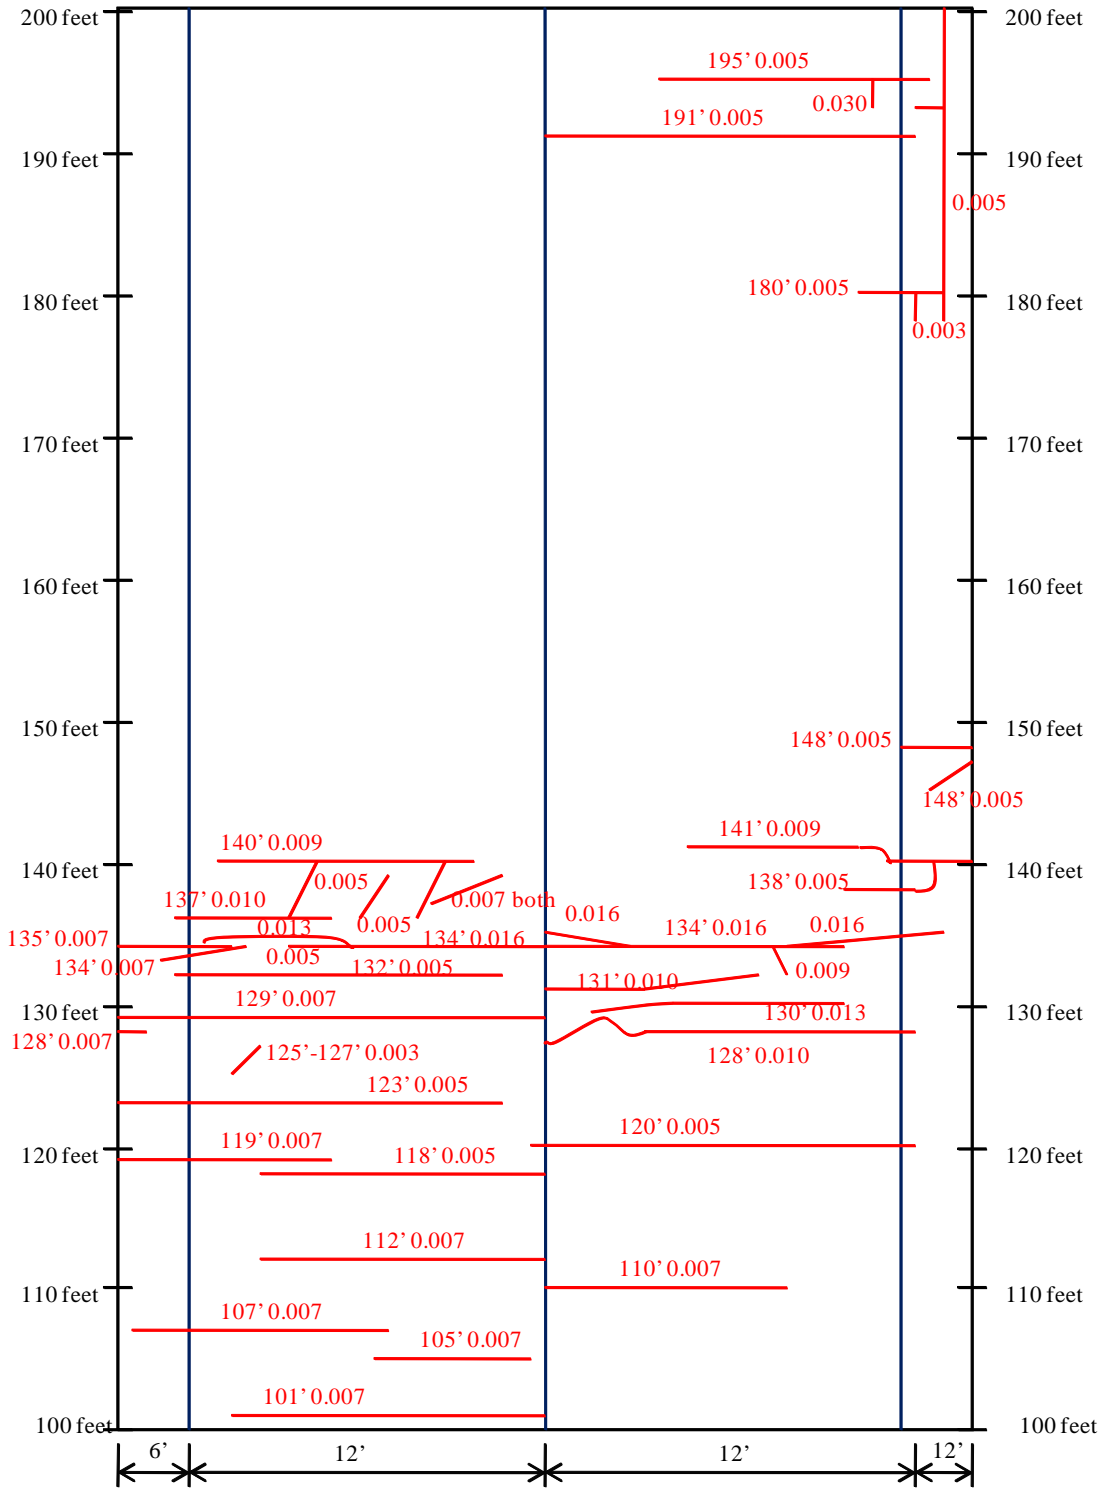
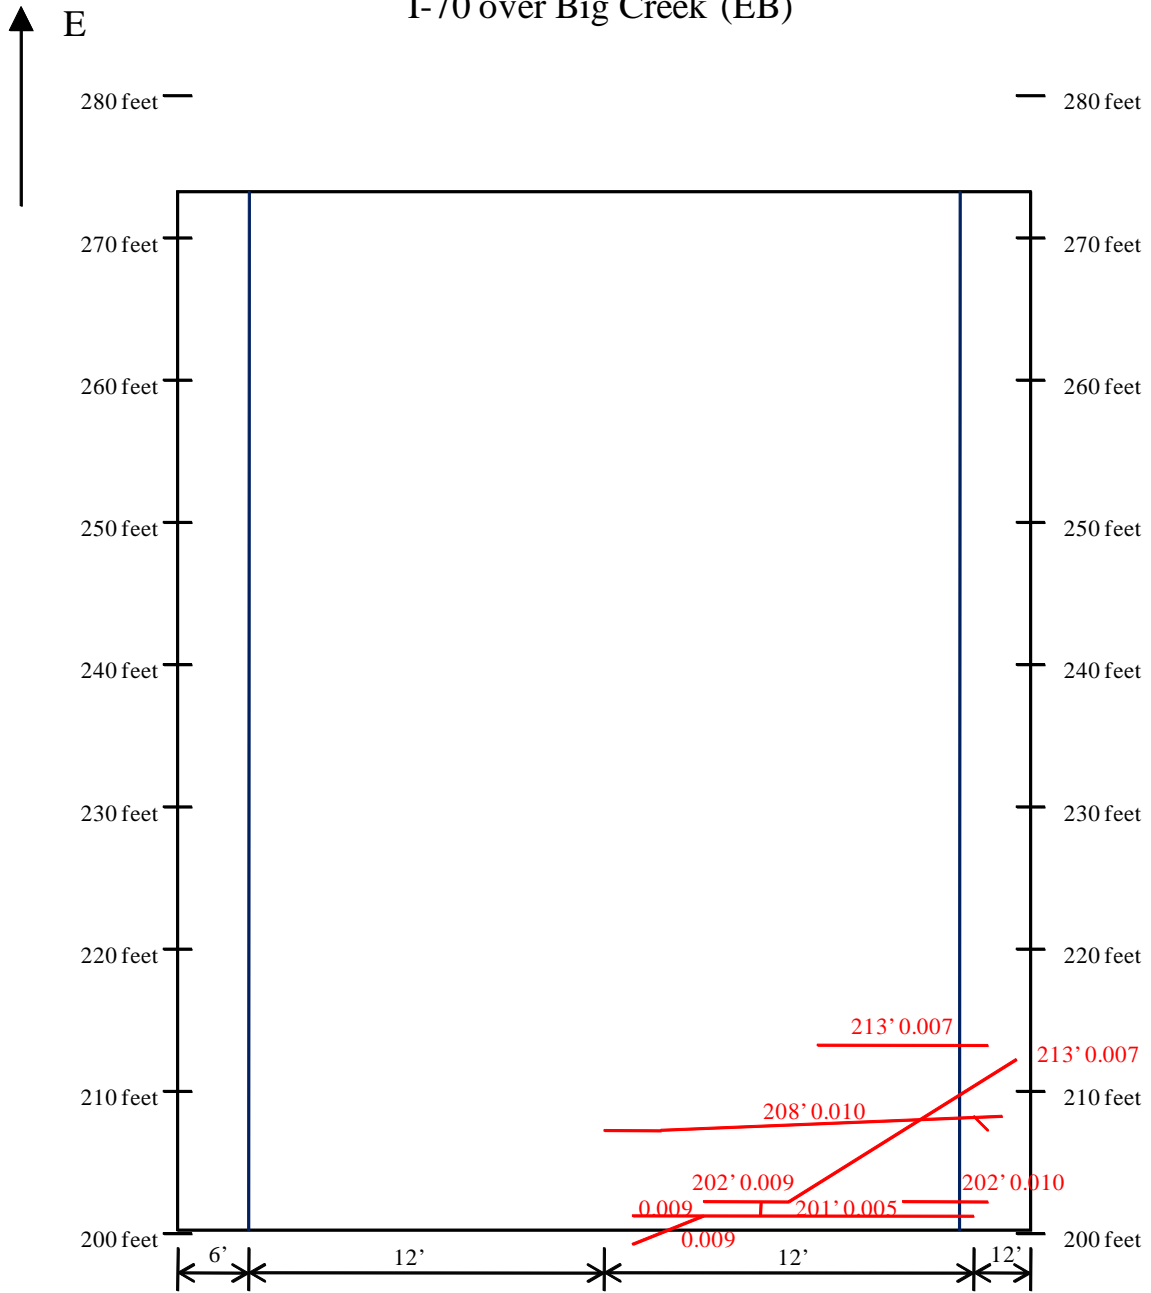
# I-70 over Big Creek (EB)

Clark County – SN# 012-0005 – Surveyed 10/1/2003  
 This survey was a partial survey due to time limitations and traffic safety.  
 a = 0.007 @ 64'; b = 0.009 @ 65'; c = 0.009; d = 0.009
