**EVALUATION OF HIGH PERFORMANCE  
CONCRETE BRIDGE DECKS  
AND  
OTHER EXPERIMENTAL BRIDGE  
DECKS THROUGHOUT ILLINOIS**

**PHYSICAL RESEARCH REPORT NO. 166  
December 2017**

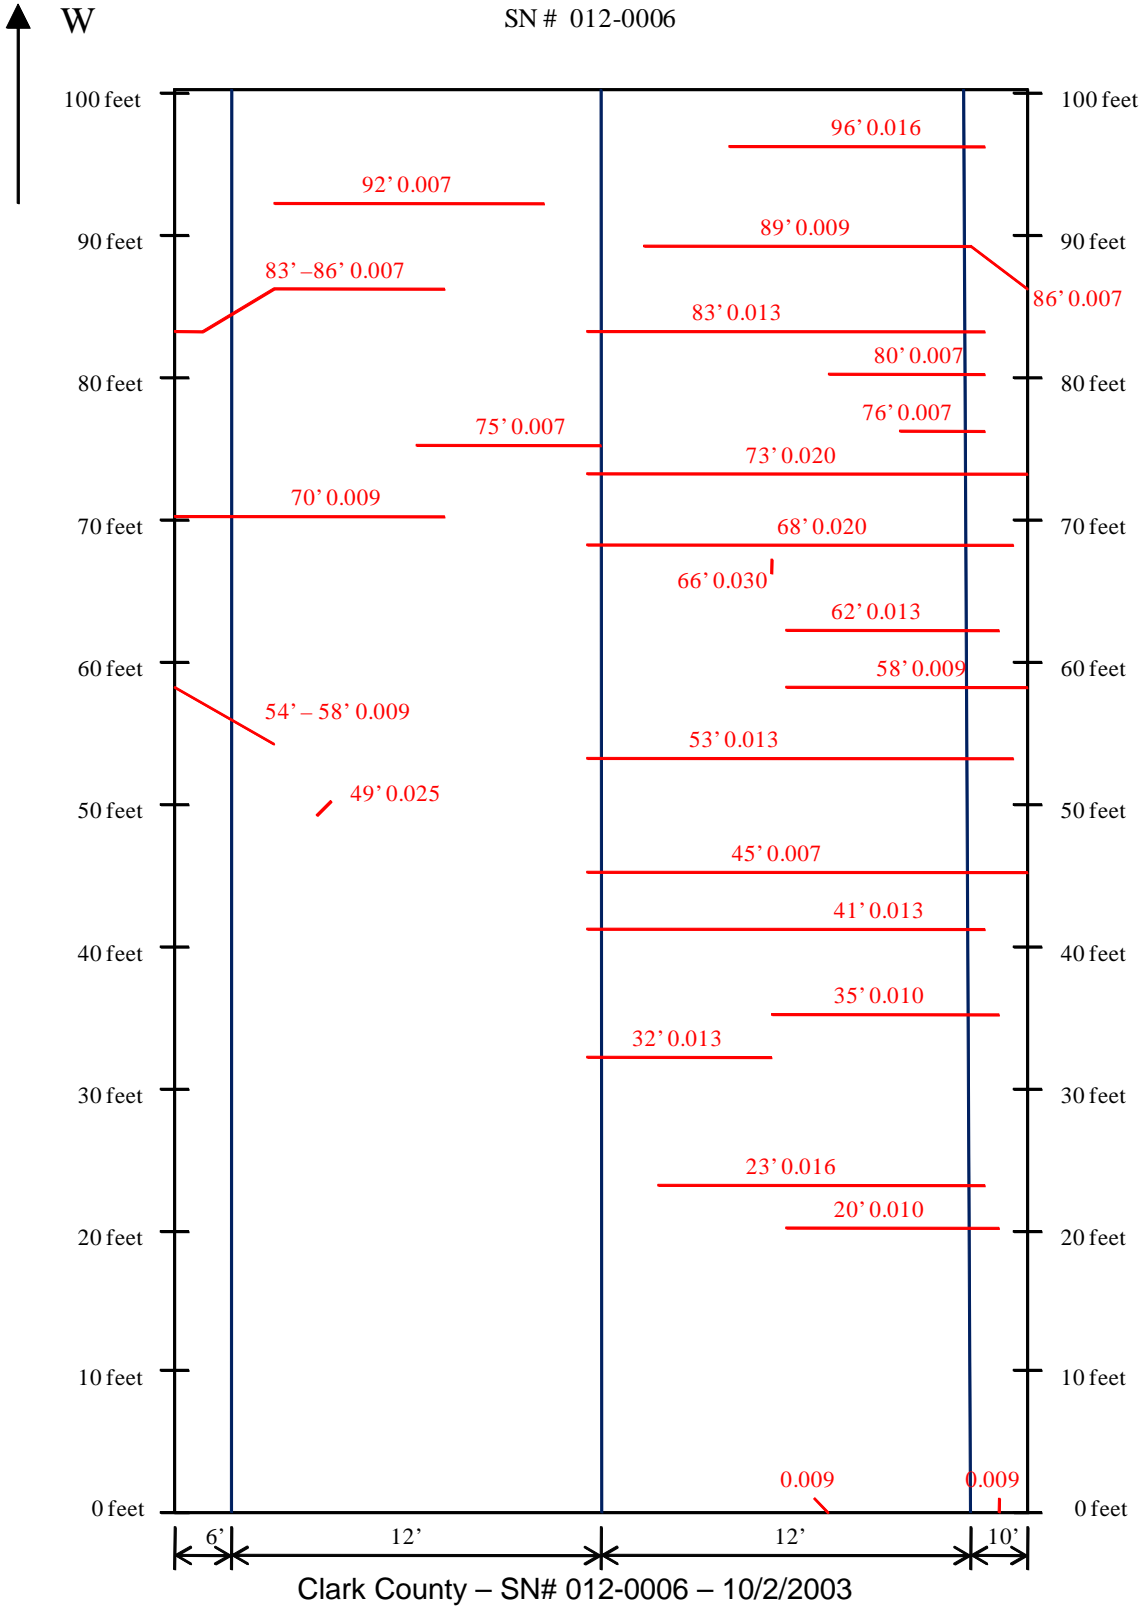
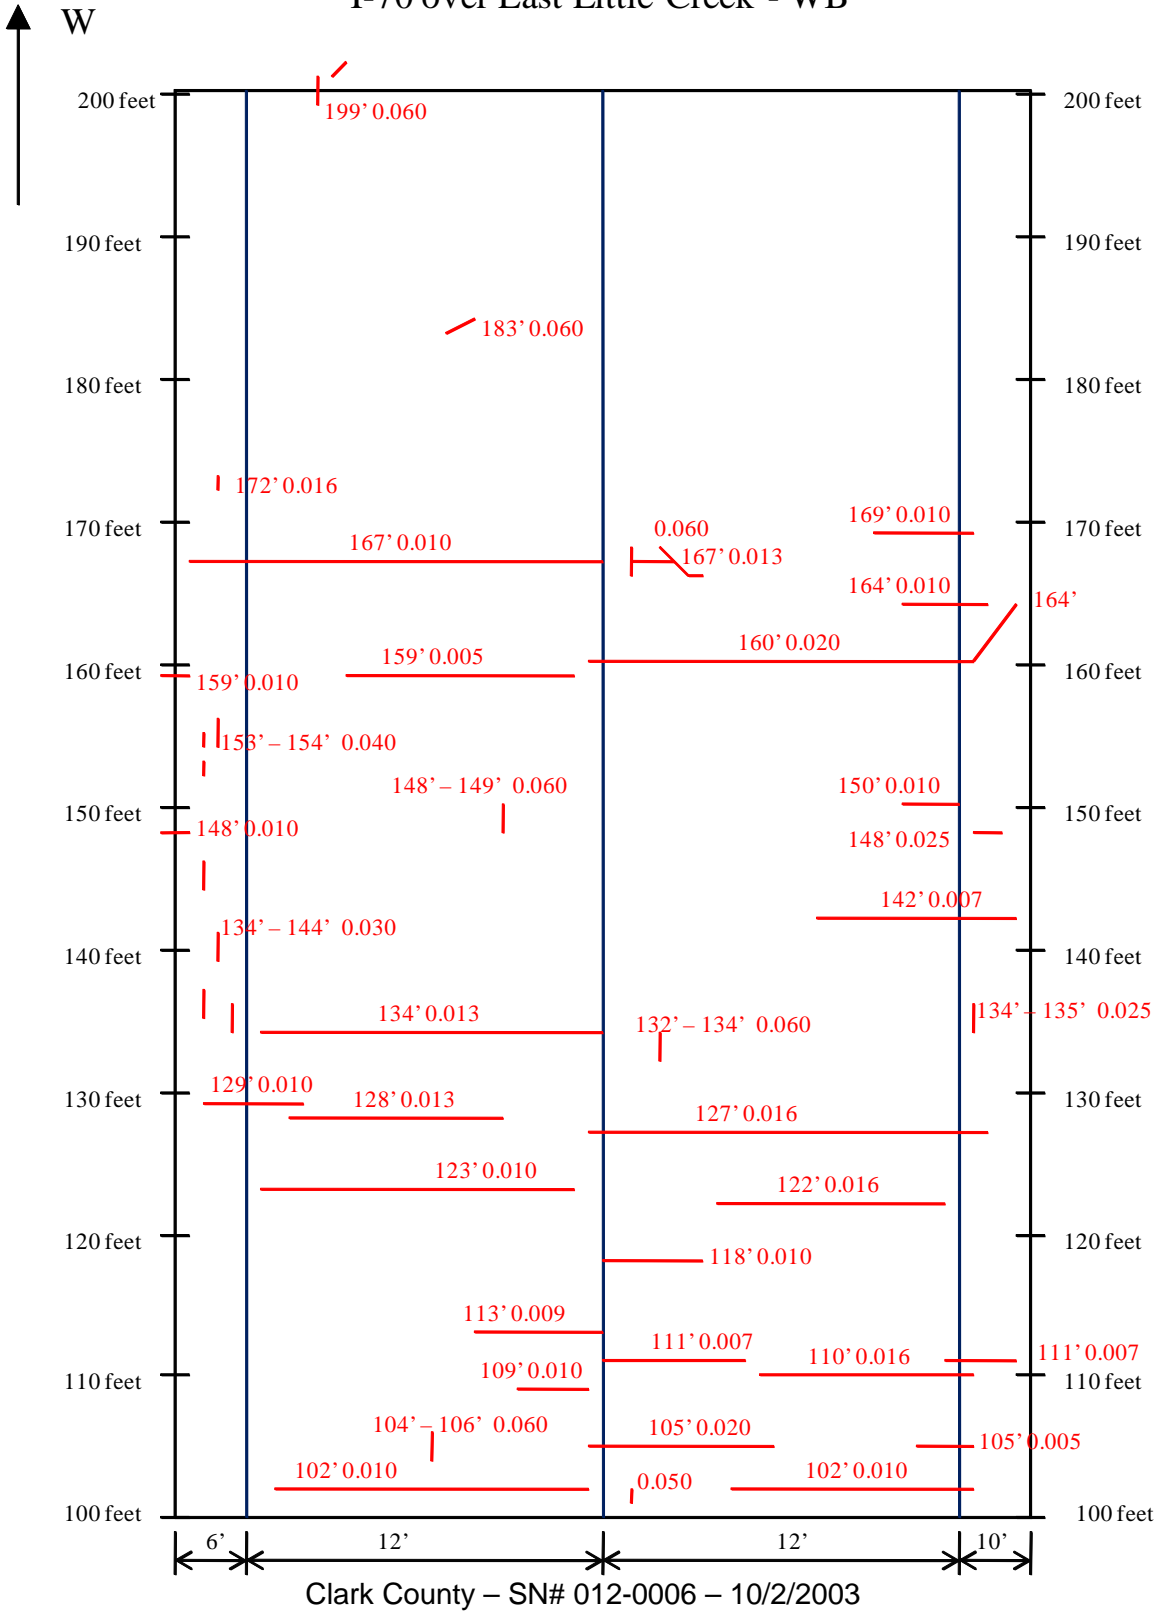
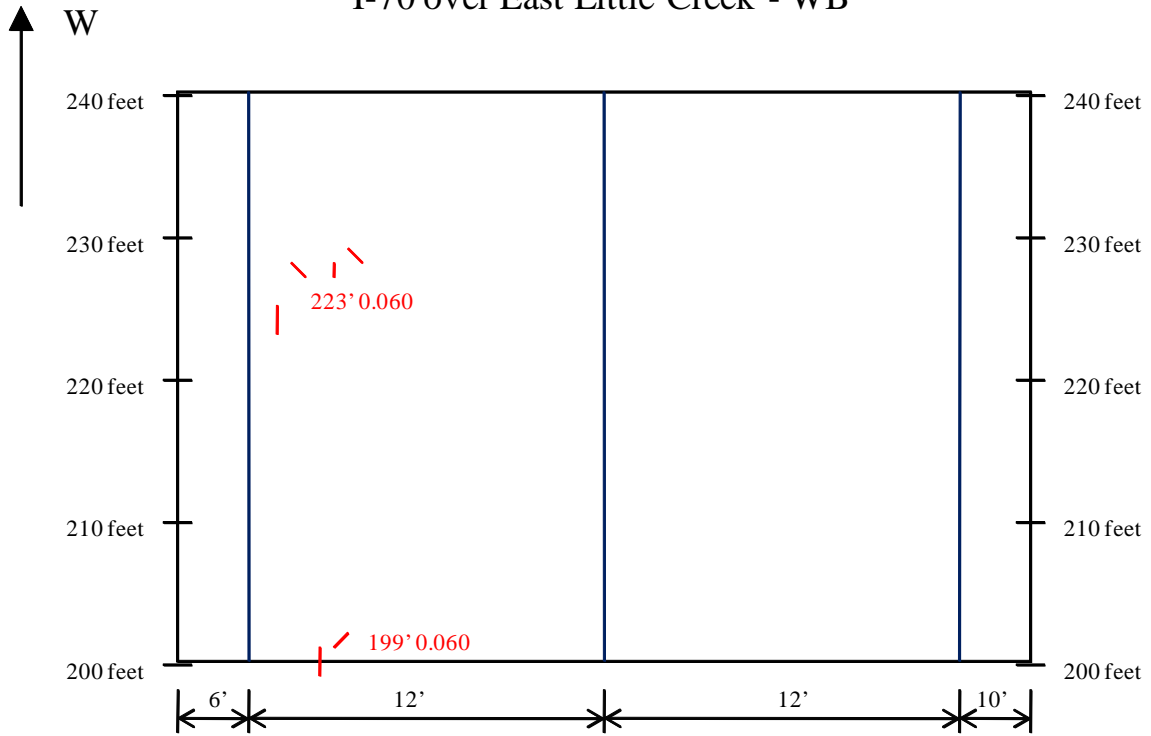
I-70 over East Little Creek – WB  
 SN # 012-0006

Clark County - SN# 012-0006 - Surveyed 10/2/2003

This is a partial deck survey due to time constraints and traffic safety concerns.

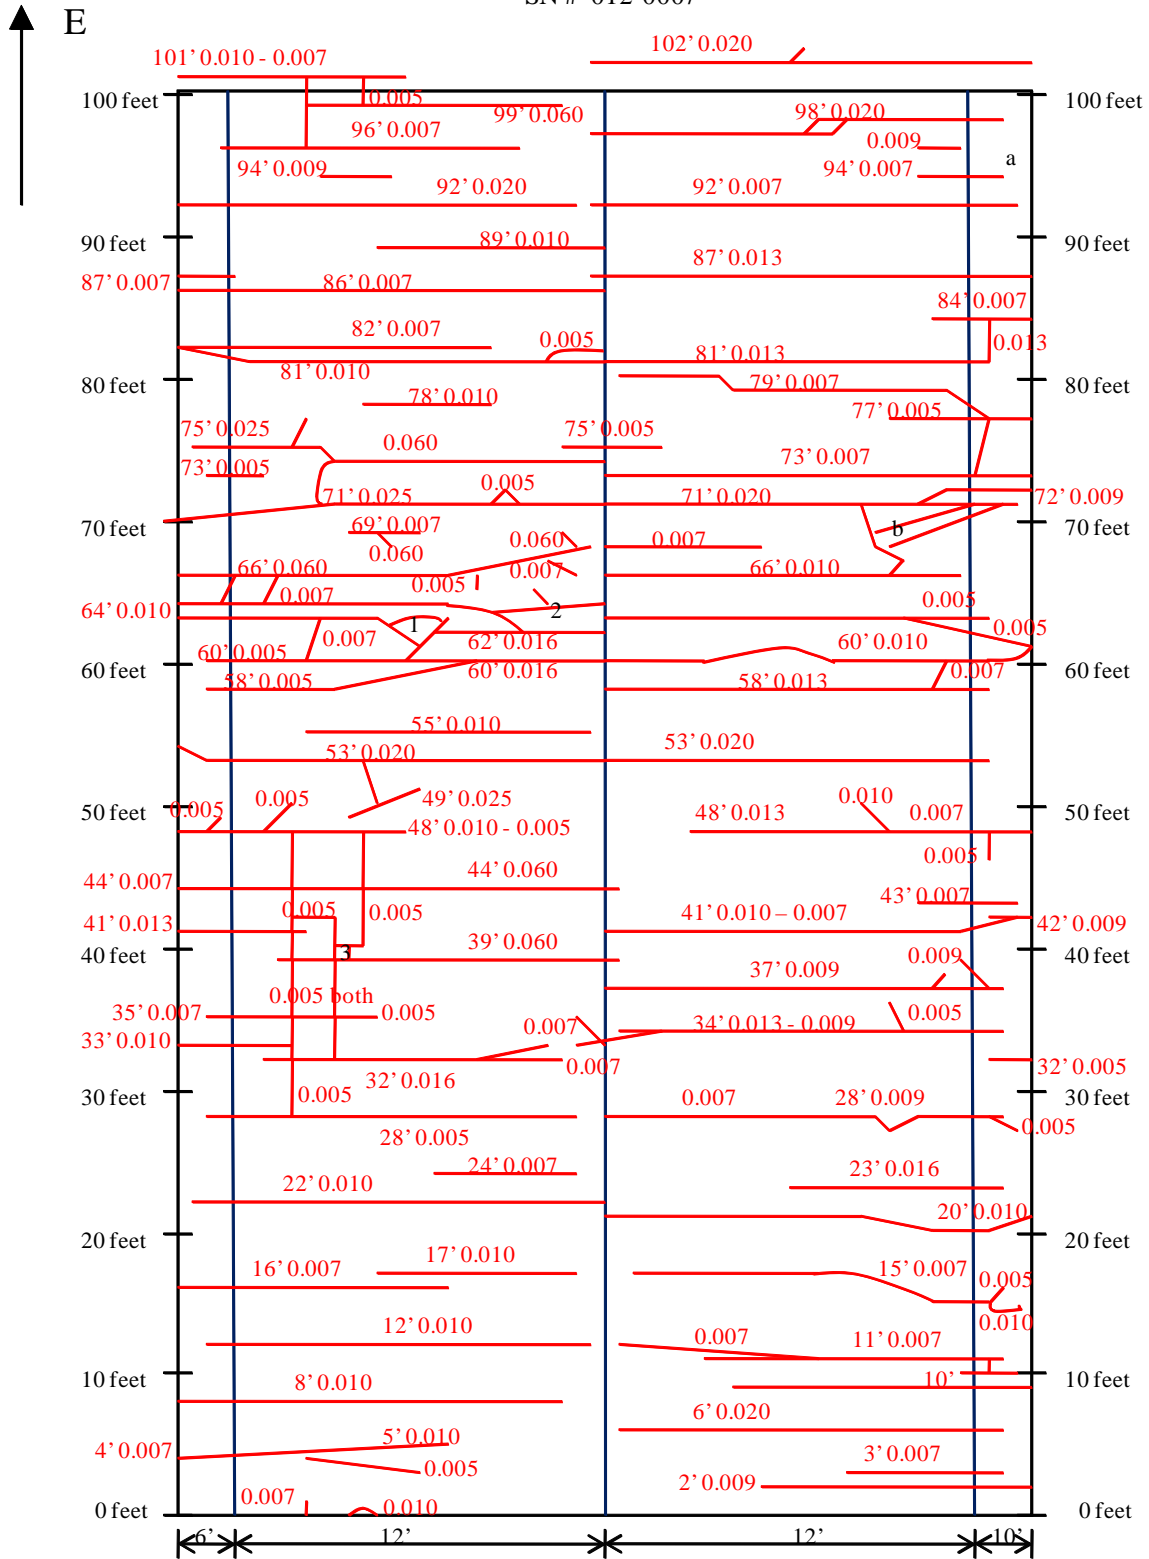
I-70 over E. Little Creek – EB  
SN # 012-0007

Clark County – SN# 012-0007 – Surveyed 10/1/2003

This is a partial deck survey due to time constraints.

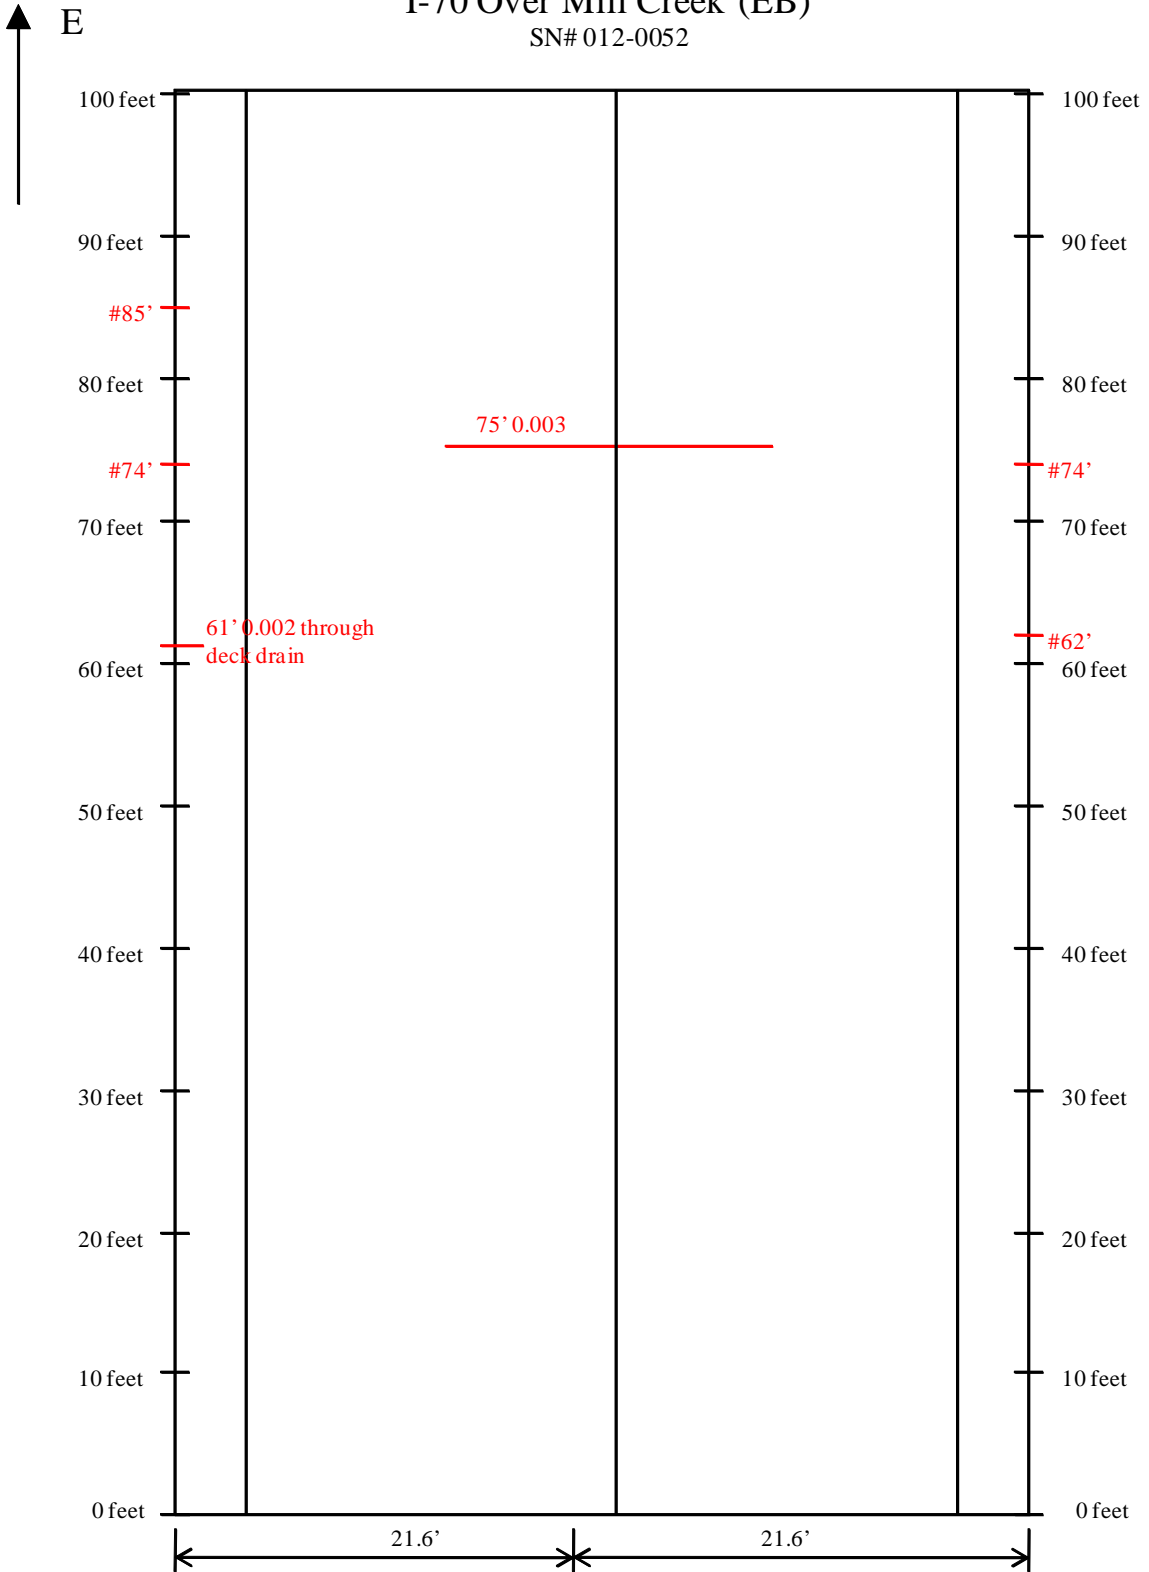
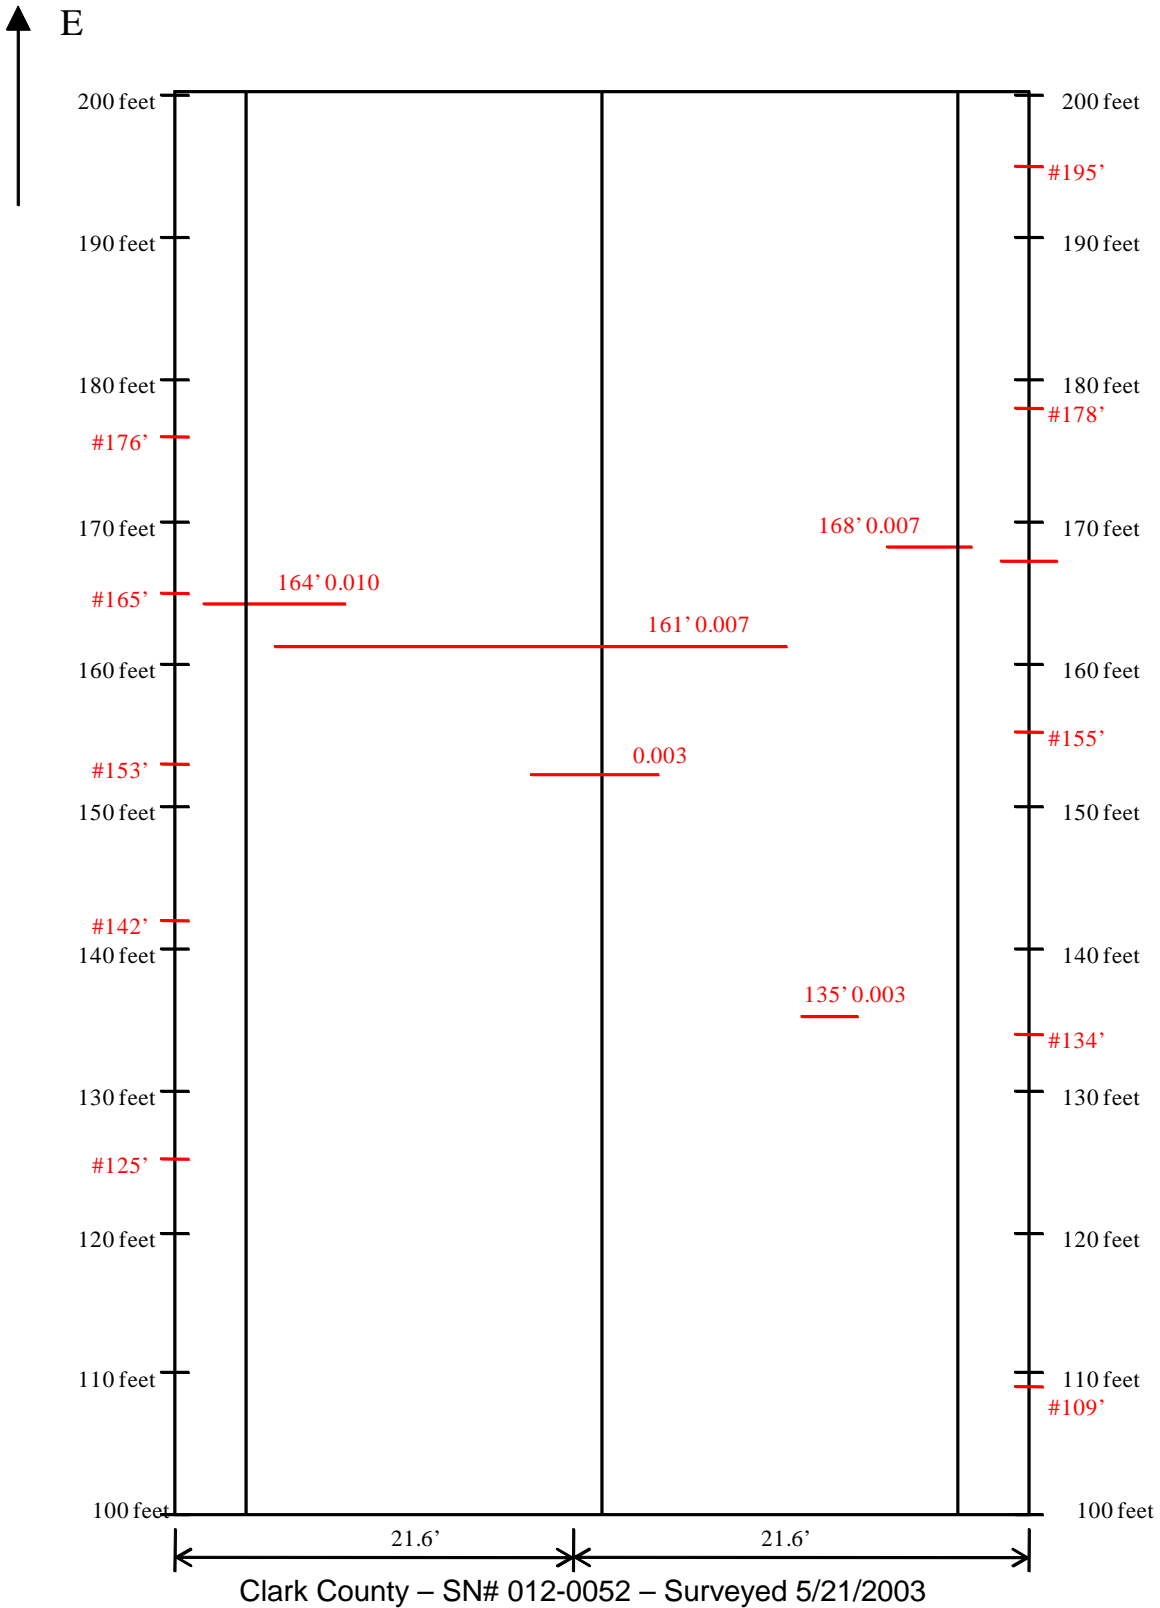
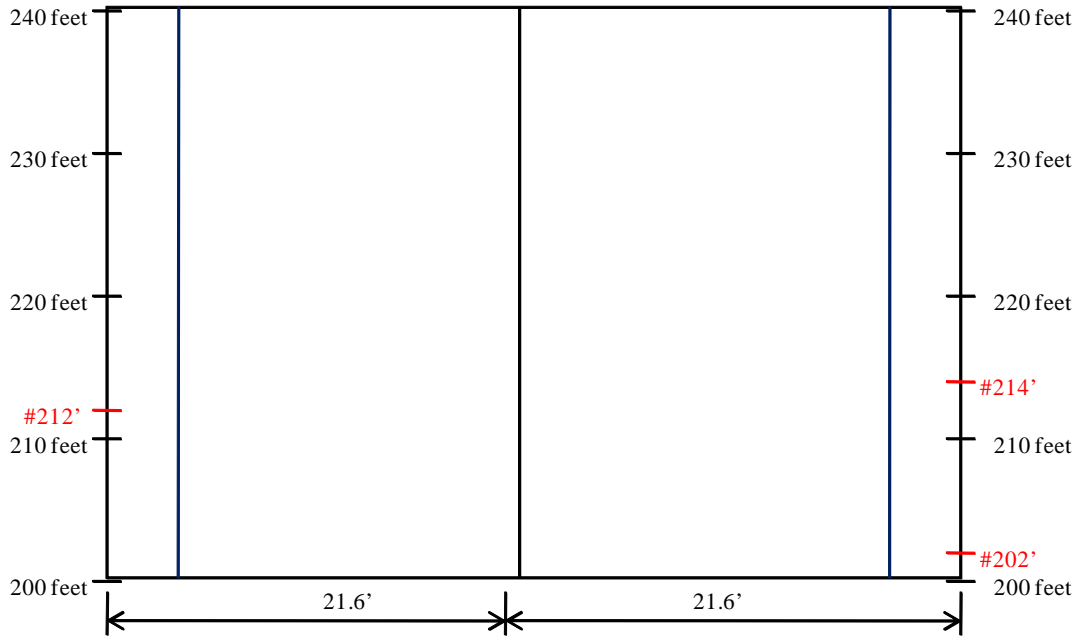
I-70 Over Mill Creek (EB)  
SN# 012-0052

Clark County – SN# 012-0052 – Surveyed 5/21/2003  
The “#” symbol represents cracks in the parapet only.

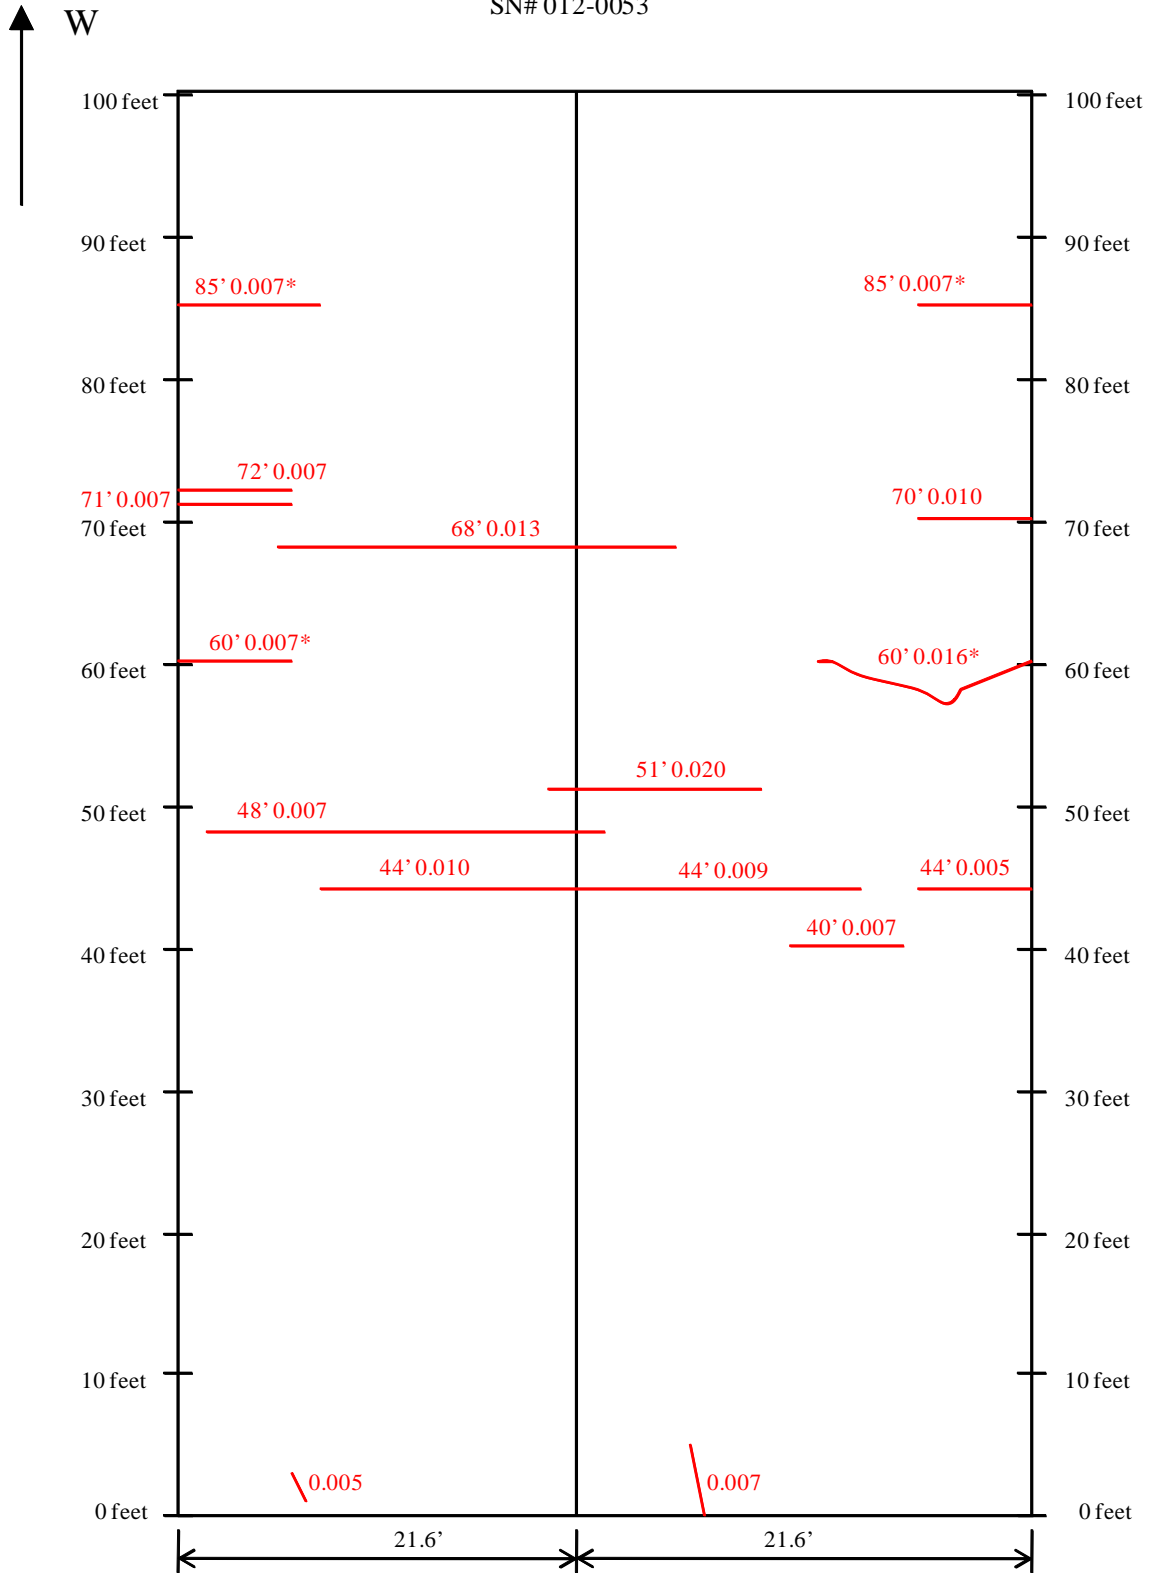
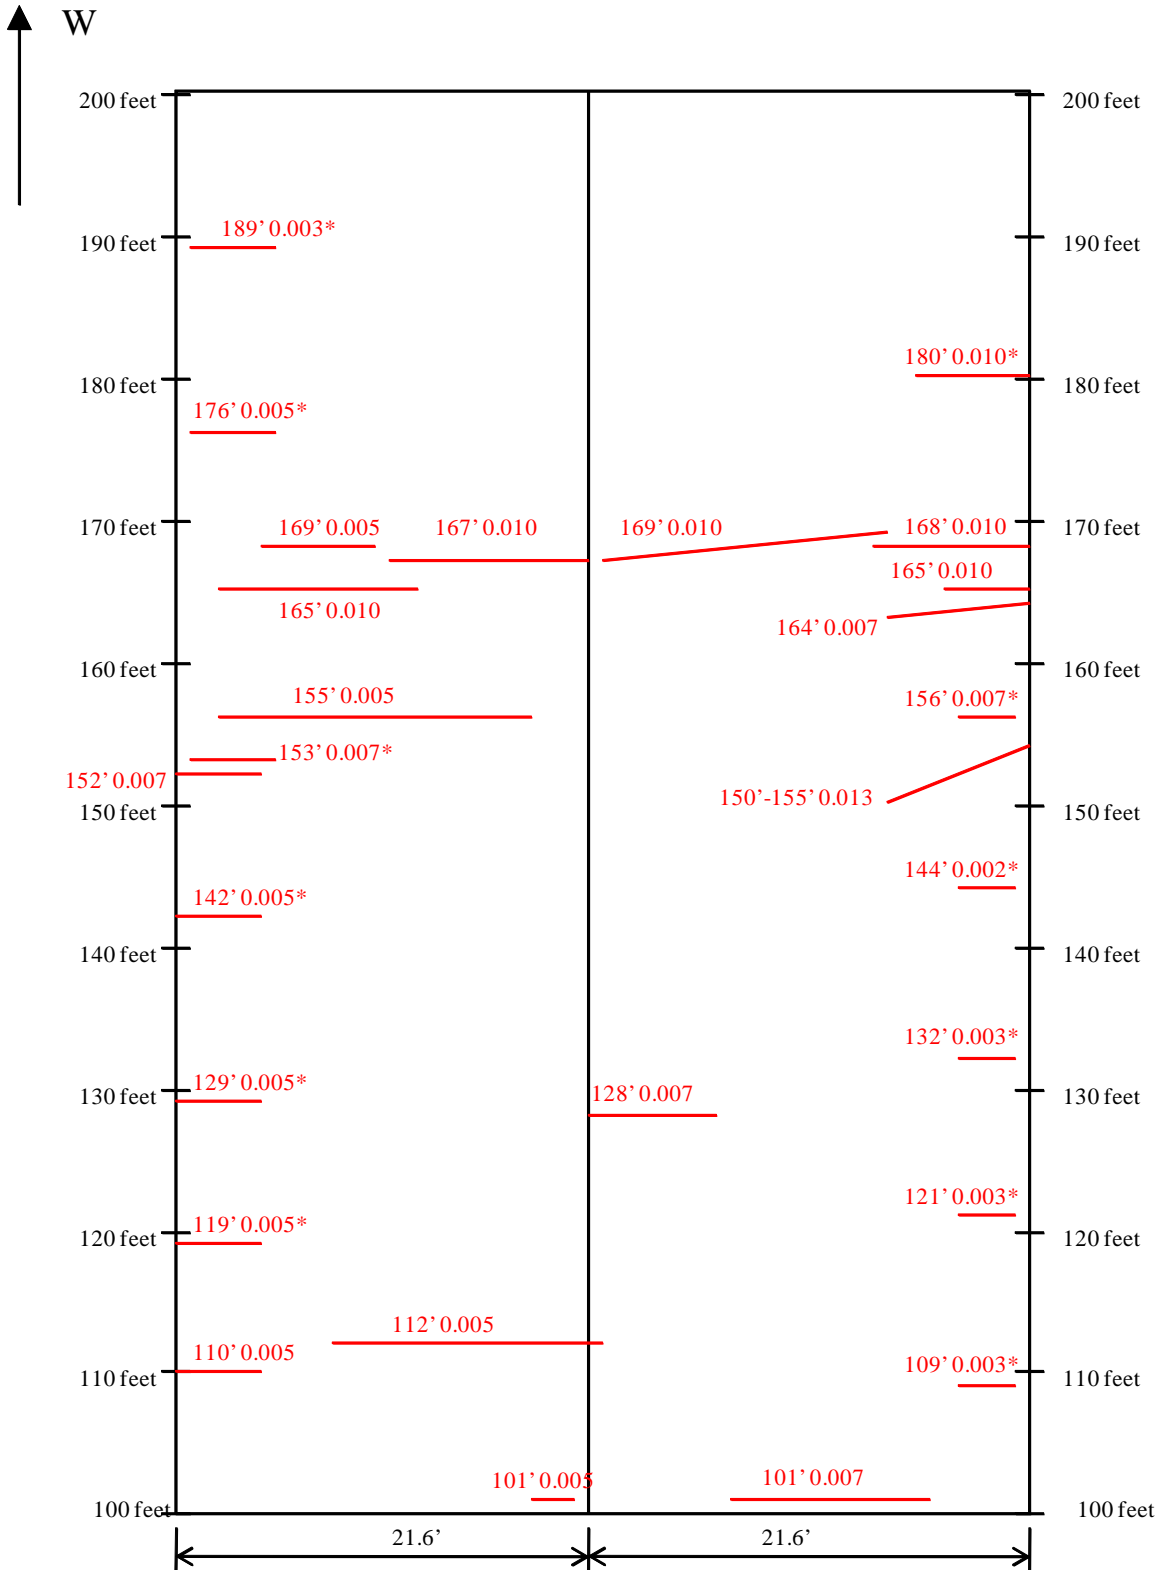
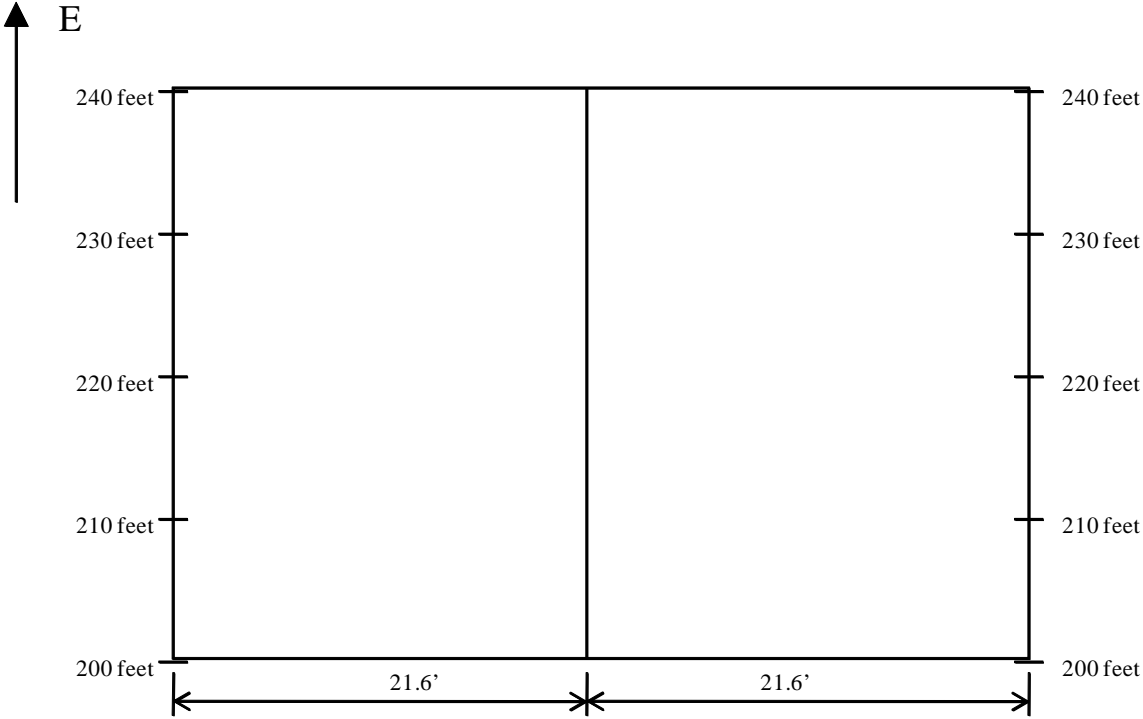
I-70 Over Mill Creek (WB)  
SN# 012-0053

Clark County – SN# 012-0053 – Surveyed 10/1/2003

\* Crack traversed through deck drain.

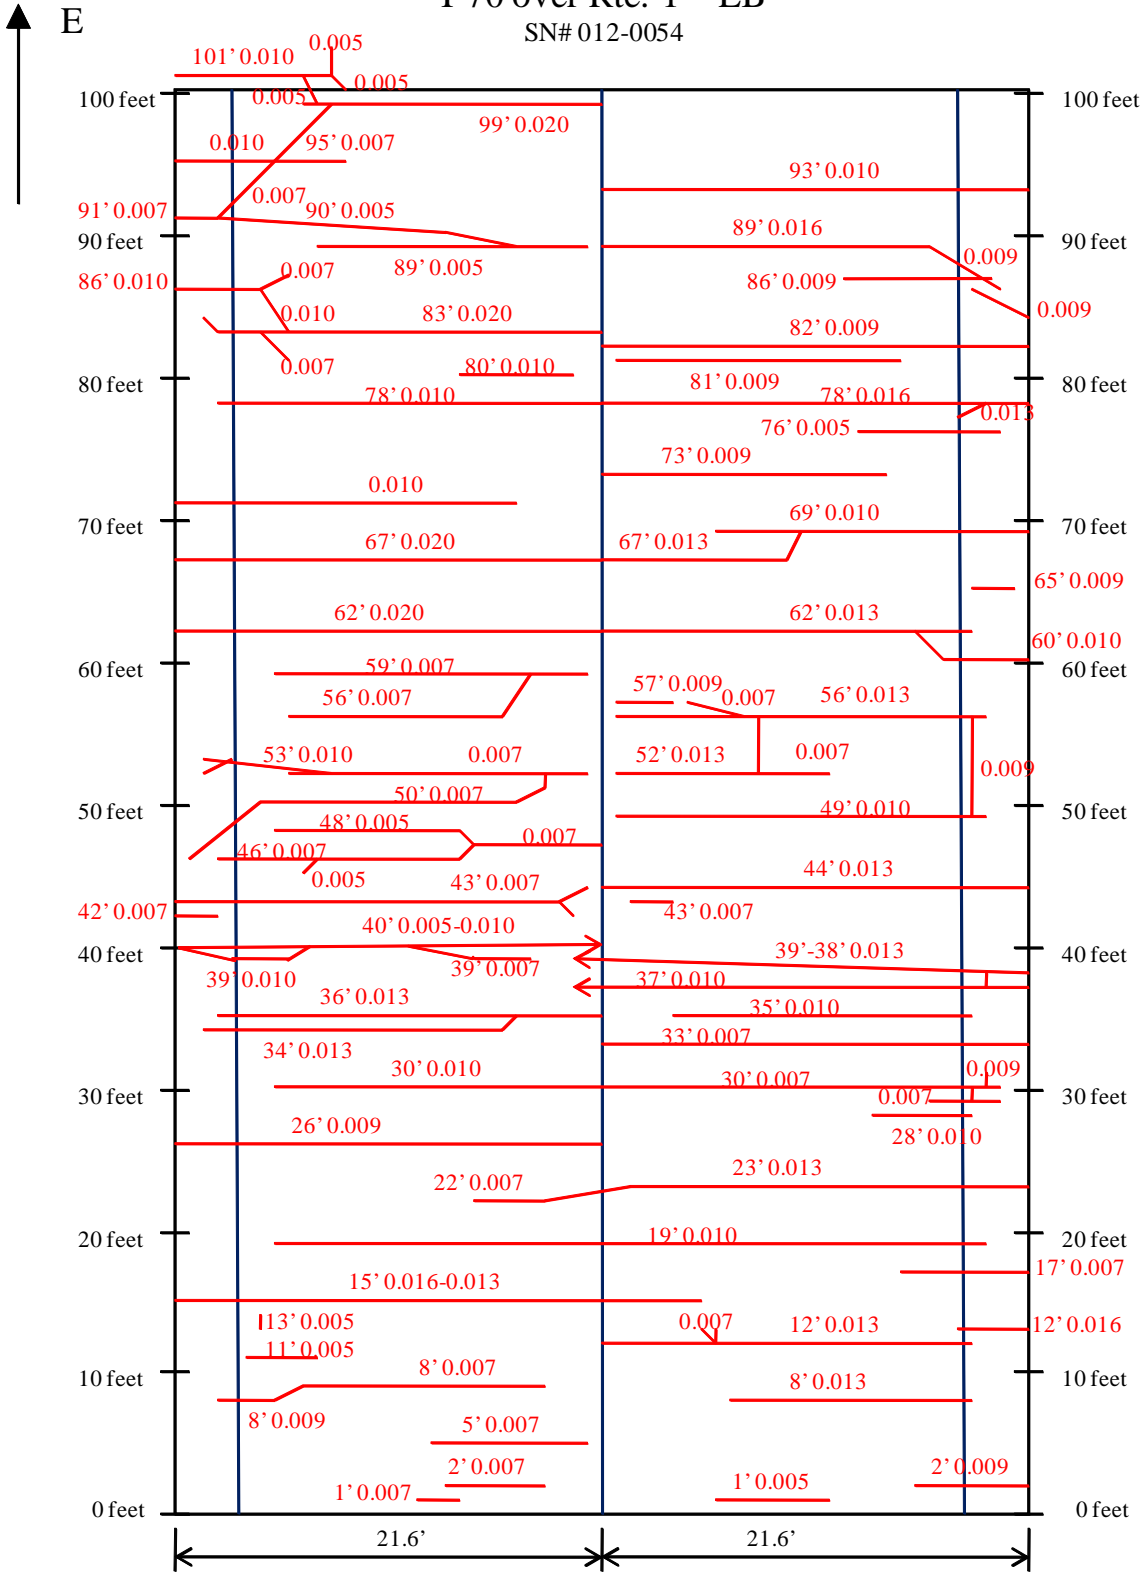
I-70 over Rte. 1 – EB  
SN# 012-0054

Clark County – SN# 012-0054 – Surveyed 10/1/2003

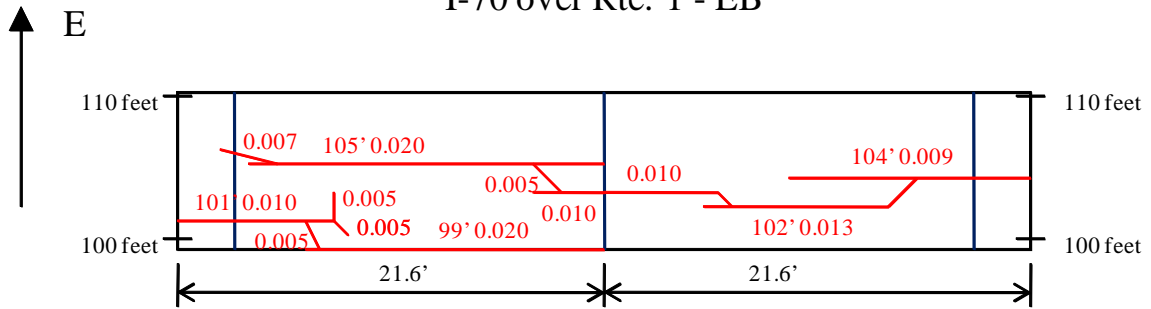
# I-70 over Rte. 1 - EB

Clark County – SN# 012-0054 – Surveyed 10/1/2003

The southwest corner was chipped off.

This was a partial deck survey due to time constraints and traffic conditions.

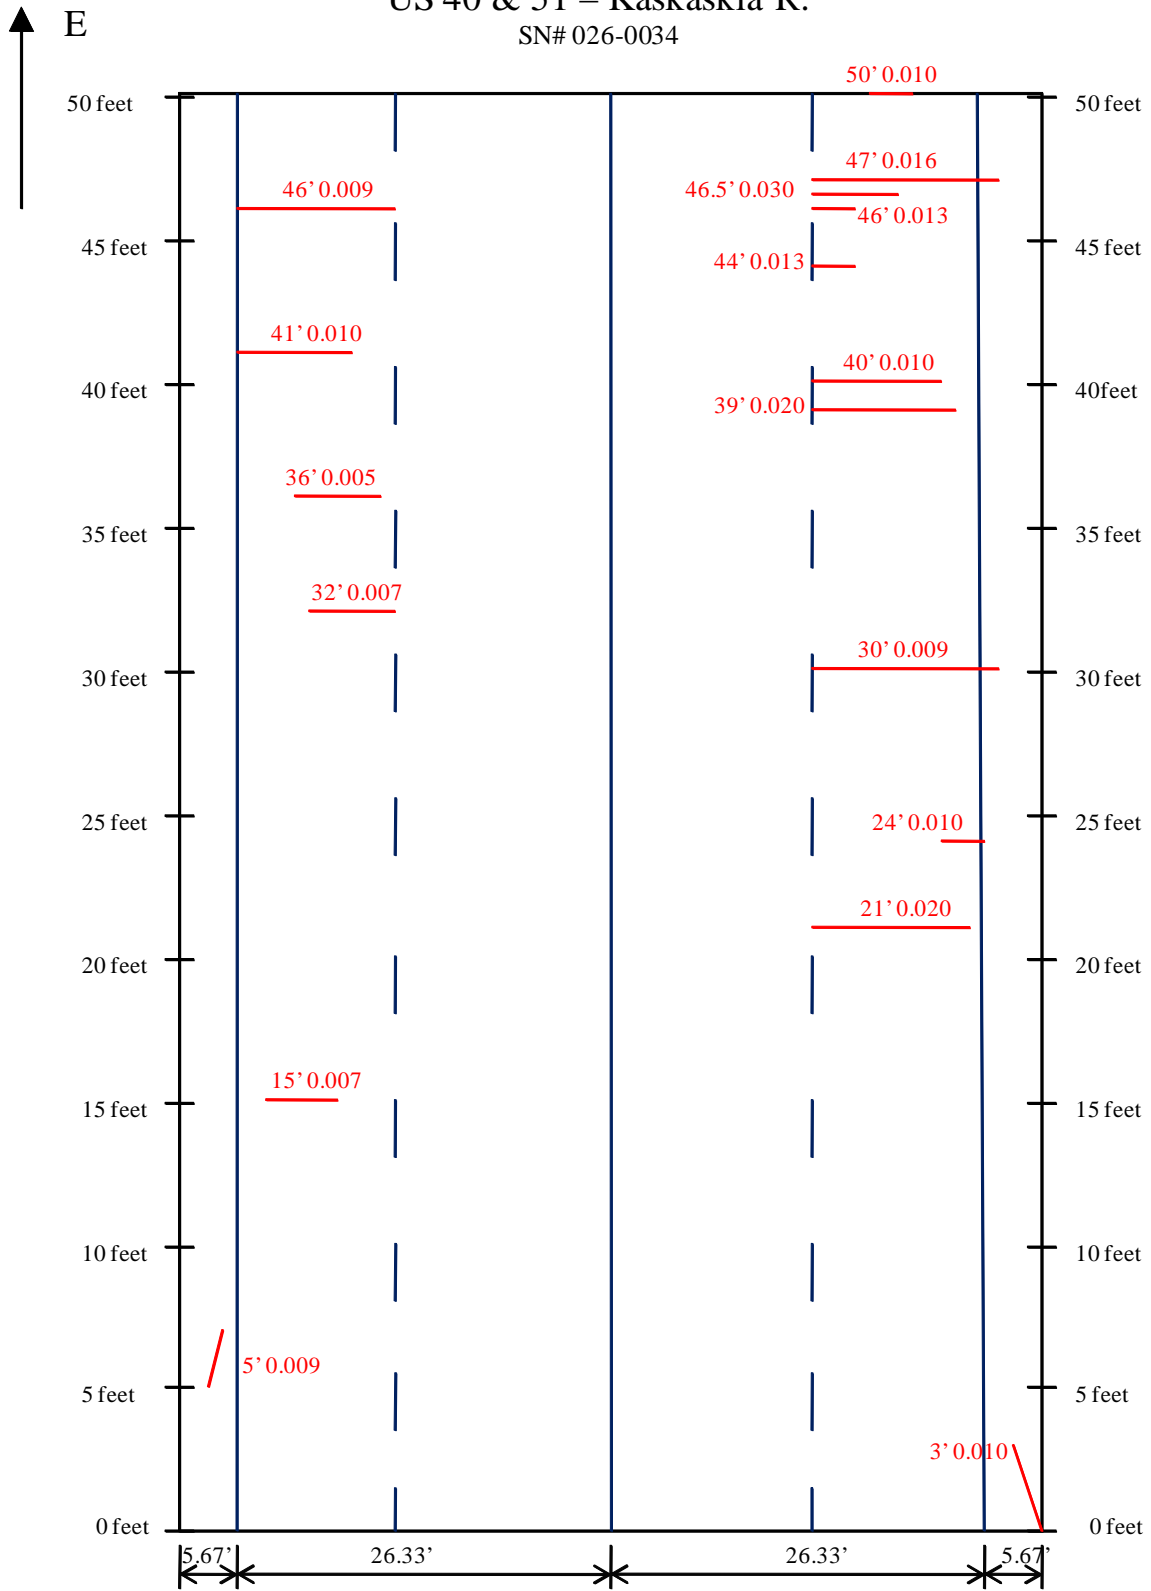
US 40 & 51 – Kaskaskia R.  
SN# 026-0034

Fayette County – SN# 026-0034 – Surveyed 11/14/2002, 12/12/2002  
 This bridge deck was surveyed on November 14, 2002, fulfilling a 28 day survey requirement.  
 This bridge deck was surveyed on December 12, 2002.  
 The “#” symbol represents cracks in the parapet only.
