**EVALUATION OF HIGH PERFORMANCE  
CONCRETE BRIDGE DECKS  
AND  
OTHER EXPERIMENTAL BRIDGE  
DECKS THROUGHOUT ILLINOIS**

**PHYSICAL RESEARCH REPORT NO. 166  
December 2017**

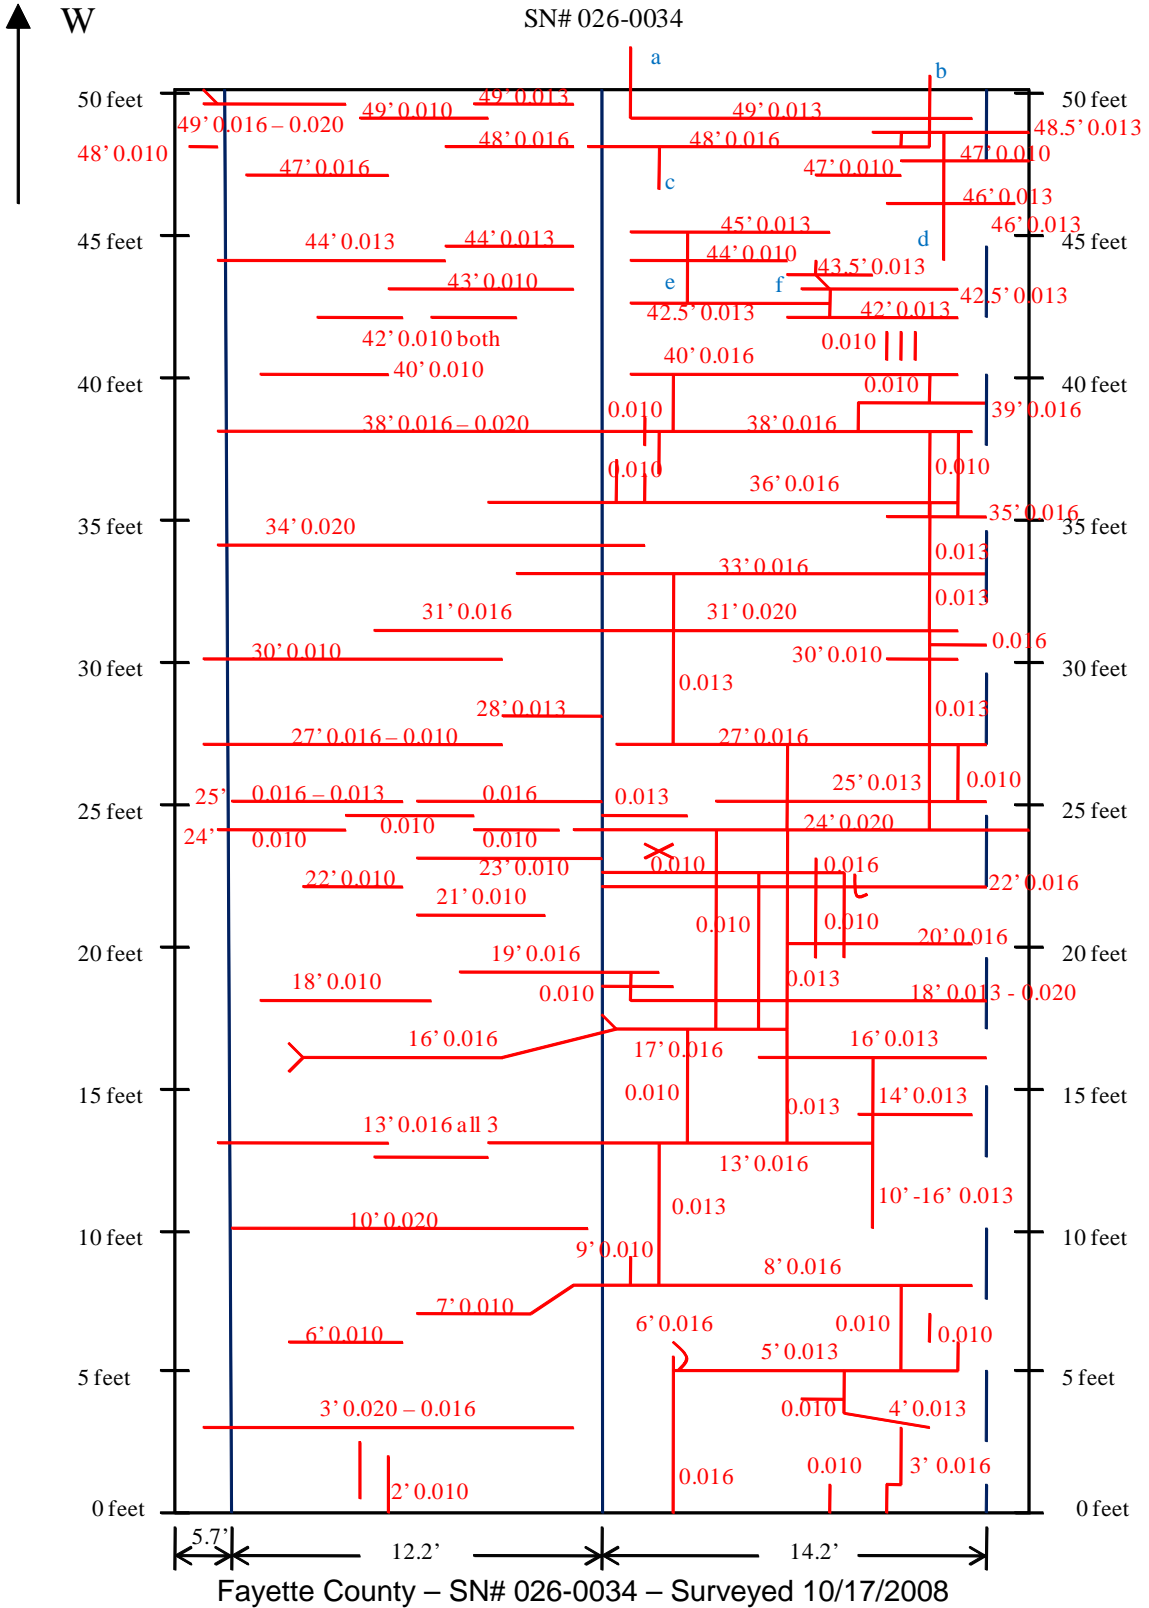
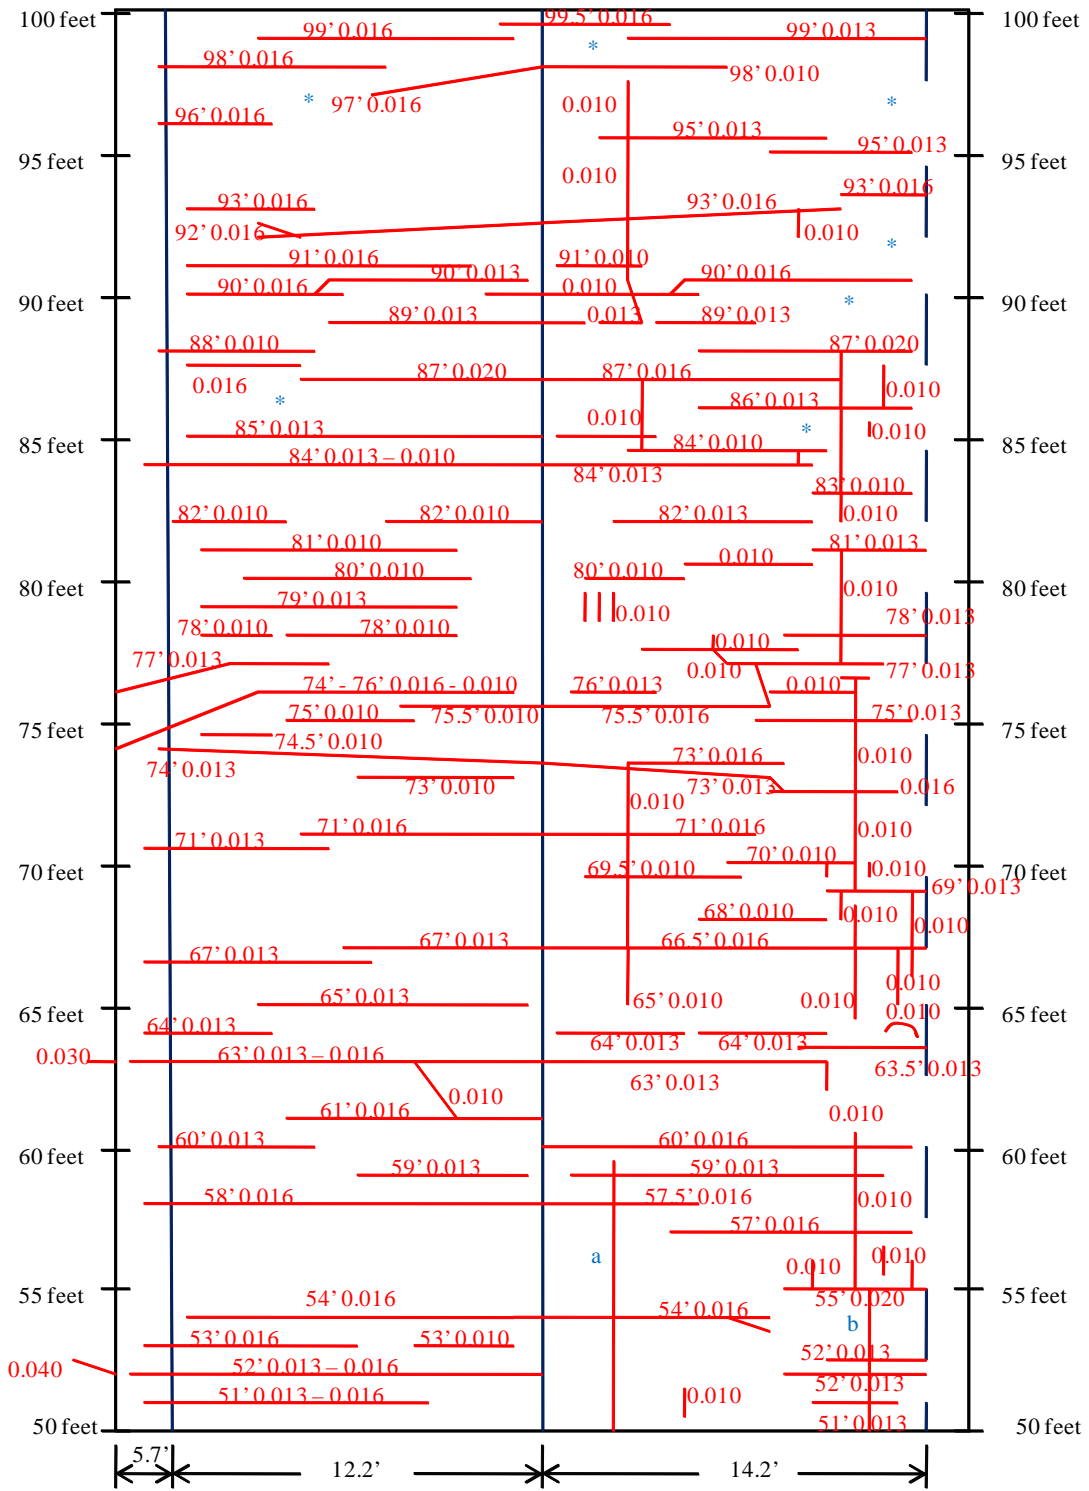
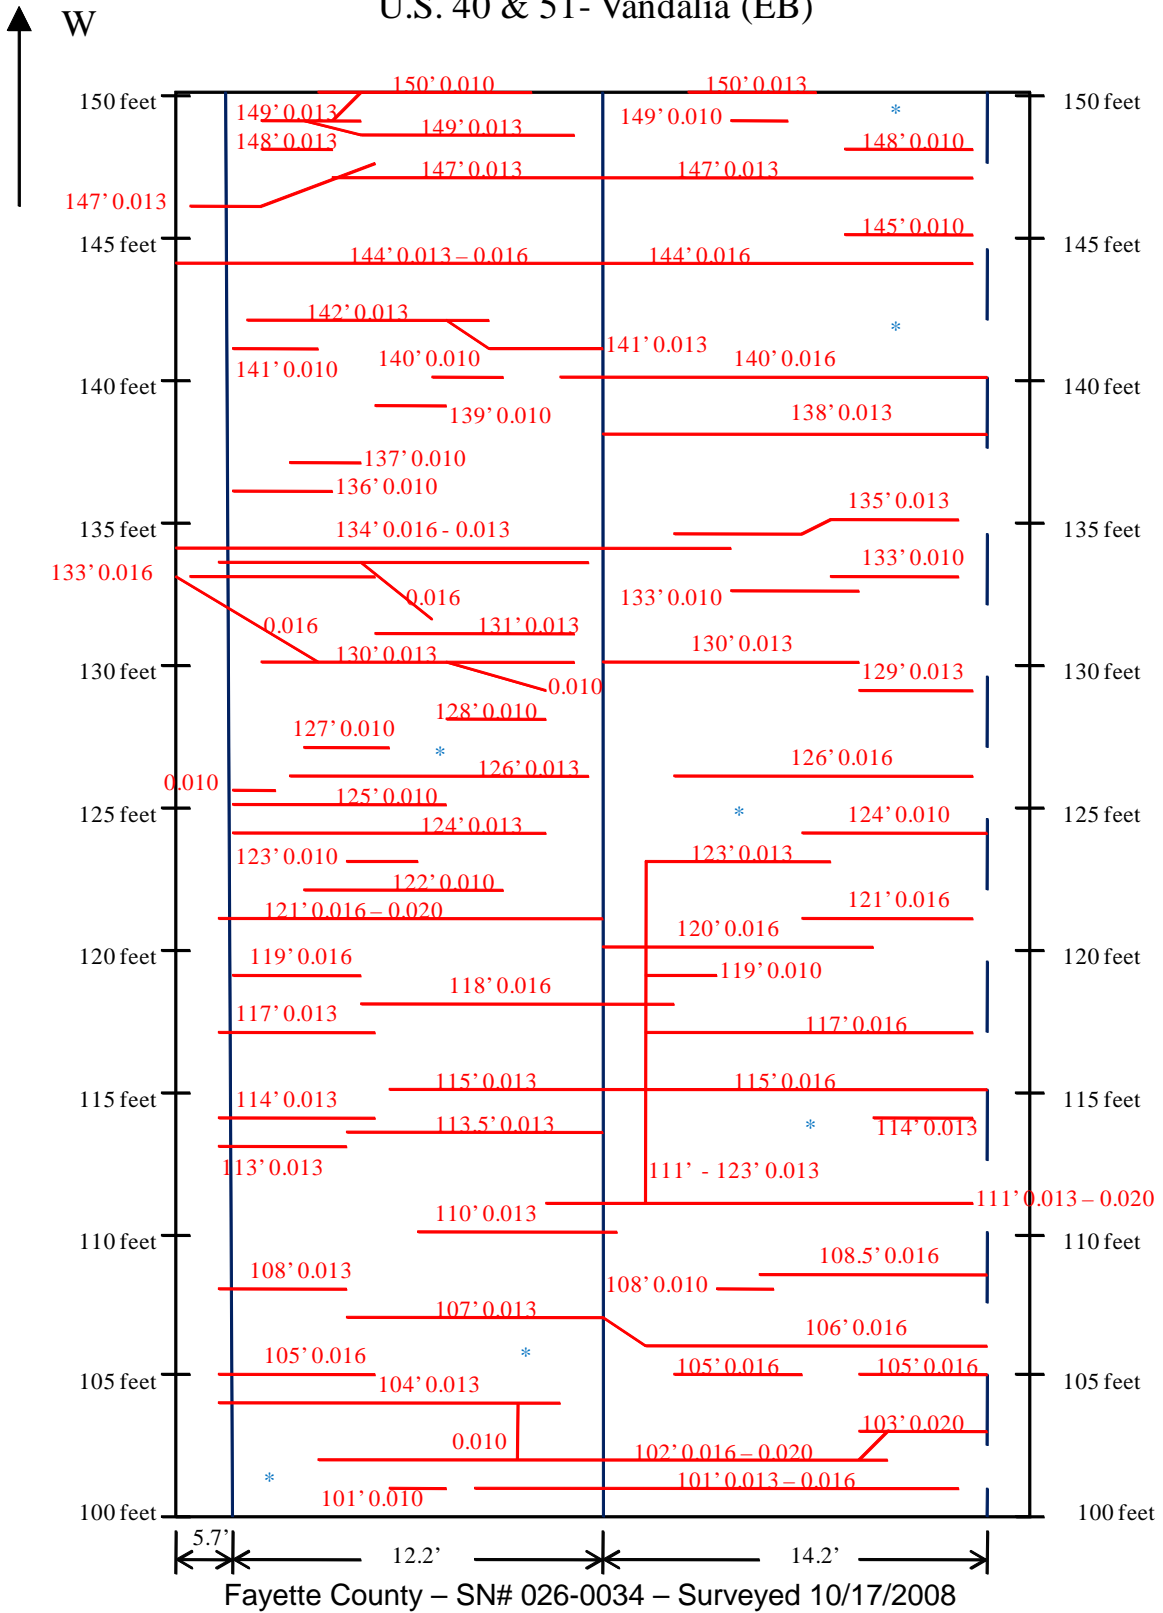
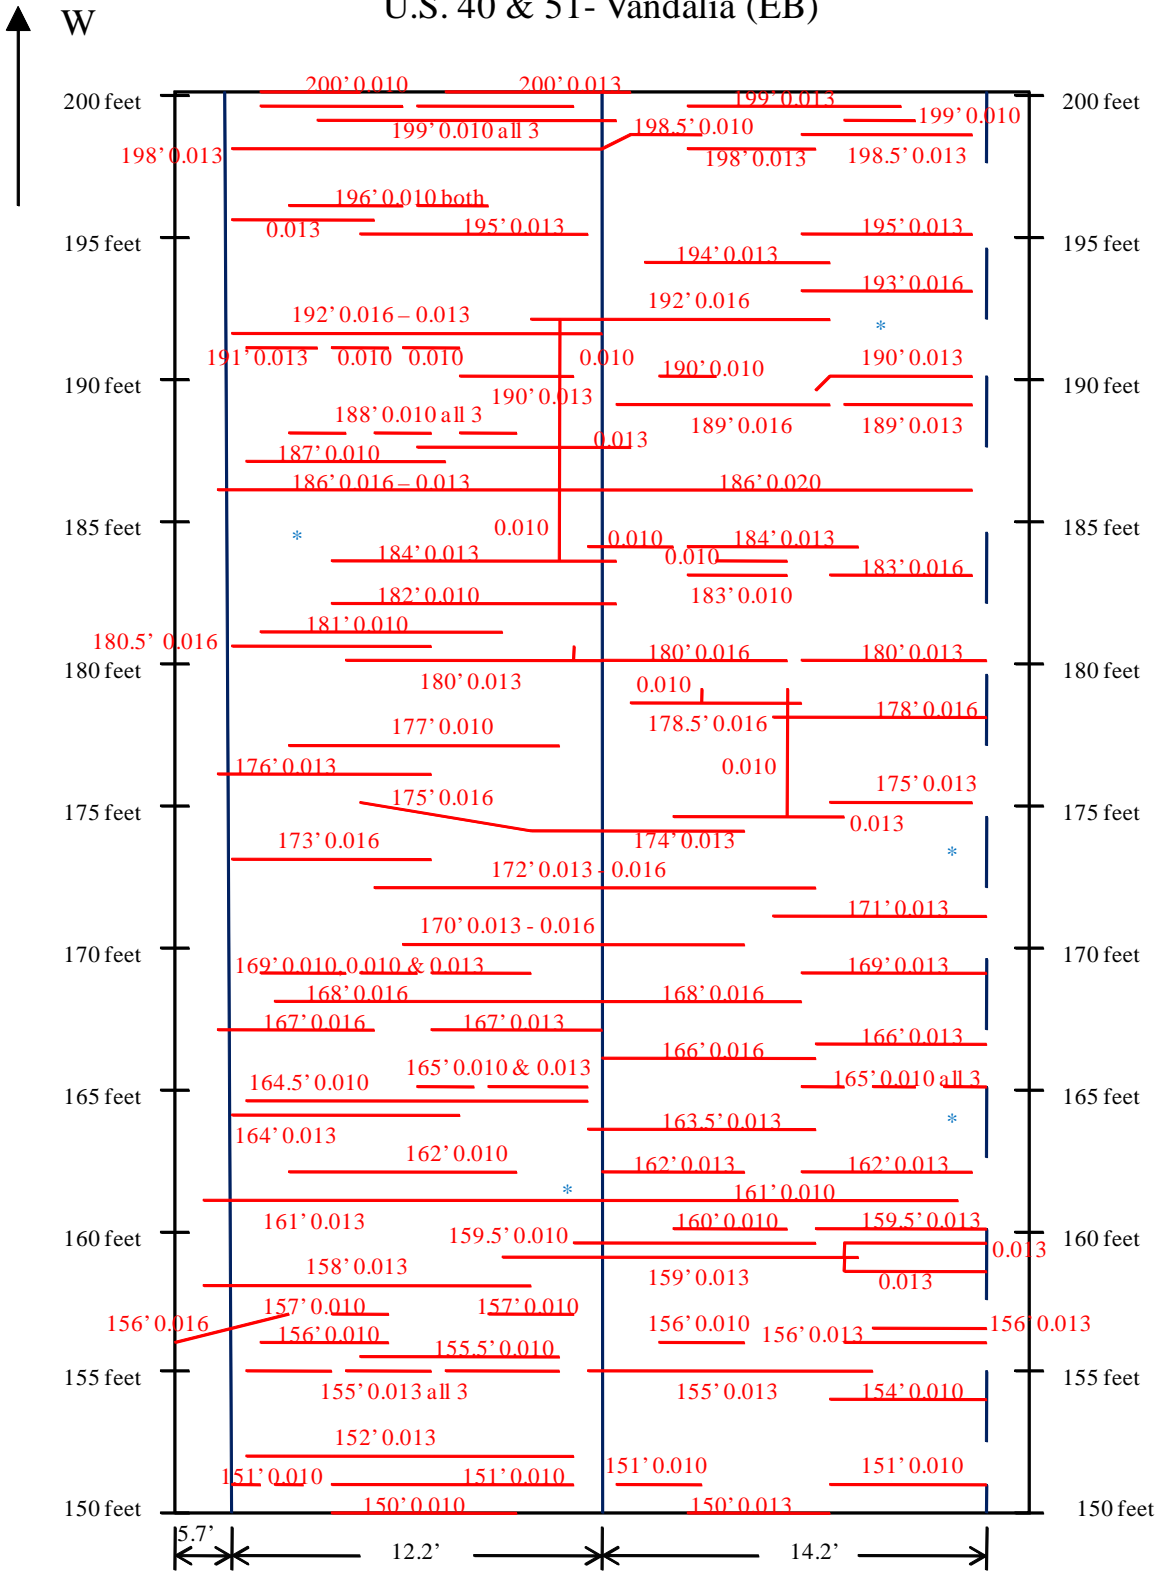
# U.S. 40 & 51- Vandalia (EB)

Fayette County – SN# 026-0034 – Surveyed 10/17/2008

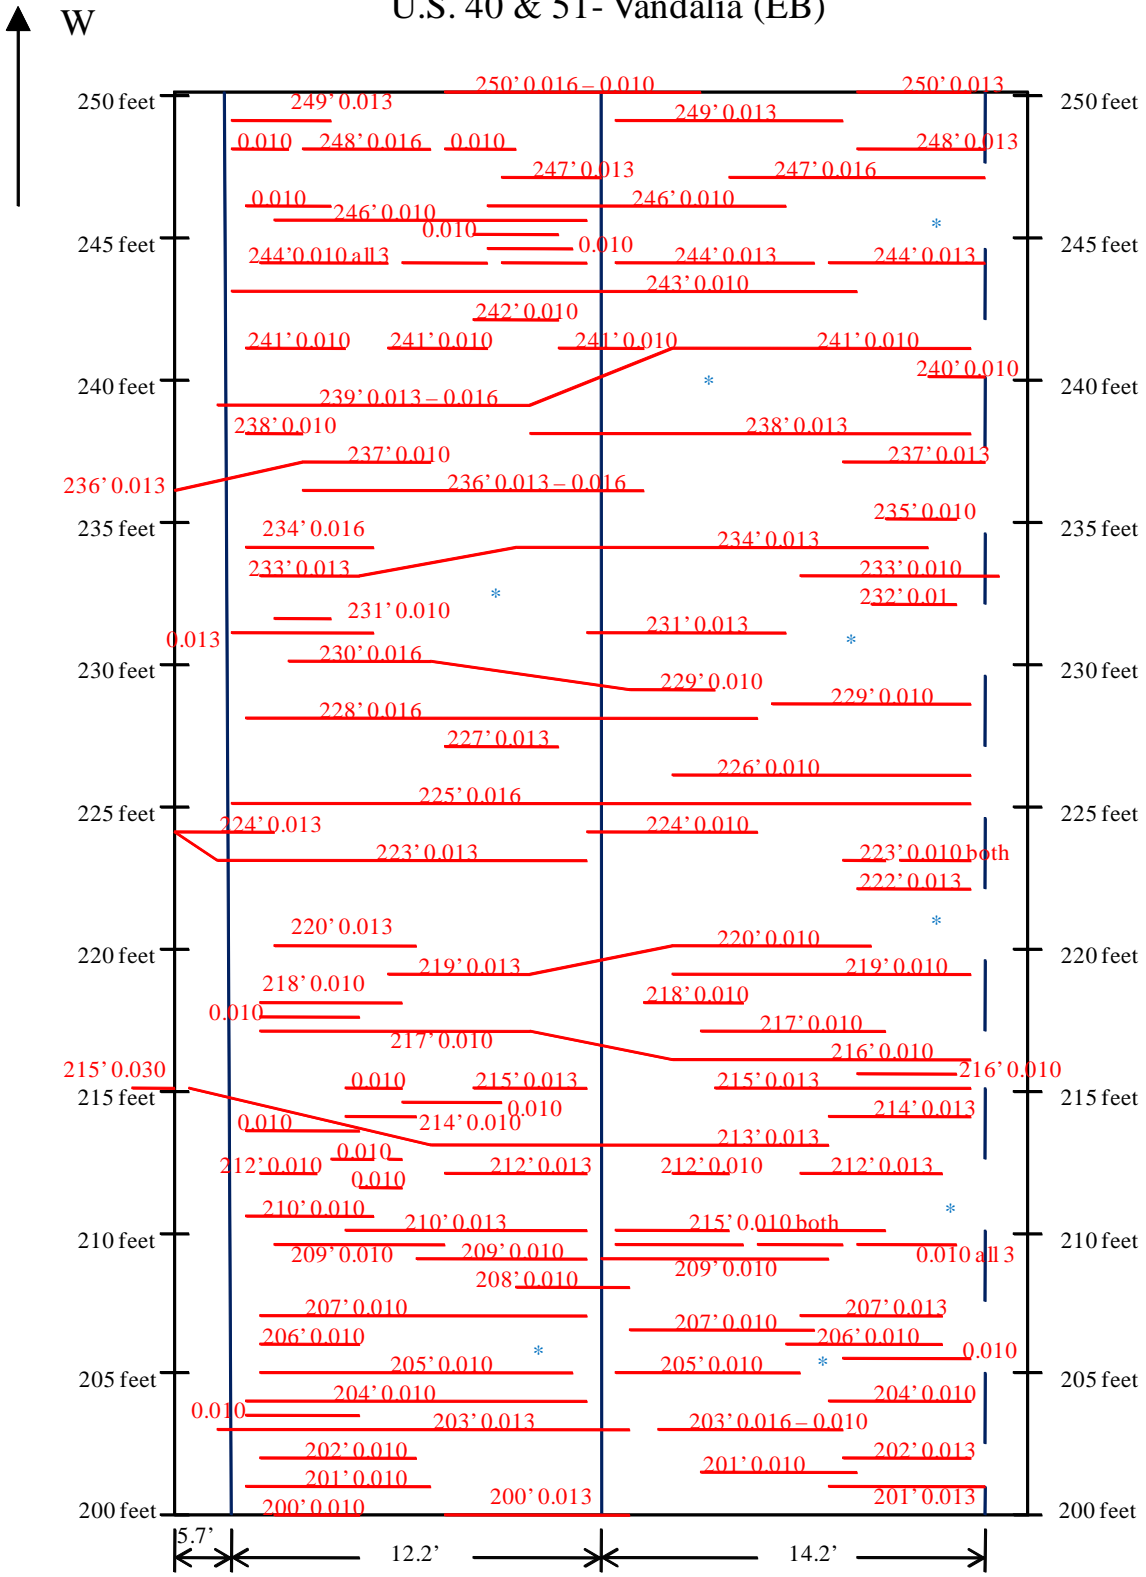
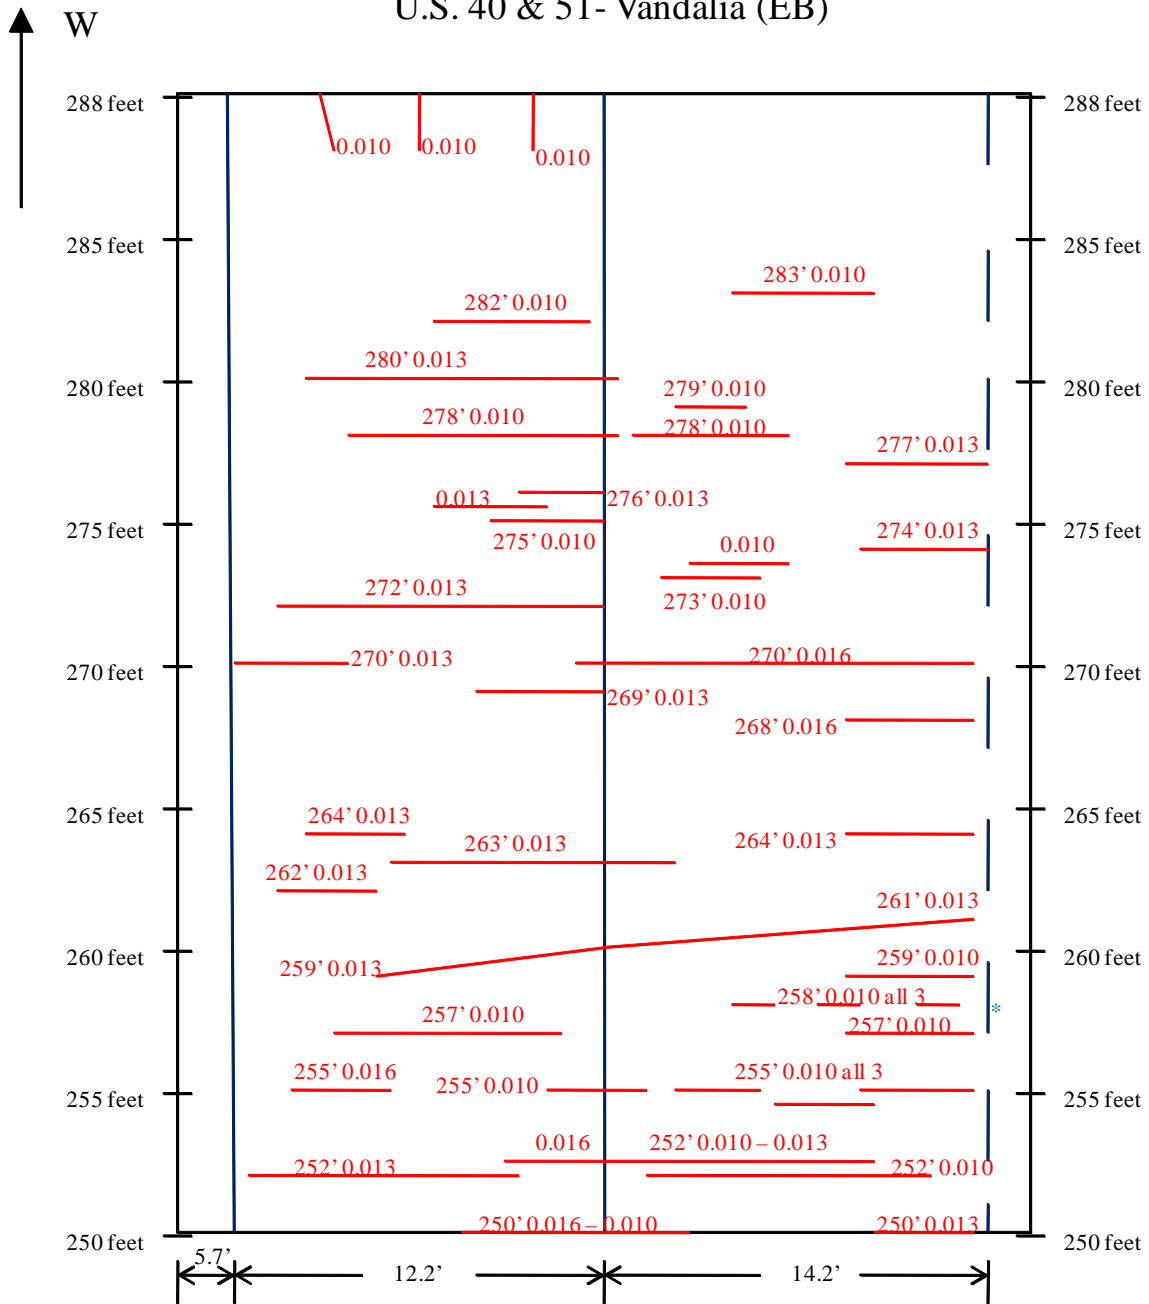
## U.S. 40 & 51- Vandalia (EB)

Fayette County – SN# 026-0034 – Surveyed 10/17/2008

The survey did not cover the entire deck because of time constraints.

Areas of longitudinal cracking: a= 49' - 59' 0.010, b= 48' - 55' 0.010, c= 46' - 48' 0.010,  
d= 43' - 48.5' 0.010, e= 42.5' - 45' 0.010, f= 42.5' - 43.5' 0.010

\* This symbol denotes areas of numerous hairline cracks located very close together. The measurements of the cracks were 0.010.

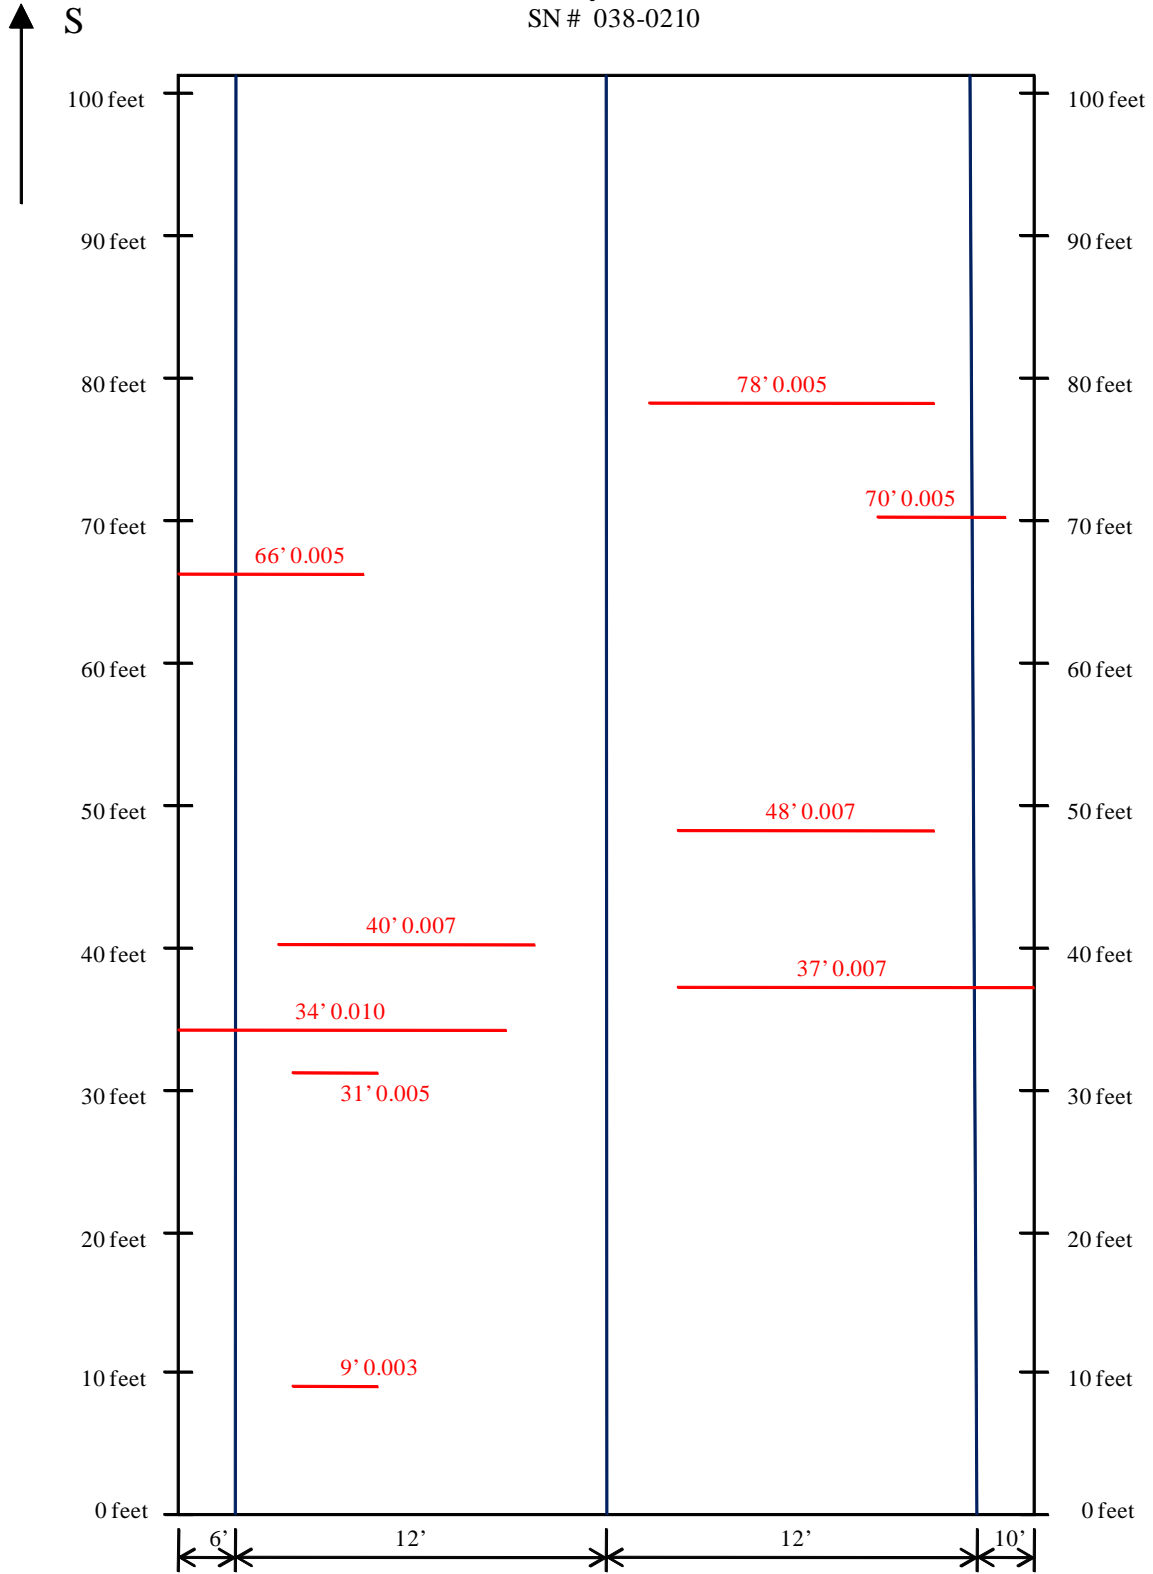
Del Ray – US 45  
SN # 038-0210

Iroquois County – SN# 038-0210 – Surveyed 11/22/2002

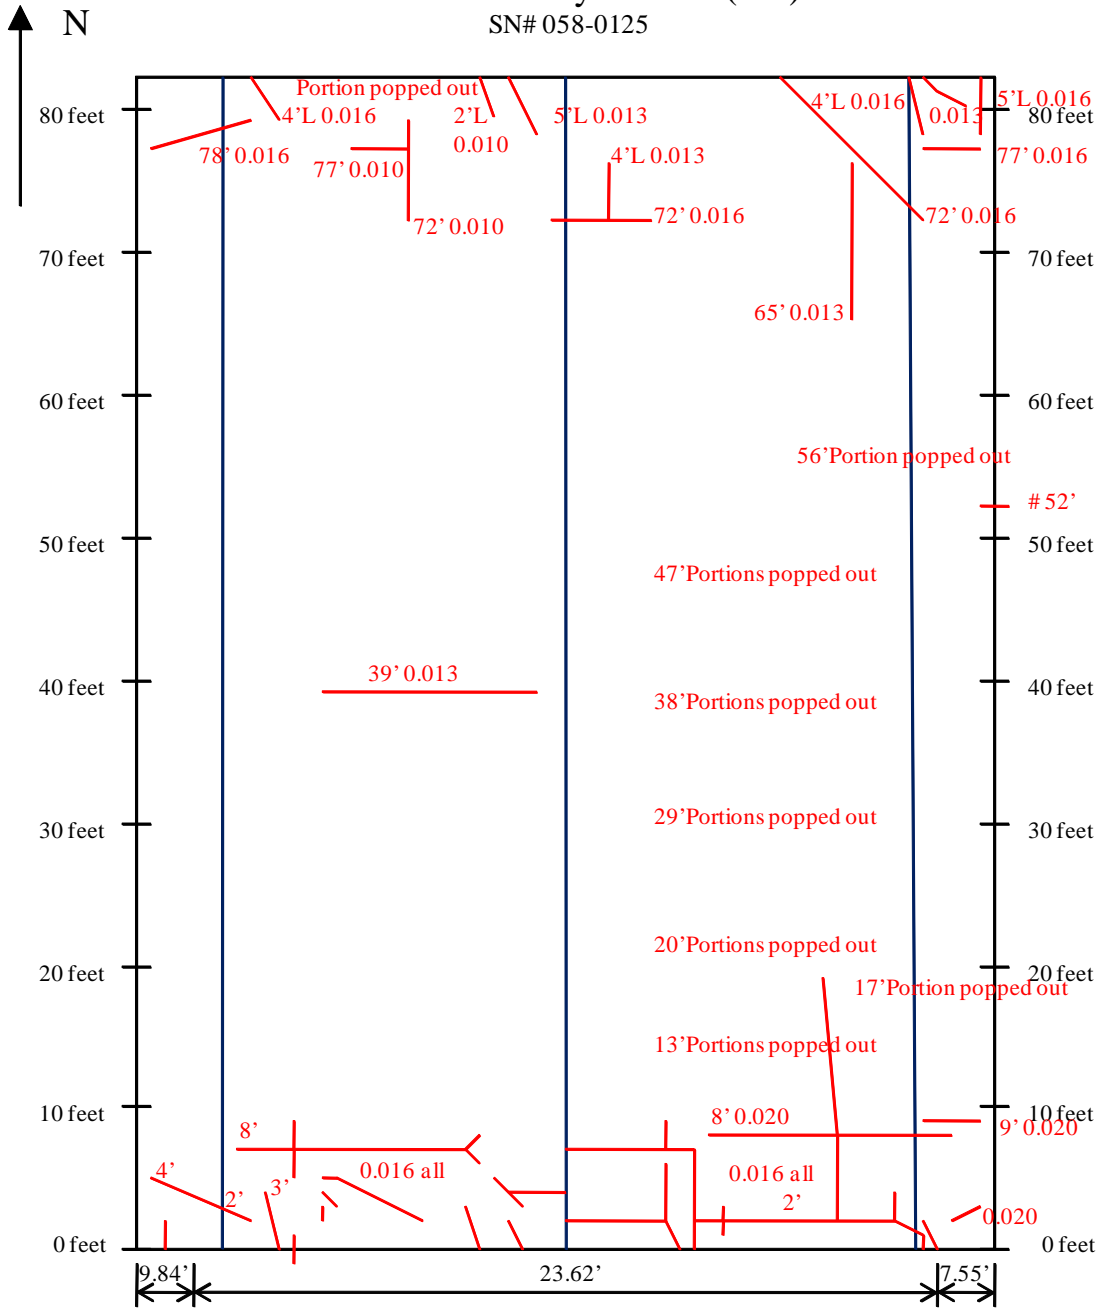
# U.S. 51 over Dry Branch (NB)

Macon County – SN# 058-0125 – Surveyed 10/25/2005  
 Some portions of the bridge deck in the driving lane were popped out.  
 The “#” means parapet only.

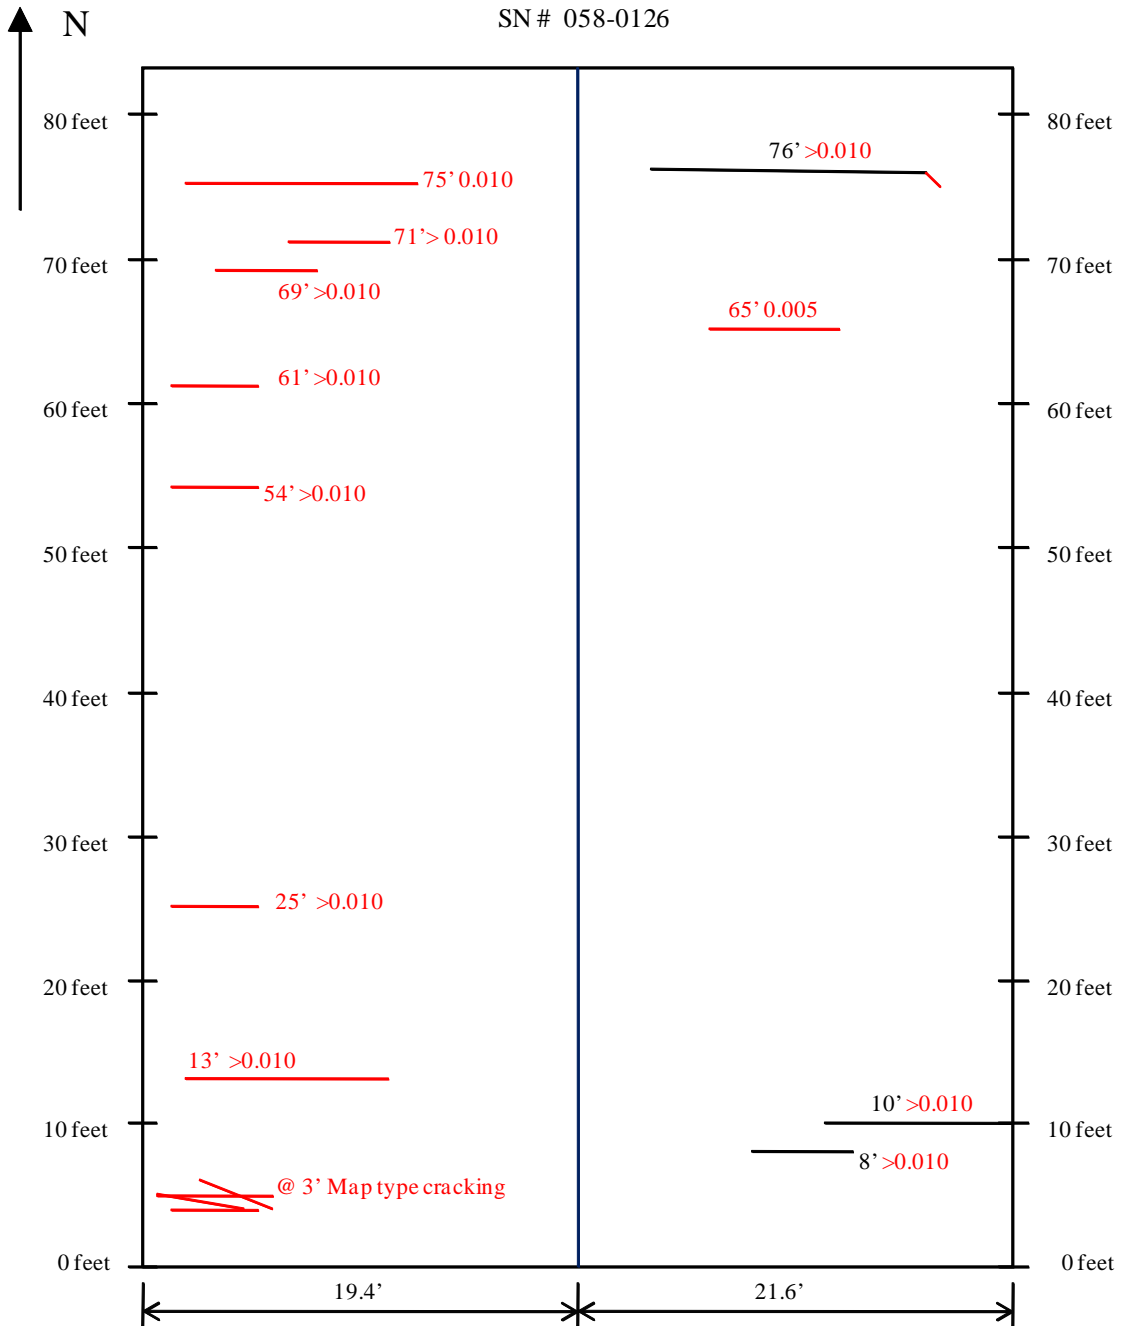
Macon U. S. 51 – SB  
SN# 058-0126

Macon County – SN# 058-0126 – Surveyed 5/7/2001, 10/19/2001  
Deck poured on October 03, 2000. No initial survey was conducted due the dirty surface.

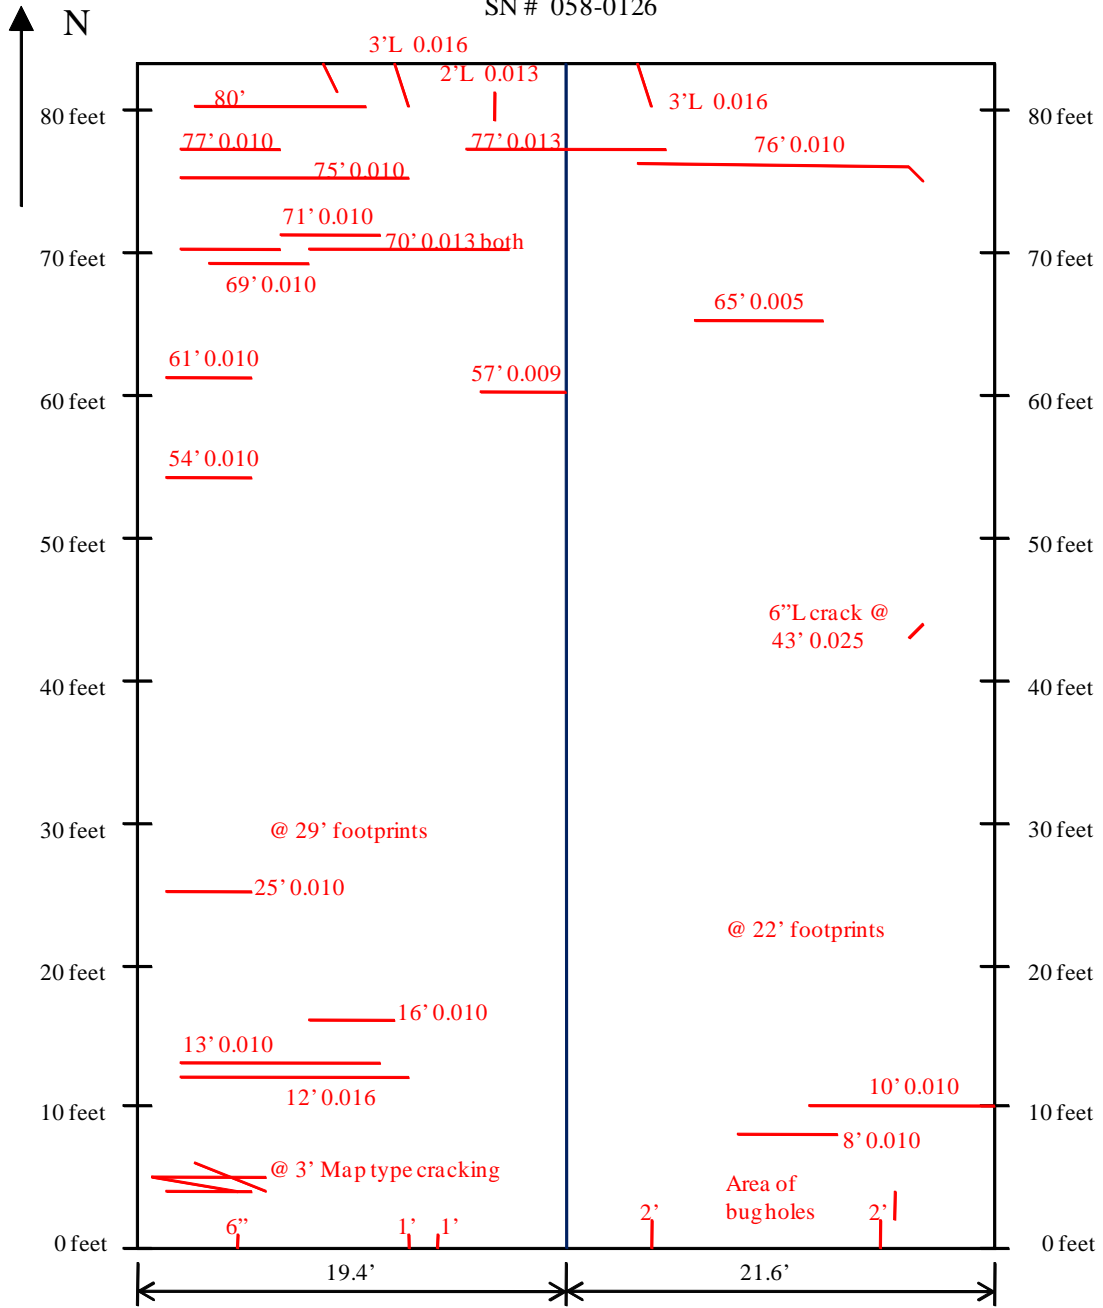
# Macon U. S. 51 – SB

Macon County – SN# 058-0126 – Surveyed 10/31/2002

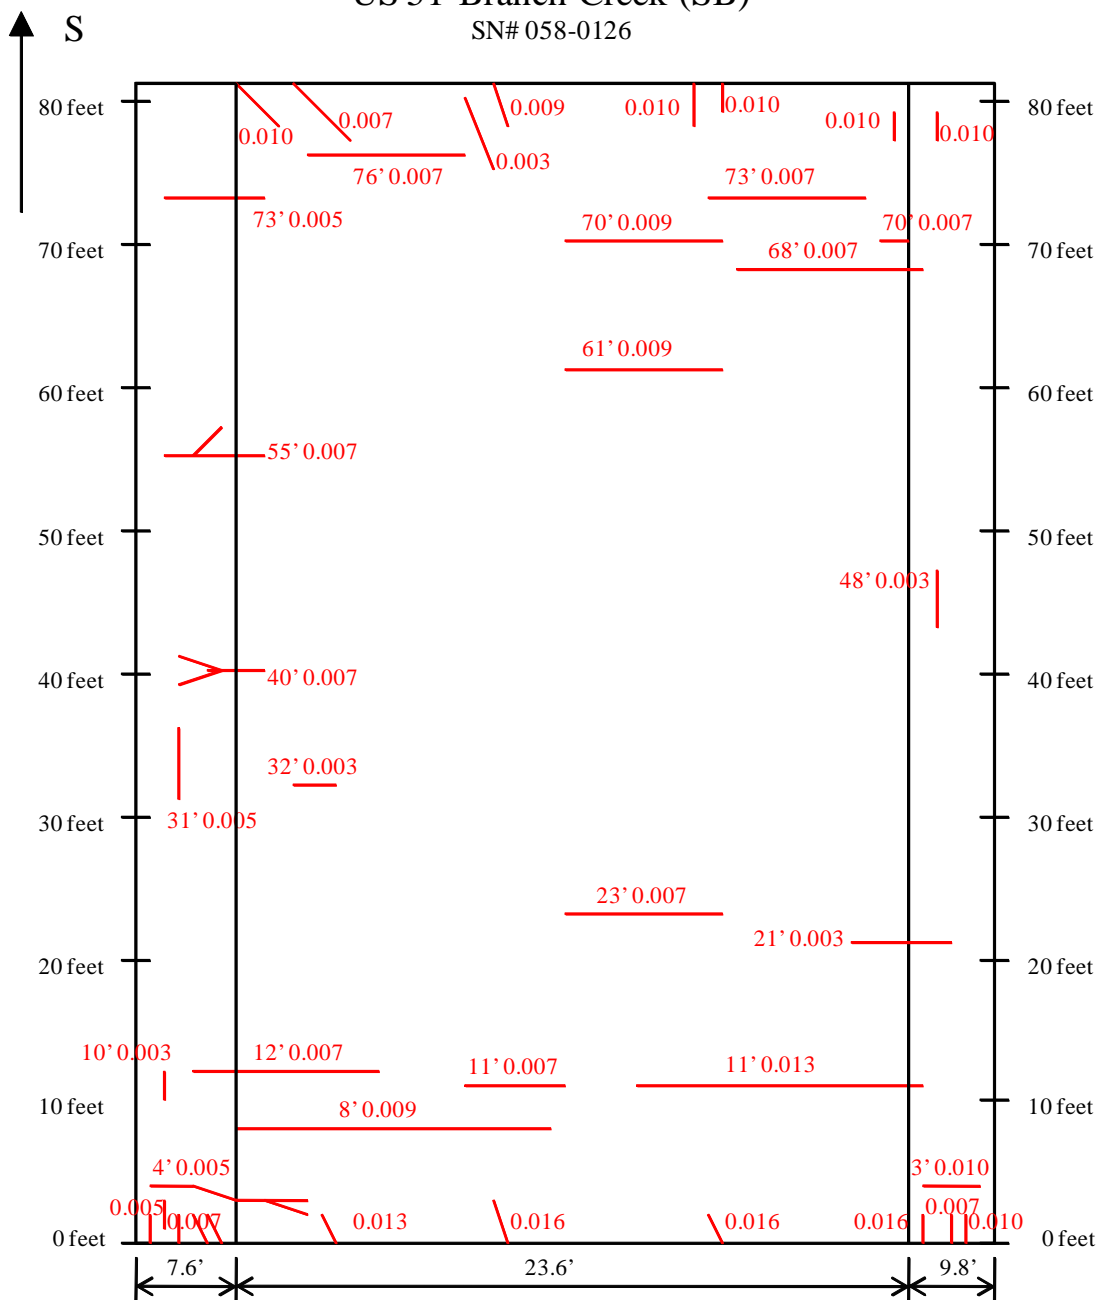
# US 51-Branch Creek (SB)

Macon County – SN# 058-0126 – Surveyed 10/7/2003  
 Footprints were noticed in the southbound lane from 48' to 57'.

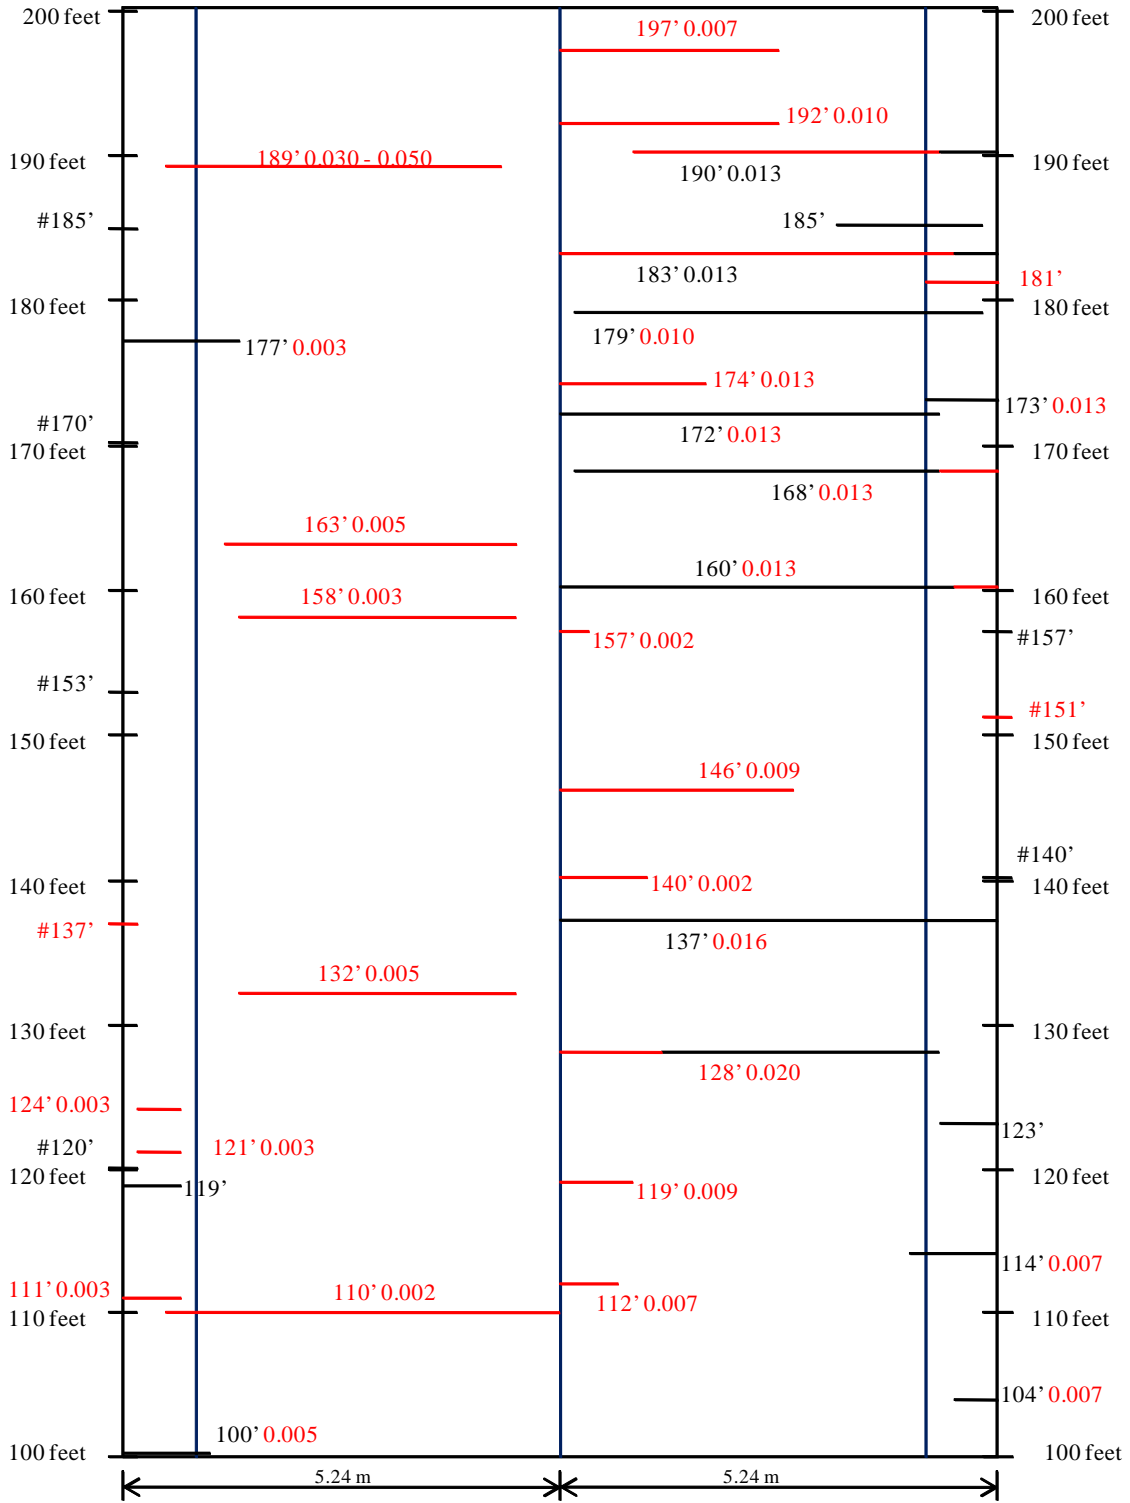
Rte. 4 over I - 70

Madison County – SN# 060-0108 – Surveyed 5/8/2001, 8/2/2001

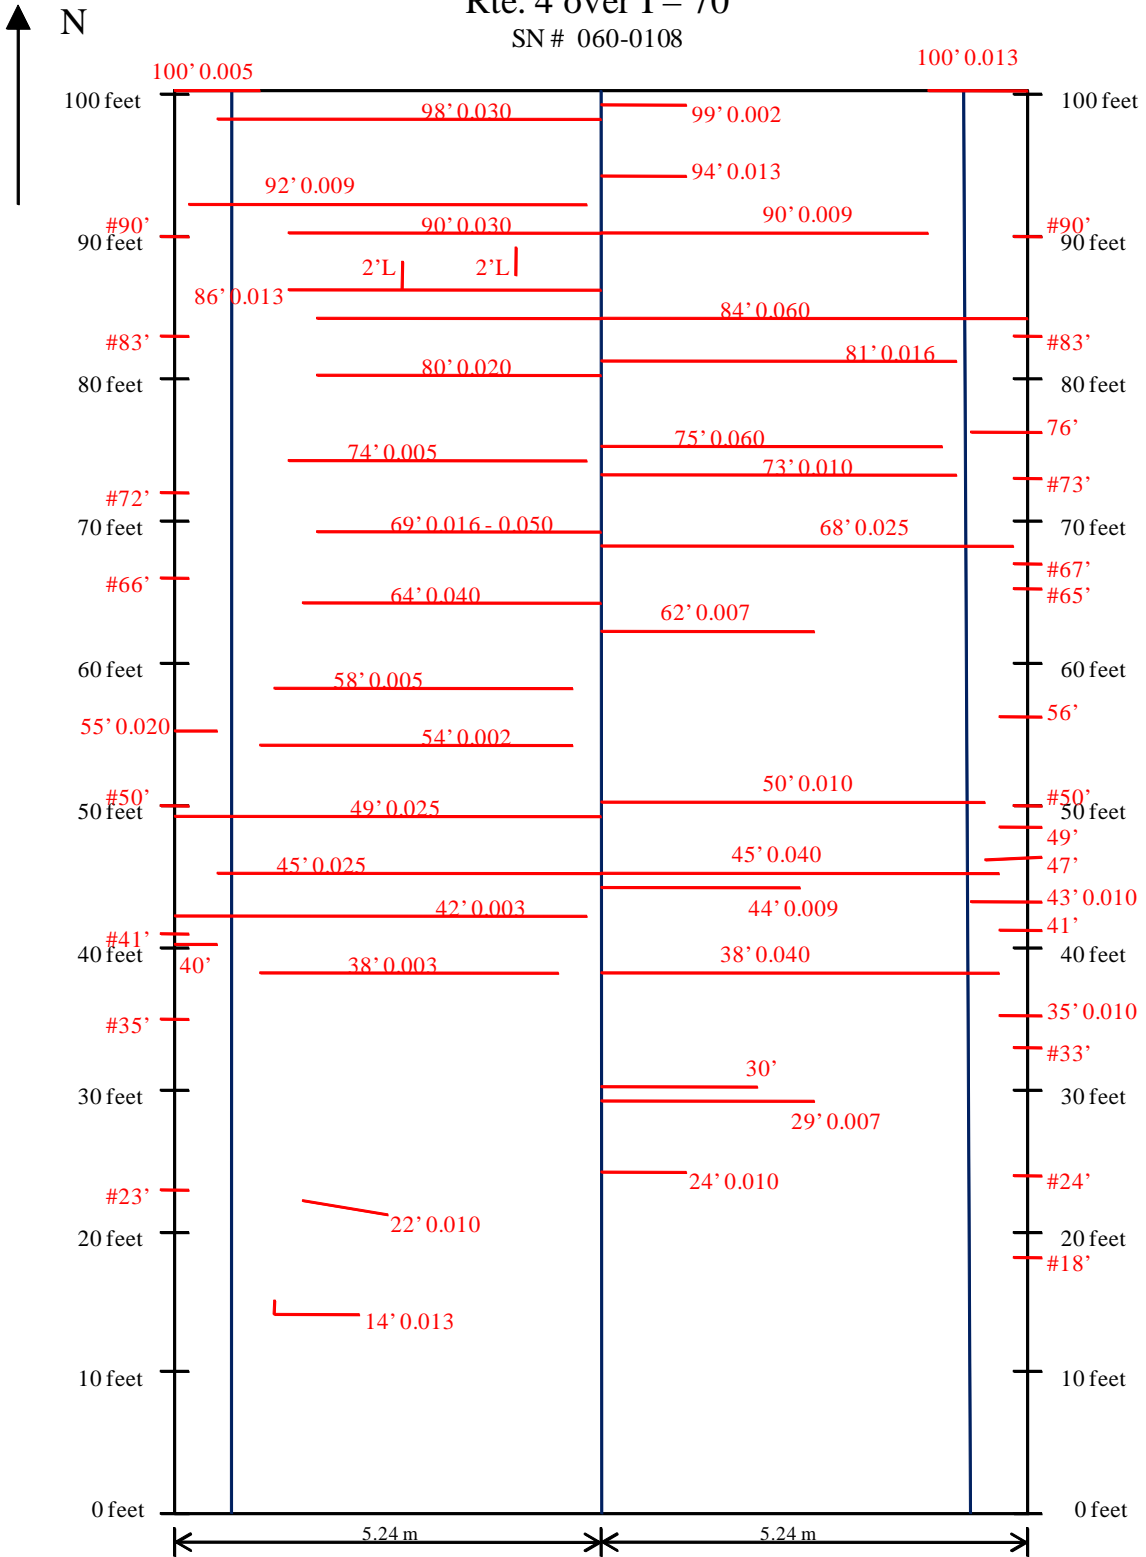
Rte. 4 over I – 70  
SN # 060-0108

Madison County – SN# 060-0108 – Surveyed 8/12/2002
