**EVALUATION OF HIGH PERFORMANCE  
CONCRETE BRIDGE DECKS  
AND  
OTHER EXPERIMENTAL BRIDGE  
DECKS THROUGHOUT ILLINOIS**

**PHYSICAL RESEARCH REPORT NO. 166  
December 2017**

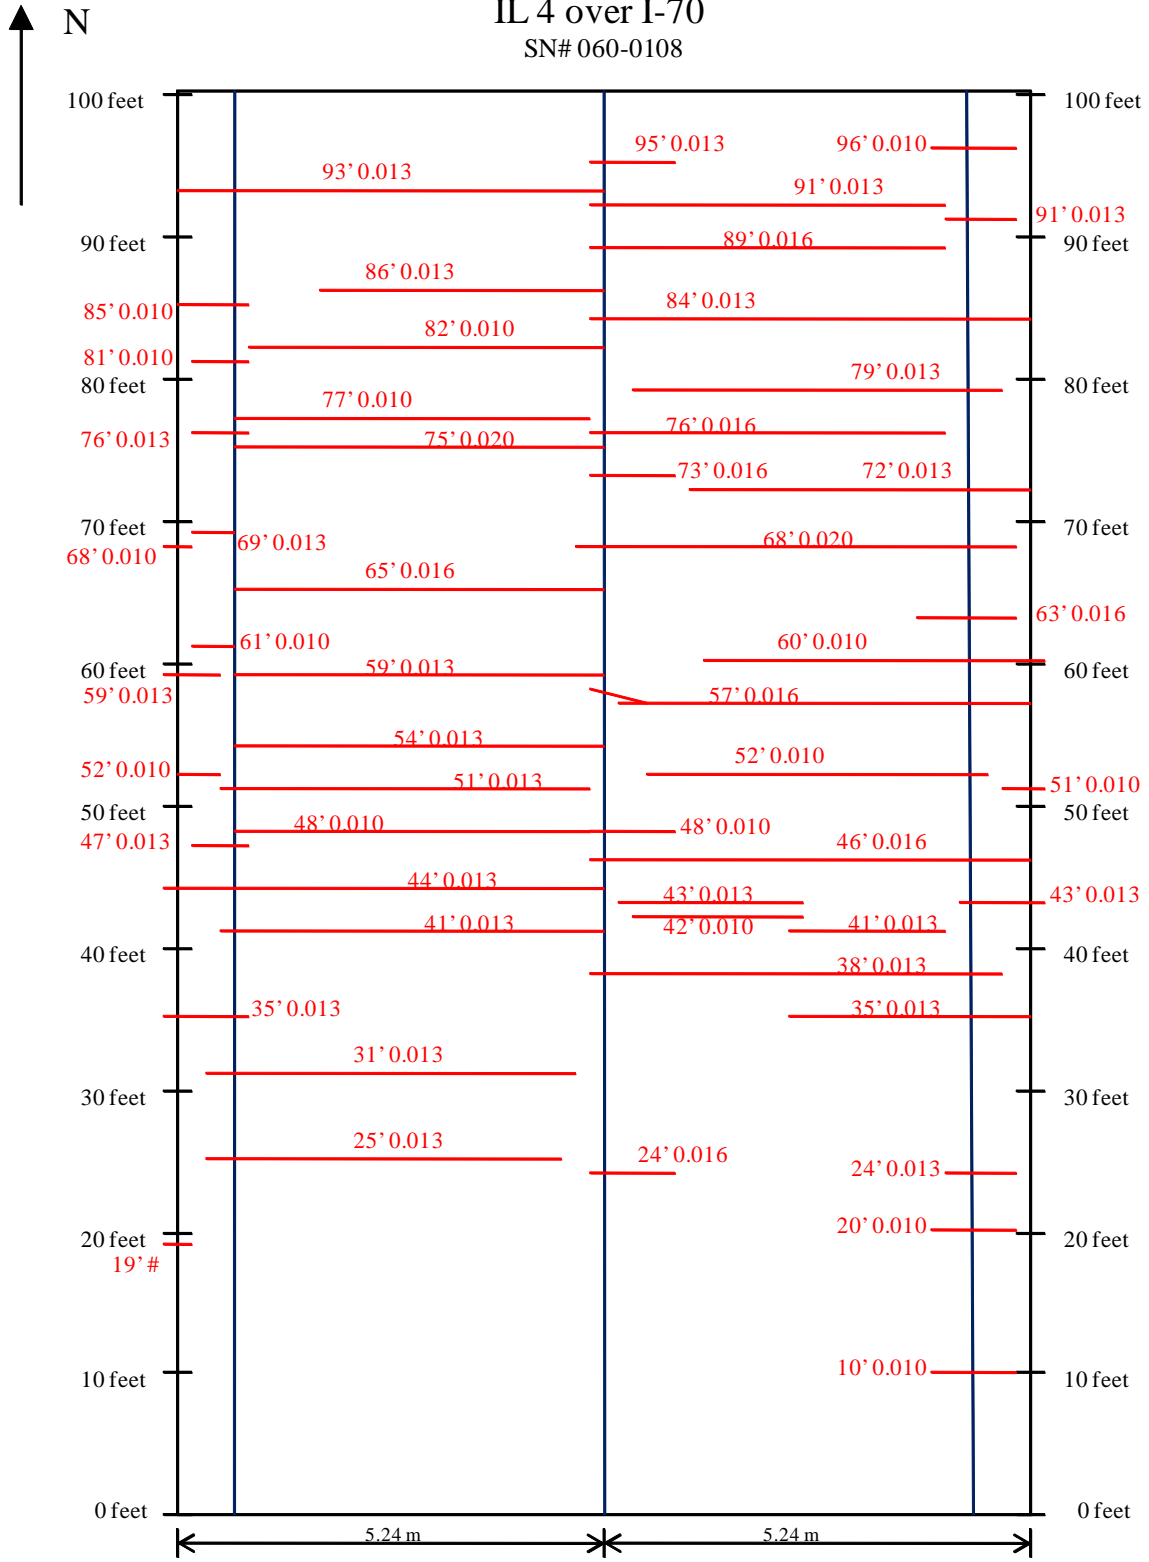
IL 4 over I-70  
SN# 060-0108

Madison County – SN# 060-0108 – Surveyed 9/28/2005

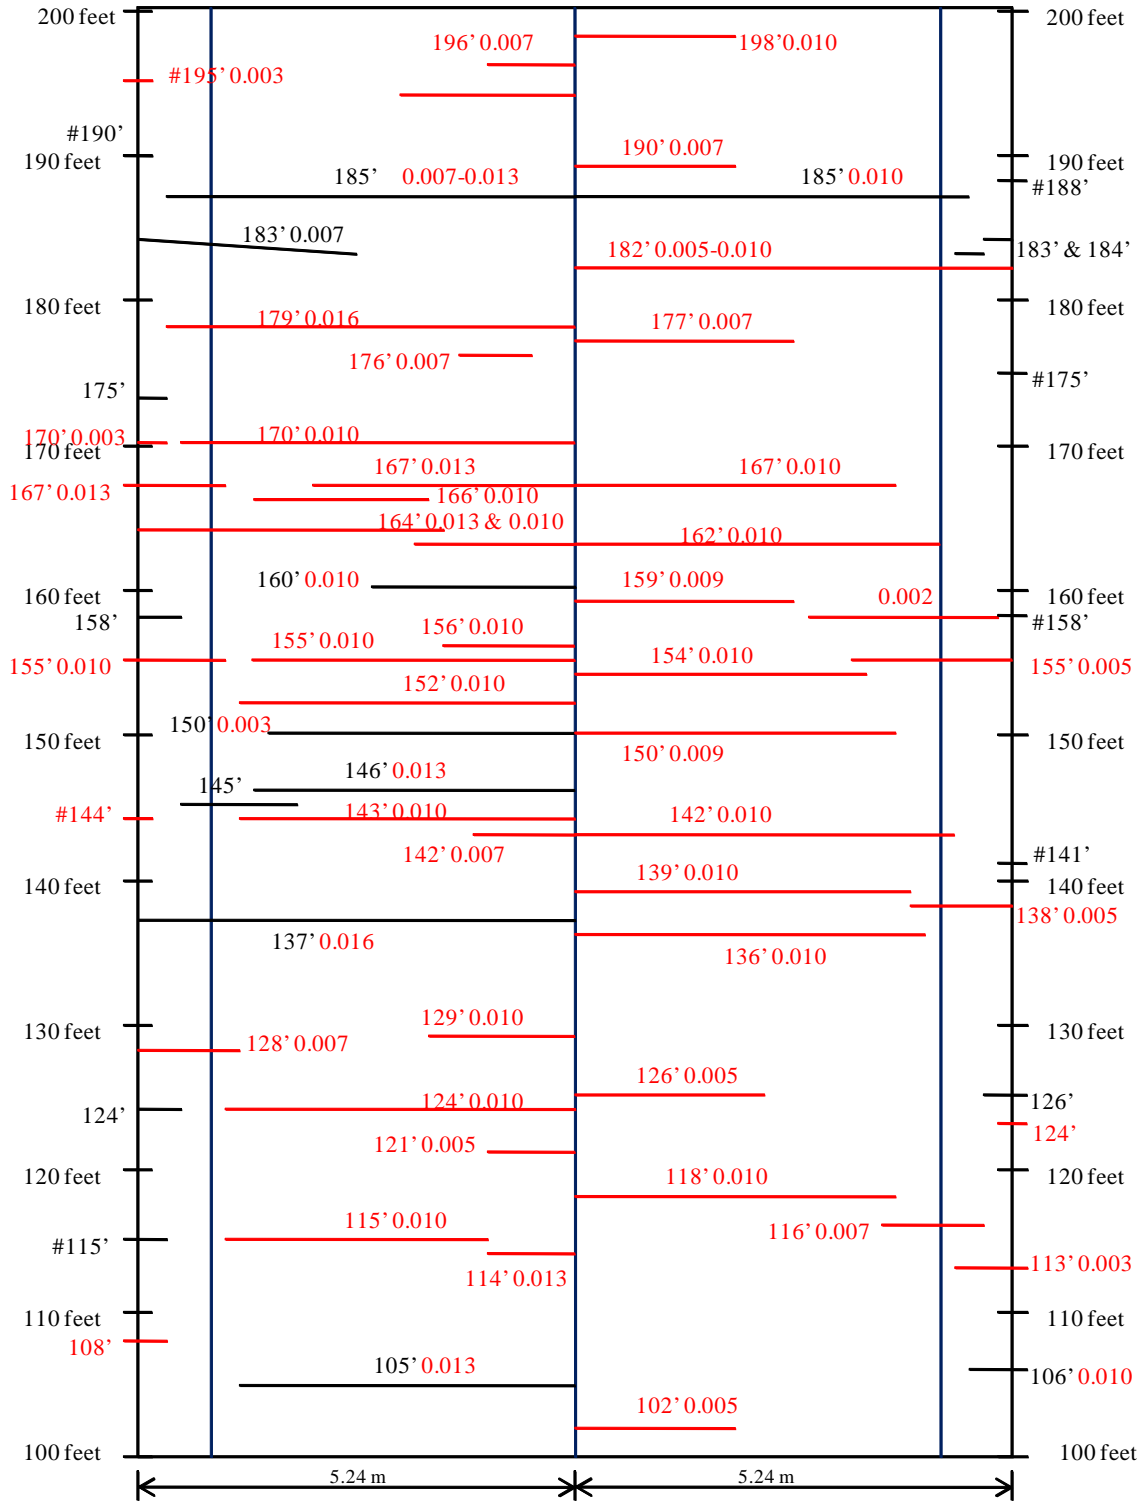
Madison County – SN# 060-0151 – Surveyed 5/8/2001, 8/2/2001  
 The initial bridge deck survey showed five hairline transverse cracks.  
 The “#” symbol represents cracks in the parapet only.

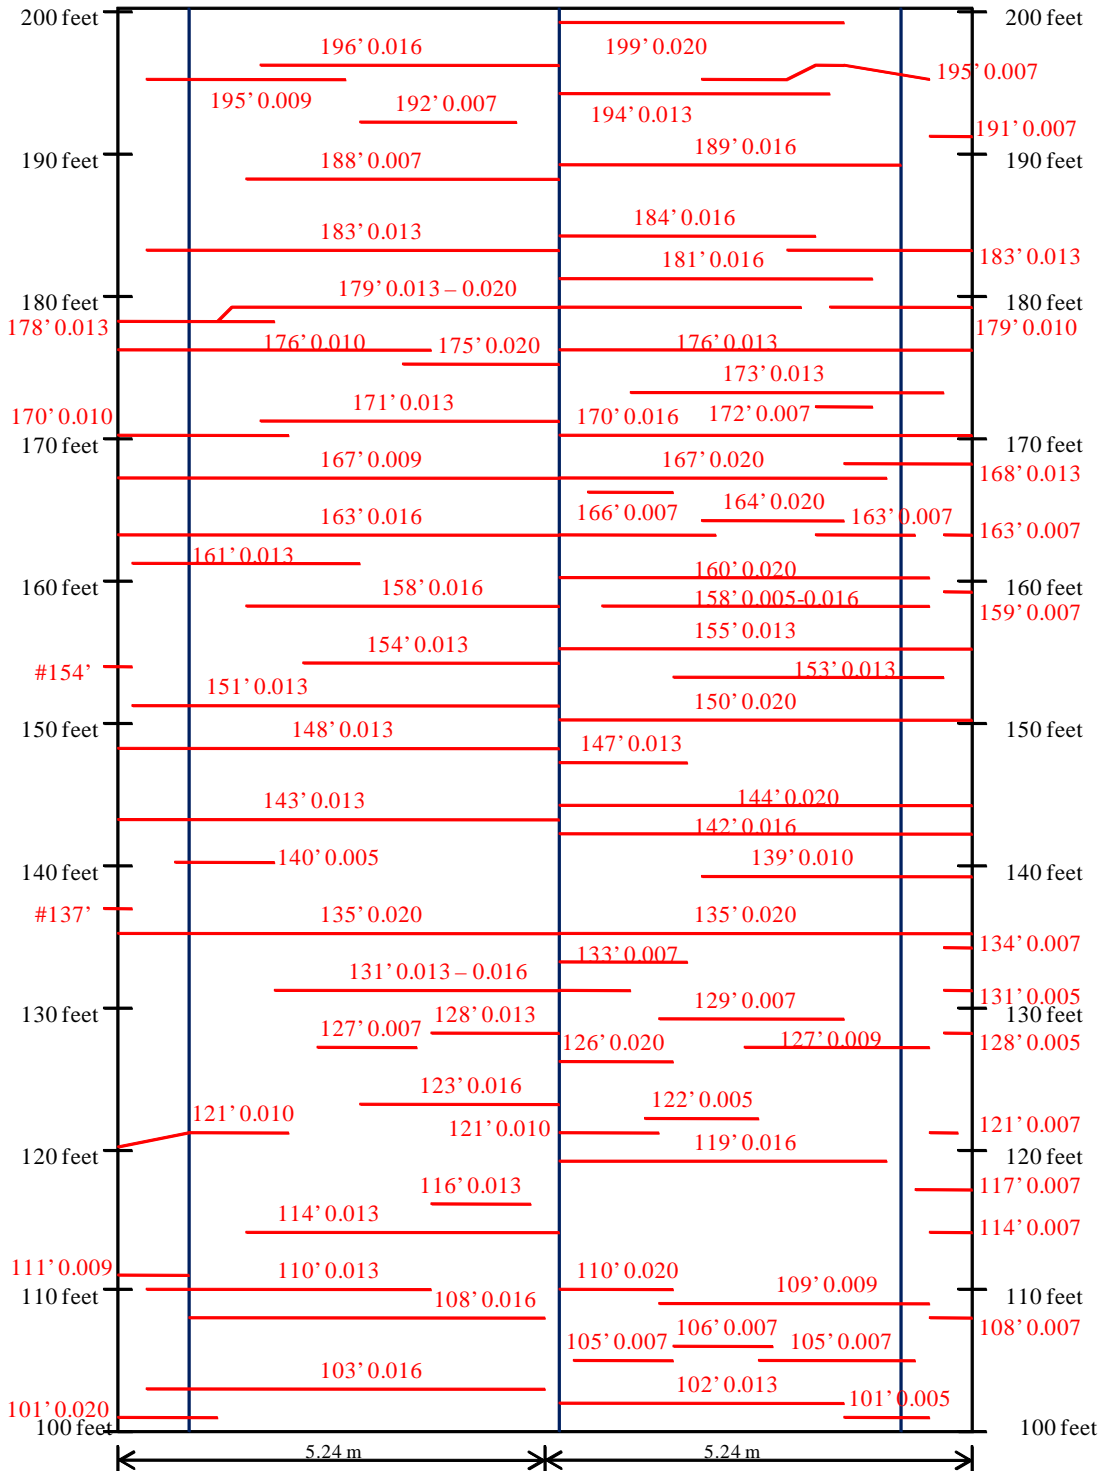
Madison County – SN# 060-0151 – Surveyed 9/29/2003  
 The “#” symbol represents cracks in the parapet only.

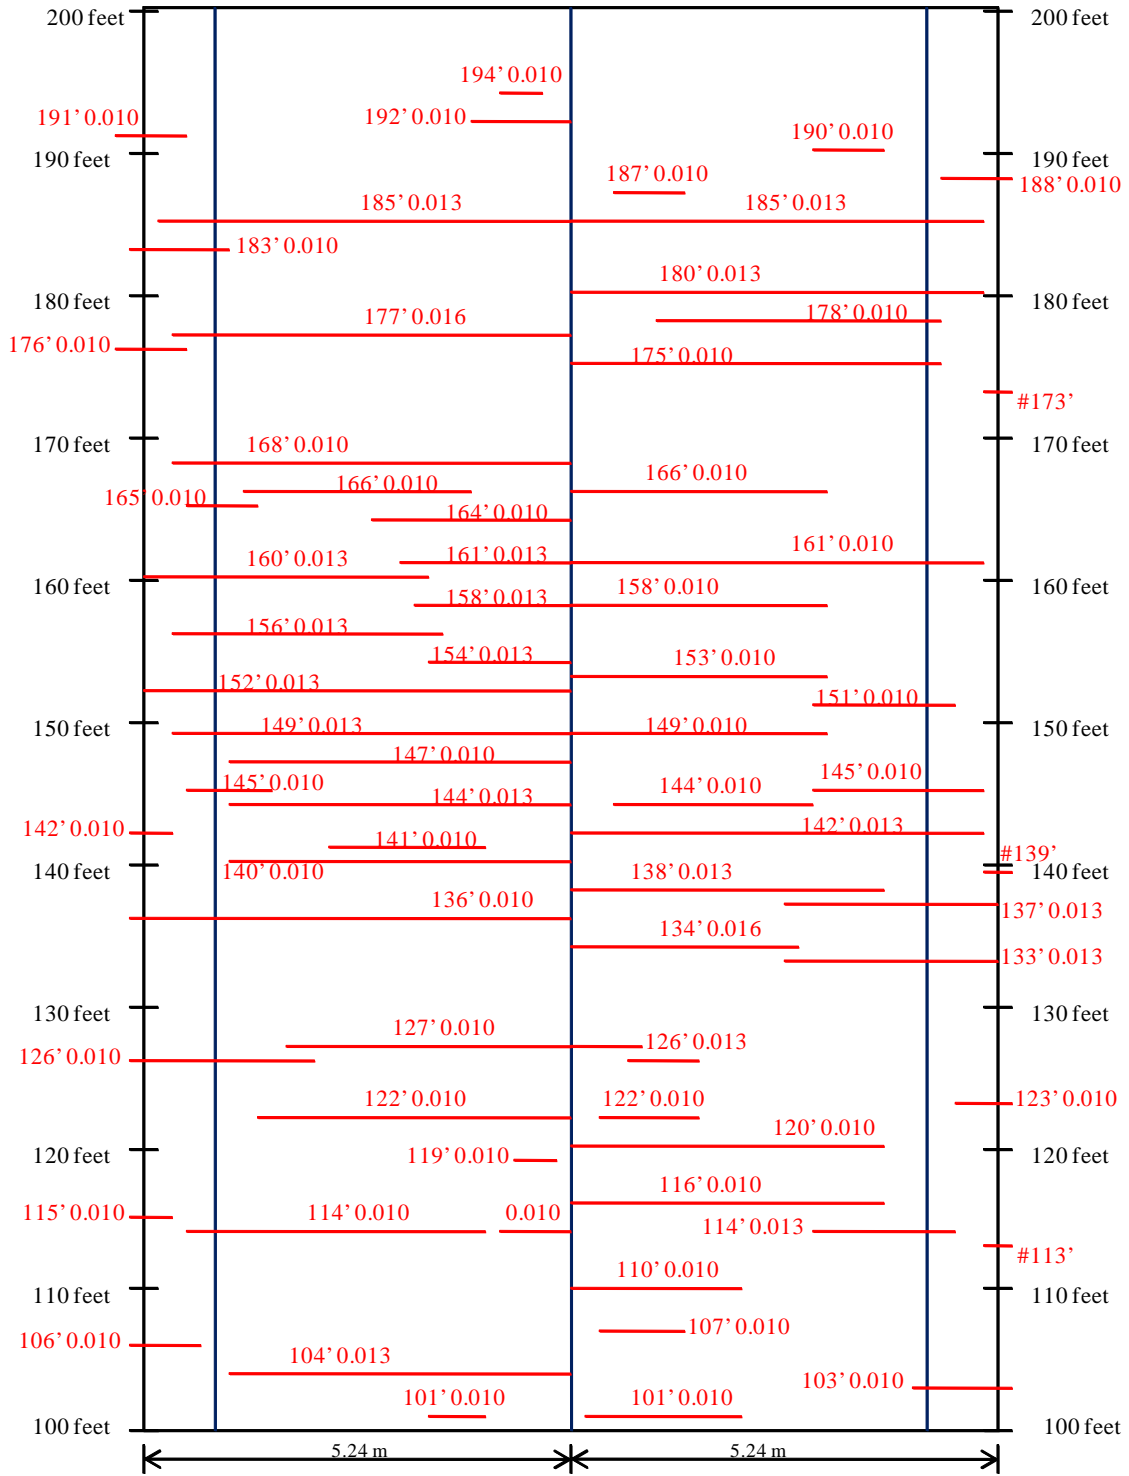
Madison County – SN# 060-0151 – Surveyed 9/28/2005  
 The “#” symbol represents cracks in the parapet only.

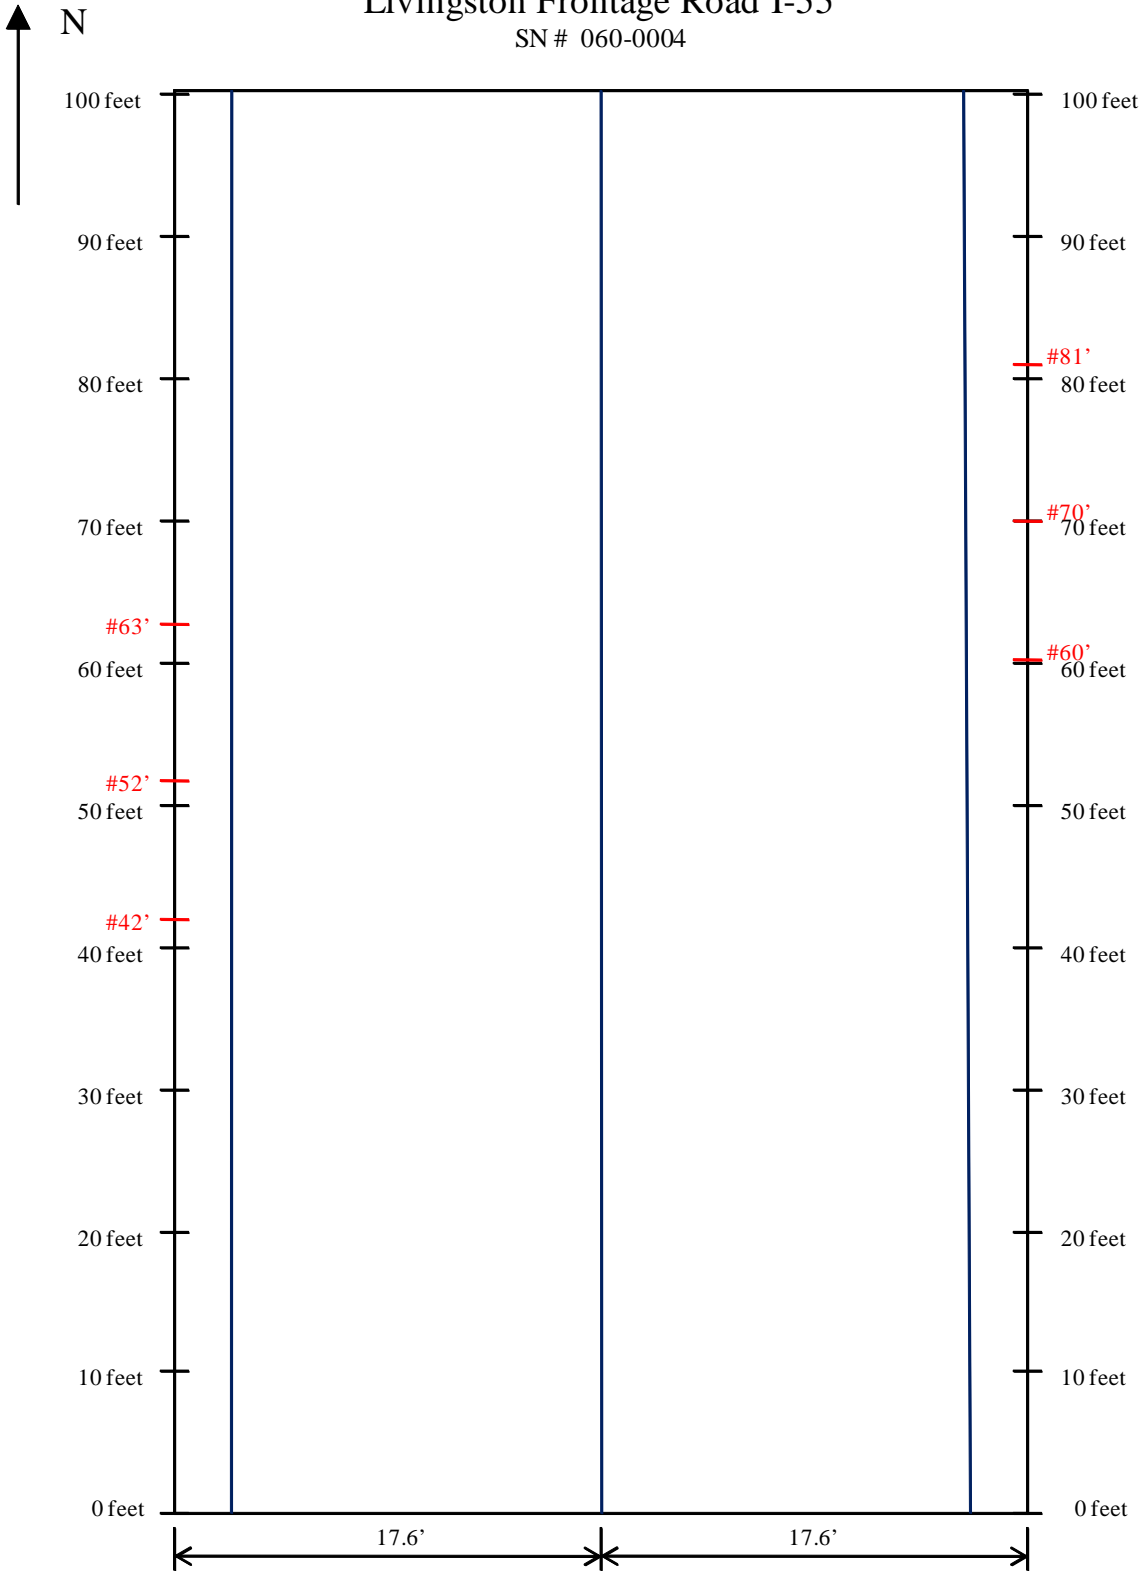
Madison County – SN# 060-0004 – Surveyed 8/12/2002  
 The “#” symbol represents cracks in the parapet only.

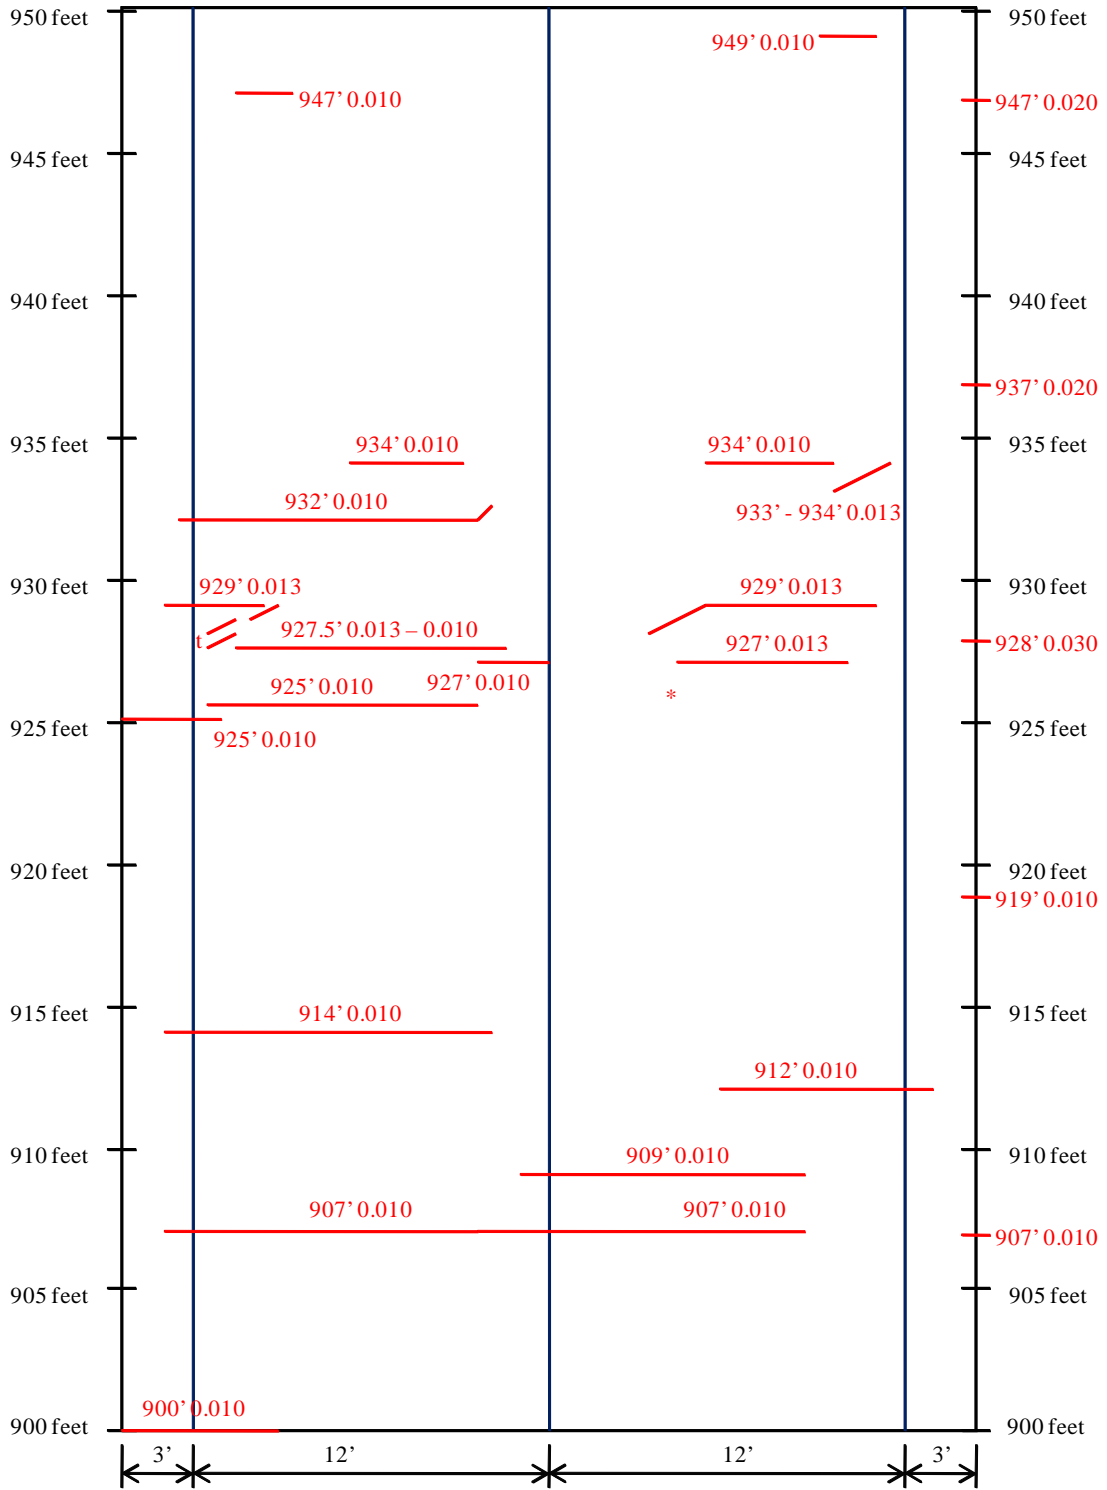
Mason/Menard County – SN# 065-0501 – Surveyed 10/2/2008, 10/20/2008

The “#” symbol represents cracks in the parapet only.

- \* Unless otherwise noted, the areas marked with this symbol contained exposed aggregate.
- A Northbound lane, from 402’ – 403’, the cracks measured from 0.013 – 0.016

- B Northbound lane, from 403’ – 405’, all the cracks measured 0.010.
  - C Northbound lane, from 412’ – 413’, the cracks measured from 0.010, 0.013 – 0.016.

- D Northbound lane, from 413.5’ – 414’, all the cracks measured 0.013.
  - E Northbound lane, from 423.5’ – 425’, the cracks measured from 0.010 – 0.013.

- F Northbound lane, from 577’ – 581.5’, the cracks measured from 0.010 – 0.013.
  - G Southbound lane, from 580’ – 582’, all the cracks measured 0.010.

- H Northbound lane, from 594’ – 599’, all the cracks measured 0.013.
  - I Northbound lane, from 597’ – 600’, the cracks measured from 0.010 – 0.013.

- J Southbound lane, from 601’ – 607’, the cracks measured from 0.010, 0.013 – 0.016.
  - K Northbound lane, from 602’ – 603’, the cracks measured from 0.010 – 0.013.

- L Northbound lane, from 605’ – 607’, all the cracks measured 0.013.
  - M Southbound lane, from 608’ – 613’, the cracks measured from 0.010, 0.013 – 0.016.

- N Northbound lane, from 609’ – 611’, all the cracks measured 0.010.
  - O Northbound lane, from 612’ – 617’, the cracks measured from 0.010 – 0.013.

- P Southbound lane, from 617.5’ – 625’, the cracks measured from 0.010 – 0.013.
  - Q Northbound lane, from 622’ – 625’, the cracks measured from 0.010, 0.013 – 0.016.

- R Southbound lane, from 626.5’ – 629’, all the cracks measured 0.010.
  - S Northbound lane, from 628’ – 631’, the cracks measured from 0.010 – 0.013.

- T Southbound lane, from 643’ – 644’, all the cracks measured 0.013.
  - U Northbound lane, around 644’, all the cracks measured 0.010.
  - V Southbound lane, from 927.5’ – 928’, all the cracks measured 0.010.

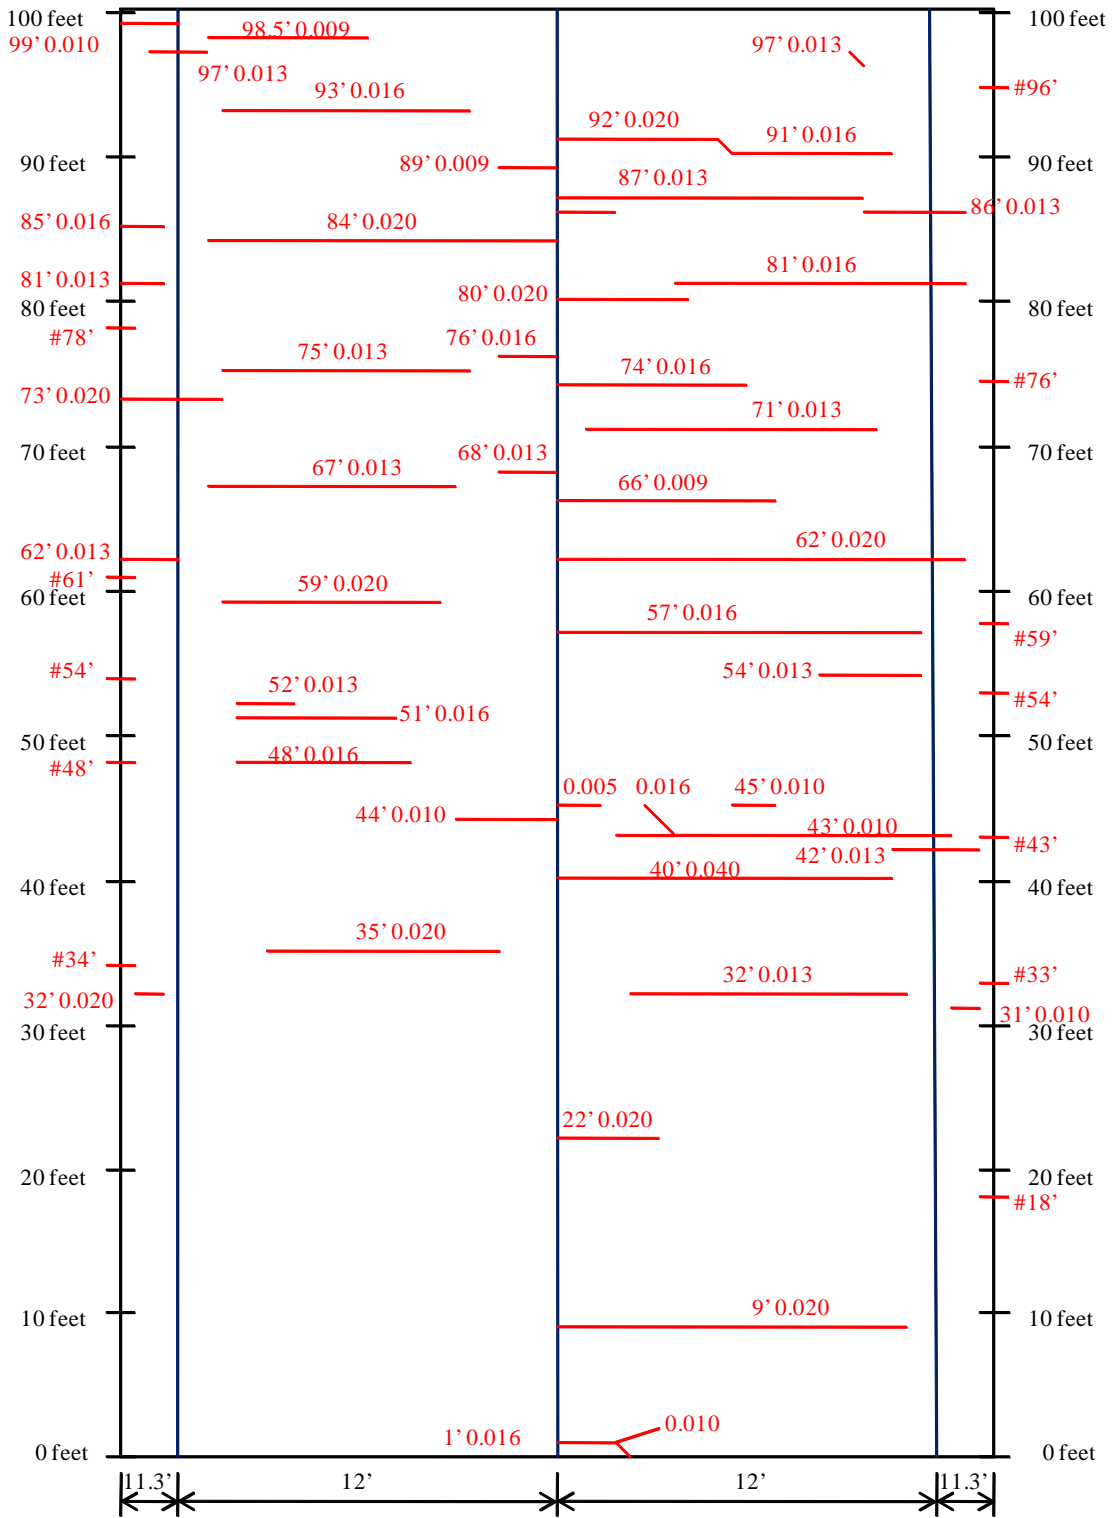
Rte. 104 over Brush Creek  
SN # 084-0065

Sangamon County – SN# 084-0065 – Surveyed 9/3/2002

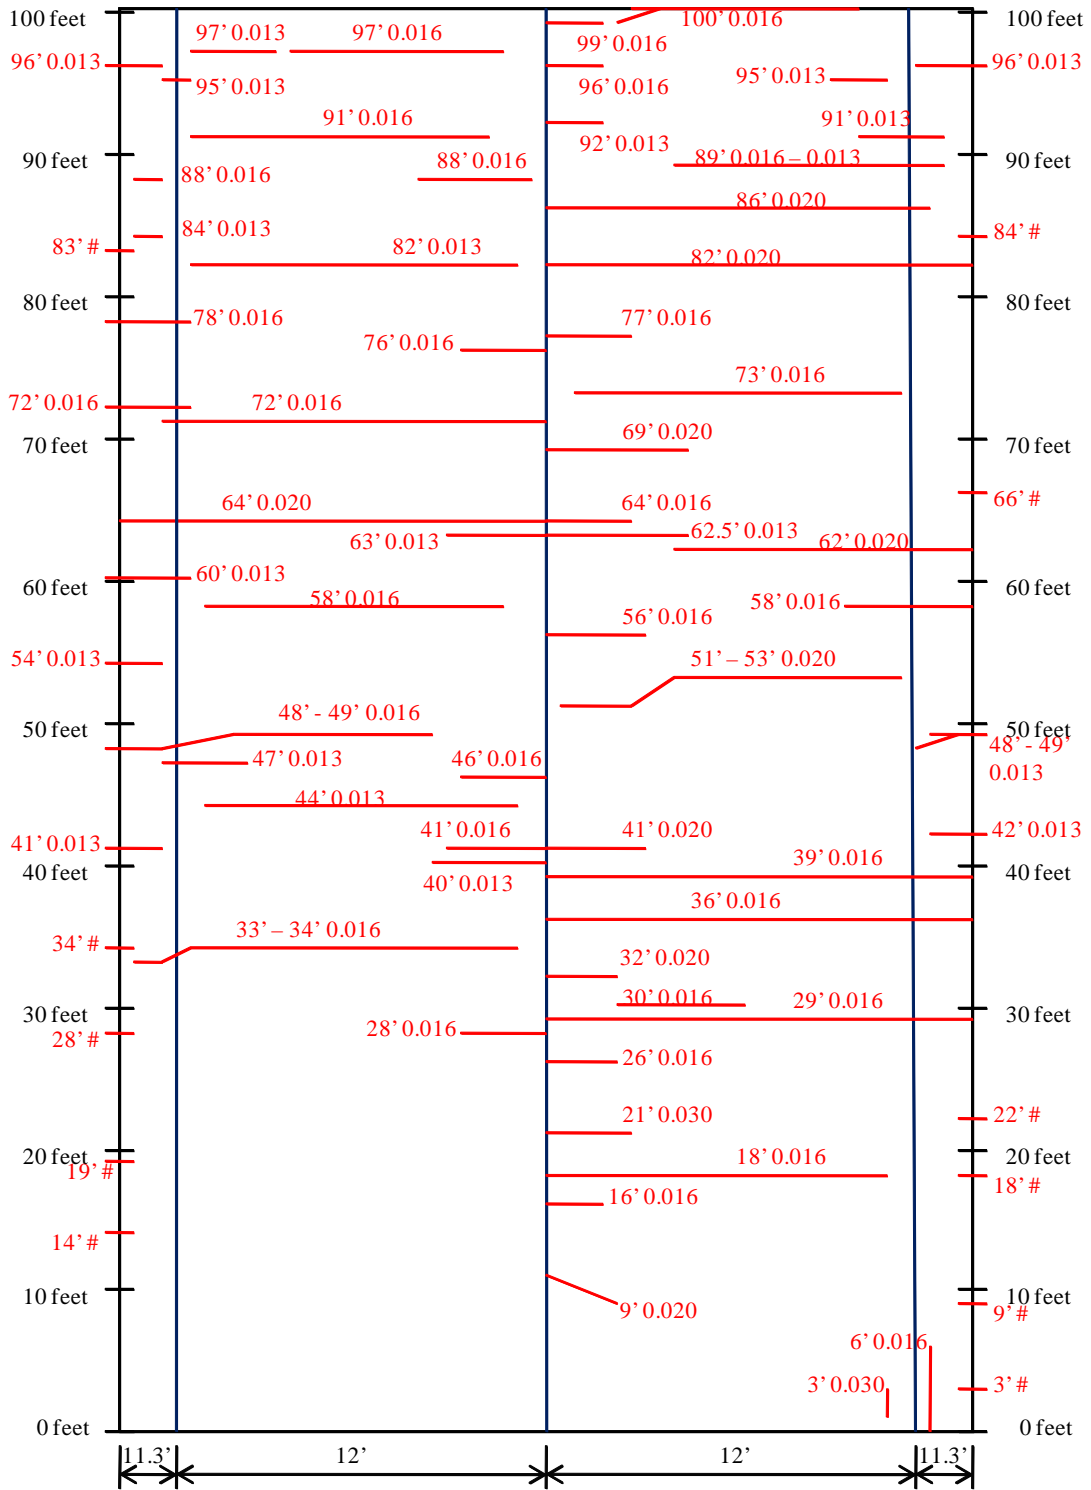
Sangamon County – SN# 084-0065 – Surveyed 9/26/2005

Map cracking was observed in the eastbound lane near the centerline from 9' to 89'.
