**EVALUATION OF HIGH PERFORMANCE  
CONCRETE BRIDGE DECKS  
AND  
OTHER EXPERIMENTAL BRIDGE  
DECKS THROUGHOUT ILLINOIS**

**PHYSICAL RESEARCH REPORT NO. 166  
December 2017**

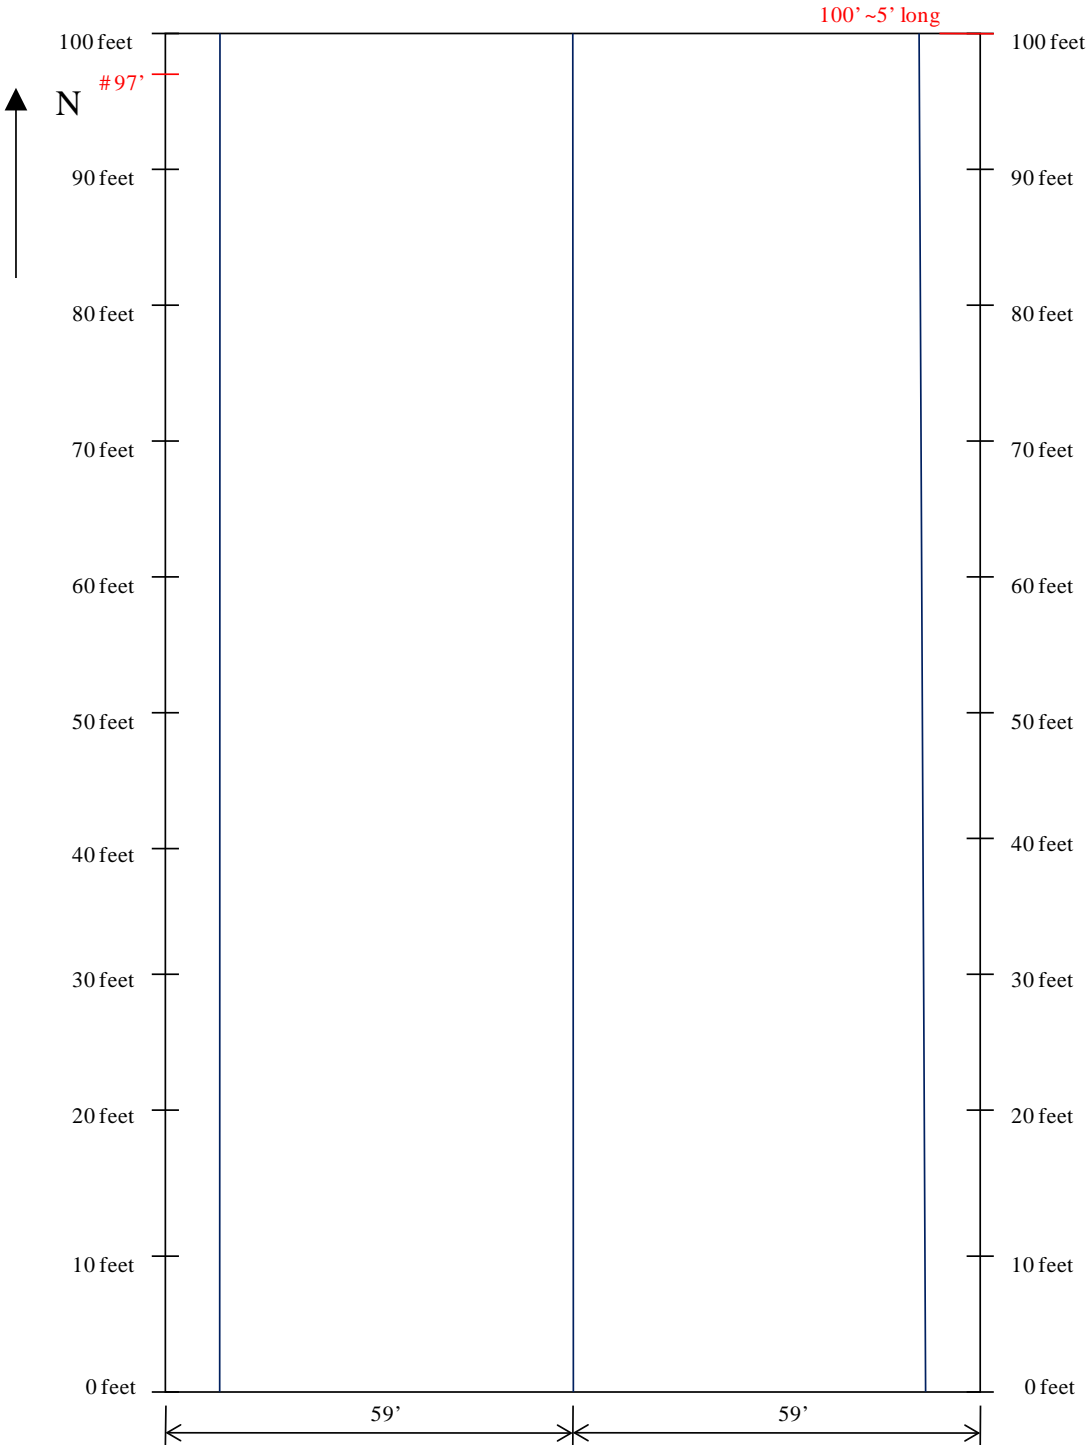
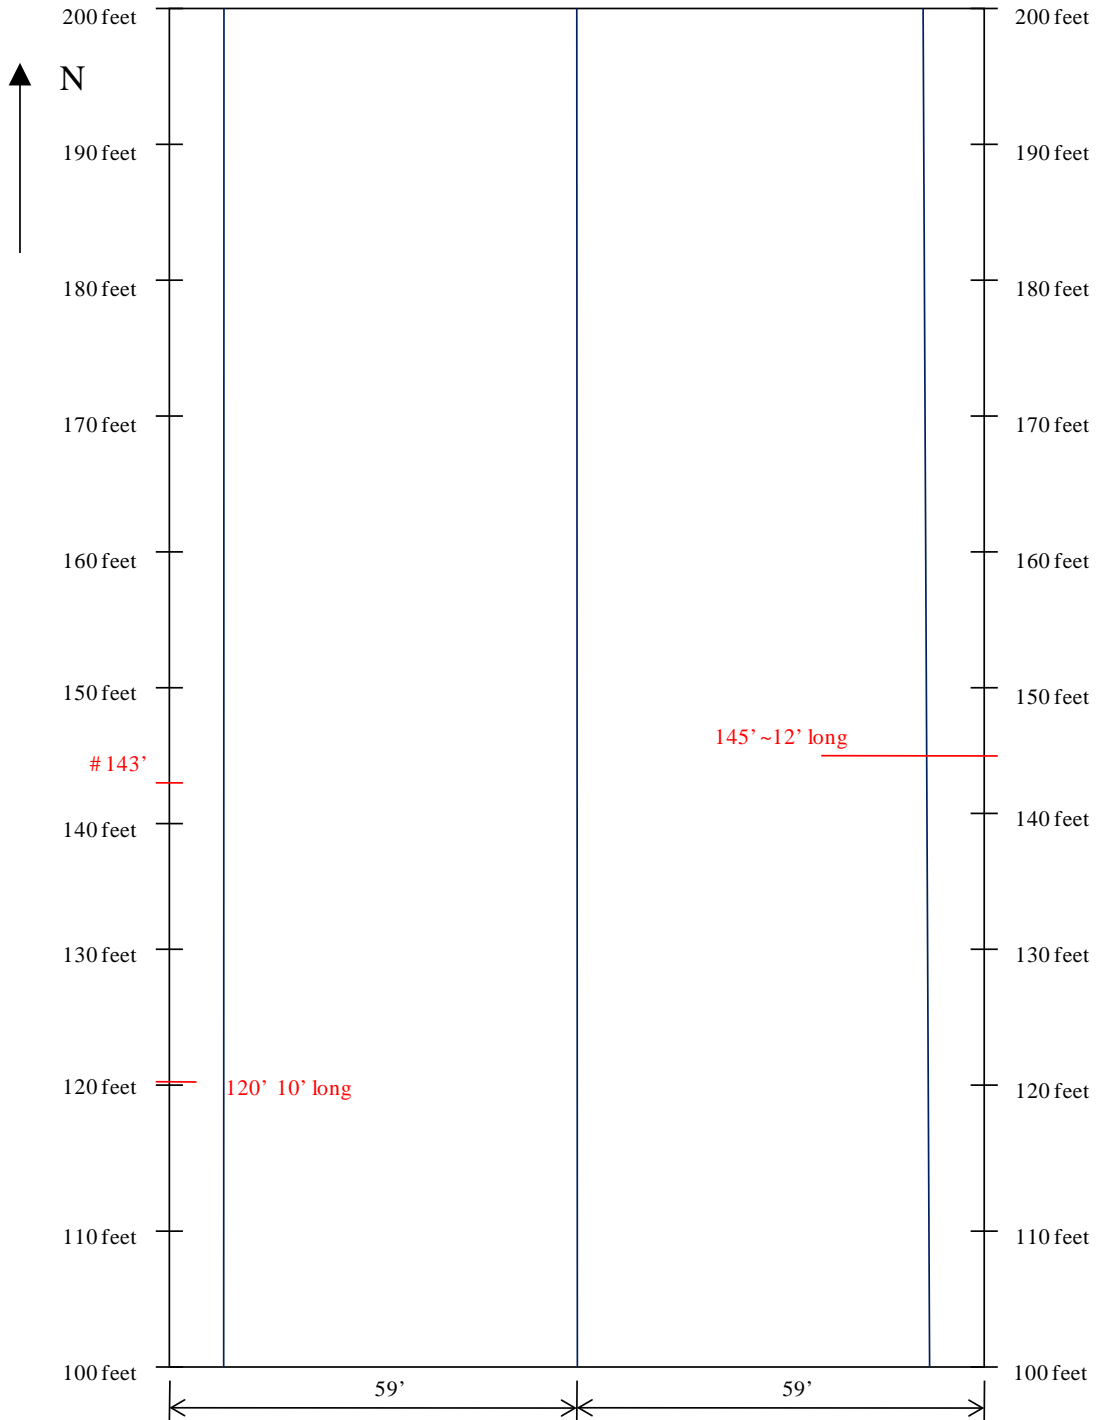
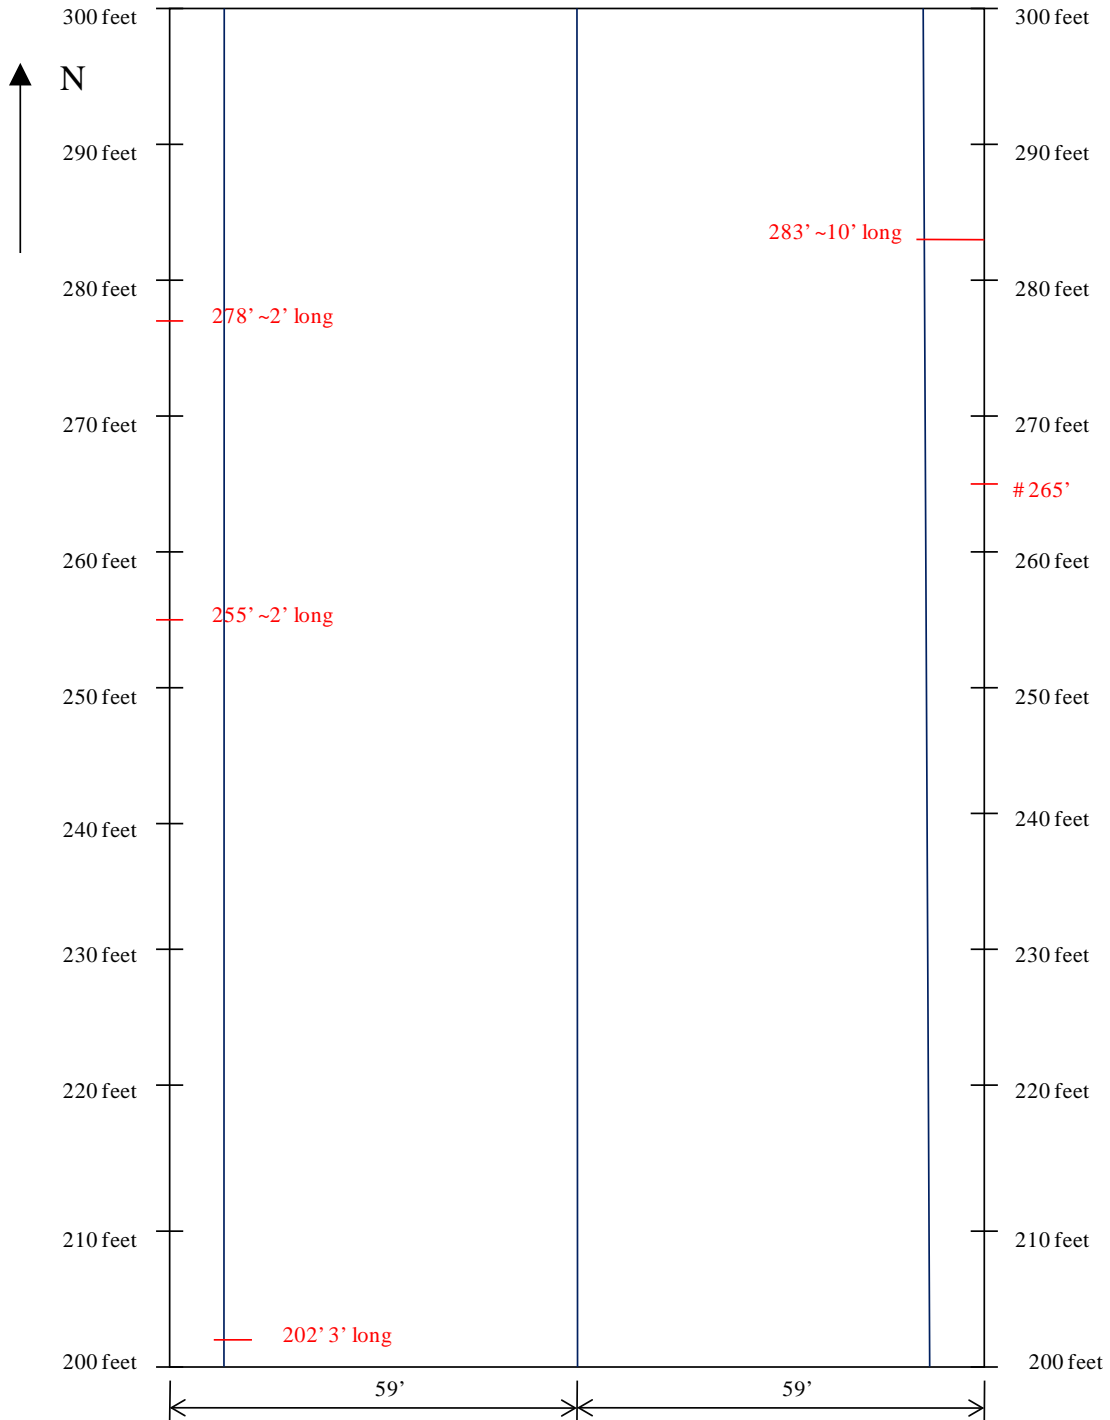
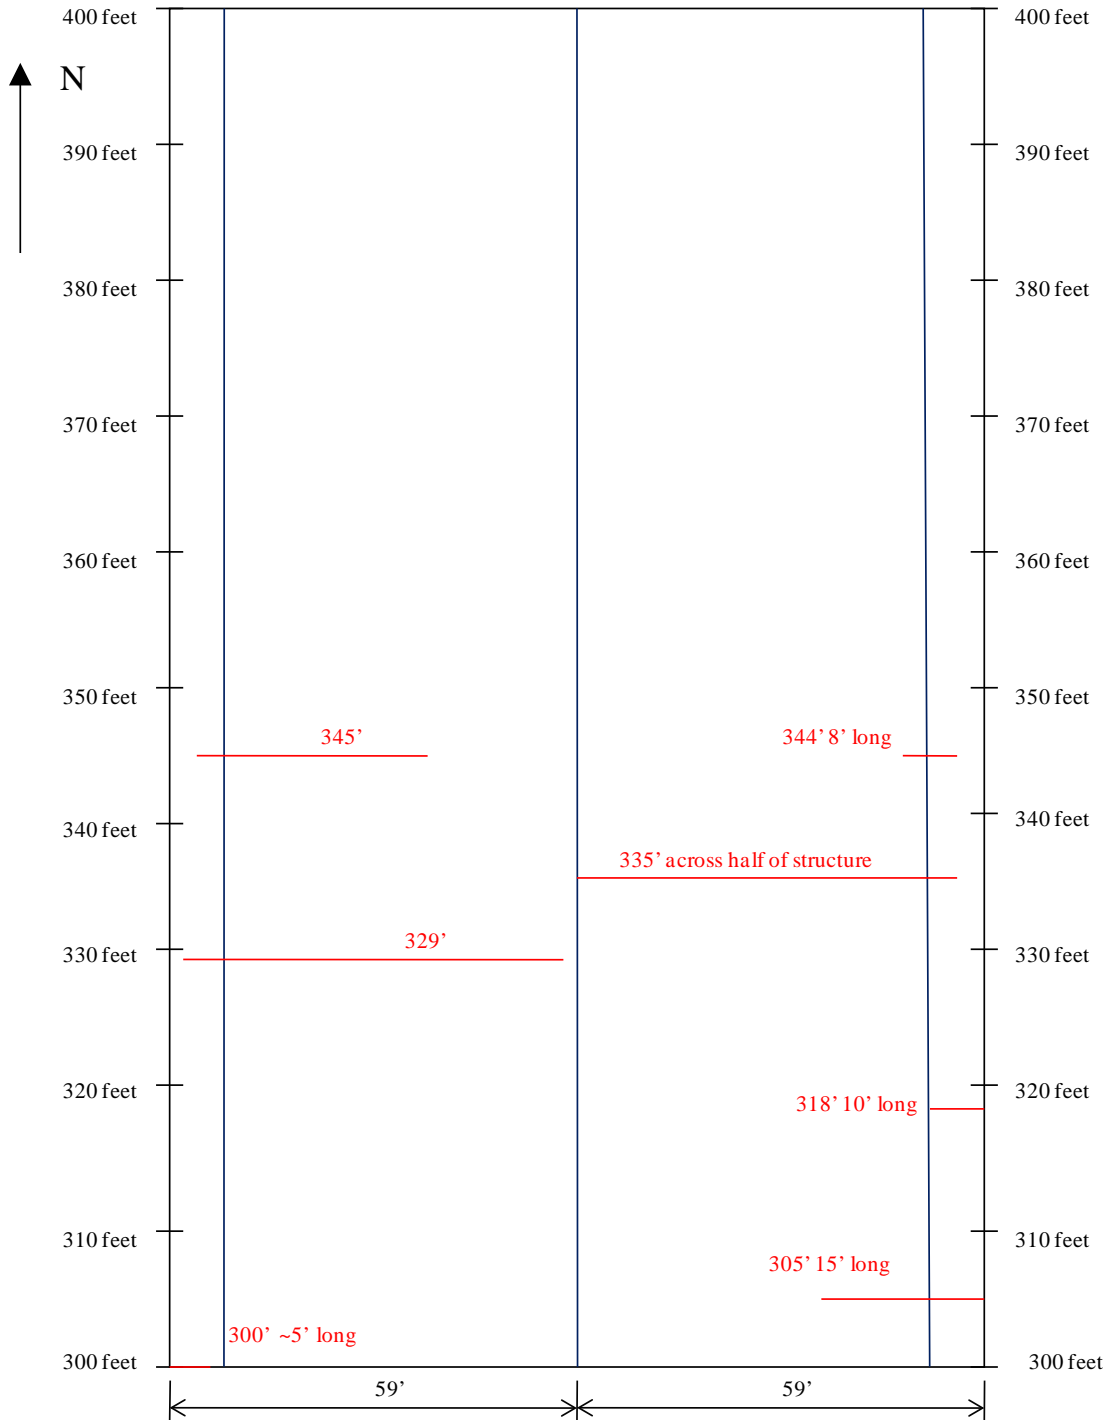
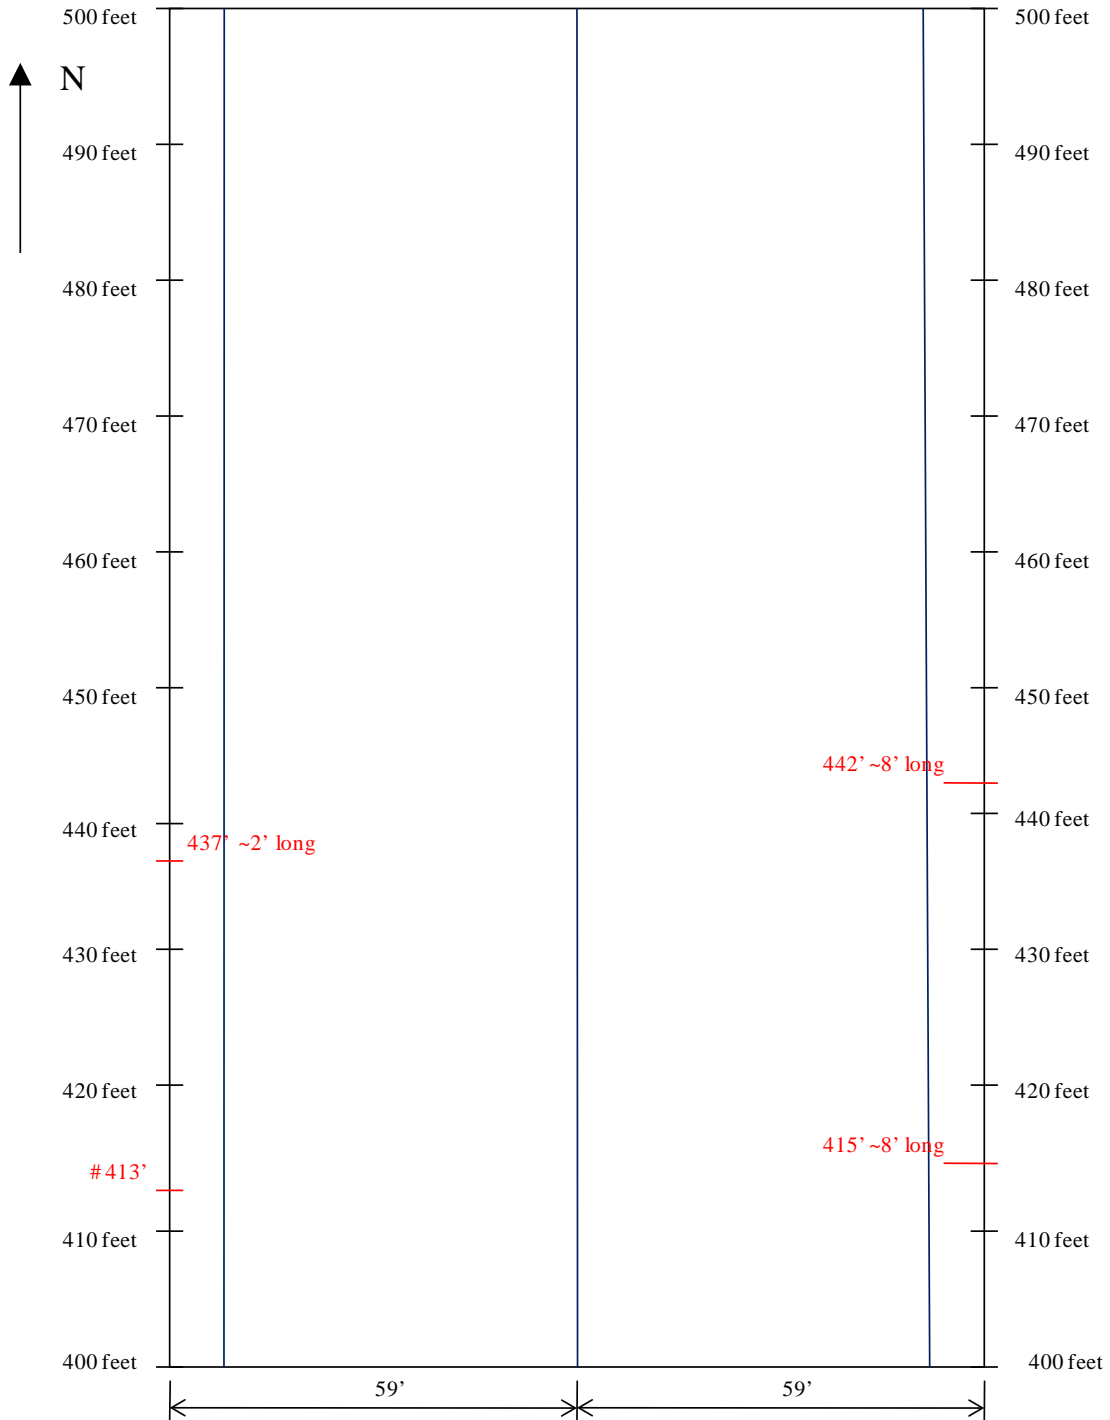
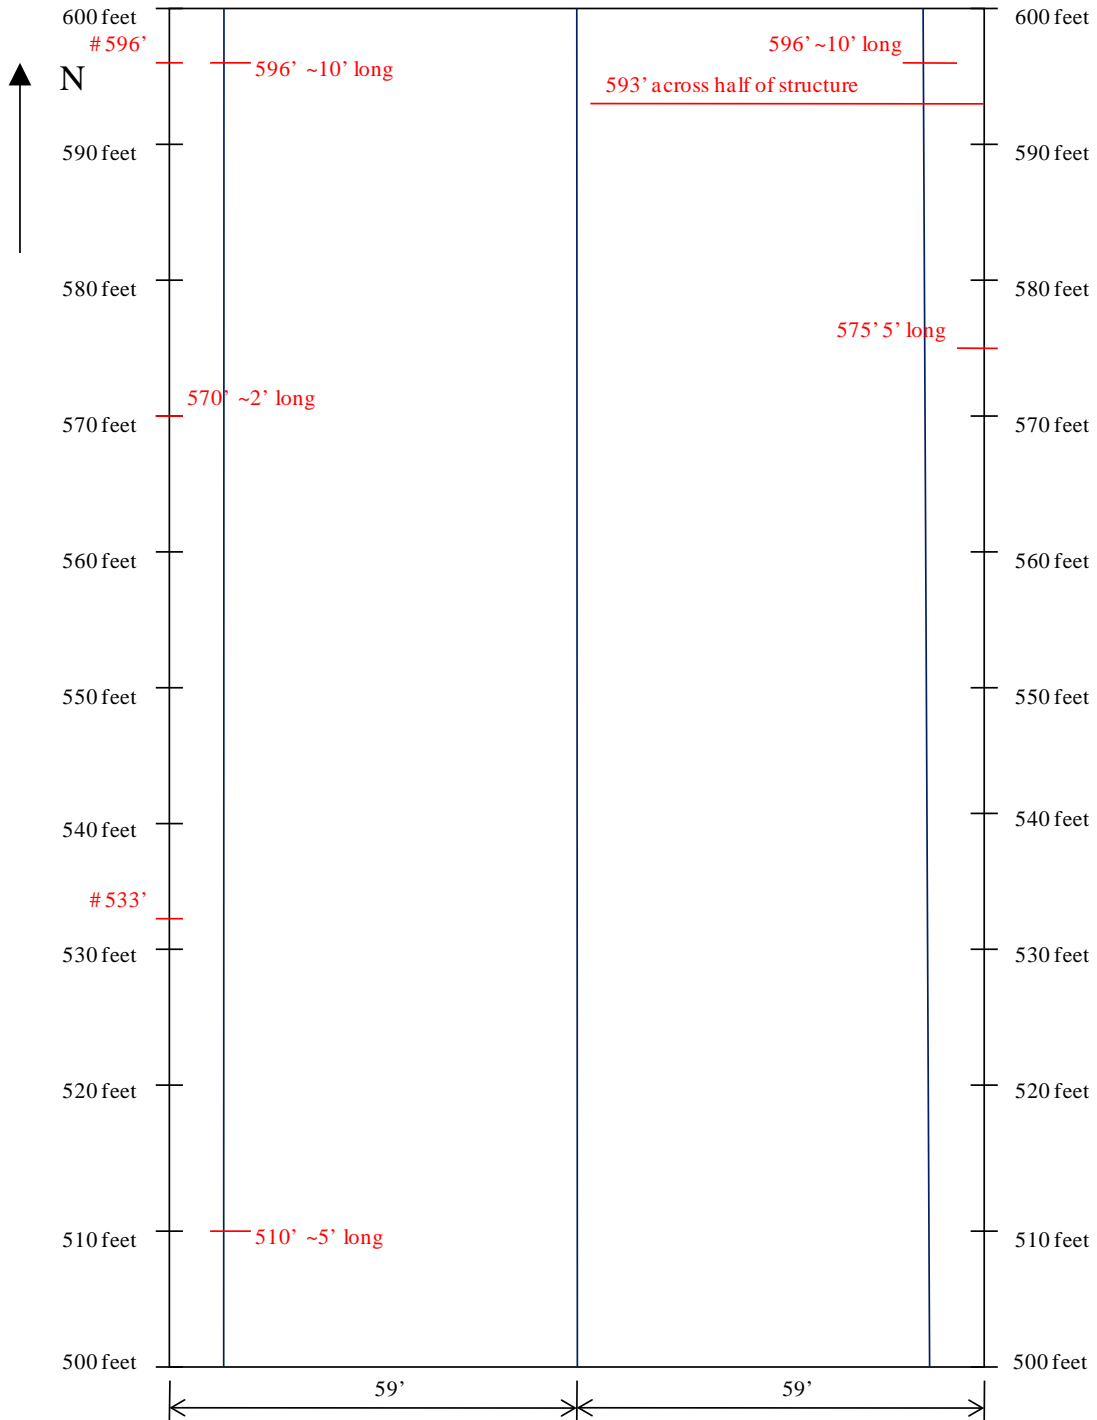
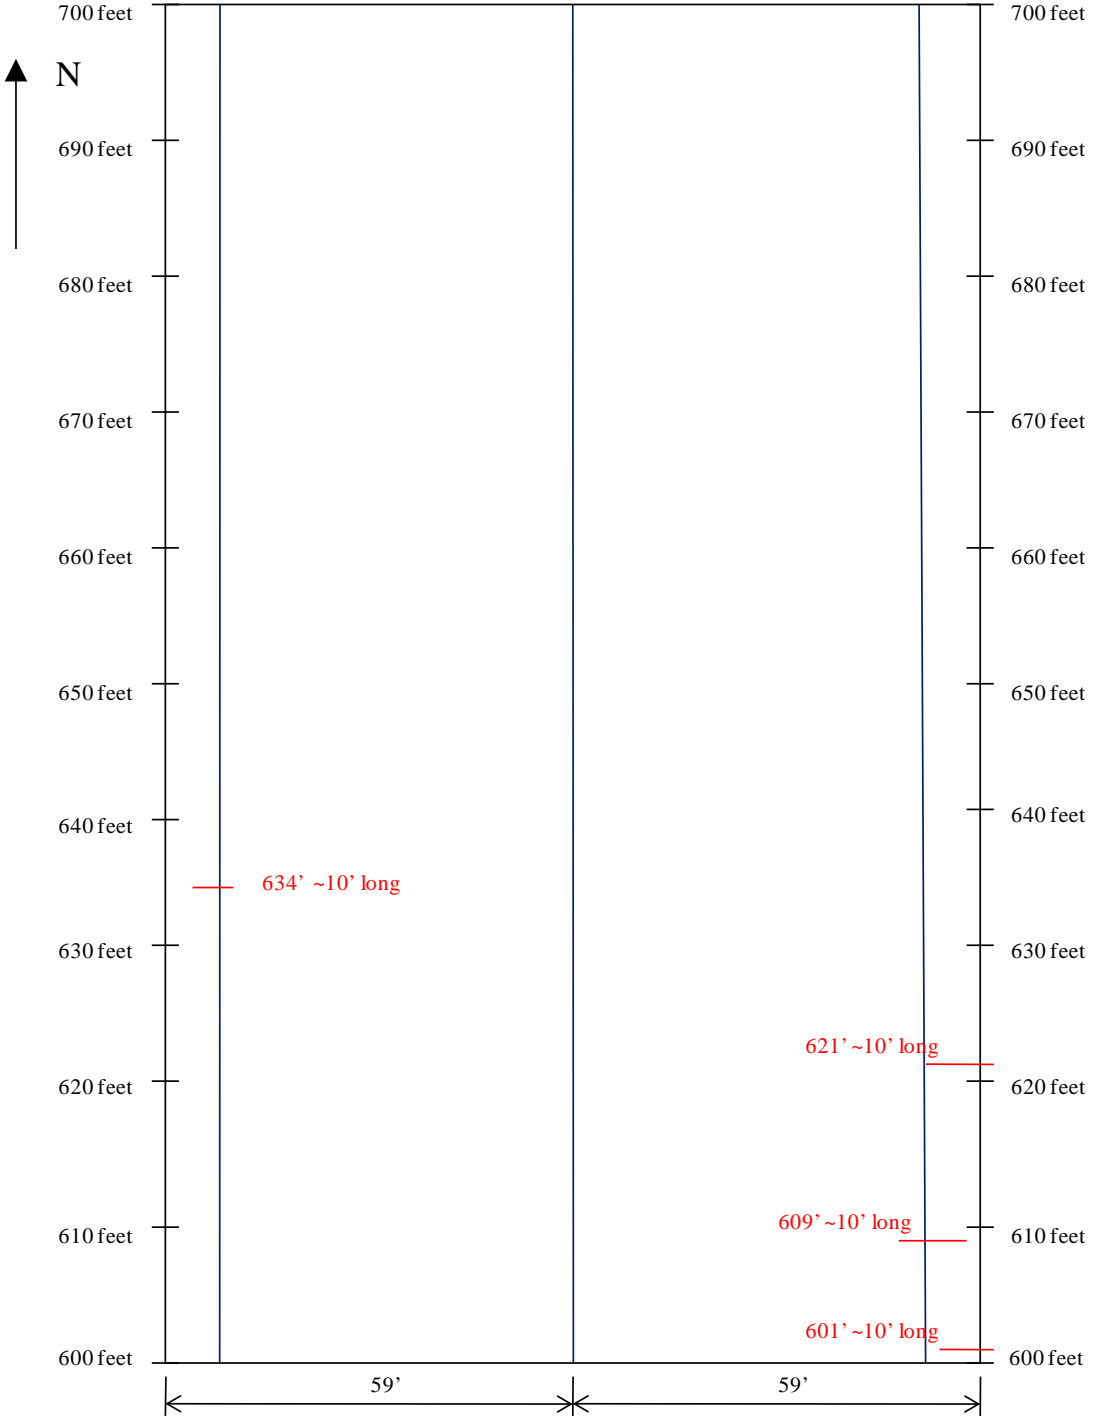
I-55 over Lake Springfield

Sangamon County – SN# 084-0500 NB – Surveyed 5/7/2002  
Sangamon County – SN# 084-0499 SB – Surveyed 5/7/2002
