Sustaining Performance of ASR-Affected Pavements: Effective Practices and Insights

Fatih Bektas, Principal Investigator
Department of Mechanical and Civil Engineering
Minnesota State University - Mankato

June 2025

Research Project
Final Report 2025-29

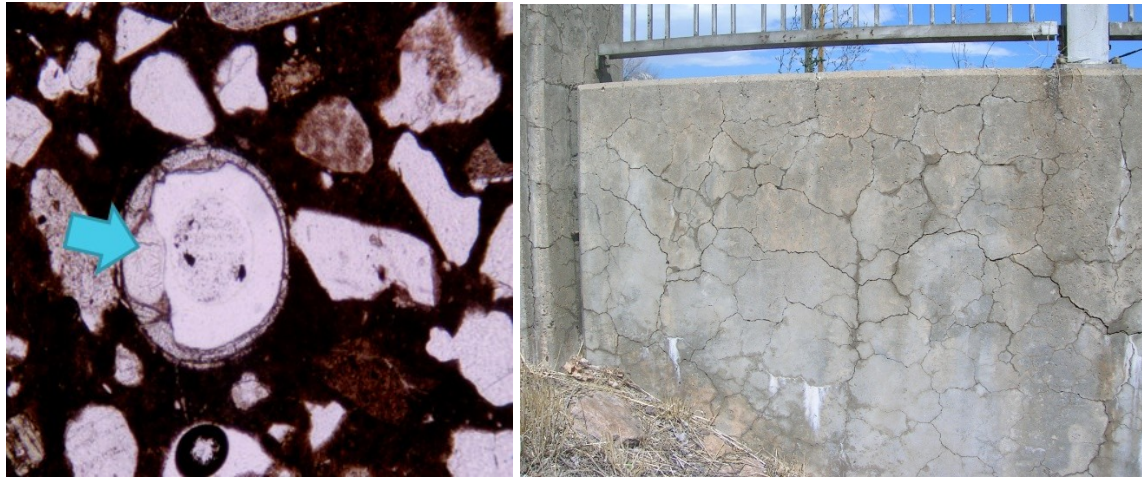
Alkali-silica reaction (ASR) is the deleterious chemical interaction of concrete alkalis in pore solution with reactive silica in aggregate. The reaction degrades the aggregate particle and produces an expansive gel known as alkali-silica gel (Figure 1). Alkali-silica gel intakes water and expands; the resulting stress is sufficient to crack concrete. A network of 3D cracking is common (Figure 1).

Figure 1.1: Alkali-silica gel lining an air void in mortar on the left, bridge abutment showing signs of ASR cracking on the right (*unpublished work*).

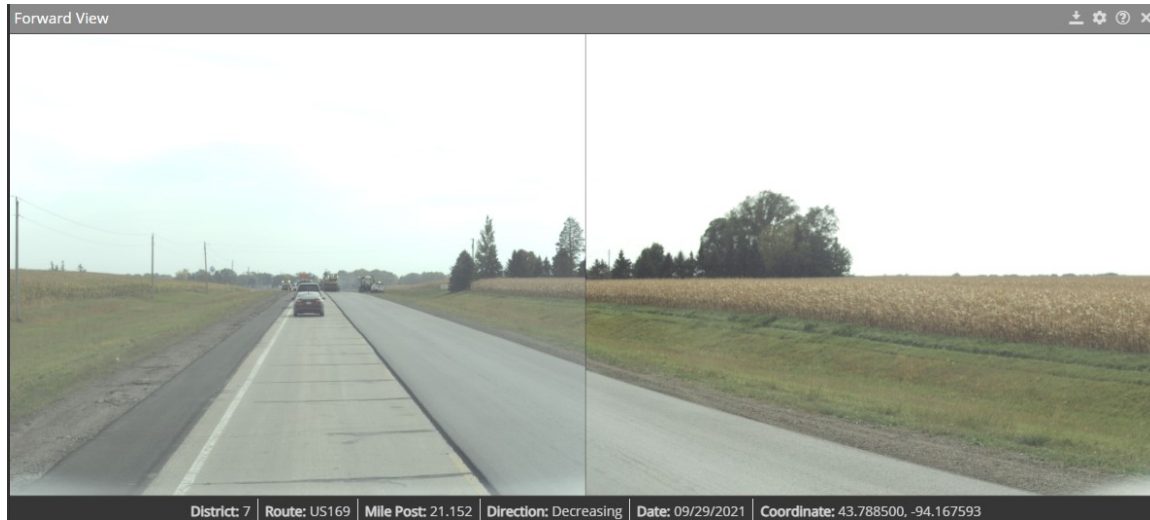
Figure 3.14 Asphalt overlay of US 169-WVC.

Some of these observations from RQI analysis are confirmed with Pathweb images collected via the MnDOT Pavement Management System (PMS), which include collection in years 2019, 2020, 2021, and 2022. US 169-BEW: seems overlaid in or just before 2019 and another surface treatment in 2022. Moreover, US 169-WVC images show original concrete pavement overlaid in 2021 (Figure 3.14).

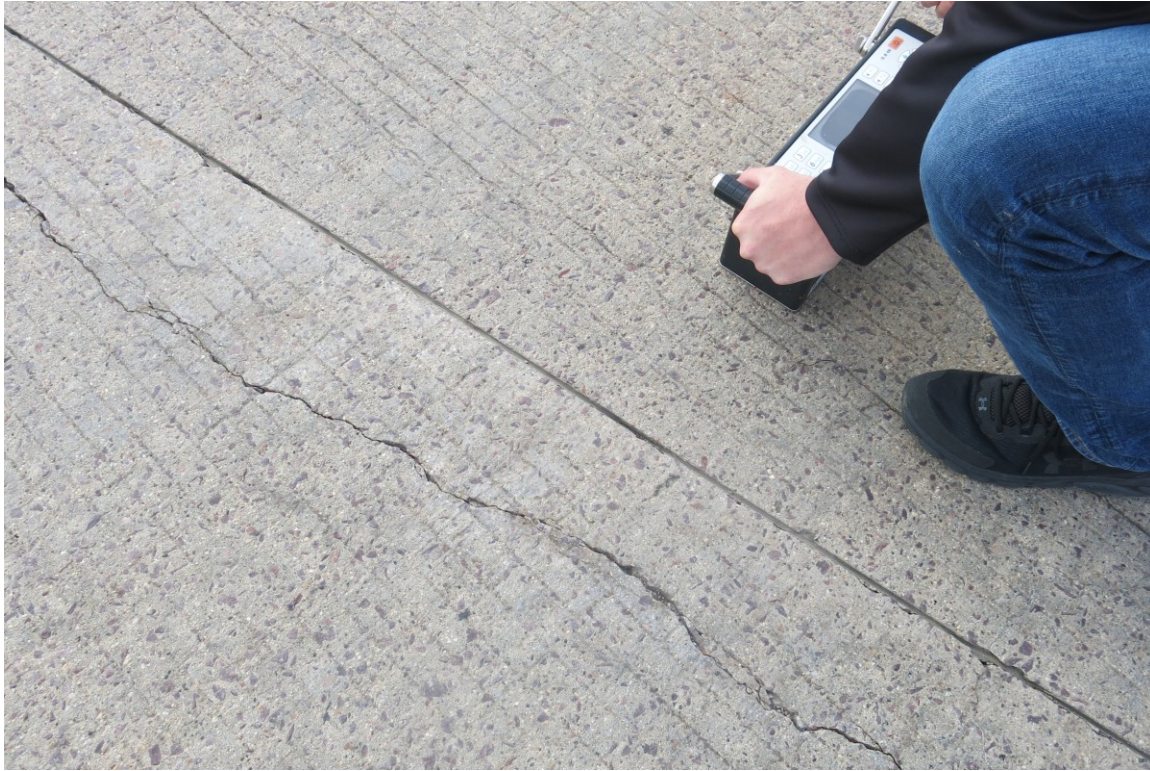
Figure 5.6 Pavement subsurface condition evaluation using ultrasonic tomography.

In this study, the ultrasonic tomography was utilized to assess the subsurface condition of concrete. An ACS A1040 model testing device was used. Alkali-silica reaction (ASR) is anticipated to manifest as a 3D cracking network within the concrete. Testing was conducted at sites with visible surface cracking (Figure 5.6) and at locations with no visible surface cracking (Figure 5.7). The working hypothesis is that ASR associated cracking may be present beneath the surface even if there are no visible signs at the surface. Measurement points were selected approximately one foot away from the joints and at mid-slab locations (Figure 5.8). Field observations indicate that cracking at the joints is severe. This is expected, as joints retain moisture longer than mid-slab sections, increasing moisture-related distress such as freeze-thaw cracking and ASR related deterioration.

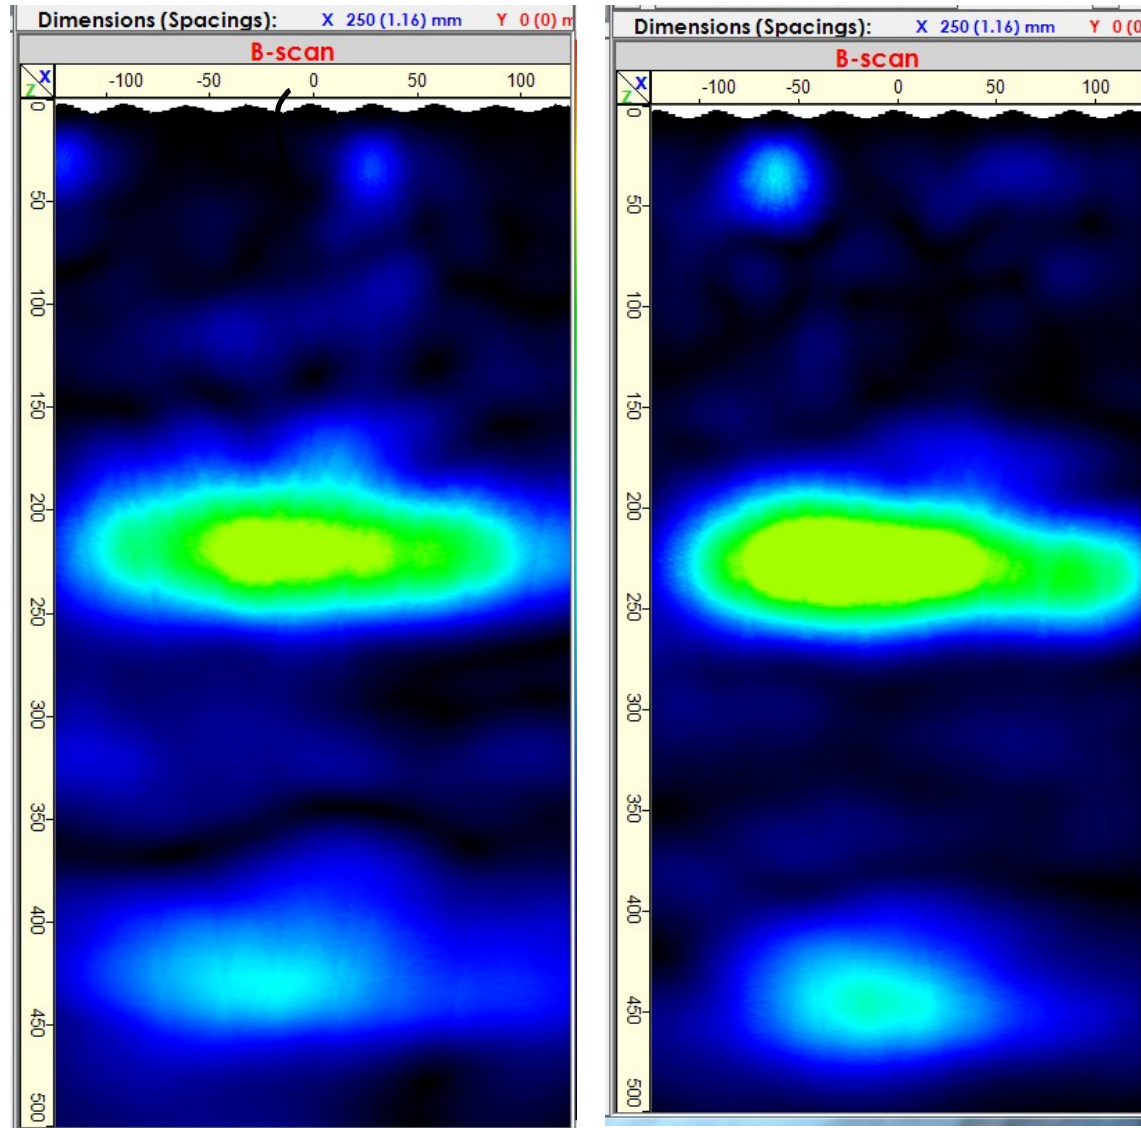
Representative ultrasonic tomography images from sites are presented in Figures 5.10-12. In these images, the green zone at between 200-250 mm represents the pavement-base interface, indicating the

transition from the dense pavement medium. The lighter-colored regions between the surface and the base indicate areas where signals travel through a medium of different density, suggesting potential cracking. Some slabs, particularly from Site #2, produced these images with higher intensity (Figure 5.13). Nonetheless, it is difficult to draw a firm conclusion. Further evaluation, such as physical sampling of the pavement cross-section, is needed to verify the connection between ultrasonic tomography imaging and ASR-associated cracking. Notably, no discernible differences were observed between joint locations and mid-slab areas.

Figure 5.10 Site #1 images taken close to joint (left) and at mid slab (right).

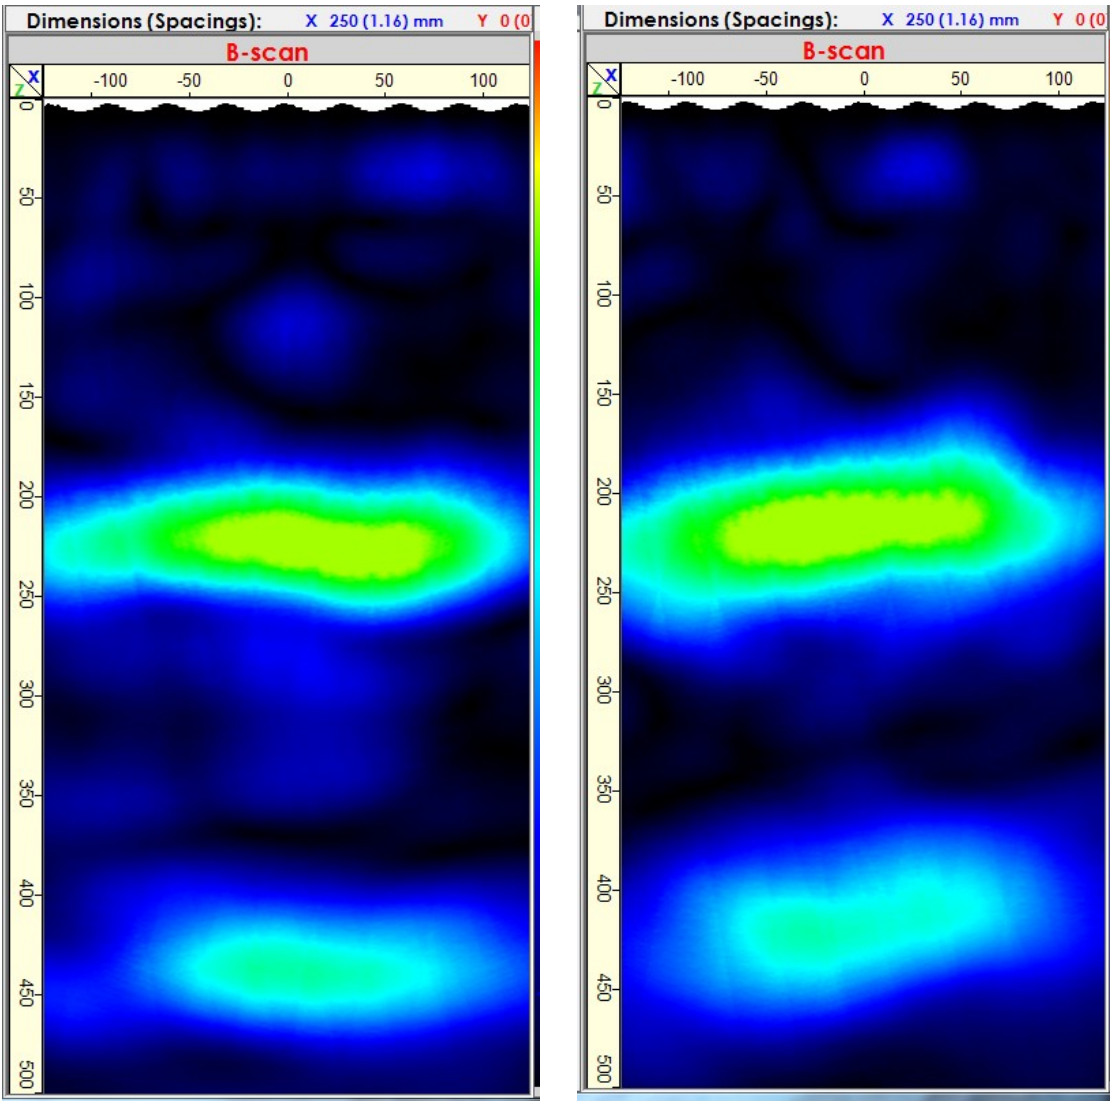
Figure 5.11 Site #2 images taken close to joint (left) and at mid slab (right).

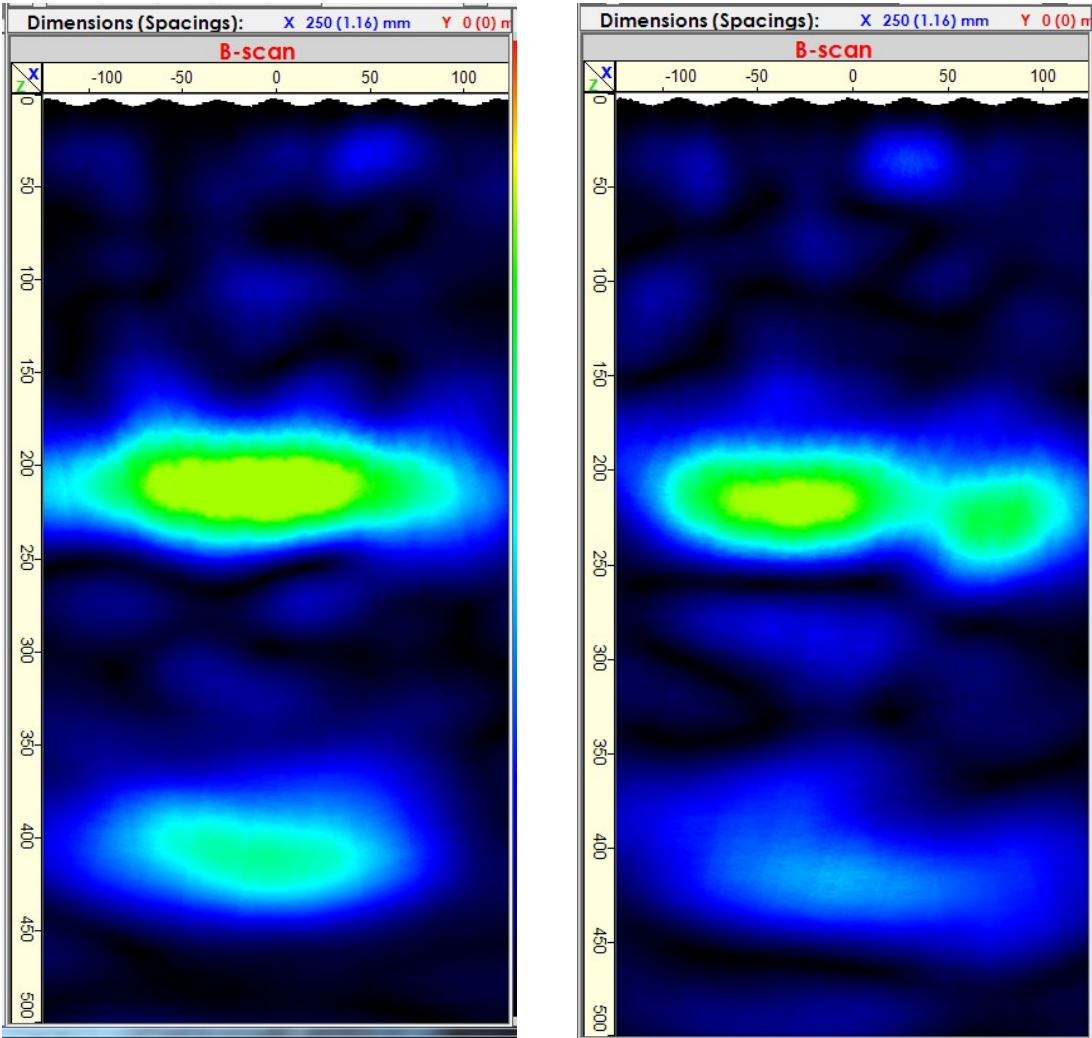
Figure 5.12 Site #3 images taken close to joint (left) and at mid slab (right).
