DOT HS 813 691

**Special Crash Investigations:
On-Site Ambulance Rollover
Crash Investigation;
Vehicle: 2019 Ford E350 Type III
Ambulance;
Location: North Carolina;
Date: January 2022**

Special Crash Investigations
On-Site Ambulance Rollover Crash Investigation
Case No.: CR22003
Vehicle: 2019 Ford E-350 Type III Ambulance
Location: North Carolina
Crash Date: January 2022

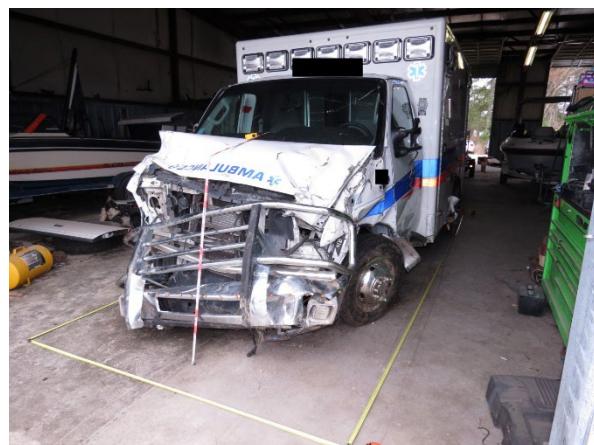
Figure 1. Left front oblique view of the ambulance

This on-site investigation documents the multi-event rollover crash of a 2019 Ford E-350 Type III ambulance (Figure 1) conducting an inter-facility transport due to the patient's heart condition. Operating without the use of its emergency lights or sirens, the ambulance was traveling westbound and negotiating the left curve of a four-lane highway when it encountered icy pavement. The ambulance lost traction and rotated counterclockwise. The driver oversteered to the right to regain control, causing the ambulance to yaw clockwise into the right lanes. It departed the right side of the roadway and struck a guardrail (Event 1). Its mass and impact angle caused the ambulance to penetrate the guardrail and go down an embankment, entering a left-side-leading rollover (Event 2), striking several trees with its undercarriage (Event 3), which interrupted the rollover. It came to rest at the bottom of the embankment on its wheels after completing four quarter-turns. The ambulance was driven by a belted 20-year-old male, with an unbelted 32-year-old male emergency medical technician (EMT) in the rear-facing captain's chair, and an 84-year-old female patient partially restrained on the cot by lateral foot and thigh straps. The driver and EMT suffered police-reported C-level possible injuries. They were transported by ambulance to a level 1 trauma center where they were treated and released. The police reported K-level (fatal) injuries for the patient. According to the driver and EMT's interviews and her medical report, the patient was transported from the crash by ambulance to a level 1 trauma center but suffered cardiac arrest during transport. She was pronounced deceased prior to admission to the trauma center. The ambulance was pulled up to the embankment and towed from the scene to a secured location for the duration of the police investigation. It was later released to the ambulance agency and towed to a secondary secured lot where it remained for this investigation.

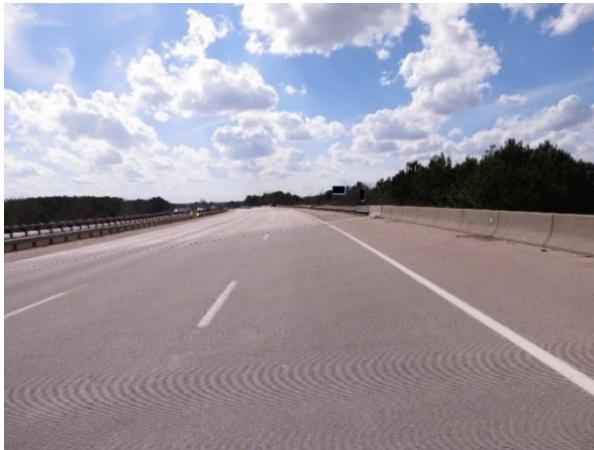
Figure 2. Approach of the ambulance looking west

The highway consisted of a large radius left curve with 2° superelevation running right to left. In the immediate area of the crash was a concrete overpass with a posted speed limit of 113 km/h (70 mph) (Figures 2 and 3). The right-most lane was an entrance lane from the overpassed roadway below. All lanes were 3.6 m (11.8 ft) wide and separated by dashed white lane lines. There was a W-beam guardrail bordering the right side of the roadway that was 65 cm (25.6 in) tall and supported by I-beams spaced every 1.9 m (6.2 ft). The roadside beyond the guardrail dropped down 11.8 m (38.4 ft) with a 40 to 45 percent graded slope. The ground was soft earth covered by a thick layer of pine needles. Small brush and softwood trees were growing sporadically along the embankment (Figure 4). The embankment bottomed out into a level wooded area of softwood pine trees (Figure 5). A crash diagram is included at the end of this report.

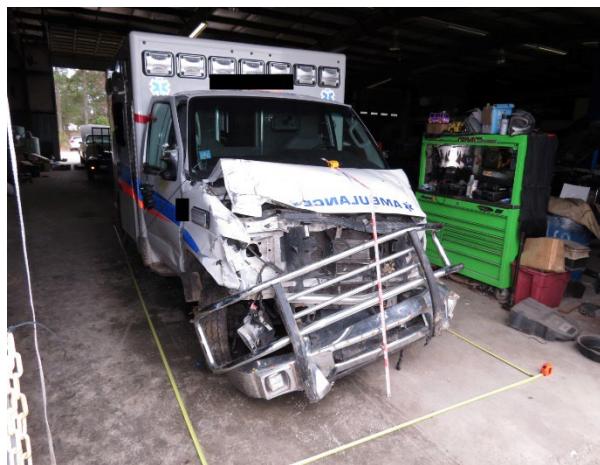
Figure 6. Right front oblique view of the Ford

The 2019 Ford E-350 (Figure 6) was identified by the VIN 1FDWE3FS8KDxxxxxx. The two-door van-based vehicle was manufactured as an incomplete unit in 2019. Due to damage, the left front door was jammed shut and the certification label was unavailable. The Ford was completed as a Type III ambulance during secondary manufacturing in September 2019 by Medix Specialty Vehicles (Elkhart, Indiana). Emergency services equipment such as warning lights, reflective signage, sirens, and radio communications were also installed in the cab and on the exterior of the vehicle. An external stainless steel bull bar was installed over the secondary manufacturer's bumper. The ambulance had a 6.8-liter, V10 gasoline engine linked to an automatic transmission with rear-wheel drive. The ambulance did not have any crash avoidance equipment. It had two forward-facing cloth bucket seats with 3-point lap and shoulder seat belts with adjustable D-rings. The overall length of the ambulance was 670 cm (263.7 in) with a width of 213 cm (83.8 in). The wheelbase was 375 cm (147.6 in) with the exterior of the patient compartment measured 370 cm (145.6 in) long by 229 cm (90.1 in) wide and 210 cm (82.6 in) tall. The interior of the compartment measured 172 cm (67.7 in) long by 115 cm (45.2 in) wide and 172 cm (67.7 in) tall.

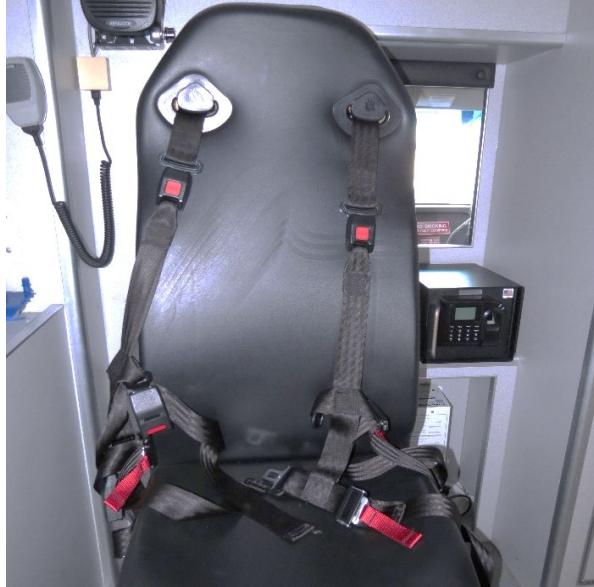
Figure 16. Viewing the belt systems of the captain's chair

The patient compartment had 5-point harnesses for the captain's chair and the bench seats on the right rear side of the compartment (Figure 16). The three seats were fitted with retractor systems

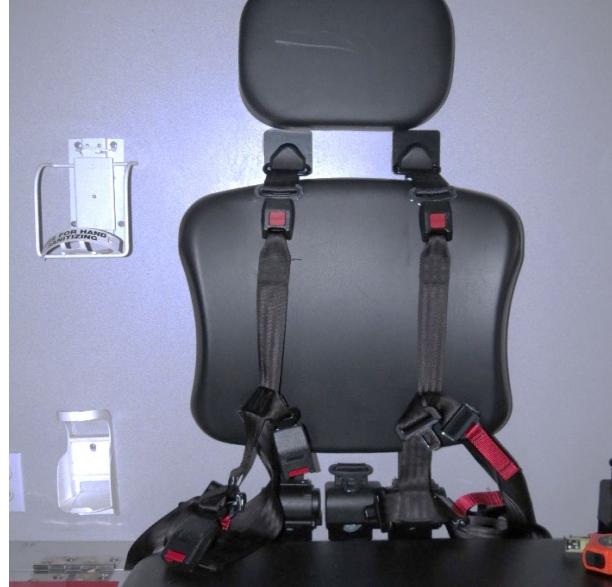
Figure 17. The right bench seat belt systems with retractors at the base

at the base of the seat backs (Figure 17). The EMT was unbelted in the captain's chair at the time of the crash.

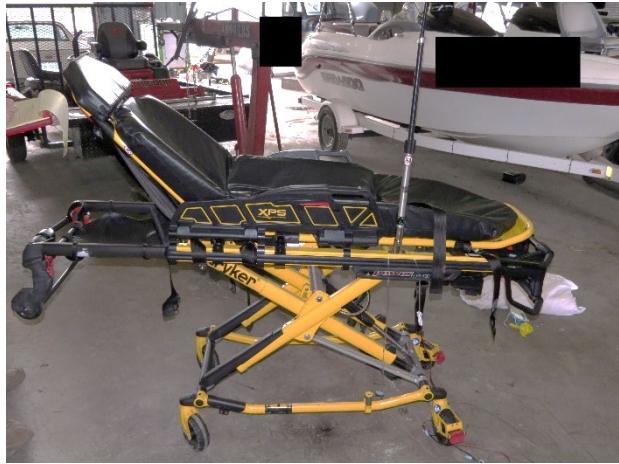
Figure 18. The Stryker cot viewing right side

The wheeled ambulance cot was a Power-Pro XT Model 6506, manufactured by Stryker. Its serial number was S/N: 1908xxxxxxxx and it was manufactured in September 2019. The Stryker cot (Figure 18) was constructed of a tubular aluminum frame with circumferential weld joints and steel hardware fasteners. The X-frame supporting the mattress platform featured power lift capabilities with infinite height positions between a minimum of 36 cm (14.1 in) and a maximum of 105 cm (41.3 in). The mattress platform featured 0- to 73° of positive backrest angular adjustment via a manually controlled gas-pressure cylinder. In a similar fashion, the leg portion featured 15° of positive angular adjustment. Overall dimensions of the cot were 58 cm (22.8 in) wide and 206 cm (81.1 in) long. A placard declared the loaded capacity limit of the cot to be 317 kg (700 lb). Electrical power was supplied by a removable 24-v nickel-cadmium direct current battery. There was no damage to the cot frame or cross members.

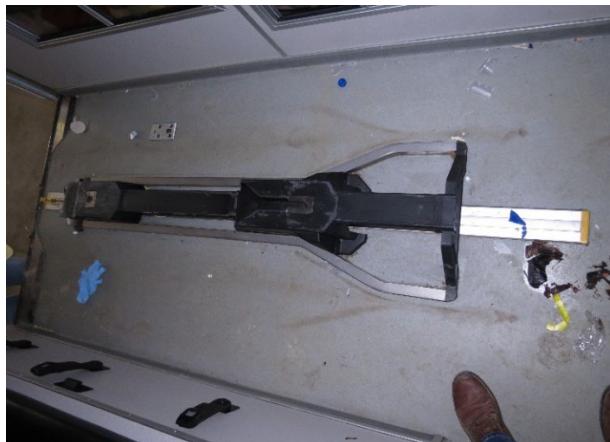
Figure 19. View of the cot latching system

The Stryker cot was secured to the ambulance by the Performance-Load² system. The mount was identified by the S/N: 2019xxxxxxxx. The cot was attached to the mounting system at the time of the investigation with no apparent damage from the crash (Figure 19). The cot remained secured to the latching system throughout the crash sequence. The Stryker cot had a multi-point harness system for manual restraint of its occupant that had lateral foot, thigh, and lap straps, and an upper torso harness. The three lateral straps had adjustable latch plates and sewn-on buckles. The torso harness had two shoulder straps with latches that buckled at the lateral lap strap position (Figure 20). The EMT reported that the patient was restrained by only the foot and lap straps. However, due to evidence observed during the SCI inspection it was determined that the patient was only restrained by the foot and thigh straps.

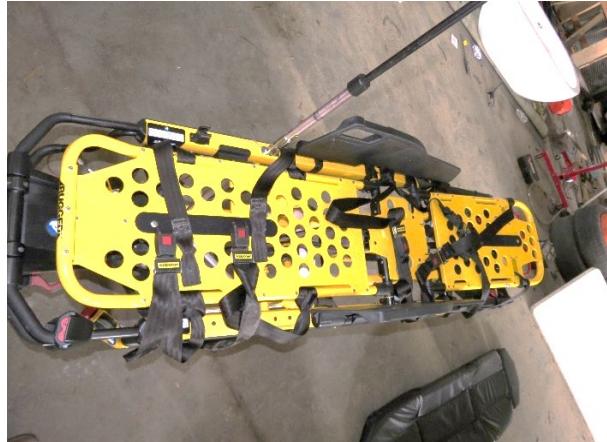
Figure 20. Safety belt system of the cot (looking left to right, foot, thigh, lap, and shoulder straps)
