# **INVESTIGATION OF MAINTENANCE BASE REPAIRS OVER EXPANSIVE SOILS: YEAR 1 REPORT**

Report 0-4395-1

Research Project Title: Optimum Spot Base/Subgrade Repair Techniques for Moderate to High  
Traffic Highways over Highly Expansive Subgrade Soils

October 2002

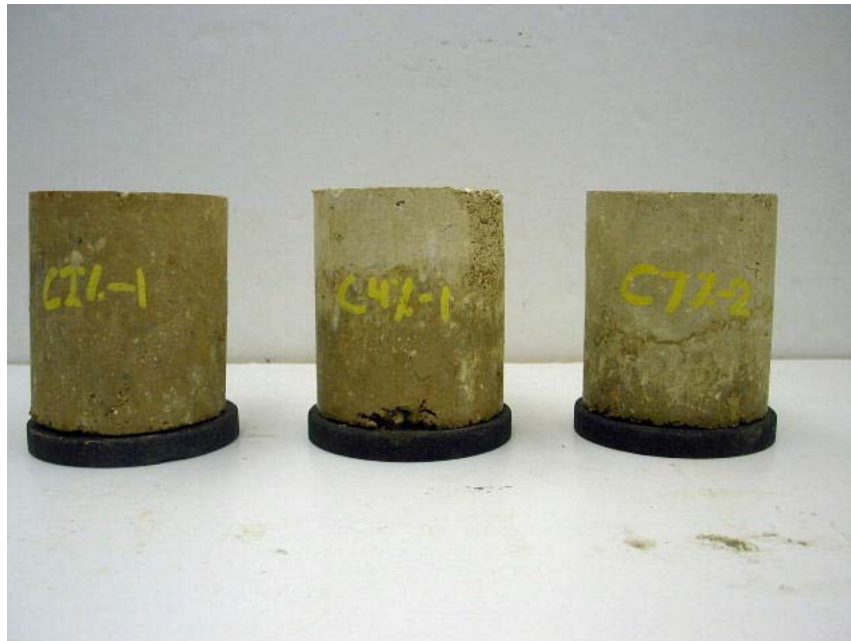
**Figure 34. Representative Colorado Cement-Treated Base after the TST.**  
*L to R: 2 percent, 4 percent, and 7 percent Type 1 Cement.*

As shown previously in Table 6, neither of the untreated materials had a final dielectric value below 10 after the TST, meaning personnel should consider some type of treatment to improve base performance if moisture is available in field conditions. Thus, TTI tested the cement-treated materials in the TST. Figure 33 presents the results from the TST on the cement-treated specimens. The Colorado Materials aggregate required 4 percent cement before a final dielectric value less than 10 was achieved, whereas the Vulcan aggregate with only 2 percent cement had a final dielectric below 10. The greater degree of moisture susceptibility of the Colorado Materials aggregate is visually evident when contrasting Figures 34 and 35. Figure 34 shows how the height of water rise progressed all the way through the Colorado aggregate with 2 percent cement. Figure 35 illustrates that the height of water rise is only about one-half that of the sample in the Vulcan aggregate with 2 percent cement.

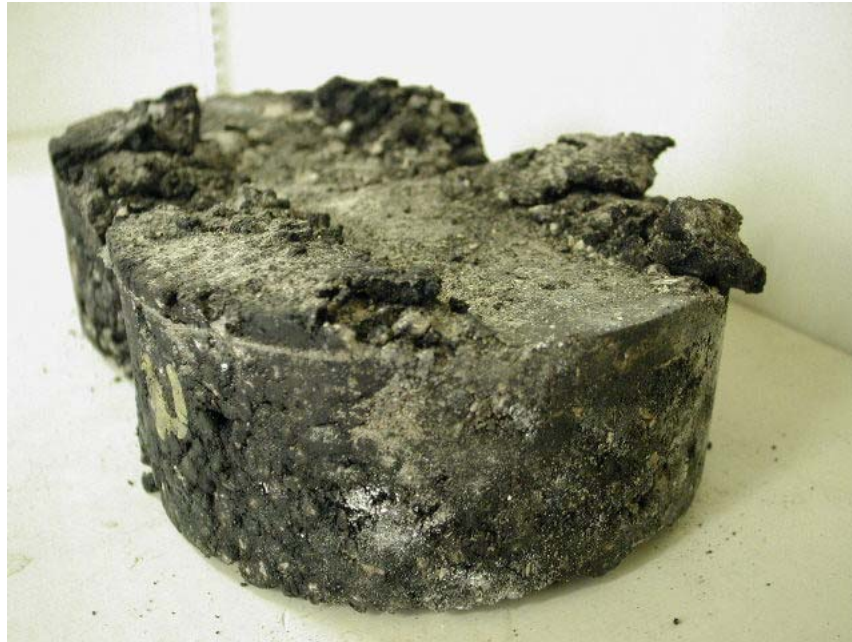
**Figure 39. Black Base after Hamburg Test.**

Table 10 presents the results from the Hamburg test on the black bases. Both the materials reached the failure limit before one-fourth of the test had been completed. Figure 39 shows a representative black base sample after the Hamburg test.

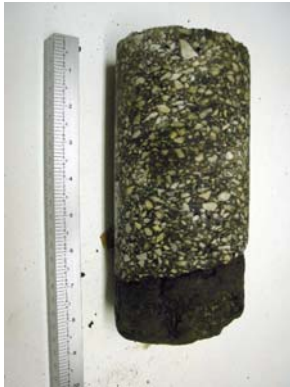
### FM 1818 Hole #1

Depth (in.)	PI	General description
0-7	---	Surface
8.5-13	10	gray sandy clay
13-16	9	tan clayey sand
16-20.5	10	tan clayey sand

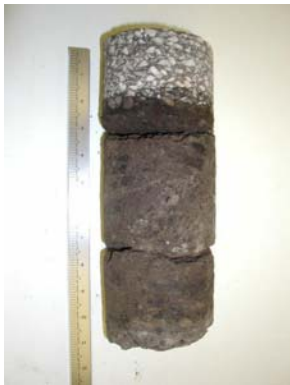
### FM 1818 Hole #2

Depth (in.)	PI	General description
0-2	---	Surface
2-10	--	Base
10-15	6	tan and gray clayey sand
15-18.5	11	gray sandy clay
18.5-22	6	tan and gray clayey sand
22-26.5	9	tan clayey sand

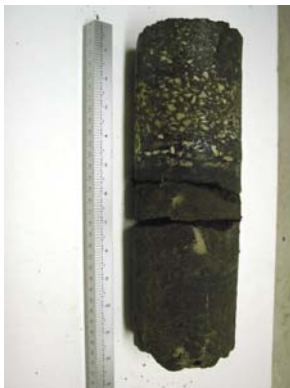
### FM 1818 Hole #3

Depth (in.)	PI	General description
0-2	---	Surface
2-5	---	black base
5-11.5	---	Subgrade
11.5-16	8	tan clayey sand
16-20	8	tan clayey sand

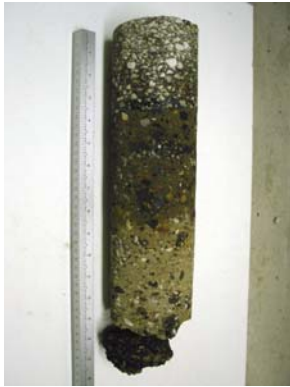
### FM 226 Hole #1

Depth (in.)	PI	General description
0-3.5	---	Surface
3.5-14	---	CTB
14-16	---	old road surface
16-21	6	reddish tan and gray clayey sand
21-29	19	sand at top and reddish clay at bottom
29-34	53	reddish tan and gray fat clay
34-38	32	reddish tan and gray clay

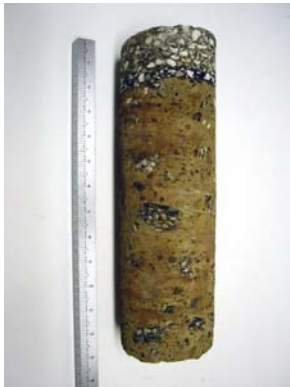
### FM 226 Hole #2

Depth (in.)	PI	General description
0-2.5	---	Surface
2.5-12.5	---	CTB
12.5-18	4	brown clayey sand
18-22	4	brown clayey sand

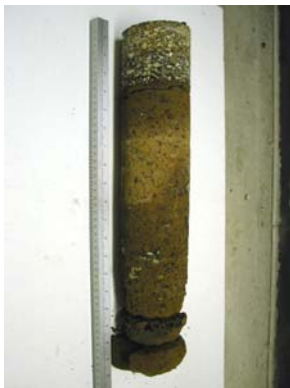
### FM 226 Hole #3

Depth (in.)	PI	General description
0-2	---	new surface
2-4	---	old surface
4-17	---	CTB
17-21	---	old road surface
21-29	13	reddish sandy clay with gravel
29-33	18	reddish sandy clay
33-36	15	reddish sandy clay

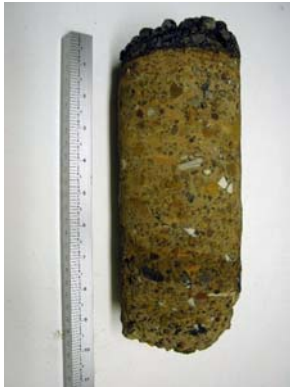
# FM 2076 Hole #1

Depth (in.)	PI	General description
0-1	---	Surface
1-11	---	CTB
11-18	---	Subgrade
18-24	48	tan clay

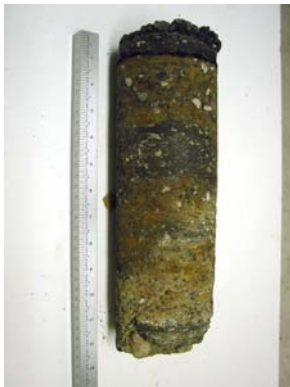
# FM 2076 Hole #2

Depth (in.)	PI	General description
0-1	---	Surface
1-12	---	CTB
12-17	9	reddish tan clayey sand with gravel
17-22	29	reddish tan sandy clay
22-27	40	tan and gray clay

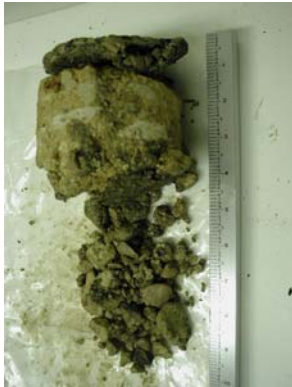
# FM 20 Hole #1

Depth (in.)	PI	General description
0-1	---	Surface
1-11	---	Base
11-17	26	brown and gray clay
17-22	24	dark gray clay
22-24	13	tan sandy clay with limestone rocks
24-26	12	tan sandy clay with limestone rocks
26-29	14	tan sandy clay with limestone rocks
29-32	21	tan and brown sandy clay

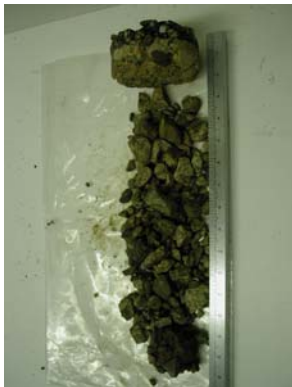
# FM 20 Hole #4

Depth (in.)	PI	General description
0-1	---	Surface
1-16	---	Base
16-20.5	25	brown clay
20.5-24	30	brown clay
24-27	20	brown sandy clay with small limestone rocks

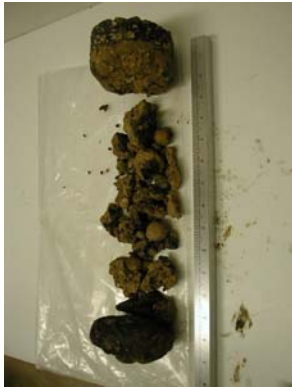
# FM 541 Hole #1

Depth (in.)	PI	General description
0-1	---	Surface
1-13.5	---	Base
13.5-15	---	old road surface
15-19	15	brown clayey sand
19-23	12	brown sandy clay
23-27.5	10	brown clayey sand

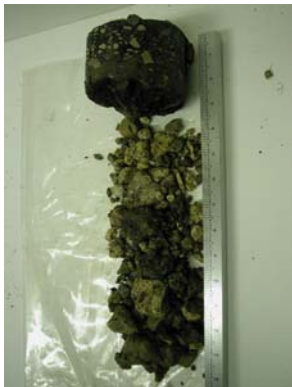
# FM 541 Hole #4

Depth (in.)	PI	General description
0-2	---	Surface
2-14	---	Base
14-19	13	brown sandy clay
19-25	15	brown sandy clay
25-31	28	dark greay clay

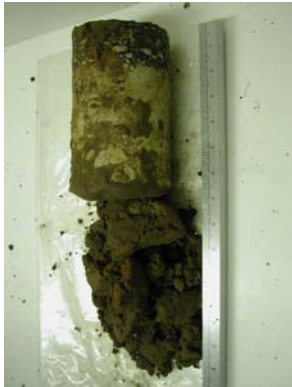
# FM 2505 SB Hole #1

Depth (in.)	PI	General description
0-2	---	Surface
2-7	---	CTB
7-14.5	---	Subgrade
14.5-20	7	reddish tan clayey sand
20-25	12	tan clayey sand
25-30	16	brown and tan sandy clay
30-35	14	dark gray and tan sandy clay

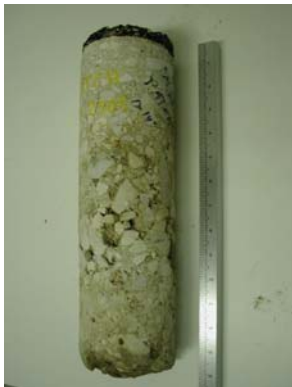
# FM 2505 SB Patch

Depth (in.)	PI	General description
0-0.5	---	surface
0.5-14	---	CTB
14-19.5	12	reddish tan clayey sand with small gravel
19.5-24	17	reddish tan clayey sand
24-29	10	reddish tan clayey sand

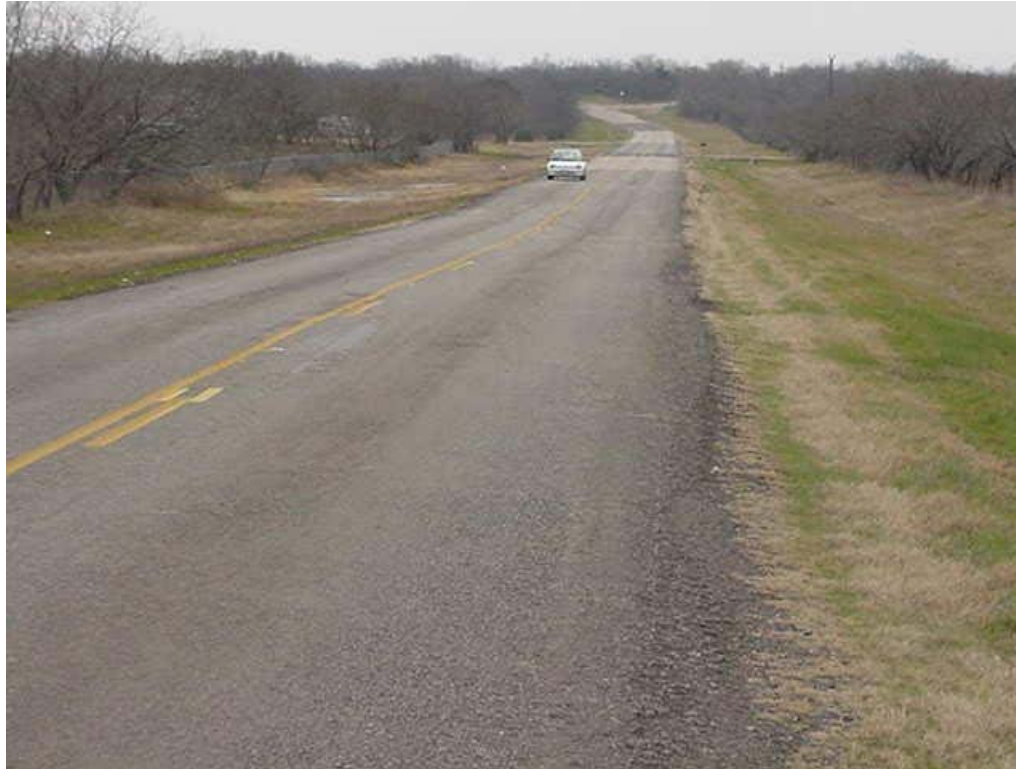
**Roughness**

**Likely Causes:** Volume changes in underlying layers (such as subgrade), physical distresses (rutting, corrugations, slippage of HMA, failures, etc.)

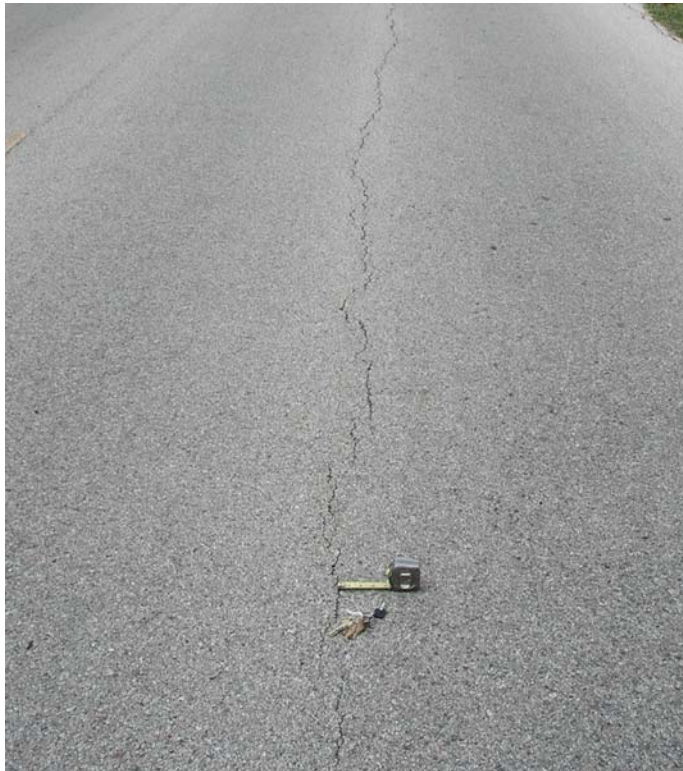
**Low Severity Longitudinal Cracking**

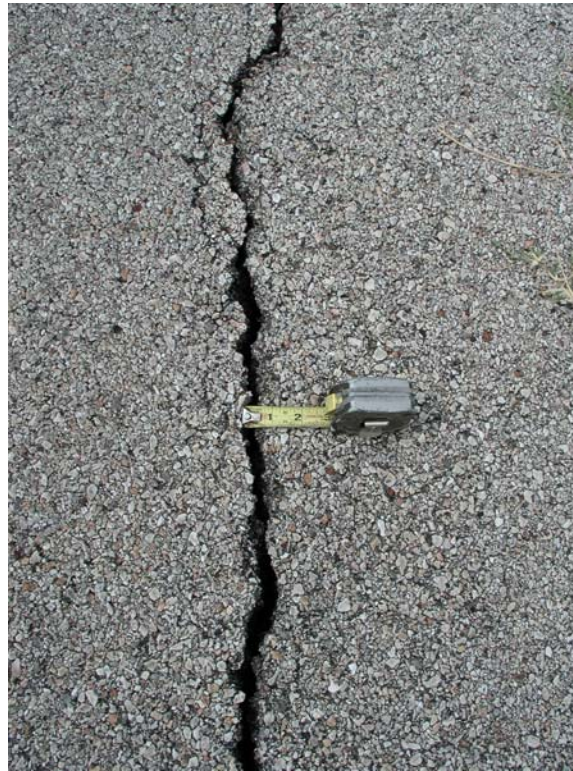
**Medium Severity Longitudinal Cracking**

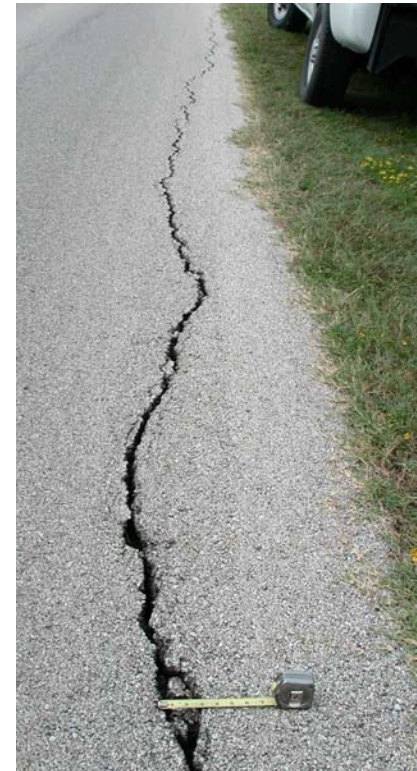
**High Severity  
Longitudinal Cracking**

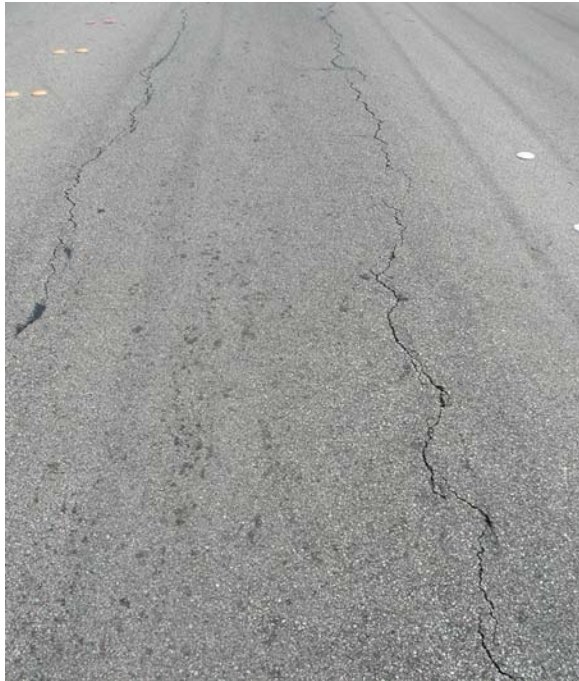
**Low Severity Fatigue Cracking**

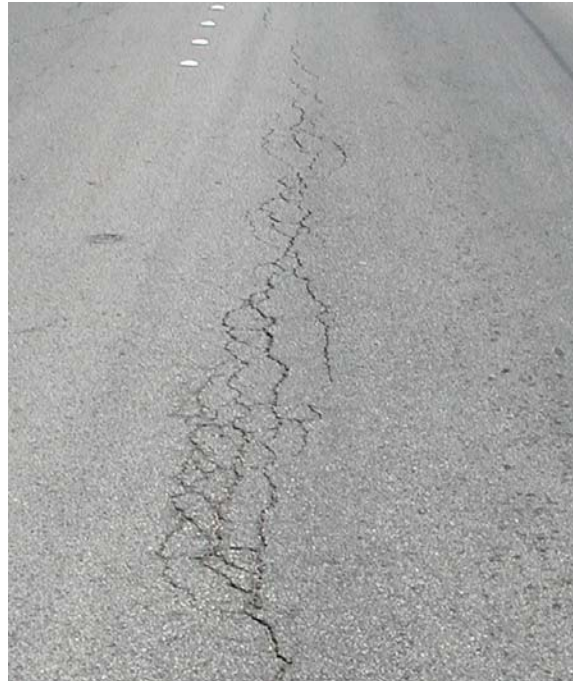
**Medium Severity Fatigue Cracking**

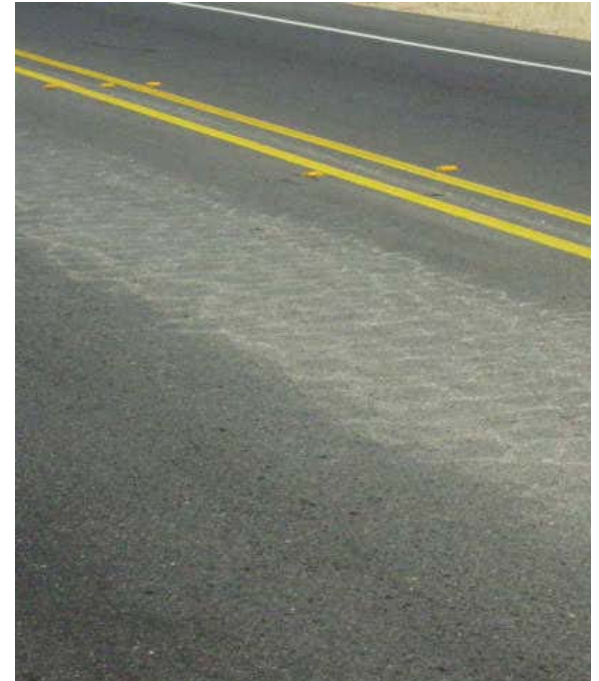
**High Severity Fatigue Cracking**

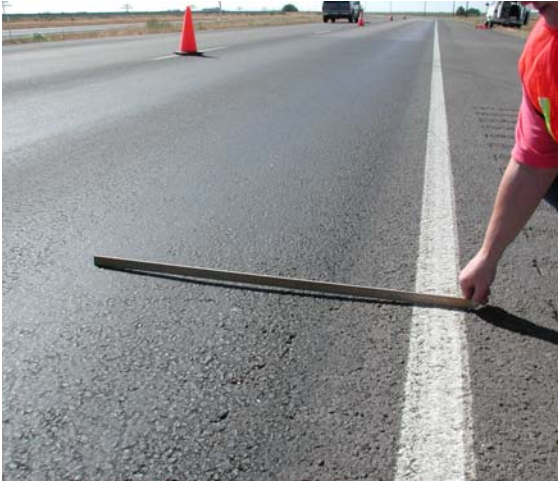
**Low Severity Rutting**

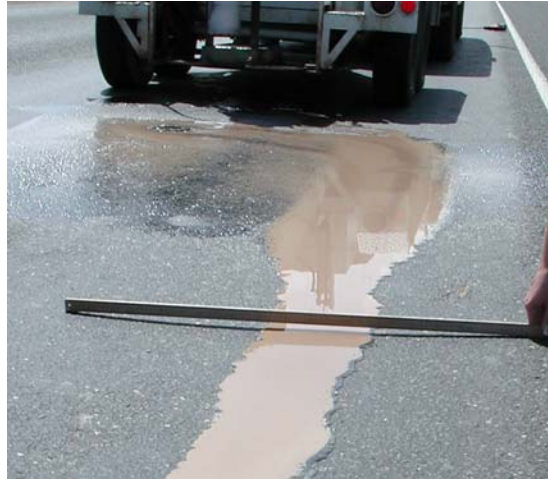
**Medium Severity Rutting**

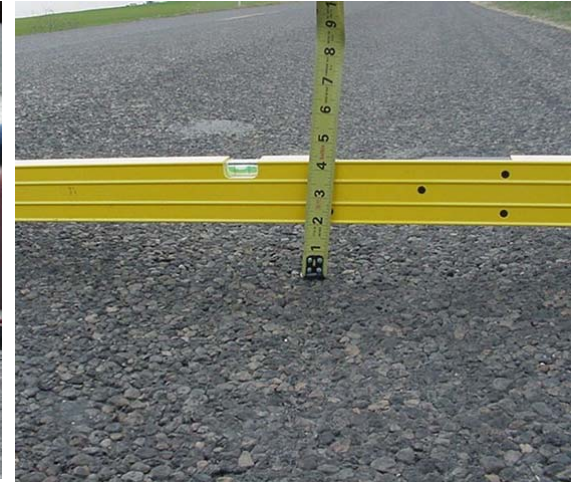
**High Severity Rutting**

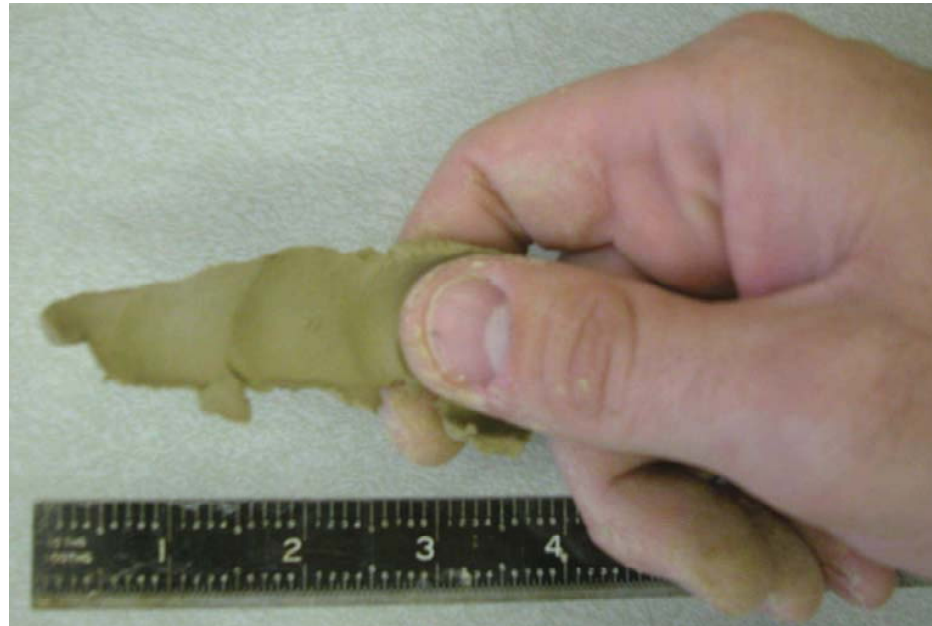
**“Ribboning” of soil Illustrating High Plasticity (scale in inches)**

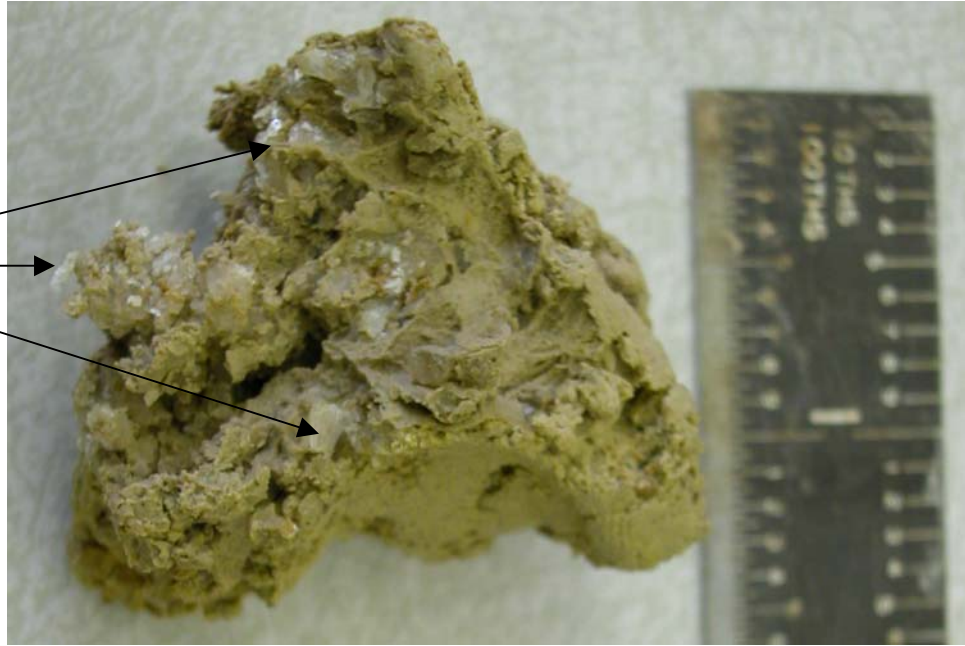
- The soil should have a soluble sulfate content below 3000 parts per million. Sometimes sulfates can be visually identified in soils in the form of gypsum crystals, which typically are shiny, glass-like crystals as shown in the photo on page 107. These crystals can vary greatly in size, as evidenced by contrasting the crystals shown on page 107 to the crystals on page 108.

**Gypsum Crystals in Soil (scale in inches)**

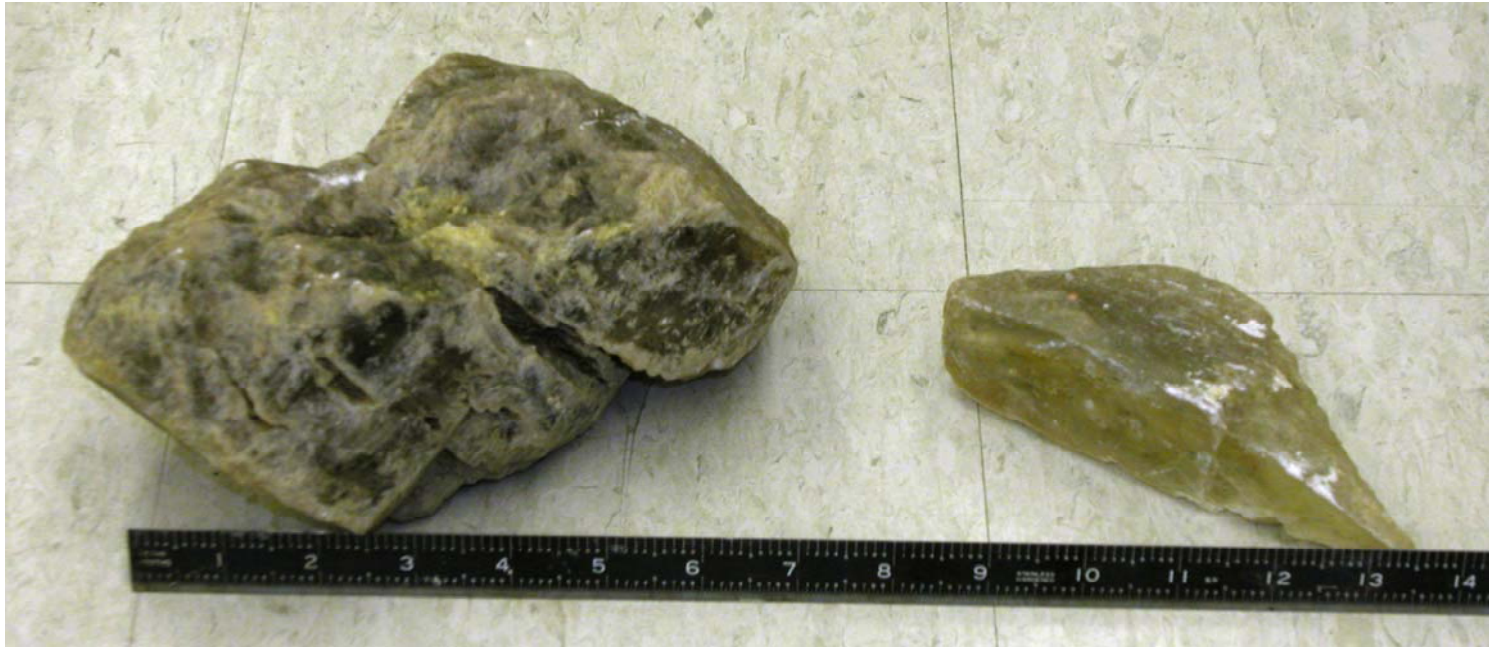
**Large Gypsum Crystals (scale in inches)**
