BRIDGE STEEL COATINGS TOLERANT OF MINIMAL SURFACE PREPARATION

**Construction Report
June 1996**

**Kimberly L. Gordon
Research Project Manager**

Construction Report

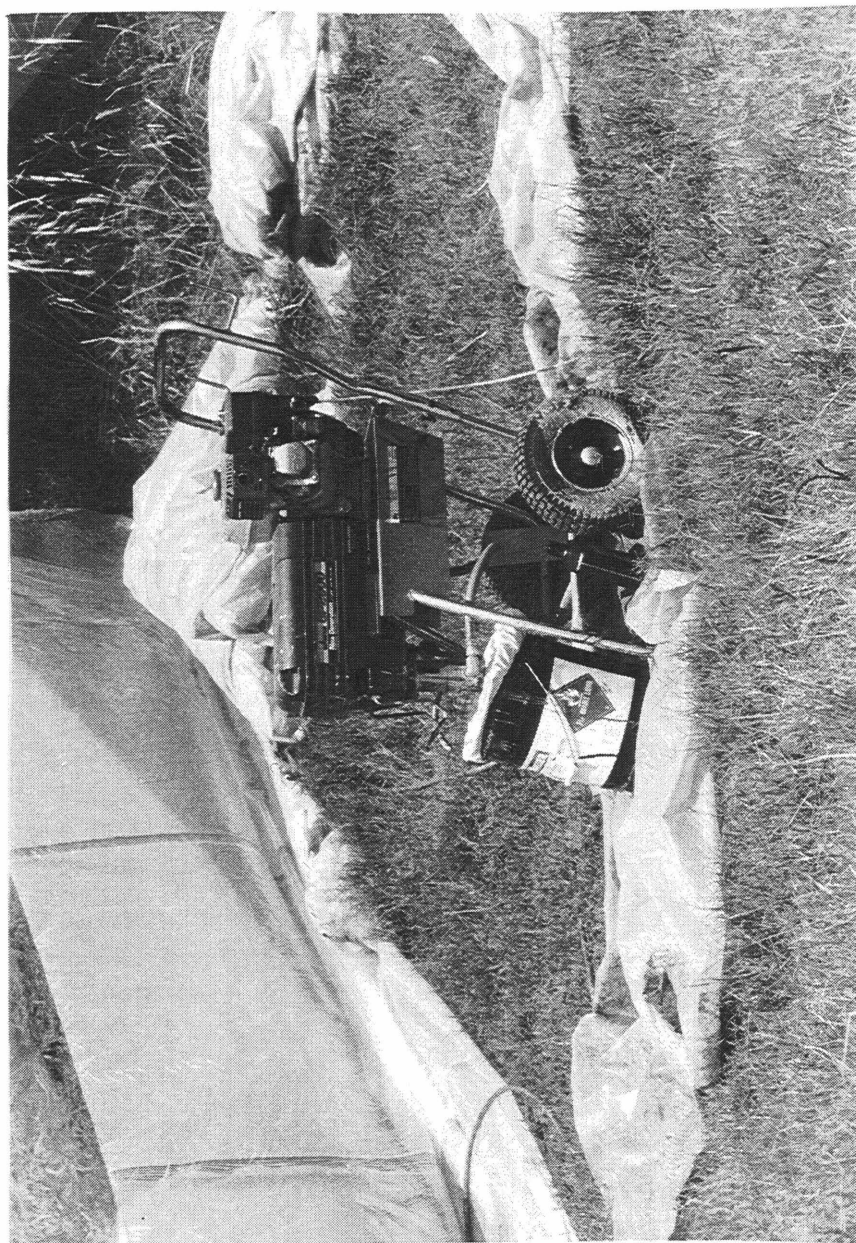
Figure 4. Airless Spray Equipment

Scaffolds and ladders were used as an aid when painting areas that were not easily accessible from the ground. The flanges were painted first by hand with brushes or rollers. The beams were then painted using an airless spray setup shown in Figure 4. The tip sizes used to paint the steel beams were within the range specified by the manufacturer listed in Table 5. Blank spaces left in the table indicate that no tip size was listed in the information available at the time that this report was written. The manufacturer's recommended dry film thickness is also listed in this table. Exceptions to these values are noted in the text.
