# Evacuation and Rescue of Elderly and Disabled Passengers from Paratransit Vans and Buses

Ketron, Inc.  
58 Charles St.  
Cambridge, MA 02141

October 1984  
Final Report

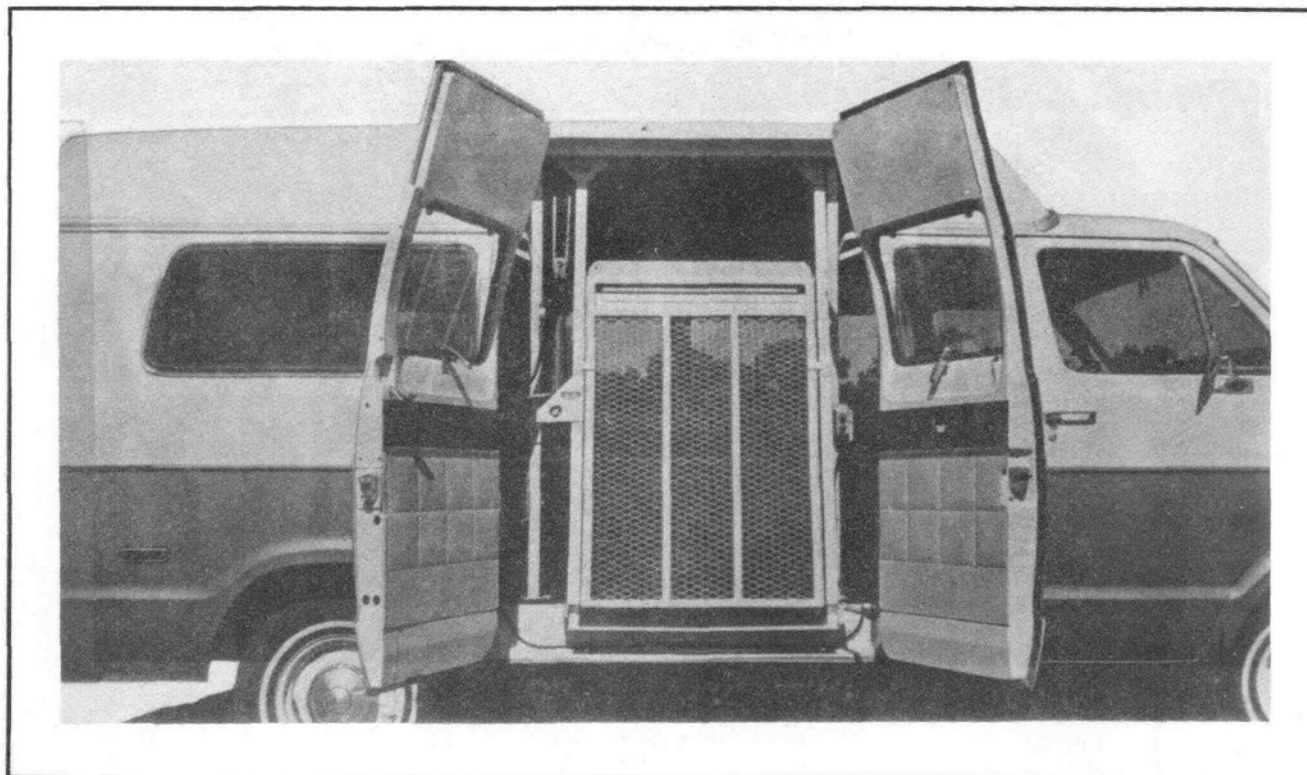
FIGURE 3-5. POWERED WHEELCHAIR LIFT IN ITS STORED POSITION ON A MODIFIED VAN

Figure 3-4 shows a powered lift installed in a modified van and being operated by a wheelchair user. Figure 3-5 shows a lift in its stored position in a van. This typical lift fully blocks the side door while stored and may become inoperative in an accident. Rescue personnel would have to use the rear or cab doors or to cut through the side of the van to gain access. In contrast, another type of side-mounted lift (Figure 3-6) folds in half when stored, thus allowing some access by rescue personnel.

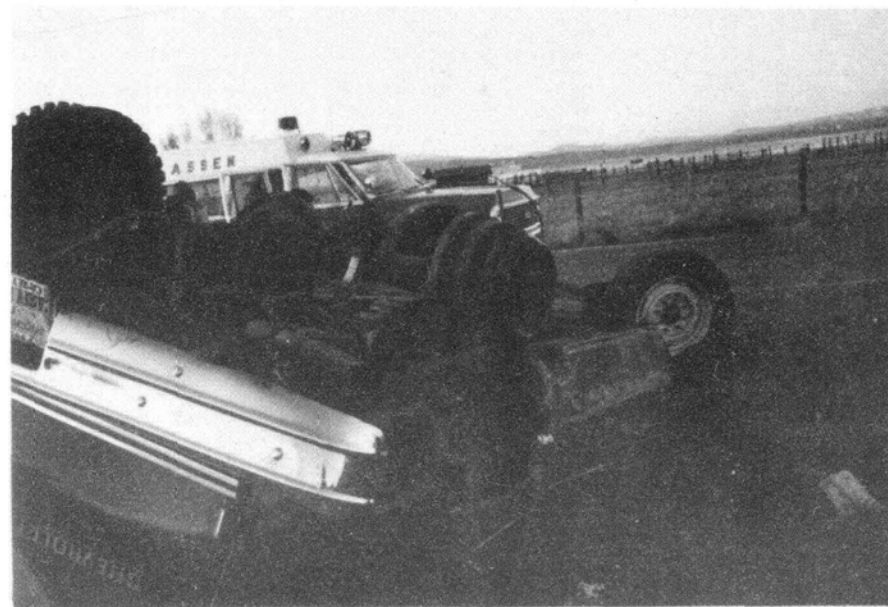
FIGURE 3-12. PARATRANSIT VAN IN FINAL RESTING POSITION AFTER  
MULTIPLE VEHICLE COLLISIONS: HOWARD COUNTY, MARYLAND

carrying a large lighted traffic control arrow, causing it to leave the roadway, and finally with a bridge parapet (Figure 3-12).

Despite the four collisions, the van remained nearly intact. Figure 3-12 shows the front of the van crushed considerably, but the raised roof stayed in position and the wheelchair lift at the side doors remained operable (Figure 3-13). Figure 4-14 shows emergency first aid being provided to one of the six persons (aged 68, 74, 80+, 84, and 89) on board. It appears from Figure 3-14 that one of the passenger bench seats partially failed as a result of the collisions. Evacuation of the passengers was facilitated by using the side doors and by lowering the wheelchair lift.

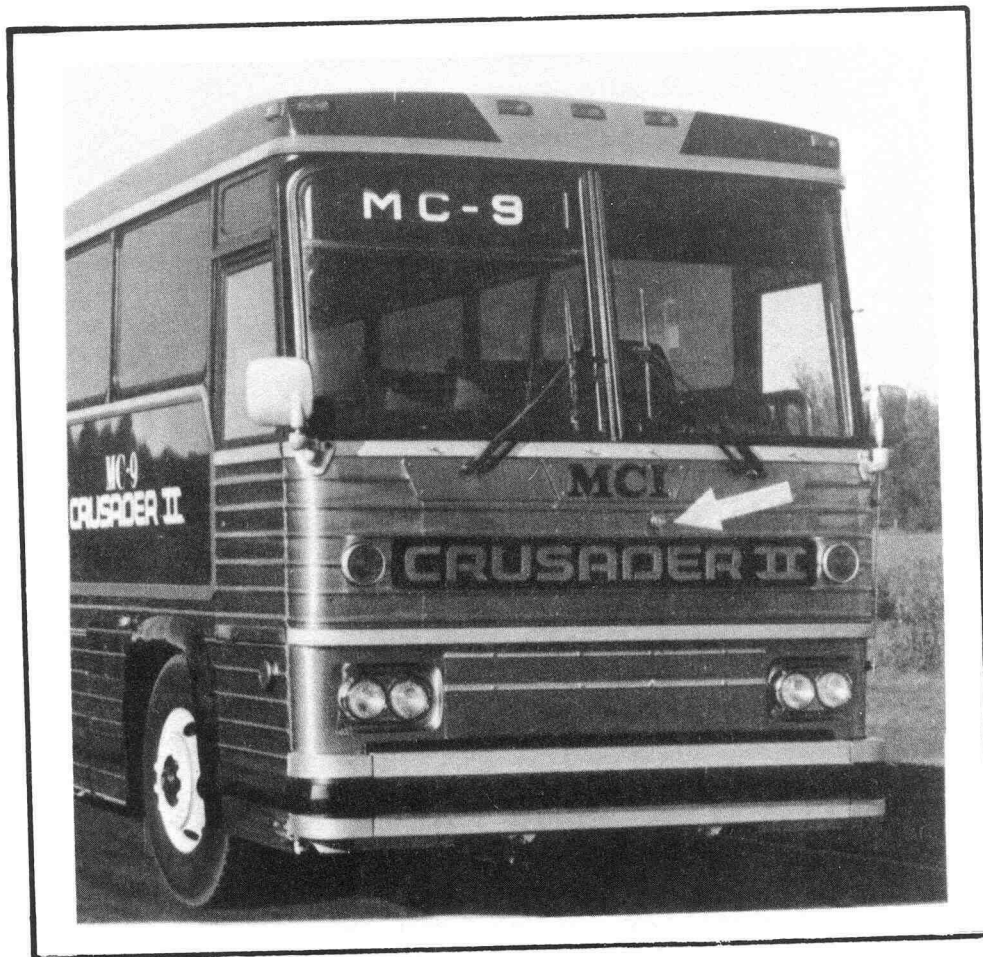
FIGURE 4-10. OUTSIDE DEVICE FOR OPENING DOOR LOCATED UNDER THE "I" IN MCI

Instructions for opening the doors should be placed on the outside of vehicles. Figure 4-10 shows an outside door opener that is not indicated in any way. The lack of indication is, of course, intentional, but some compromise between the safety of passengers and the security of the bus must be reached.

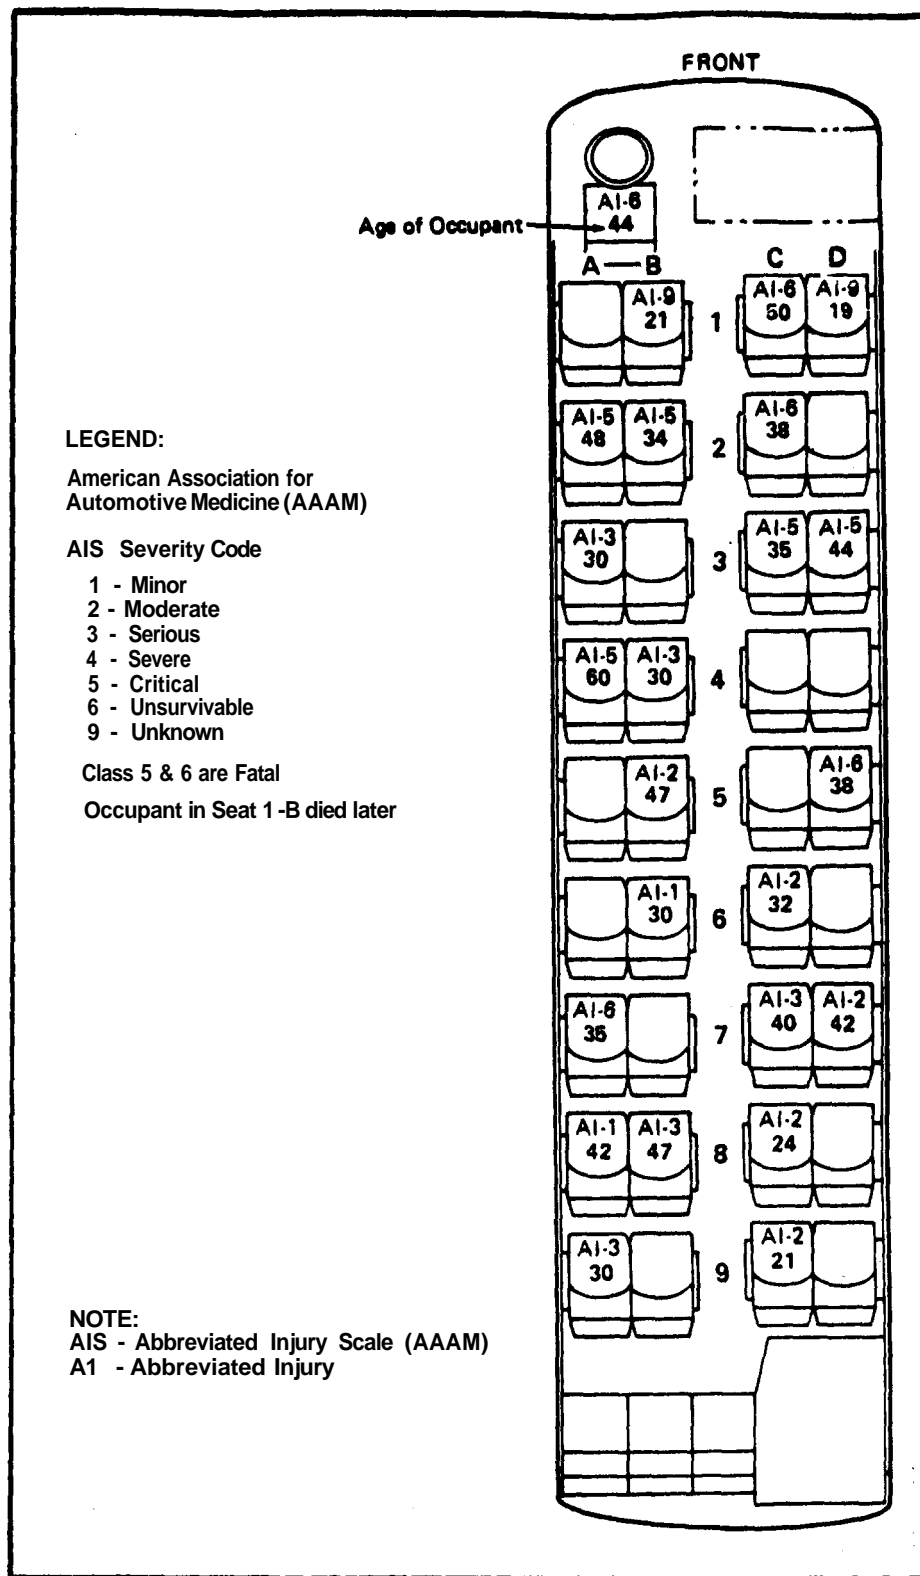
FIGURE 4-19. TRIANGLE, VIRGINIA, TRANSIT BUS ACCIDENT: OCCUPANT SEATING DIAGRAM, INJURY CLASSIFICATION, AND AGE

The ages of the bus occupants ranged from 19 to 60 years. Figure 4-19 shows their age, seat position, and degree of injury.
